# Building and Timber Pest Inspection Report

Inspection Date: Thu, 5 Mar 2026

Property Address: 30 Greenbank Street, Hurstville, NSW 2220

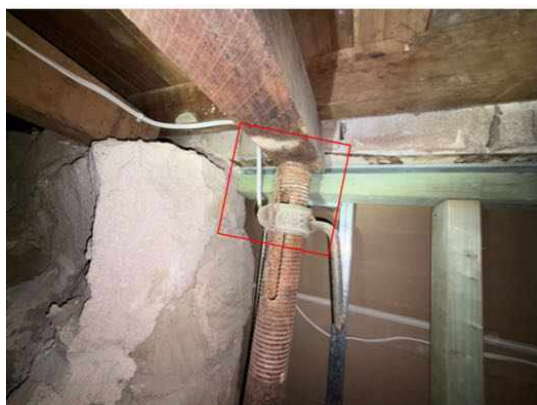
Location: Subfloor  
 Finding: Unconventional handyman work  
 Information: This handyman work appears to have been completed to a substandard level and does not comply with regular building practices. Where handyman work is not completed satisfactorily, accelerated deterioration of the associated building elements is likely to occur and secondary defects to surrounding structures may develop.

It is highly recommended that the substandard work be rectified by professional services. Works to improve this area are likely to increase the safety and the operation of the associated building elements.

The client should exercise care when coming into the immediate vicinity of the substandard works. Rectification works are advised as soon as possible by a licensed builder.

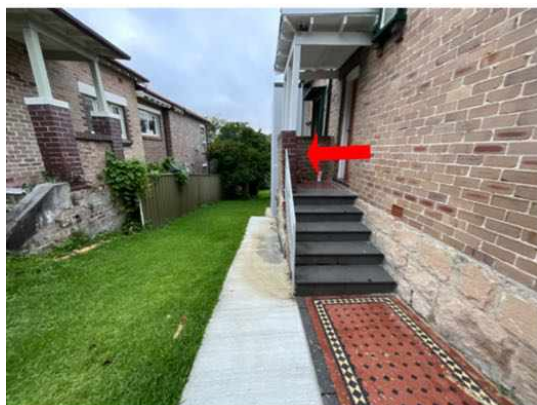
## Finding 2.02

Building: Main Building  
 Location: Right hand side  
 Finding: Subsidence  
 Information: It appears that the subfloor structure has been affected by movement of the foundations, often referred to as sinking or subsidence. Whilst a degree of movement is expected in subfloors over time, especially as environmental conditions change and

General subsidence is usually initiated by changes in soil moisture content. The most critical factor is identifying the specific causes, and identifying if this is a recurring or ongoing problem, or one that has been resolved by previous works in the past.

Subsidence can have complex and varying causes, which will influence the required remedial works. It is advised to begin by consulting a structural engineer to determine the required scope of works. This generally includes some form of underpinning, as well as addressing the underlying cause. Consultation with a geotechnical engineer may also be necessary where changes to soil moisture content is apparent.

A licensed Builder would then generally carry out works as advised by an Engineer.

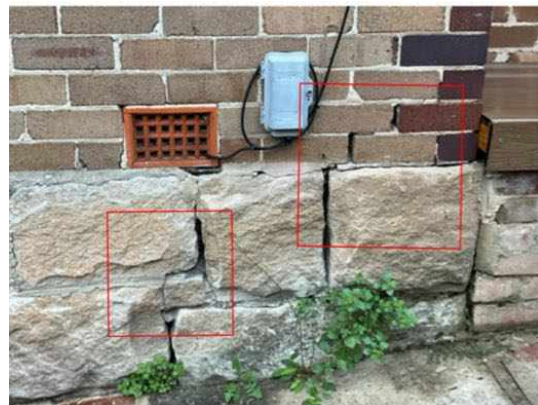
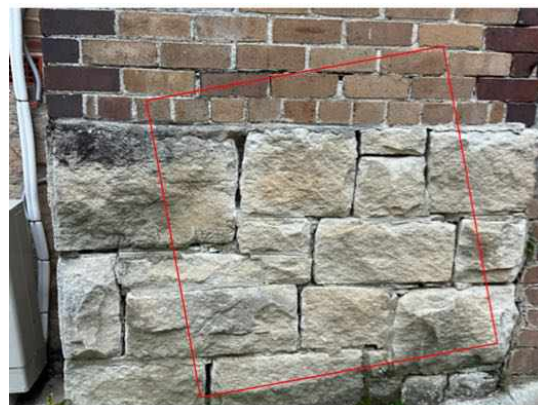
Building: Main Building  
 Location: Front right corner  
 Finding: Mortar - Deteriorated (Erosion)  
 Information: The mortar to the brickwork in this area was found to be deteriorated. Mortar, or 'bedding', is the material which fills joins and intersections between bricks in masonry walls and structures.

Commonly referred to as corrosion or erosion, the bricks and mortar are aged and likely to have been affected by a variety of factors, including moisture, salt-based deterioration, and more.

Mortar and brickwork should be replaced to ensure the structure remains in their intended location and to prevent gaps, which would allow water or moisture ingress and secondary damage as a result.

This can be addressed by a licensed bricklayer where areas of deterioration are localised and easily accessible.

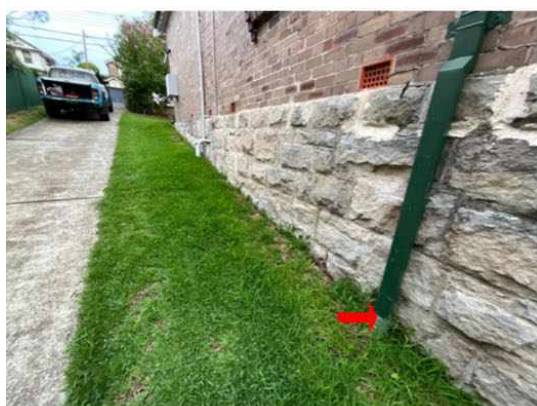
### Finding 3.04

Building: Main Building  
 Location: Exterior walls - left side  
 Finding: Unconventional handyman work

Information: This handyman work appears to have been completed to a substandard level and does not comply with regular building practices. Where handyman work is not completed satisfactorily, accelerated deterioration of the associated building elements is likely to occur and secondary defects to surrounding structures may develop.

It is highly recommended that the substandard work be rectified by professional services. Works to improve this area are likely to increase the safety and the operation of the associated building elements.

The client should exercise care when coming into the immediate vicinity of the substandard works. Rectification works are advised as soon as possible by a licensed roof plumber.

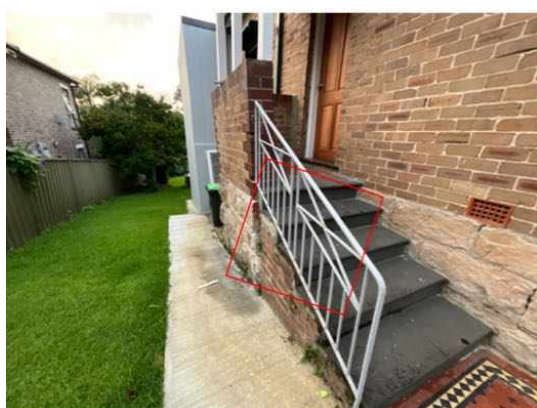
| Finding: | Building element - Rusted or corroded |
| Information: | This building element shows evidence of rusting and corrosion, which is likely to have developed as a result of excessive exposure to moisture and or inadequate coatings. |

As surface rust provides no protection to the underlying iron, the deteriorating condition is likely to worsen if not addressed in the short-term future.

Where possible, the use of galvanized (treated) metals or aluminium coated metals aid in rust prevention, as does regular general maintenance. Rust formation can be controlled with coatings, such as paint, that isolate the iron from the environment.

Rusting and corrosion should be managed by ideally removing or limiting the affected surface from exposure to moisture. A registered builder may be appointed to replace any building elements that have been severely affected by rust or water damage.

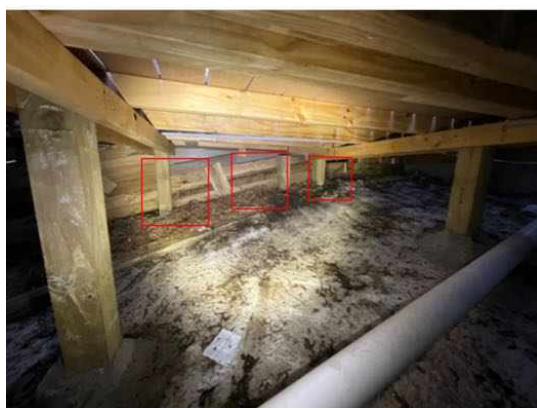
### Finding 3.07

| Finding: | Untreated or non-durable timbers in a hazardous environment |

Information: To reduce the risk of timber pest attack it is essential that timber used in a hazardous environment (e.g. in direct contact with the ground or frequently exposed to damp conditions) is of sufficient durability and/or is adequately preservative treated.

Untreated timbers in direct contact with the ground are likely to develop severe wood rot and/or fungal decay if left unattended creating attraction for subterranean termites to infest the timbers from surrounding areas.

If untreated or non-durable timbers are found to be in a hazardous environment it is highly advised that replacement of these building elements be performed as soon as possible to aid the protection of the property against termite / timber pest attack.

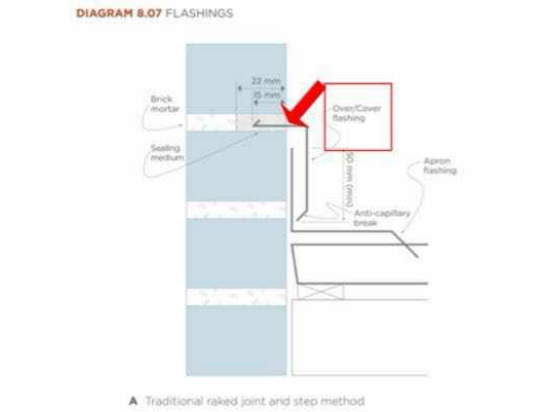
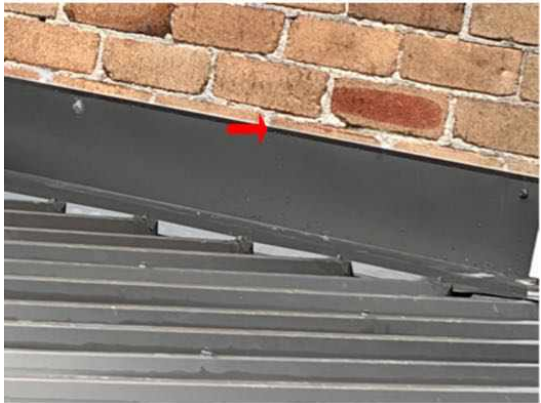
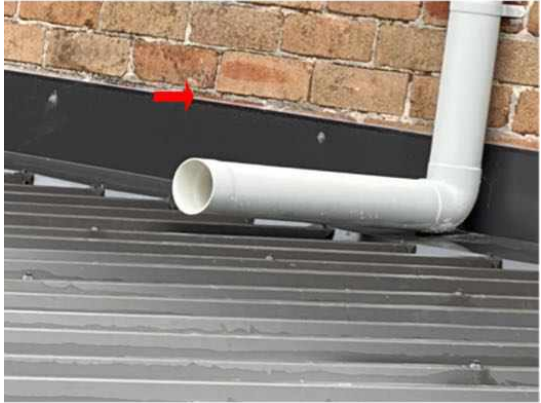
### Finding 3.08

Building: Main Building  
 Location: Rear extension, front verandah  
 Finding: Flashing - Defective  
 Information: Instances where flashings are defective were noted. It is expected the silicon to wear out causing water leaks in this area.

Flashings that are not installed adequately or are missing are likely to result in water penetration to the interior of the property, as well as creating excessively damp conditions against the exterior surfaces and around the base perimeter of the building.

Premature ageing and secondary building defects are imminent where roof plumbing is missing or inadequately installed. Additionally, water pooling also creates an environment that is susceptible to termite and pest infestation.

This must be rectified immediately by a licensed roof contractor. The solution is to chase the brickwork and insert the flashing or otherwise to install over flashings with appropriate fixings.

The client is highly advised to ensure the manufacturer installation guide is followed.

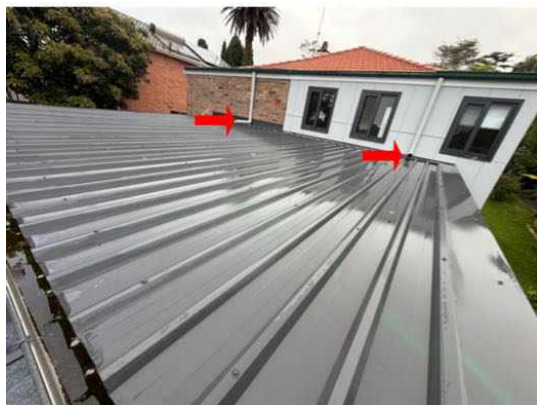
**Finding 3.09**

Building: Main Building  
 Location: Rear extension  
 Finding: Downpipe Spreader — Missing  
 Information: The downpipe spreader to the lower roof is missing. A spreader has a series of holes and is designed to spread the water so it is distributed evenly. This is considered to be incomplete works and should be completed urgently by a licensed roof plumber to avoid potential water leaks.

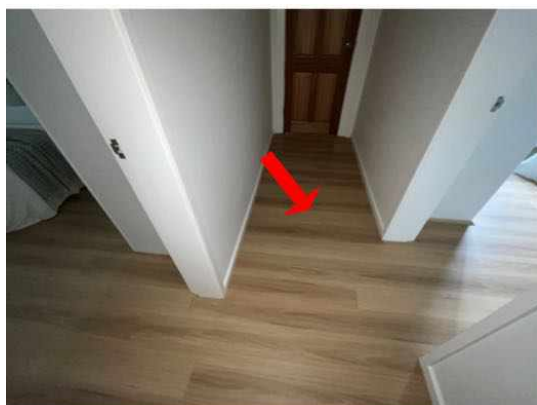
### Finding 3.10

Bouncy floors generally indicate that the floorboards or the subfloor structures are coming loose from the joists that they are installed on. Bouncy flooring may also be the result of gaps between flooring and joist structures, which require packing.

Although not a matter of urgency, the client is advised to seek quotations for required repairs from a licensed Builder.

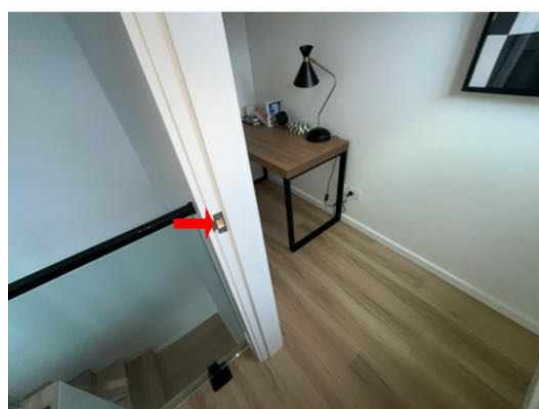
This is a common defect and is expected in a property of this age, whether being due to substandard installation or general deterioration of the door hardware.

Readjustment of the striker plate is recommended at client discretion. Works such as these can be completed by a general handyman or qualified carpenter.

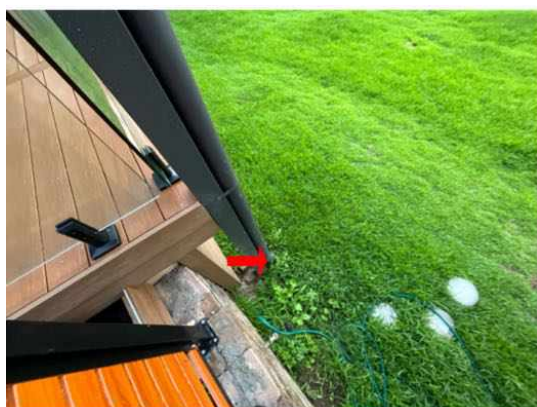
become excessively damp, potentially creating an environment that is susceptible to rust and corrosion of surrounding building elements, as well as attracting termites and other pests.

It is highly recommended that a plumber be appointed to further inspect the area and to install adequate drainage equipment where necessary.

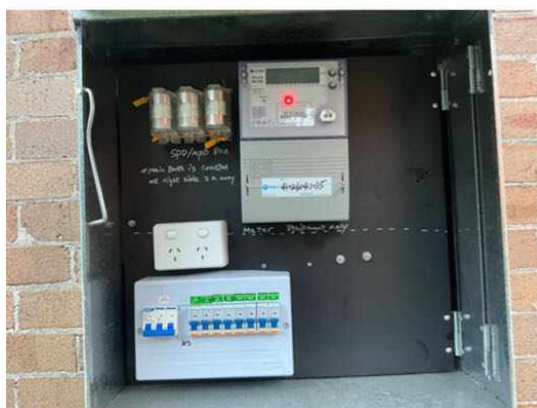
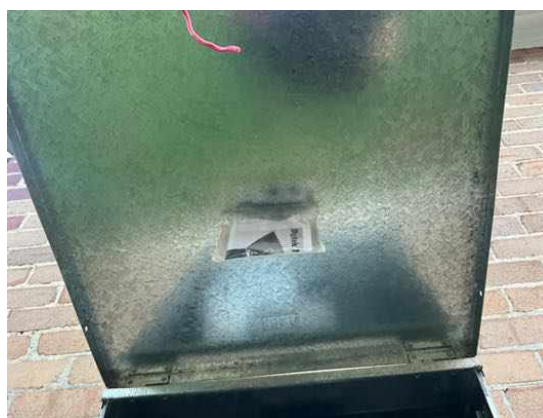
| Information: | The application of a post-construction chemical termite barrier is highly recommended for all properties, particularly if live termite activity has been found on the site previously. Such barriers are highly effective in preventing termite attack on any timber building elements throughout the property. |

A durable notice should be placed in the switchboard unit to indicate current termite barriers. At the time of inspection, it appeared as though no termite management system has been installed, with no evidence to suggest preventative works taking place.

The client may consider gaining further advice from a pest controller as to the costs and procedures involved with this application. It is recommended that obtaining such advice be a short-term priority.

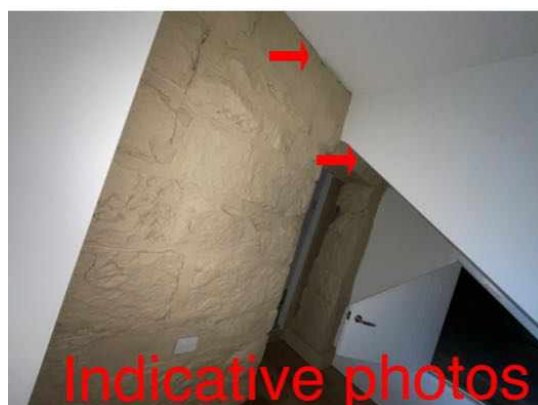
Where ant caps have not been installed, frequent monitoring of these areas should be carried out in order to identify any signs of termite or timber pest workings.

A licensed builder must be appointed urgently to replace any missing ant caps.

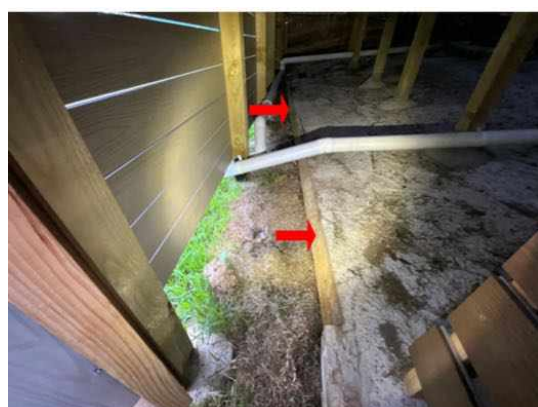
### Finding 6.12

| Finding: | Formwork timbers - left in situ |
| Information: | Formwork timber appears to have been left on site and in situ after concrete construction. Formwork timber is used to support and shape the concrete while pouring during the construction process. Leaving formwork timbers in the subfloor space or around the exterior of the property increases the risk of termite activity being present. As they are likely to come into contact with weather conditions or excessive moisture wood rot is likely to develop on timbers that are not treated. It is highly recommended that any formwork timbers be immediately removed from areas in which they may attract any termite/timber pest attack. Minimisation of risk/prevention of termite attack is far more adequate than dealing with the presence of termite activity. |

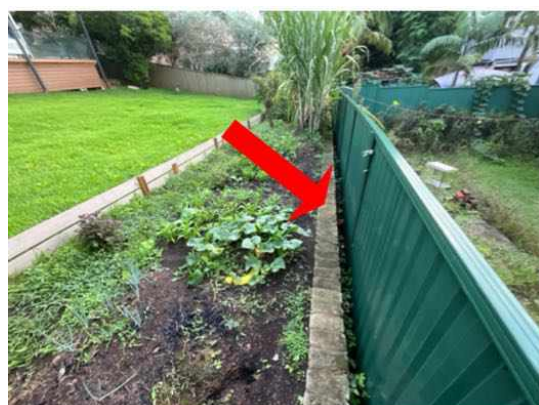
Building: Main Building  
 Location: Retaining walls  
 Finding: Retaining walls  
 Information: At the time of inspection the retaining walls were checked and no defects were observed other than those which May have been mentioned earlier in this report.

AS4349.1-2007 requires all retaining walls in excess of 700mm to be inspected by a licensed and practicing structural engineer.
