# Building and Timber Pest Inspection Report

Inspection Date: Sat, 14 Feb 2026

Property Address: 61 Devlin St, Ashcroft NSW 2168, Australia

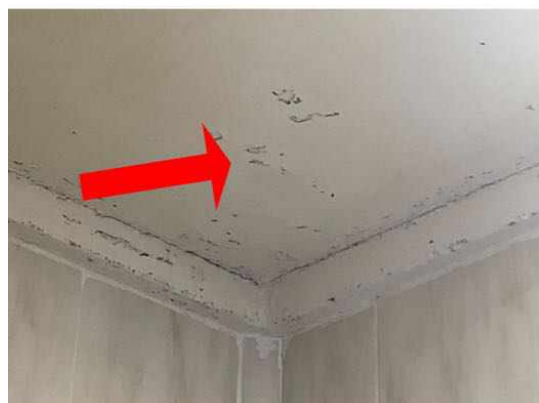
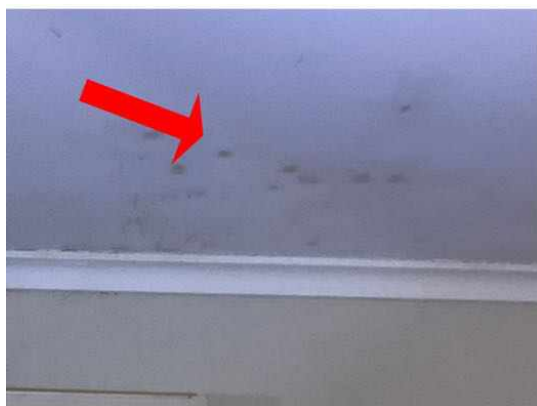
| Finding: | Moisture Damage and Possible Mould – Ceiling |
| Information: | Visible discolouration and patchy staining were observed on the ceiling, indicative of possible mould or mildew growth. This is likely caused by poor ventilation, inadequate exhaust fan performance, or excessive humidity from regular use of the bathroom. |

Prolonged moisture exposure can lead to fungal decay, damage to plasterboard, or create conditions conducive to timber pest activity above the ceiling line.

It is recommended that:

- A licensed plumber or building professional assess for hidden water leaks.
- Exhaust fan performance and airflow be reviewed and upgraded if necessary.
- The affected area be cleaned, treated, and repainted with mould-resistant paint.
- The roof void or ceiling cavity above be inspected for hidden moisture or damage if accessible.

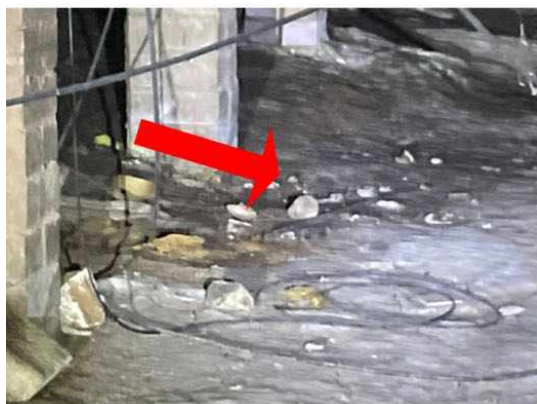
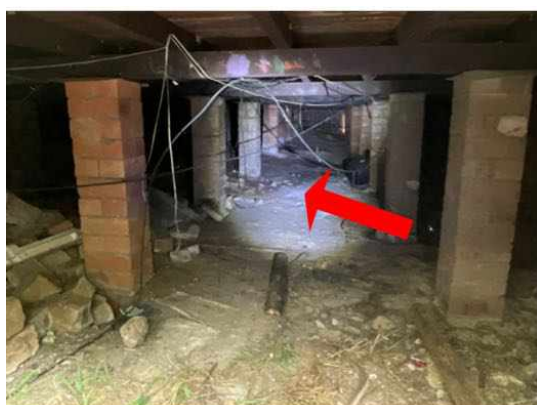
### Finding 1.02

Information: Where evidence of mould growth was noted, there may be environmental, biological or health issues associated with the report. A specialist inspection by a suitably qualified environmental health inspector is warranted, where mould is extensive or where any queries regarding air quality spores or other related issues apply.

Generally, the client is advised to ensure that the general environment is free of moisture and humidity to aid in the prevention of mould formation and development. Any mould found during the inspection should be cleaned immediately by a cleaning

contractor or the homeowner as applicable.

Please note that severely affected building elements may require replacement by a registered builder or qualified carpenter.

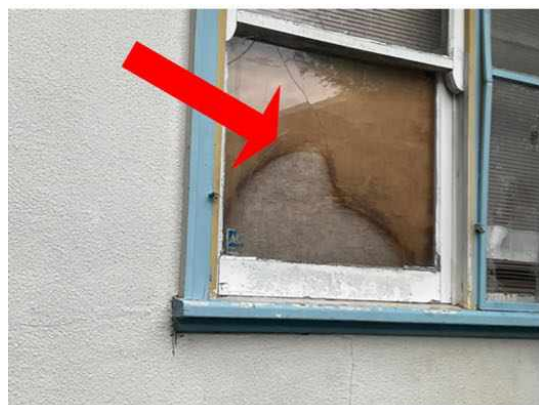
| Finding: | Window - Cracked |
| Information: | Cracks were identified in the window in this area. Cracking in windows is generally the result of impact damage, and is likely to develop further when left unmanaged. |

The likelihood of this windowpane further cracking and shattering is increased exponentially, providing a safety hazard in the area. The cracked window also impairs the weather tightness of the building, creating potential for minor water leaks.

A qualified glazier is required to repair the window as soon as possible. Depending on the extent of the cracking, replacement of the window may be required. Please be advised that any persons coming into contact with the cracked window should do so with due caution to avoid any personal injury that may ensue.

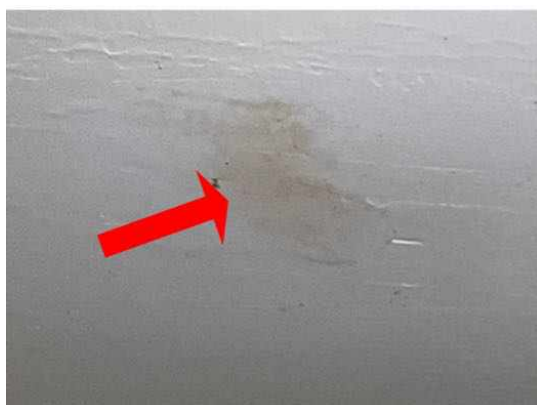
| Finding: | Ceiling - Water damaged |
| Information: | Water damage to the ceiling lining is generally an indication of excessive moisture being present in the roof void, usually via a leak to the roof covering. |

Where water damage is evident to the ceiling, the primary requirement is to identify and rectify the source of the leak. A roofing plumber should be appointed as soon as possible to identify the leak and perform rectification works as necessary, ensuring the water damage is restricted.

Once the leak is repaired, consultation with relevant tradespeople, including plasterers and painters, is advised. Rectification works may include replacement of ceiling lining or minor repainting, depending on the extent of the damage.

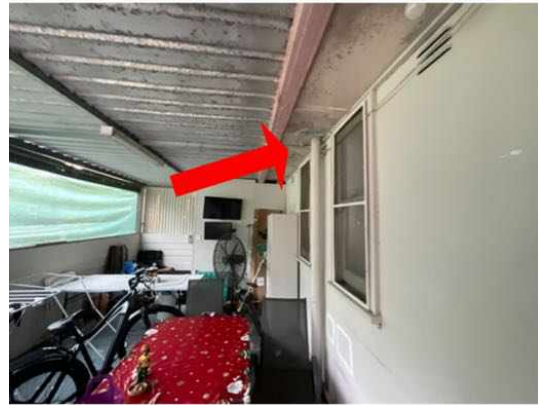
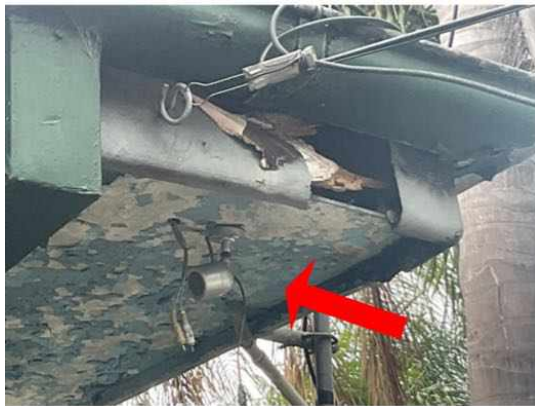
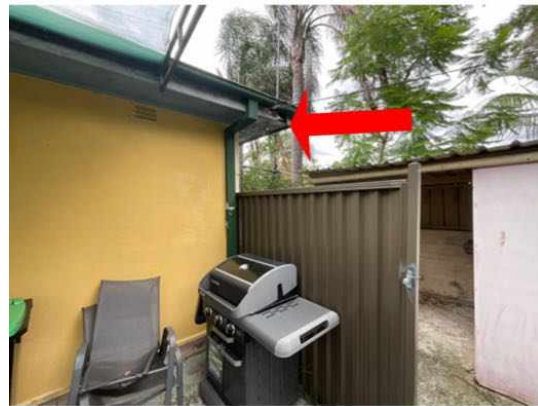
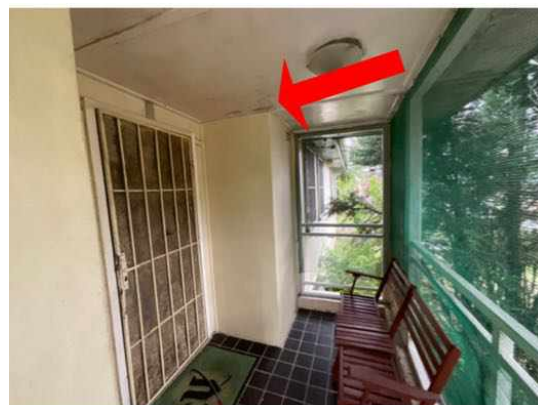
Building: Main Building  
Location: Roof Exterior  
Finding: Eaves - Water damaged

Information: Water damage to the eave lining is generally an indication of excessive moisture being present in the roof void, usually via a leak to the roof covering.

Where water damage is evident to the eaves, the primary requirement is to identify and rectify the source of the leak. A roofing plumber should be appointed as soon as possible to identify the leak and perform rectification works as necessary, ensuring the water damage is restricted.

Once the leak is repaired, consultation with relevant tradespeople, including carpenter, plasterers and painters, is advised. Rectification works may include replacement of eaves lining or minor repainting, depending on the extent of the damage.

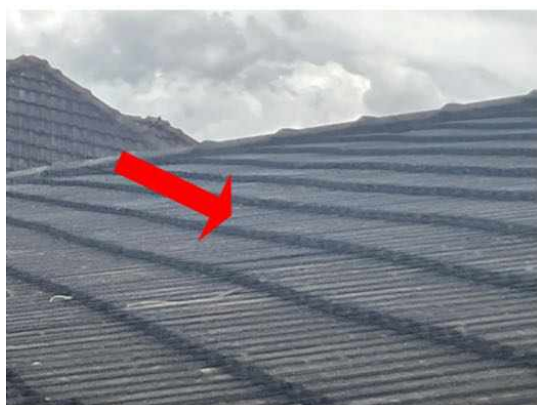
## Finding 2.05

| Information: | The hipped roofing structure was found to be sagging in sections at the time of inspection. It appears that the weight of the roof tiles on the corner has caused the hip to sag which in turn has left fascia's and guttering out of level. Further inspection could reveal currently hidden defects. |

Sagging roof structures are likely to create strain on associated building elements, creating potential for secondary damage due to these stresses and gutter not falling towards down pipes. The roof is also unlikely to have sufficient support, which will lead to further sagging if left unmanaged.

It is highly advised that a roofing contractor be appointed as soon as possible to provide further advice on repair options.

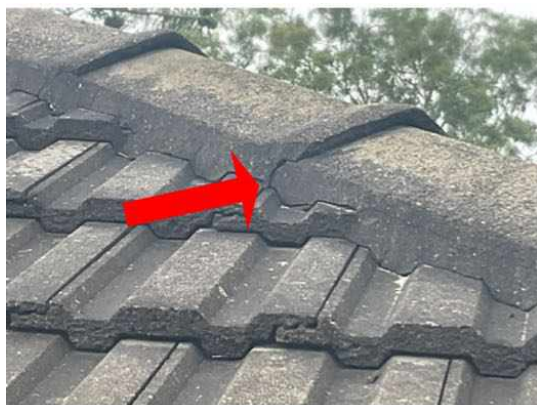
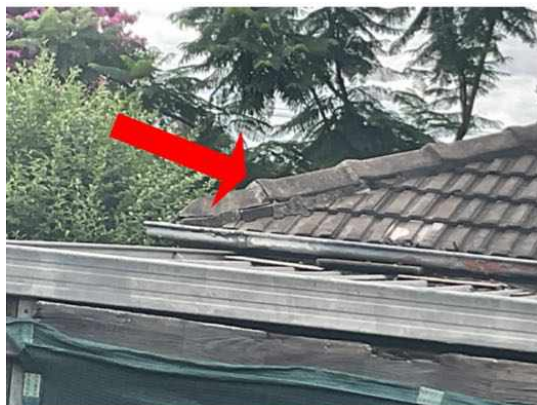
## Finding 2.06

| Finding: | Mortar - Deterioration |
| Information: | Mortar, or 'bedding', is the material which fills joints and intersections between tiles and other building elements on the exterior roof covering, such as gable ends, hip capping and valleys. Upon inspection of the exterior roof, it was noted that sections of the mortar show varying levels of deterioration. |

Mortar generally deteriorates as a result of frequent exposure to weather conditions over a prolonged period of time. Mortar that is deteriorating may allow water ingress into the roof void, putting associated building elements and roofing structures at risk of water damage. Deteriorated mortar also detracts from the functionality of roof tiles and other roofing elements, potentially decreasing weather tightness and roof drainage.

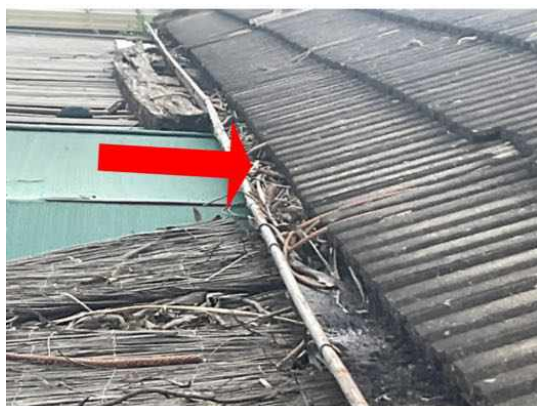
### Finding 2.07

Blocked gutters are likely to lead to high levels of moisture in the affected areas. Such moisture will not only cause rust and decay of the associated building materials, but can also provide conditions that are conducive to termite and timber pest activity. Blockages in gutters should therefore be removed immediately to ensure dry conditions are maintained.

Consult a Licensed Plumber for further specific advice on remedial works that may be required. In the interim, it is highly advised that blocked gutters be removed by the homeowner or a general handyperson as a matter of urgency.

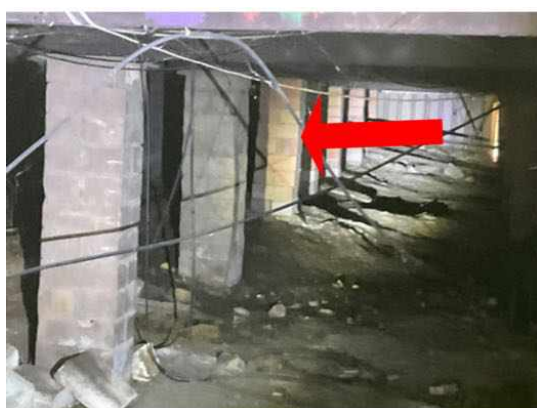
### Finding 2.08

| Information: | Damages were evident in the structure in the subfloor of the property indicating that it may not be structurally sound or compliant with current building regulations. While some damages are expected of structures of this design, it is suspected that land slippage, footing damaged or forceful impact may cause the stability of the walls to further decline. Additional bracing and supporting of the is required immediately to ensure its safety and structural integrity. |

If left unmanaged, the structure is likely to deteriorate further, potentially creating an environment which is unsafe.

An structure engineer and a registered builder with the assistance of trades, e.g. qualified carpenter, should be appointed to perform remedial works as a matter of urgency.

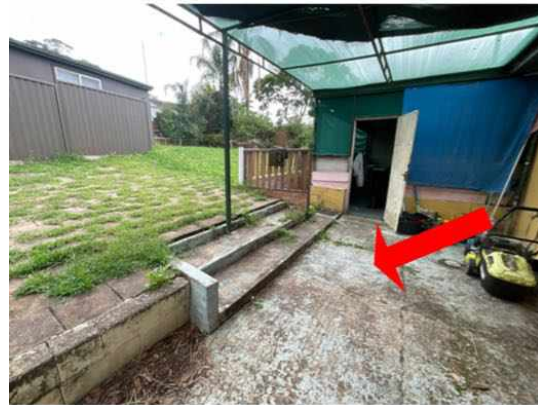
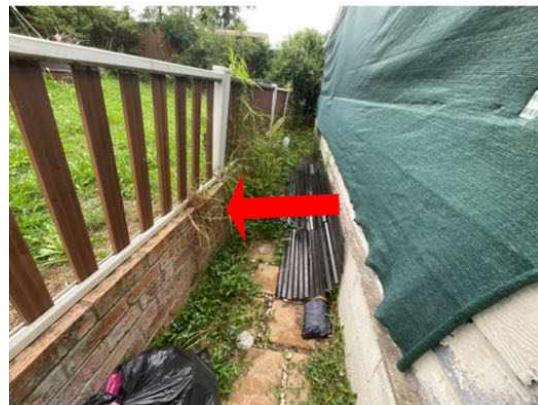
### Finding 2.09

Finding: Site drainage - Inadequate  
 Information: The site drainage in this area was found to be inadequate at the time of inspection, creating potential for subsequent water damage to associated building elements.

It is important that water does not lie against the base of walls; surrounding paths and ground levels should be sloped to drain water away from walls. Downpipes should not discharge stormwater onto lower walls or plinths. Stormwater should be carried away by large, regularly cleaned drains. Ground levels may need to be lowered to expose a buried DPC.

Where site drainage is inadequate, installation of an Agricultural (Aggie) Drain may be required. A qualified plumber should be appointed to further inspect the property and perform any remedial works as necessary. Water damage and secondary defects are likely to occur if left unmanaged.

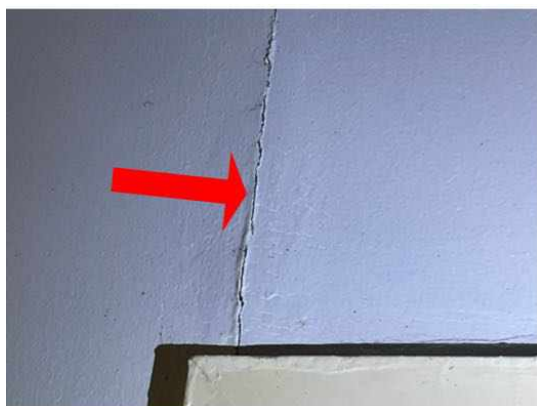
### Finding 3.02

Building: Main Building  
 Location: All Internal Areas  
 Finding: Cracking - Damage Category 1 - Fine (up to 1mm)

Although fine cracks are quite noticeable, they are often only considered to be an appearance defect, and usually do not indicate any structural damage. Generally, the cause of a fine crack is indicative of a separation between building materials and finishes (e.g. paint, plaster, etc.) along joins.

Cracking of this nature can generally be repaired with minor sanding, filling and/or repainting. Such works should be performed by a qualified painter or a general handyman.

Monitoring of all cracking should be conducted frequently. Always contact a building inspector should cracks widen, lengthen, or become more numerous.

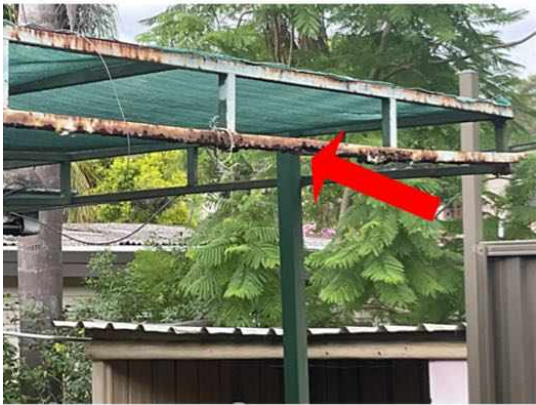
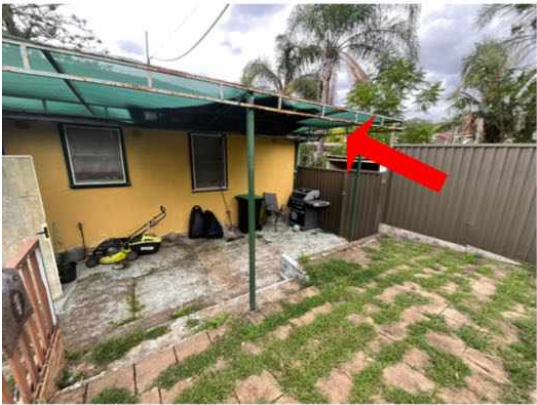
| Finding: | Building element - Rusted or corroded |
| Information: | This building element shows evidence of rusting and corrosion, which is likely to have developed as a result of excessive exposure to moisture and or inadequate coatings. |

As surface rust provides no protection to the underlying iron, the deteriorating condition is likely to worsen if not addressed in the short-term future.

Where possible, the use of galvanized (treated) metals or aluminium coated metals aid in rust prevention, as does regular general maintenance. Rust formation can be controlled with coatings, such as paint, that isolate the iron from the environment.

Rusting and corrosion should be managed by ideally removing or limiting the affected surface from exposure to moisture. A registered builder may be appointed to replace any building elements that have been severely affected by rust or water damage.

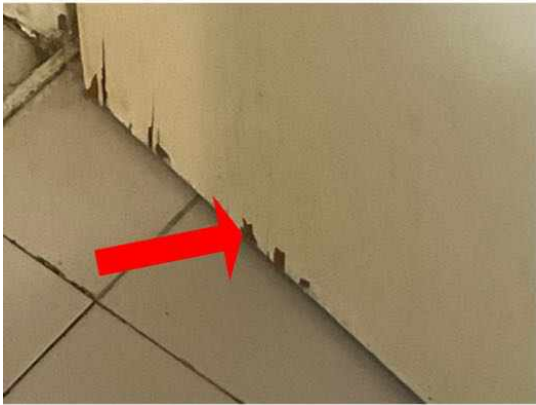
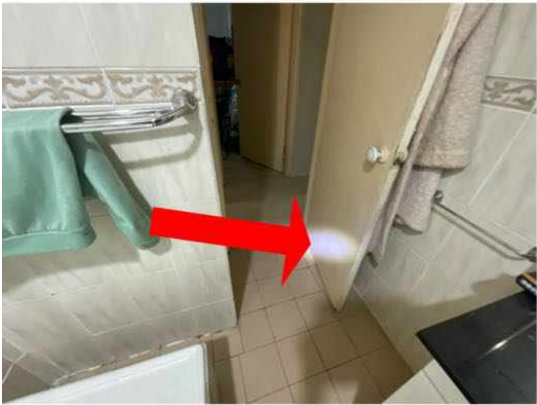
**Finding 3.03**

Building: Main Building  
Location: Bathroom  
Finding: Door - swelling and damage at the bottom edge  
Information: Swollen and damaged door base in bathroom due to moisture exposure. Edges show fraying and surface degradation.

Replace or seal the affected door. Ensure door edges are properly sealed to prevent future water damage.

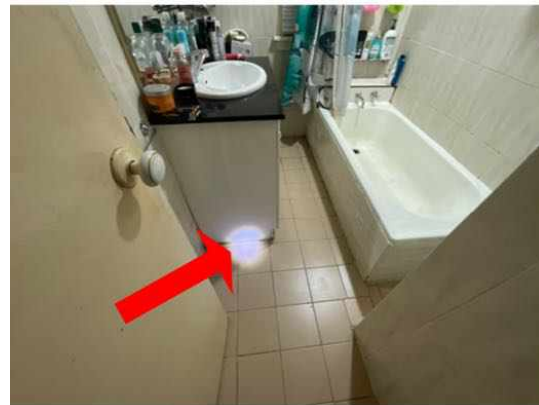
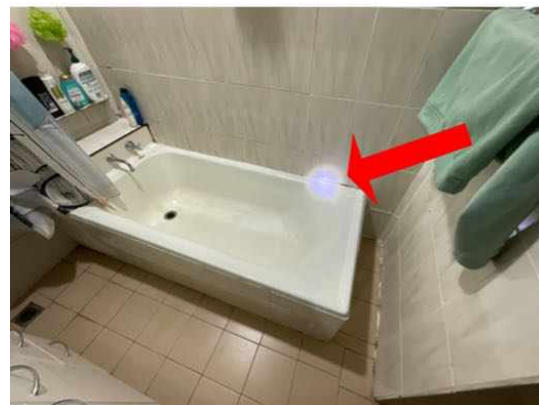
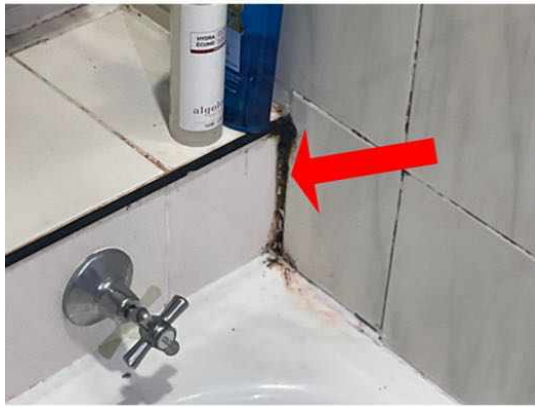
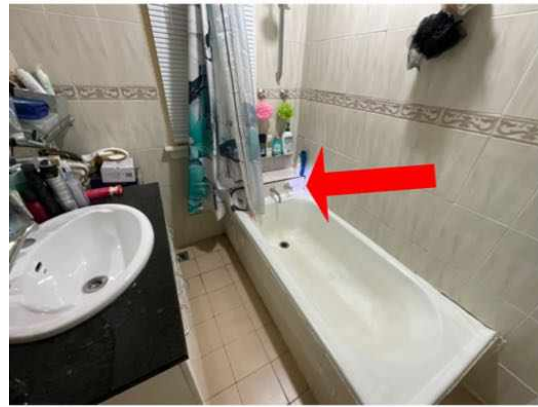
**Finding 3.04**

Building: Main Building  
Location: Bathroom  
Finding: Sealant and grouting - Missing or damaged  
Information: It was noted on inspection that sealant or grout is degraded to the tiled shower alcove and or other areas of the bathroom.

Different materials and floor areas move at different rates, generally causing cracking to grout or sealant at this point. A flexible sealant is required to allow for expected expansion and contraction, while keeping the joint water tight and protective of all associated building materials.

There appears to be excessive mould to the sealant and grout which will likely require scraping out and replacement.

Flexible and mould resistant materials should be applied to affected areas to prevent any subsequent water damage that is likely to occur. Regular maintenance and replacement of damage or missing or damaged sealant and grout is highly recommended to the wet areas, as this is a regular wear and tear defect. Sealant and grouting in areas that come into regular contact with water should be maintained for the long term care of your property.

A sealant specialist or tiling contractor should be appointed to complete these works as soon as possible

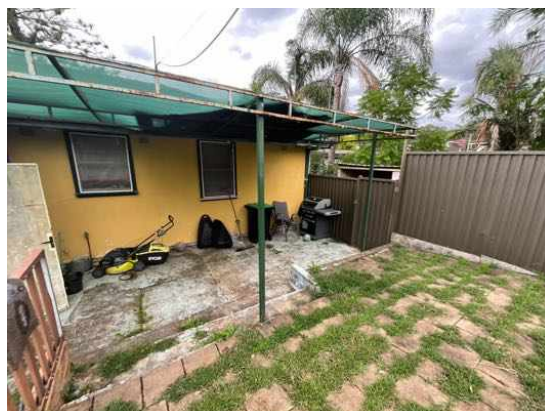
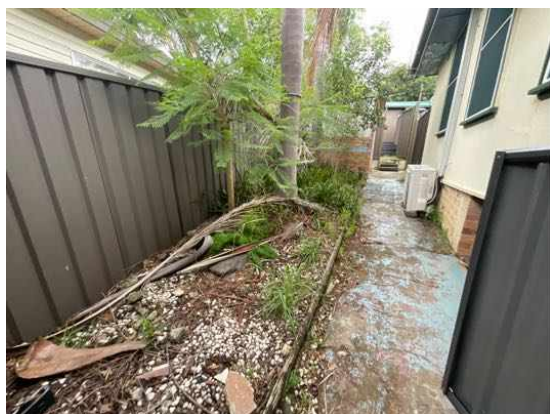
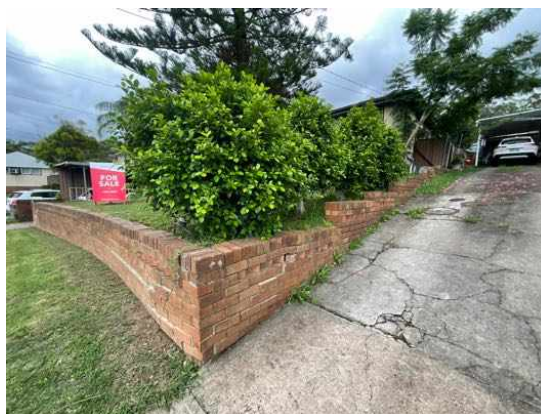
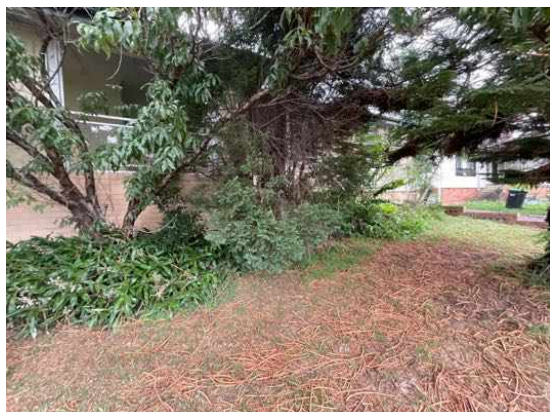
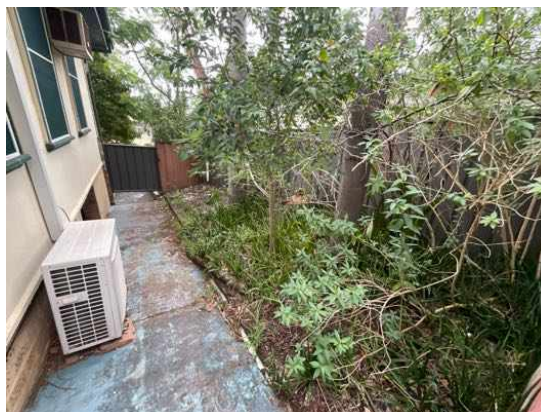
#### Finding 6.01

Building: Main Building  
Location: All Areas  
Finding: Garden Beds - Conditions Conducive to Termites  
Information: Garden beds were found to be evident in the garden area. These garden beds can include untreated timber, and with a combination of moisture from watering hosing can make conditions conducive to termite activity and termite ingress.

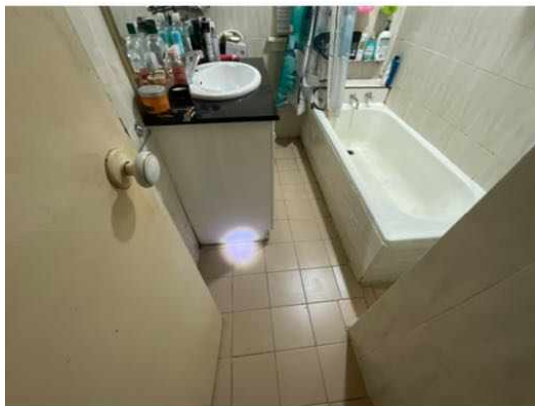
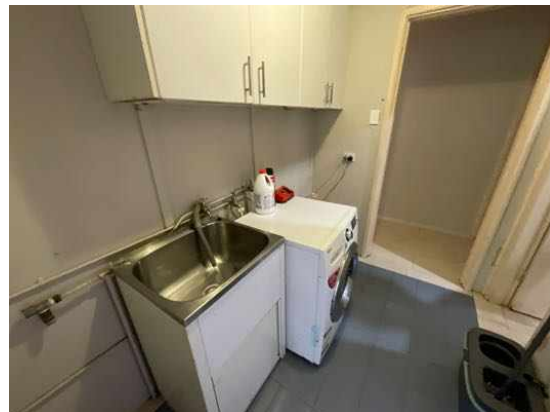
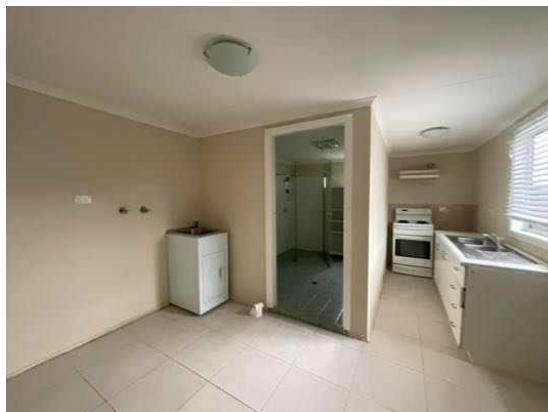
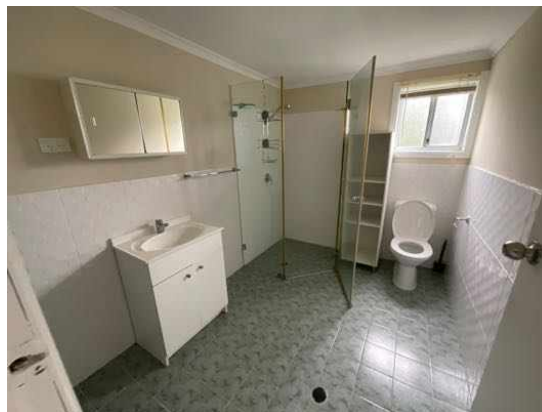
| Finding: | Water Proofing Membranes - Information Only |
| Information: | Internal Water Proofing Membranes, are crucial in preventing water ingress into the property is important to know that the Membrane System used is to Australian Standards and has been installed correctly. Please refer to the original Building Documents or Maintenance Schedule for the relevant information including; - Membrane used and Manufacturers Specifications. - The Installer and Installation Certification. Especially with older property's where this information is unavailable, all wet areas should be monitored. Generally new waterproofing with a certificate may only have a guarantee of 8yrs. If any leaks, water staining, peeling or bubbling of the paint become evident to any adjacent walls or ceilings below a licensed builder or waterproofing specialist is recommended to investigate further. |

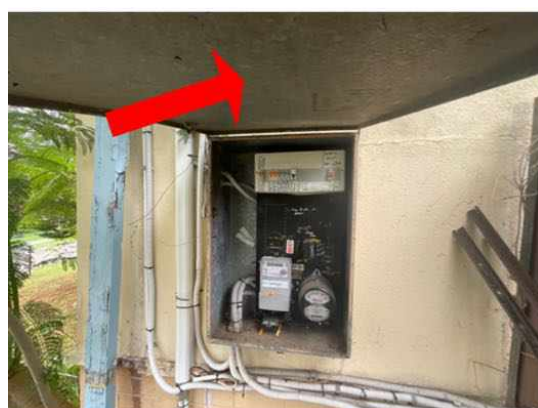
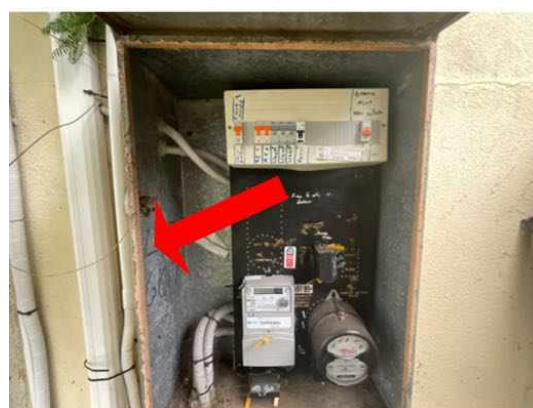
Building: Main Building  
 Location: All Areas  
 Finding: Termite Management System - no evidence of a chemical installation  
 Information: The application of a post-construction chemical termite barrier is highly recommended for all properties, particularly if live termite activity has been found on the site previously. Such barriers are highly effective in preventing termite attack on any timber building elements throughout the property.

A durable notice should be placed in the switchboard unit to indicate current termite barriers. At the time of inspection, it appeared as though no termite management system has been installed, with no evidence to suggest preventative works taking place.

The client may consider gaining further advice from a pest controller as to the costs and procedures involved with this application. It is recommended that obtaining such advice be a short-term priority.
