Building and Timber Pest Inspection Report

Inspection Date: Fri, 27 Feb 2026

Property Address: G05/690 Princes Highway, Kogarah NSW
2217

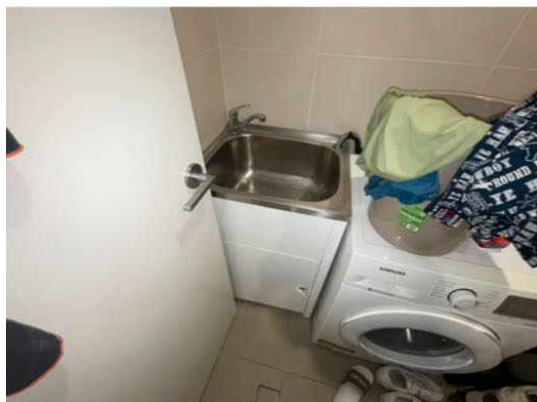
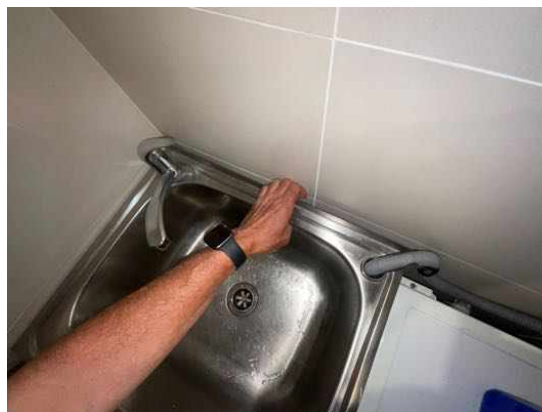
- The laundry tub unit is not securely fixed to the wall, which presents a potential risk of movement.
- If left unattended, this movement could dislodge or strain the plumbing connections, potentially leading to leaks or water damage.
- Additionally, sealant is missing at the wall junctions around the unit, leaving gaps that may allow moisture ingress, promoting mould growth and damage to surrounding cabinetry or wall surfaces.
- The drainage plumbing pipes are leaking, rust or corrosion was noted to the bottom of the cabinetry indicating an ongoing maintenance issue.

- Unsecured fixtures can compromise the integrity of plumbing connections, potentially resulting in leaks or costly water damage.
- Lack of sealant may lead to ongoing moisture exposure, which can deteriorate cabinetry materials and create an environment conducive to mould and mildew.

- Secure the laundry tub unit firmly to the wall to prevent movement and ensure plumbing stability.
- Apply appropriate waterproof sealant to all wall junctions and gaps around the unit to prevent moisture ingress.
- Repair leaking drainage pipe

The laundry tub unit requires immediate attention to secure its position and prevent further plumbing or moisture-related issues. Rectification by a suitably qualified tradesperson will help maintain the longevity and functionality of the laundry area.

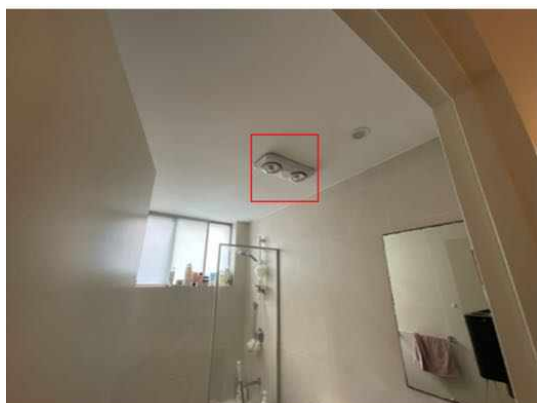
Finding 3.02

Building:	Main Building
Location:	Bathroom
Finding:	Exhaust fan - Not Operational
Information:	Observation:

At the time of inspection, the exhaust fan in this area was tested and found to be non-operational. A window is present, which is capable of providing natural ventilation to the room.

- The absence of a functioning exhaust fan may reduce the effectiveness of moisture control within the room.

- Prolonged moisture retention may contribute to condensation, surface deterioration, and potential mould growth over time.
- While natural ventilation is available via the window, reliance solely on passive ventilation may be less effective during periods of high humidity or limited air movement.

It is recommended that a suitably licensed Electrician be engaged to assess the exhaust fan and carry out repairs or replacement as required. Rectification is considered a minor maintenance item and may be undertaken at the client's discretion.

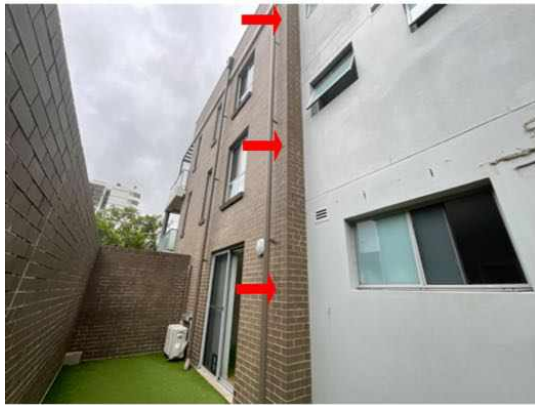
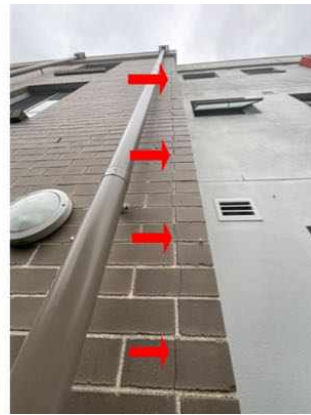
Finding 3.03

Building:	Main Building
Location:	Exterior walls - rear
Finding:	Brickwork - Cracking Moderate. (Vertical)
Information:	Observation:

Cracking was noted in the external brickwork and appeared to be moderate at the time of inspection.

Vertical cracking may indicate thermal movement, while other patterns could suggest more localised stress within the wall.

- Cracks of this nature may progress or widen if underlying movement continues.
- There is potential for remedial works or brickwork repair/replacement in the future.
- Moisture ingress may occur through open cracks, which may contribute to deterioration of internal building elements if not addressed.

- Although the cracking appears moderate and non-structural at this stage, monitoring of the affected areas is recommended.
- For a more detailed assessment, consultation with a qualified Structural Engineer is advised to determine whether movement is ongoing and whether remedial action is required.
- Clarification should be sought from the Owners Corporation or Strata Manager regarding maintenance responsibility and any previous repairs or movement history affecting the building.

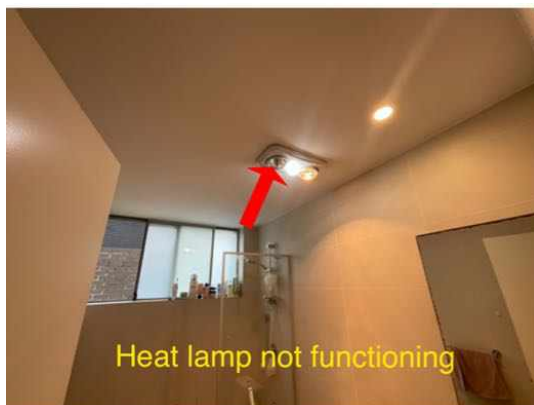
Finding 3.04

Building:	Main Building
Location:	All Areas
Finding:	Photographic Reference Note.
Information:	Additional photos have been provided for your general reference.

Arrows have been included in the images to highlight areas where minor defects or general wear and tear are present.

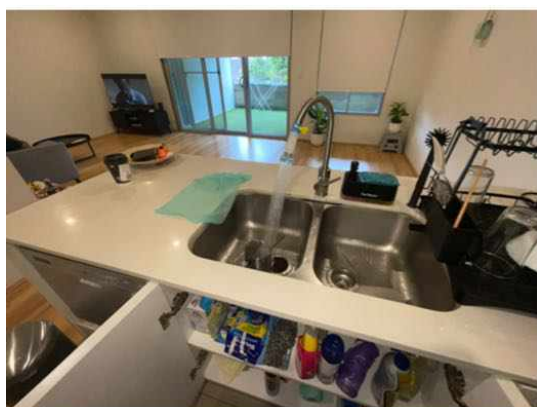
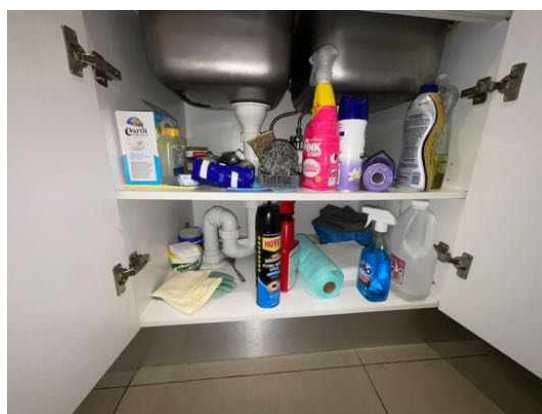
Building: Main Building
 Location: Kitchen
 Finding: Kitchen Sink – Overall Condition & Recommendations.
 Information: Observations:

- The kitchen sink tap(s) were water tested at the time of inspection, with no evidence of leaks or blockages observed in the visible plumbing or drainage.
- No significant water damage was observed to the cabinetry/unit.
- Stored items under the sink obstructed access, limiting a full inspection of the plumbing and internal cabinetry.

- Further monitoring and testing are recommended once the tap(s) are in constant use, to identify any drainage issues or signs of slow leaks not evident during the limited inspection.
- For long-term property care, it is advised that sealant and grouting in water-exposed areas be regularly inspected and maintained. A sealant specialist or tiling contractor may be engaged to carry out these works where necessary.
- It is recommended that the stored items beneath the sink be removed to allow for a full re-inspection of the plumbing and cabinetry, ensuring no concealed defects are present.

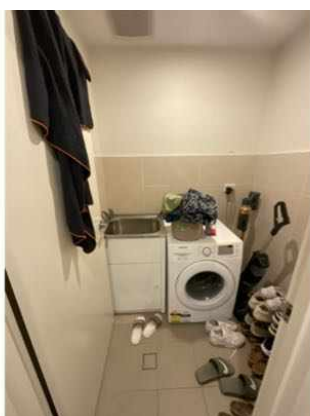
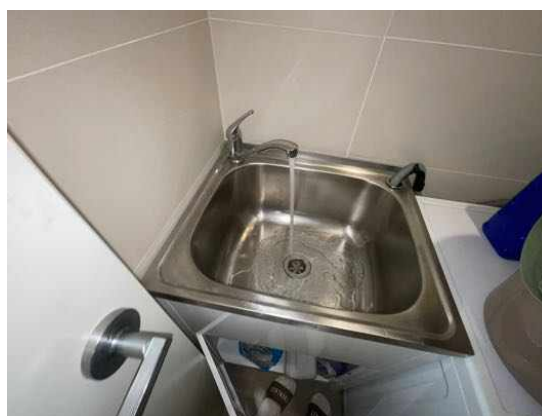
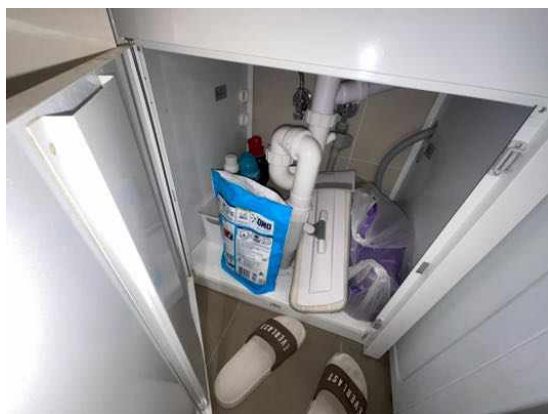
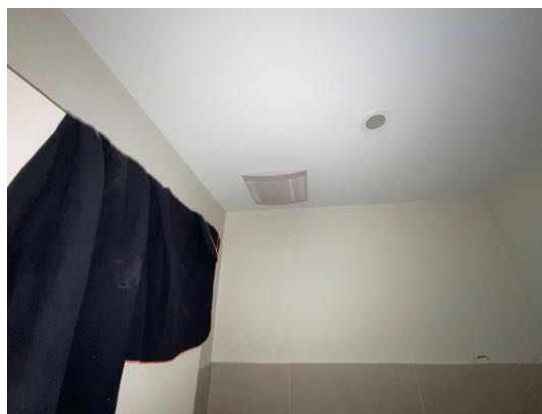
Building: Main Building
 Location: Laundry

- The taps to the laundry tub were water tested and inspected, with no evidence of plumbing or drainage leaks observed at the time of inspection.
- No visible signs of water damage, rust, or corrosion were noted to the cabinetry or surrounding unit during the inspection.
- The exhaust fan appeared to be operational, which supports moisture control.

- Further monitoring or testing is recommended once the taps are placed into regular use, to ensure no leaks develop over time and that the drainage system continues to perform adequately.
- Flexible and mould-resistant sealant should be applied to junctions between the basin and the wall to prevent water ingress that may lead to damage.
- Regular maintenance and prompt replacement of missing or deteriorated sealant is highly recommended, as this is a common wear-and-tear issue.
- Sealant and grouting in wet areas should be maintained as part of the long-term care and upkeep of the property.
- Where required, a sealant specialist or qualified tiling contractor should be appointed to carry out remedial sealing works.

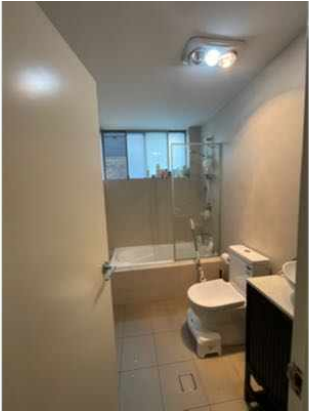
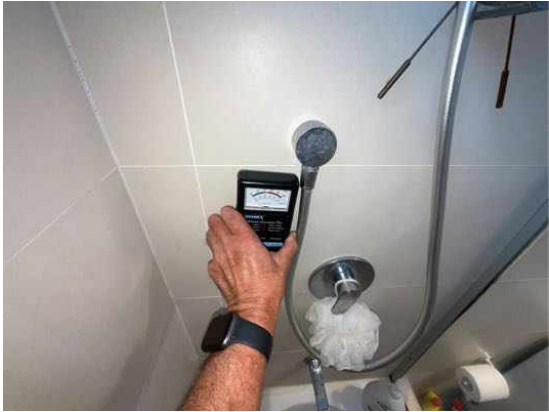
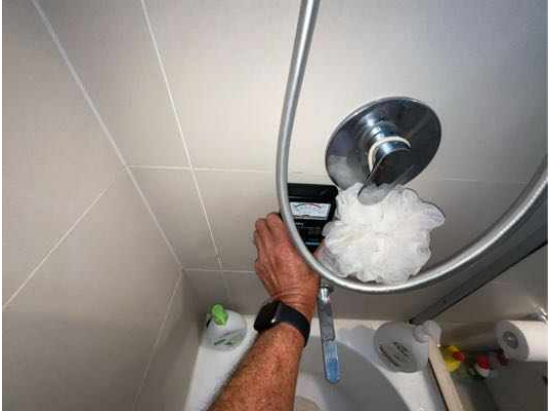
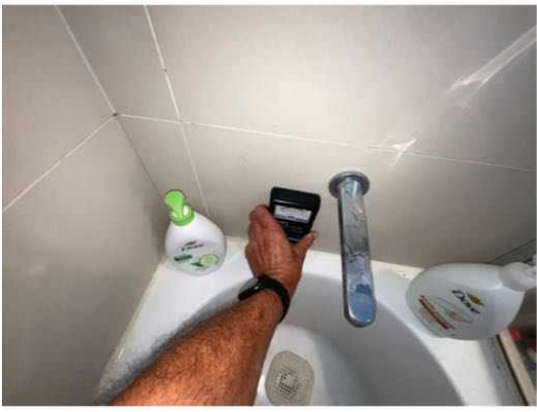
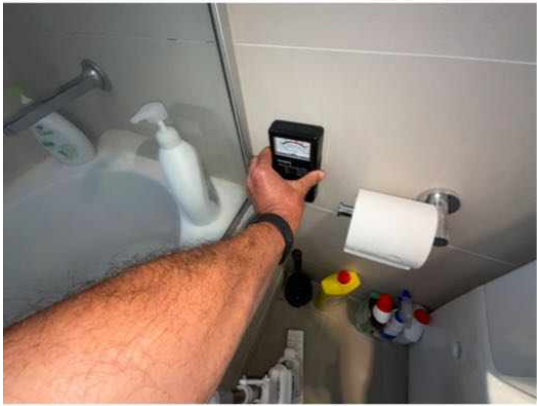
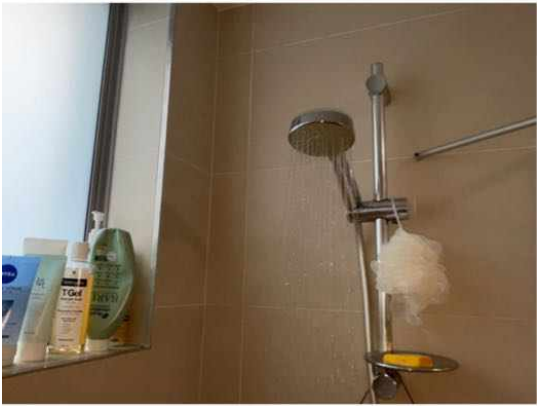
Building: Main Building
 Location: Bathroom
 Finding: Wet Areas - Bathroom(s) - Overall Condition & Recommendations.
 Information: Overall Condition & Recommendations

- Sealing of grout and tiles is recommended to prevent moisture buildup and mould growth in damp areas such as showers.
- The condition of grout and sealant appeared to be below average, with some areas potentially requiring cleaning or replacement.

- Mould growth was noted in some areas of grout/sealant. Cleaning or, if necessary, replacing affected grout or sealant is recommended to maintain hygiene and waterproofing integrity.

- The exhaust fan did not appear to be operational, which supports moisture control in the bathroom. Recommend further investigation by a Licensed Electrician.

- Grout in wall and/or floor junctions may crack and deteriorate over time. It is recommended to remove any rigid grout from junctions and replace with flexible, mould-resistant sealant in accordance with best building practices.
