Building Inspection Report

Inspection Date: Tue, 31 Mar 2026

Property Address: 5/92 New St, South Kingsville VIC 3015,
Australia

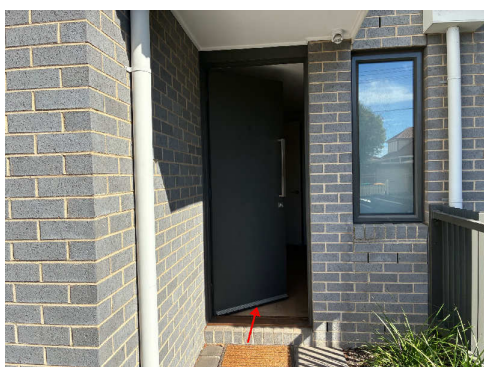
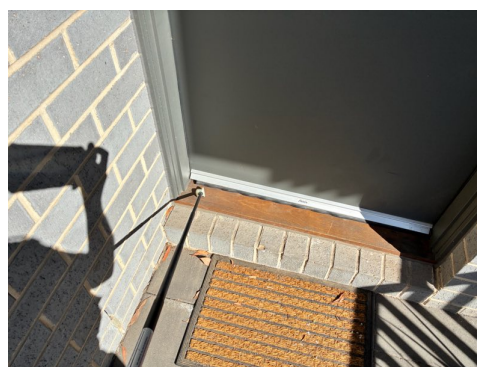
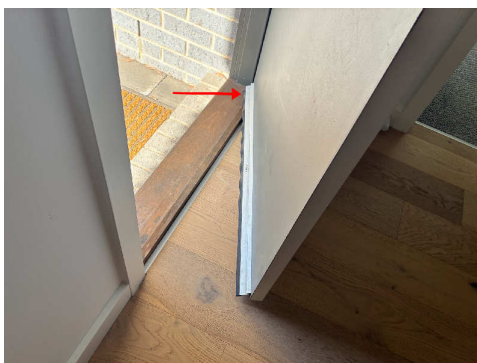
Defects 3.01

Location: Entry Door

Finding: Door seal - Damage/Deteriorated

Information: At the time of inspection the Entry Door bottom seal is showing signs of the rubber warping. This is causing the rubber to catch the Door sill when closing. It is suspected to be caused by weather exposure.

Where Door seals have been damaged or deteriorated, the door is no longer drought-tight and insulation of the area against external weather conditions will also be compromised.

It is recommended that all damaged and deteriorated door seals be replaced by a general handyman or sealant specialist to restore the door to a fully functional level.

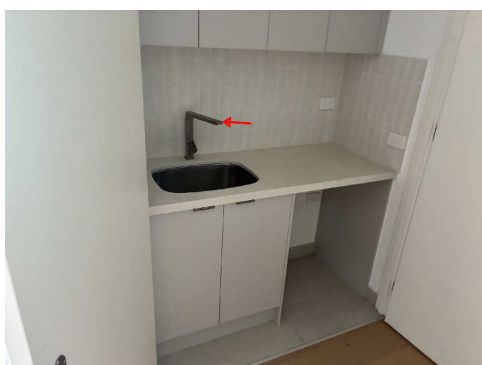
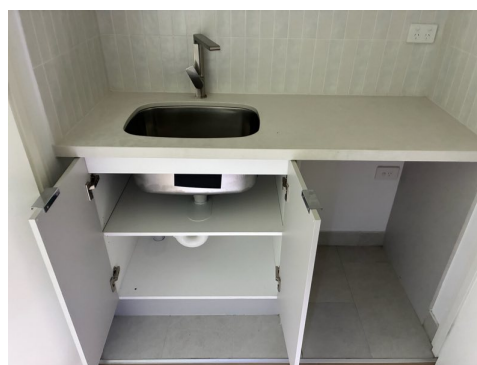
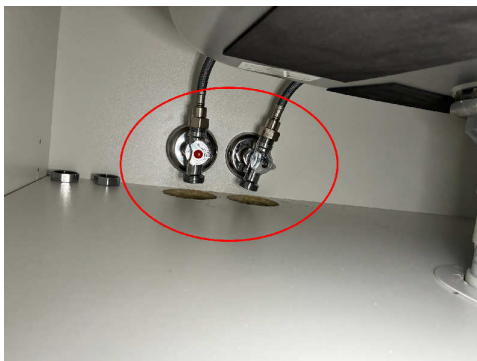
Defects 3.02

Location: Laundry

Finding: Laundry Sink Tap - Not connected

Information: At the time of inspection, the hot and cold water for the laundry sink were not connected to the mixer tap and/or appliances. As a result, the laundry plumbing could not be operated or tested. The disconnection prevents confirmation of correct function, flow, and the presence of any leaks.

☒ The water taps should be connected to the relevant fixtures or appliances, and the plumbing system tested to confirm correct operation.

It is advised that a licensed plumber be appointed to connect the laundry tap and check for correct function, flow, and the presence of any leaks.

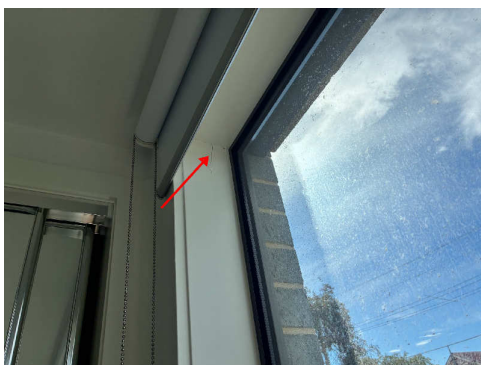
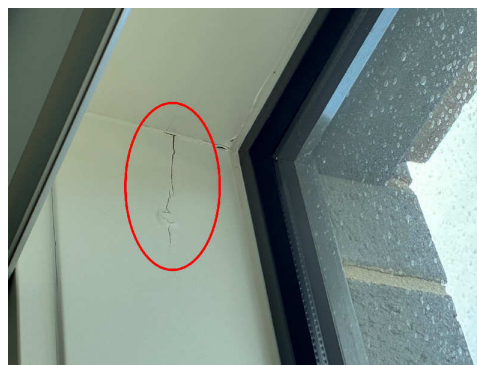
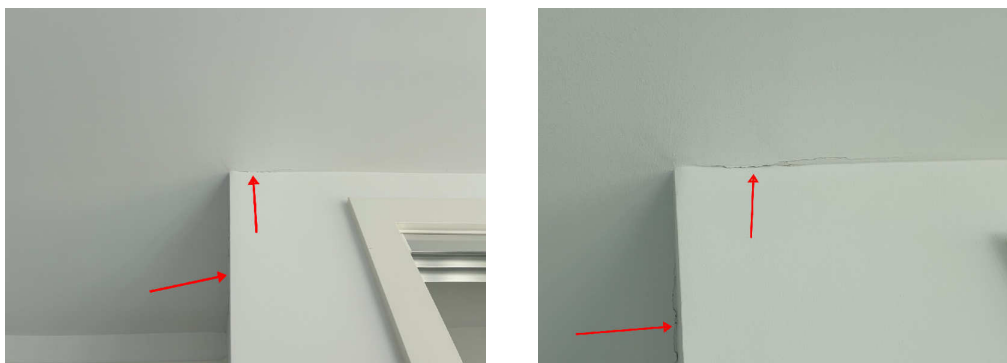
Defects 3.03

Location: Guest Bedroom

Finding: Cracking to Window frame and Plaster - Category 1 - Fine (up to 1mm)

Information: At the time of inspections fine cracks were observed in ground floor Guest Bedroom. They are often only considered to be an appearance defect, and usually do not indicate any structural damage. Generally, the cause of a fine crack is indicative of a separation between building materials and finishes (e.g. paint, plaster, etc.) along joins.

Cracking of this nature can generally be repaired with minor sanding, filling and/or repainting.

Such works should be performed by a qualified painter or a general handyperson.

Monitoring of all cracking should be conducted frequently. Always contact a building inspector should cracks widen, lengthen, or become more numerous.

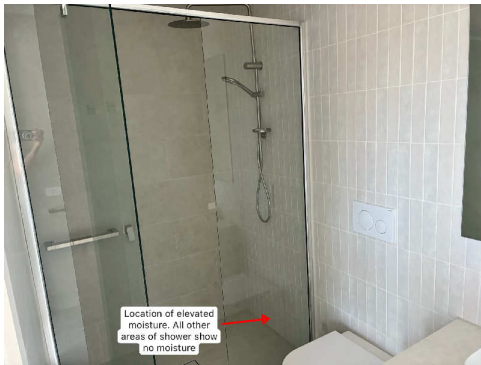
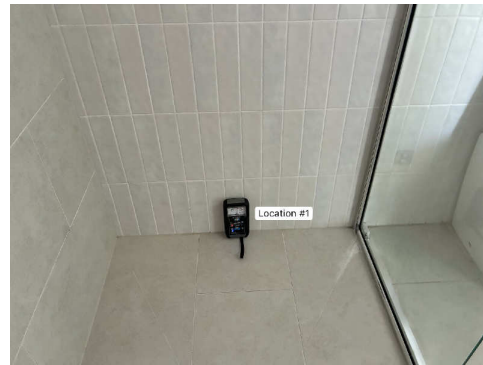
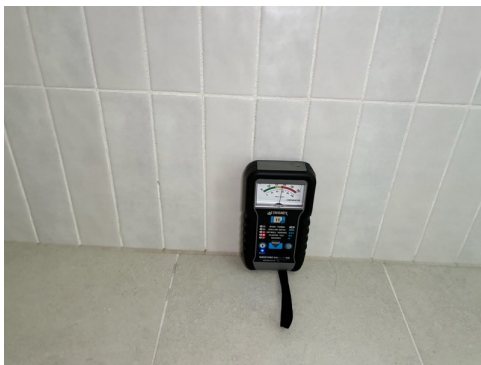
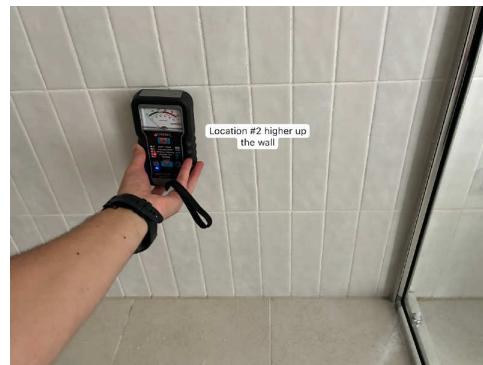
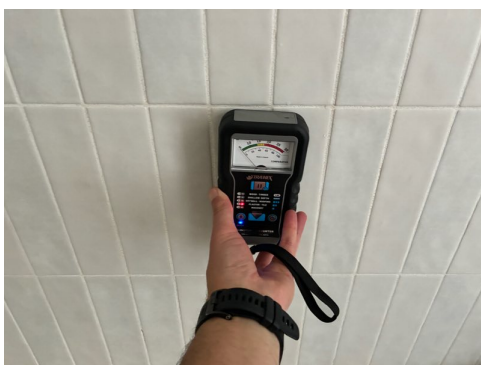
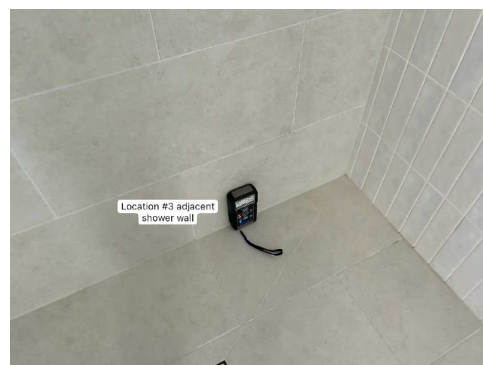
Defects 3.04

Location: GF Guest Ensuite

Finding: Shower moisture (damp) - Monitor

Information: At the time inspection moisture was evident to the lower 400mm of wall to the shower wall (shower head side only) of the Ground Floor Guest Ensuite. There is no high reading around the taps nor are there high readings transferring to the other side of the wall. Both sealant and grout appear in acceptable condition at present.

This defect is quite common, and is suspected to have been caused by moisture permeating or leaching through the grouting and perhaps gaps in the sealant.

Monitoring the area is advised and if any visual signs of excessive moisture appear (peeling paint, mould) then consultation with a qualified plumber or bathroom specialist would be advised to identify the cause of damp and to perform remedial works as required.

Always ensure that sealant and grout is in good condition to prevent any moisture issues occurring in the future.

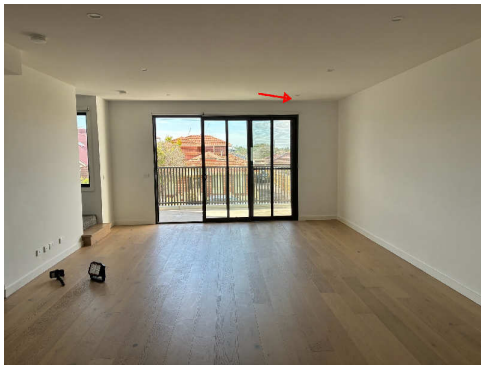
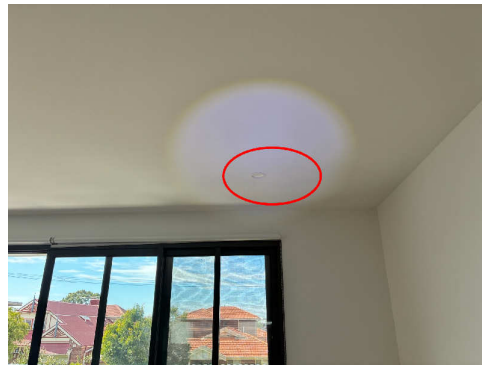
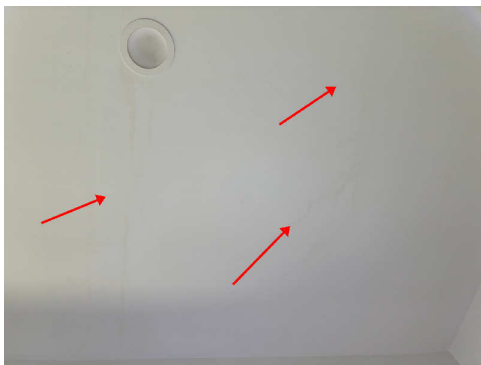
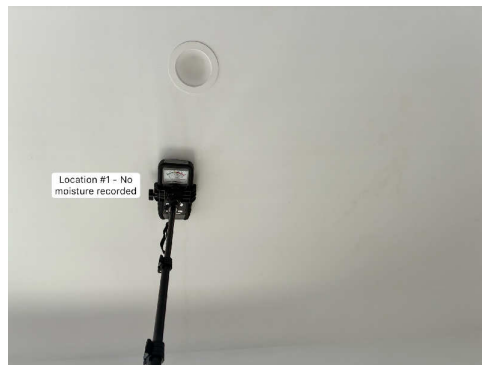
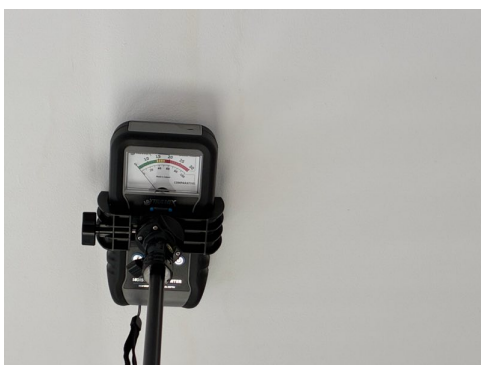
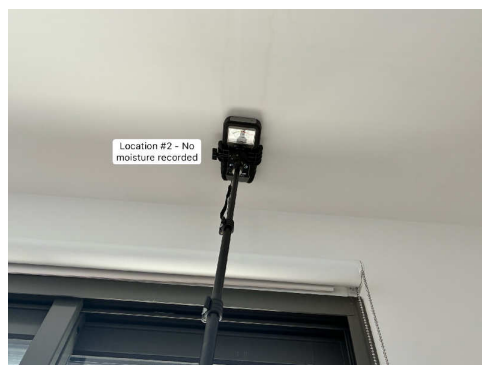
Defects 3.05

Location: FF Living Room

Finding: Ceiling - Water stained

Information: At the time of inspection water staining to ceiling linings was evident to the First Floor Living room area. Although there was no current moisture recorded in this areas, water staining indicates that surfaces have been exposed to excessive moisture over time.

While mostly an appearance defect, water staining can be indicative of more serious defects, which may be currently concealed by interior ceilings.

Where water staining is active, a licensed plumber must be consulted to identify the cause of the staining and to provide advice on any reparation works that may be required.

Replacement of any damaged structures is advised.

Conversely, where water staining is old and inactive, affected building materials may be repaired or replaced at client discretion by a general handyperson or qualified painting contractor.

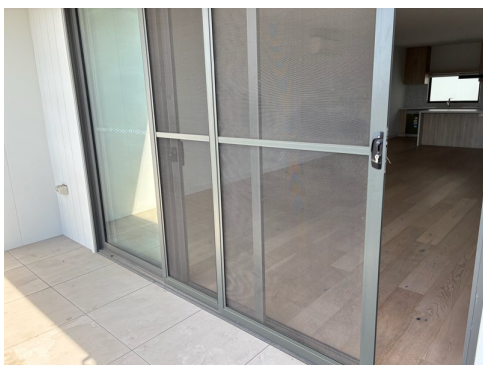
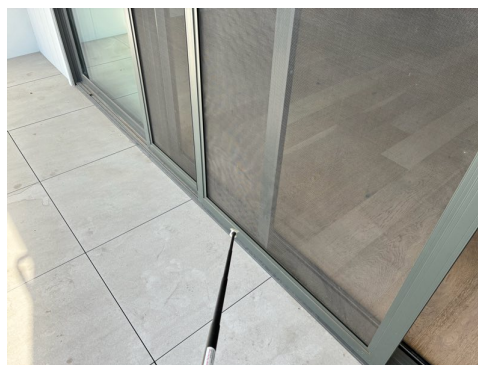
Defects 3.06

Location: FF Living Room

Finding: First Floor Balcony Fly Door - Stiff to slide

At the time of inspection, the first-floor balcony flyscreen door was observed to be stiff and difficult to slide. Flyscreen doors should operate smoothly to allow effective ventilation and convenient access while maintaining insect protection.

Restricted operation may reduce user comfort and may cause damage to the door or track if forced.

☒ The restricted operation is generally associated with normal wear and tear, lack of routine maintenance, dirt or debris buildup in the door track, or deterioration or misalignment of the rollers and hardware.

☒ It is recommended that the flyscreen door be serviced and adjusted. Rectification may include cleaning the door tracks, lubricating or replacing rollers, realigning the door frame, or repairing or replacing worn components as required. Works can be carried out by a competent handyperson, glazier, or suitably qualified tradesperson to restore smooth operation.

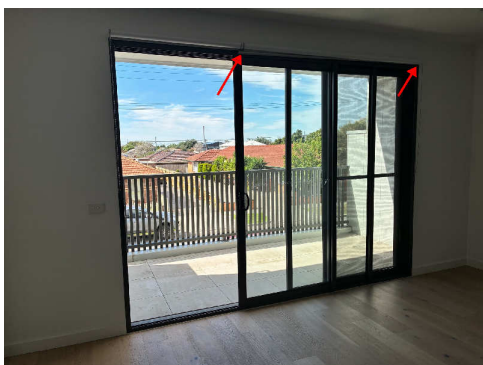
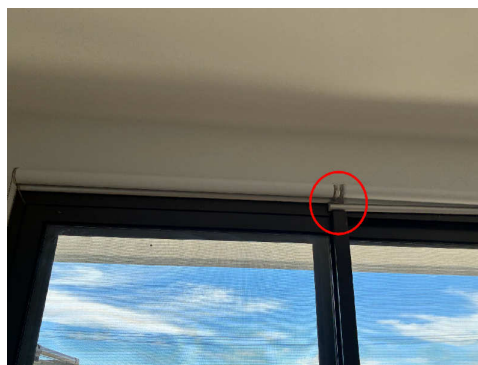
Defects 3.07

Location: Balcony Sliding Door Blinds

Finding: Balcony Sliding Door Blinds Unable to Be Tested

Information: At the time of inspection, the blinds fitted to the balcony sliding door could not be operated or tested. The blinds appeared to be stuck and obstructed due to interference, preventing confirmation of correct operation. As a result, the functionality and condition of the blinds could not be verified.

☒ The inability to operate the blinds may be due to mechanical failure, misalignment, interference with the sliding door, or deterioration of internal components or poor workmanship.

☒ It is recommended that the blinds be inspected by a suitably qualified blind installer or handyperson to identify the cause of the obstruction and undertake repairs or adjustments as required. If the blinds are found to be damaged or beyond repair, replacement may be necessary to restore full functionality.
