Building and Timber Pest Inspection Report

Inspection Date: Tue, 10 Mar 2026

Property Address: 7 Lynch Cl, Epping VIC 3076, Australia

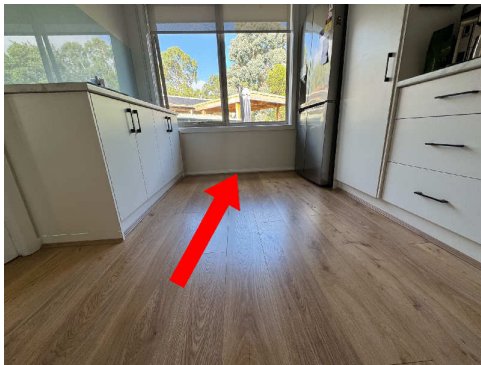
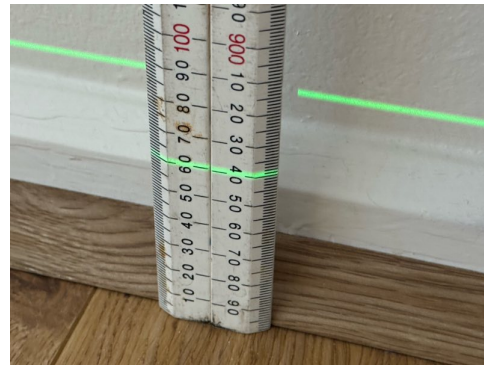
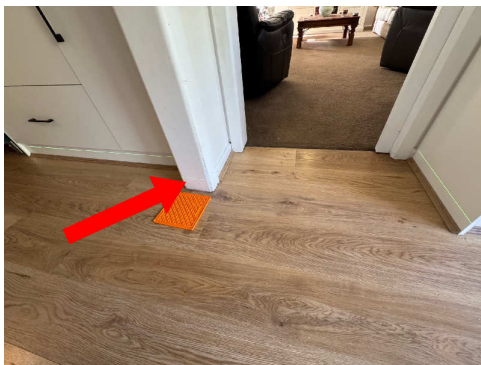
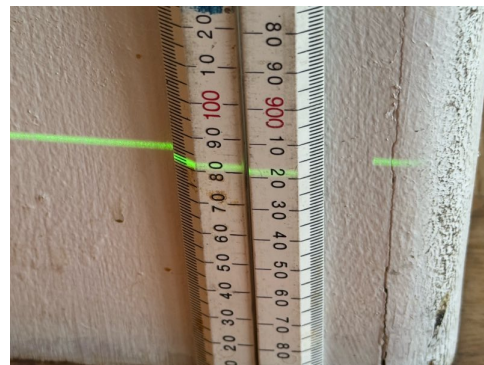
Information: It appears that the subfloor structure has been affected by movement of the foundations, often referred to as sinking or subsidence. A degree of movement is expected in subfloors over time, especially as environmental conditions change and buildings settle after construction.

The apparent subsidence is evidenced by some or all of the following, gapping and movement to eave linings, gaps and cracks to brickwork, usually adjacent to windows or openings, excessive footpath movement and undulation of floors.

General subsidence is usually initiated by changes in soil moisture content. The most critical factor is identifying the specific causes, and identifying if this is a recurring or ongoing problem, or one that has been resolved by previous works in the past.

Subsidence can have complex and varying causes, which will influence the required remedial works. If movement continues It is advised to consult a structural engineer to determine if repair works are warranted. Works may include some form of underpinning, as well as addressing the underlying cause. Consultation with a geotechnical engineer may also be necessary where changes to soil moisture content is apparent.

At this point it is recommended to contain storm water flows, ensure pavements flow away from the building to lessen any excessive wetting and drying effects.

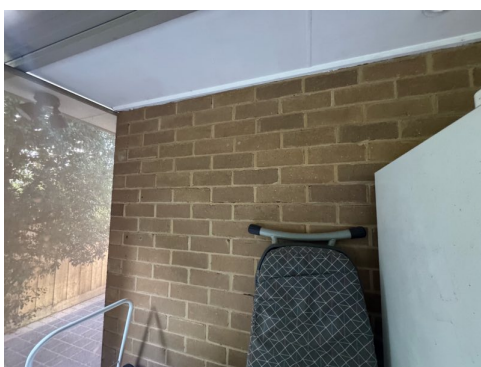
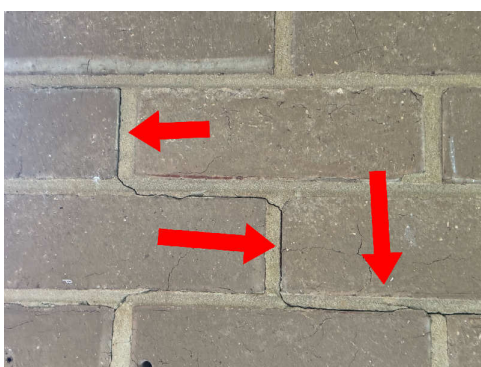
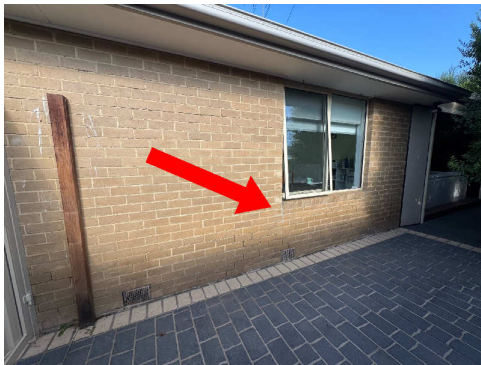
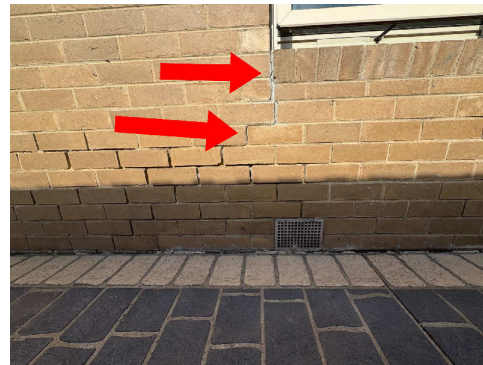
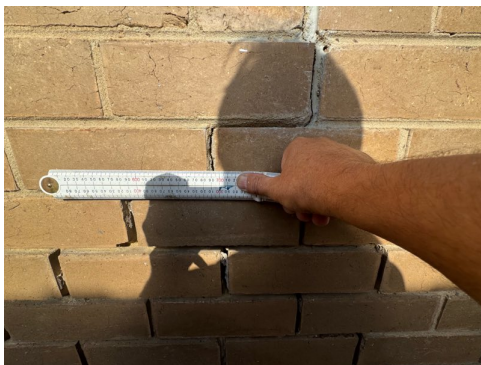
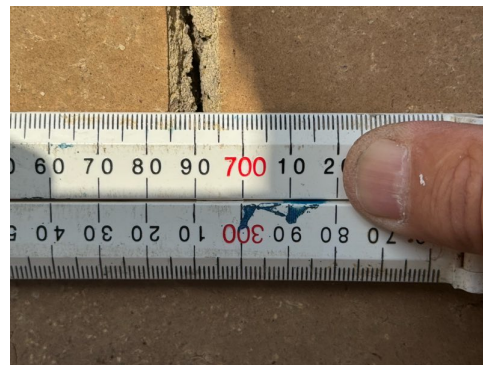
Finding 3.02

Building: Main Building
Location: Walls All Areas
Finding: Brickwork - Step cracking

Step cracking was identified to the brickwork in this area at the time of inspection. Step cracking, which is similar to other forms of cracking, has a variety of possible causes. However, the most common is the subsidence of adjacent footings.

Step cracking is a relatively common defect, and is most likely to occur adjacent to windows, doors and other openings. Mortar failure in the gaps between affected bricks indicates the stresses and tensions affecting the wall.

Where step cracking is extensive or severe, the client is advised to consult a structural engineer. Minor step cracking can be used as a warning sign to address factors causing stress to the wall, which can include the effect of surrounding trees, water leaks, soil erosion, or even the presence of reactive soils in the surrounding area.

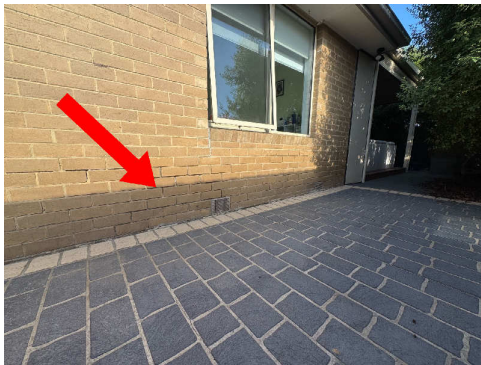
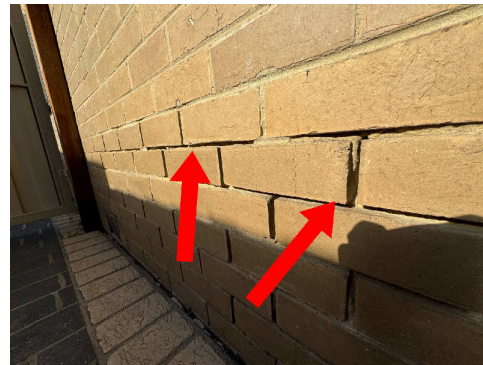
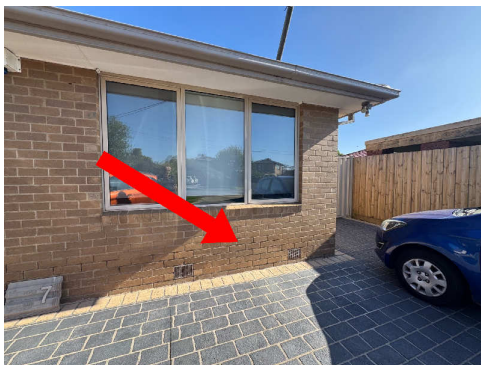
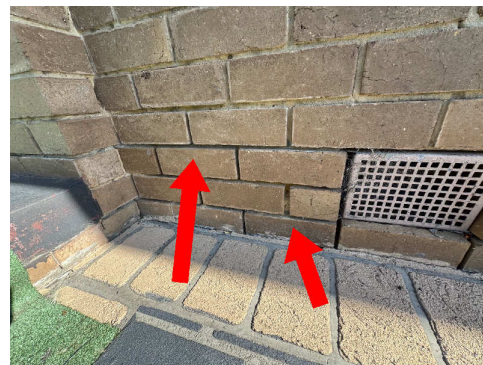
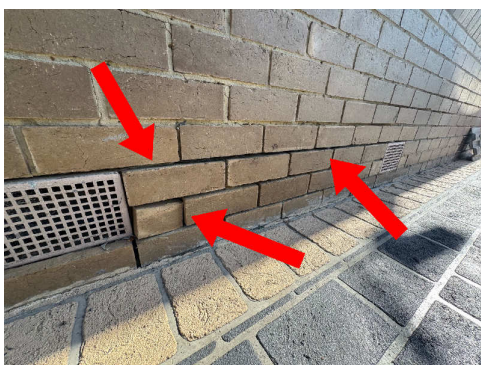
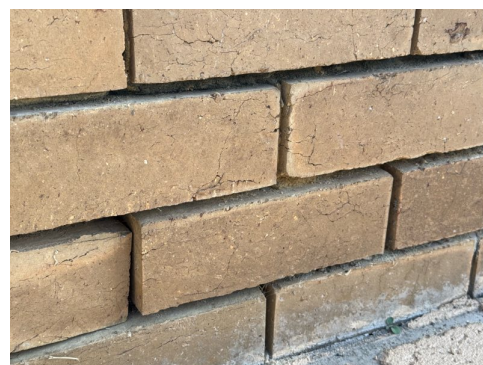
Finding: Brickwork - Deteriorated mortar

Information: Mortar, or 'bedding', is the material which fills joins and intersections between bricks in masonry walls and structures. Sections of mortar in this brickwork were identified as having deteriorated, which is generally expected for a property of this age and condition.

Mortar may deteriorate as a result of age of building materials, minor movement of bricks, or frequent exposure to weathering. Mortar should be replaced to ensure that bricks remain in their intended location and to prevent gaps, which would allow water or moisture ingress and secondary damage as a result.

Mortar deterioration can be addressed by a bricklayer where areas of deterioration are localised and easily accessible. Alternatively, appointment of a registered builder is advised, to repoint large areas of decaying mortar. Where secondary structural defects have become evident, consultation with a structural engineer may be required.

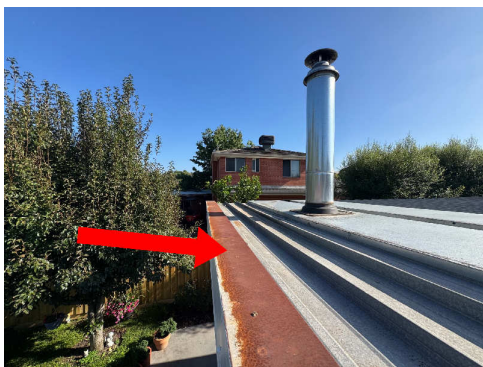
Finding 3.04

Building: Main Building
Location: Roof Exterior
Finding: Building element - Rusted or corroded

Information: This building element shows evidence of rusting and corrosion, which is likely to have developed as a result of excessive exposure to moisture and or inadequate coatings.

As surface rust provides no protection to the underlying iron, the deteriorating condition is likely to worsen if not addressed in the short-term future.

Where possible, the use of galvanized (treated) metals or aluminium coated metals aid in rust prevention, as does regular general maintenance. Rust formation can be controlled with coatings, such as paint, that isolate the iron from the environment.

Rusting and corrosion should be managed by ideally removing or limiting the affected surface from exposure to moisture. A registered builder may be appointed to replace any building elements that have been severely affected by rust or water damage.

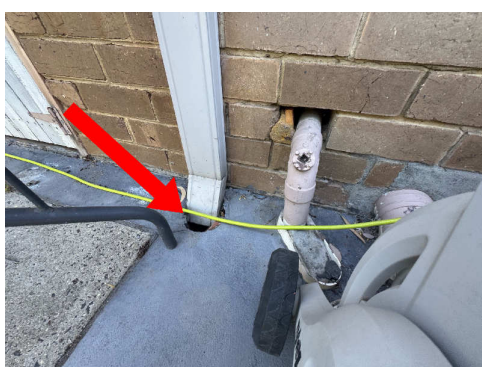
Finding 3.05

Building: Main Building
Location: Exterior walls - right side
Finding: Stormwater drain - Not sealed

Information: At the time of inspection it was noted that the storm water system was not sealed, creating potential for subsequent blockages and water damage to associated building elements
The storm water system should be sealed against vermin and debris entering the storm water system,

A qualified plumber should be appointed to further inspect the property and perform any necessary remedial works. It is also recommended that a CCTV inspection of the stormwater drainage system be carried out to identify any blockages, damage, or defects that may be contributing to poor site drainage. Water damage and secondary defects are likely to occur if the issue remains unmanaged.

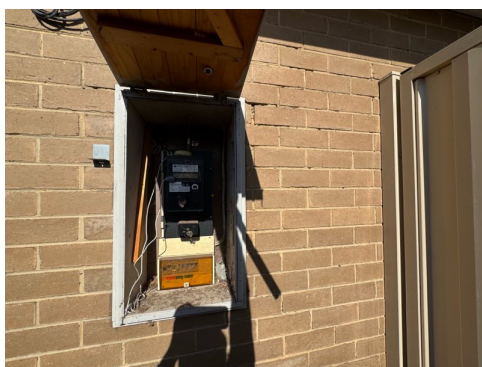
Information: The application of a post-construction chemical termite barrier is highly recommended for all properties, particularly if live termite activity has been found on the site previously. Such barriers are highly effective in preventing termite attack on any timber building elements throughout the property.

A durable notice should be placed in the switchboard unit to indicate current termite barriers. At the time of inspection, it appeared as though no termite management system has been installed, with no evidence to suggest preventative works taking place.

The client may consider gaining further advice from a pest controller as to the costs and procedures involved with this application. It is recommended that obtaining such advice be a short-term priority.

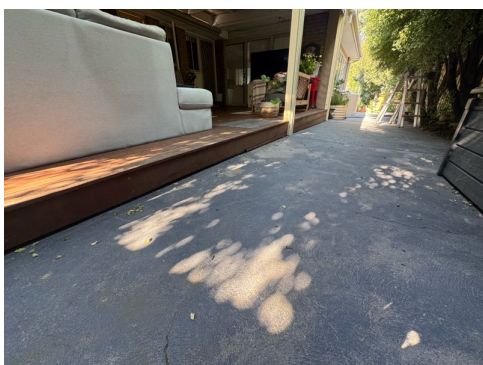
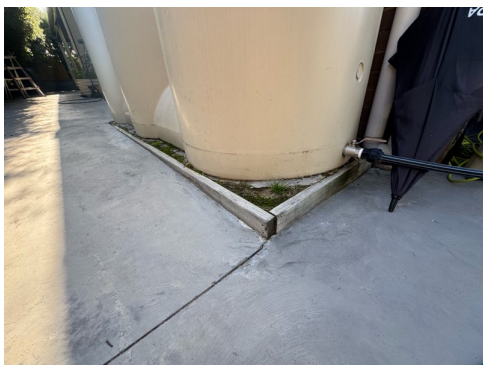
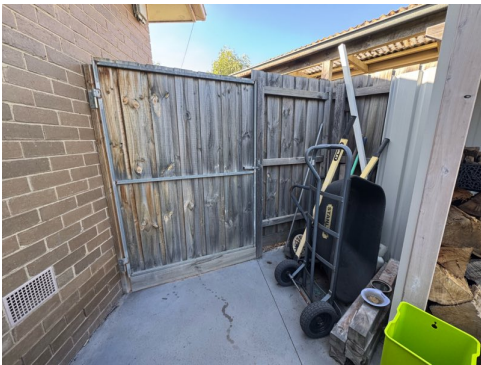
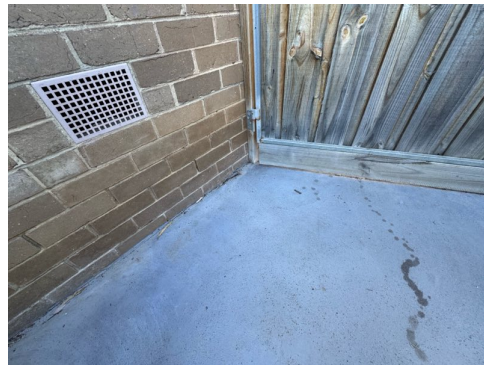
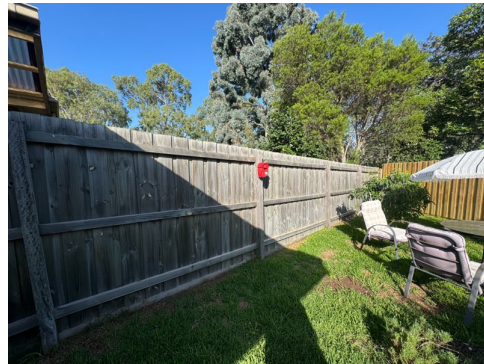
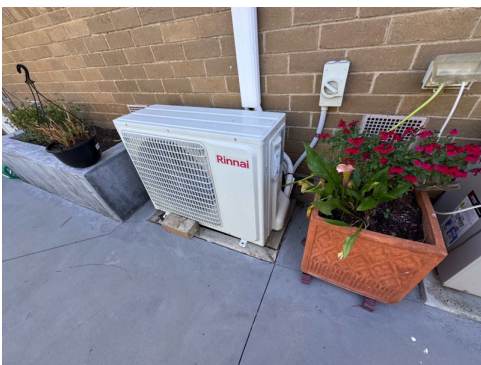
Finding 6.02

Building: Main Building
Location: All External Areas
Finding: Building materials in direct ground contact - conducive to termites

Where timber elements are in direct contact with the ground and consequently moisture or dampness they become conducive to termite activity. Whether timber is used as a building element part of a fencing structure or stored as an unused item they can provide an environment that is attractive to termite infestation.

When met with excessive moisture timber begins to decay and develop wood rot. Any timbers that are in direct contact with external grounds especially if left untreated or non-durable also provide ingress for subterranean termites into that particular element. Consider replacement with more durable materials i.e. treated timber or non timber elements.

The removal of any such materials that may be conducive to termite activity should be removed as soon as possible to minimise the risk of termite attack. Where it is not possible frequent inspections of these areas shall be undertaken to provide early detection of infestation

It is highly recommended that termite or timber pest inspections be carried out every 6-12 months to aid protection of the property against infestation.

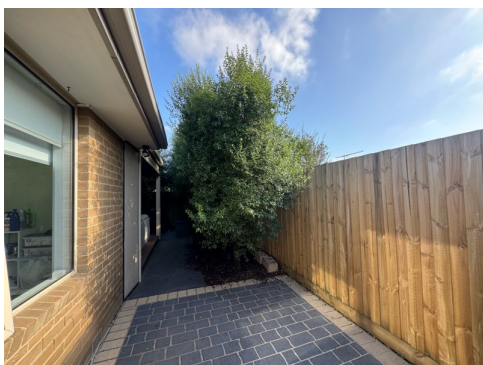
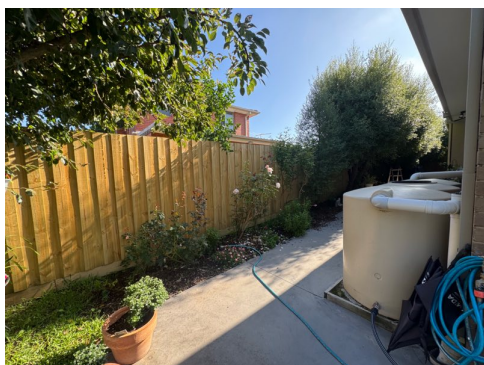
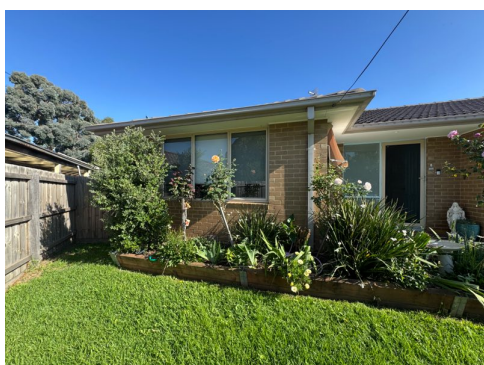
Finding 6.03

Finding: Garden Beds - Conditions Conducive to Termites

Information: Garden beds were found at the time of inspection. These garden beds can include untreated timber, and with a combination of moisture from watering hosing can make conditions conducive to termite activity and termite ingress.

The building of gardens or planting of shrubs close to the perimeter of the building may promote termite activity. It is highly recommended that termite or timber pest inspections be carried out every 6-12 months to aid protection of the property against infestation.

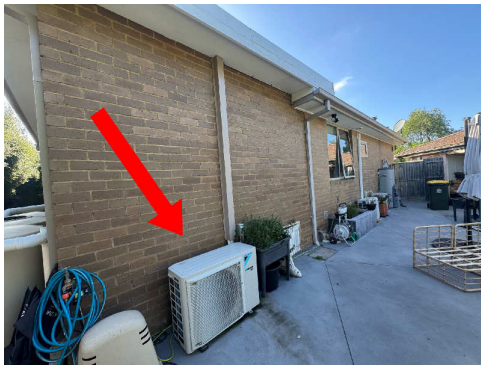
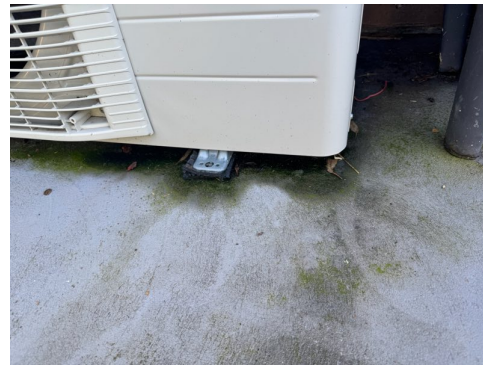
Finding 6.04

Finding: Air conditioner - Disconnected overflow

Information: The Air Conditioner (A/C) overflow was found to be disconnected from storm water drainage and is creating excessive moisture in the surrounding area. Such leaking creates an environment which is conducive to an array of defects, including water damage to associated building elements and the attraction of termite or timber pest infestation. It is highly recommended that a licensed plumber be appointed to connect the A/C overflow in order to prevent such an environment from being created. These minor works should be carried out as soon as possible.

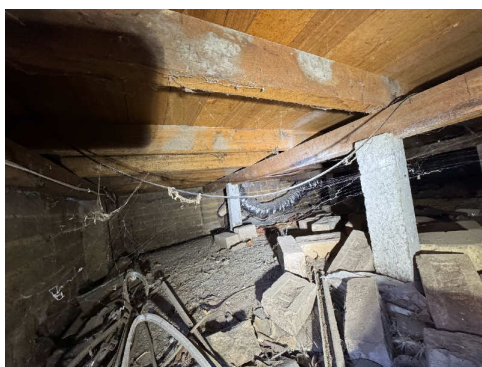
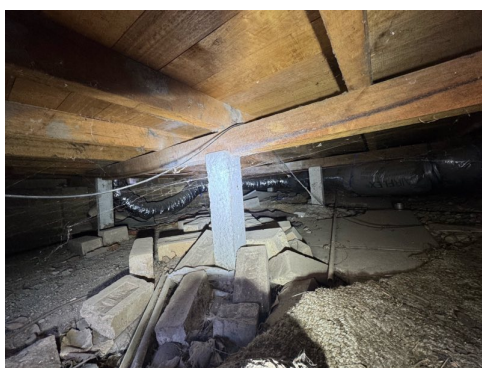
An array of debris was found in the subfloor area at the time of inspection. Debris in this area restricts subfloor ventilation and creates potential for concealed pest entry. Stored timbers and other materials may also make the area susceptible to termite activity and wood rot.

A clear and empty subfloor will be better ventilated and easier to maintain in a dry condition. The removal of any timber debris is vital in minimising the risk of termite or wood borer activity.

Debris in the subfloor should be removed as soon as possible. Depending on the location and amount of debris and stored items, the homeowner may elect to undertake this task. Alternatively there are a large number of rubbish removal subcontractors that could undertake these works.

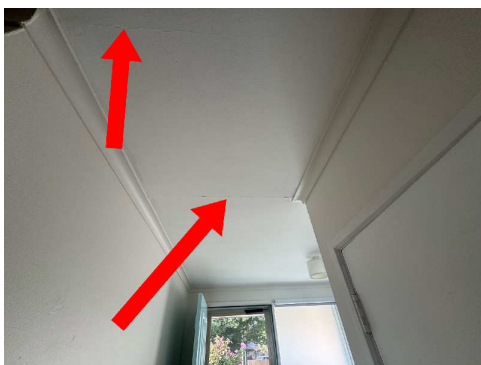
Finding: Cracking - Damage Category 1 - Fine (up to 1mm)

Information: Although fine cracks are quite noticeable, they are often only considered to be an appearance defect, and usually do not indicate any structural damage. Generally, the cause of a fine crack is indicative of a separation between building materials and finishes (e.g. paint, plaster, etc.) along joints.

Cracking of this nature can generally be repaired with minor sanding, filling and/or repainting. Such works should be performed by a qualified painter or a general handyman.

Monitoring of all cracking should be conducted frequently. Always contact a building inspector should cracks widen, lengthen, or become more numerous.

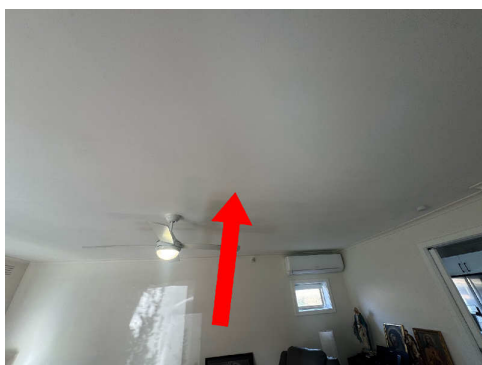
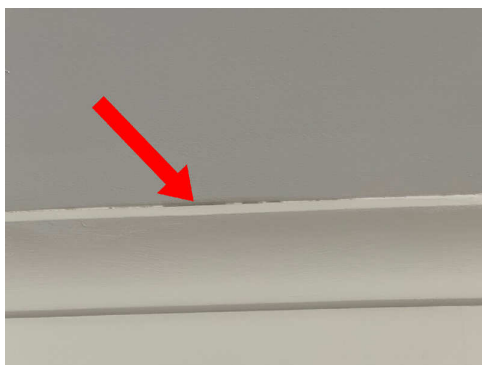
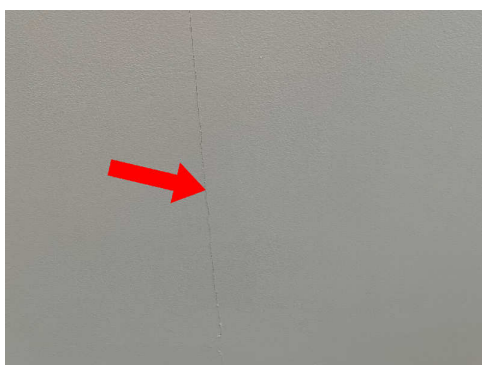
Finding: Cracking - Damage Category 0 - Hairline (less than 1 mm)

Cracking of this nature can generally be repaired with minor sanding, filling and/or repainting. Such works should be performed by a qualified painter or a general handyman.

Monitoring of all cracking should be conducted frequently. Always contact a building inspector should cracks widen, lengthen, or become more numerous.

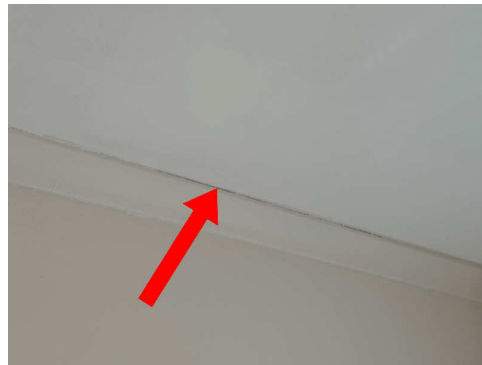
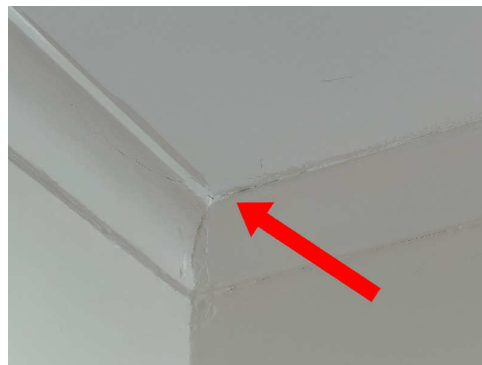
Finding: Cracking - Damage Category 0 - Hairline (less than 1mm)

Cracking of this nature can generally be repaired with minor sanding, filling and/or repainting. Such works should be performed by a qualified painter or a general handyman.

Monitoring of all cracking should be conducted frequently. Always contact a building inspector should cracks widen, lengthen, or become more numerous.

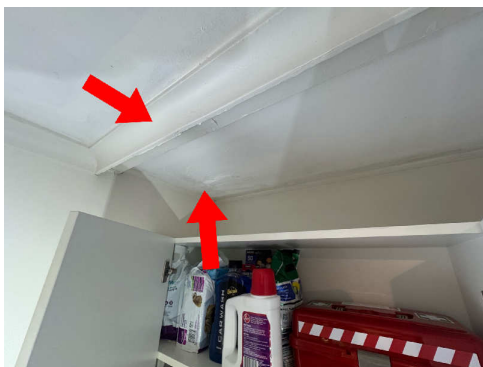
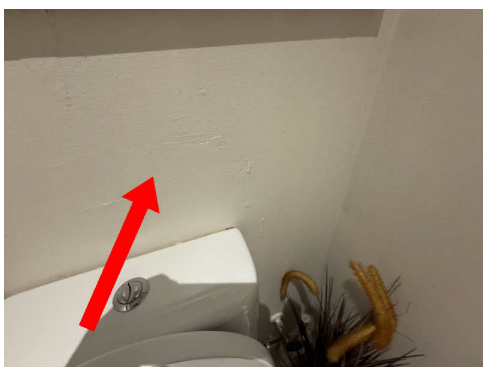
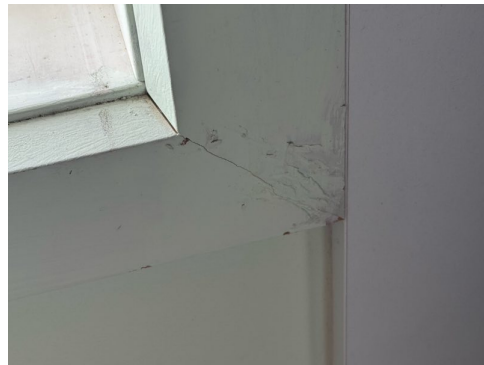
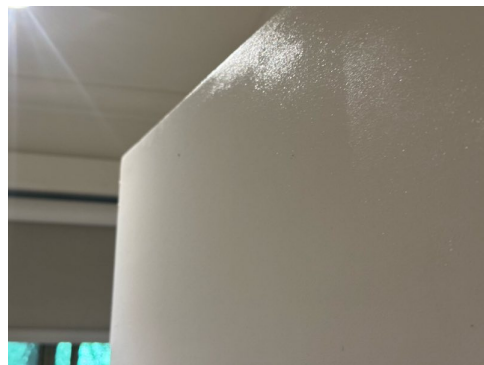
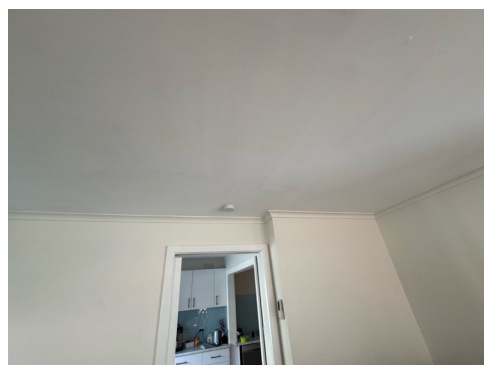
Building: Main Building
Location: All Internal Areas
Finding: Paint finish - Substandard (all areas)

Substandard paint finishes should be sanded back, filled, leveled and repainted, as applicable.

A painting contractor should be appointed to perform necessary works to aid the appearance of the affected area and to ensure that the area is protected against further deterioration at the clients discretion.

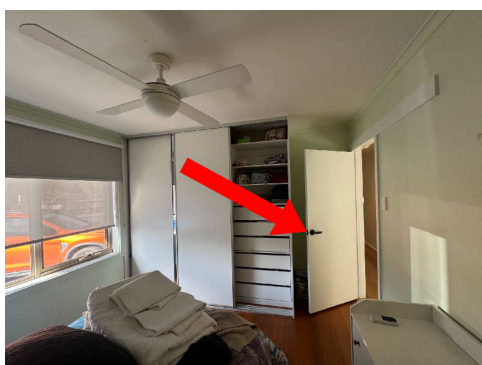
| Finding: | Door - Striker plate misaligned |
| Information: | <p>The striker plate to this door appears to have become misaligned and has consequently resulted in the door's operation being compromised.</p> <p>This is a common defect, whether being due to substandard installation or general deterioration of the door hardware.</p> <p>Readjustment of the striker plate is recommended as soon as possible to improve the operational state of the associated door.. Works such as these can be completed by a qualified carpenter or general handyperson.</p> |

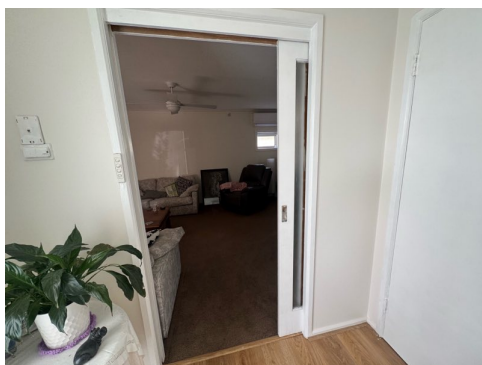
| Finding: | Door - Stiff to slide |
| Information: | <p>The door to this area was difficult to slide along the associated track at the time of the inspection.</p> <p>Generally, factors such as the general age of the building element and a lack of maintenance are the usual causes for this defect.</p> <p>Minor repairs and/or cleaning is advised to improve the operational state of the associated door.</p> <p>A qualified carpenter or general handyperson should be appointed to perform rectification works as soon as possible.</p> |

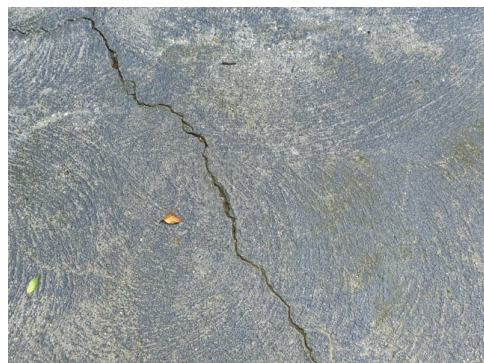
Hairline cracks may also be due to poor original installation of the concrete. Factors such as poor compaction of the sub surface and/or inadequate reinforcing of the slab may create cracking and other secondary defects.

Monitoring of all cracking should be conducted frequently. Always contact a building inspector should cracks widen, lengthen, or become more numerous.

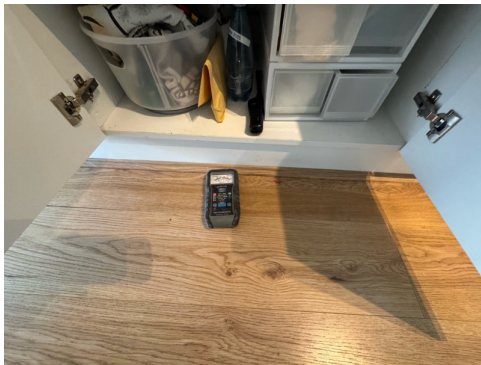
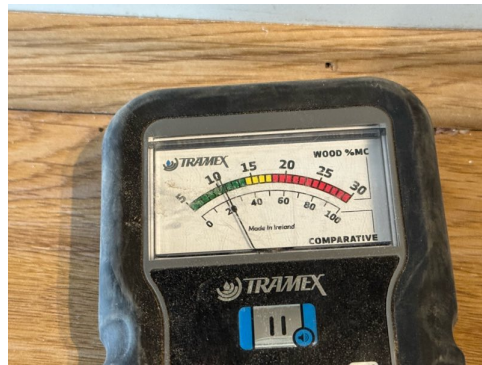
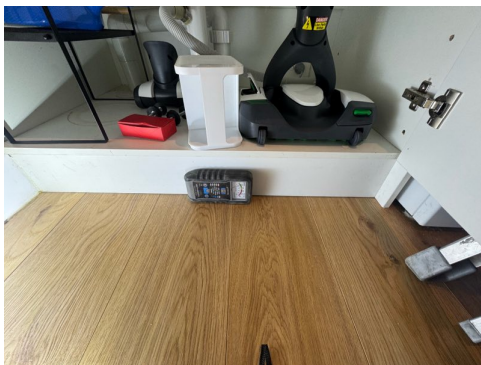
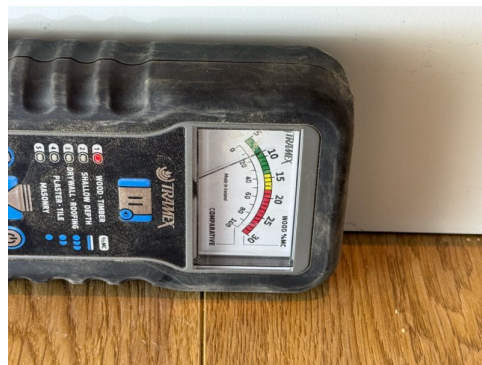
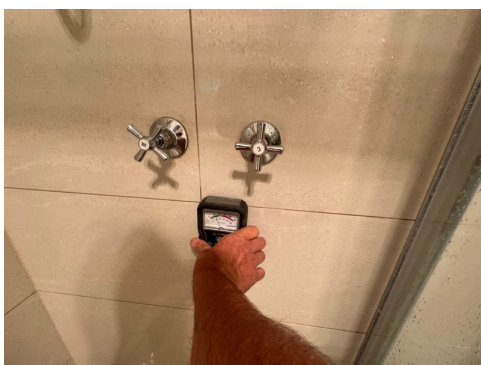
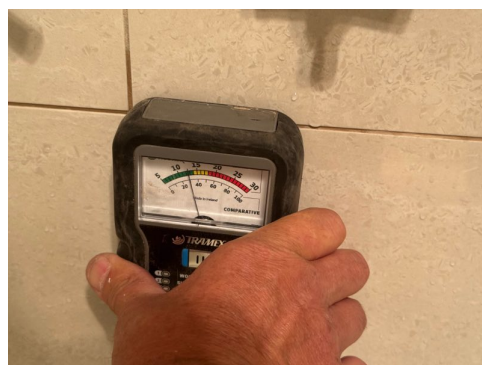
Finding: Wet area - Inspection

Information: There was no visible evidence of water escape from the accessible areas around the wet areas of the property at the time of inspection. Plasterboard walls, ceilings, carpet, cabinetry or timber skirting adjoining the wet areas showed no evidence of water staining or damage. Moisture readings taken did not indicate any areas of elevated dampness to the external areas and to the opposing walls. The client should be aware that all wet areas should be inspected regularly. Deteriorated grout and sealants should be immediately addressed to prevent water from escaping. Even the smallest break in sealants or grout will allow water to escape into the adjoining structures. If there are any signs of deterioration to sealants and grout, cracked tiles or bases, water damage or water escape a registered building practitioner should be immediately engaged.
