## Building Inspection Report

Inspection Date: Tue, 10 Mar 2026

Property Address: 175/1 Fontenoy Rd, Macquarie Park NSW  
2113, Australia

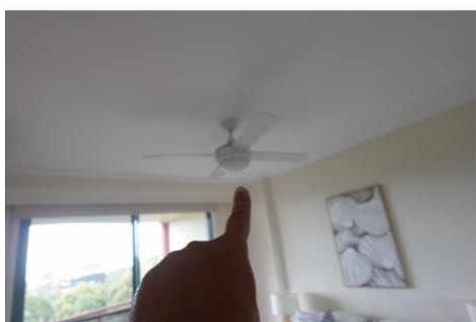
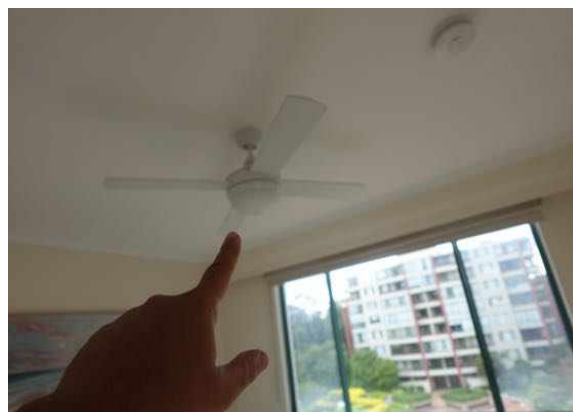
#### Defects 3.01

Building: Main Building  
 Location: Several lights  
 Finding: Down lights - Inoperable  
 Information: Several down lights were found to be inoperable at the time of inspection.

It is advised to engage a licensed electrician to replace such lights.

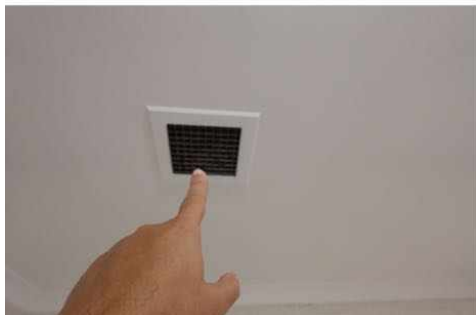
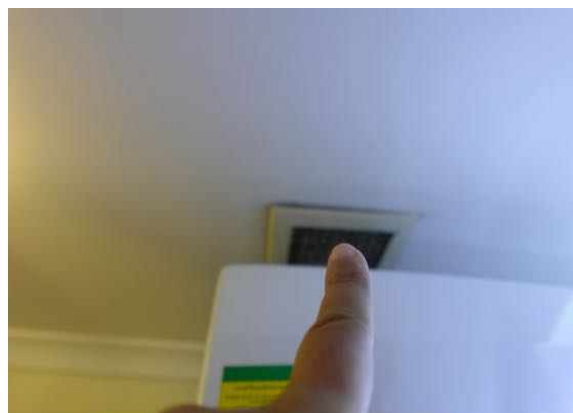
#### Defects 3.02

Building: Main Building  
 Location: Main bathroom/laundry  
 Finding: Exhaust fan - Not operating  
 Information: These exhaust fans appears to be damaged or blocked and is not operating as intended. If left unmanaged, a lack of general maintenance is likely to lead to the development of more significant defects, such as water damage to surrounding building materials from inadequate ventilation. If left unattended for a prolonged period of time, poor ventilation in this area may also be conducive to the development of mould.

Where no secondary damage has developed, the Homeowner may undertake minor

cleaning of the area and consider replacement of the exhaust fan. Alternatively, consultation with a Licensed Electrician is required to check for any secondary or concealed damage and consider repair or replacement.

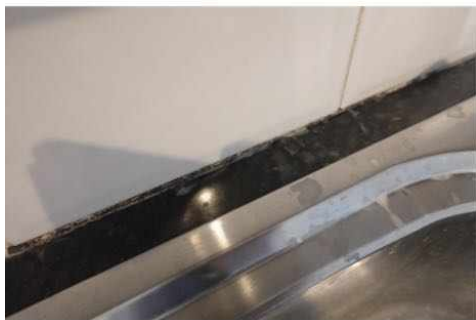
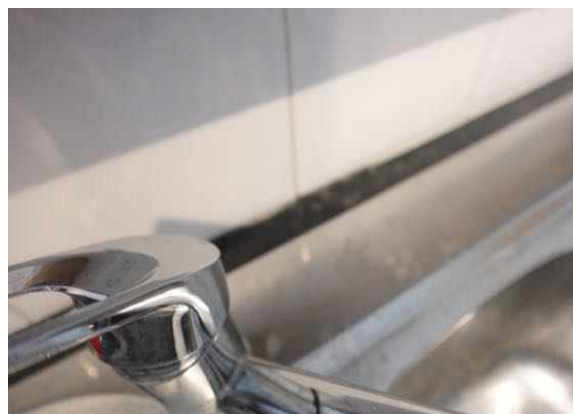
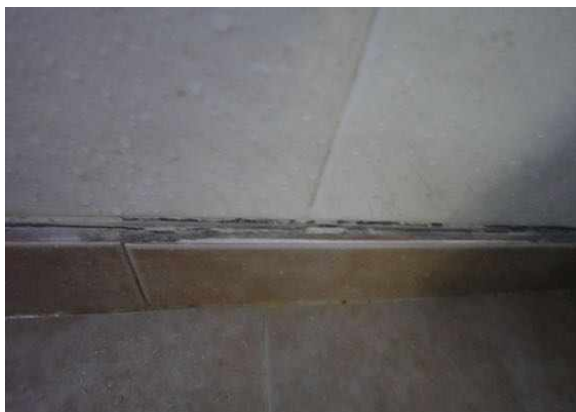
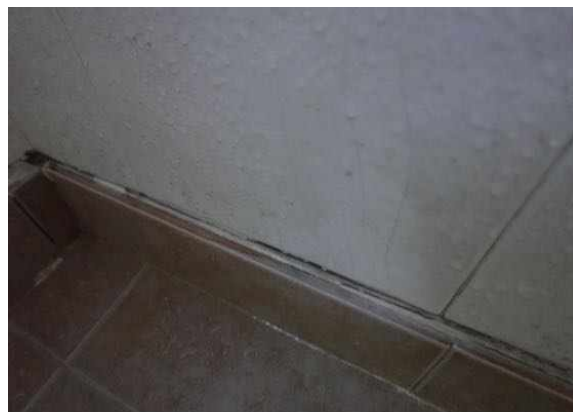
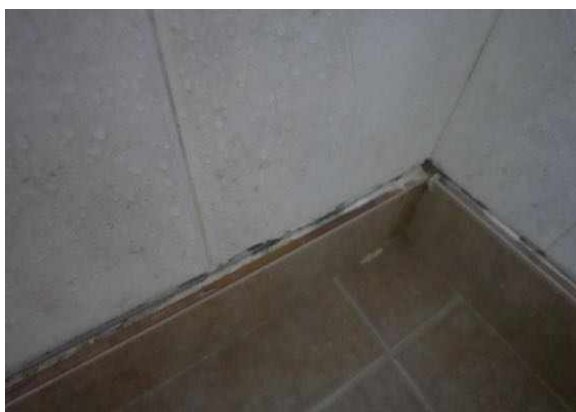
### Defects 3.03

Building:	Main Building
Location:	several wet areas
Finding:	Sealant and grouting - Inadequate
Information:	It was noted on inspection that sealant or grout is degraded to several wet areas. Different materials and floor areas move at different rates, generally causing cracking to grout or sealant at this point.

A flexible sealant is required to allow for expected expansion and contraction, while keeping the joint water tight and protective of all associated building materials.

Flexible and mould resistant materials should be applied to affected areas to prevent any subsequent water damage that is likely to occur. Regular maintenance and replacement of damage or missing or damaged sealant and grout is highly recommended to the wet areas, as this is a regular wear and tear defect

Sealant and grouting in areas that come into regular contact with water should be maintained for the long term care of your property.

A licensed sealant specialist /licensed tiling contractor should be appointed to complete these works as soon as possible.

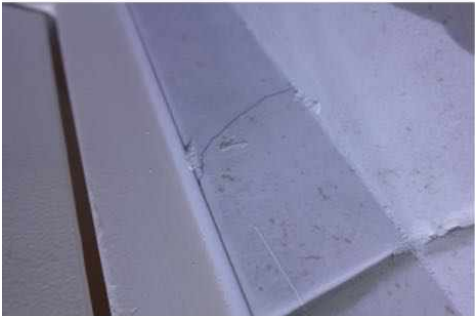
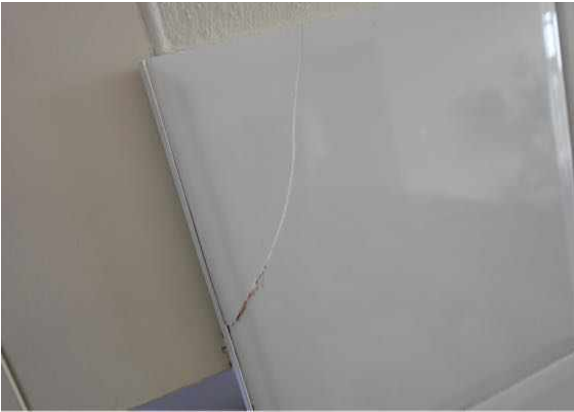
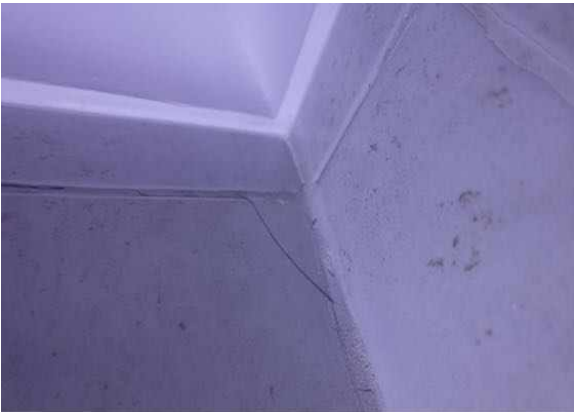
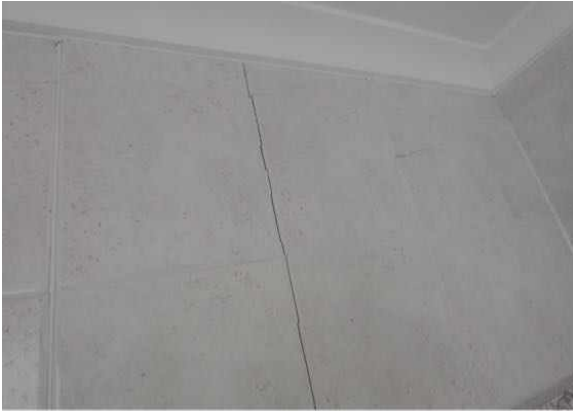
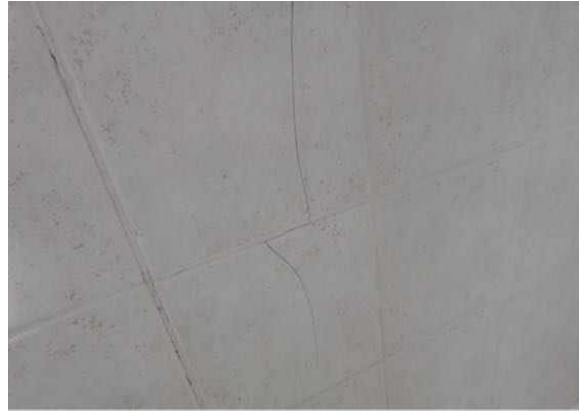
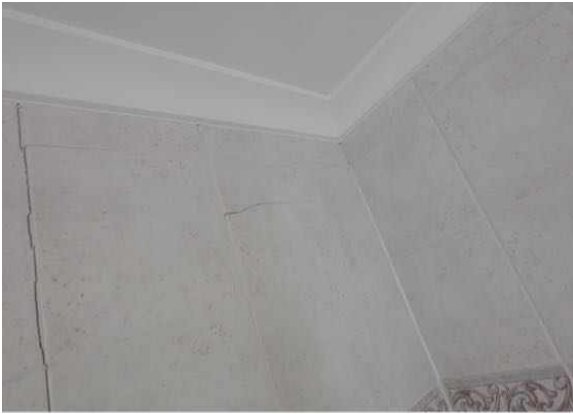
### Defects 3.04

Building:	Main Building
Location:	Several tiles
Finding:	Tiles - Cracked or damaged
Information:	Cracking were evident to the tiling in these area at the time of inspection. While the cracking appears to be minor, these area are frequently exposed to water, allowing potential for water penetration into adjoining sections of walls or flooring.

If left unmanaged, water penetration to these areas may lead to subsequent water damage, which is likely necessitate repair work to affected building elements.

A licensed tiling contractor should be appointed urgently to ensure that no further

water damage occurs. The re-application of silicone and grouting throughout remaining tile work is also advised, to further protect the area against water penetration.

Where water penetration has led to water damage, appointment of a relevant licensed tradesperson may be required to repair damaged building elements.

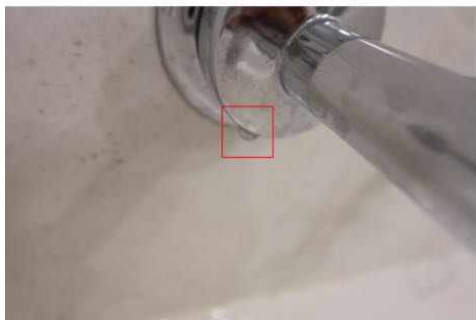
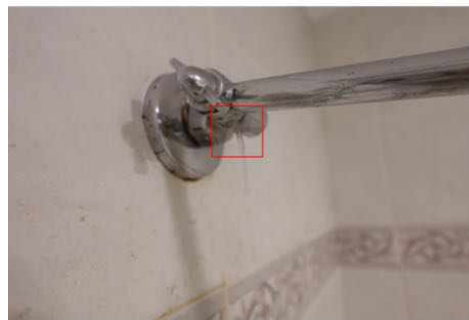
### Defects 3.05

Building: Main Building  
Location: Several taps  
Finding: Taps - Loose  
Information: These taps have not been installed correctly, or has deteriorated with age, and is consequently loose.

Taps being loose creates potential for water leaks and subsequent water damage to the surrounding area.

Where taps or spouts are loose, a licensed plumber should be appointed to re-fix the plumbing fitting.

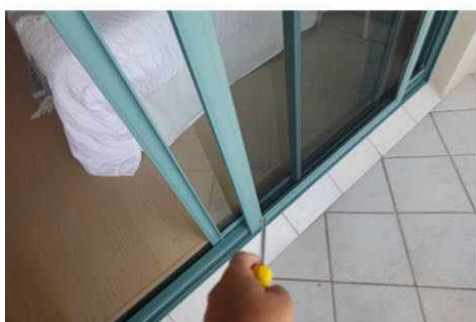
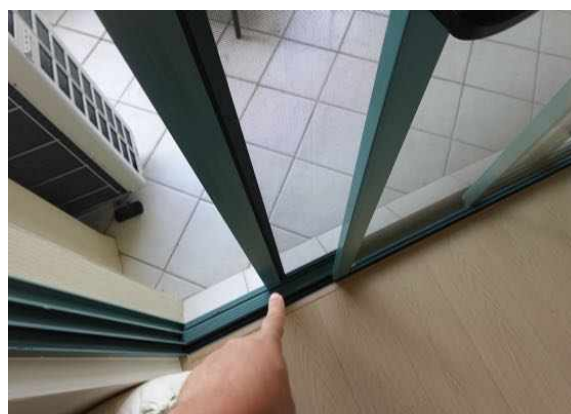
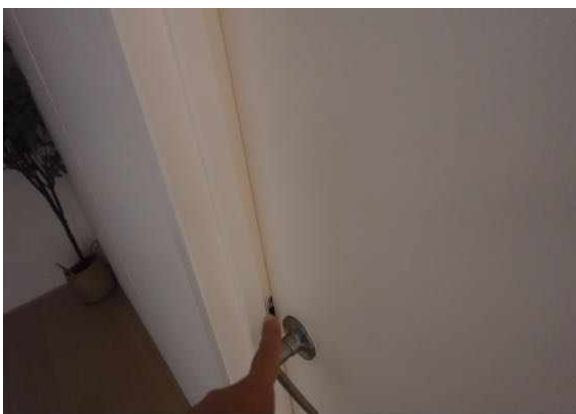
## Defects 3.06

Building:	Main Building
Location:	Several doors
Finding:	Door - Binding/jamming
Information:	Binding and/or jamming of these doors are evident during standard operation. This defect inhibits the functionality of the affected door as well as creating potential for secondary defects to associated building elements, such as damage to the floor covering.

A door that binds to flooring or to the associated door frame may have several causes, ranging from minor defects, such as poor installation of the door or deteriorated hinges, through to major structural issues, such as damage to floor, door frames or subfloor structures if applicable.

Where door binding/jamming appears to indicate major structural issues, a registered builder should be appointed to provide an estimate on the cost of rectification.

For minor causes, a licensed carpenter should be appointed to perform minor rectification works at client discretion.

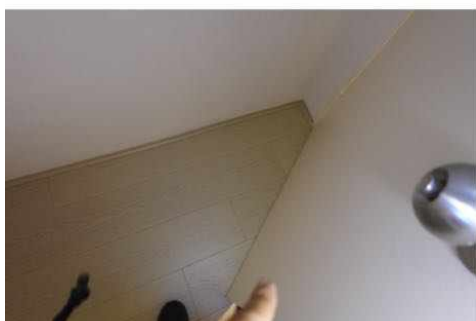
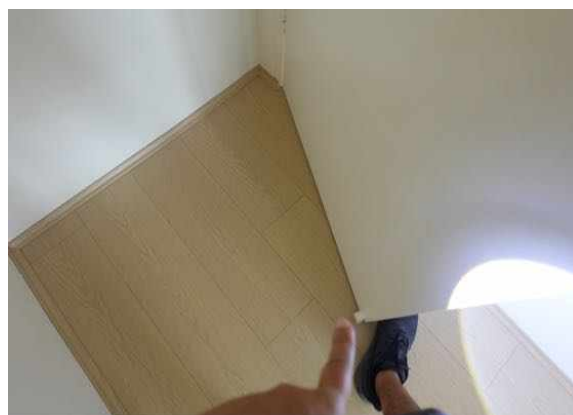
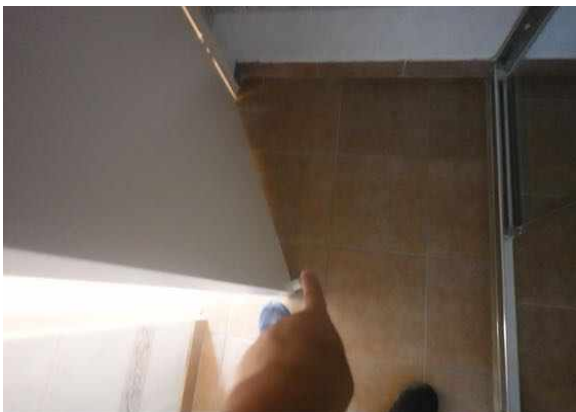
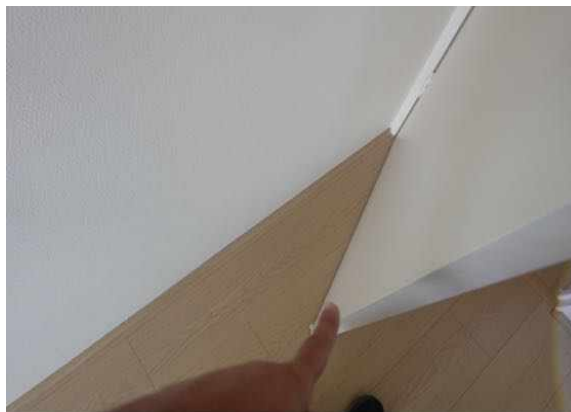
### Defects 3.07

Building:	Main Building
Location:	Several doors
Finding:	Door stop - Missing
Information:	The door stop were missing or is inadequate to stop the door handle from damaging the wall. Although some building elements may seem irrelevant or unnecessary, all building elements play a key role in the operation and function of the overall structure and its performance.

Re-installation or replacement of door stop is advised as soon as possible to prevent any subsequent damage to the door or associated structures.

A licensed carpenter may be appointed to perform these works at client discretion.

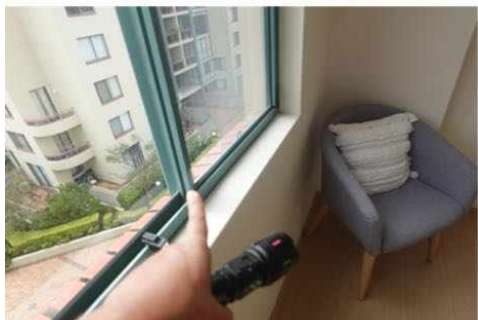
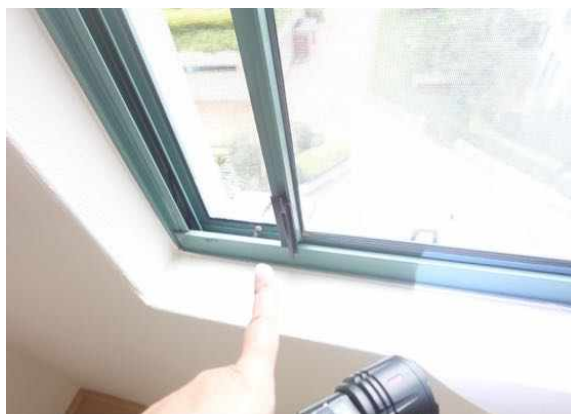
### Defects 3.08

Building:	Main Building
Location:	Several windows
Finding:	Window - Stiff to slide
Information:	The window in these area were jammed and difficult to operate at the time of the inspection. Windows provide ventilation to the adjoining area and should be at a fully operational level to ensure user comfort.

Restricted function of the window may also pose as a potential safety hazard if required for emergency egress from the building.

Generally, factors such as general age of the building element and a lack of maintenance are the usual causes for this type of defect.

Replacement of window hardware or frame may be required, as well as minor repairs and cleaning.

A registered builder or licensed carpenter will be required to repair the window.

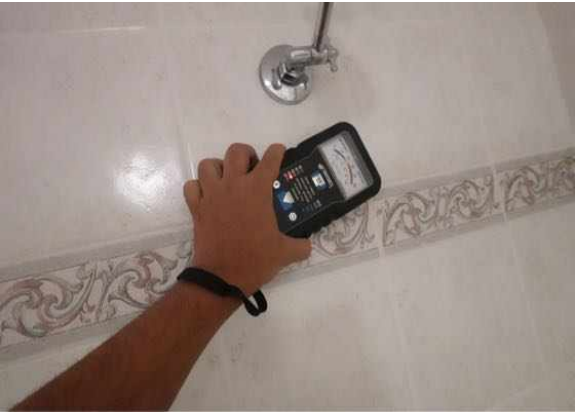
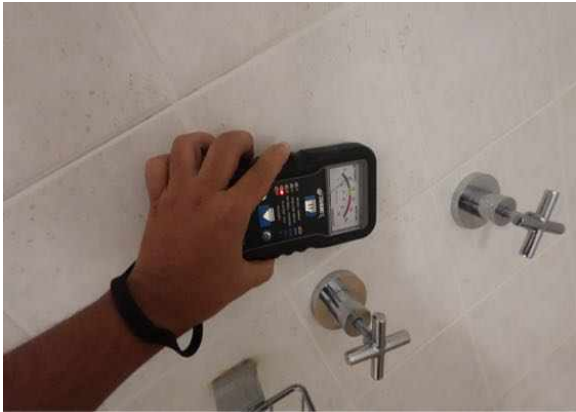
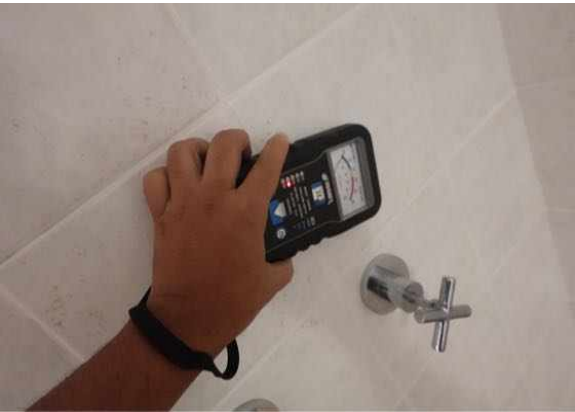
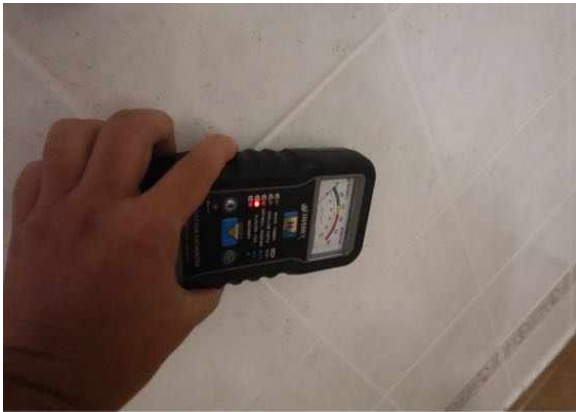
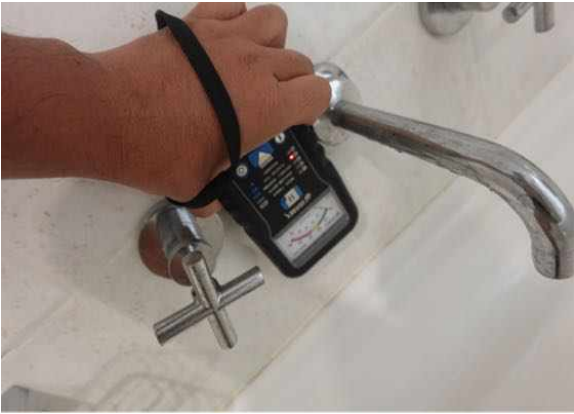
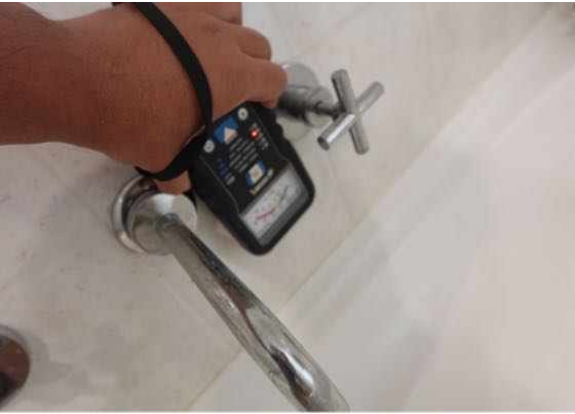
Building: Main Building  
Location:  
Finding: Moisture check  
Information: During inspection, moisture meter was used and no high moisture detected at the time of inspection.

Please note if the wet areas have not been used for some time, moisture readings would not vary significantly and this can lead to erroneous results.

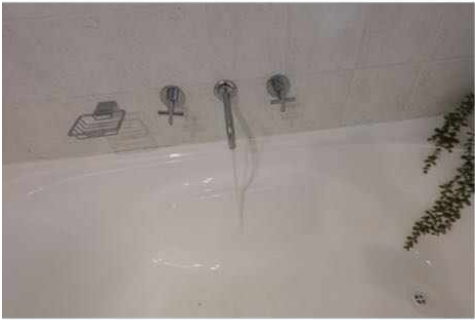
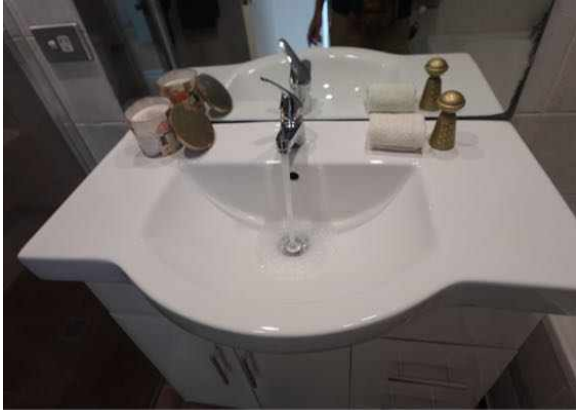
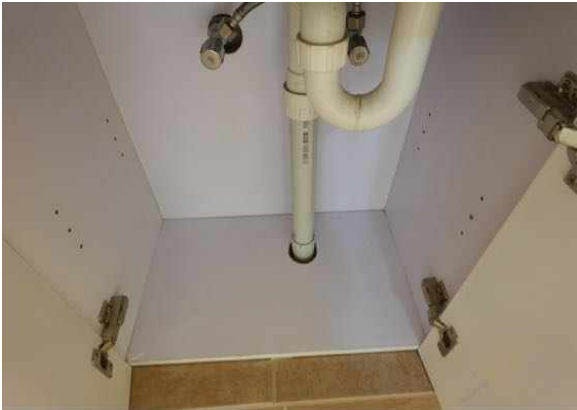
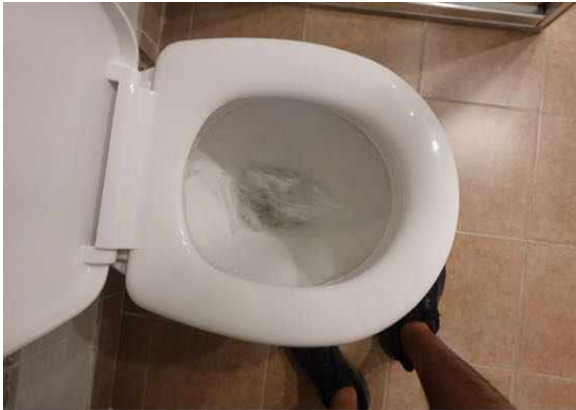
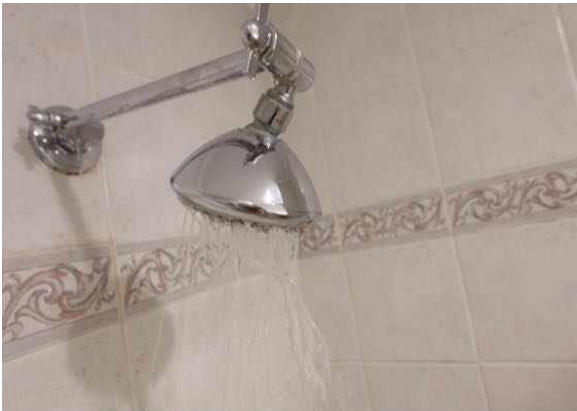
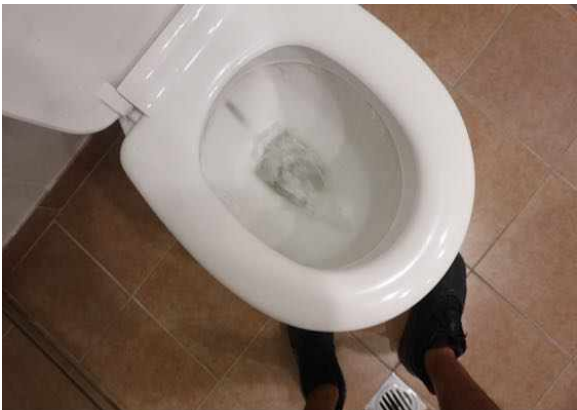
Building:	Main Building
Location:	All internal areas
Finding:	Taps, toilets and sinks tested : Visual only
Information:	Taps, drainage and toilets were checked for water flow and drainage was checked for leakage.

Unless identified in a separate defect, no remedial work appears to be required on these items at the time of the inspection.

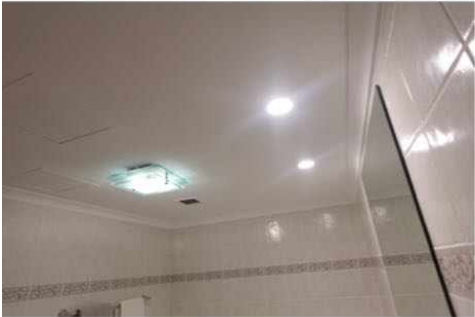
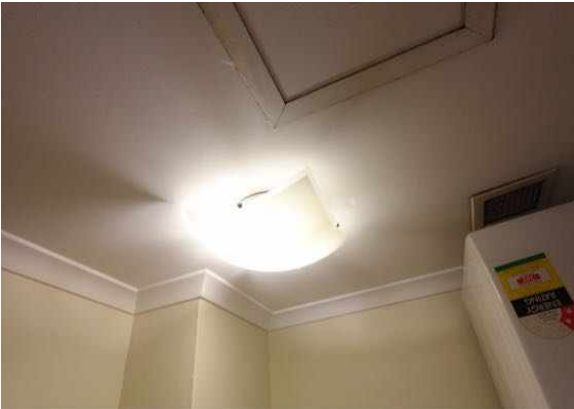
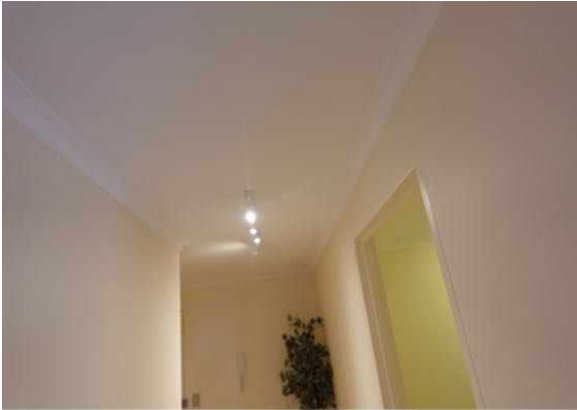
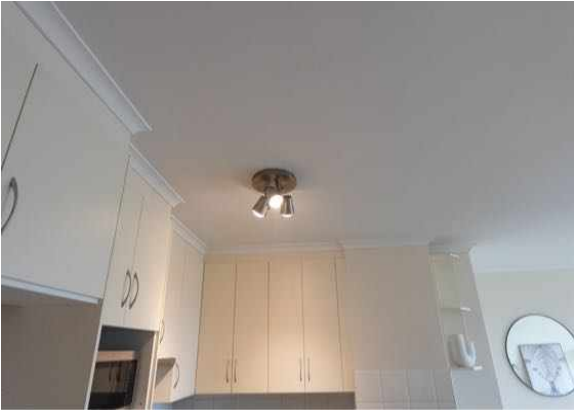
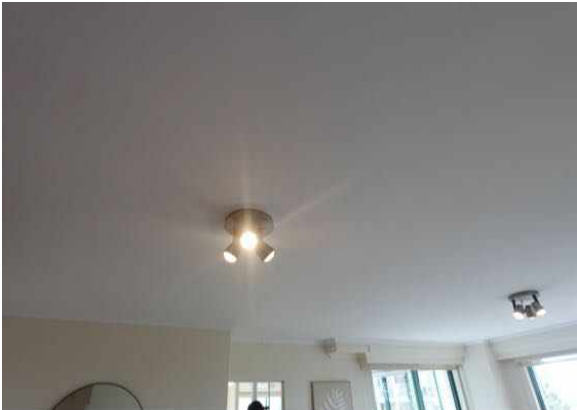
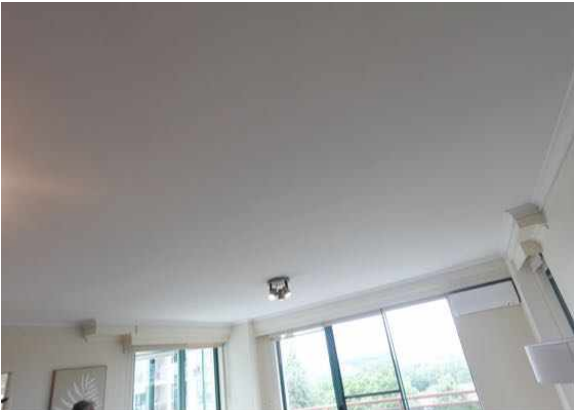
Building: Main Building  
 Location: All Lights  
 Finding: Electrical switches and light tested : Visual only  
 Information: Electrical inspections are outside the scope of the building inspection and must be conducted by a Licensed and registered Trades person.

It is highly recommended that the client makes arrangements to have the electrical checked by a licensed tradesperson to ensure that they are working safely and efficiently.
