Building and Timber Pest Inspection Report

Inspection Date: Tue, 3 Feb 2026

Property Address: 19 Sanibel Ct, Parrearra QLD 4575,
Australia

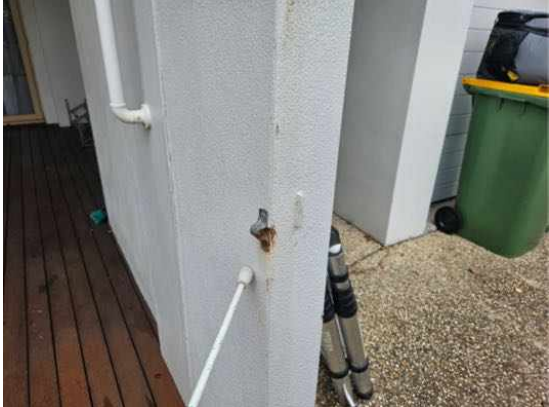
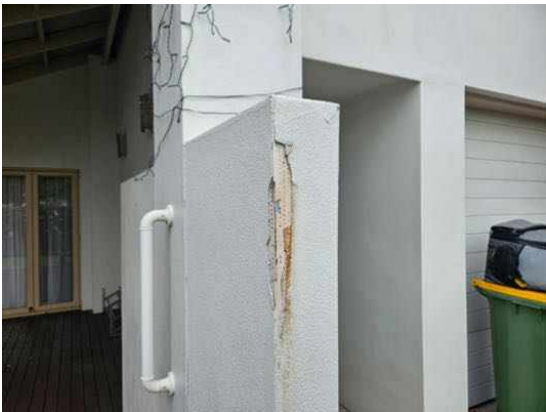
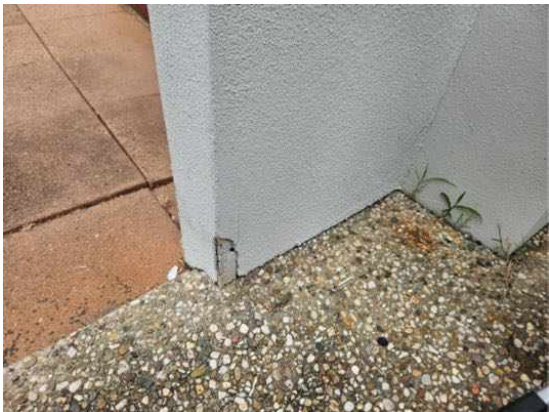
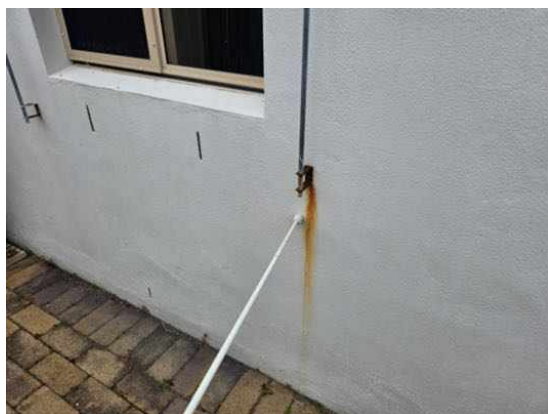
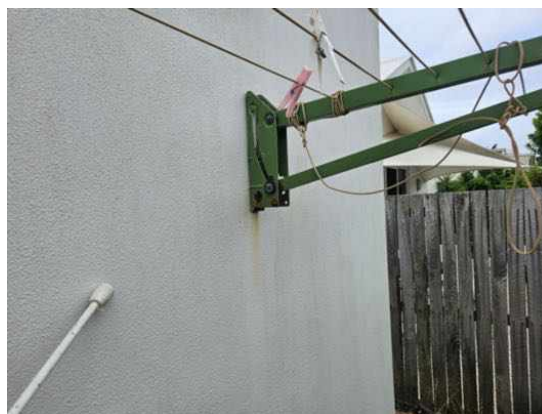
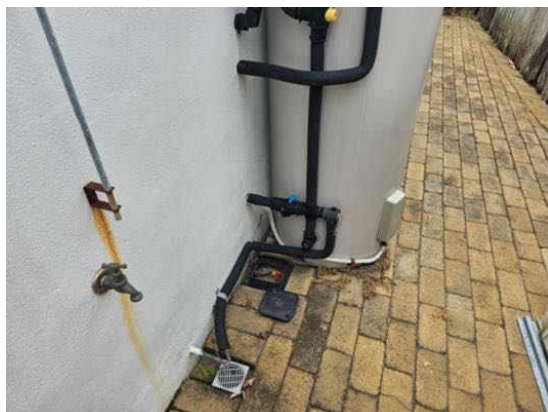
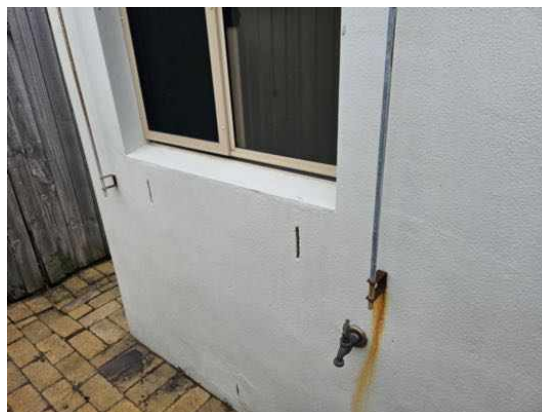
Finding 3.01

Building: Main Building
Location: As shown
Finding: Damage / deterioration to external walls.
Information: Noted during the inspection of the external areas was rust, paint deterioration and minor damage to walls.

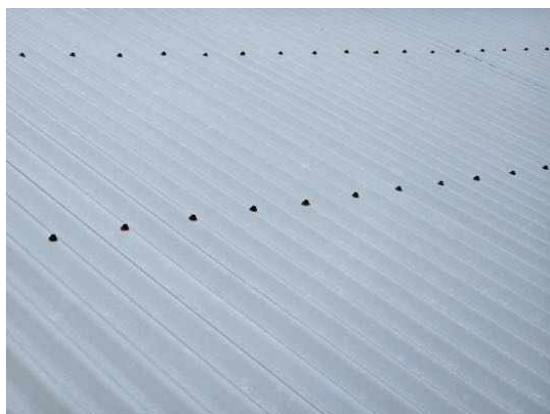
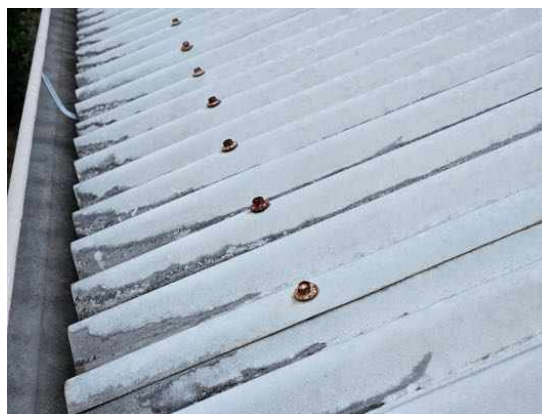
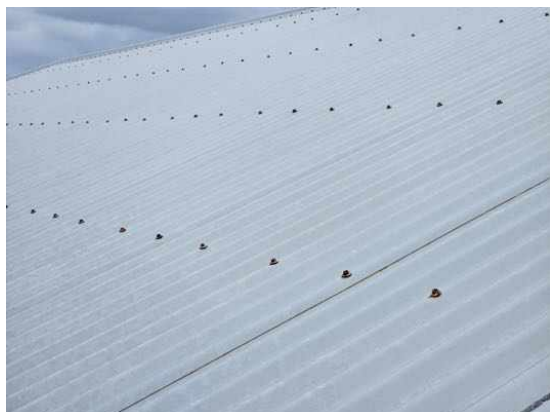
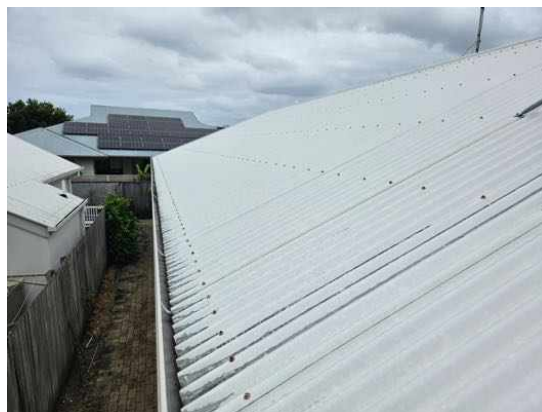
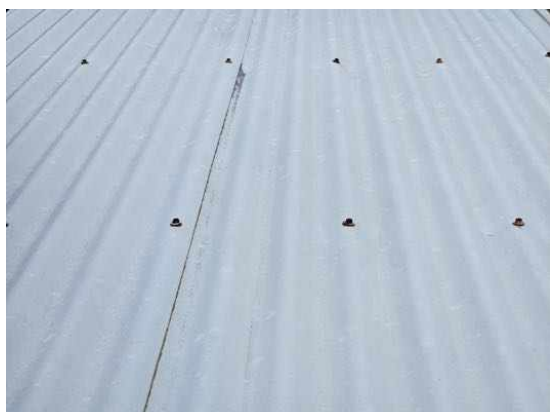
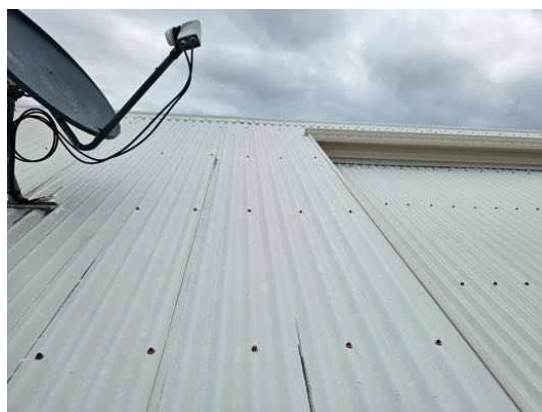
Finding 3.03

Building: Main Building
 Location: All External Areas
 Finding: Roof screws - rusting
 Information: It was noted during inspection, that throughout the roof surface the majority of roof screws are showing signs of rust at varying degrees ranging from minor to moderate.

The roof condition is noted as a minor defect ; however it should be made a priority to maintain the surface condition and prevent possible leaks and further deterioration.

This should be monitored over time, and should the condition worsen, consider replacement of the screws. As roof screws deteriorate they can have an effect on the adjoining roof materials.

A roofing plumber could be appointed at the clients discretion to replace the screws in question.

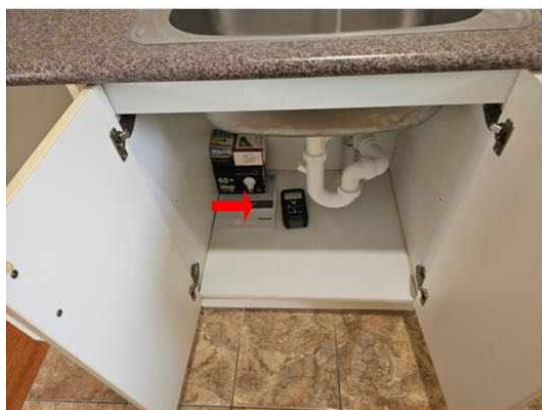
Finding 3.04

Building: Main Building
 Location: Laundry
 Finding: Laundry tub cabinet - moisture
 Information: It was observed during the inspection that the floor of the laundry tub cabinet has minor elevated moisture readings. This is possibly from a previous leak.

This should be monitored and if there is a deterioration, repairs carried out accordingly.

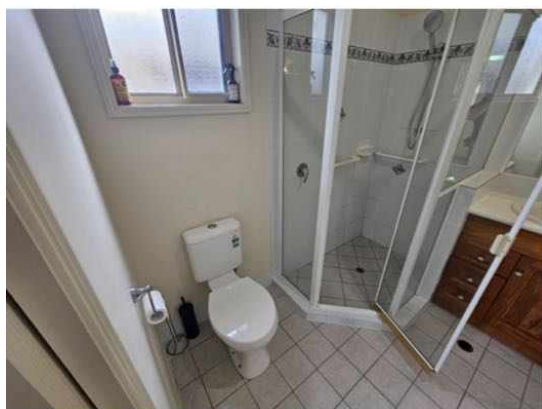
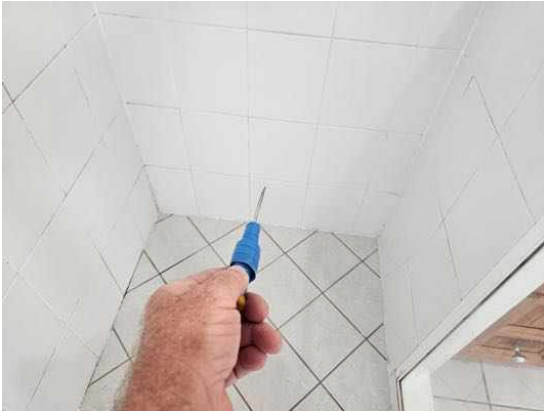
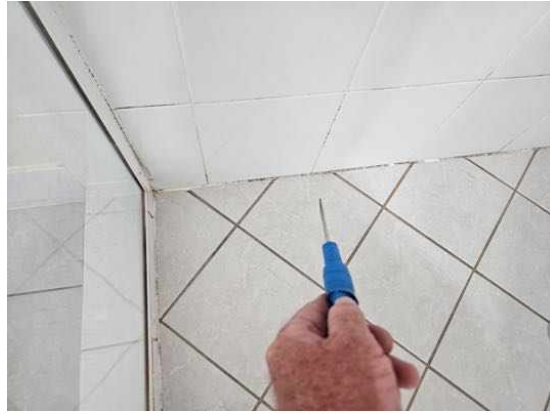
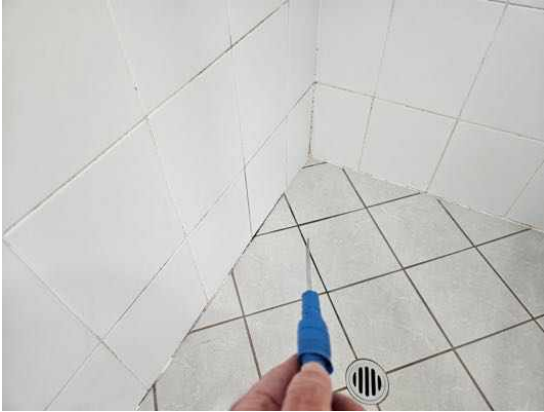
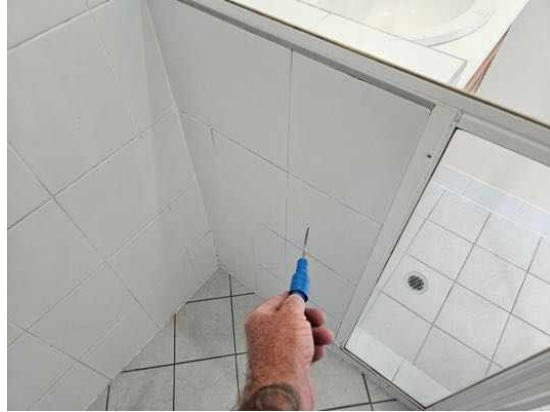
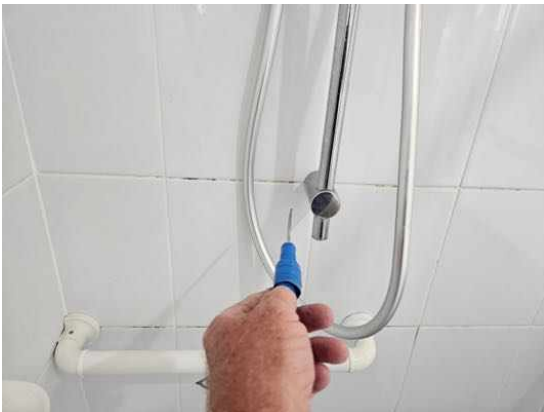
Finding 3.05

Building:	Main Building
Location:	Ensuite - Master
Finding:	Sealant and grouting - degraded
Information:	It was noted on inspection that the sealant and grout is degraded to the ceramic tiled shower alcove of the ensuite.

Different materials and floor areas move at different rates, generally causing cracking to grout or sealant at this point. A flexible sealant is required to allow for expected expansion and contraction, while keeping the joint water tight and protective of all associated building materials.

Flexible and mould resistant materials should be applied to affected areas to prevent any subsequent water damage that is likely to occur. Regular maintenance and replacement of damage or missing or damaged sealant and grout is highly recommended to the wet areas, as this is a regular wear and tear defect. Sealant and grouting in areas that come into regular contact with water should be maintained for the long term care of your property.

A sealant specialist or tiling contractor should be appointed to complete these works as soon as possible

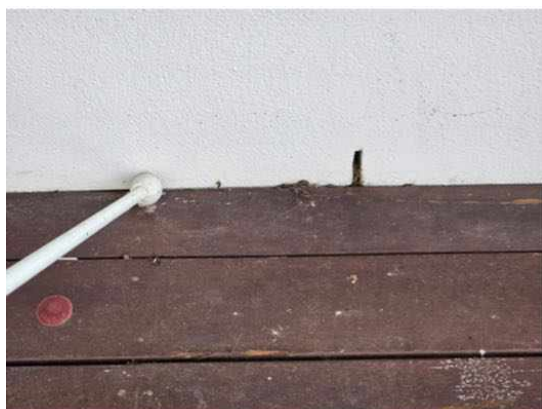
Finding 6.01

Building: Main Building
Location: Front patio deck
Finding: Deck against house - inspection zone
Information: The entry deck as inspected on the day, is built against the house perimeter and above the weep holes. An inspection zone between decking and the house exterior is required to maintain visual inspection area, gap of greater than 25mm between structures and the slab edge of the home is required.

Where the slab edge cannot be properly inspected, there is a high risk of termite attack. It is usually recommended that termite or timber pest inspections be carried out every 6-12 months to aid protection of the property against infestation.

The deck structure is close to the ground and cannot be inspected visually from under the structure, a chemical barrier system appears to be in place to mitigate much of the risk created by the reduction of inspection ability. The barrier must be kept current.

This inspection zone should be maintained in order to force termites into the open where they can be detected more readily during regular inspections. The slab edge should not be concealed by anything that may prevent inspection of the area, including render, landscaping, soil, turf, paving, concrete, cladding or other structures.

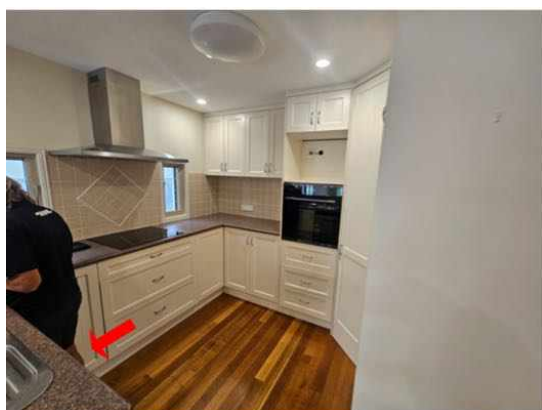
Building:	Main Building
Location:	Meter box, kitchen cupboard
Finding:	Durable pest inspection notice - not assessable
Information:	On the day of inspection it was noted that the durable timber pest inspection / treatment notice was missing, not visible or out of date. These notices / stickers are to verify the timber pest inspection dates, the inspector, the currency and type of timber pest system / barrier in place or being used in and around the property.

Annual, or more regular, inspections are crucial in maintaining and managing the properties timber pest risk profile. By not having regular inspections of the property raises the properties risk of undetected defects and damage. Without regular inspection at intervals of not greater than annually the buildings risk profile will be categorised as high. Properties with trees within 50m and with gardens close to the building are at greater risk and will have a high risk profile.

It is recommended that a licensed timber pest controller be contacted to assess the properties needs and provide costings for an annual inspection programme.
