# Building and Timber Pest Inspection Report

Inspection Date: Fri, 30 Jan 2026

Property Address: 46 Warrain Cres, Currarong NSW 2540, Australia

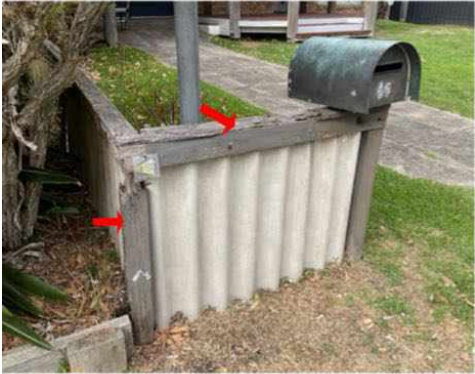
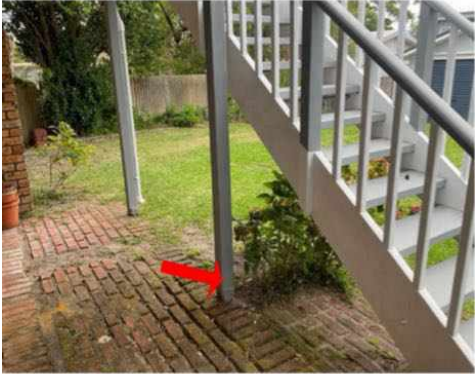
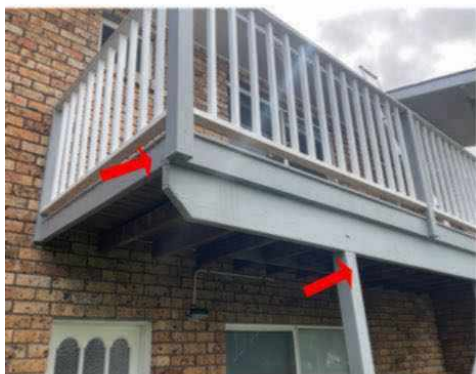
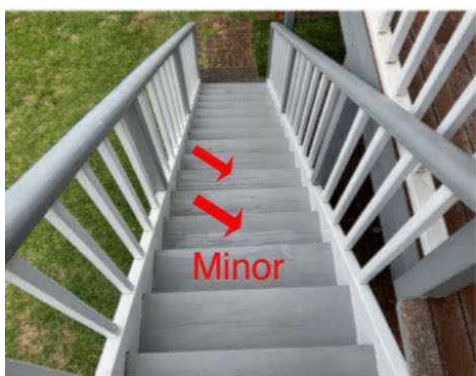
Building:	Building 1
Location:	Front and rear decks, some posts may require replacement.
Finding:	Wood rot
Information:	The building shows evidence of wood rot. Photos 5-8 of the 2 areas of the rear deck will need repair or replacement in the next year.

Wood rot, also known as Fungal Decay, occurs when timbers and other cellulose building materials are exposed to damp conditions on an ongoing basis. This could be the result of exposure to weathering over a prolonged period of time, or the attraction of excessive moisture from other abutting building materials.

Early intervention and regular maintenance, particularly of exterior timbers, will prolong the useful life of these building elements. Replacement of affected these timbers may then be a necessary step in protecting surrounding building elements from such deterioration.

A qualified carpenter or registered builder may also be required to replace affected building materials.

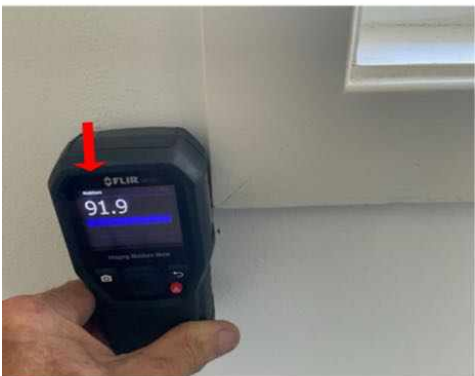
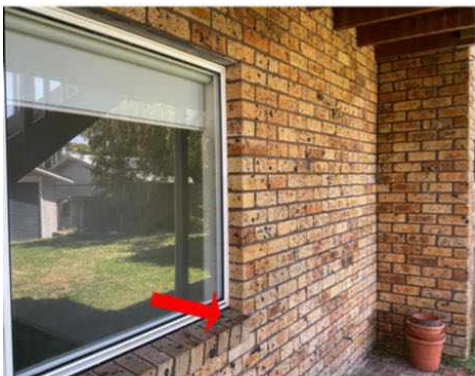
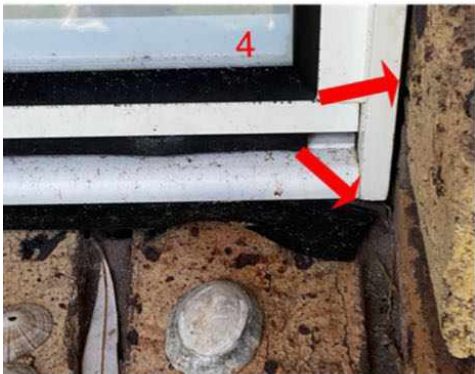
Building:	Building 1
Location:	Garage and lower bedrooms
Finding:	Evidence of excessive moisture was present at the time of inspection
Information:	Excessive moisture was found in 4 lower areas. High readings of 63.1 to 96.1 were recorded. No damage was visible in these areas except the sagging garage ceilings.

Excessive moisture can attract termites and produce conditions that promote termite attack, fungal growth and wood decay.

Excessive moisture is generally caused by deteriorated inadequate or missing roof drainage, missing external sealant or mortar, leaking plumbing pipes or fixtures poorly plumbed HWS overflows or condenser units and poor site drainage.

It is highly recommended that all plumbing and drainage fixtures and fittings be maintained regularly in order to prevent excessive moisture being present in the internal property.

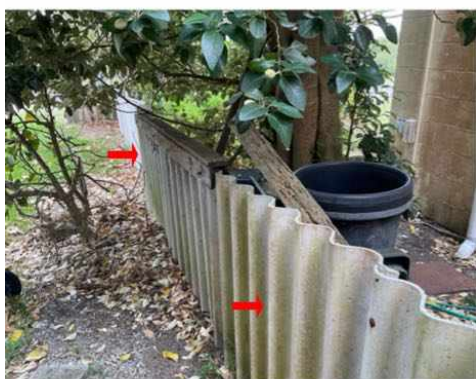
Building:	Building 1
Location:	Pictured fences
Finding:	Left fences damaged and leaning
Information:	Evidence of damage to the pictured left fences was identified at the time of the inspection. The likely cause of this fence leaning is not enough concrete used in the post footings, wood rot and wood bora damage. If left unmanaged these fences may deteriorate further.

It is suggest a fencing contractor be engaged for rectification when convenient.

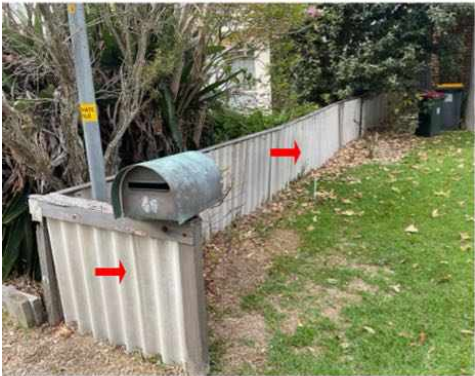
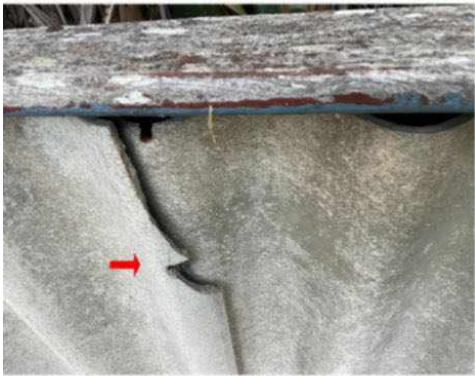
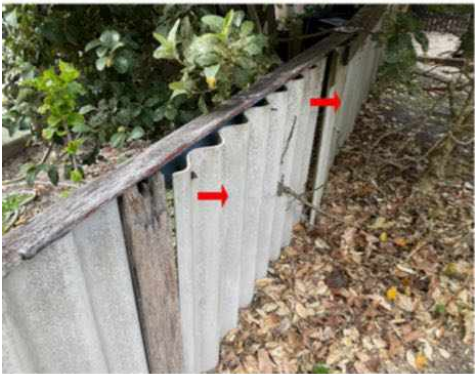
Building:	Building 1
Location:	Exterior left fences and rear shed
Finding:	Asbestos - Suspected ACM Identified on Site
Information:	Reporting on Asbestos is outside the Scope of this Report. This suspected defect is highlighted as a caution only. We suspect, based on our experience in the building industry, that there is a higher risk of the identified fences and rear shed containing asbestos, some poor condition.

As Asbestos Reporting is outside the scope of this report, we advise that you consider a separate Asbestos Inspection and Condition Audit, which can include the taking of samples for definitive confirmation of the presence of Asbestos.

In the interim, the client is advised to act with caution, especially when considering any damage to building materials general wear and tear renovations extensions demolition and general maintenance activities due to the suspected presence of Asbestos.

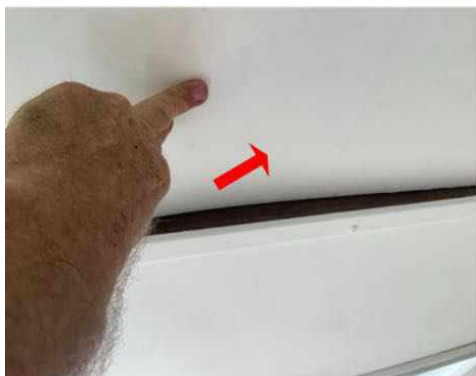
**Finding 3.10**

Building: Building 1  
 Location: Pictured external areas  
 Finding: Building elements - Damaged  
 Information: Evidence of minor missing or damaged areas was identified at the time of the inspection. These include -

- 1. The rear shed has minor damage to some wall cladding (possibly asbestos) and the right side wall electrical conduit.

2. The rear house external entry has paving damage where some water may pool in high rain events.

3. The rear roof external eave shows minor sagging and loose panels.

A carpenter would be the trade responsible for rectification of these areas when convenient.

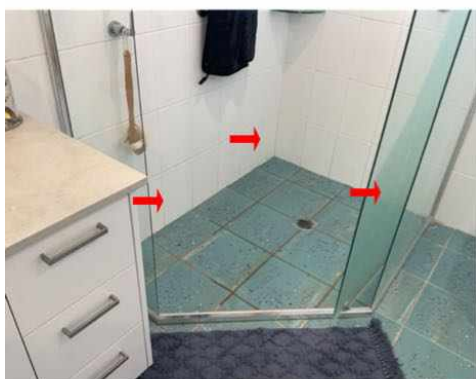
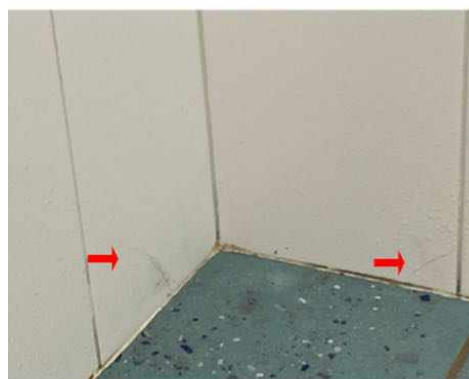
### Finding 3.11

Building:	Building 1
Location:	Bathroom
Finding:	Tiles - crazing
Information:	Some minor damaged tiles were evident in the upstairs shower at the time of inspection.

The tiles have suffered crazing. Crazing is internal fracturing without a change of the surface texture. Crazing can be a precursor to cracking if it extends to the surface, but even if it stops short of the surface, crazing still decreases the strength of the material.

These tiles still appear to be waterproof but may need replacement in the future and can be undertaken by a tiling contractor.

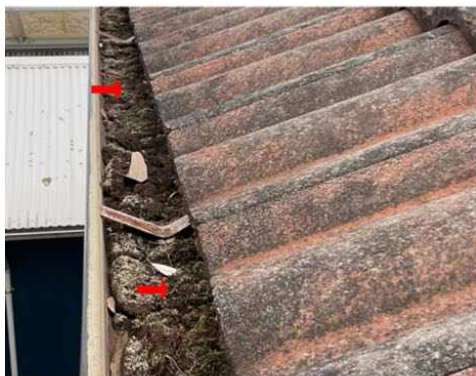
Building:	Building 1
Location:	Roof exterior
Finding:	Gutters - Full and blocked
Information:	The guttering on around the roof was found to be blocked at the time of the inspection. Roof plumbing structures, such as guttering and downpipes, should be free of all debris to prevent blockages. Blockages of the guttering and downpipes will lead to pooling and accumulated water overflows, which is likely to subsequently flood eaves and exterior walls.

Blocked gutters are likely to lead to high levels of moisture in the affected areas which can cause rust and decay of the gutters and downpipes and wood rot to adjoining timber areas. Blockages in gutters should therefore be removed immediately to ensure dry conditions are maintained.

It is highly advised that gutters be cleaned by the homeowner or a general handyperson as a matter of urgency.

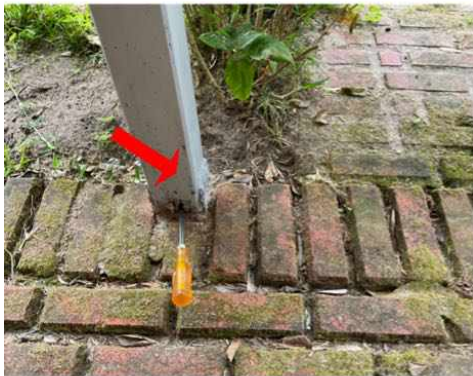
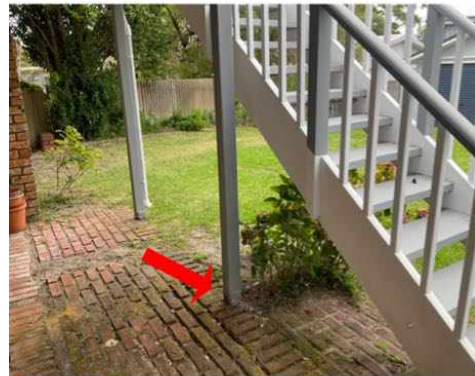
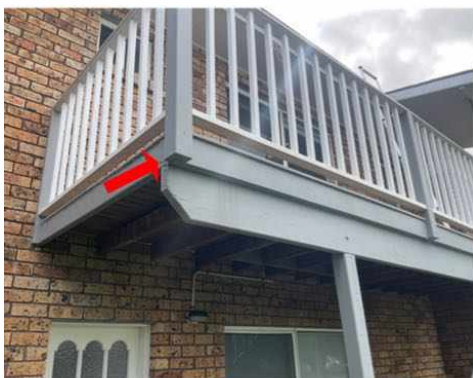
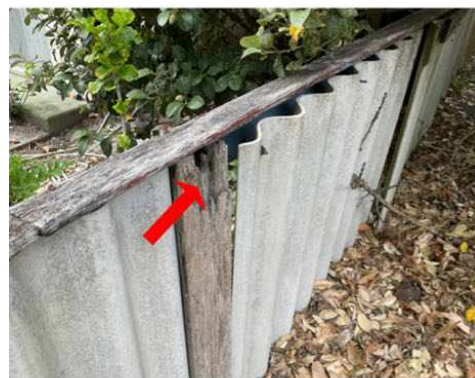
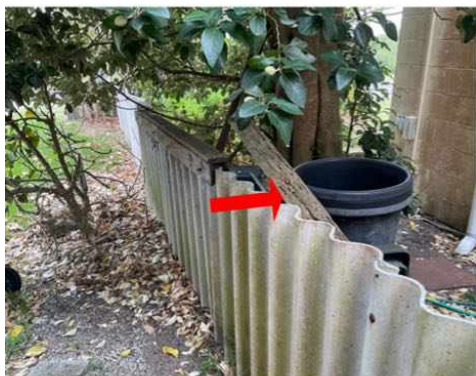
Building:	Building 1
Location:	Pictured areas
Finding:	Fungal decay - present (localised)
Information:	Fungal decay also known as wood decay or wood rot generally refers to the deterioration of timber elements when in contact with excessive levels of moisture for a prolonged period of time.

The development of fungal decay is accelerated by temperatures from 5degreeC to 40degreeC as well as the presence of oxygen. Generally fungal decay develops on timber elements that are in use in an external environment which are exposed to rain penetration.

In this case, these affected timber element are in a decaying state and will need replacement by a carpenter or licensed builder in the future. The rear middle verandah post requires urgent replacement.

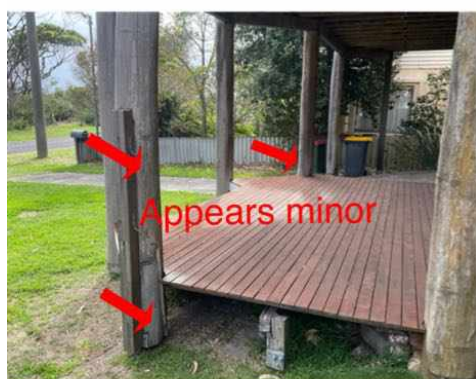
### Finding 8.01

Building:	Building 1
Location:	Many decking areas
Finding:	Evidence of wood borer activity identified (all appears minor)
Information:	Wood borers small beetles that colonise in exposed timber elements are a common timber pest that are regularly mistaken for termites. Although wood borer activity is generally not detrimental to the affected timber they may lead to serious damage and necessitate replacement of certain building elements if left unattended.

As no live wood borer activity was identified, treatment is not required at this time. Annual monitoring should be undertaken in areas where wood rot is occurring due to bora damage.
