Building and Timber Pest Inspection Report

Inspection Date: Fri, 16 Jan 2026

Property Address: 16 Devine St, Harristown QLD 4350,
Australia

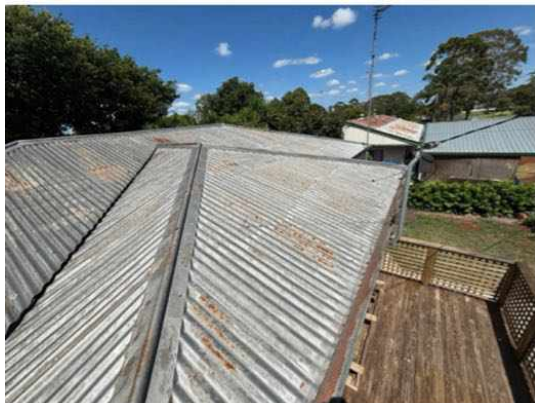
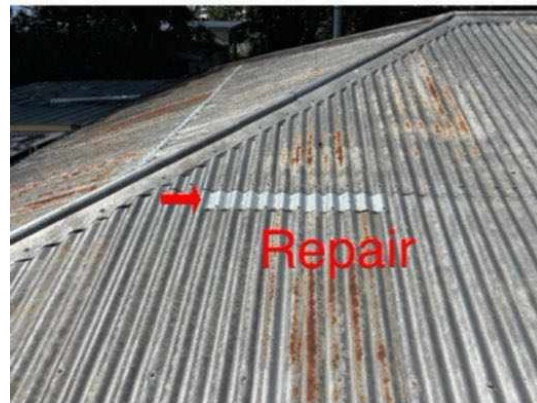
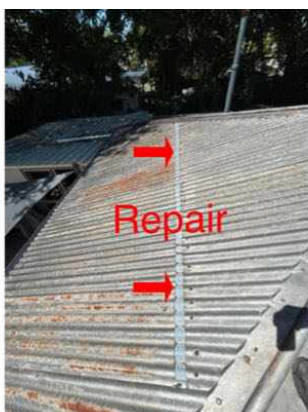
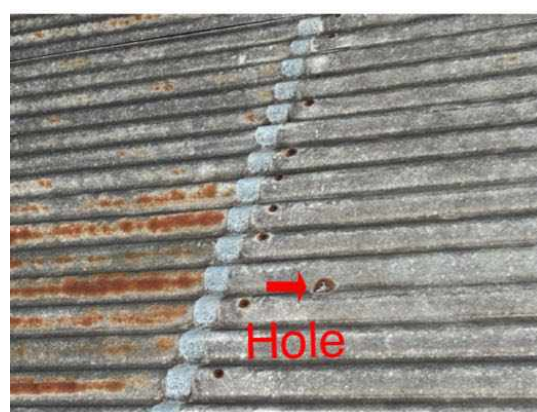
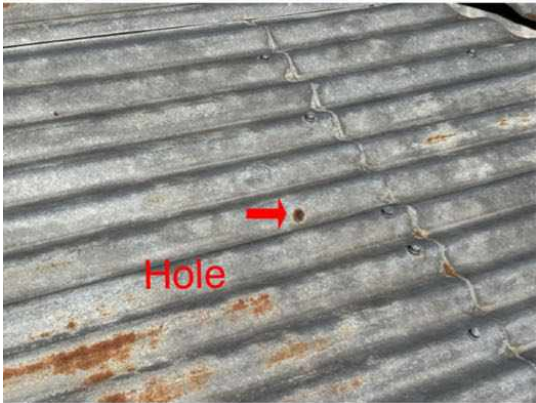
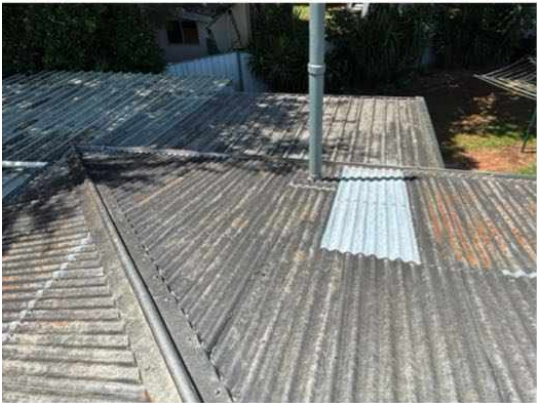
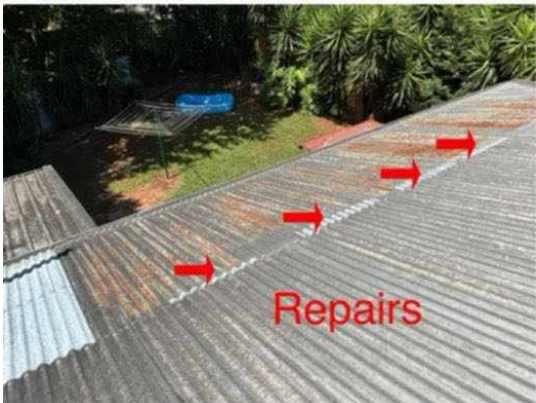
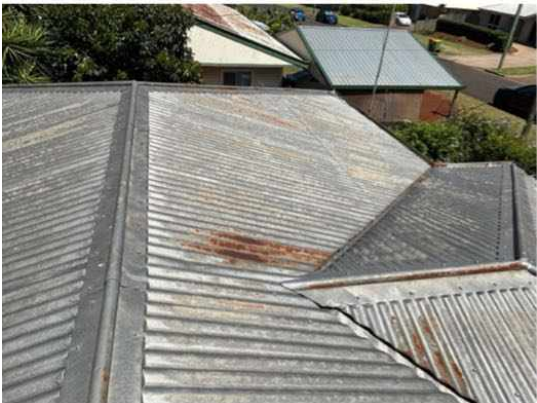
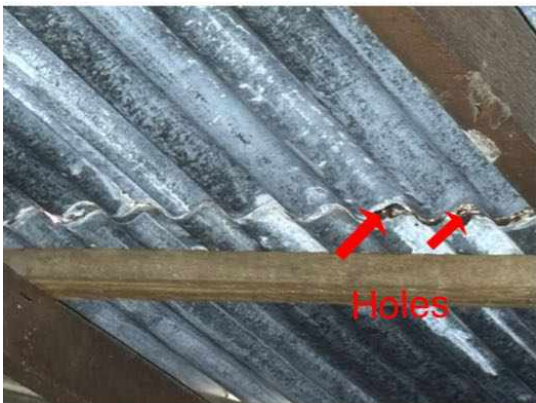
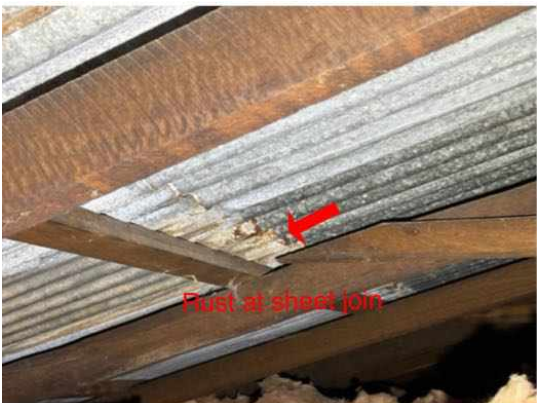
Finding: Roof exterior - evidence of rusting and repairs

Information: At the time of the inspection, it was noted that the metal roof covering had signs of rusting to it. The roof covering may be original. Several sections of the roof have had patch repairs carried out. There are holes in the metal roof sheeting in these areas. From inside the roof cavity, light can be seen through at least two holes.

If left unaddressed, further deterioration will occur which will lead to moisture entering the roof void and causing undetected damage to building materials.

A roofing contractor should be engaged to replace the roof. This should be done as a matter of urgency.

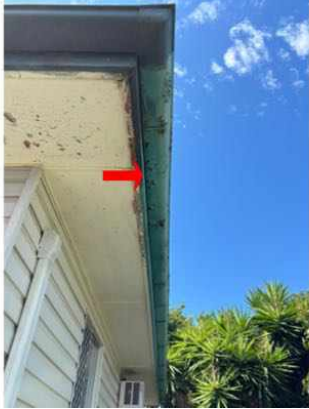
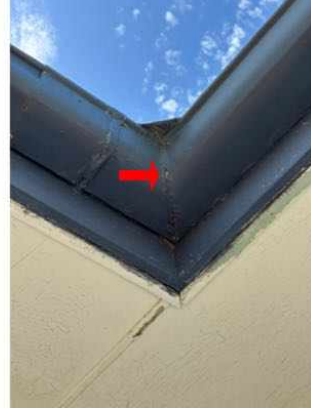
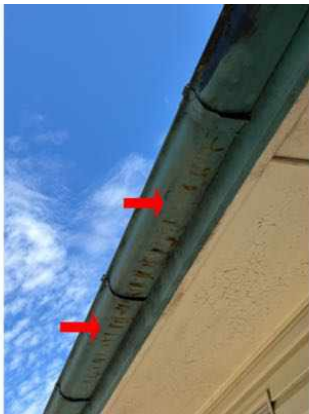
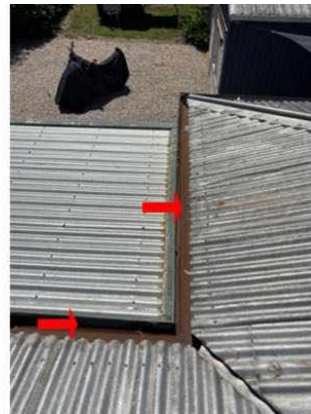
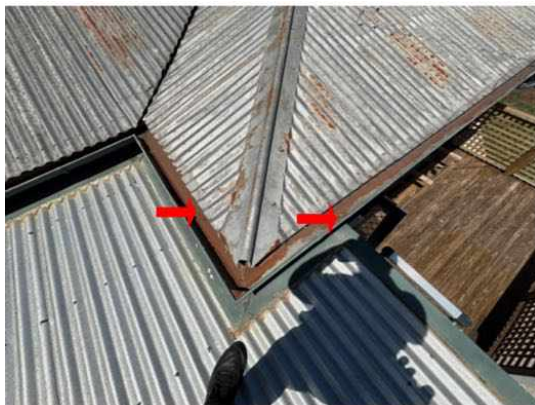
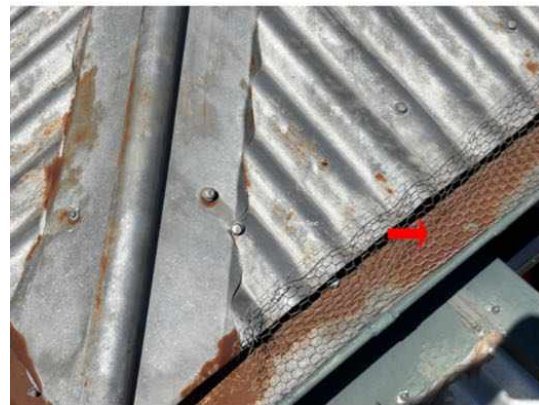
Finding 3.01

Building: Main Building
Location: Roof Exterior
Finding: Gutters - rusting
Information: At the time of the inspection, it was noted that the gutters were rusting and as such may be leaking in numerous areas. Gutters need to be in good working order to drain the roof properly.

If gutters are leaking, moisture may get to areas of the building that are meant to be kept dry. Damage to building elements may result of moisture ingress.

A licensed roof plumber should be appointed to inspect the gutters and advise on necessary rectification works. This should be done as a matter of urgency.

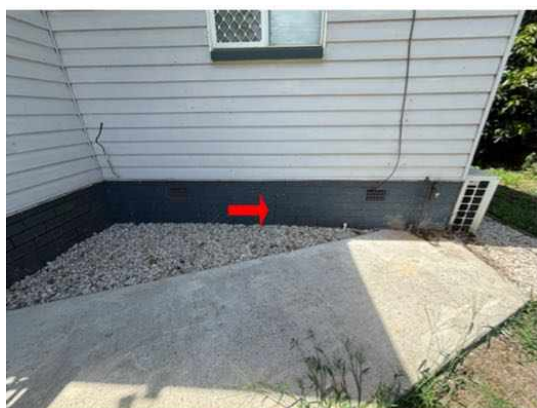
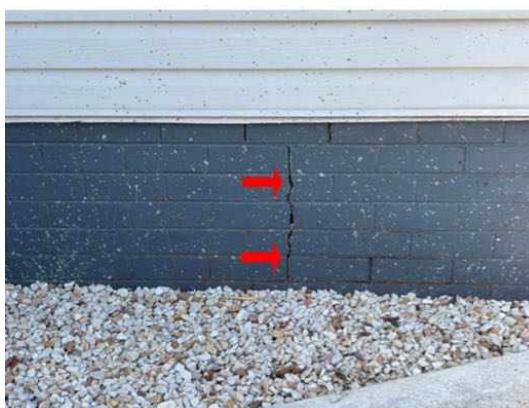
Finding 3.02

Building:	Main Building
Location:	Front elevation
Finding:	Brickwork - Step cracking
Information:	At the time of the inspection, it was noted that there was minor step cracking to the

brickwork on the front of the dwelling. The client should monitor this area for any change to the step cracking.

Step cracking, which is similar to other forms of cracking, has a variety of possible causes. However, the most common is the subsidence of adjacent footings.

Step cracking is a relatively common defect, and is most likely to occur adjacent to windows, doors and other openings. Mortar failure in the gaps between affected bricks indicates the stresses and tensions affecting the wall.

Where step cracking is extensive or severe, the client is advised to consult a structural engineer. Minor step cracking can be used as a warning sign to address factors causing stress to the wall, which can include the effect of surrounding trees, water leaks, soil erosion, or even the presence of reactive soils in the surrounding area.

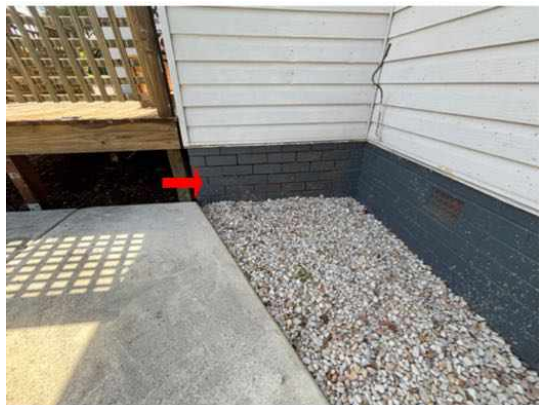
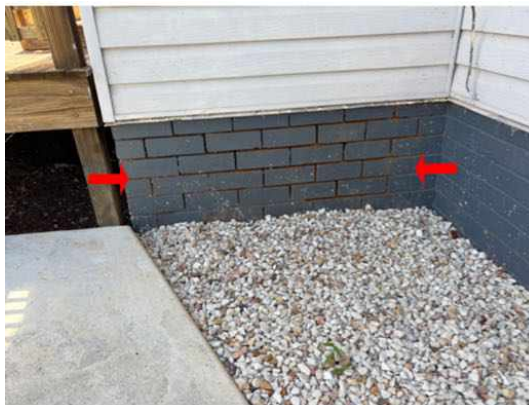
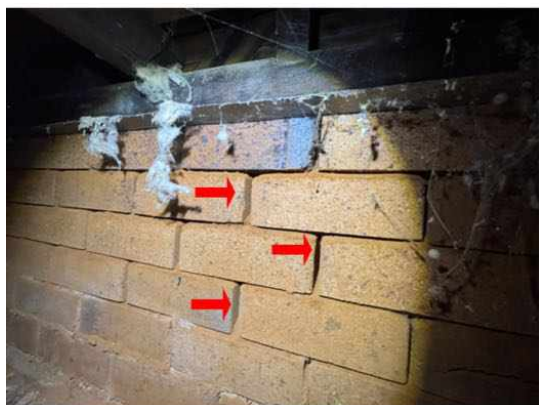
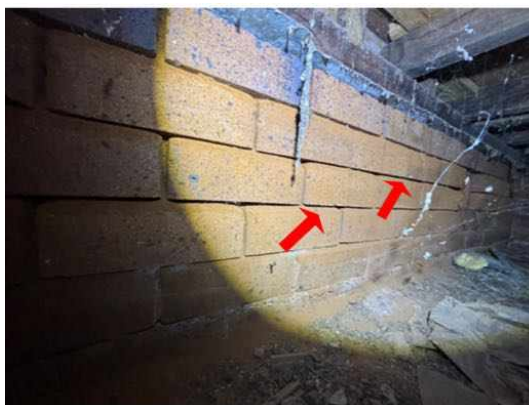
Finding 3.03

Building:	Main Building
Location:	Front elevation
Finding:	Brickwork - Deteriorated mortar
Information:	At the time of the inspection, it was noted that sections of the mortar to the bricks at the front of the dwelling has deteriorated. This brickwork is supporting the timber bearers for the suspended flooring. If left unaddressed, this may become a major defect.

Mortar, or 'bedding', is the material which fills joins and intersections between bricks in masonry walls and structures. Sections of mortar in this brickwork were identified as having deteriorated, which is generally expected for a property of this age and condition.

Mortar may deteriorate as a result of age of building materials, minor movement of bricks, or frequent exposure to weathering. Mortar should be replaced to ensure that bricks remain in their intended location and to prevent gaps, which would allow water or moisture ingress and secondary damage as a result.

Mortar deterioration can be addressed by a bricklayer where areas of deterioration are localised and easily accessible. Alternatively, appointment of a registered builder is advised, to repoint large areas of decaying mortar. Where secondary structural defects have become evident, consultation with a structural engineer may be required.

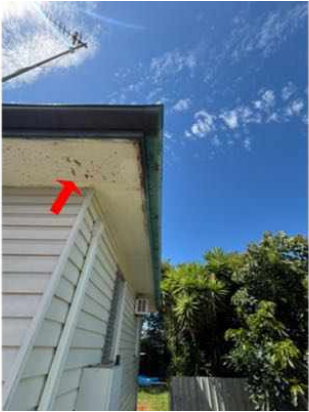
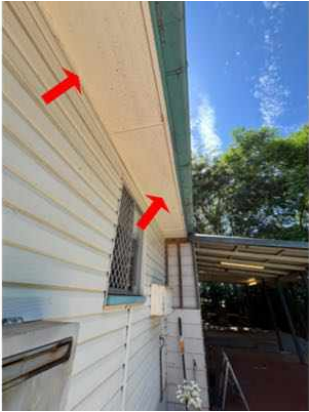
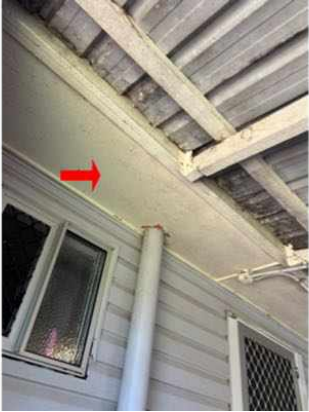
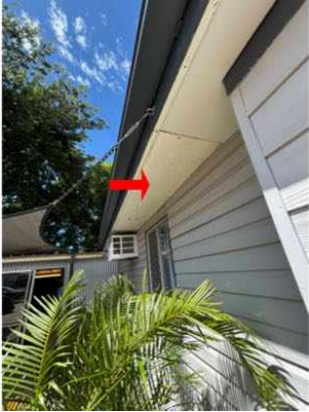
Finding 3.04

Building:	Main Building
Location:	All External Areas
Finding:	Eaves - paint peeling
Information:	At the time of the inspection, it was noted that the eave linings were peeling.

Peeling paint can be caused by moisture, poor preparation or age. There was no evidence of moisture found.

A painter or building maintenance professional could be engaged to rectify this issue. This can be done at the clients discretion.

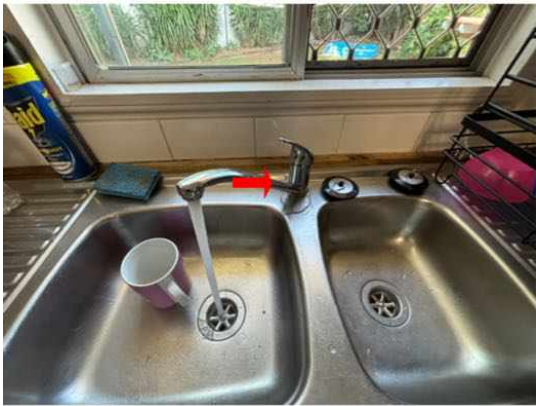
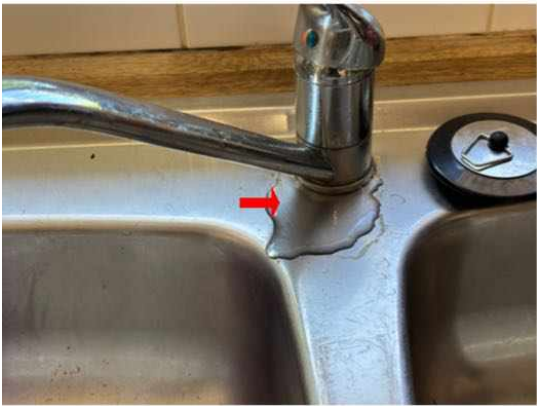
Finding 3.05

Building: Main Building
Location: Kitchen
Finding: Kitchen - mixer tap leaking
Information: At the time of the inspection, it was noted that the mixer tap in the kitchen was leaking at its base when turned on. This may be due to general wear and tear of the seals in the mixer tap.

A licensed plumber should be engaged to replace the kitchen mixer tap. This should be done as a short term priority.

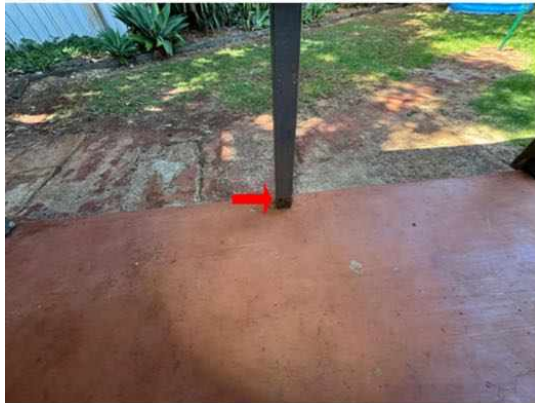
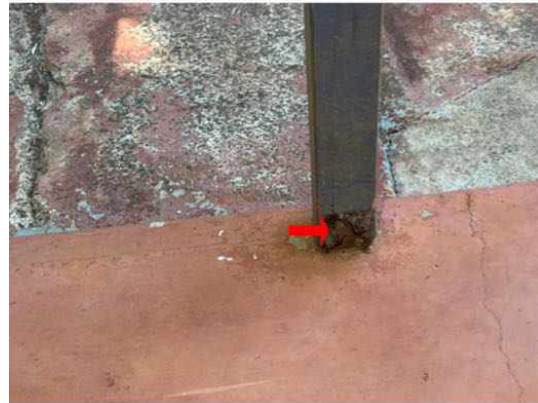
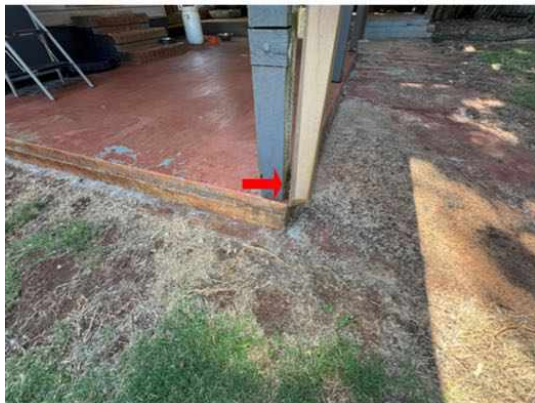
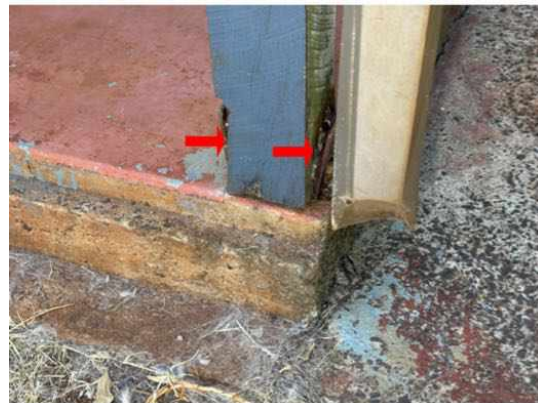
Finding 3.06

Building: Main Building
 Location: Patio area
 Finding: Patio area - stirrups rusting
 Information: At the time of the inspection, it was noted that two of the metal stirrups for the patio roof posts were rusting.

A building maintenance professional or licensed carpenter should be engaged to replace the affected stirrups. This should be done as a short term priority.

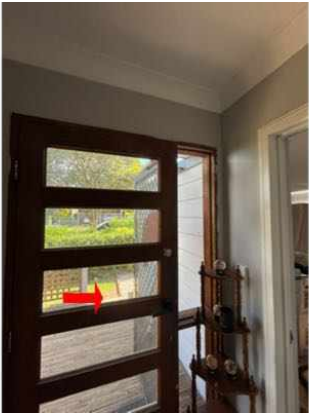
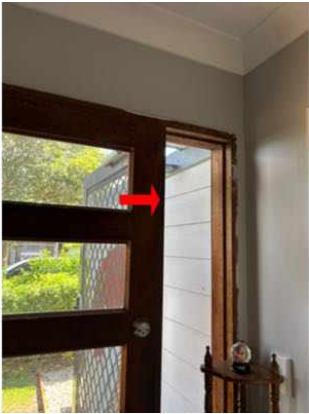
Finding 3.07

Building: Main Building
 Location: Entry
 Finding: Entry - front door binding on the door jamb
 Information: At the time of the inspection, it was noted that the hinged front door was binding against the door jamb during normal operation. This appears to be general wear and tear.

For minor causes, a qualified carpenter or building maintenance professional should be appointed to perform minor rectification works at client discretion.

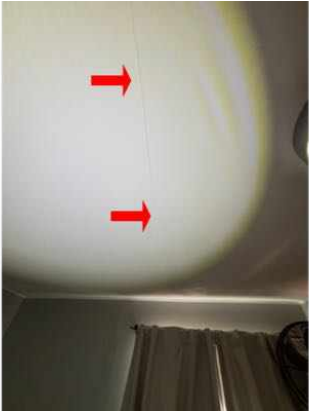
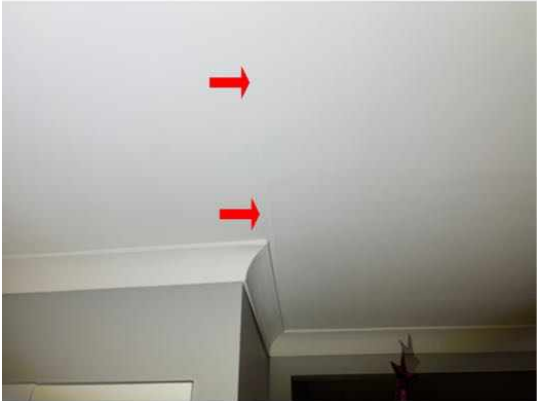
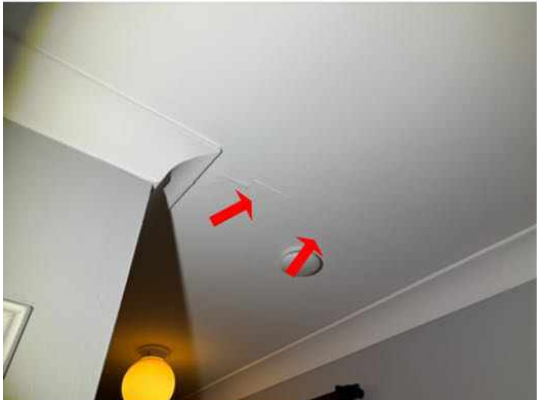
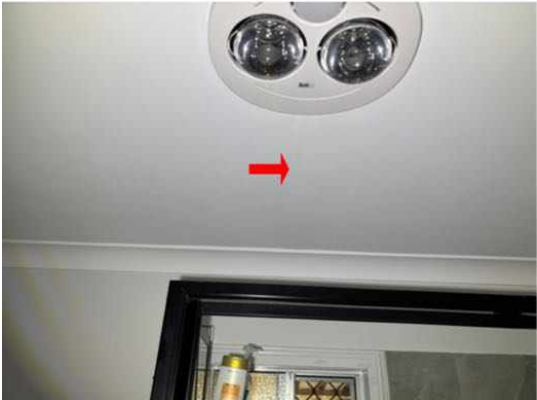
Finding 3.08

Building: Main Building
Location: All Internal Areas
Finding: Ceiling lining - cracking
Information: At the time of the inspection, it was noted that there was minor cracking to sections of the ceiling lining in the dwelling. This appears to be general wear and tear and movement of the associated building materials.

The functionality of the ceiling lining is not affected at present. A plasterer could be engaged to repair the minor cracks. This can be done at the clients discretion.

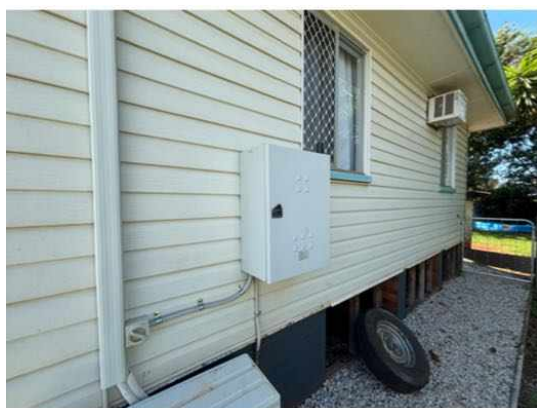
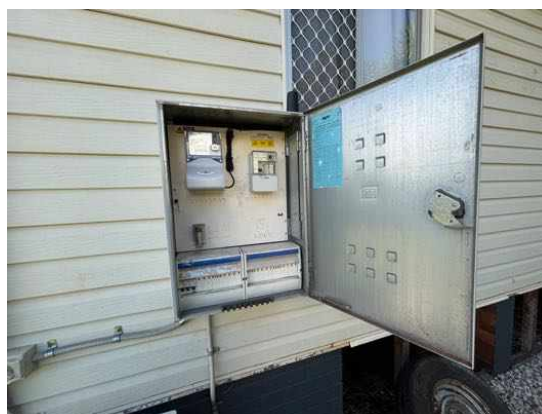
Building: Main Building
 Location: All External Areas
 Finding: Termite Management System - no evidence of a chemical installation
 Information: At the time of the inspection, no evidence of a chemical termite management system was found. There is no durable notice in the meter box. The dwelling does a physical termite barrier in the form of metal ant caps. Metal ant caps as designed to expose concealed termite activity by forcing them into the open.

A durable notice should be placed in the switchboard unit to indicate current termite barriers. At the time of inspection, it appeared as though no termite management system has been installed, with no evidence to suggest preventative works taking place.

The application of a post-construction chemical termite barrier is highly recommended for all properties, particularly if live termite activity has been found on the site previously. Such barriers are highly effective in preventing termite attack on any timber building elements throughout the property.

The client may consider gaining further advice from a pest controller as to the costs and procedures involved with this application. It is recommended that obtaining such advice be a short-term priority.

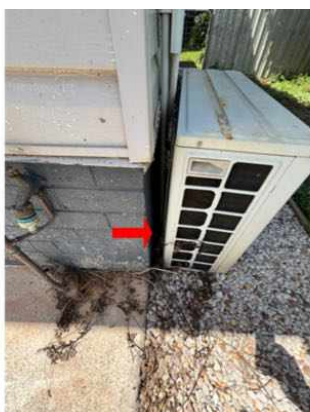
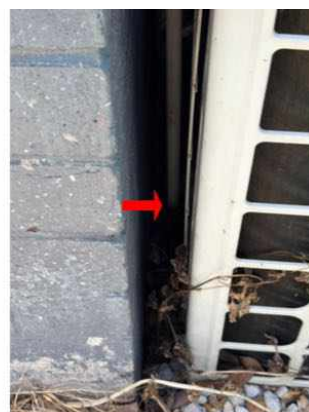
Finding 6.02

Building:	Main Building
Location:	Side yard
Finding:	Air conditioner - Disconnected overflow
Information:	At the time of the inspection, it was noted that the air conditioner drain overflow to all the unit on the side of the dwelling was not connected to the storm water drainage and as a result are draining next to the foundations of the dwelling.

Air conditioning overflows that are not connected to the storm water drainage and are draining near the foundation can create excessive moisture in the surrounding area.

Such leaking creates an environment which is conducive to an array of defects, including water damage to associated building elements and the attraction of termite or timber pest infestation.

It is highly recommended that a licensed plumber be appointed to connect the A/C overflow in order to prevent such an environment from being created. These minor works should be carried out as soon as possible.

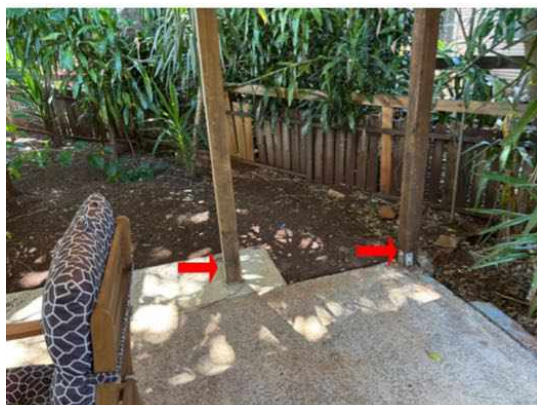
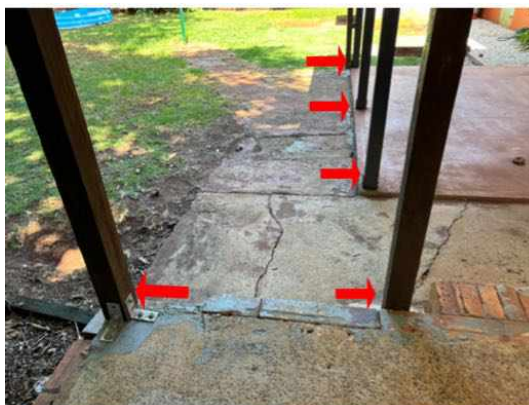
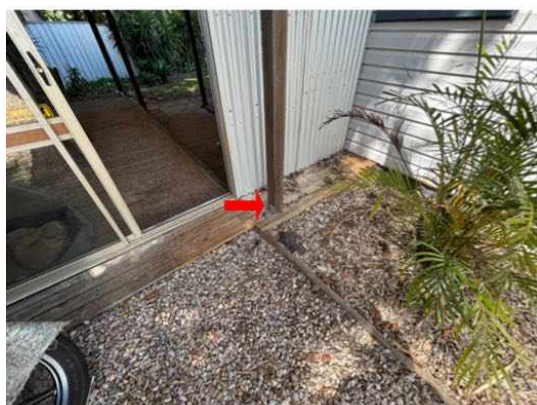
Finding 6.03

Building:	Main Building
Location:	All External Areas
Finding:	Building materials in direct ground contact - conducive to termites
Information:	At the time of the inspection, it was noted that the timber posts for the rear patio were in direct contact with the ground. There is no visual inspection zone below the timber posts.

Where timber elements are in direct contact with the ground and consequently moisture or dampness they become conducive to termite activity. Whether timber is used as a building element part of a fencing structure or stored as an unused item they can provide an environment that is attractive to termite infestation.

When met with excessive moisture timber begins to decay and develop wood rot. Any timbers that are in direct contact with external grounds especially if left untreated or non-durable also provide ingress for subterranean termites into that particular element.

The removal of any such materials that may be conducive to termite activity should be removed as soon as possible to minimise the risk of termite attack.

Annual termite inspections should be carried out in order to further protect the dwelling.

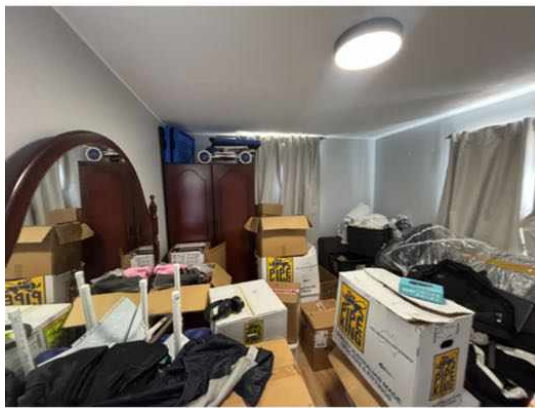
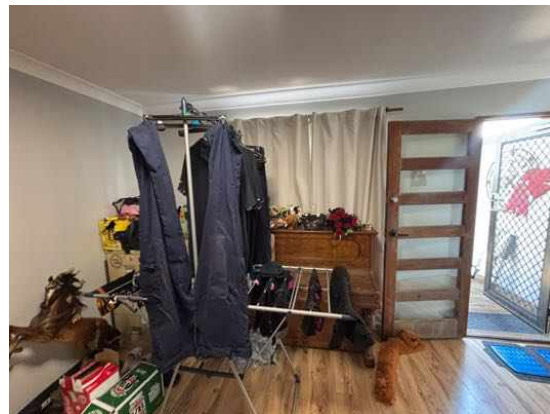
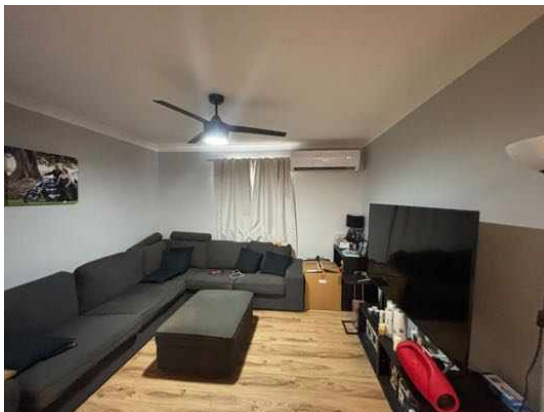
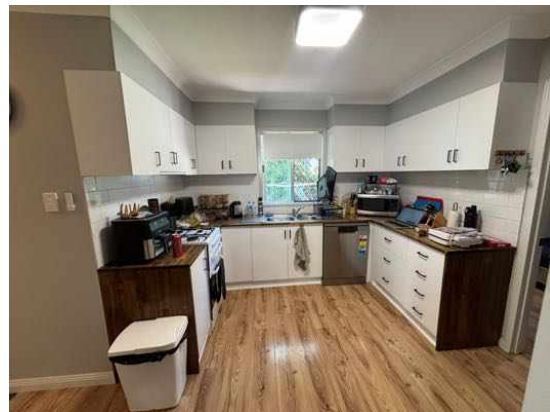
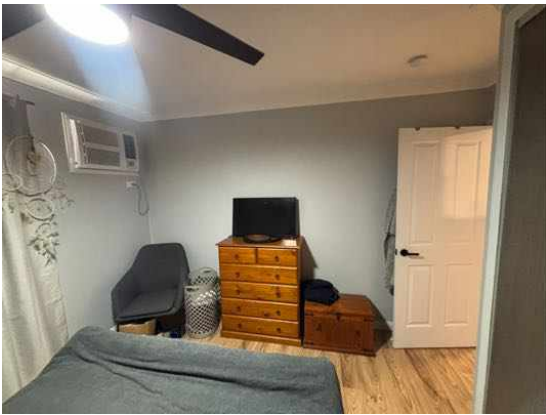
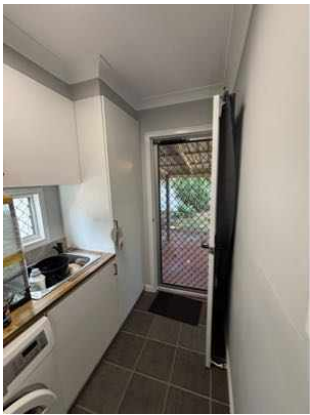
Noted Item

Building: Main Building
Location: All Internal Areas
Finding: Obstructions and Limitations - Internal areas
Information: These photographs are an indication of the obstructions and limitations which impeded full inspection of the property of the internal areas at the time of inspection. These obstructions can hide an array of defects and should be removed to allow full inspection to be carried out. A re-inspection is recommended once the areas are made accessible.

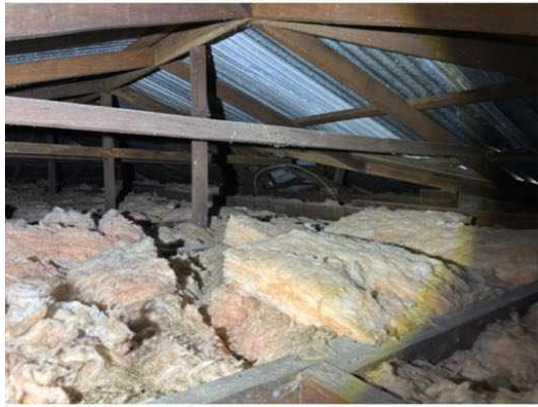
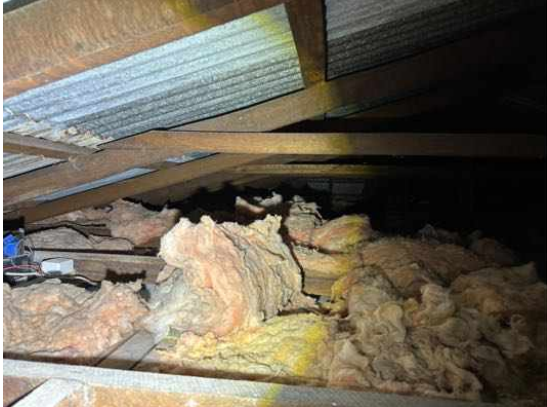
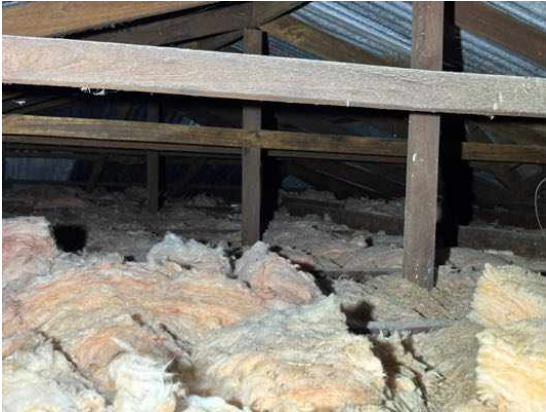
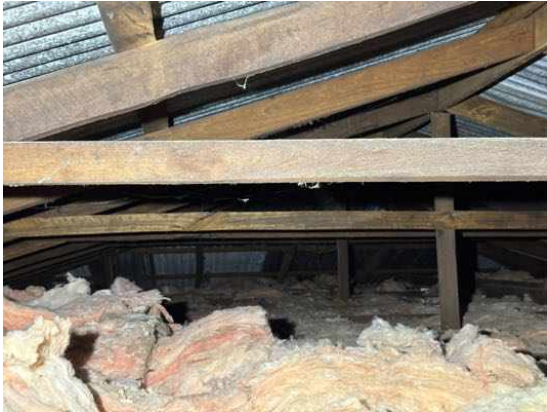
Noted Item

Building: Main Building
Location: Roof Void
Finding: Obstructions and Limitations - Roof cavity
Information: These photographs are an indication of the obstructions and limitations which impeded full inspection of the property of the roof cavity

at the time of inspection. These obstructions can hide an array of defects and should be removed to allow full inspection to be carried out. A re-inspection is recommended once the areas are made accessible.

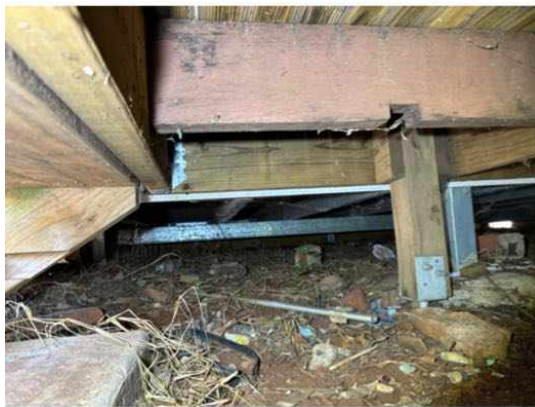
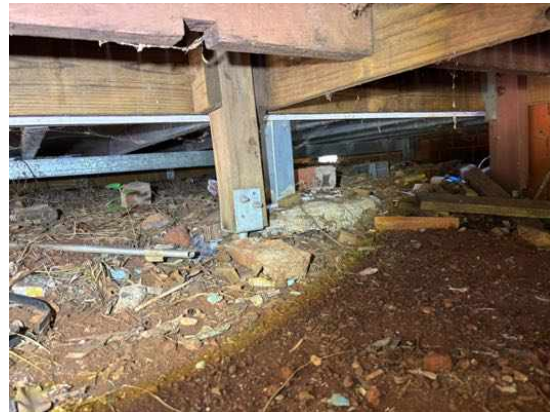
Noted Item

Building: Main Building
Location: Subfloor
Finding: Obstructions and Limitations - Sub floor cavity
Information: These photographs are an indication of the obstructions and limitations which impeded full inspection of the property of the sub floor cavity

at the time of inspection. These obstructions can hide an array of defects and should be removed to allow full inspection to be carried out. A re-inspection is recommended once the areas are made accessible.
