Building Inspection Report

Inspection Date: Mon, 16 Feb 2026

Property Address: 2/38 Oakes Ave, Clayton South VIC 3169,
Australia

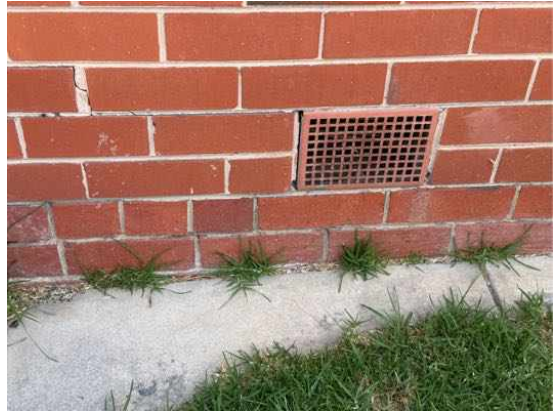
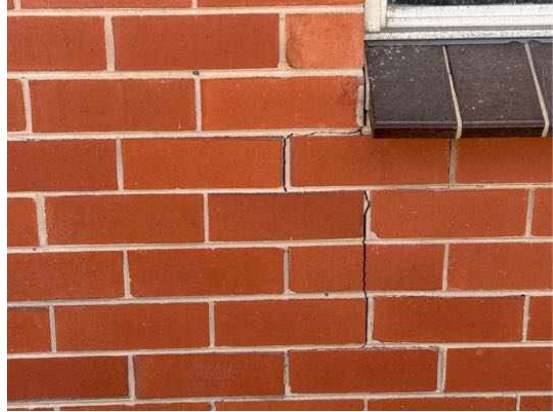
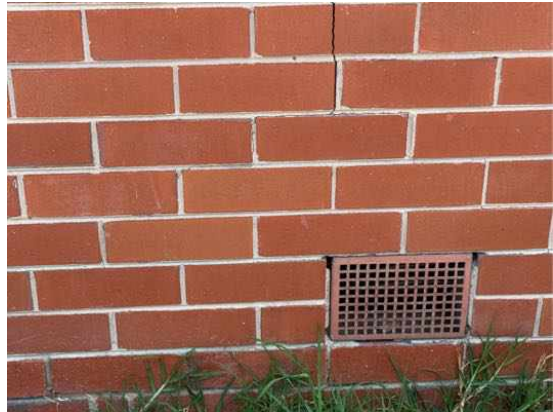
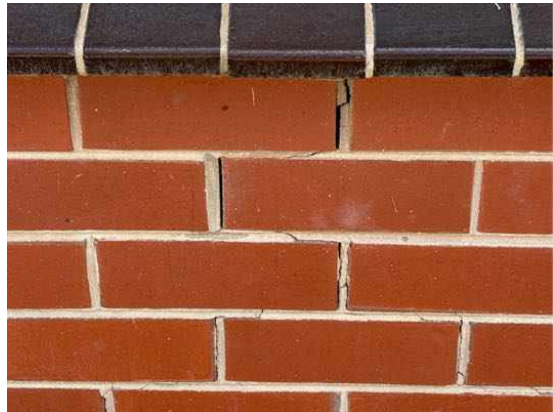
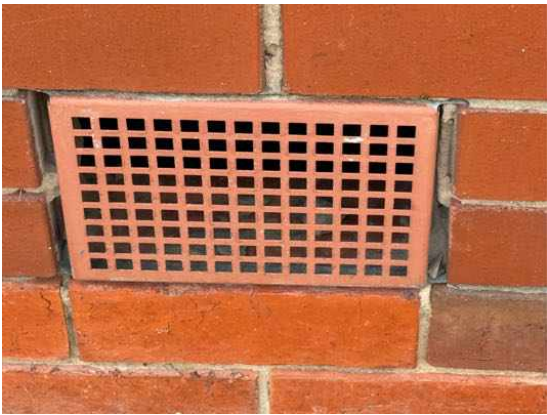
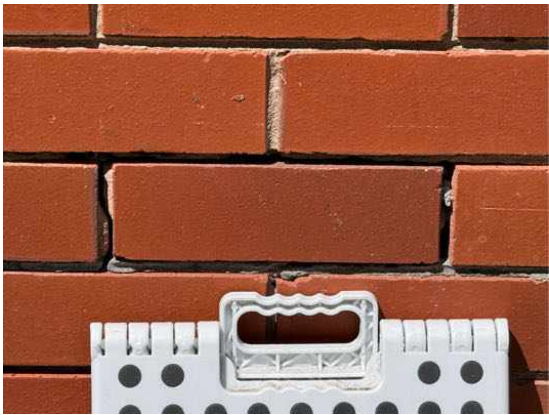
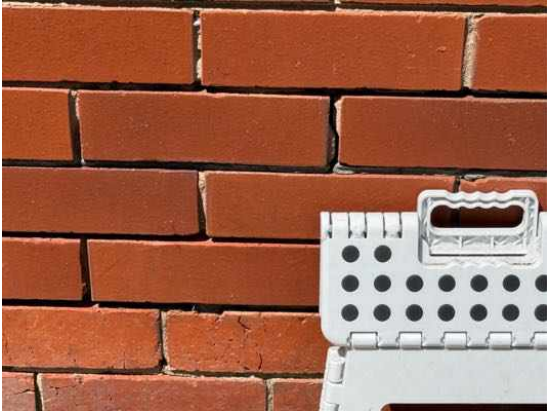
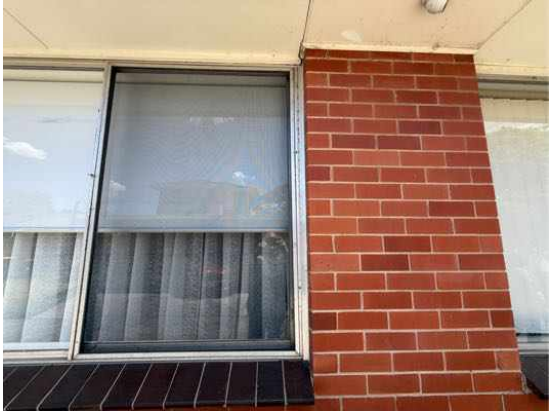
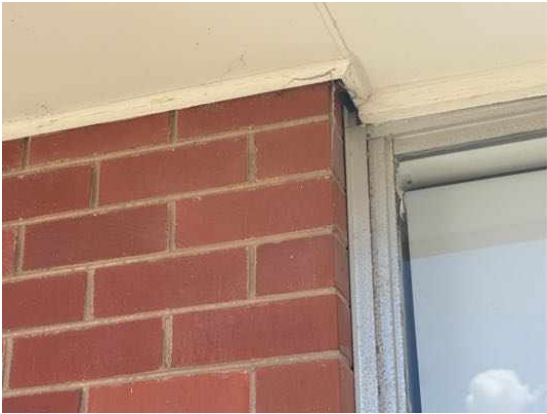
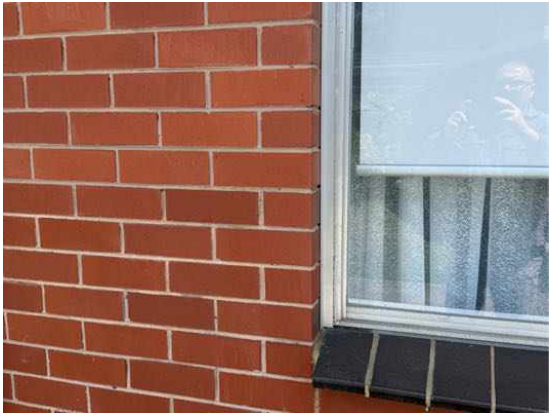
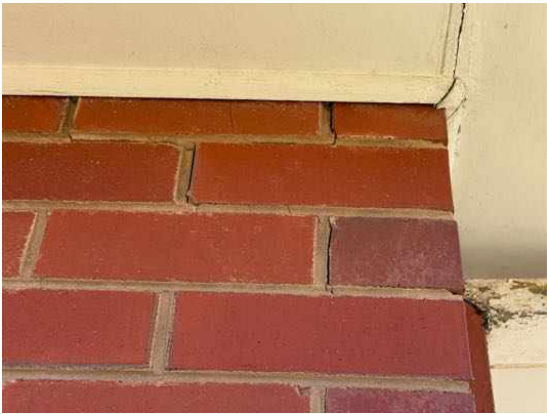
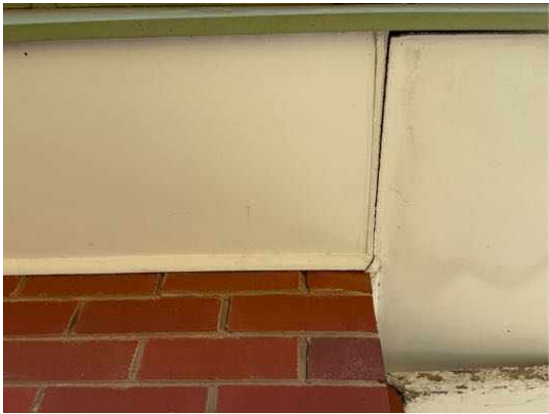
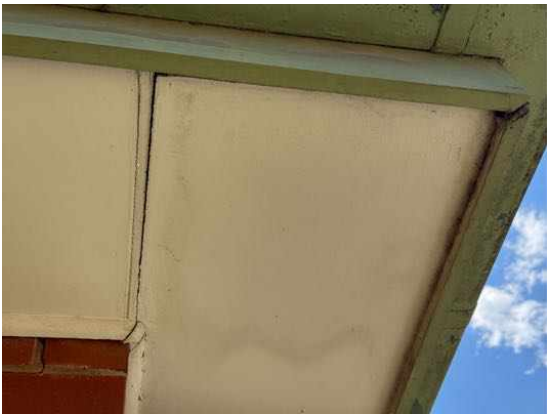
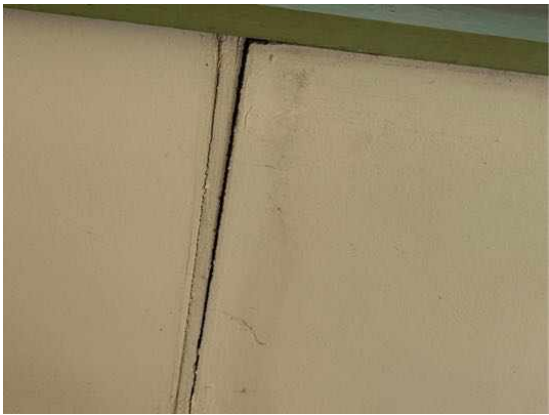
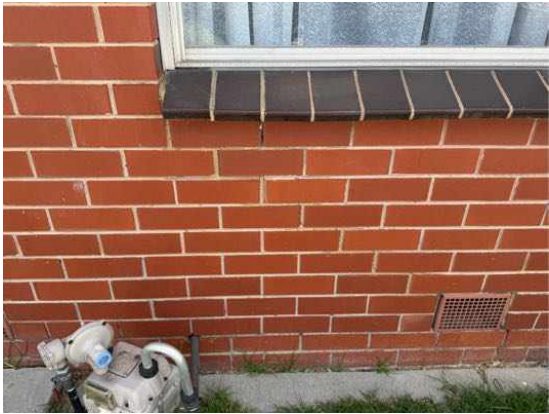
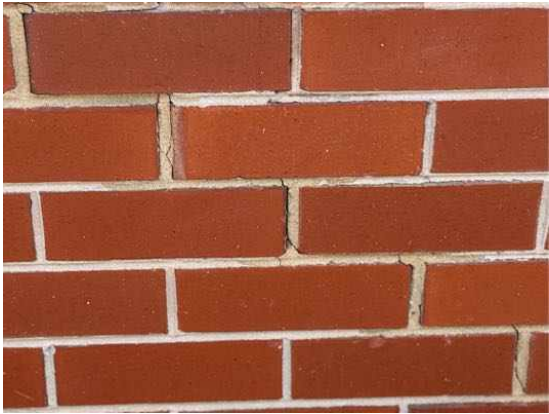
Defects 2.01

Building:	Building 1
Location:	All Areas > All Areas
Finding:	Brickwork - cracks and excessive movement
Information:	At the time of the inspection numerous cracks throughout the front brickwork were observed. Due to the number of areas of brickwork cracks, damage and the expected further movement over time and the amount of remedial repair involved to rectify, they are considered to be a major defect. The front brickwork showed excessive movement which is suspected to require repair at some time in the future, which will necessitate in major remedial works and or replacement of the brickwork. A Structural Engineer is recommended to further inspect these areas.

Structural issues are generally the underlying cause of these types of brickwork cracking and movement. Brickwork cracks are a common occurrence and are a likely result of excessive movement, subsidence, and expansion and contraction of building materials in different weather conditions. Cracks in brickwork such as these are suspected to further develop over time. And if left unattended with potential for necessitating major remedial works or replacement of the brickwork.

The client should elect to appoint a structural engineer and a builder to inspect the structural integrity of these areas of affected brickwork, to assess the safety of the associated structures. The engineer can also nominate a scope of works required for the rectification. Always contact a Registered builder or engineer should cracks widen lengthen or become more numerous, even after repair works have been completed.

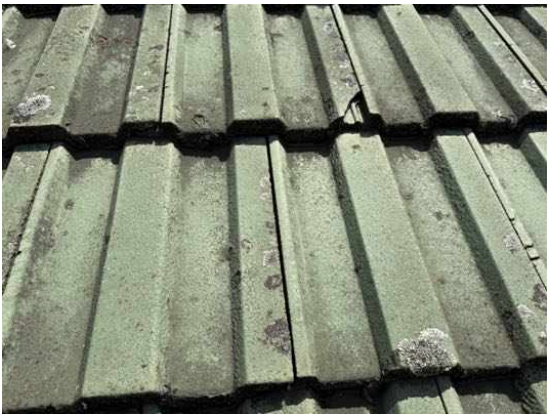
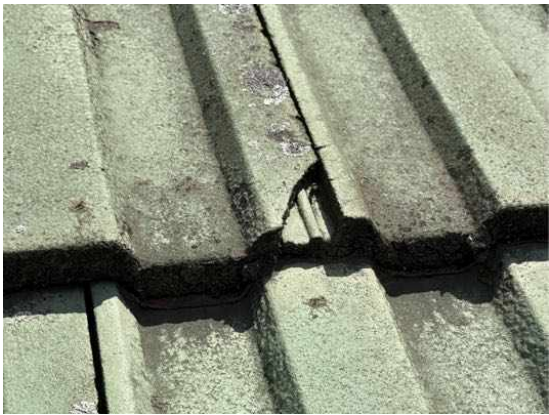
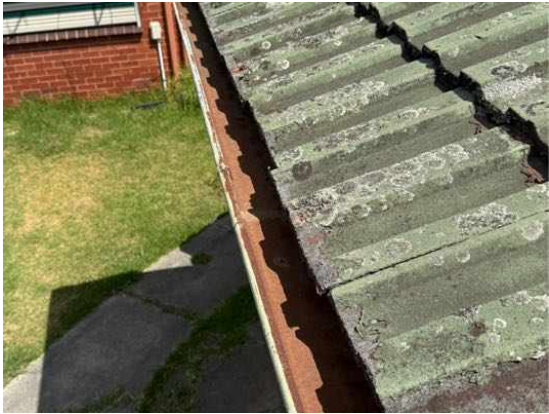
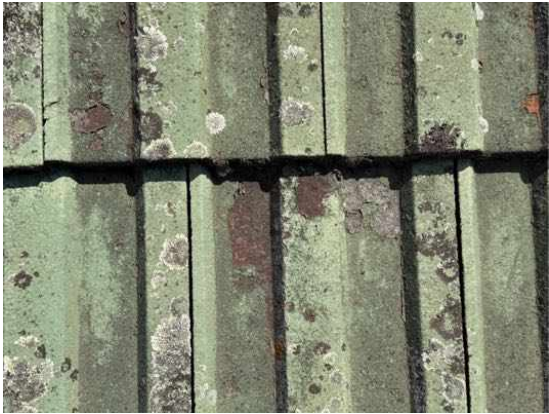
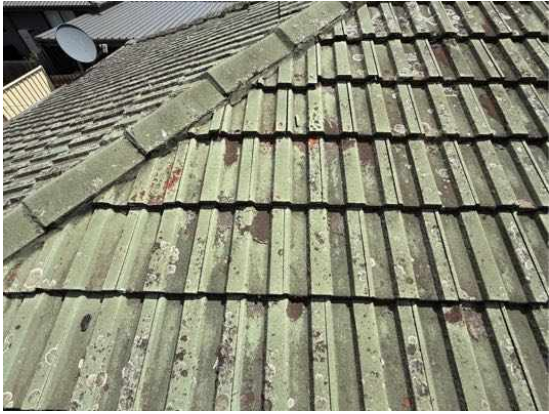
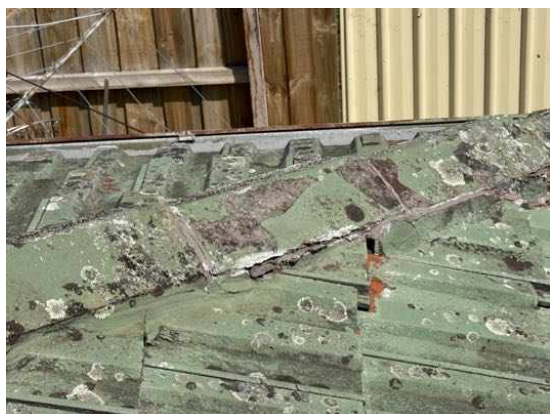
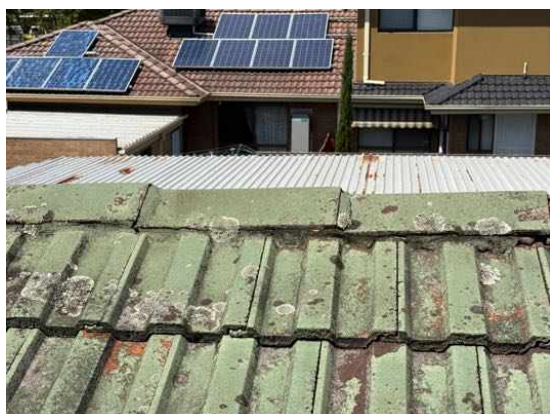
Defects 3.01

Building:	Building 1
Location:	All Areas > All Areas
Finding:	Roof tiles - aged and weathered
Information:	Upon inspection of the exterior roofing, the roof tiles were considered to be showing weathering, ageing and deterioration. The roof tiles are essentially a concrete porous material and when the roof tiles get aged and deteriorated the top finish of the roof tiles is diminished, the roof tile will eventually begin to absorb moisture into the concrete porous material and secondary defects can result. Over time the roof tiles top protective surfaces will further deteriorate which can lead to water penetration via the roof into the ceiling space, causing secondary damage to roof structure, ceiling linings, insulation. They are suspected to require re-sealing and maintenance to keep the roof tiles watertight in the future.

Where left unmanaged, deteriorating roof tiles are likely to lead to a number of secondary defects, including minor water leaks and weather exposure to internal roofing structures. Consultation with a roof sealing company or a roofing contractor is recommended to gain advice on cost of future works that may be required. Remedial works and maintenance of the roof tiles will increase the longevity of the roof tiles and the roofing structure.

Replacement of some areas of the roof pointing and any broken or chipped roof tiles is required and should be performed by a roofing contractor as soon as possible. As time goes on the concrete tiles will become more porous during outside wet conditions and therefore the possibility of secondary defects in the future. While weathering of the tiles is consistent with the age of the property, maintenance works are and will be required in the future to maintain a weather and waterproof roof.

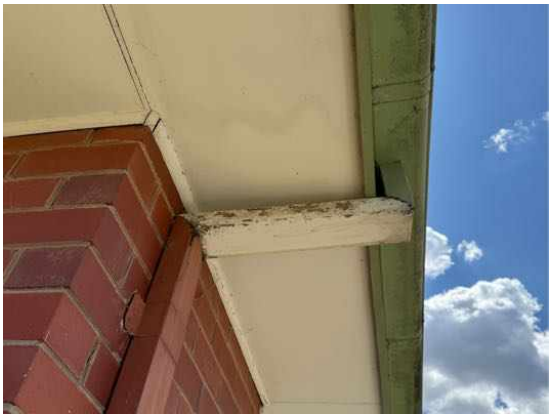
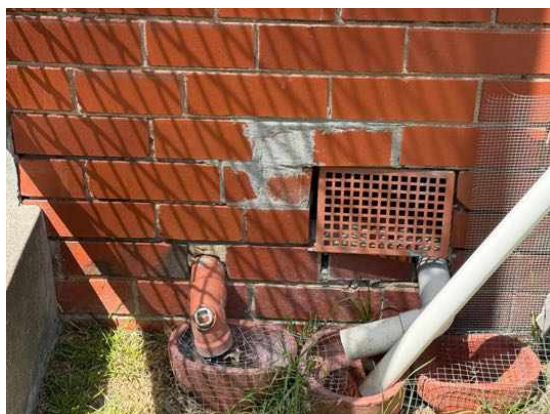
Defects 3.02

Building:	Building 1
Location:	All Areas > All Areas
Finding:	Downpipes weeping from joins
Information:	It was observed at the time of inspection that some down-pipes were weeping from joins. This will therefore make these areas susceptible to moisture, wood rot, rust, corrosion, termite and pest. If left unmanaged, moisture, wood rot, rust and corrosion is likely to lead to damage to adjoining areas, building structures and building elements, this also makes these areas more susceptible to termite or timber pest activity.

It is recommended that client appoint and seek advice and consultation with a licensed plumber to rectify these downpipes.

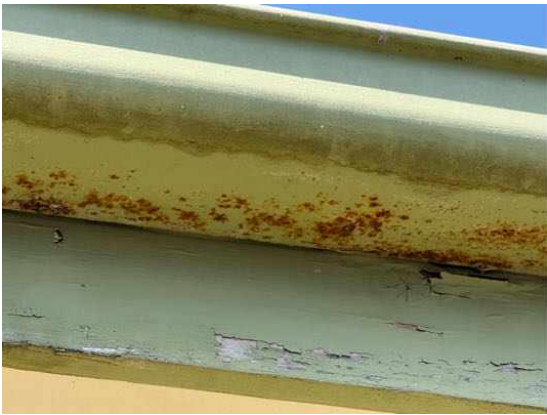
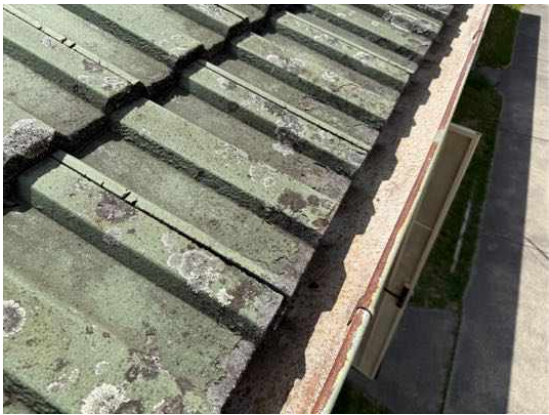
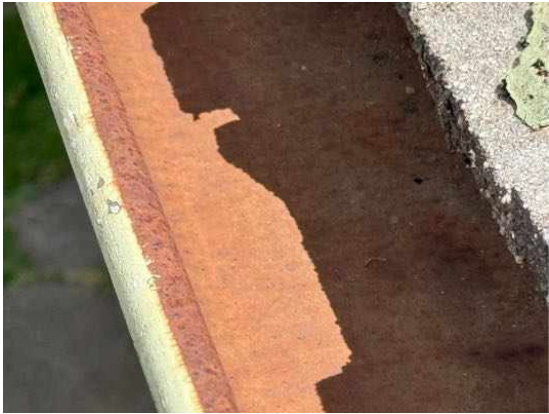
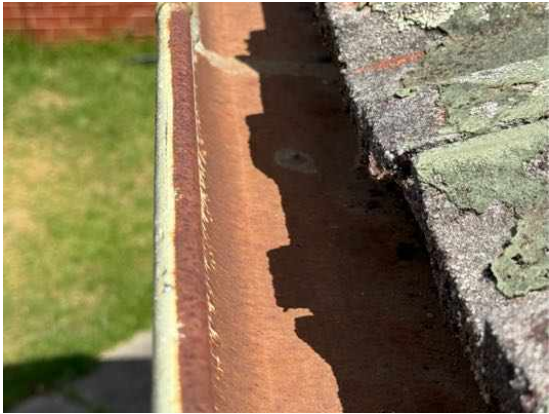
Defects 3.03

Building:	Building 1
Location:	All Areas > All Areas
Finding:	Roof gutters - Rusted or corroded
Information:	The roof guttering in some areas around the perimeter of the home were observed to be rusted and deteriorated, It is suspected that this has been caused by blockages within the gutters over time, resulting in water pooling or standing water, this type of defect may have prematurely rusted guttering and other elements of the roof plumbing.

Rusted roof plumbing will generally develop holes and leaks that can affect other building elements with poor drainage of storm water. Poorly drained roof areas will also lead to damp conditions surrounding the base perimeter of the building which, if left unmanaged, can lead to a range of secondary building defects. Client may consider to repair or replacement of rusted roof plumbing in order to reinstate the roof drainage system to a good operational level. To further maintain these areas, gutters should be cleaned frequently, allowing the avoidance of any partial blockages.

A licensed plumber should be appointed to undertake these works. It is recommended that such works be completed as soon as possible to prevent any further damage and deterioration.

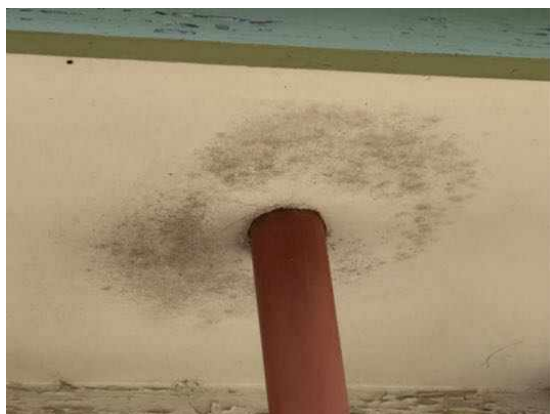
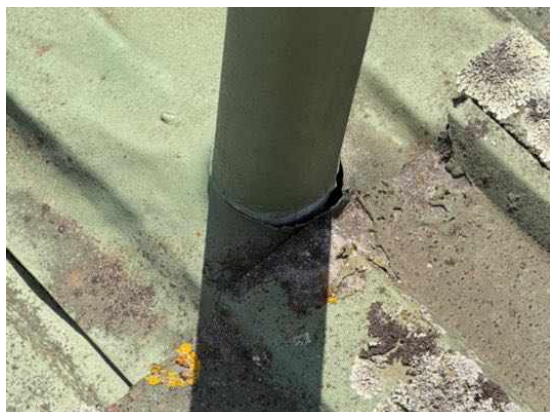
Defects 3.04

Building: Building 1
Location: All Areas > All Areas
Finding: Eaves damage- deterioration
Information: Due to excessive movement in the brickwork, moisture damage and staining from roof leaks, numerous areas throughout the roof exterior eaves linings, some remedial work is suspected to be required. Most of the damage is suspected to have come from the excessive movement however some has also come from either as a result of old and deteriorated roof flashing, dislodged roof tiles or overwhelmed roof gutters above. Where the eaves shows signs of moisture and stains the primary requirement is to identify and rectify any source of excessive moisture and or roof leaks.

The damage to the eave sheeting in these areas detracts from the appearance of the structure, as well as potentially compromising the adjoining roof structures and integrity of the adjoining roof structure. Where eaves show moderate to severe damage, remedial works are suspected to be required immediately to prevent further and secondary damage and defects. Where water damage is suspected as being the underlying cause, appointment of a roofing contractor and licensed plumber is recommended to find a solution and identify the source of the damage and or water leak in the short term future.

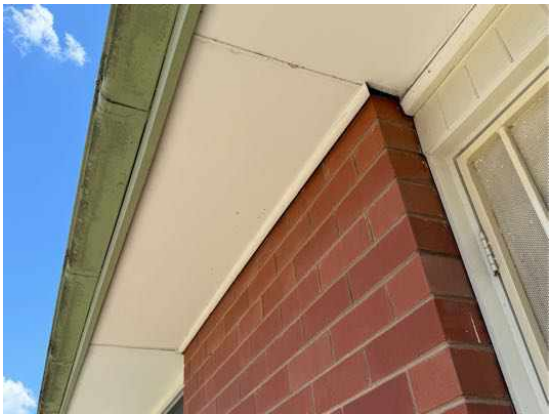
Defects 3.05

Building:	Building 1
Location:	Entry > Front Left
Finding:	Beads - quads to the exterior eaves have dislodged and missing
Information:	It was observed at the time of inspection that the front entry eaves beads have been dislodged and missing, it is suspected that this defect has resulted from the excessive movement in these areas over time. Beads - quads to the eaves acts like cornice or skirtings to cover the intersections or joins of building materials. These types of defects will allow water, moisture, insects and other pests to gain access and occupy these areas to the internal areas between the brickwork and wall framing.

Quads and beading is also important in weatherproofing the surrounding building elements and preventing water, moisture, insects termite and other pest ingress. Quads and beading works to protect the joins of building materials, which are more susceptible to deterioration and decay. Remedial work to re-fit some of the beading or quads or fill these areas with the appropriate building sealant is recommended to ensure the protection and longevity of any associated building elements. Such works may be performed by a qualified carpenter or relevant capable tradespersons.

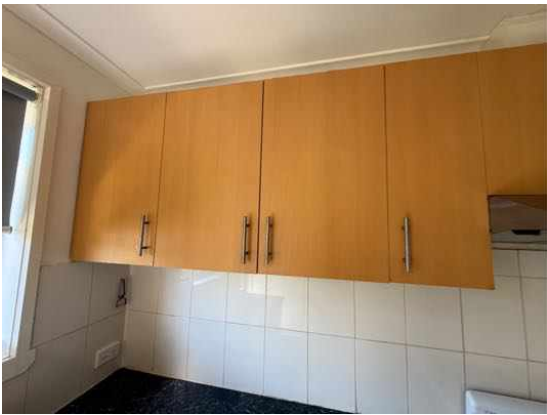
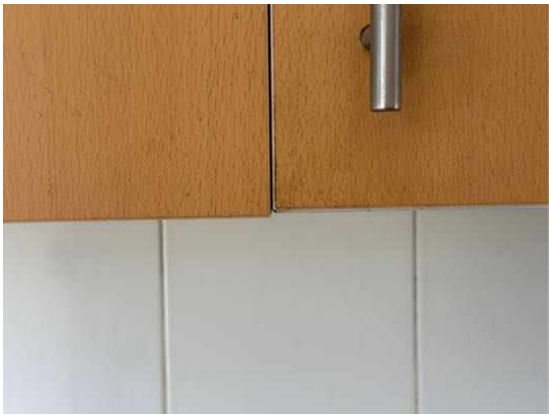
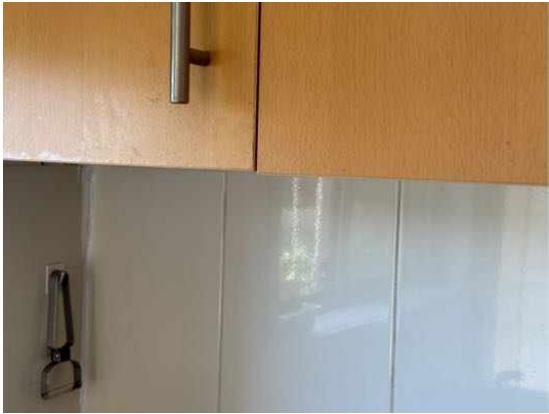
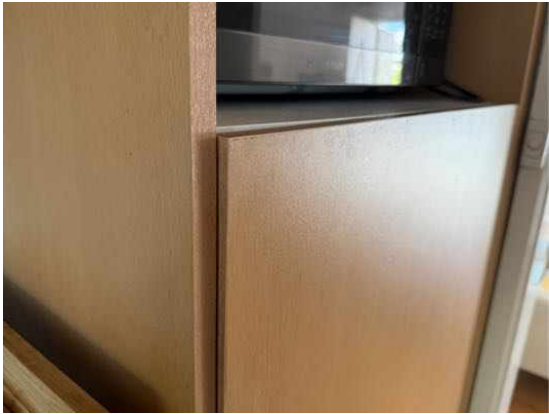
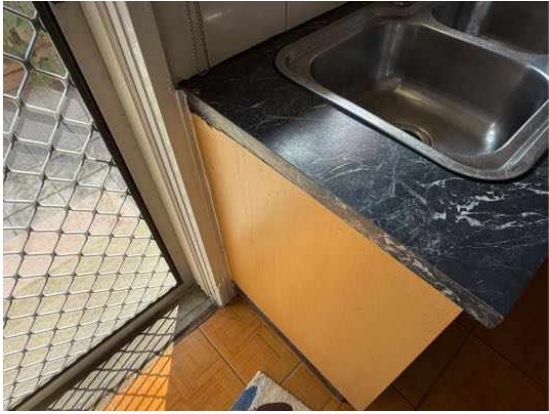
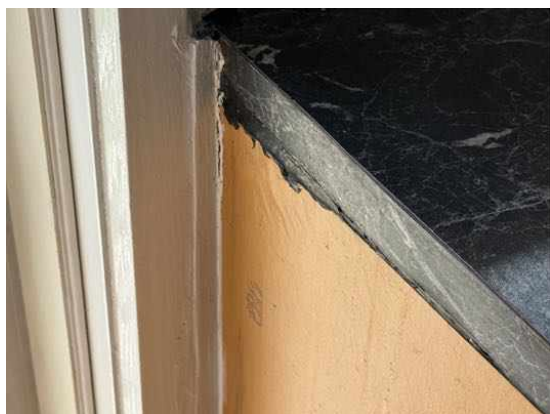
Defects 3.08

Building: Building 1
Location: Bathroom > All Areas
Finding: Cabinet doors
Information: Cabinet doors were observed to be out of misalignment, some with chips to cabinet doors and drawers, more damage may occur to cabinets, cabinet doors and drawers if left unmanaged, these defects detract from the appearance of the cabinetry. Numerous doors may require adjustment to make good, mostly they are in an operational state and appear to be working correctly. To improve operation of the affected cupboard doors and or drawers, a qualified cabinet maker or carpenter may be appointed. Such works should be completed at discretion of the client.

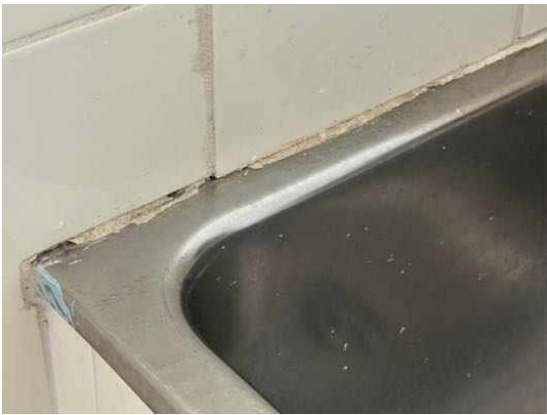
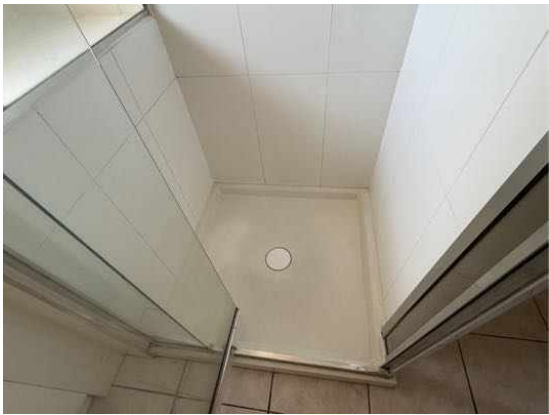
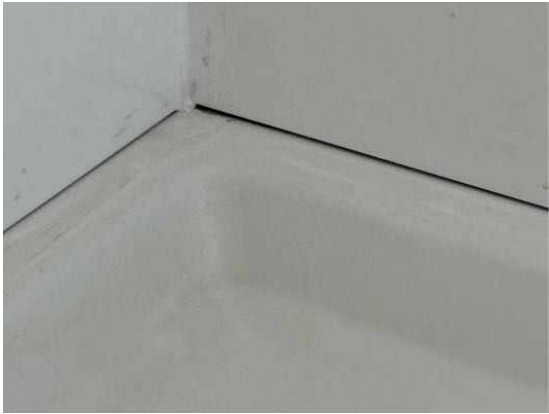
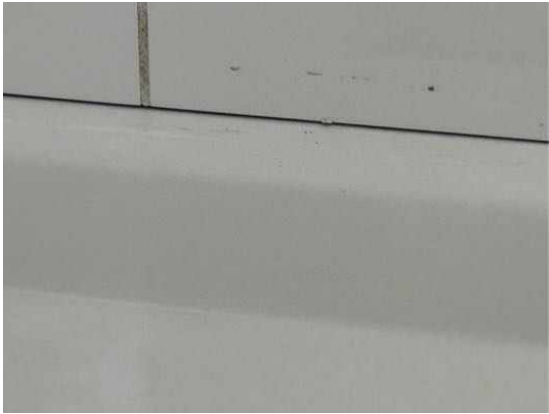
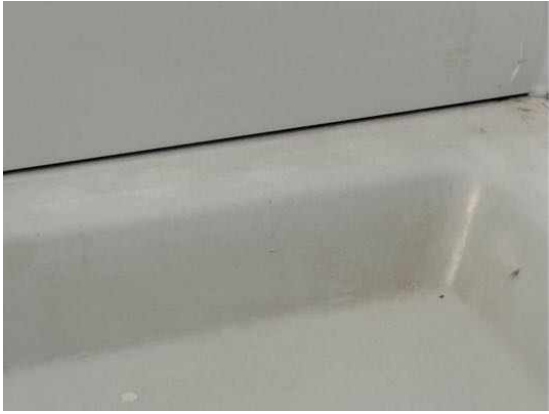
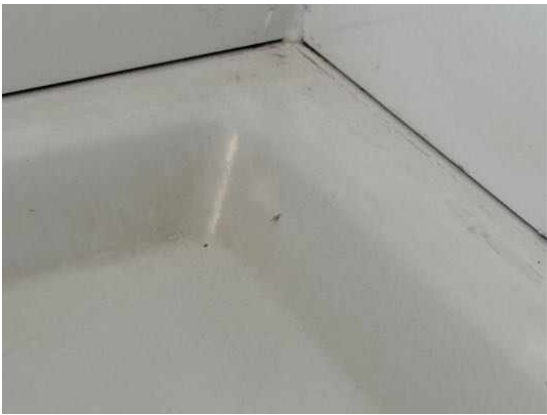
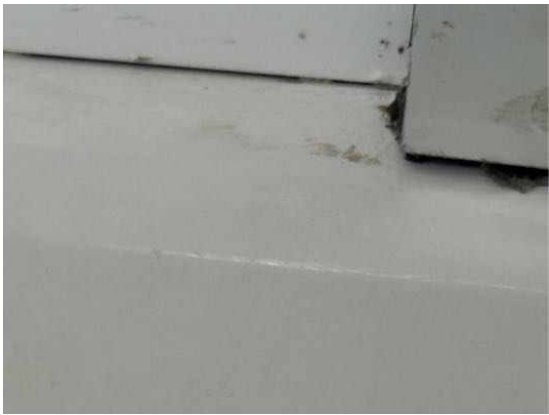
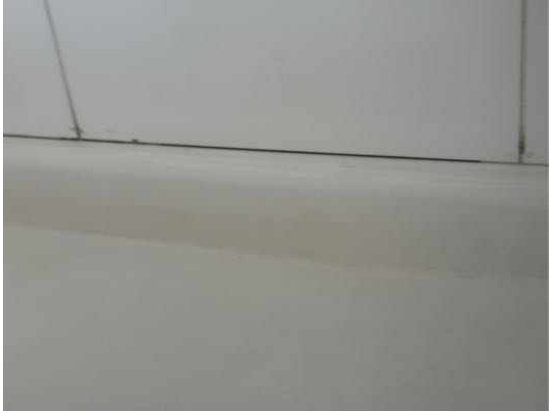
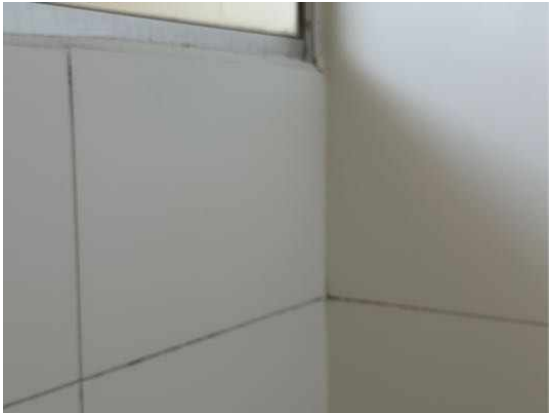
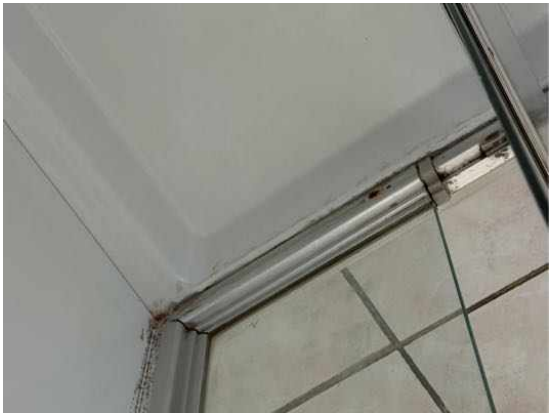
Defects 3.09

Building:	Building 1
Location:	Bathroom > All Areas
Finding:	Grout and sealant missing
Information:	Grout and sealant was observed to be missing in numerous areas of the bottom laundry floor, . Grout and sealants are used to protect gaps and crevices between the wall and floor tiles and other building materials to ensure that they are water-tight and prevent water penetration to the associated structures. These wet areas are frequently exposed to water and excessive moisture, allowing the potential for water penetration into substrate and subsequently damaging the surrounding building elements. Further deterioration is expected if left unmanaged, water penetration to these areas may lead to subsequent water damage, which is likely necessitate repair work to affected building elements.

Where grout is missing, a tiling contractor should be appointed immediately to apply grout and re-apply any silicone where necessary. Failure to do so is likely to lead to water damage to the surrounding area. A tiling contractor should be appointed to ensure that these types of defects are rectified adequately and quickly. The re-application of grout and sealants throughout these wall and floor tile areas is highly recommended, to protect these areas against water penetration getting into and below the substrate.

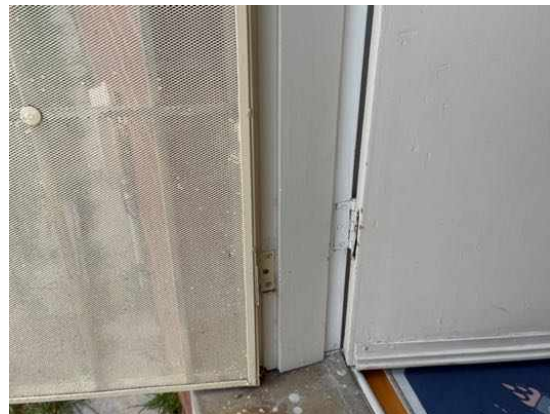
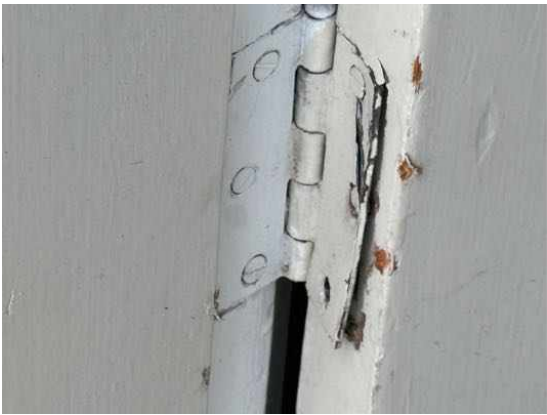
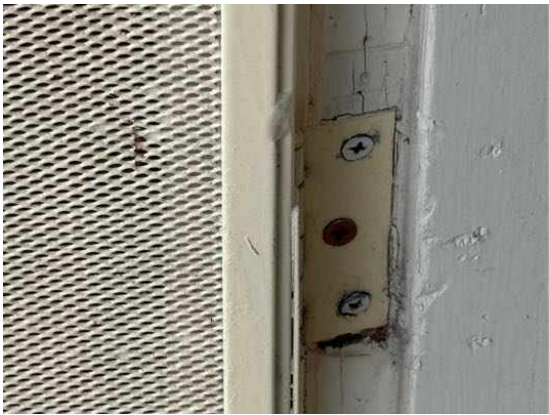
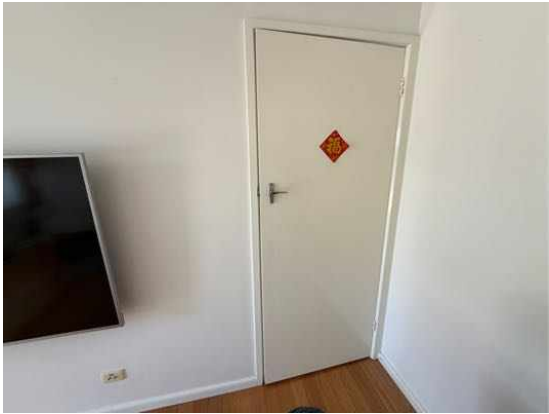
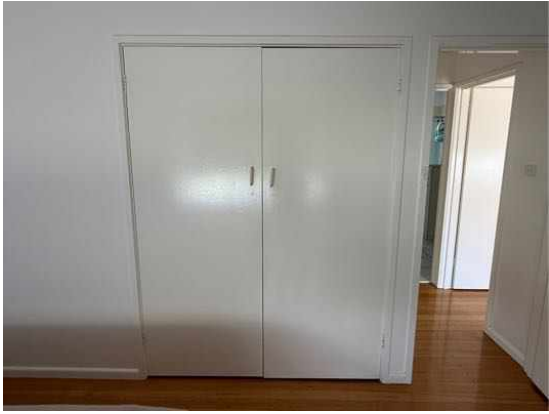
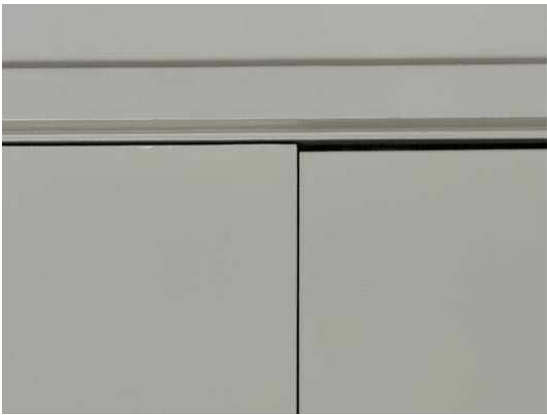
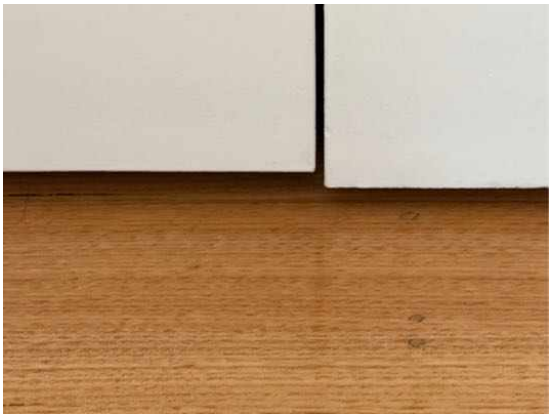
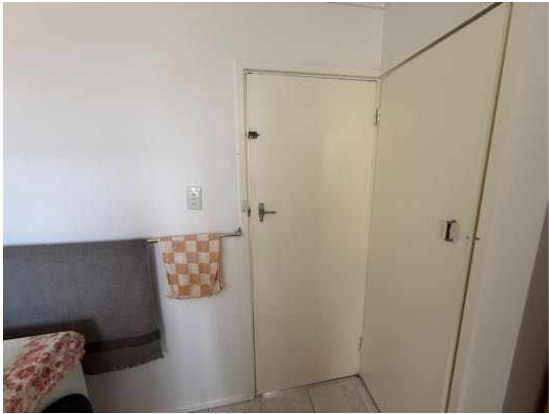
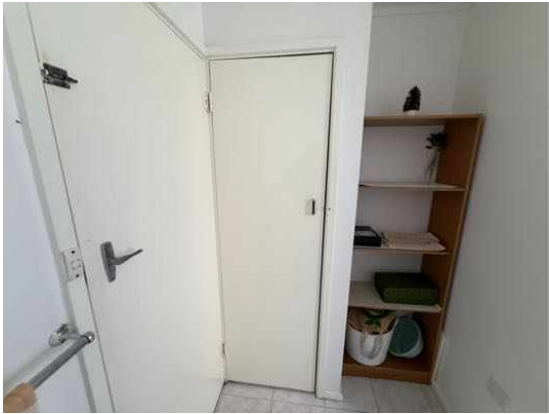
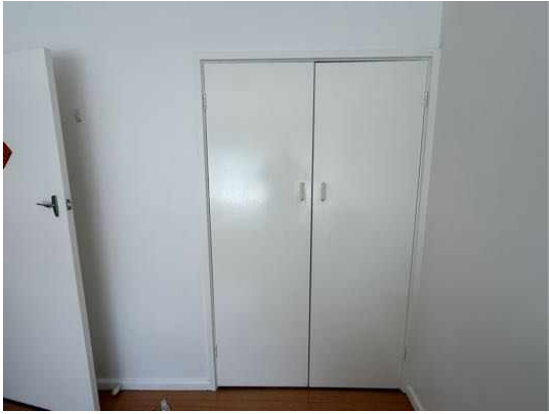
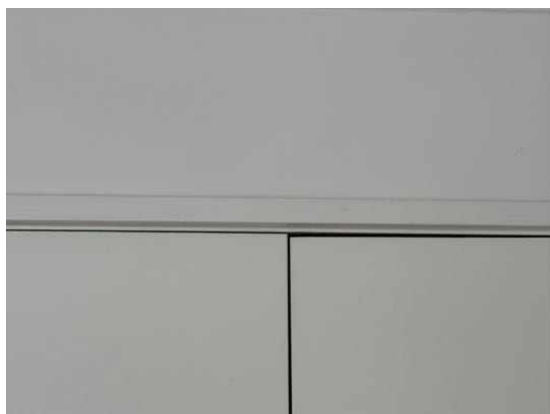
Defects 3.10

Building:	Building 1
Location:	All Areas > All Areas
Finding:	Doors adjustments and maintenance
Information:	Some doors throughout the home were observed to require only minor maintenance and adjustments to make good during standard operation. Doors should get some adjustment and maintenance to ensure doors operate correctly during standard operation. These types of defects can inhibit the functionality of the affected doors as well as creating potential for secondary defects to associated building elements, such as the door jamb and floor. Generally, factors such as a lack of maintenance or general deterioration are the usual causes for these types of defects.

It is suspected that back garage door is damaged and deteriorated beyond repair. Replacement of some door hardware may be required where deemed to be necessary, as well as minor repairs and cleaning. A qualified carpenter should be appointed to perform minor rectification works in the future.

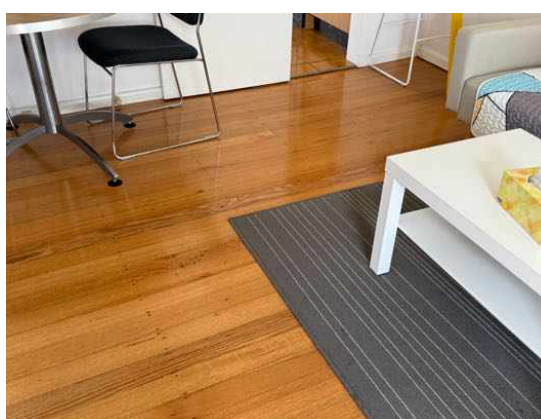
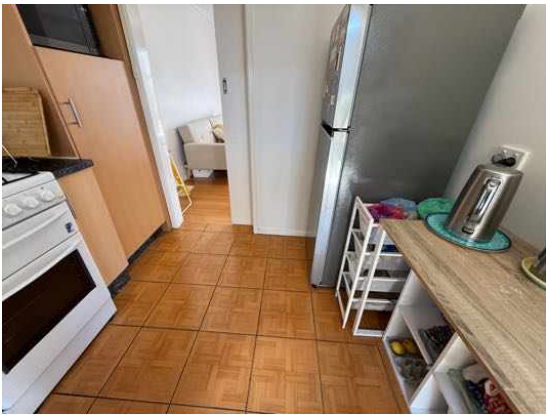
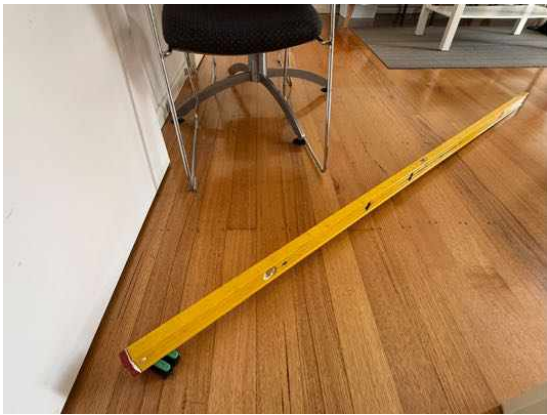
Defects 3.11

Building:	Building 1
Location:	All Areas > All Areas
Finding:	Floor levels
Information:	The numerous internal flooring areas throughout the home were observed to be showing signs of being out of level and uneven. The uneven and out of level floors were considered excessive in a couple of areas. The uneven and out of level floors throughout the home is suspected to indicate some subsidence and or movement. No access to the subfloor at the time of the inspection.

Floor levels can have complex and varying causes, which will influence the required remedial works. It is recommended that any remedial works required should be in conjunction with other works at the same time as addressing other underlying causes. A Registered Builder would generally carry out these types of works or can be guided and advised by a structural engineer where deemed to be required. It is advised that the floors be closely monitored to identify any further movement even after floor have been rectified.

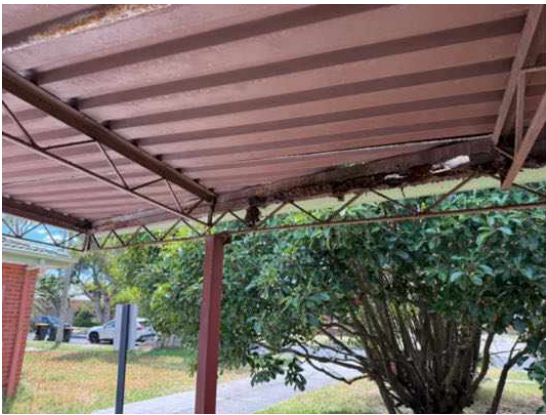
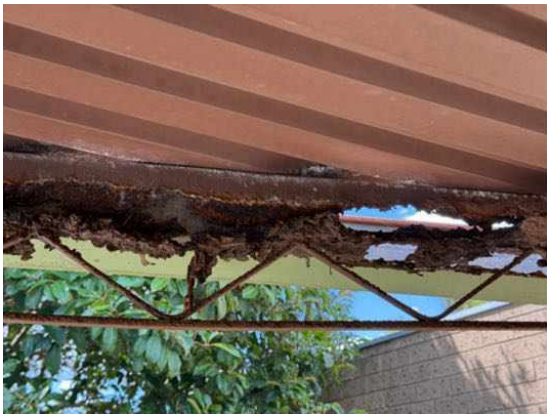
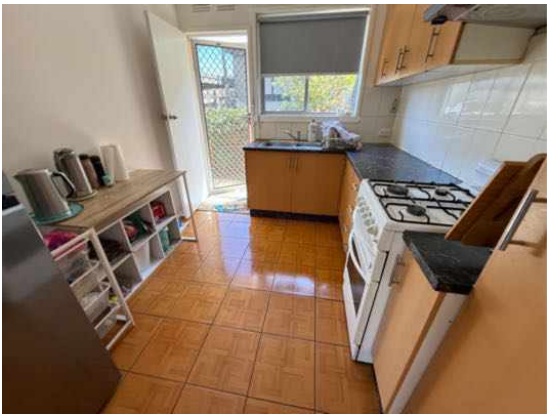
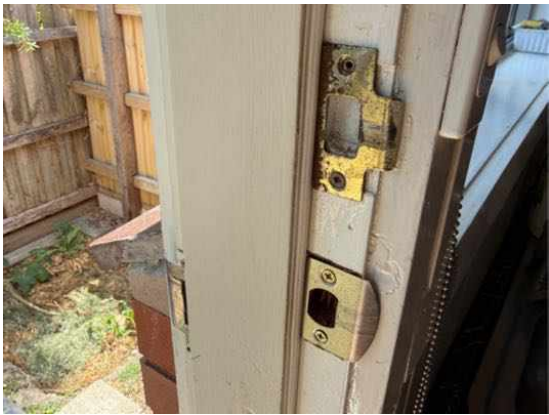
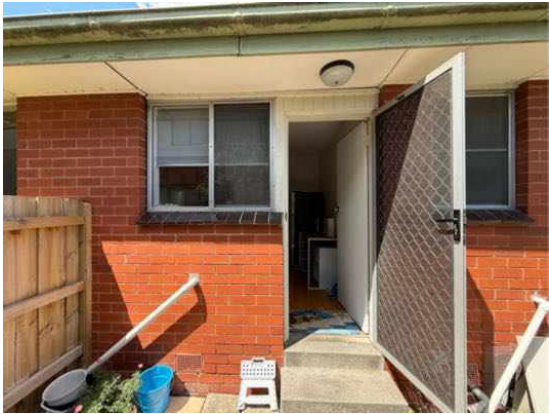
Building: Building 1
Location: All Areas > All Areas
Finding: Additional Photos
Information: Additional photos are provided for either future maintenance items for clients attention and or general reference. Arrows may have been included to highlight areas of importance. Please discuss these photos with your building consultant for clarification.

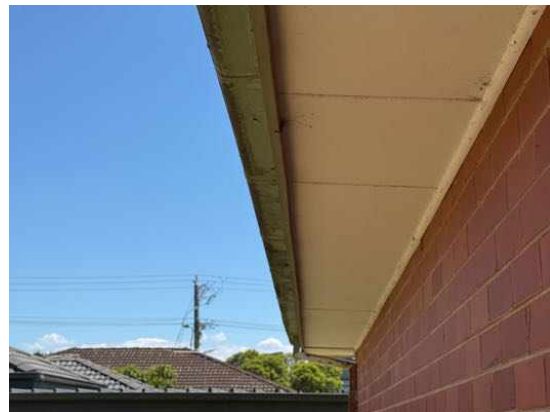
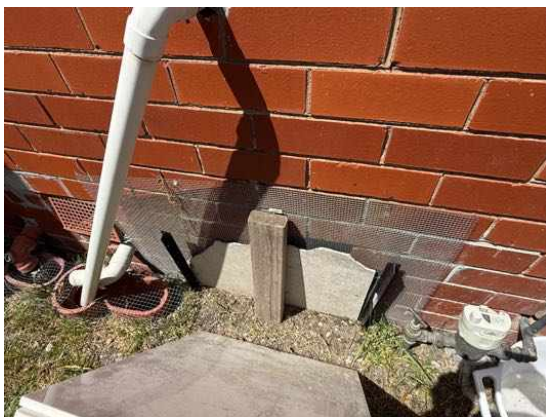
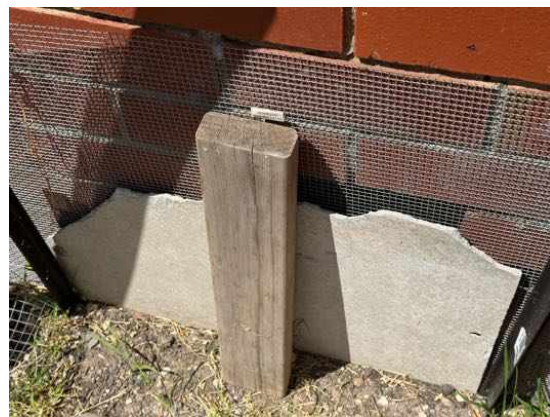
Location: All Areas > All Areas
Finding: Asbestos - Suspected ACM Identified on Site
Information: Reporting on Asbestos is outside the Scope of this Report. This suspected defect is highlighted as a caution only. We suspect, based on our experience in the building industry, that there is a higher risk of the identified building element containing asbestos.

As Asbestos Reporting is outside the scope of this report, we advise that you consider a separate Asbestos Inspection and Condition Audit, which can include the taking of samples for definitive confirmation of the presence of Asbestos. Asbestos sampling can only be taken upon ownership of the property only, due to being an invasive procedure.

In the interim, the client is advised to act with caution, especially when considering any damage to building materials general wear and tear renovations extensions demolition and general maintenance activities due to the suspected presence of Asbestos.
