Building and Timber Pest Inspection Report

Inspection Date: Wed, 11 Feb 2026

Property Address: 14A Caley St, Chifley NSW 2036, Australia

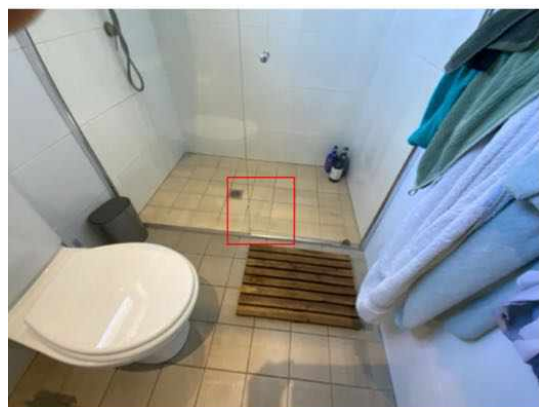
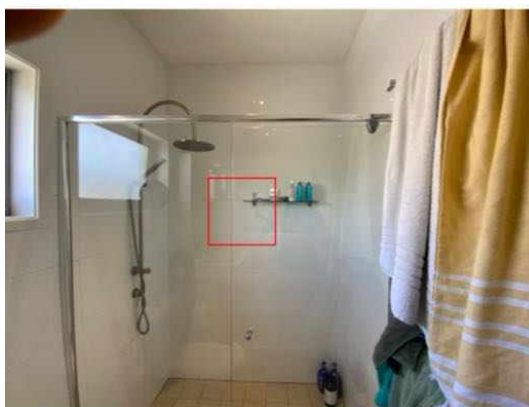
Building:	Main Building
Location:	Ensuite - Master
Finding:	Shower screen defective
Information:	At the time of inspection it was noted that the shower screen door can only open inwards. This is a serious safety hazard if the occupant becomes incapacitated and falls against the shower screen from the inside.

I would strongly recommend replacing or modifying the screen to insure the door can be opened outwards as per Australian standards requirements.

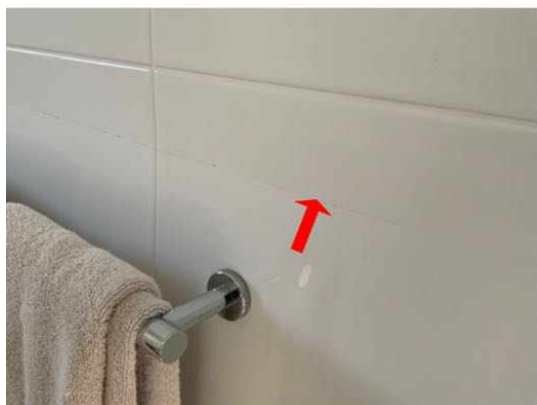
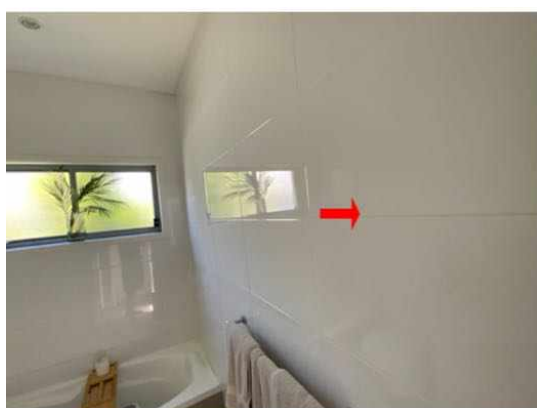
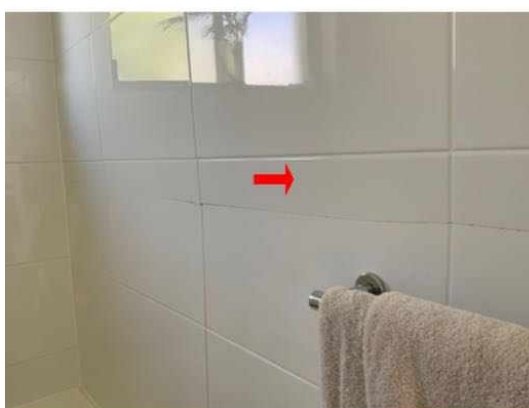
Finding 2.01

Building:	Main Building
Location:	Bathroom
Finding:	Tiles - Cracked and bulging
Information:	Cracking was evident to the tiling in this wall area at the time of inspection. the cracking appears to be major, this area is frequently exposed to water, allowing potential for water penetration into adjoining sections of walls or flooring.

If left unmanaged, these tiles may also pose a safety hazard, which is likely necessitate repair work to affected building elements.

A tiling contractor should be appointed to ensure that no further water damage occurs. The re-application of silicone and grouting throughout remaining tile work is also advised, to further protect the area against water penetration.

Where water penetration has led to water damage, appointment of a relevant tradesperson may be required to repair damaged building elements.

-replace cracked tiles and secure wall .

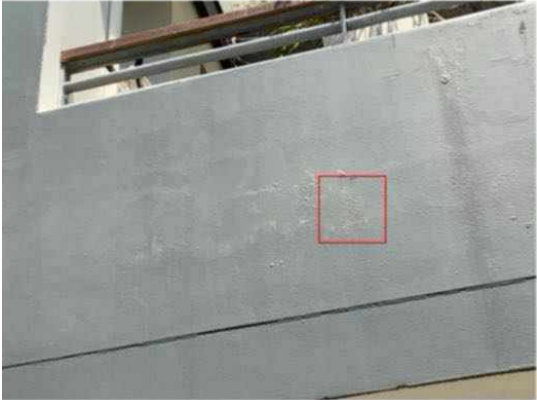
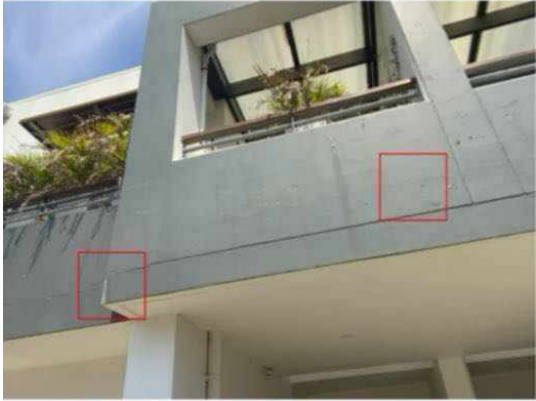
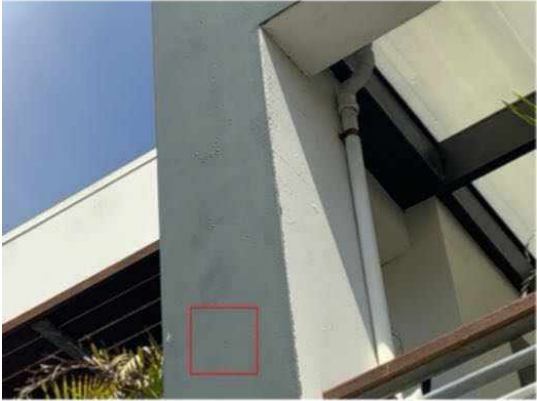
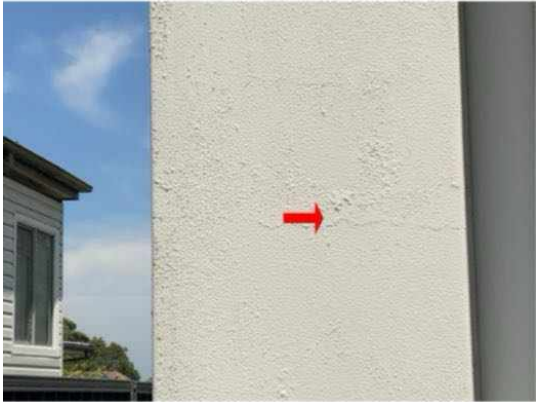
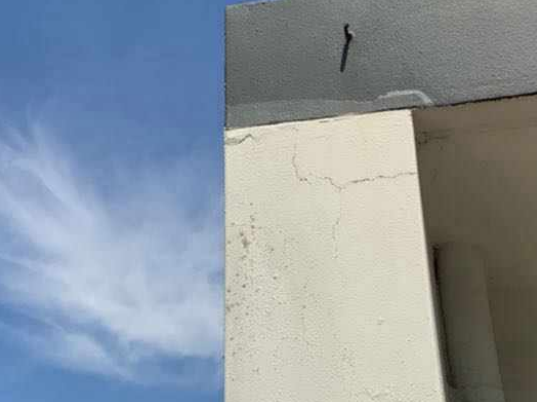
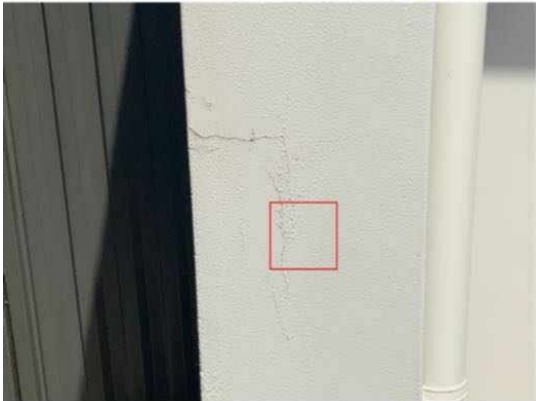
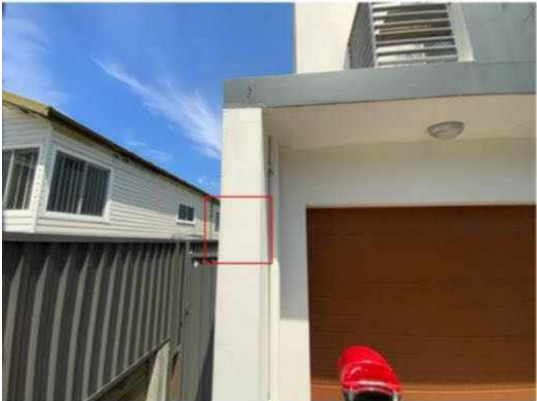
Finding 3.01

Building:	Main Building
Location:	Exterior walls - front
Finding:	Painted surface - Bubbling
Information:	Sections of paint in this area was found to have bubbled and deteriorated. Paint bubbling is generally an indication of excessive moisture in the area, that is currently hidden by the painted surface.

The presence of excessive moisture can have major implications on associated building elements if left unattended. While only seemingly minor at this stage, the damage cannot be determined due to the paint obstructing any further inspection of the damage.

It is highly advised that the affected paint be cleaned to allow a further, more invasive inspection by a licensed plumber. Failure to act on this defect may necessitate major works in the future.

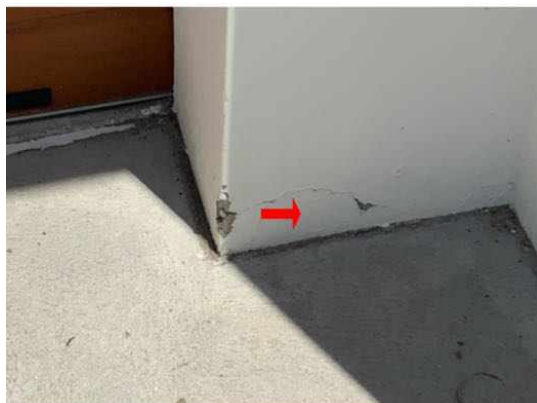
Finding 3.02

Building: Main Building
 Location: Exterior walls - front
 Finding: Cracking - Damage Category 2 - Noticeable (up to 5mm)
 Information: Noticeable cracks are a common occurrence as a result of many primary defects. Such causes may include age, general wear and tear, expected building movement, general expansion/contraction of building materials in different weather conditions, and/or minor failings in the installation or application of building materials.

However, noticeable cracks are easily filled and repaired. A plasterer can be consulted to install an expansion joint at this point to allow for this movement during different weather conditions.

Monitoring of all cracking should be conducted frequently. Always contact a building inspector should cracks widen, lengthen, or become more numerous.

Relevant tradespeople, painters and plasterers, should be appointed to perform remedial works, as deemed necessary.

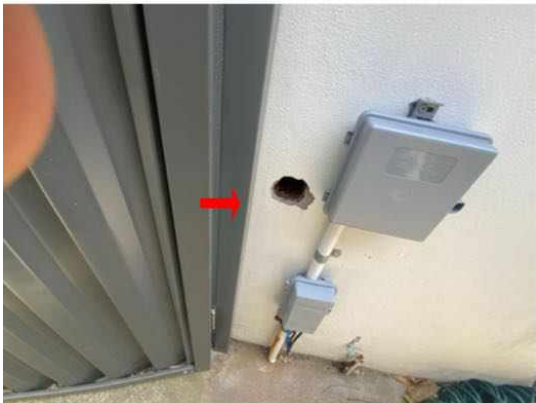
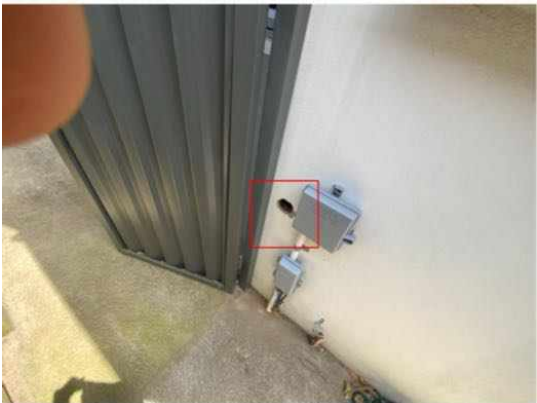
Finding 3.03

Building: Main Building
 Location: Exterior walls - left side
 Finding: External walls - Holes
 Information: Significant hole was identified in this wall section.

Gaps and holes makes the area susceptible to insect and vermin ingress, as well as allowing water penetration to the cavity wall. As such, associated building elements are likely to deteriorate at an accelerated rate, and major implications are expected if holes are left unmanaged.

All excessive holes, gaps or cracks should be adequately filled by a suitable sealant or trimmings as soon as possible to prevent any further damage. Such works may be

conducted by a general handyperson .

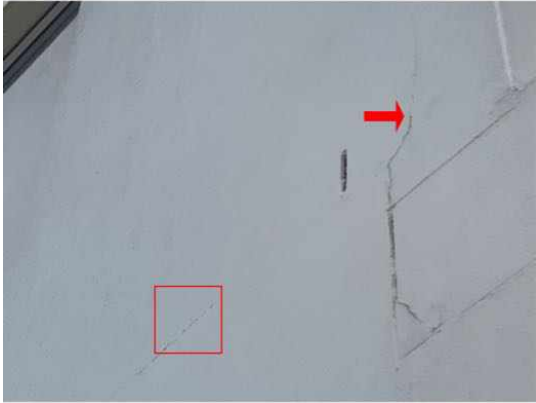
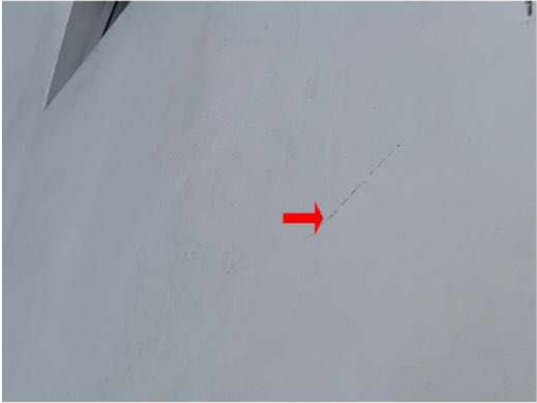
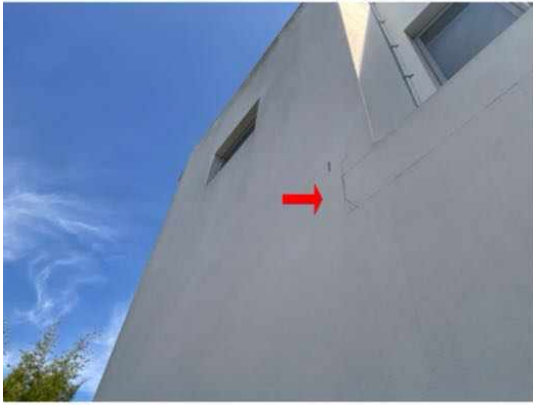
Finding 3.04

Building: Main Building
 Location: Exterior walls - left side
 Finding: Brickwork - Cracking noticeable
 Information: There were several cracks evident to external brickwork.

Noticeable cracks are a common occurrence in external brickwork and are a likely result of age expected building movement, general expansion, and/or contraction of building materials in different weather conditions. Noticeable cracks in brickwork may develop if left unattended, with potential for necessitating major remedial works or replacement of the brickwork.

It is highly advised that a qualified bricklayer be appointed to provide necessary works to cracked brickwork to prevent any further damage. Such works should be conducted as soon as possible.

Always monitor these cracks and contact a building inspector should cracks widen, lengthen, or become more numerous.

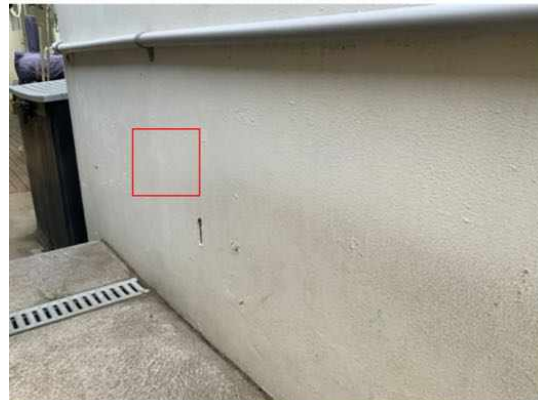
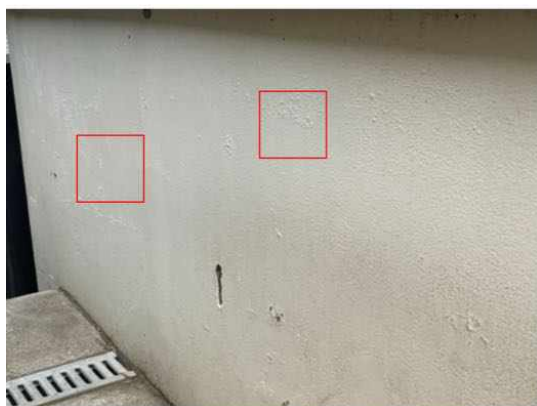
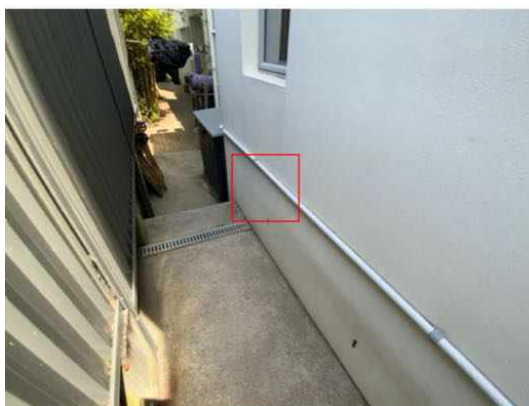
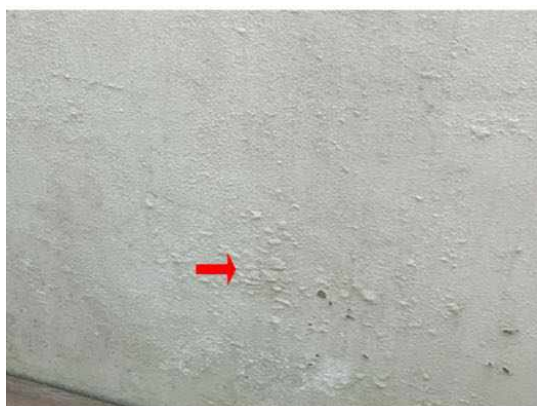
Finding 3.05

Building:	Main Building
Location:	Exterior walls - left side
Finding:	Painted surface - Bubbling
Information:	Sections of paint in this area was found to have bubbled and deteriorated. Paint bubbling is generally an indication of excessive moisture in the area, that is currently hidden by the painted surface.

The presence of excessive moisture can have major implications on associated building elements if left unattended. While only seemingly minor at this stage, the damage cannot be determined due to the paint obstructing any further inspection of the damage.

It is highly advised that the affected paint be cleaned to allow a further, more invasive inspection by a licensed plumber. Failure to act on this defect may necessitate major works in the future.

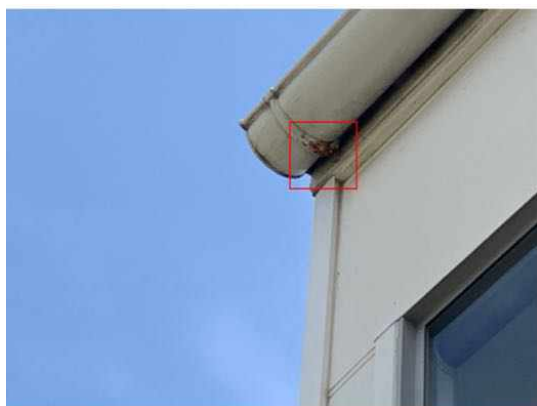
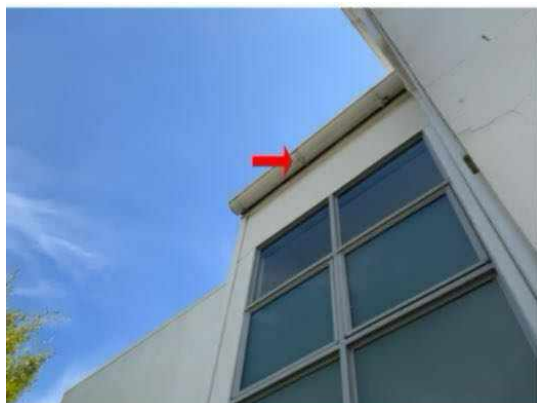
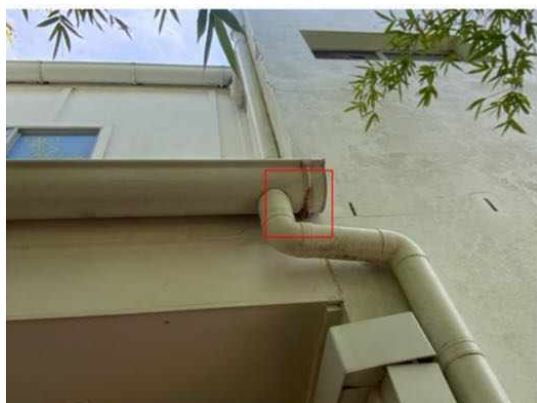
Finding 3.06

Building:	Main Building
Location:	Exterior walls - left side
Finding:	Gutter brackets- Rusted or corroded
Information:	The gutter brackets shows evidence of rusting and corrosion, which is likely to have developed as a result of excessive exposure to moisture and or inadequate coatings.

As surface rust provides no protection to the underlying iron, the deteriorating condition is likely to worsen if not addressed in the short-term future.

Where possible, the use of galvanized (treated) metals or aluminium coated metals aid in rust prevention, as does regular general maintenance. Rust formation can be controlled with coatings, such as paint, that isolate the iron from the environment.

Rusting and corrosion should be managed by ideally removing or limiting the affected surface from exposure to moisture. A registered builder may be appointed to replace any building elements that have been severely affected by rust or water damage.

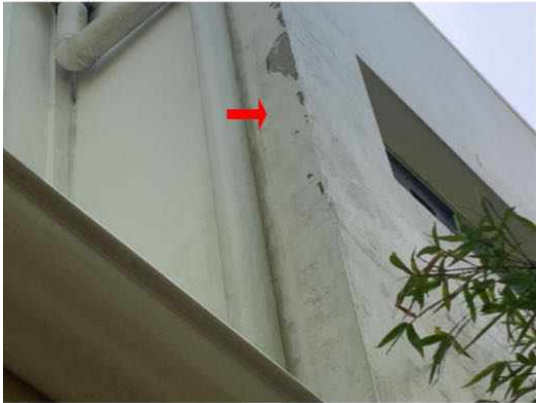
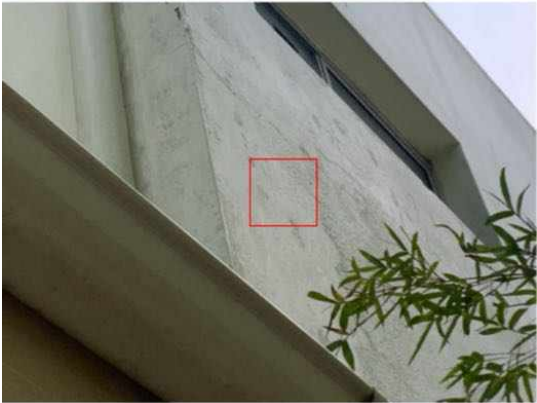
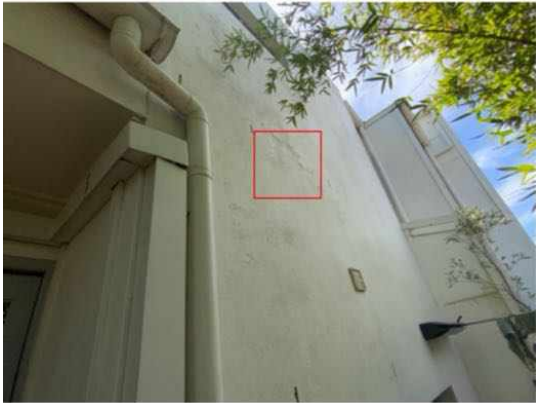
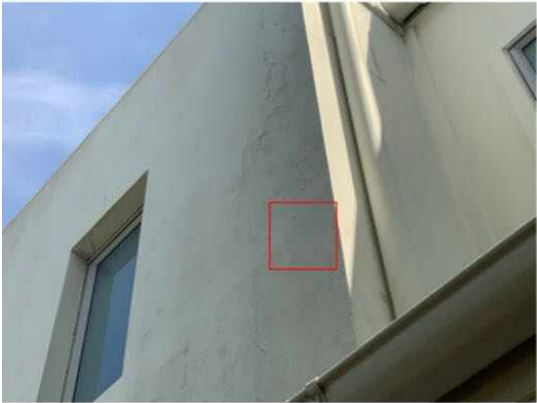
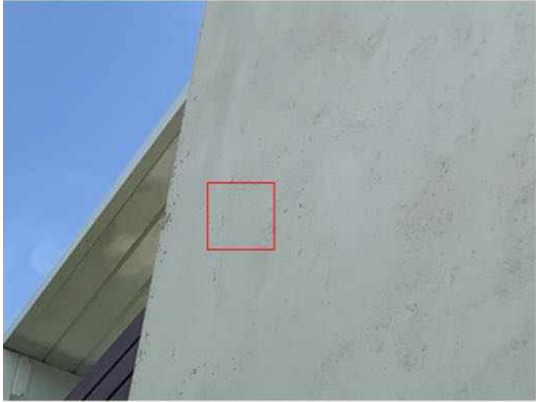
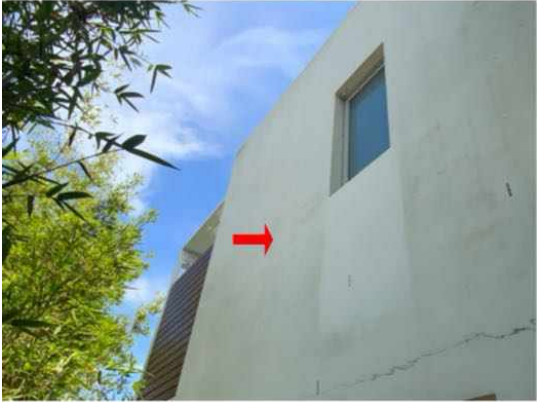
Finding 3.07

Building:	Main Building
Location:	Exterior walls - left side
Finding:	External painting deteriorated
Information:	Much of the external paintwork including but not limited to windows, fascias, guttering, veranda and other external fitments have been neglected and require attention to prepare and re-paint.

Whilst incomplete or missing paint finish is generally an appearance defect, it can also lead to the development of secondary building defects over time. Incomplete areas of paint finish expose the area to moisture, potentially accelerating the deterioration of underlying building materials.

Degraded paint finishes should be sanded back, filled, leveled and painted, as applicable. Where inadequate or missing paint protection has led to the deterioration of the associated building element, repair and/or replacement of this building element may be required.

A painting contractor should be appointed as soon as possible to perform necessary works to aid the appearance of the affected area and to ensure the area is protected against further deterioration. Alternatively, the homeowner following manufacturer instructions may perform these works.

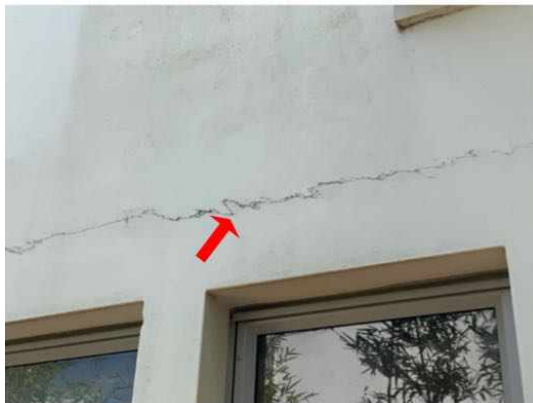
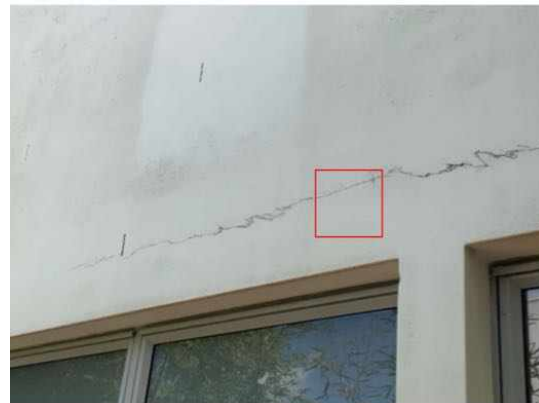
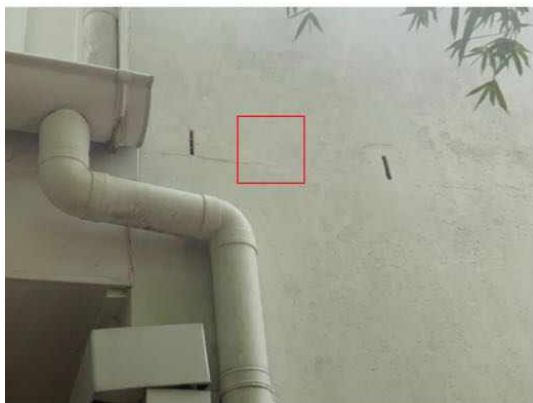
Finding 3.08

Building: Main Building
 Location: Exterior walls - left side
 Finding: Cracking - Damage Category 2 - Noticeable (up to 5mm)
 Information: Noticeable cracks are a common occurrence as a result of many primary defects. Such causes may include age, general wear and tear, expected building movement, general expansion/contraction of building materials in different weather conditions, and/or minor failings in the installation or application of building materials.

However, noticeable cracks are easily filled and repaired. A plasterer can be consulted to install an expansion joint at this point to allow for this movement during different weather conditions.

Monitoring of all cracking should be conducted frequently. Always contact a building inspector should cracks widen, lengthen, or become more numerous. Additionally, your building inspector should also be contacted if associated building elements such as doors and windows become more difficult to operate over time.

Relevant tradespeople, such as carpenters, painters and plasterers, should be appointed to perform remedial works, as deemed necessary.

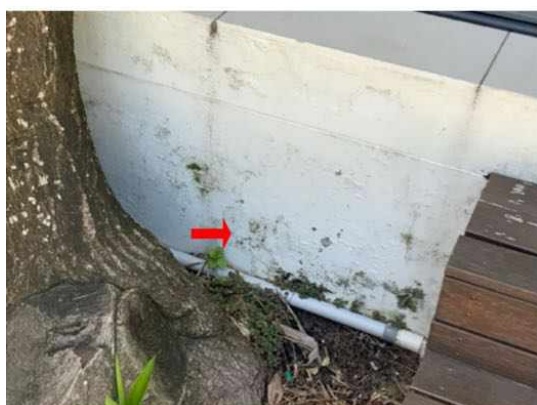
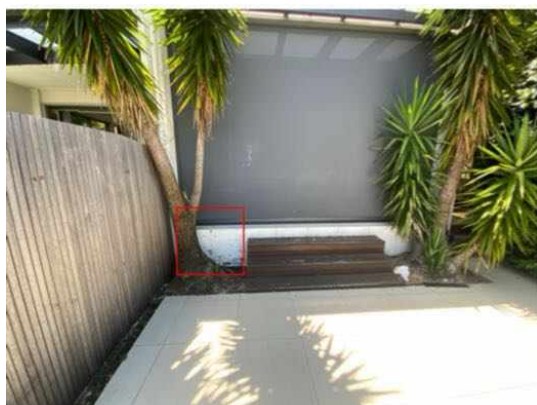
Finding 3.09

Rising damp is generally managed by the installation of a damp proof course during construction. The DPC may have been omitted as a consequence of poor workmanship, or it may have been bridged where materials built up against the side of the house allow moisture ingress above the DPC level.

The first step in addressing rising damp is to diagnose the cause. The identified cause should be addressed first before addressing the appearance and other defects which have resulted from the rising damp. If the original cause is not resolved, further cases of damp are likely to ensue, resulting in secondary defects.

Consultation with a qualified plumber is advised immediately to identify the cause of the damp and perform remedial works as required.

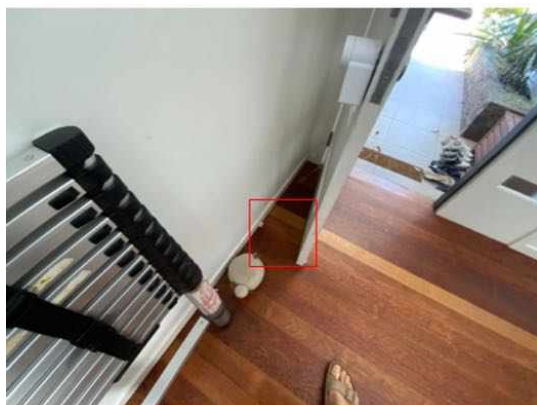
Finding 3.10

Building:	Main Building
Location:	Entry
Finding:	Door stop - Missing
Information:	The door stop is missing or is inadequate to stop the door handle from damaging the wall. Although some building elements may seem irrelevant or unnecessary, all building elements play a key role in the operation and function of the overall structure and its performance.

Re-installation or replacement of the door stop is advised as soon as possible to prevent any subsequent damage to the door or associated structures. A general handyman may be appointed to perform these works at client discretion.

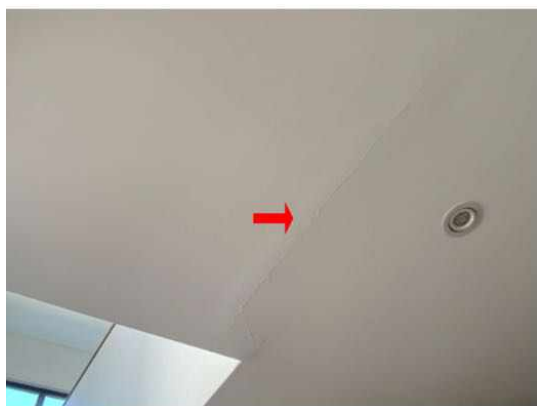
Finding 3.11

Building:	Main Building
Location:	Entry
Finding:	Cracking - Damage Category 1 - Fine (up to 1mm)
Information:	Although fine cracks are quite noticeable, they are often only considered to be an appearance defect, and usually do not indicate any structural damage. Generally, the cause of a fine crack is indicative of a separation between building materials and finishes (e.g. paint, plaster, etc.) along joins.

Cracking of this nature can generally be repaired with minor sanding, filling and/or repainting. Such works should be performed by a qualified painter or a general handyman.

Monitoring of all cracking should be conducted frequently. Always contact a building inspector should cracks widen, lengthen, or become more numerous.

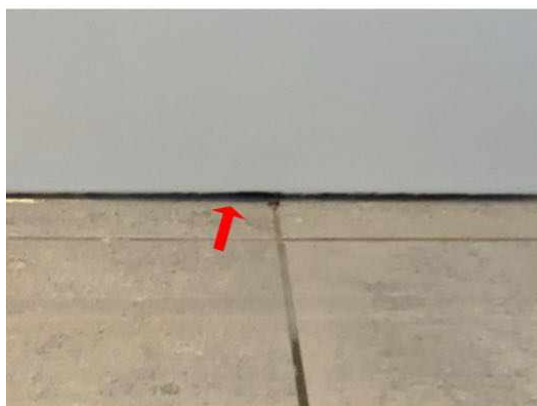
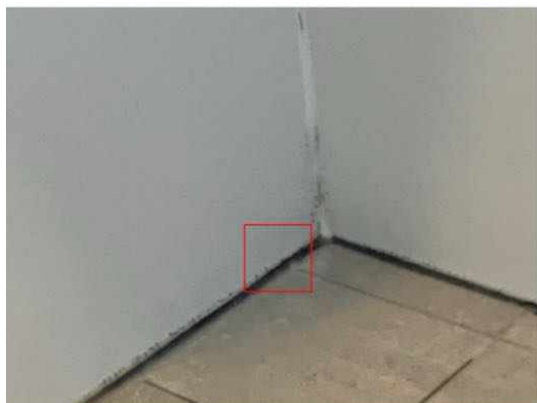
Finding 3.12

Building:	Main Building
Location:	Ensuite - Master
Finding:	Sealant and grouting - damaged
Information:	It was noted on inspection that sealant is degraded to the tiled shower alcove and other areas of the bathroom.

Different materials and floor areas move at different rates, generally causing cracking to sealant at this point. A flexible sealant is required to allow for expected expansion and contraction, while keeping the joint water tight and protective of all associated building materials.

There appears to be excessive mould to the sealant which will likely require scraping out and replacement.

Flexible and mould resistant materials should be applied to affected areas to prevent any subsequent water damage that is likely to occur. Regular maintenance and replacement of damage or missing or damaged sealant and grout is highly recommended to the wet areas, as this is a regular wear and tear defect. Sealant and grouting in areas that come into regular contact with water should be maintained for the long term care of your property.

A sealant specialist or tiling contractor should be appointed to complete these works as soon as possible

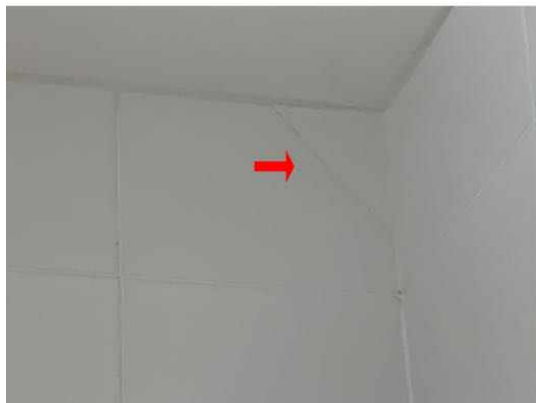
Finding 3.13

Building:	Main Building
Location:	Ensuite - Master
Finding:	Tiles - Cracked or damaged
Information:	Cracking was evident to the tiling in this area at the time of inspection. While the cracking appears to be minor, this area is frequently exposed to water, allowing potential for water penetration into adjoining sections of walls or flooring.

If left unmanaged, water penetration to these areas may lead to subsequent water damage, which is likely necessitate repair work to affected building elements.

A tiling contractor should be appointed to ensure that no further water damage occurs. The re-application of silicone and grouting throughout remaining tile work is also advised, to further protect the area against water penetration.

Where water penetration has led to water damage, appointment of a relevant tradesperson may be required to repair damaged building elements.

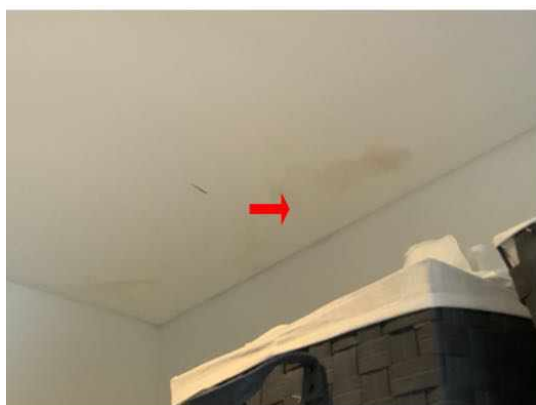
Finding 3.14

Building:	Main Building
Location:	Walk-In Robe - Master
Finding:	Ceiling - Water damaged
Information:	Water damage to the ceiling lining is generally an indication of excessive moisture being present in the roof void, usually via a leak to the roof covering.

Where water damage is evident to the ceiling, the primary requirement is to identify and rectify the source of the leak. A roofing plumber should be appointed as soon as possible to identify the leak and perform rectification works as necessary, ensuring the water damage is restricted.

Once the leak is repaired, consultation with relevant tradespeople, including plasterers and painters, is advised. Rectification works may include replacement of ceiling lining or minor repainting, depending on the extent of the damage.

-address water stain in ceiling

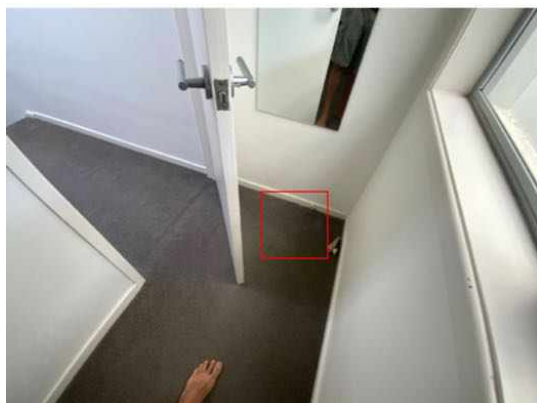
Finding 3.15

Building:	Main Building
Location:	All Internal Areas
Finding:	Door stop - Missing
Information:	The door stop is missing or is inadequate to stop the door handle from damaging the

Re-installation or replacement of the door stop is advised as soon as possible to prevent any subsequent damage to the door or associated structures. A general handyman may be appointed to perform these works at client discretion.

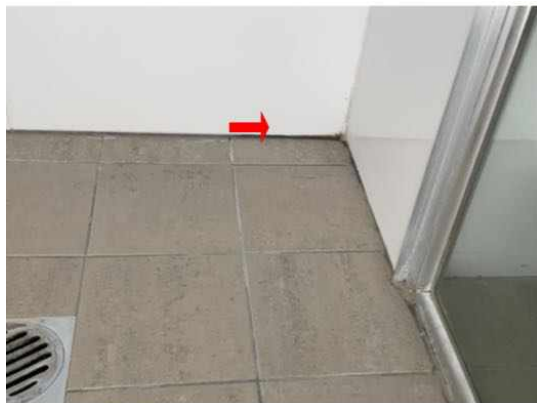
Finding 3.16

Building:	Main Building
Location:	Bathroom
Finding:	Sealant - Missing or damaged
Information:	It was noted on inspection that sealant is degraded to the tiled shower alcove and other areas of the bathroom.

Different materials and floor areas move at different rates, generally causing cracking to sealant at this point. A flexible sealant is required to allow for expected expansion and contraction, while keeping the joint water tight and protective of all associated building materials.

There appears to be excessive mould to the sealant which will likely require scraping out and replacement.

Flexible and mould resistant materials should be applied to affected areas to prevent any subsequent water damage that is likely to occur. Regular maintenance and replacement of damage or missing or damaged sealant is highly recommended to the wet areas, as this is a regular wear and tear defect. Sealant and grouting in areas that come into regular contact with water should be maintained for the long term care of your property.

A sealant specialist or tiling contractor should be appointed to complete these works as soon as possible

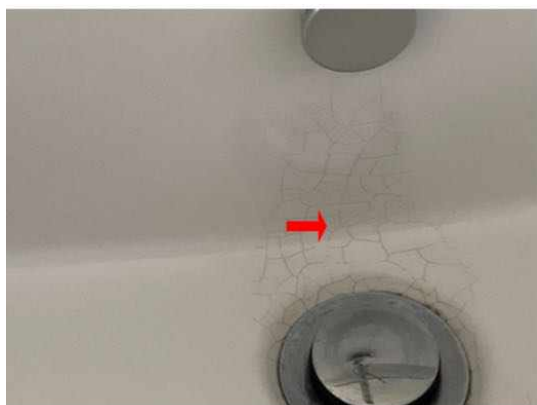
Finding 3.17

Building:	Main Building
Location:	Bathroom
Finding:	Basin - Cracked
Information:	Cracking was evident to the basin at the time of inspection, which is suspected to have been by wear and tear. While the cracking appears to be minor, any further impact damage sustained by the basin may lead to additional cracking.

As the cracking provides potential ingress for water, secondary water damage may occur to associated cabinetry, walls or flooring, if the cracking is left unmanaged.

Consultation with a plumber regarding basin repair or replacement is required. Remedial works may be required to protect against any further damage.

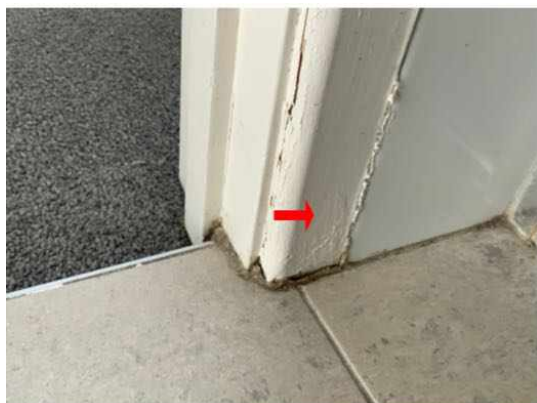
Finding 3.18

Building:	Main Building
Location:	Bathroom
Finding:	Painted surface - Bubbling
Information:	Bottom of architrave in this area shows evidence of moisture it is suspected due to water exiting the shower area. Paint bubbling is generally an indication of excessive moisture in the area, that is currently hidden by the painted surface.

The presence of excessive moisture can have major implications on associated building elements if left unattended. While only seemingly minor at this stage, the damage cannot be determined due to the paint obstructing any further inspection of the damage.

It is highly advised that the affected paint be cleaned to allow a further, more invasive inspection by a licensed plumber. Failure to act on this defect may necessitate major works in the future.

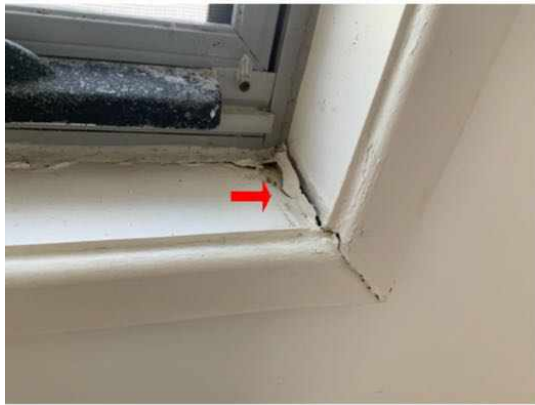
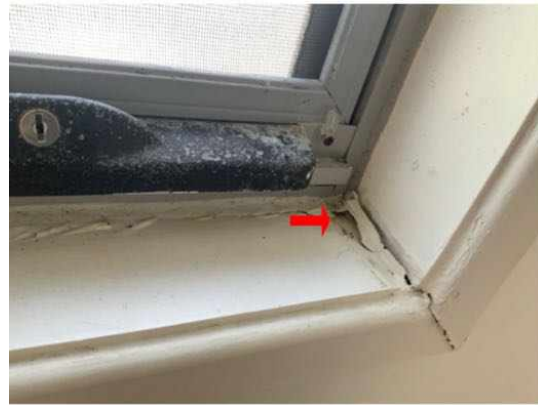
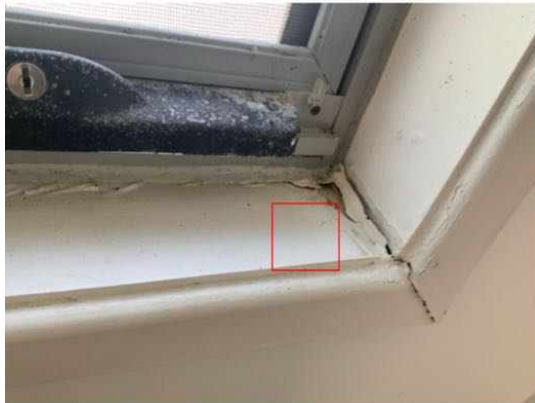
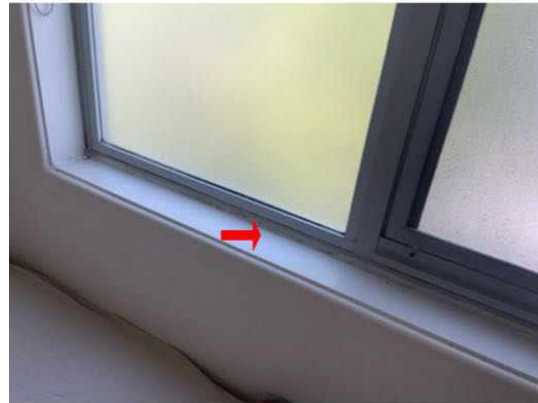
Finding 3.19

Building:	Main Building
Location:	Bedroom 3
Finding:	Window reveal - Damaged
Information:	Damage occurs generally when the building materials have either aged and decayed, or as a result of damage (accidental or deliberate).

Repair and/or replacement of damaged reveal is advised to ensure that additional secondary defects do not arise as a consequence. Such works are necessary, as all building elements play a key role in the operation and function of the overall structure and its performance.

A qualified carpenter should be appointed to repair or replace the affected building element prior to any subsequent damage being caused.

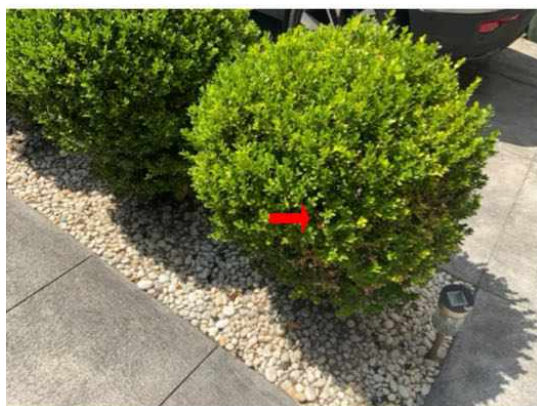
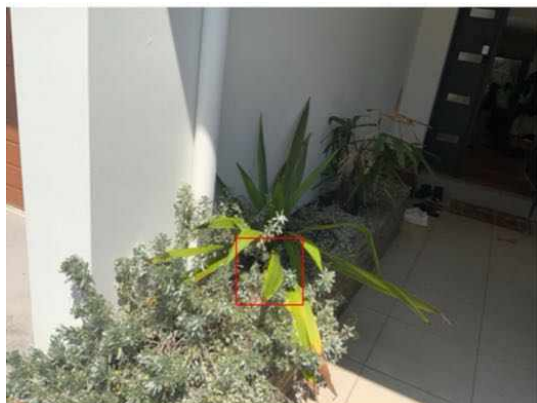
Finding 6.01

Building:	Main Building
Location:	Exterior walls - front
Finding:	Garden Beds - Conditions Conducive to Termites
Information:	Garden beds were found to be evident in the garden area. These garden beds can include untreated timber, and with a combination of moisture from watering hosing can make conditions conducive to termite activity and termite ingress.

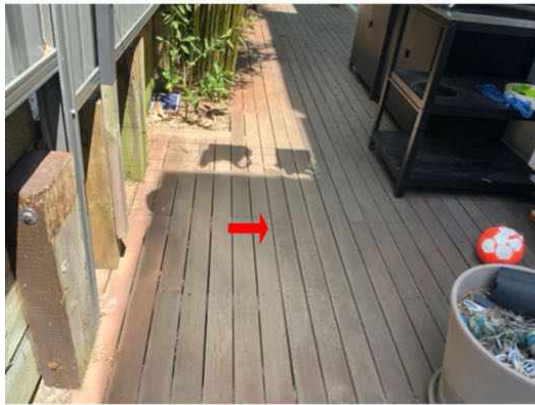
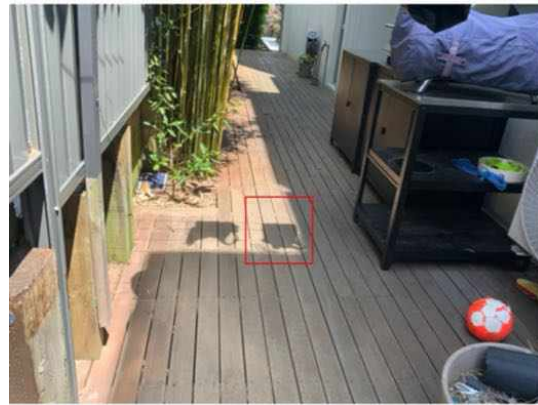
Finding 6.02

Building:	Main Building
Location:	Exterior walls - left side
Finding:	Building materials in direct ground contact - conducive to termites
Information:	Where timber elements are in direct contact with the ground and consequently moisture or dampness they become conducive to termite activity. Whether timber is used as a building element part of a fencing structure or stored as an unused item they can provide an environment that is attractive to termite infestation.

When met with excessive moisture timber begins to decay and develop wood rot. Any timbers that are in direct contact with external grounds especially if left untreated or non-durable also provide ingress for subterranean termites into that particular element.

The removal of any such materials that may be conducive to termite activity should be removed as soon as possible to minimise the risk of termite attack.

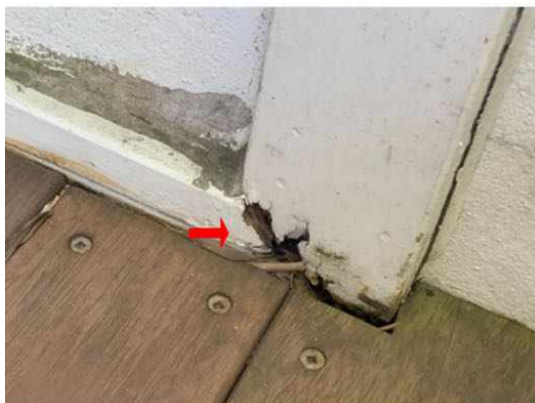
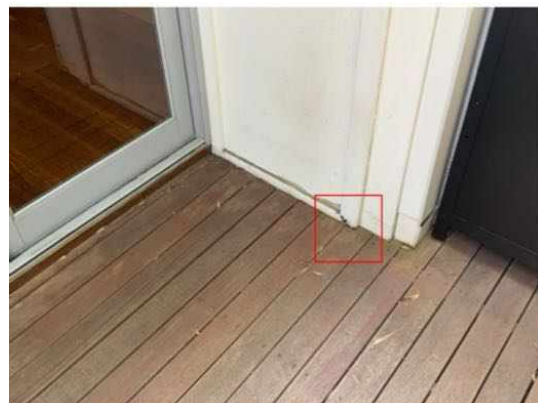
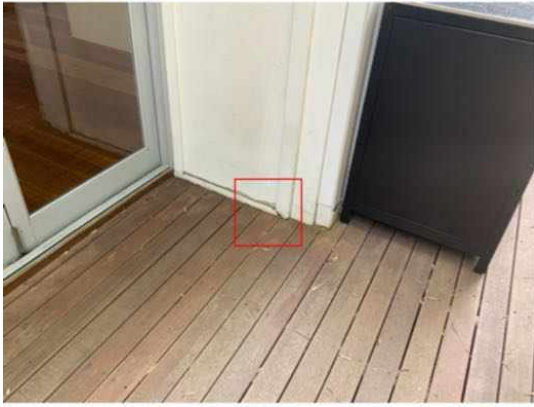
Finding 7.01

Building:	Main Building
Location:	Exterior walls - left side
Finding:	Wood rot
Information:	The wall trim shows evidence of wood rot. Wood rot, also known as Fungal Decay, occurs when timbers and other cellulose building materials are exposed to damp conditions on an ongoing basis. This could be the result of exposure to weathering over a prolonged period of time, or the attraction of excessive moisture from other abutting building materials. Contributing factors also include poor air ventilation in the area.

Early intervention and regular maintenance, particularly of exterior timbers, will prolong the useful life of these building elements. Prior to any works being performed, the cause of the moisture that has created the visible wood rot should be identified and addressed in a suitable manner. Replacement of affected timbers may then be a necessary step in protecting surrounding building elements from such deterioration.

A qualified carpenter or registered builder may also be required to replace affected building materials.

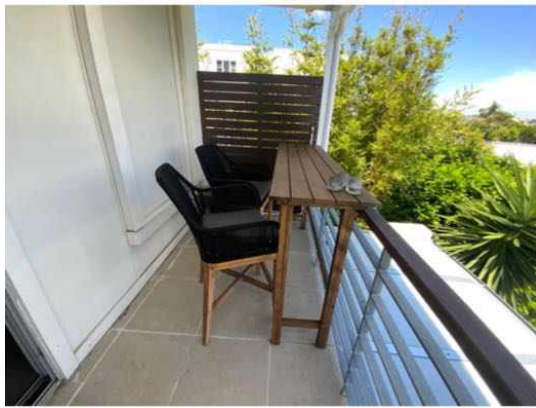
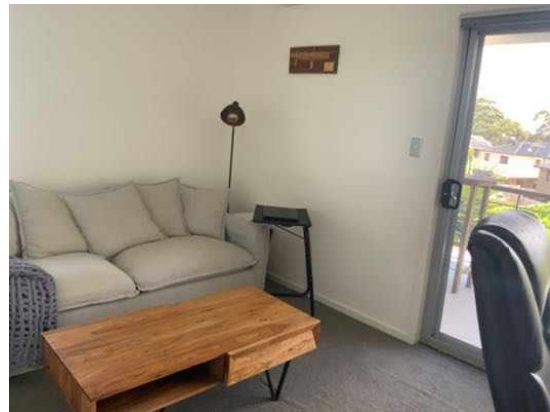
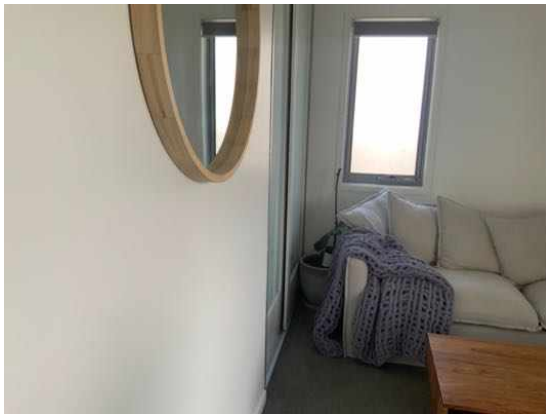
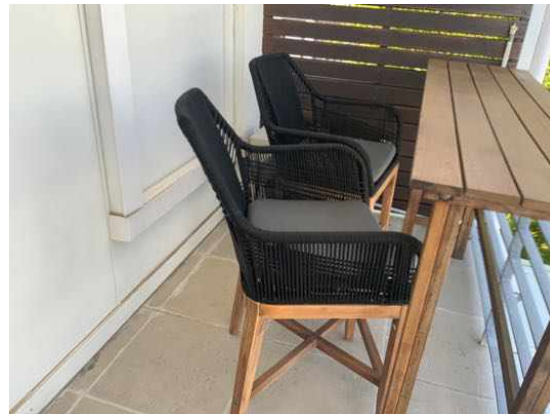
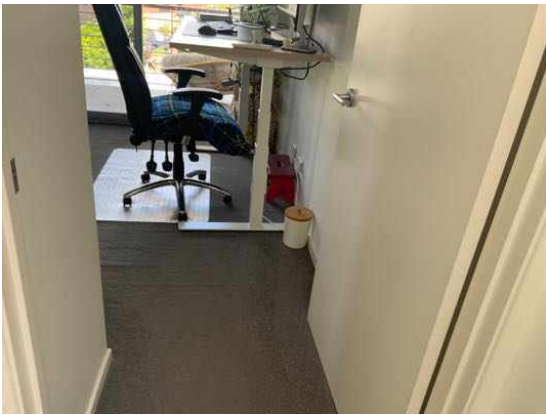
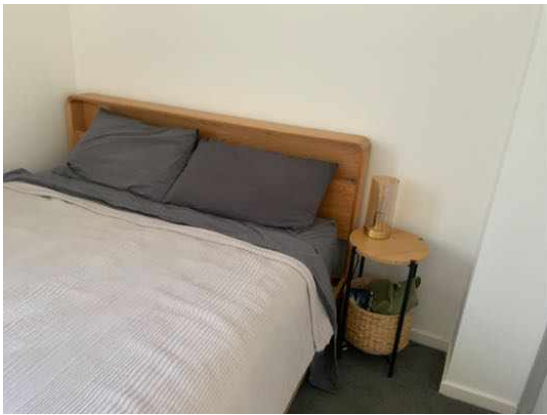
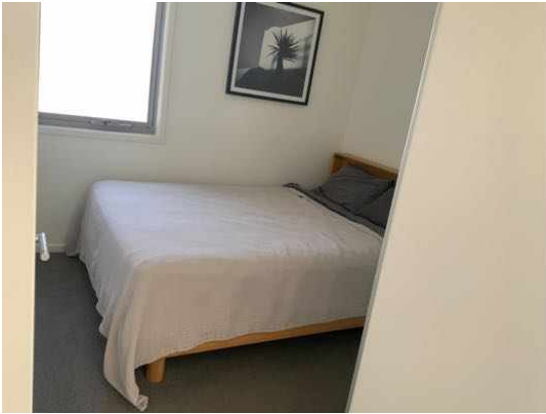
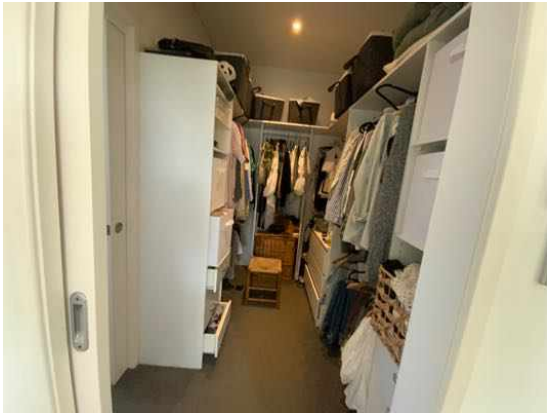
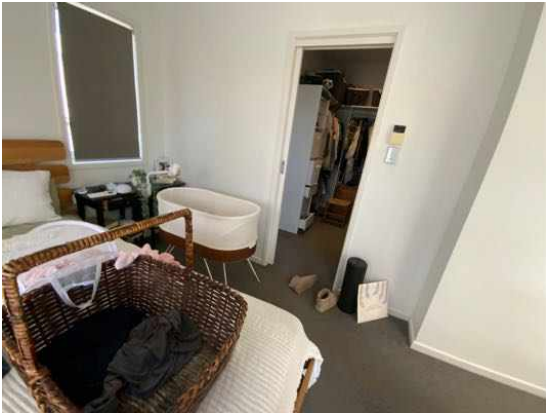
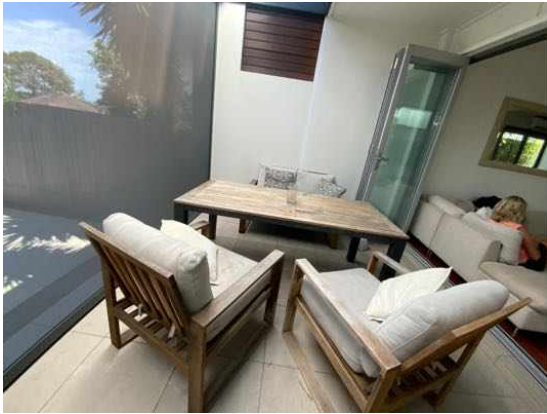
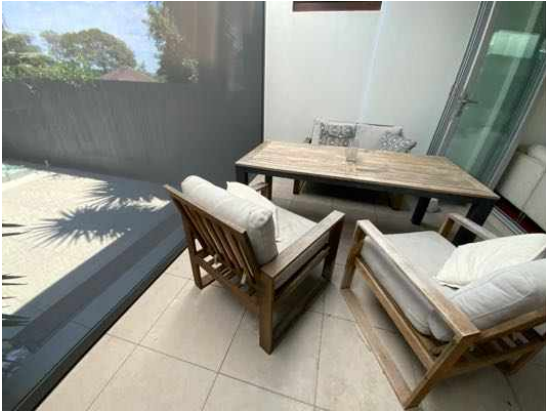
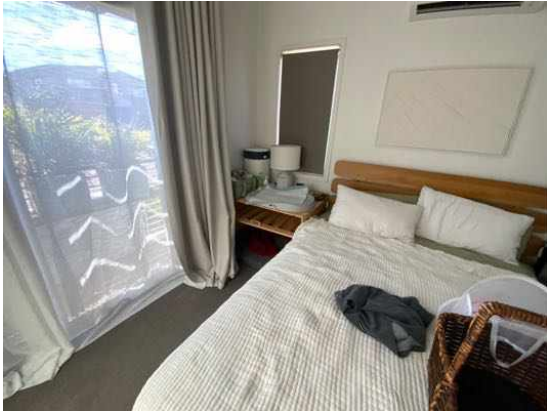
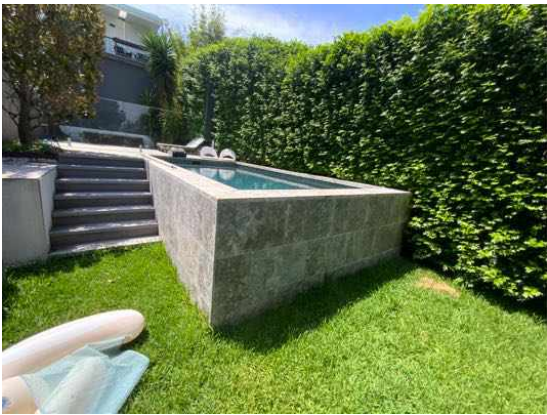
Building: Main Building
Location: All Areas
Finding: Additional Photos - Obstructions and Limitations
Information: These photographs are an indication of the obstructions and limitations which impeded full inspection of the property at the time of inspection. These obstructions can hide an array of defects and should be removed to allow full inspection to be carried out. A re-inspection is recommended once the areas are made accessible.
