Building and Timber Pest Inspection Report

Inspection Date: Mon, 23 Mar 2026

Property Address: U1 197 Willarong Rd, Caringbah NSW 2229,
Australia

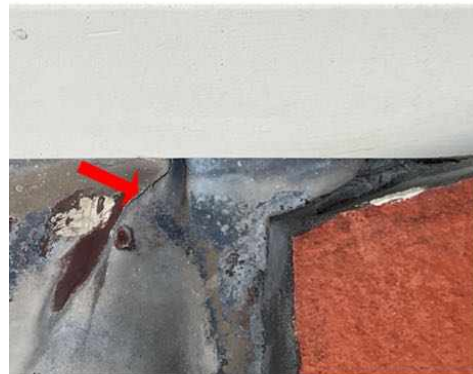
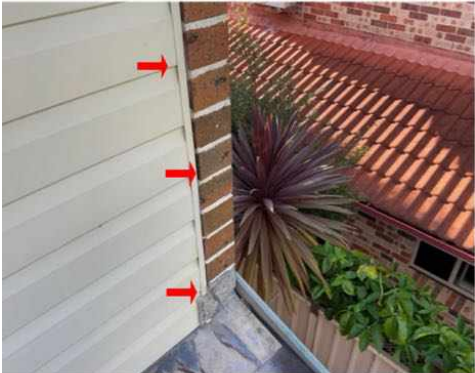
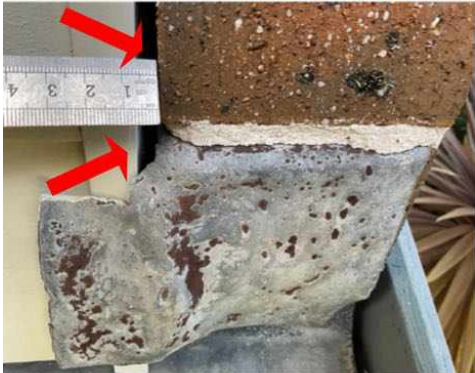
Building:	Building 1
Location:	Pictured roof areas
Finding:	Flashing and cladding areas cracked / missing
Information:	Missing and cracked flashings and one cladding area were evident to external roof and wall areas at the time of inspection.

Regardless of the location, if left unmanaged, even minor leaks that can occur in these areas can lead to serious damage of internal building elements, potentially resulting in the need for replacement of building materials. Damage to ceilings and wood rot may also arise if these missing / damaged flashings are left unmanaged, leading to deterioration of internal areas.

A roofing contractor should be engaged to repair / install/ replace these flashing areas immediately.

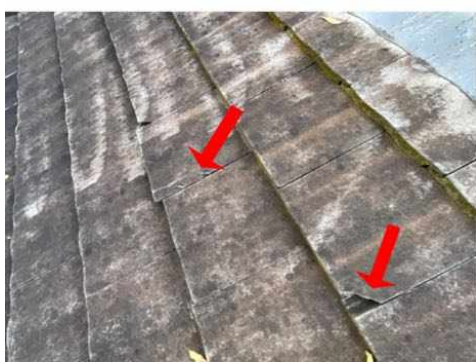
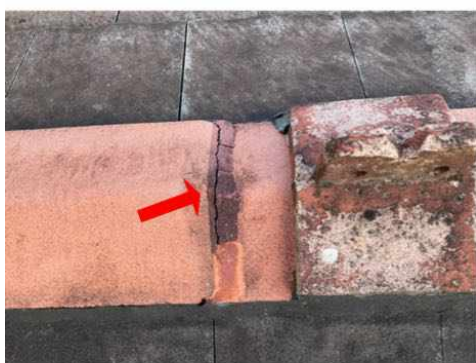
flashings) were considered to be in a good condition. While weathering of the tiles is consistent with the age of the property, maintenance works are required.

Isolated areas of mortar and tiles show minor cracking present. Re-pointing and re-sealing the may be considered as an interim solution by the client to help preserve and extend the life span of the tiles. Where left unmanaged, deteriorating roof tiles are likely to lead to a number of secondary defects, including minor water leaks and weather exposure to internal roofing structures.

Consultation with a roofing contractor is highly advised to gain advice on cost of remedial works that may be required in the short to medium term. Remedial works are likely to increase the longevity of the exterior roofing structure (see also missing and damaged flashings defect).

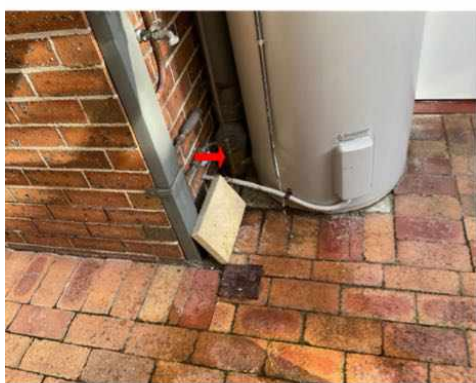
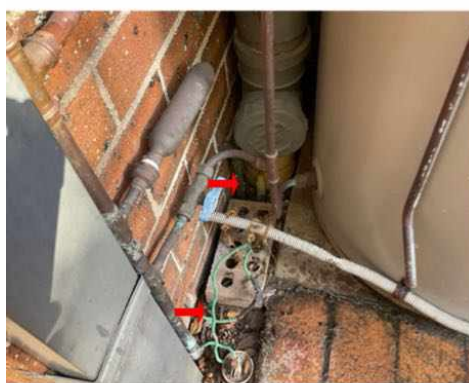
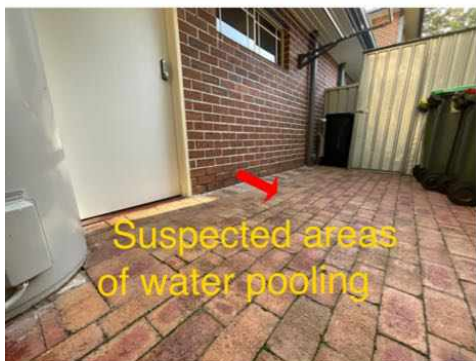
Finding 3.03

Building:	Building 1
Location:	Rear / side walls
Finding:	Site drainage - Inadequate
Information:	The site drainage in these areas appears to be inadequate at the time of inspection, creating potential for subsequent water damage to associated building elements.

No drainage is evident to these wall areas. Water may pool in these areas, evidenced by a rusted rear garage door frame, the damaged garage wall mortar, the ground

It is important that water does not lie against the base of walls; surrounding paths and ground levels should be sloped to drain water away from walls. Downpipes should not discharge stormwater onto lower walls or plinths. Stormwater should be carried away by large, regularly cleaned drains. Ground levels may need to be lowered to expose a buried DPC.

Where site drainage is inadequate, installation of an Agricultural (Aggie) Drain may be required. A qualified plumber should be appointed to further inspect the property and perform any remedial works as necessary. It appears a rear strip drain is required to stop further defects.

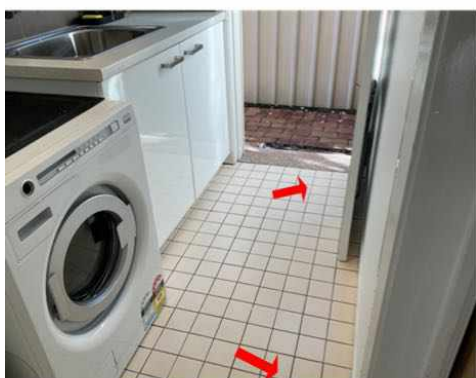
Building:	Building 1
Location:	Laundry
Finding:	Tiles - Drummy
Information:	Drummy tiled areas were identified at the time of inspection. The term 'drummy' refers to tiles that have become detached from their fixing, despite otherwise being in relatively good condition. Such defects are generally caused by physical or moisture damage to the area. Drummy tiled areas may also be a direct result of poor workmanship during the construction process.

Tiled areas may swell and shrink with changes in air humidity if the area has sustained moisture damage. Any exposure to moisture is capable of causing tiled areas to become drummy and/or cracked over a prolonged period of time. Drummy tiled areas generally require removal and replacement of affected tiles, with adequate sealant and grouting.

Specialist trades are available for these types of services. A tiling contractor be appointed to perform works as necessary.

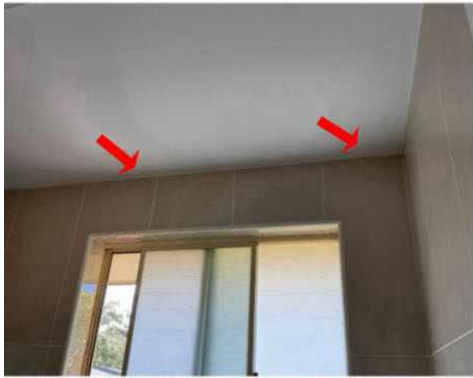
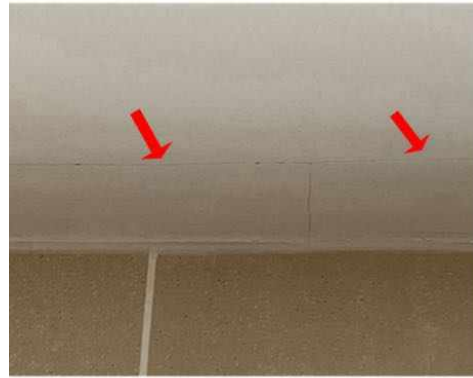
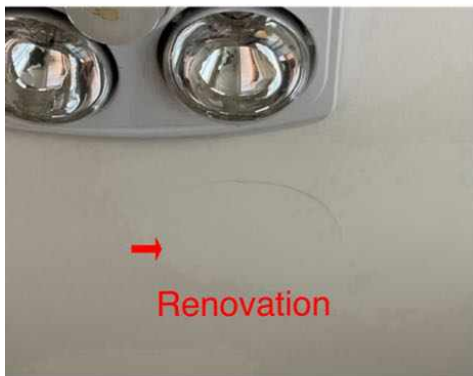
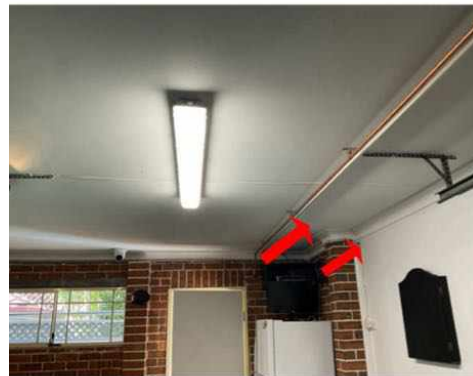
Finding 3.09

Building:	Building 1
Location:	Bathrooms, stairs, lounge, garage & other small areas
Finding:	Cracking - Damage Category 1 - Fine (up to 1mm)
Information:	Although fine cracks are quite noticeable, they are often only considered to be an appearance defect, and usually do not indicate any structural damage. Generally, the cause of a fine crack is indicative of a separation between building materials and finishes (e.g. paint, plaster, etc.) along joins.

Cracking of this nature can generally be repaired with minor sanding, filling and/or repainting. Such works should be performed by a qualified painter or a general handyman.

Monitoring of all cracking should be conducted frequently. Always contact a building inspector should cracks widen, lengthen, or become more numerous.

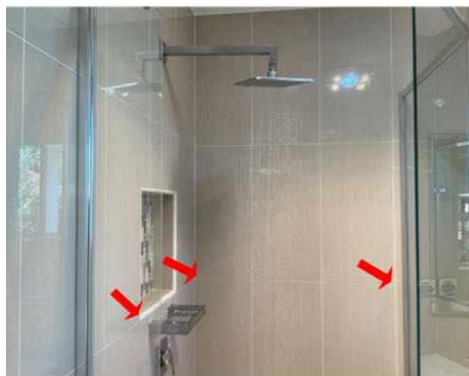
Finding 3.10

Building:	Building 1
Location:	Bathrooms
Finding:	Sealant and grouting - Missing or damaged
Information:	It was noted on inspection that sealant or grout is degraded to these pictured areas.

Different materials and floor areas move at different rates, generally causing cracking to grout or sealant at this point. A flexible sealant is required to allow for expected expansion and contraction, while keeping the joint water tight and protective of all associated building materials.

Flexible and mould resistant materials should be applied to affected areas to prevent any subsequent water damage that is likely to occur. Regular maintenance and replacement of damage or missing or damaged sealant and grout is highly recommended to the wet areas, as this is a regular wear and tear defect. Sealant and grouting in areas that come into regular contact with water should be maintained for the long term care of your property.

A sealant specialist or tiling contractor should be appointed to complete these works as soon as possible

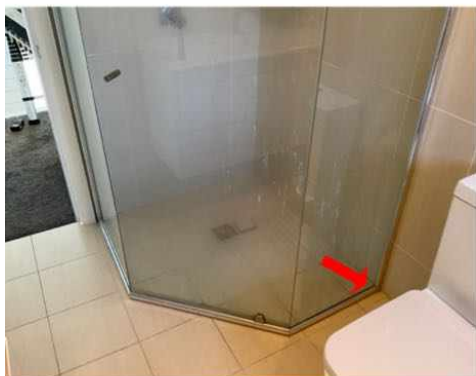
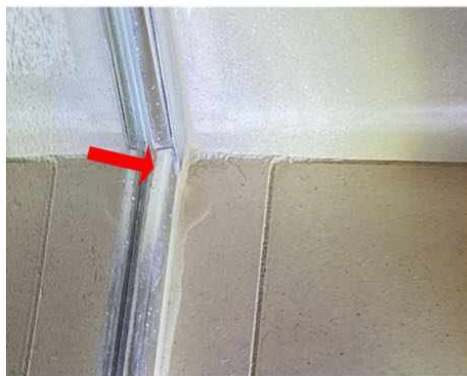
Finding 3.11

Building:	Building 1
Location:	Bathroom
Finding:	Shower screen - Leaking
Information:	Leaking was evident to the shower screening at the time of inspection. It is suspected that the leaking has occurred as a result missing sealant. Leaking from the shower , where left unattended, is likely to lead to water damage to adjoining flooring and walls. Such damage can lead to water damage and necessitate extensive remedial works being required. Active water leaks may also create an environment that is susceptible to the formation and development of mould.

Appointment of a sealant expert is required to repair or replace this missing sealant.

Such works should be performed as soon as possible to ensure that no further damage occurs.

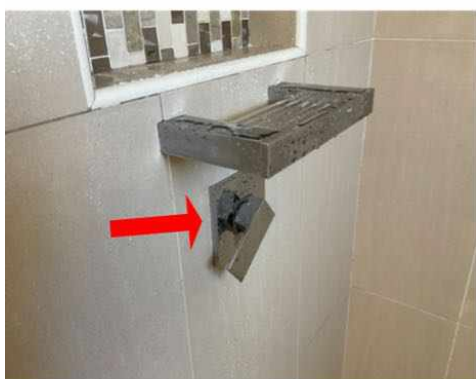
Finding 3.12

Building:	Building 1
Location:	Bathroom- ensuite
Finding:	Taps - Water hammer
Information:	These taps shows evidence of water hammer being present. Water hammer, a pressure surge resulting when a fluid is forced to suddenly change direction, is a common defect in plumbing fittings, particularly those that are aged and not frequently maintained. Water hammer is generally caused by factors that create high water pressure in the affected plumbing fixture, usually evidenced by a faint banging noise during operation of the affected tap.

Although water hammer is generally considered to be a minor defect, subsequent damage such as erosion of tap hardware and/or water damage to associated building elements is likely to occur if left unmanaged.

A licensed plumber should be appointed as soon as possible to replace any affected tap hardware and perform any remedial works as necessary. Please be advised that the appointment of a cabinet maker or qualified carpenter may be necessary if water damage to associated building elements has occurred.

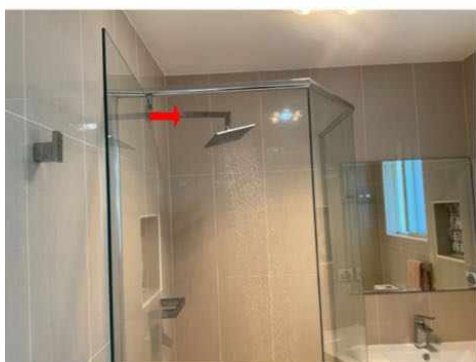
Finding 3.13

Building: Building 1
Location: Shower arm
Finding: Building elements - Damaged
Information: The shower are is loose requiring tightening.

A plumber would be the trade responsible for rectification of this arm when convenient.

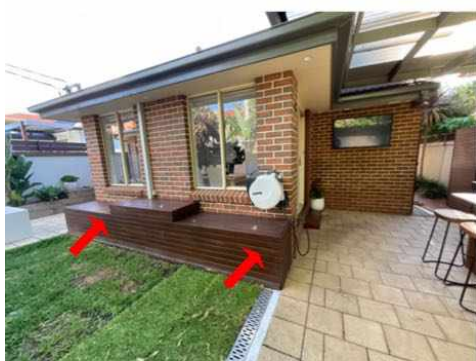
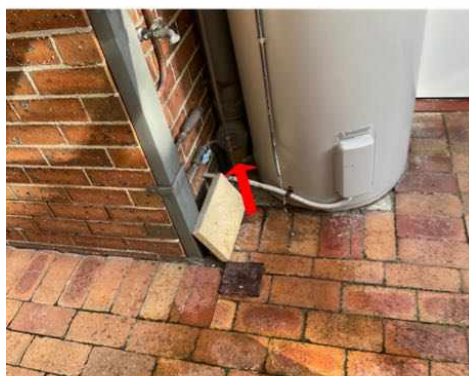
Building:	Building 1
Location:	Yard - front
Finding:	Bridging of termite barriers
Information:	Where these boxes obstructs inspection of building elements, also known as bridging as it provides a bridging point for the access of termites, full inspection can not be achieved. Consequently moisture or dampness may be present and the areas becomes conducive to termite activity. Plants, decks and these boxes against or very close to buildings provide cover, shade and can provide an environment that is attractive to termite infestation.

The removal of any such materials that may be conducive to termite activity should be carried out as soon as possible and arrange re inspection to minimize the risk of termite attack.

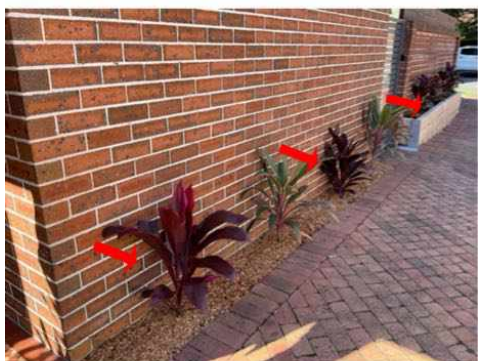
Finding 6.03

If the slab edge is not properly exposed there is a high risk of termite attack. Sometimes, in order to determine the type of slab, a suitably qualified person such as an architect or builder may be required to consult the construction plans.

Where the slab edge cannot be properly inspected, it is highly recommended that termite or timber pest inspections be carried out every 6-12 months to aid protection of the property against infestation.

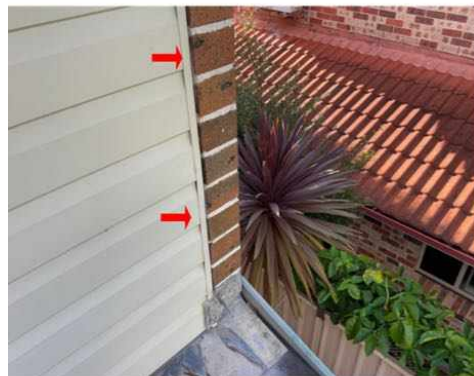
Finding 6.04

Building:	Building 1
Location:	All missing/ damaged sealant/ flashing areas
Finding:	Sealant (external) - missing and attractive to termites
Information:	It was noted on inspection that areas of external sealant was missing to small areas of the external walls. A flexible sealant or flashing is required to protect the associated building materials from rainwater ingress. Any moisture ingress into the property is very attractive to termites. Flexible sealants or flashing should be applied to these affected areas to prevent termite activity.

A roofing contractor/ roof plumber should be appointed to complete these works as soon as possible.

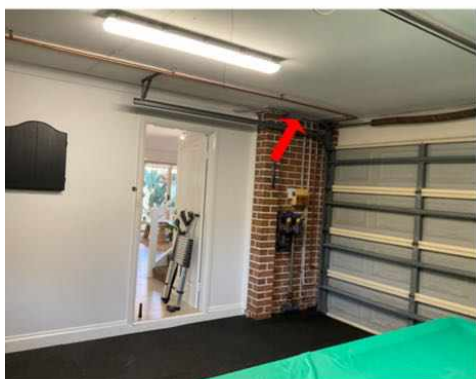
Building: Building 1
 Location: Garage
 Finding: Elevated moisture - identified
 Information: A slightly elevated moisture reading of 25 and minor paint damage was found in the front right garage wall. Nearby readings were all zero.

Elevated moisture is generally caused by deteriorated, inadequate or missing roof drainage and damaged sealant or missing flashings.

Prior to any internal remedial works being performed, a qualified roof plumber or roofing contractor should be appointed to repair or replace all damaged and missing flashings on the external walls/roof areas.
