# Building and Timber Pest Inspection Report

Inspection Date: Tue, 24 Feb 2026

Property Address: 99 Broughton St, Camden NSW 2570,  
Australia

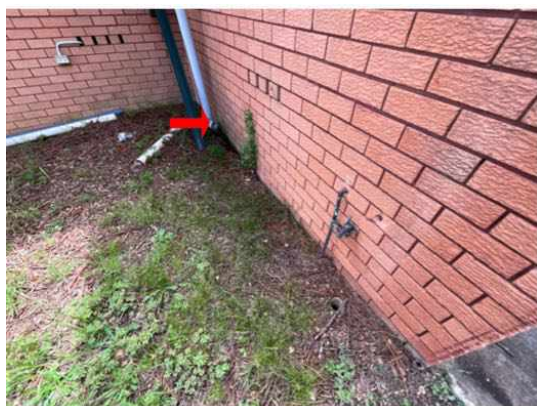
Where roof plumbing doesn't drain adequately, the area at the base perimeter can become excessively damp, potentially creating an environment that is susceptible to rust and corrosion of surrounding building elements, as well as attracting termites and other pests.

It is highly recommended that a plumber be appointed to further inspect the area and to install adequate drainage equipment where necessary.

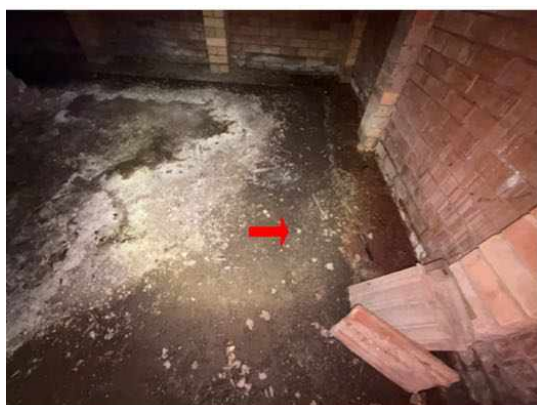
### Finding 2.02

Building:	Main Building
Location:	Extension
Finding:	Site drainage— Inadequate
Information:	The site drainage in this area was found to be inadequate at the time of inspection, creating potential for subsequent water damage to associated building elements. This is additionally conducive to termite activity.

Where site drainage is inadequate, installation of an Agricultural (Aggie) Drain may be required. A licensed plumber should be appointed to further inspect the property and perform any remedial works as necessary. Water damage and secondary defects are likely to occur if left unmanaged.

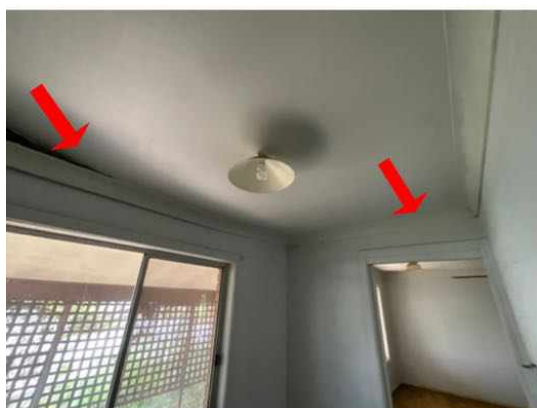
Building:	Main Building
Location:	Rear bedroom
Finding:	Ceiling - Sagging
Information:	Sections of the ceiling were found to be sagging at the time of inspection. Sagging to the fixed ceiling structure generally indicates that the building materials have swollen, due to contact with water, or that fixings (e.g. nails or glue) have become loose and require reattachment.

Where minor sagging is evident, comparatively minor works, such as re-gluing of ceiling sheets, may be required. Such works may be performed by relevant tradespeople, such as plasterers and painters. Where excessive moisture has caused the roofing structure to swell and sag, the source of the water leak should primarily be identified prior to any remedial works being performed.

The appropriate action should be taken by the client as soon as possible to ensure that any potential further damage is limited.

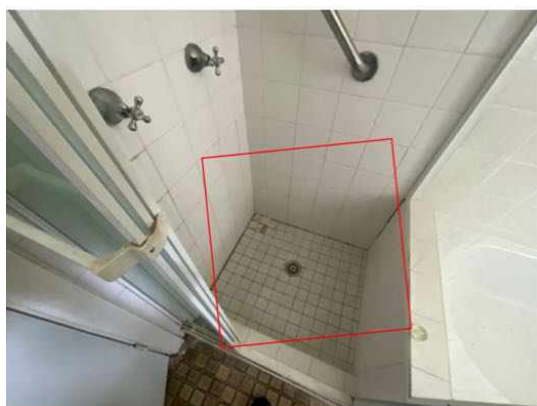
Building: Main Building  
 Location: All Wet Areas  
 Finding: Sealant and grouting - Missing or damaged  
 Information:

It was noted on inspection that sealant or grout is degraded to this area.

Different materials and floor areas move at different rates, generally causing cracking to grout or sealant at this point. A flexible sealant is required to allow for expected expansion and contraction, while keeping the joint water tight and protective of all associated building materials.

Flexible and mould resistant materials should be applied to affected areas to prevent any subsequent water damage that is likely to occur. Regular maintenance and replacement of damage or missing or damaged sealant and grout is highly recommended to the wet areas, as this is a regular wear and tear defect. Sealant and grouting in areas that come into regular contact with water should be maintained for the long term care of your property.

A sealant specialist should be appointed to complete these works as soon as possible.

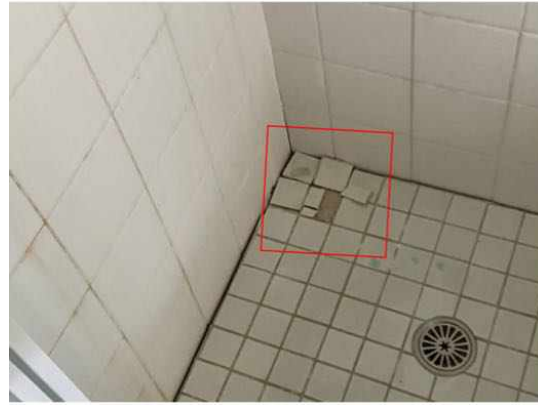
### Finding 2.09

Finding: Tiles - Damaged

Information: Damage was evident to the tiling in this area at the time of inspection. This area is frequently exposed to water, allowing potential for water penetration into adjoining sections of walls or flooring.

If left unmanaged, water penetration to these areas may lead to subsequent water damage, which is likely necessitate repair work to affected building elements.

A tiling contractor should be appointed to ensure that no further water damage occurs. The re-application of silicone and grouting throughout remaining tile work is also advised, to further protect the area against water penetration.

Where water penetration has led to water damage, appointment of a relevant tradesperson may be required to repair damaged building elements.

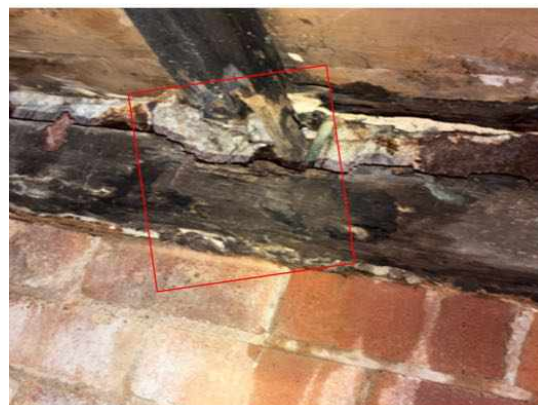
### Finding 2.10

Building:	Main Building
Location:	Subfloor
Finding:	Subfloor structure - Wood rot
Information:	The subfloor structure in this area is showing signs of deterioration and wood rot (fungal decay) of the timbers. It is suspected that this defect has developed as a result of water leak at some stage.

Damp conditions cause the timbers to fail, resulting in the subfloor structures failing to bear the load (or weight) of the building as originally intended. Without repairs and maintenance, including potential replacement of affected elements, it is likely that serious structural faults will result, as well as an array of minor defects.

The presence of wood rot to the subfloor structure is also conducive to termite infestation.

Rectification or replacement of the affected timber building element is required immediately by a licensed builder.

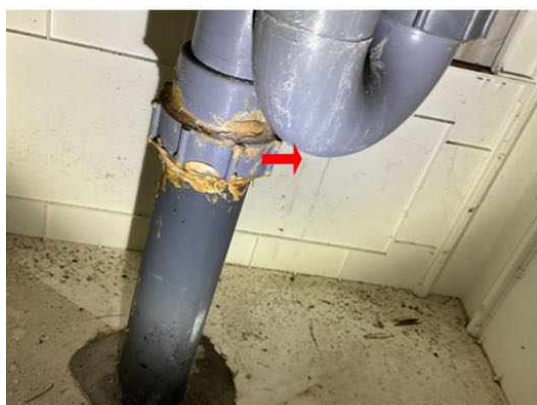
#### Finding 3.01

Regardless of the location, even minor leaks that are left unmanaged can lead to serious damage of associated building elements and result in the need for replacement of building materials. Mould and other hazards such as electrical hazards may also arise if the leak is left to develop.

It is highly advised that the cause of the leak be identified and resolved immediately by a licensed plumber to prevent any further damage. Depending on the extent of the damage previously sustained, repair and/or replacement of any affected building materials may be required.

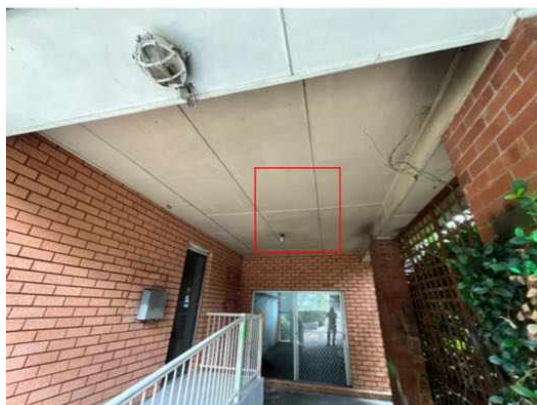
### Finding 3.02

Building:	Main Building
Location:	Carport
Finding:	Ceiling sagging - Carport
Information:	Sections of the ceiling were found to be sagging at the time of inspection. Sagging to

While damage is minimal at this stage a licensed plasterboard contractor should be appointed to repair the ceiling. Insulating the area could be a considered by the client once repaired.

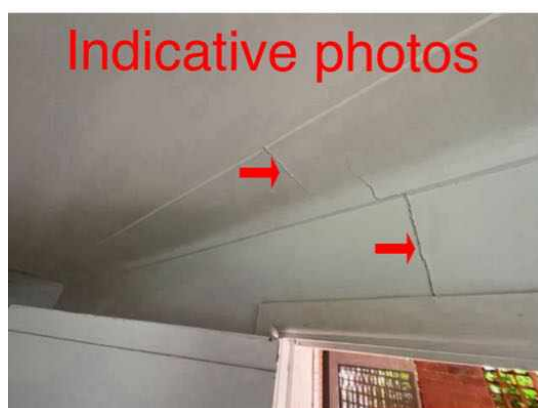
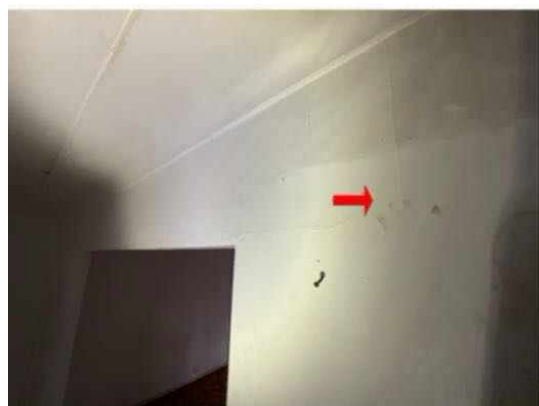
### Finding 3.03

Building:	Main Building
Location:	Dining/bed, Bathroom
Finding:	Cracking - Damage Category 2 - Noticeable (up to 5mm)
Information:	Noticeable cracks are a common occurrence as a result of many primary defects. Such causes may include age, general wear and tear, expected building movement, general expansion/contraction of building materials in different weather conditions, and/or minor failings in the installation or application of building materials.

Monitoring of all cracking should be conducted frequently. Always contact a building inspector should cracks widen, lengthen, or become more numerous.

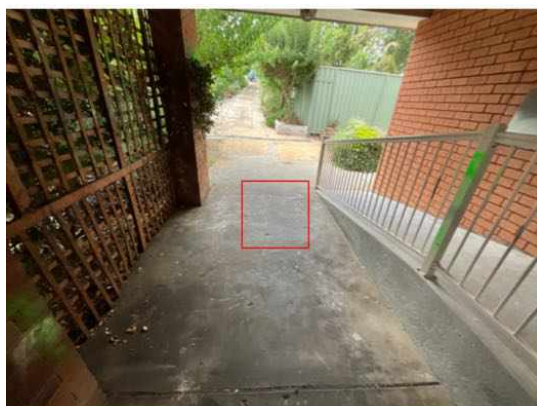
### Finding 3.09

Building:	Main Building
Location:	Carport
Finding:	Cracking - External Concrete Paving Damage Category 1 - Fine (less than 2mm)
Information:	Fine cracks were identified in external concrete paving. Although fine cracks are quite noticeable, they are often only considered to be an appearance defect, and usually do not indicate any structural damage. To be considered a Category 1 or fine crack, the crack is found to be less than 2mm in width.

Monitoring of all cracking should be conducted frequently. Always contact a building inspector should cracks widen, lengthen, or become more numerous.

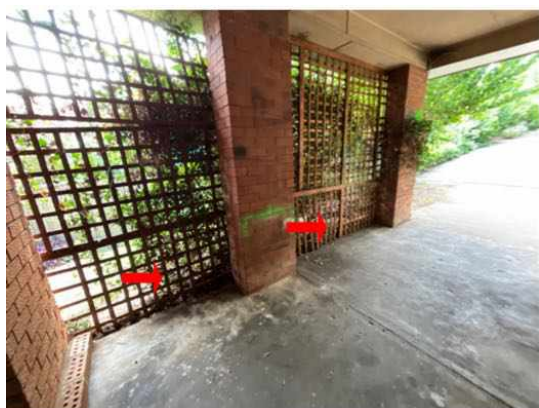
### Finding 3.10

Building:	Main Building
Location:	Carport
Finding:	Untreated or non-durable timbers in a hazardous environment
Information:	To reduce the risk of timber pest attack it is essential that timber used in a hazardous environment (e.g. in direct contact with the ground or frequently exposed to damp conditions) is of sufficient durability and/or is adequately preservative treated.

If untreated or non-durable timbers are found to be in a hazardous environment it is highly advised that replacement of these building elements be performed as soon as possible to aid the protection of the property against termite / timber pest attack.

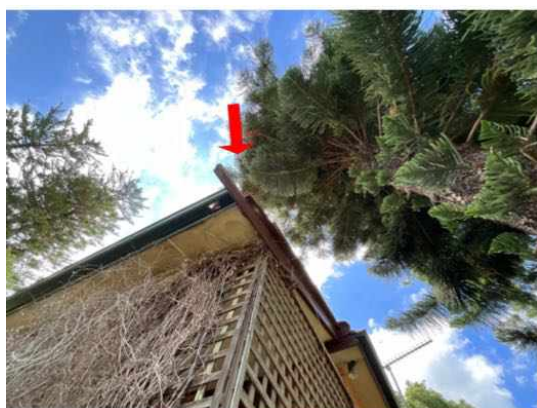
### Finding 3.11

Building:	Main Building
Location:	Roof Exterior
Finding:	Trees - Overhanging and filling gutters
Information:	Overhanging trees often result in excessive amounts of leaf debris accumulating in gutters.

plumber is required where guttering has been damaged.

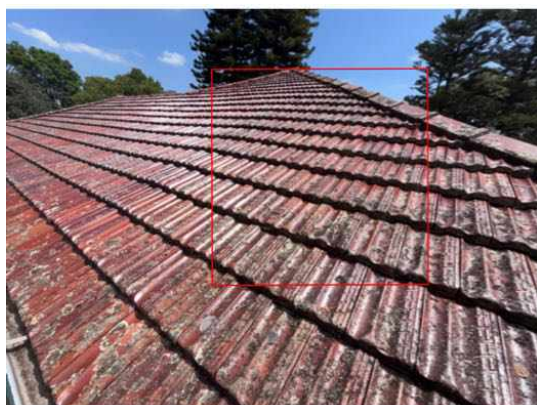
### Finding 3.12

Building: Main Building  
 Location: Roof Exterior  
 Finding: Roof tiles - Weathered  
 Information:

Consultation with a licensed roofing contractor is highly advised to gain advice on cost of remedial works that may be required in the short to medium term. Remedial works are likely to increase the longevity of the exterior roofing structure.

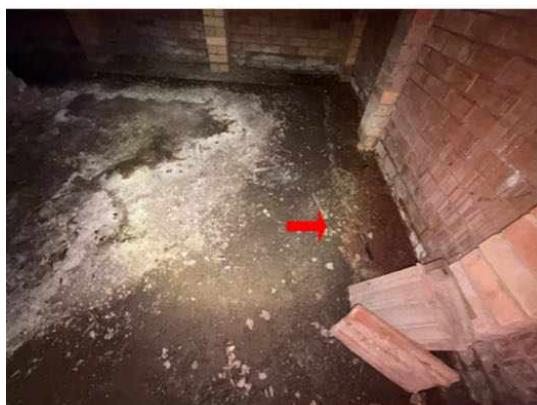
### Finding 6.02

Building:	Main Building
Location:	Extension
Finding:	Site drainage— Inadequate
Information:	The site drainage in this area was found to be inadequate at the time of inspection, creating potential for subsequent water damage to associated building elements. This is additionally conducive to termite activity.

Where site drainage is inadequate, installation of an Agricultural (Aggie) Drain may be required. A licensed plumber should be appointed to further inspect the property and perform any remedial works as necessary. Water damage and secondary defects are likely to occur if left unmanaged.

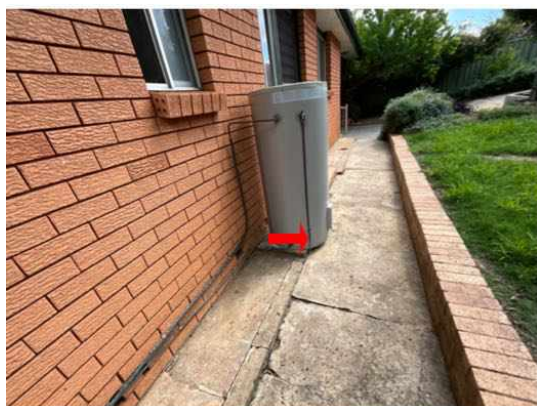
**Finding 6.05**

Building: Main Building  
 Location: Yard - Side  
 Finding: Overflow - Not plumbed for drainage  
 Information: The overflow is not plumbed or connected to suitable drainage, which can result in the surrounding area becoming excessively damp.

It is highly recommended that a licensed plumber be appointed to install adequate drainage to the overflow. These works will ensure that the area remains dry and free of any secondary defects.

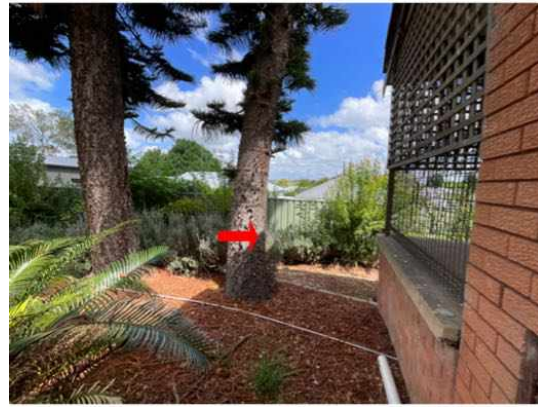
### Finding 6.11

Building:	Main Building
Location:	Vegetation
Finding:	Vegetation - Abutting property
Information:	Vegetation against external wall may have an invasive root system. If there are weak points in the brick work or concrete slab, it is possible for the roots to gain entry into these areas. Once the roots have gained entry, it is possible for termites to gain concealed entry via these roots. It is recommended to remove the vegetation and root system where possible.

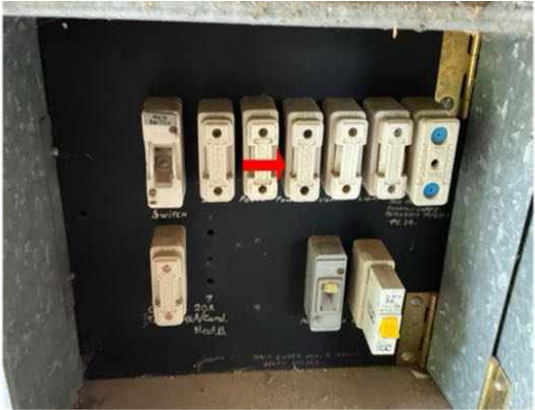
While this on its own on is not considered a defect it is noted for the clients consideration that a switchboard upgrade may be required in the short to mid term to improve the functionality of the electrical system. A licensed electrician could be appointed to provide quotation for the works at the client's discretion which may in turn expose other required works to bring the system up to a compliant state.

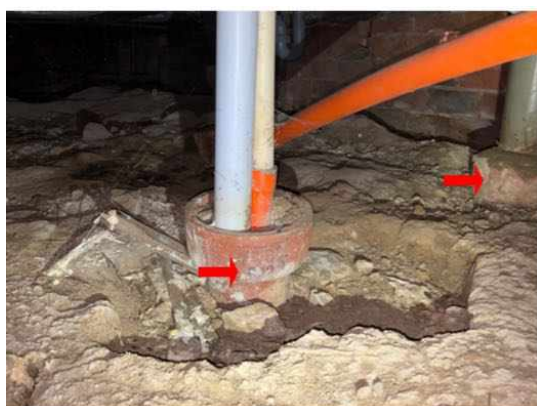
Building:	Main Building
Location:	Plumbing/electrical/gas/aircon/appliances/pool equipment/fire safety etc
Finding:	Plumbing & Electrical
Information:	Plumbing and electrical inspections including appliances are outside the scope of the building inspection and must be conducted by a Licensed and registered Trades person. It is highly recommended that the client makes immediate arrangements to have the gas appliances checked by a licensed gas plumber to ensure that the appliances are working safely and efficiently. We recommend all other installations be checked also. Whilst we note and comment of visually apparent defects that present during the building inspection, legislation requires the checking and documenting of

Consultation with a licensed plumber is advised. CCTV inspection on pipes may be required.
