Building and Timber Pest Inspection Report

Inspection Date: Thu, 19 Feb 2026

Property Address: 21/37 Stephen's Street Yarraville

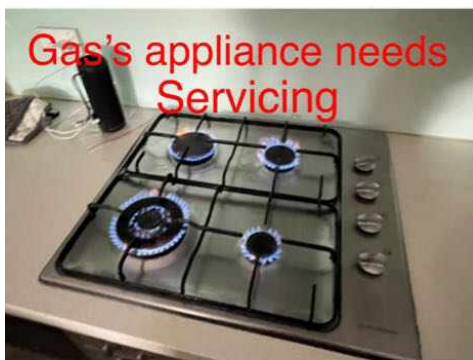
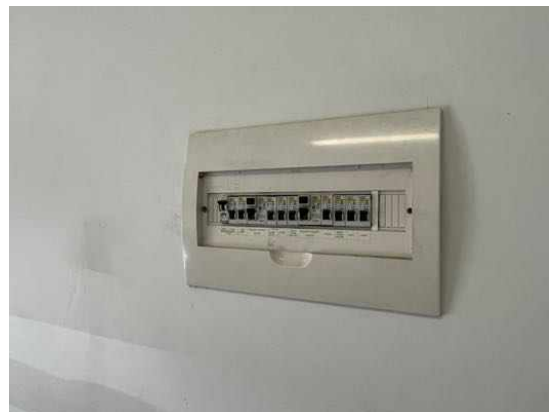
Finding 1.01

Building:	Main Building
Location:	Front Elevation
Finding:	Gas Appliances - Need to be serviced / Electrical trio switches, unprotected
Information:	All gas appliances need to be serviced.

It is unlikely that these gas appliances have ever been serviced and there may be in in poor condition

A licensed gas plumber needs to be engaged to service lol the gas ppliances as soon as possible.

The electrical sub panel should have a cover to protect the trip switches.

This item should be rectified to meet the electrical comments safe and in good working order.

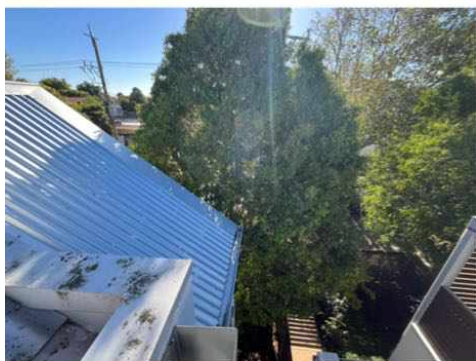
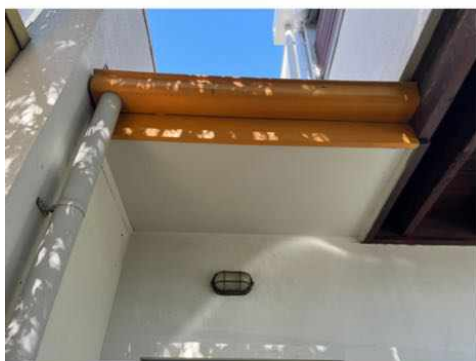
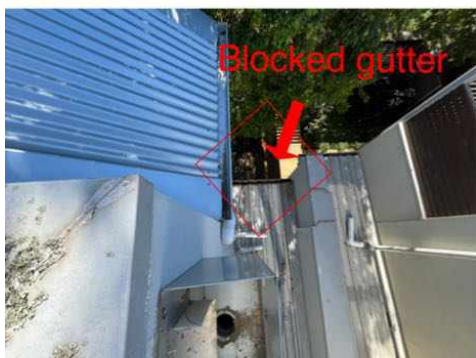
Finding 3.01

Building:	Main Building
Location:	Front Elevation
Finding:	Trees - Overhanging and filling gutters

Information: Overhanging trees often result in excessive amounts of leaf debris accumulating in gutters.

Gutters are a critical part of the building's management of storm water and rain. It is therefore important that they be kept clear to prevent secondary damage to associated building elements, including exterior and interior walls, ceiling linings and any adjoining building elements. Where gutters are blocked, pooling of rainwater is likely to occur, fast-tracking rust and corrosion of the roof plumbing elements.

We noted that most of the guttering was actually clean but the gutter nearest the entry door was heavily filled with leaf litter.

It is highly advised that all overhanging tree branches be removed as soon as possible to prevent any further damage.

Such works should be performed by the homeowner; however, appointment of a landscape contractor or an arborist may be required. Consultation with a licensed roof plumber is required where guttering has been damaged or alternative methods of litter management are required.

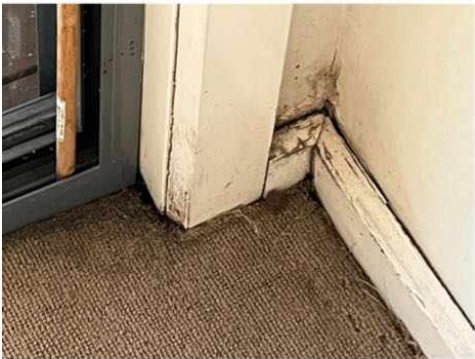
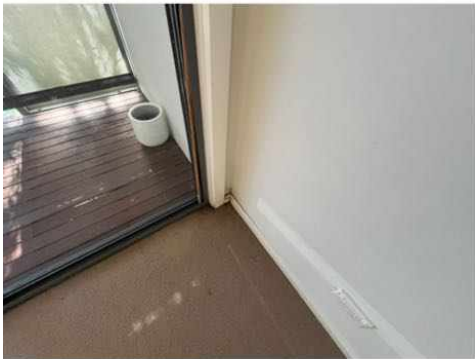
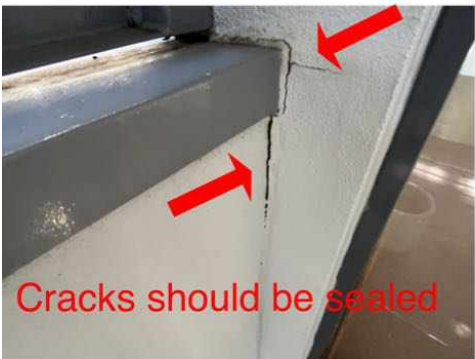
Finding 3.02

Building:	Main Building
Location:	Upstairs front bedroom
Finding:	Evidence of historical moisture - identified
Information:	There is staining and minor moisture damage on the surface of the plaster, skirting board, carpet and door frame in the front bedroom.

An invasive inspection may reveal further moisture damage behind the surface layer.

At the time of the inspection there was no elevated moisture readings when the surfaces were checked with a moisture meter.

This maybe due to a lack of recent rain or it may be that moisture is only an issue under certain conditions, such as blocked and overflowing gutters, the impact,of rain only coming from a certain direction or repairs that have been carried out have addressed the entry of moisture.

There is some minor cracking around the exterior wall - glass patio doors that could be sealed which might also assist.

Prior to any remedial works being performed an invasive inspection should be considered to gain a better understanding of any damage behind the surface layers.

Works to remove affected building elements may then be necessary and should be performed by an appropriate tradesperson.

It may be necessary to engage a qualified plumber should to help identify the cause of the excessive moisture if dampness returns or becomes an issue after rain.

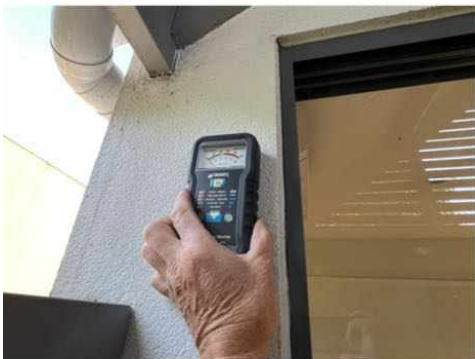
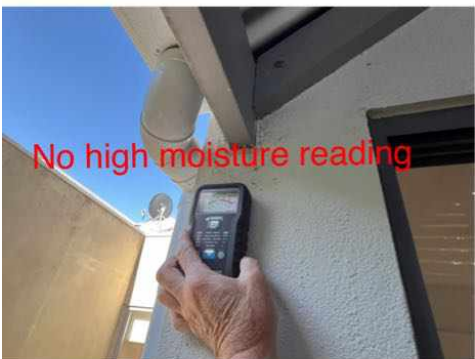
Cracks should be sealed

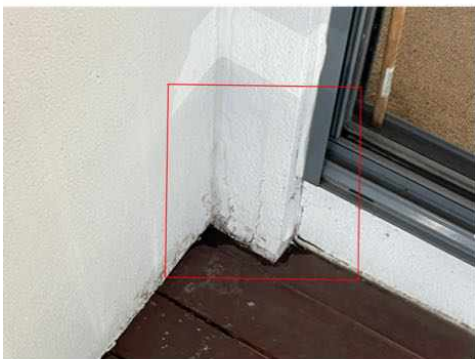
No high moisture reading

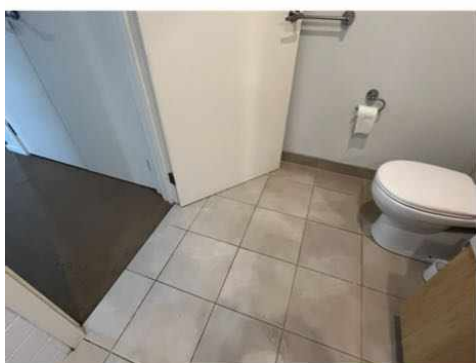
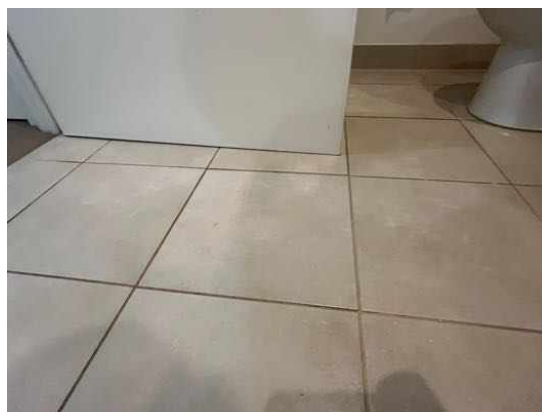
Finding 3.03

Building: Main Building
 Location: Bathroom door
 Finding: Doors - Binding/Jamming
 Information: Binding and/or jamming of the bathroom door was evident during standard operation.

This defect inhibits the functionality of affected doors as well as creating potential for secondary defects to associated building elements, such as damage to the floor covering.

A door that binds to flooring or to the associated door frame may have several causes, ranging from minor defects, or it could be from moisture seeping through the tiled grout floor causing the substrate to swell - the substrate is likely to be particle board flooring.

If the problem worsens it is likely the waterproof membrane beneath the tiled surface has been compromised - if it was installed correctly.

Where door binding/jamming, a qualified carpenter or general handyperson should be appointed to perform minor rectification works at client discretion.

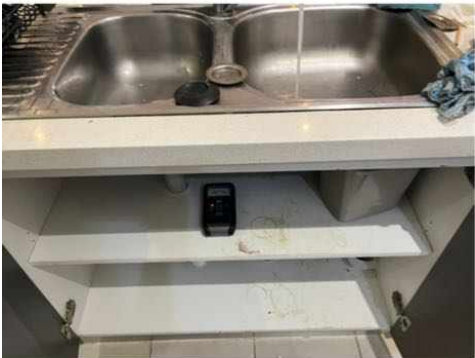
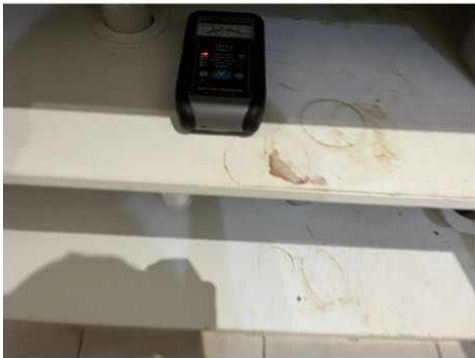
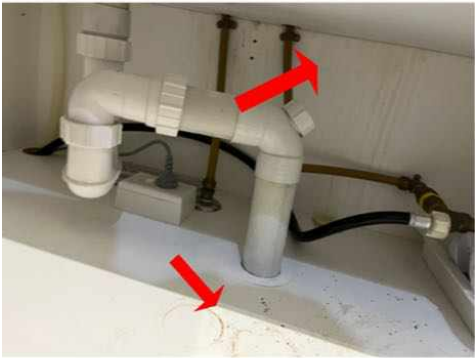
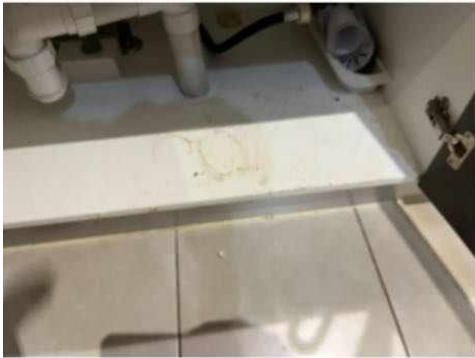
Finding 3.04

Building: Main Building
 Location: Kitchen
 Finding: Water stain - minor - other (Kitchen)
 Information: Evidence of a water stain can be seen inside the kitchen sink cupboard - on the shelf and also the wall at the back inside the cupboard.

The satins seen under the bench along the inside back wall of the cupboard are typically from water being able to penetrate under the sink if it is not properly sealed to the bench-top. A plumber may need to be consulted to reseal the sink.

The stains on the shelf appears to be a surface stain, rather than an active leakage may be the result of to poor housekeeping.

This item should be fixed to prevent any potential damage.

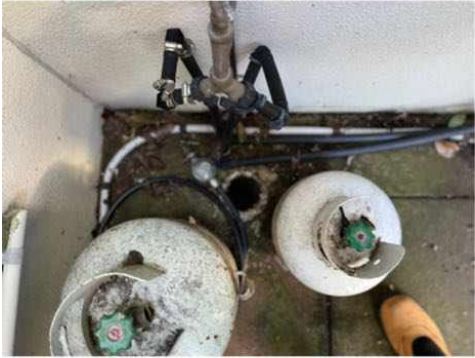
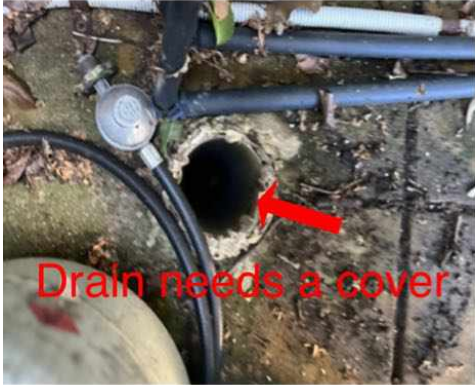
Finding 3.05

Building: Main Building
Location: Rear patio
Finding: Open waste / drain pipe
Information: There is an uncapped pipe in the patio area at the rear of the property.

A cover should be installed to prevent foreign material entering the drain.

Consultation with a licensed plumber is recommended.

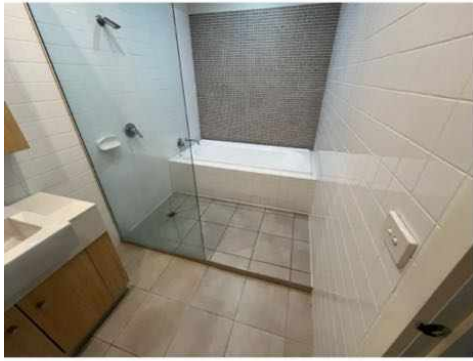
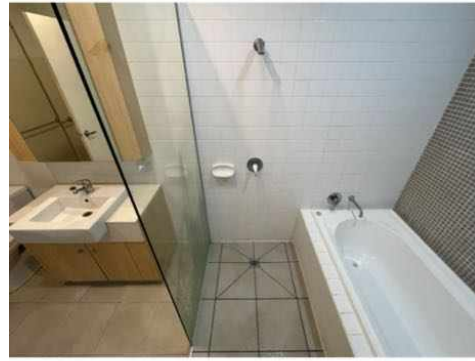
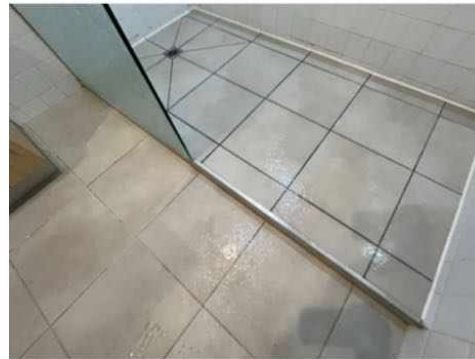
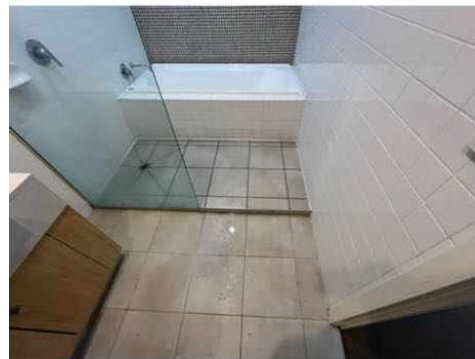
There is no additional floor drain to accommodate escaping waste water and the water stop is inadequate.

Water pooling occurs when there is inadequate fall in the way the screed bed below the tiles was set up.

Where water is pooling, deterioration of the tiled surface is a risk if left unattended, which may necessitate major repair works.

These properties have a history of waterproofing failures and it appears the Ensuite Has been reworked in the next room.

It is likely the current occupants rarely used the bathroom as no elevated moisture readings were detected at the time of the inspection.

The moisture check also included a close inspection and moisture metre check of the plaster ceiling immediately below the bathroom and the ensuite, including the ceiling and walls.(no concerns at the time of the inspection were identified)

Consultation with a tiler is recommended. Rework is required to ensure adequate fall to the drain.

Consideration should be given to renovating the bathroom as well particularly if regular usage is anticipated.
