Building and Timber Pest Inspection Report

Inspection Date: Wed, 7 Jan 2026

Property Address: 6/5 Dunlop Rd, Blue Haven NSW 2262,
Australia

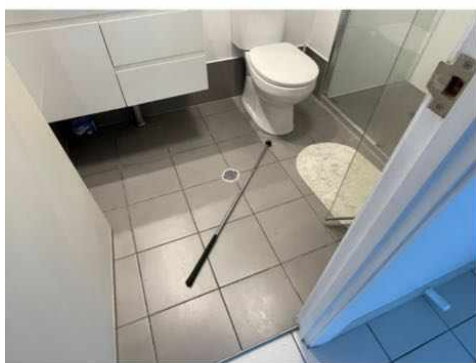
Finding 3.02

Building: Main Building
Location: Bathroom > Rear Right
Finding: Tiles - Drummy
Information: Drummy tiled areas were identified to approximately 30% of the tiles to the bathroom and several tiles to the shower alcove. at the time of inspection. The term 'drummy' refers to tiles that have become detached from their fixing, despite otherwise being in relatively good condition. Such defects are generally caused by physical or moisture damage to the area. Drummy tiled areas may also be a direct result of poor workmanship during the construction process.

Tiled areas may swell and shrink with changes in air humidity if the area has sustained moisture damage. Any exposure to moisture is capable of causing tiled areas to become drummy and/or cracked over a prolonged period of time. Drummy tiled areas generally require removal and replacement of affected tiles, with adequate sealant and grouting.

Specialist trades are available for these types of services. A builder may be required to undertake works if damage is extensive or if secondary building defects have resulted. Otherwise, it is advised that a tiling contractor be appointed to perform works as necessary. Immediate action is recommended to ensure that no further damage is sustained in the affected area.

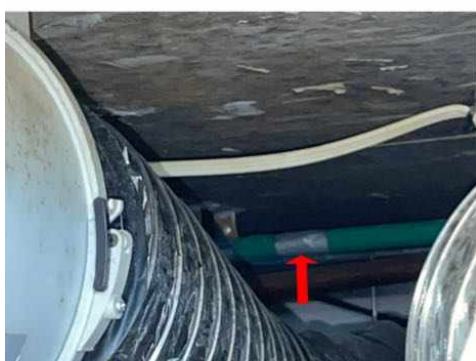
Finding 3.03

Building:	Main Building
Location:	Bathroom > Rear Right
Finding:	Pipework Repair - Inadequate
Information:	Pipework within the roof space above the shower was observed to have been patched using duct tape at the time of inspection. This type of repair does not appear to be a permanent or appropriate method for sealing or repairing pipework and suggests a temporary measure may have been undertaken previously.

The use of duct tape may not provide a durable seal and could deteriorate over time due to temperature changes, moisture, or general ageing. If the underlying issue relates to a leak or defect in the pipe, this may increase the risk of future leakage, which could result in moisture damage to insulation, ceiling linings, or structural elements below.

It is recommended that a licensed plumber be engaged to inspect the affected pipework and carry out proper repairs or replacement as required. This would help ensure the pipework is compliant, durable, and reduces the risk of future leaks or associated damage.

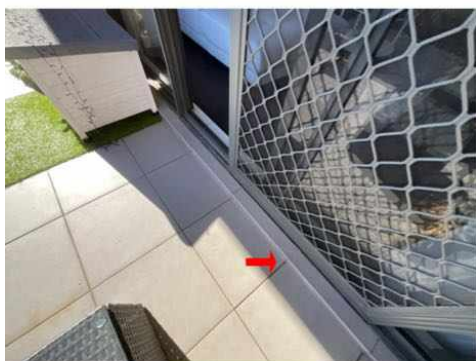
Finding 3.04

Location: Balcony > Front
 Finding: Floor tiles - Cracked
 Information: Cracking in the floor tiles was evident to the balcony step the time of inspection. It is suspected that this cracking has occurred as a result of the floor being uneven and lacking a solid or suitable foundation for the tiles to be laid on or potential impact damage.

Cracked tiles detract from the overall appearance of the affected areas, as well as creating potential for water penetration to adjoining building elements. If left unmanaged, water damage may occur as a result of constant water penetration over a prolonged period of time.

While not considered a matter of urgency, replacement of cracked floor tiles is advised as a solution. A tiling contractor or general handyperson may be appointed to perform these works at client discretion.

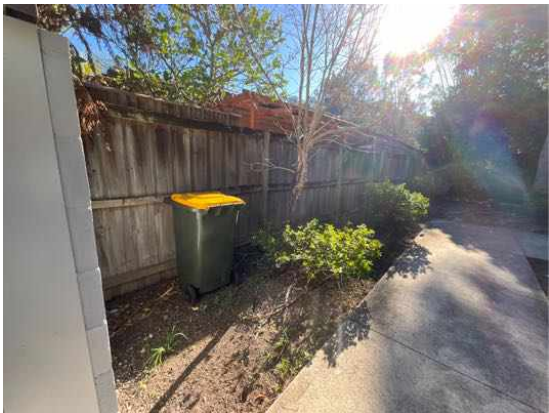
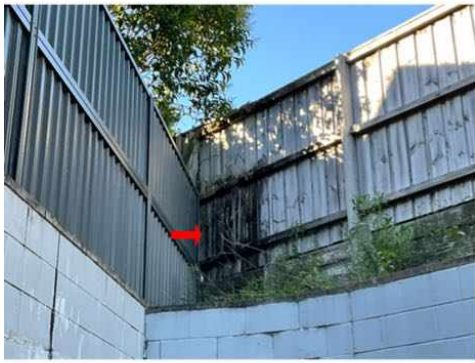
Finding 3.07

Building:	Main Building
Location:	All External Areas > All Areas
Finding:	External Defects
Information:	Although these items form part of the strata-managed areas, a number of external defects were observed at the time of inspection. These include capping to sections of the retaining wall not being fixed adequately, graffiti to several areas, and slight weathering to timber fencing with localised staining evident.

If left unattended, these issues may continue to detract from the overall presentation of the property and could gradually worsen through ongoing exposure to weather and general use. While the defects appear largely maintenance-related in nature, timely attention would help preserve the condition and appearance of the common areas.

It is recommended that these items be referred to the owners corporation or strata manager for review. Remedial works may include securing the retaining wall capping,

removal of graffiti, maintenance or treatment of the timber fencing, and general landscaping works to address overgrowth and areas in disrepair.
