Building and Timber Pest Inspection Report

Inspection Date: Fri, 6 Mar 2026

Property Address: 8 Verna Avenue Clyde North

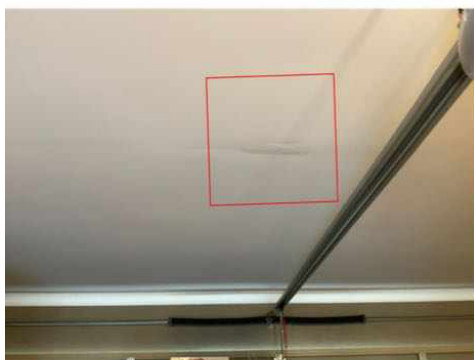
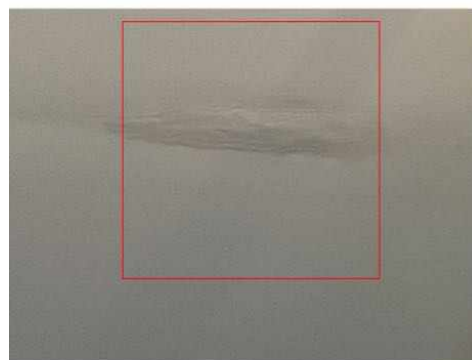
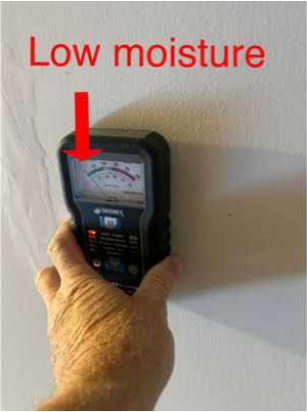
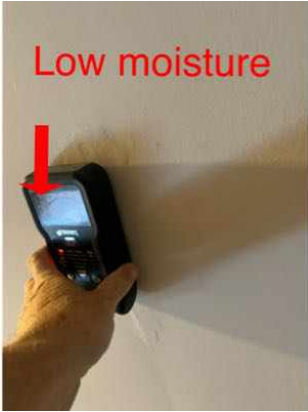
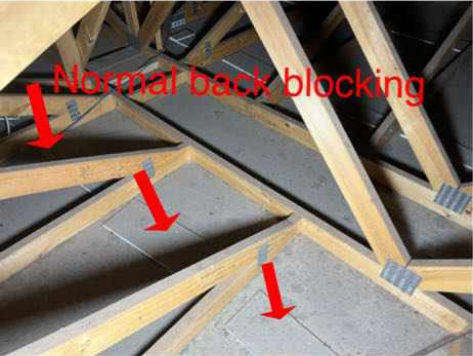
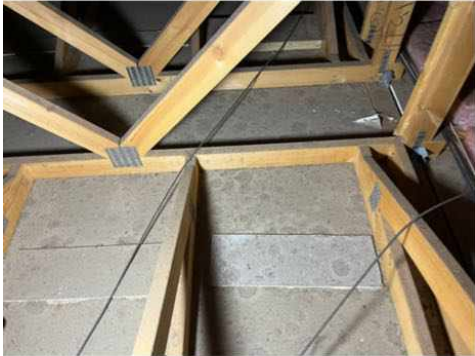
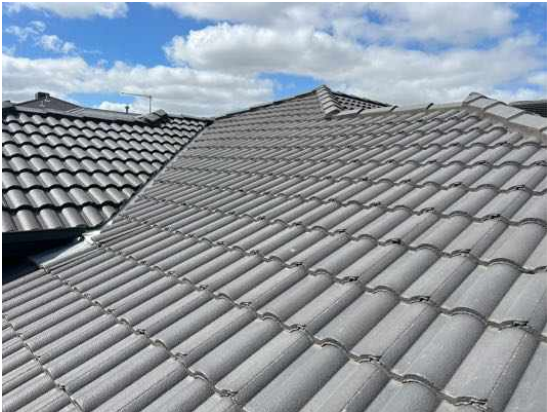
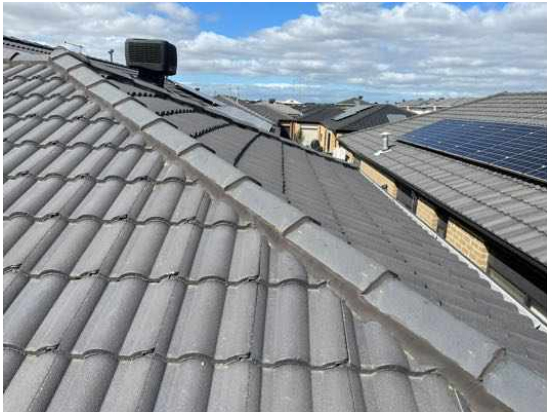
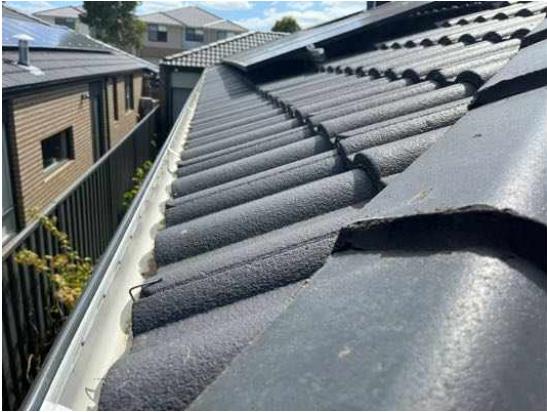
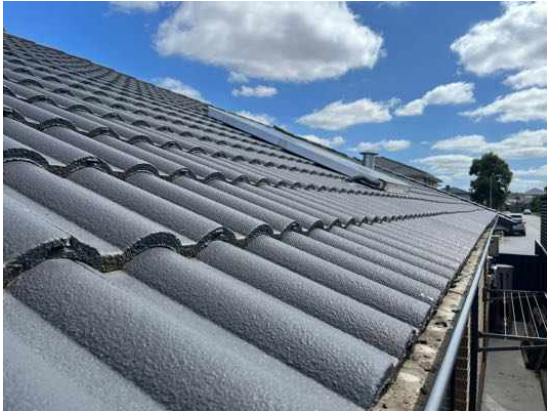
Finding 3.01

Building: Main Building
 Location: Garage
 Finding: Garage plaster ceiling - substandard or Inadequate repair
 Information: It appears that interim plaster repair has previously been undertaken, which has included a rough application of plaster filler.

The current owner confirmed he had conducted the repair himself after noticing a crack in the plaster join.

A check of the plaster ceiling found no evidence of moisture at the time of the inspection. A further check of the exterior roof cladding found no issues with the tiled roof, therefore water damage was ruled out as a concern.

Whilst home maintenance is encouraged, the repair is considered substandard and would benefit from being sanded back, top coated with soft fill and then repainted.

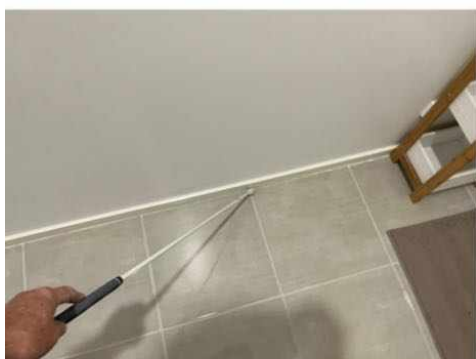
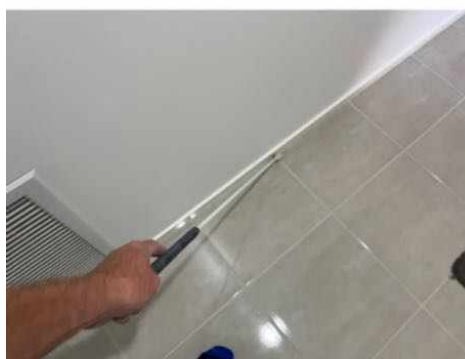
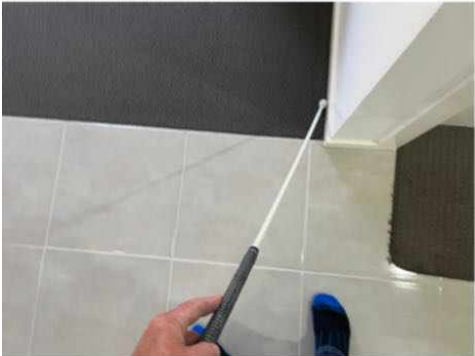
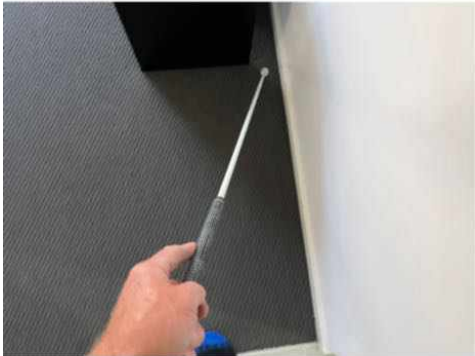
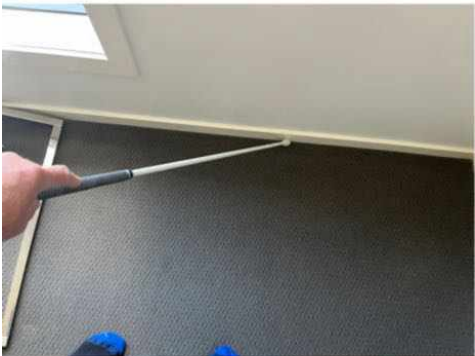
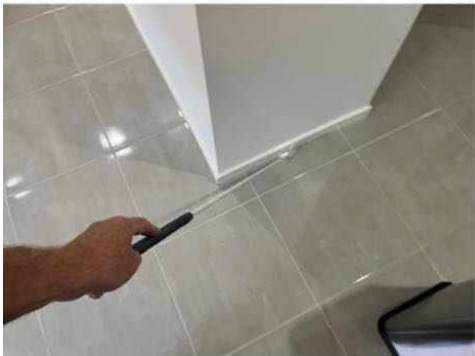
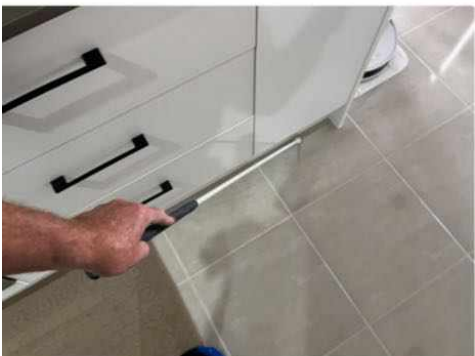
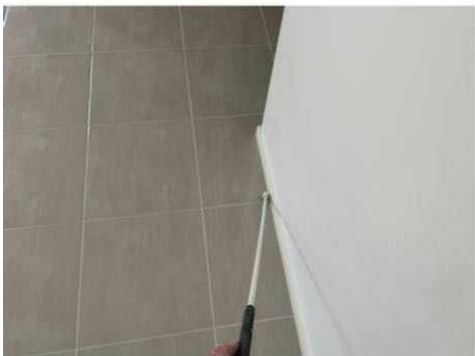
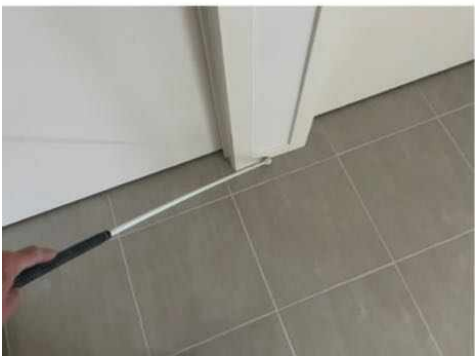
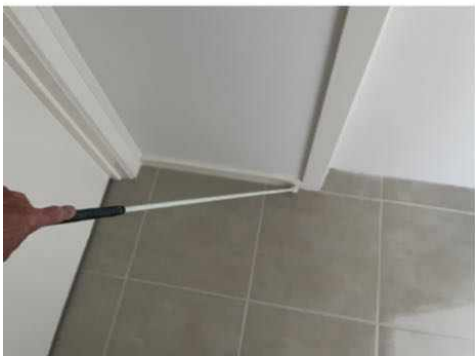
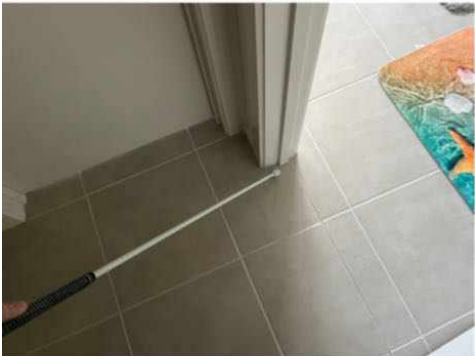
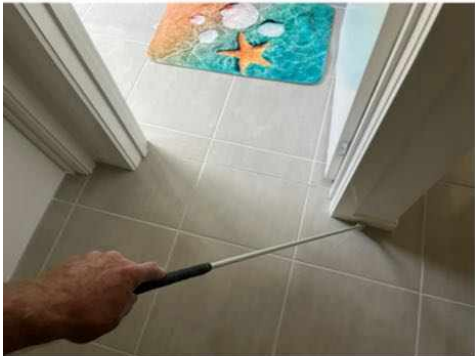
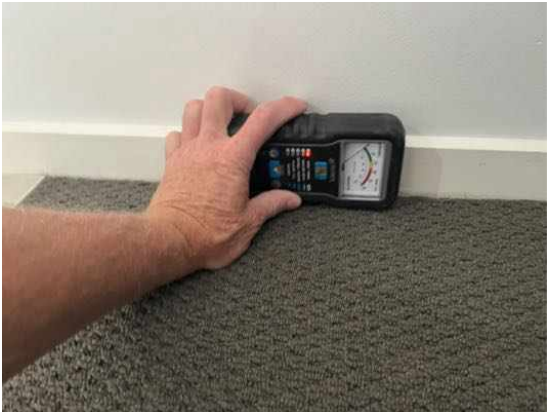
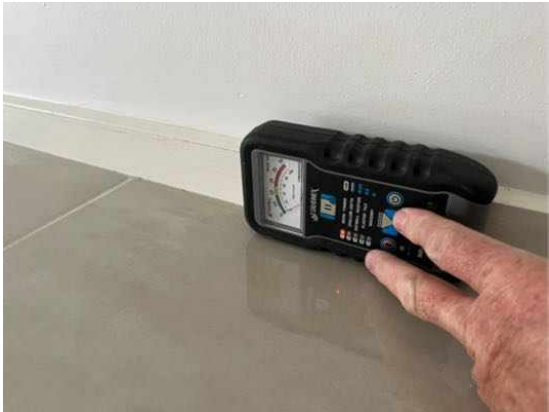
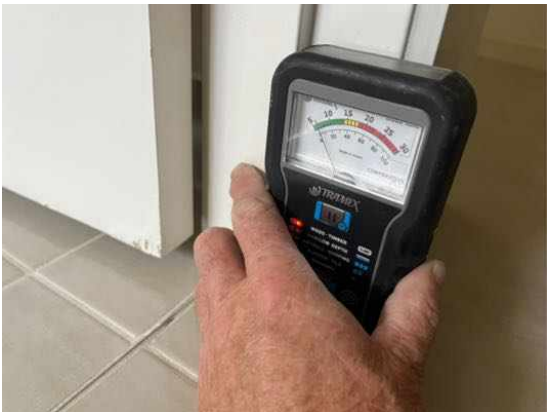
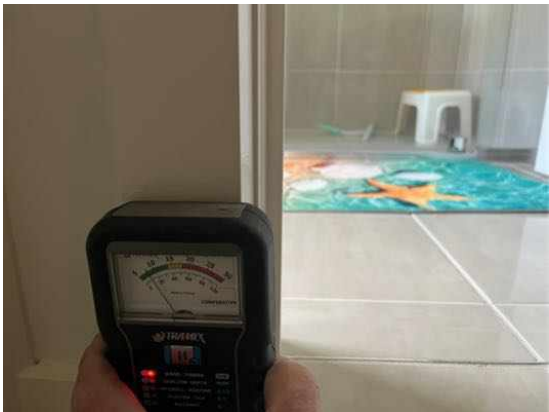
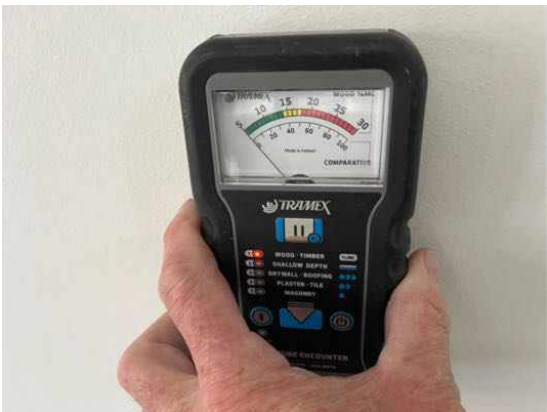
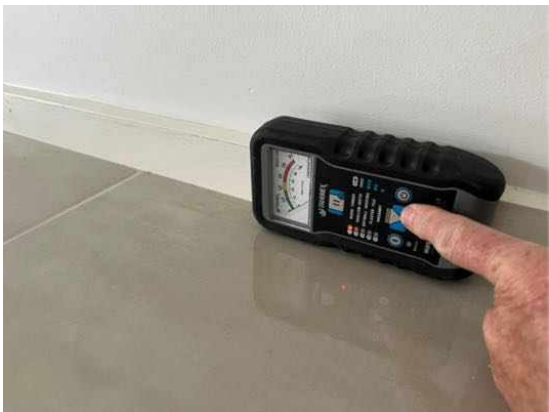
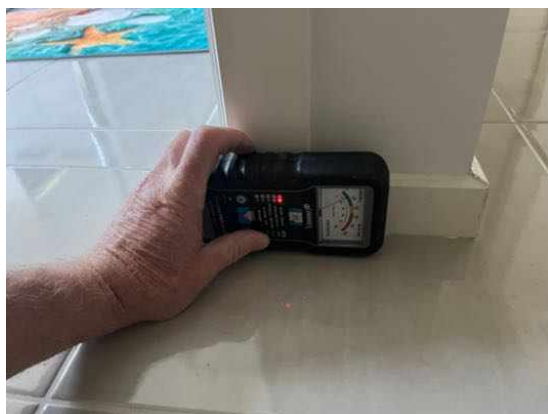
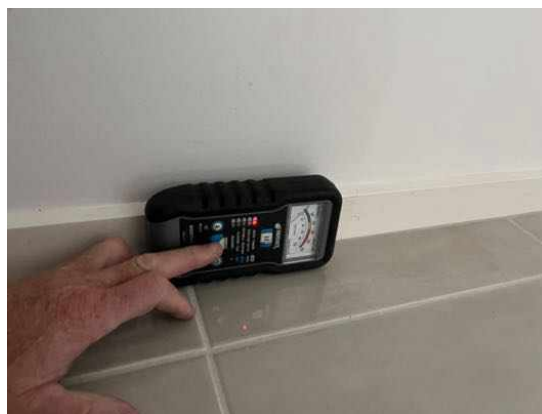
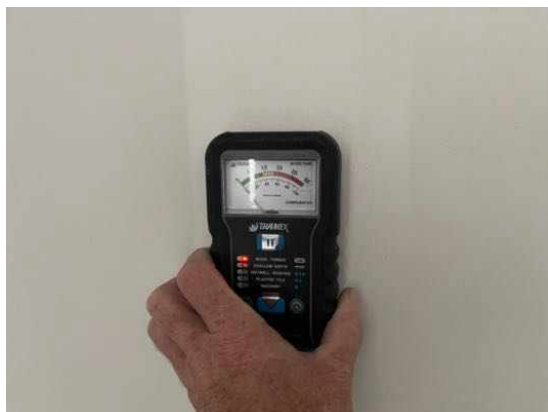
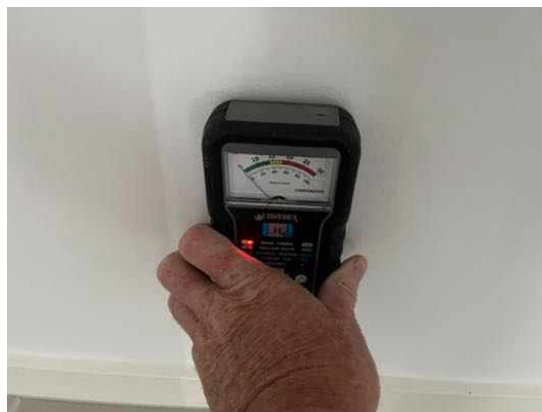
Finding 6.01

Building: Main Building
 Location: All Areas
 Finding: Termite Techniques
 Information: All areas of the dwelling are checked with particular attention paid to wet areas which were closely assessed to check for excessive levels of moisture and temperature anomalies.

No evidence of termite activity was found inside the house at the time of the inspection.

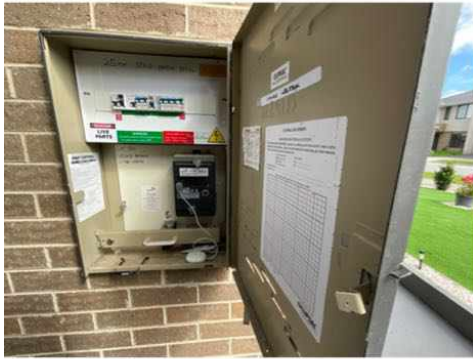
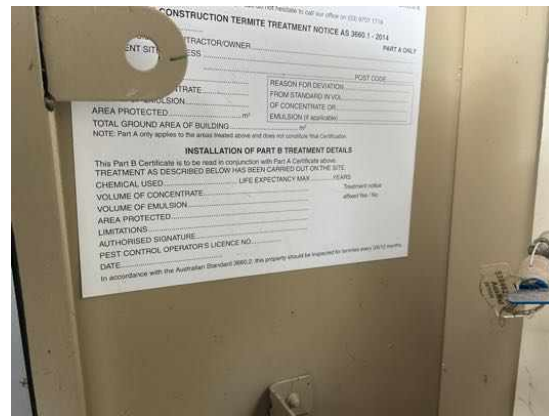
Finding 6.02

Building:	Main Building
Location:	All Areas
Finding:	Termite Management System - no evidence of a chemical installation
Information:	The application of a post-construction chemical termite barrier is highly recommended for all properties, particularly if live termite activity has been found on the site previously. Such barriers are highly effective in preventing termite attack on any timber building elements throughout the property.

The notice in the electrical meter box has no details at all.

The owner confirmed the system has never been maintained and he was unaware of the need to do so.

A check of the property found no evidence of termite activity or active timber pest damage at the time of the inspection.

The client should consider gaining further advice from a pest controller as to the costs and procedures involved with this application.

It is recommended that obtaining such advice be a short-term priority.

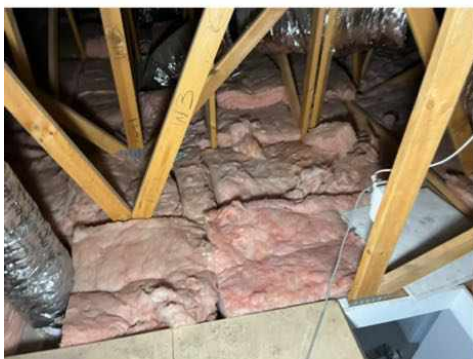
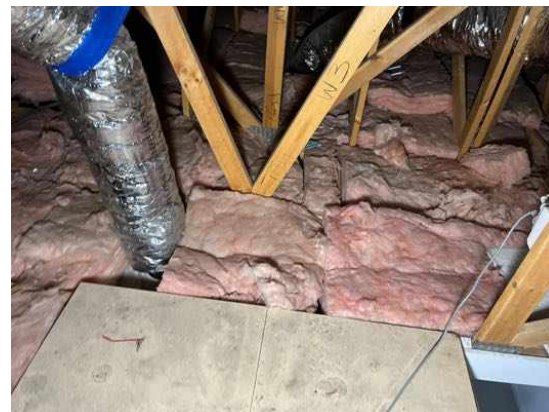
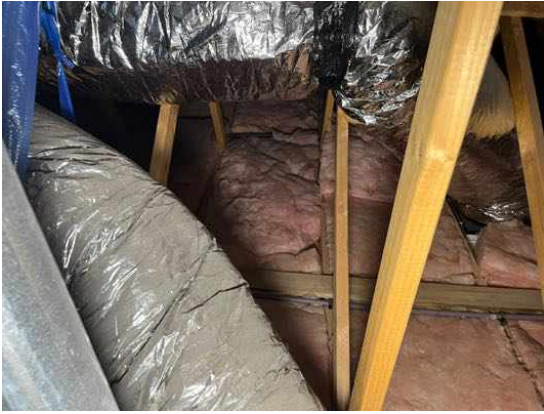
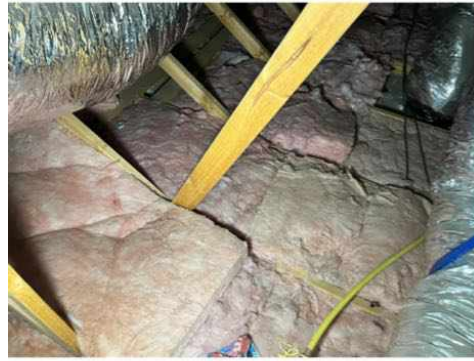
Finding 6.03

Building: Main Building
 Location: Roof Void
 Finding: Additional Photos - Obstructions and Limitations
 Information: These photographs are an indication of the obstructions and limitations which impeded full inspection of the property at the time of inspection.

Bulk insulation is covering almost 50% of the timber surfaces where termite activity is able to go on undetected.

These obstructions can hide an array of defects and where possible, should be removed to allow full inspection to be carried out.

A re-inspection is recommended once the areas are made accessible.

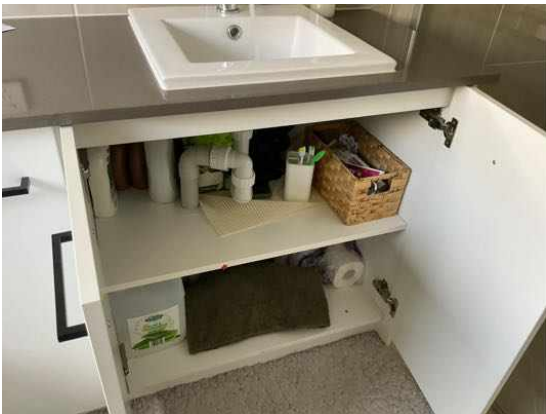
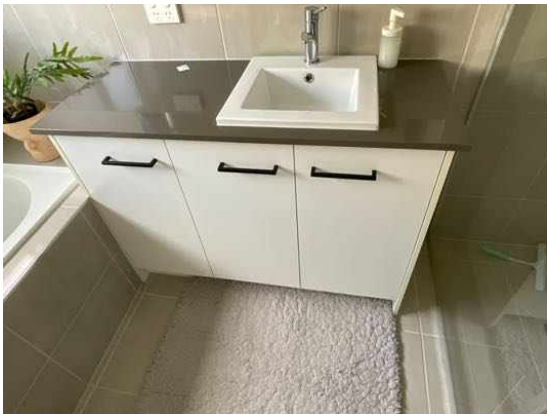
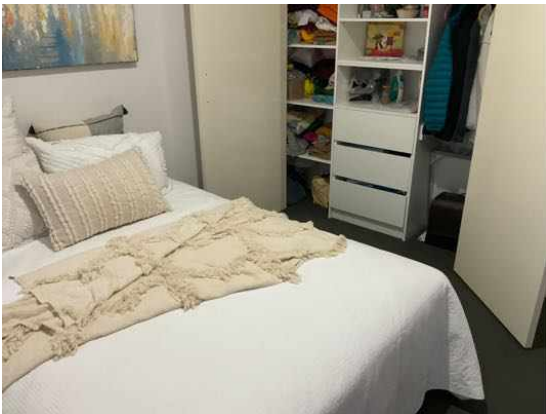
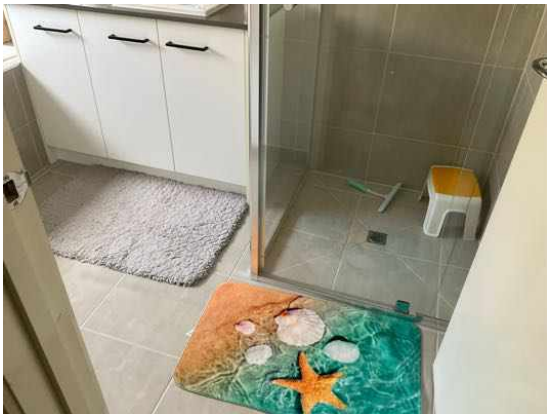
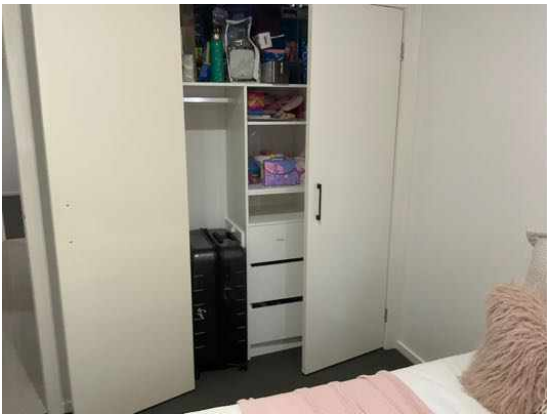
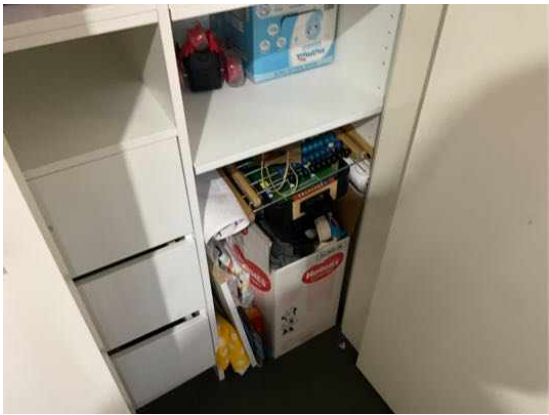
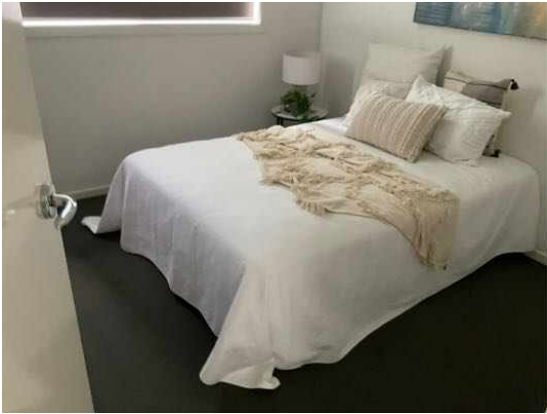
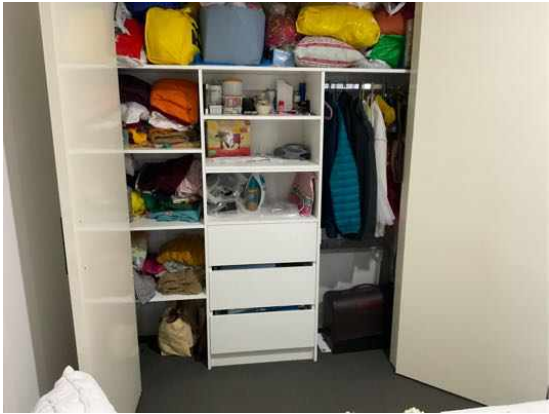
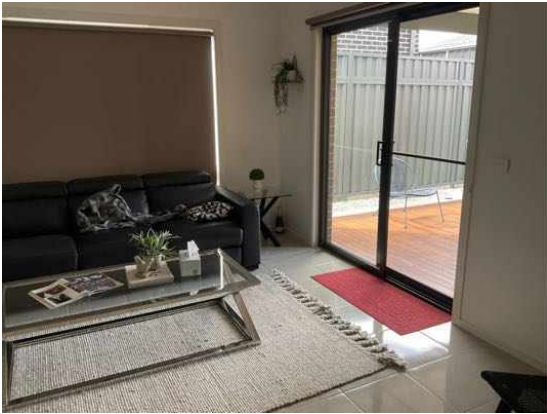
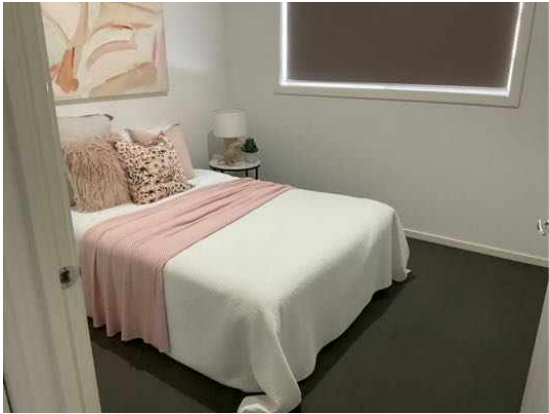
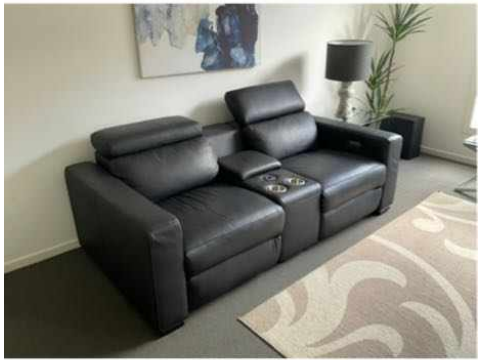
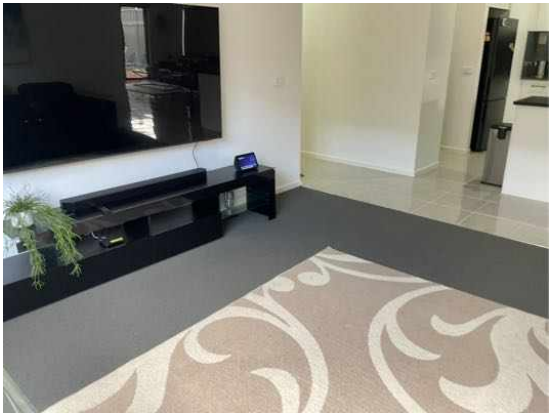
Building: Main Building
Location: All Areas
Finding: Additional Photos - Obstructions and Limitations
Information: These photographs are an indication of the obstructions and limitations which impeded full inspection of the property at the time of inspection. These obstructions can hide an array of defects and should be removed to allow full inspection to be carried out. A re-inspection is recommended once the areas are made accessible.

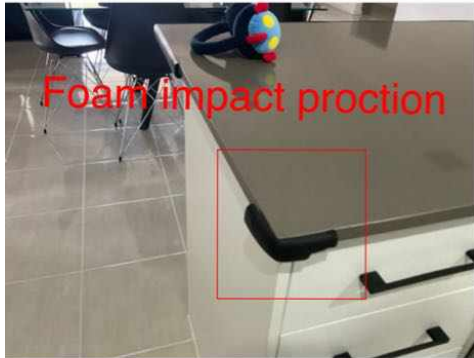
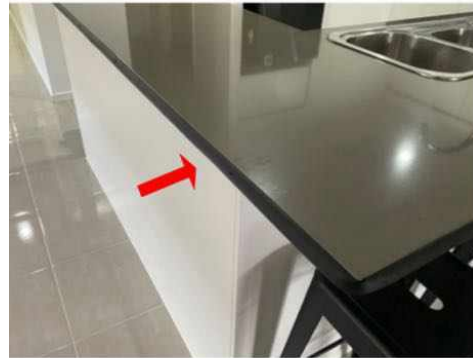
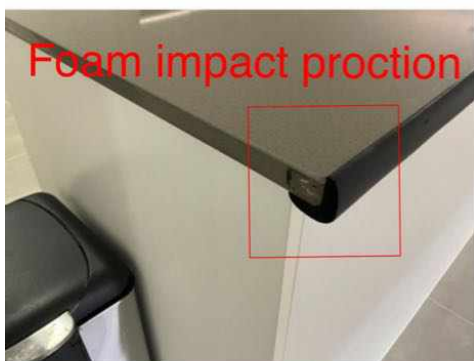
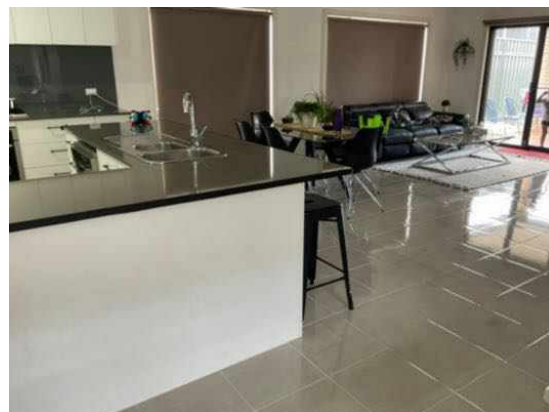
Building: Main Building
 Location: Kitchen
 Finding: Additional Photos
 Information: Additional photos are provided for your general reference.

This is not considered a defect but the new owners may the foam edge strip removed.

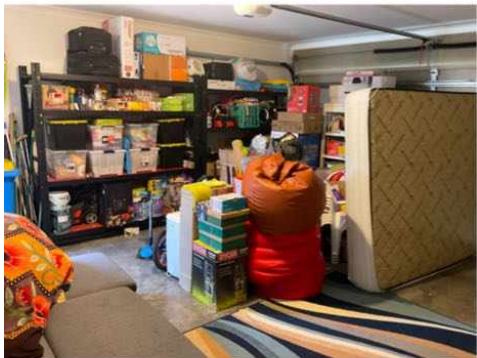
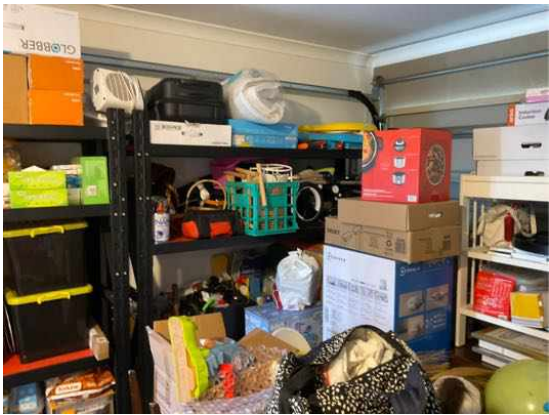
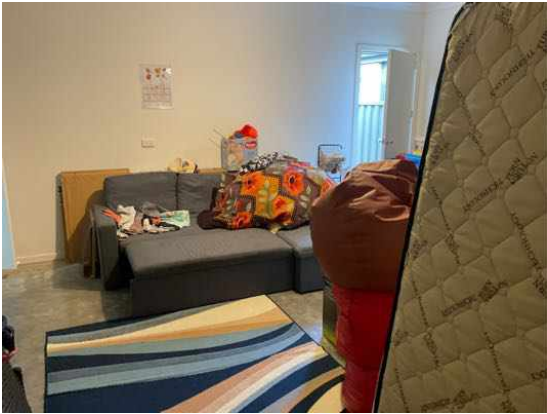
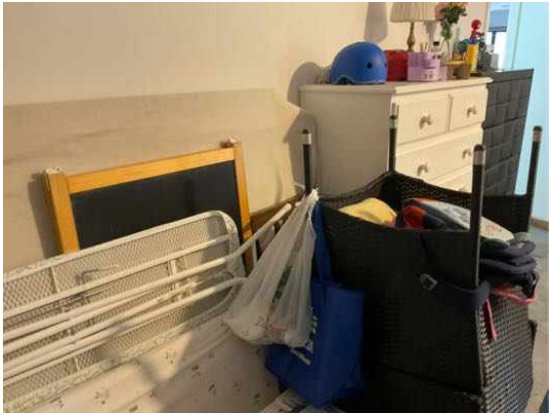
Building: Main Building
 Location: Garage
 Finding: Additional Photos - Obstructions and Limitations
 Information: These photographs are an indication of the obstructions and limitations which impeded full inspection of the property at the time of inspection. These obstructions can hide an array of defects and should be removed to allow full inspection to be carried out. A re-inspection is recommended once the areas are made accessible.
