# Building and Timber Pest Inspection Report

Inspection Date: Wed, 11 Feb 2026

Property Address: 2/2 Orr St, Yarrowonga VIC 3730, Australia

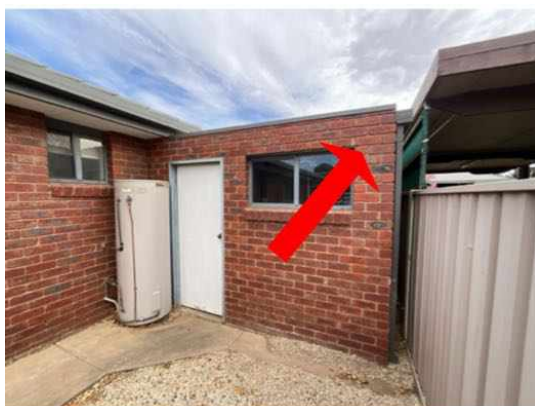
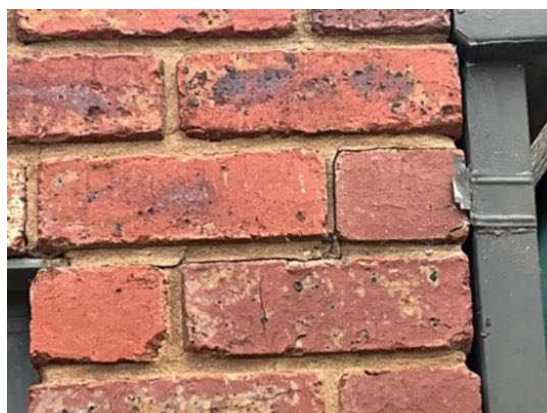
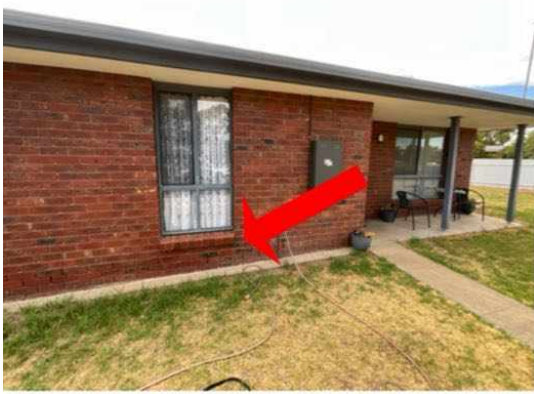
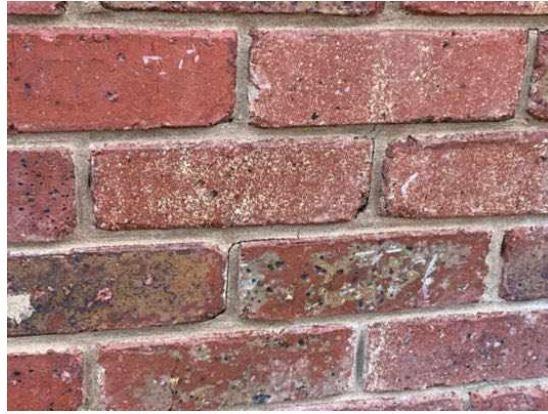
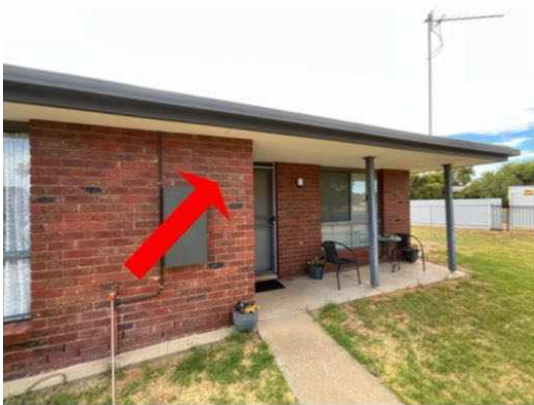
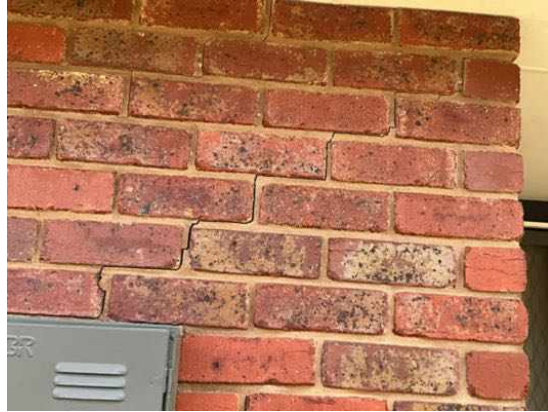
#### Finding 3.01

Building: Building 1  
Location: Garage, front wall  
Finding: Brickwork- Step cracking  
Information: Step cracking was identified to the brickwork in this area at the time of inspection. Step cracking, which is similar to other forms of cracking, has a variety of possible causes. However, the most common is the subsidence of adjacent footings.

Step cracking is a relatively common defect, and is most likely to occur adjacent to windows, doors and other openings. Mortar failure in the gaps between affected bricks indicates the stresses and tensions affecting the wall.

Minor step cracking can be used as a warning sign to address factors causing stress to the wall, which can include the effect of surrounding trees, water leaks, soil erosion, or even the presence of reactive soils in the surrounding area.

If cracks increase in size or number contact a Licensed builder immediately to make all needed repairs.

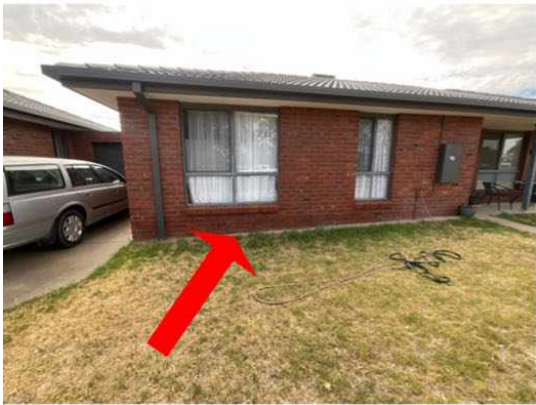
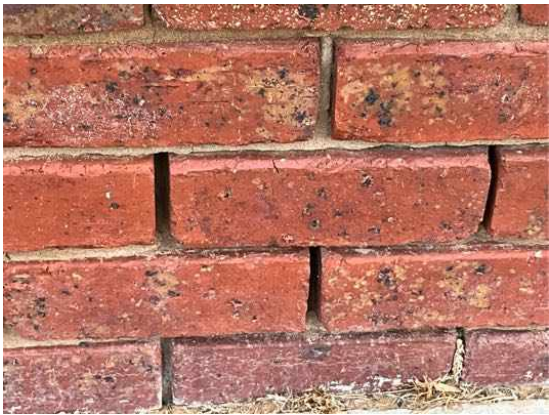
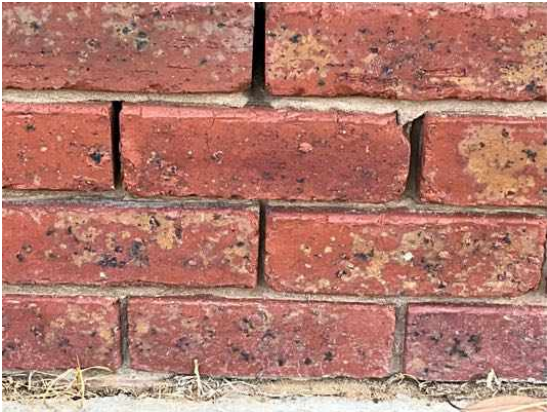
### Finding 3.02

Building:	Building 1
Location:	Front wall
Finding:	Brickwork - Deteriorated mortar
Information:	Mortar, or 'bedding', is the material which fills joins and intersections between bricks in masonry walls and structures. Sections of mortar in this brickwork were identified as having deteriorated, which is generally expected for a property of this age and condition.

Mortar may deteriorate as a result of age of building materials, minor movement of bricks, or frequent exposure to weathering. Mortar should be replaced to ensure that bricks remain in their intended location and to prevent gaps, which would allow water or moisture ingress and secondary damage as a result.

Mortar deterioration can be addressed by a bricklayer where areas of deterioration are localised and easily accessible. Alternatively, appointment of a registered builder is advised, to repoint large areas of decaying mortar. Where secondary structural defects have become evident, consultation with a structural engineer may be required.

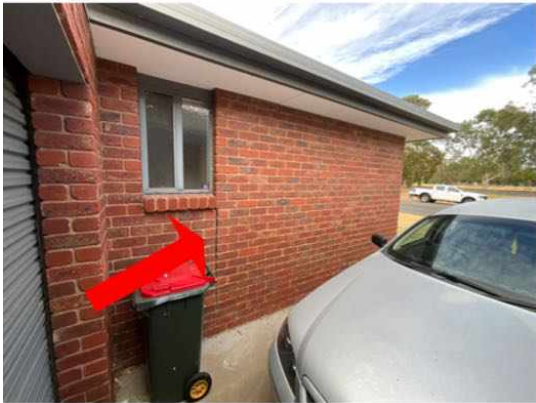
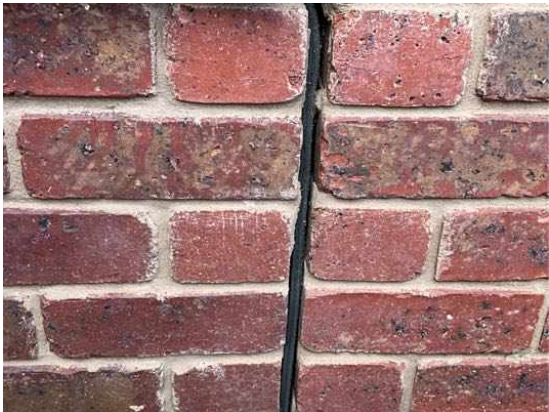
**Finding 3.03**

Building: Building 1  
 Location: Driveway  
 Finding: Inadequate sealant/caulking  
 Information: This area has a lack of effective Sealant or Grout. This may be allowing the ingress of water to the structure.

The presence of water encourages Termite attack, Mould and Fungal Decay.

A Caulker or General Handy person must be contacted soon to effect repairs and prevent possible deterioration.

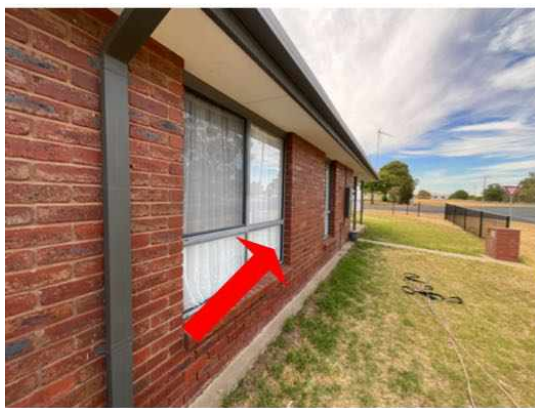
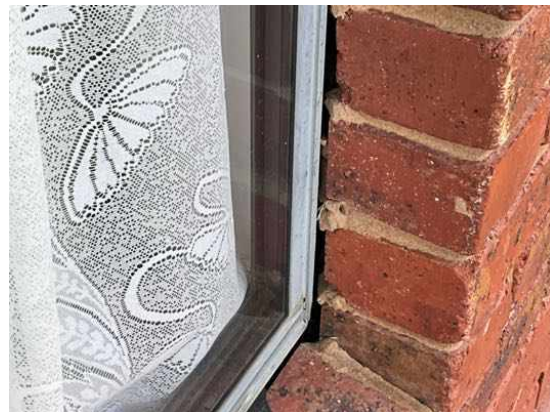
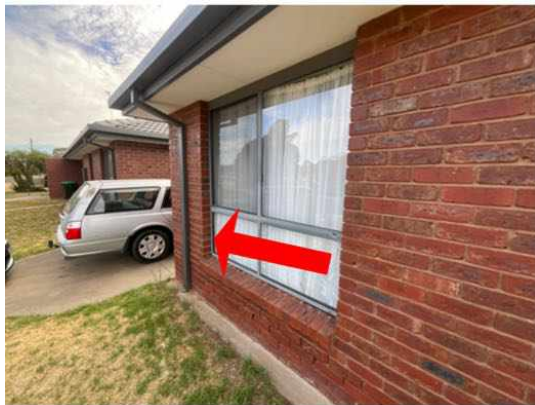
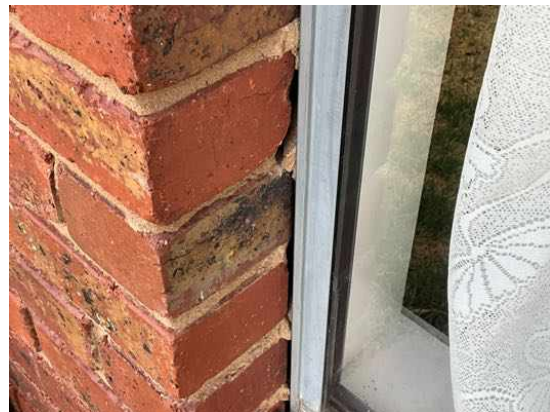
### Finding 3.04

Building:	Building 1
Location:	Bedroom window
Finding:	Inadequate sealant/caulking
Information:	This area has a lack of effective Sealant or Grout. This may be allowing the ingress of water to the structure.

The presence of water encourages Termite attack, Mould and Fungal Decay.

A Caulker or General Handy person must be contacted soon to effect repairs and prevent possible deterioration.

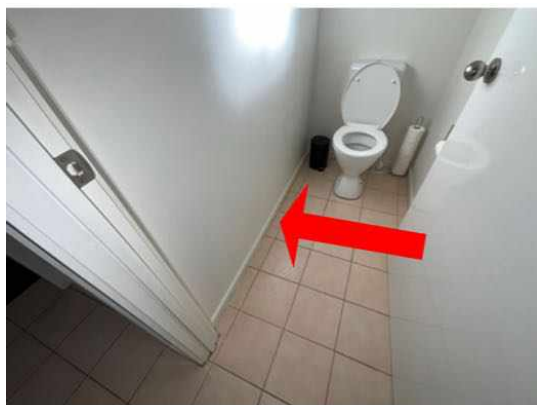
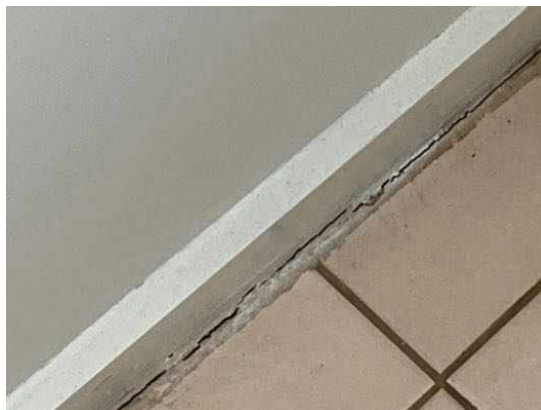
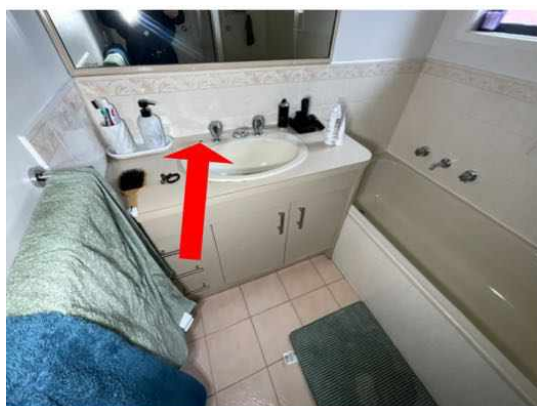
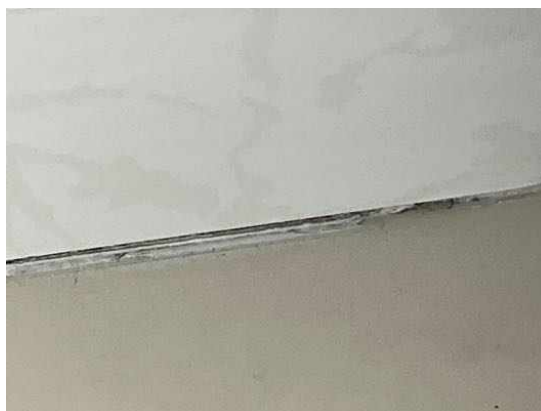
### Finding 3.05

Building:	Building 1
Location:	Toilet (WC), bathroom
Finding:	Inadequate sealant or Grout
Information:	This area has a lack of effective Sealant or Grout. This is allowing the ingress of water to the structure inside the wall.

The presence of water encourages Termite attack, Mould and Fungal Decay.

A Tiler or General Handy person must be contacted as soon as possible to effect repairs and prevent further deterioration.

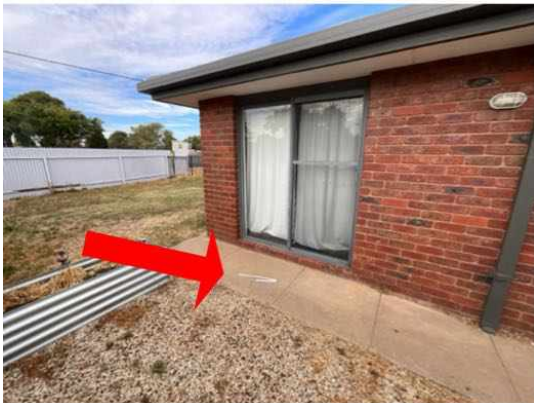
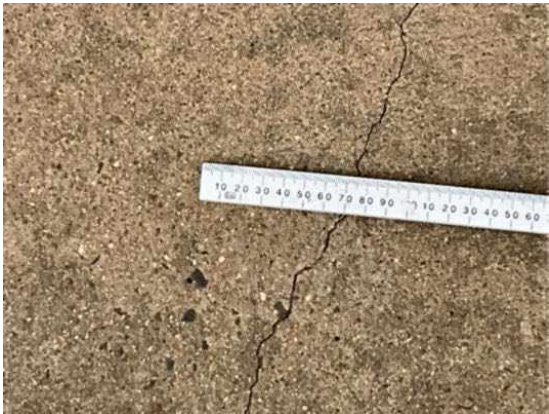
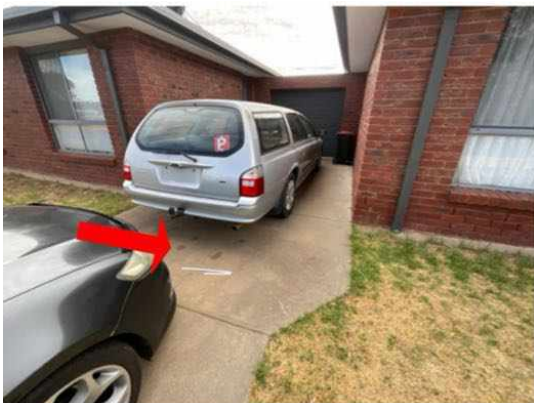
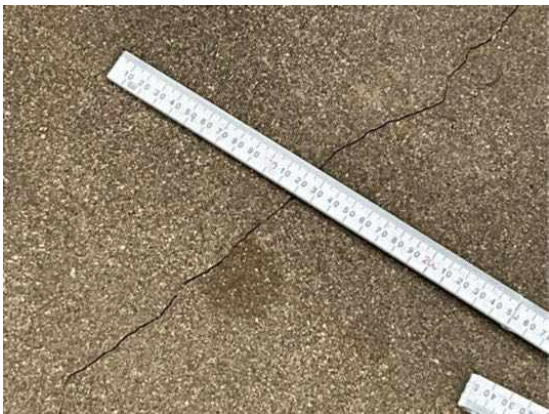
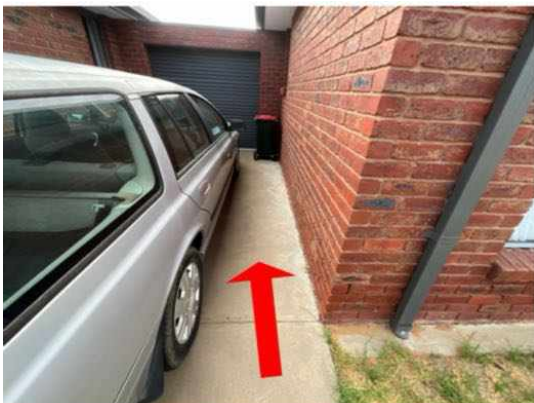
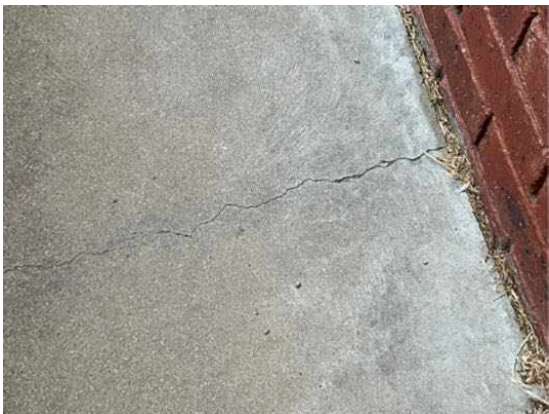
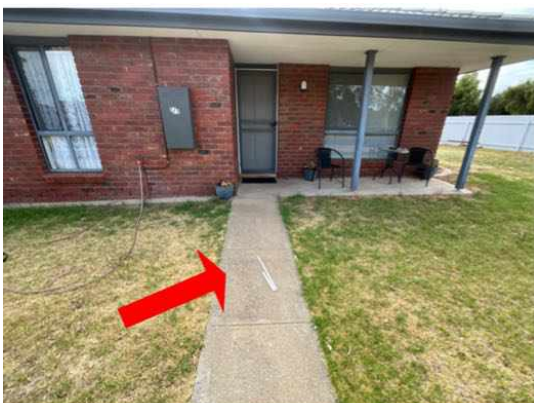
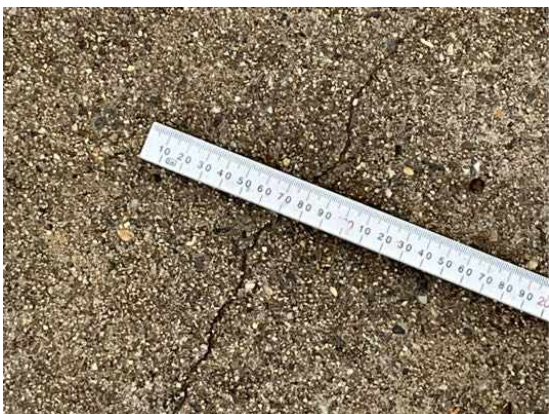
### Finding 3.06

Building:	Building 1
Location:	Yard - Back, front, driveway,
Finding:	Cracking - External Concrete Paving Damage Category 1 - Fine (less than 2mm)
Information:	Fine cracks were identified in external concrete paving. Although fine cracks are quite noticeable, they are often only considered to be an appearance defect, and usually do not indicate any structural damage. To be considered a Category 1 or fine crack, the crack is found to be less than 2mm in width.

Generally the cause of a hairline crack in existing concrete paving such as driveways and pathways is indicative of the expansion and contraction of the concrete. Such causes are generally due to environmental factors, such as moisture levels, weather conditions, root systems of nearby trees or the soil types on which they are laid.

Fine cracks may also be due to poor original installation of the concrete. Factors such as poor compaction of the sub surface and/or inadequate reinforcing of the slab may create cracking and other secondary defects.

Monitoring of all cracking should be conducted frequently. Always contact a building

inspector should cracks widen, lengthen, or become more numerous.

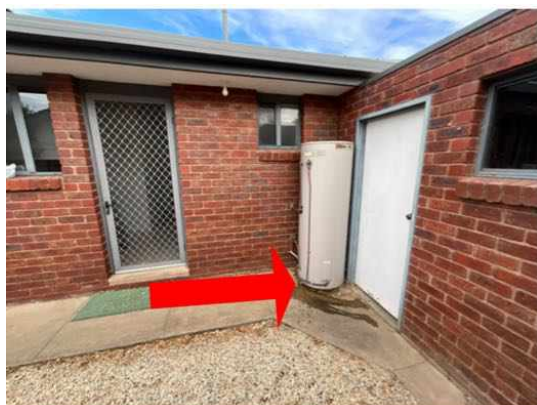
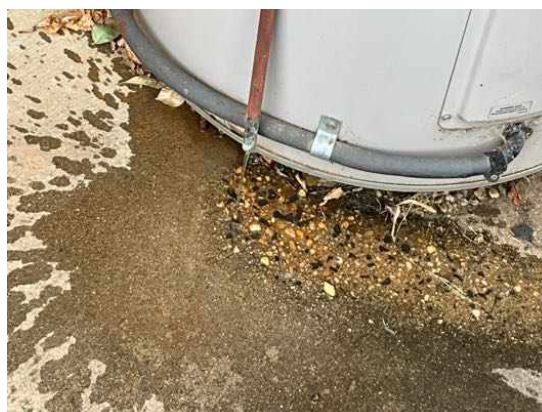
### Finding 6.01

Building: Building 1  
 Location: Yard - Back  
 Finding: HWS Overflow - Not Connected  
 Information: The Hot Water System (HWS) overflow was found to be disconnected from storm water drainage and is creating excessive moisture in the surrounding area.

These damp conditions can lead to secondary defects such as rot, rust or corrosion of associated building elements, the formation of fungal decay, or even the creation of potential slip hazards. When coupled with poor site drainage, pooling of water may also attract termite activity to this area.

It is highly recommended that a licensed plumber be appointed to connect the HWS overflow in order to prevent such an environment from being created. These minor works should be carried out as soon as possible.

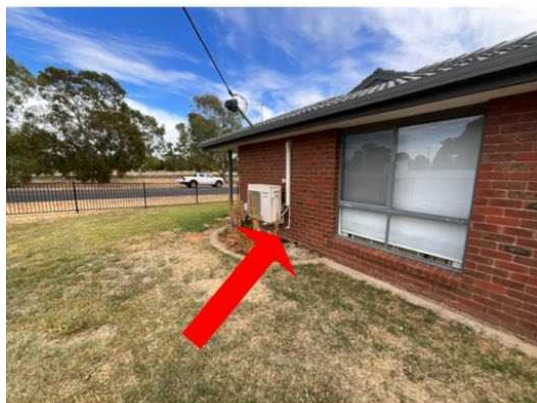
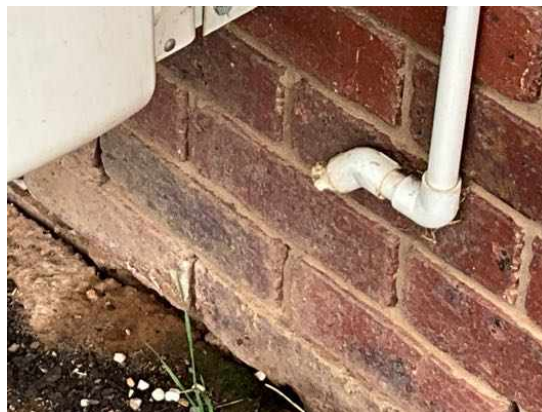
### Finding 6.02

Building: Building 1  
 Location: Yard - Side  
 Finding: Air conditioner - Disconnected overflow

Information: The Air Conditioner (A/C) overflow was found to be disconnected from storm water drainage and is creating excessive moisture in the surrounding area.

Such leaking creates an environment which is conducive to an array of defects, including water damage to associated building elements and the attraction of termite or timber pest infestation.

It is highly recommended that a licensed plumber be appointed to connect the A/C overflow in order to prevent such an environment from being created. These minor works should be carried out as soon as possible.

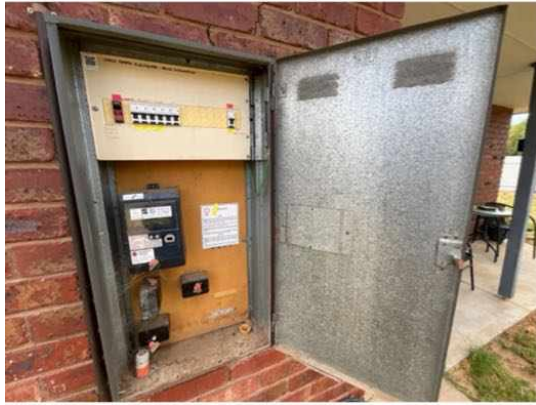
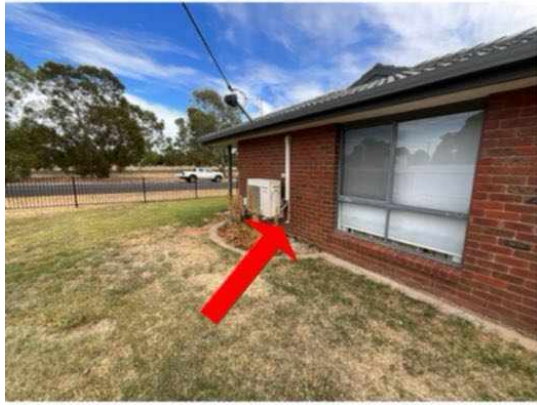
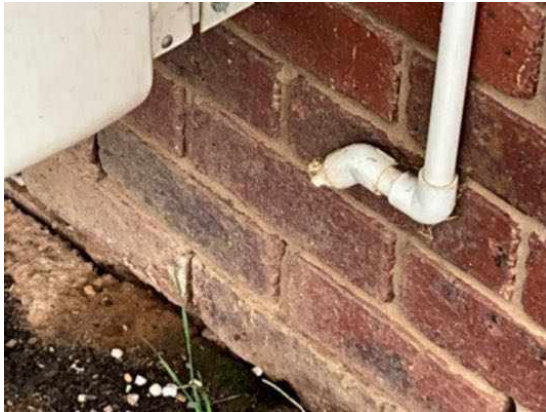
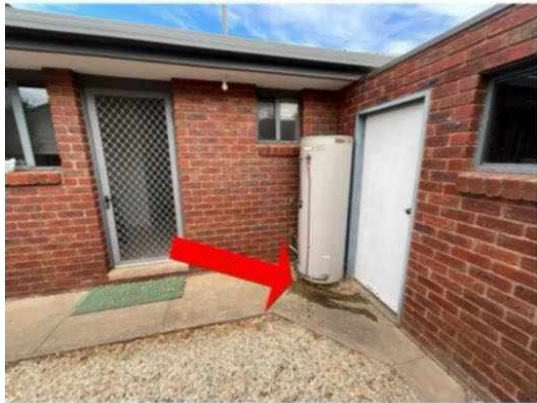
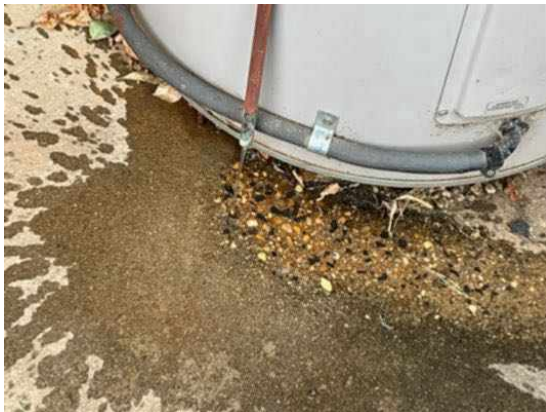
### Finding 6.03

Finding: Termite Management System - no evidence of a chemical installation

Information: The application of a post-construction chemical termite barrier is highly recommended for all properties, particularly if live termite activity has been found on the site previously. Such barriers are highly effective in preventing termite attack on any timber building elements throughout the property.

A durable notice should be placed in the switchboard unit to indicate current termite barriers. At the time of inspection, it appeared as though no termite management system has been installed, with no evidence to suggest preventative works taking place.

The client may consider gaining further advice from a pest controller as to the costs and procedures involved with this application. It is recommended that obtaining such advice be a short-term priority.

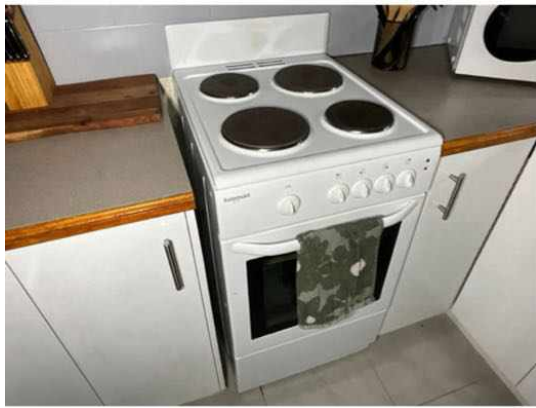
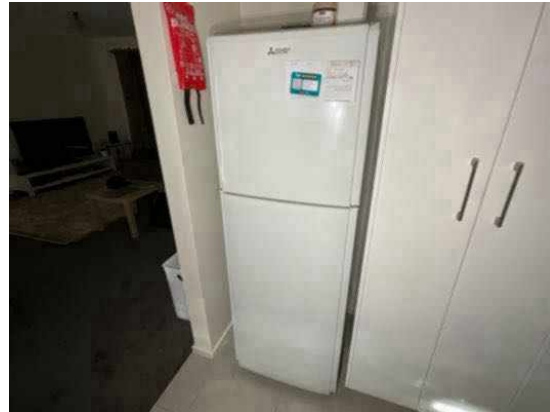
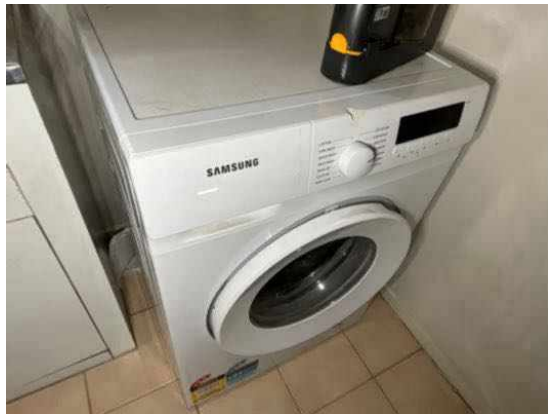
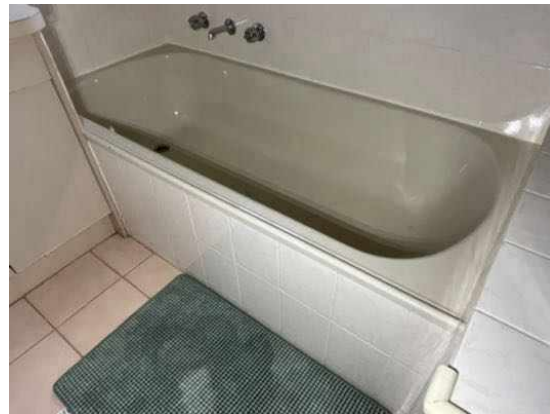
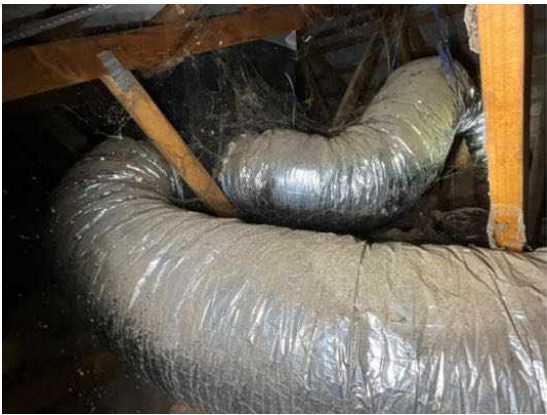
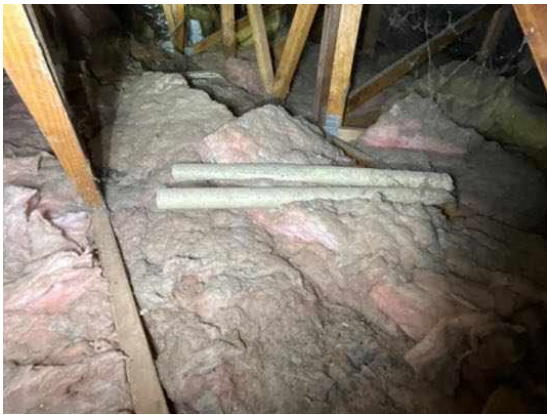
#### Noted Item

Building: Building 1  
Location: All Areas  
Finding: Additional Photos - Obstructions and Limitations  
Information: These photographs are an indication of the obstructions and limitations which impeded full inspection of the property at the time of inspection. These obstructions can hide an array of defects and should be removed to allow full inspection to be carried out. A re-inspection is recommended once the areas are made accessible.
