# Building and Timber Pest Inspection Report

Inspection Date: Mon, 16 Feb 2026

Property Address: 80 Douglas McInnes Dr, Laidley QLD 4341,  
Australia

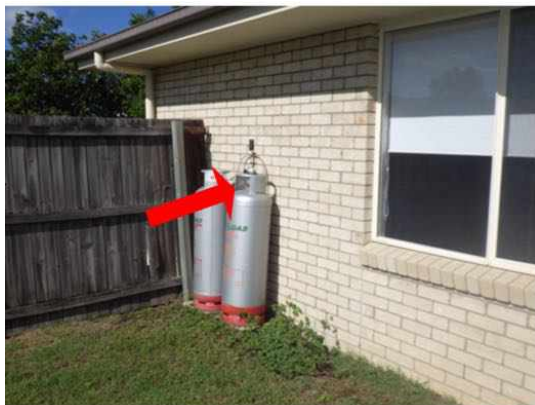
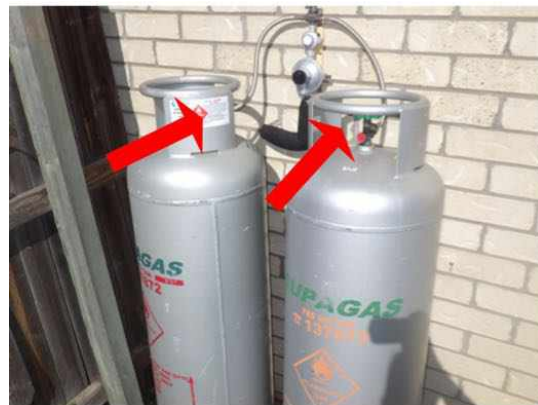
Building:	Main Building
Location:	Exterior walls - right side > Front Right
Finding:	Gas Bottle - Non-compliant
Information:	At the time of inspection there was no safety chain securing the gas bottles to the wall. Safety chains are required on gas bottle installations to prevent the gas bottles from being knocked over either by accident or on purpose.

Where the gas bottles are not securely fastened a licensed plumber or general handyman could be engaged to install a chain or rack to secure the bottles. Where installation is substandard and/or incomplete, the client should contact the responsible trade (gas plumber) to undertake rectification.

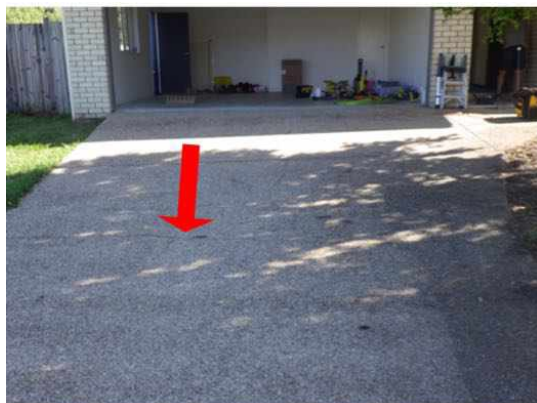
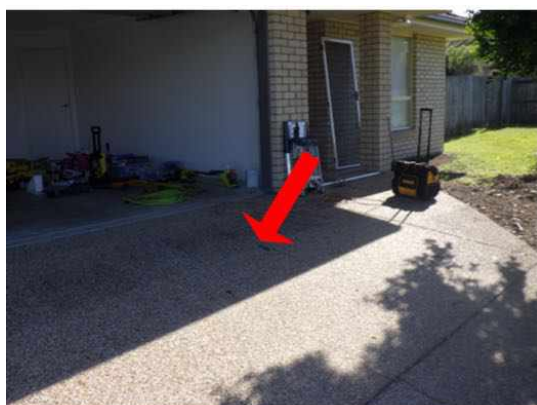
Building:	Main Building
Location:	Driveway > Ground Level
Finding:	Cracking in concrete slab - Category 1
Information:	Cracking coded as Category 1 was identified in the driveway and footpaths concrete slab (as per example photos). A Category 1 crack is described as a fine but noticeable crack, with the slab at an otherwise reasonable level.

To be considered Category 1, the approximate width of the crack is less than 1.0mm, or a less than 10mm change in offset when a 3m straight edge is placed over the defect.

Category 1 cracks should be monitored for a period of 12 months. At the end of the monitoring period, identified cracks that are rated greater than Category 2 are considered defects, and require rectification.

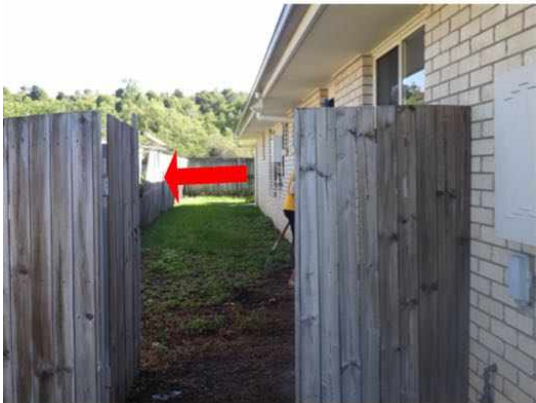
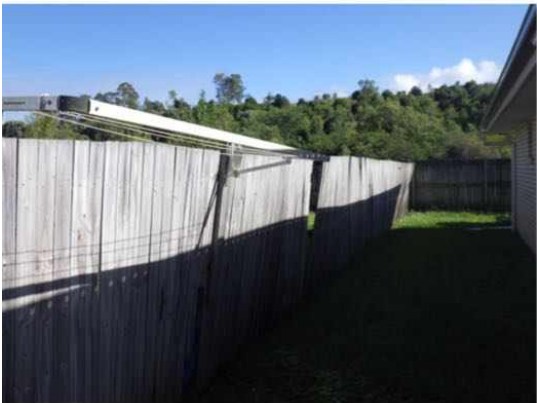
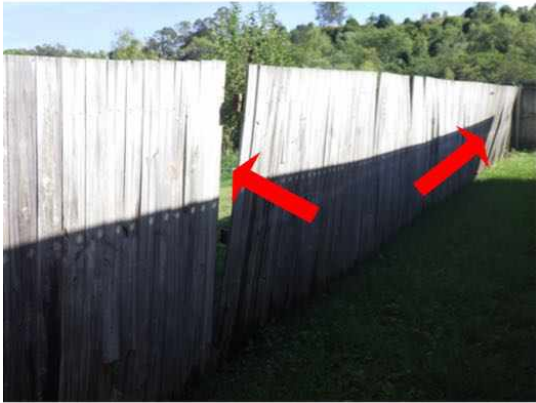
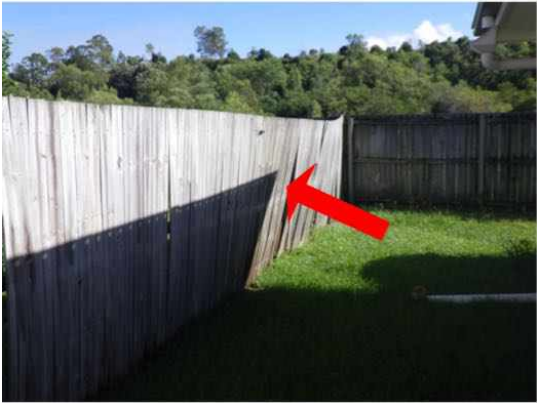
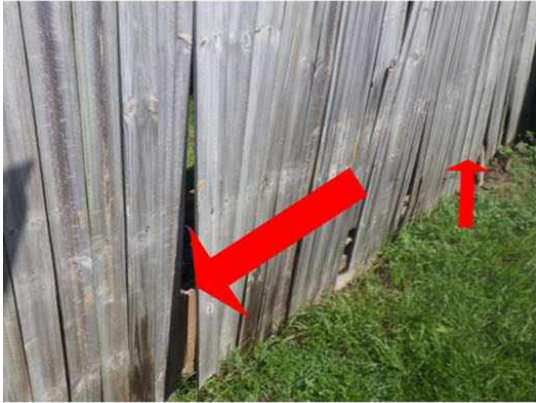
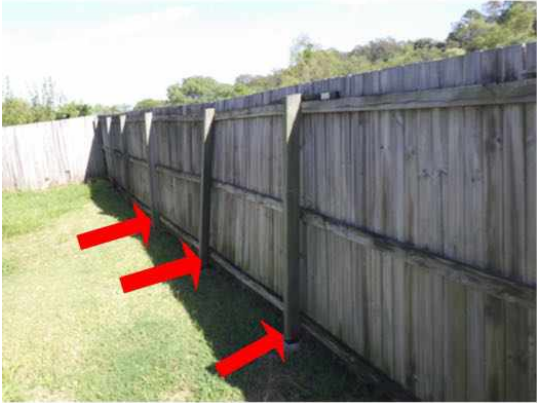
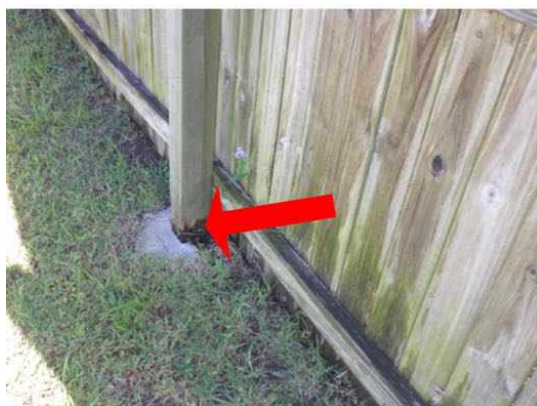
### Finding 3.02

Building:	Main Building
Location:	Yard > All Areas
Finding:	Fencing - Deteriorated
Information:	It was noted at the time of inspection that sections of the fencing and gates throughout the property have deteriorated. Typically fencing deteriorates due to age and or wear, rot and or rust which is generally expected for a structure of this age, due to prolonged exposure to weather conditions. Sometimes inadequate installation or maintenance can be to blame.

If left unattended, it is likely that further damage will occur. It is suspected that repair of several elements of the fencing may be required however replacement may be a consideration of the client also.

A licensed fencing contractor should be appointed to provide further advice and perform rectification works as necessary.

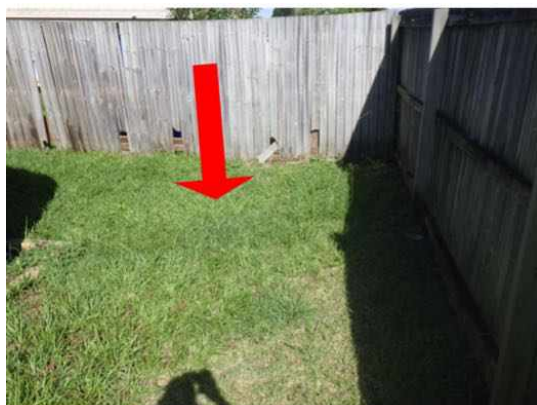
### Finding 3.03

Building:	Main Building
Location:	Yard - Back > Rear Left
Finding:	Sewer line - Caps Missing
Information:	At the time of inspection it was noted the sewer line was missing the protective riser cap to the rear left side of the property.

It is assumed the cap has been previously removed or damaged. The missing sewer line cap creates potential for sewer line blockages.

A licensed plumber or general handyman should be engaged to replace the sewer line cap..

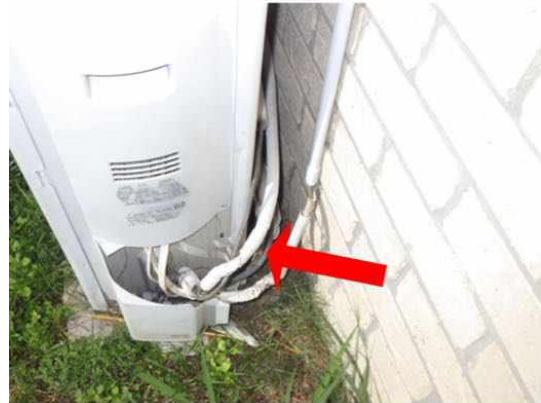
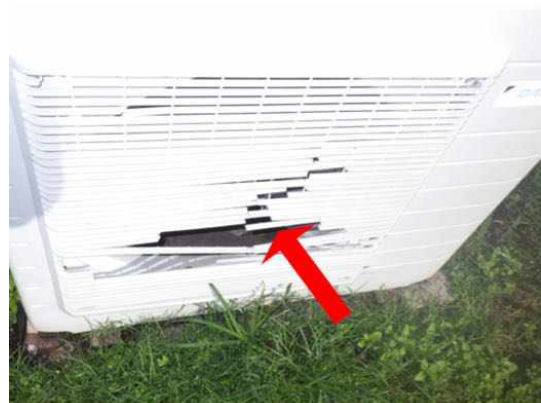
### Finding 3.04

Building:	Main Building
Location:	Exterior walls - right side > Centre Right
Finding:	Air Conditioning Unit deteriorated
Information:	At the time of inspection sections of the air conditioning unit, electrical cabling and pipe work insulation showed evidence of damage and deterioration. It is suspected that this deterioration has developed as a result of excessive exposure to weather, including UV exposure in daylight. Deteriorated insulation reduces the effectiveness of

If left in an exposed position, it is likely that the deterioration will continue and worsen over time, potentially resulting in secondary building defects as well as a further loss in insulating properties.

Some areas of replacement of pipe insulation is likely to be required. Further preventative measures to remove or protect the material from future exposure are also advisable. Consultation with a licensed air conditioning installer is advised to gain quotes for the repair and/or replacement of deteriorated insulation and/or unit.

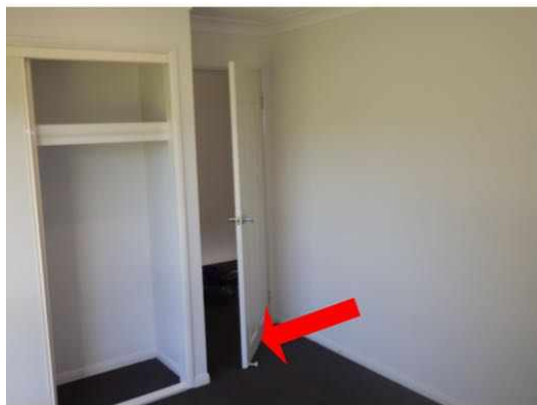
### Finding 3.05

Building:	Main Building
Location:	Bedroom 2 > Front
Finding:	Door Rubbing
Information:	It was noted that the bottom edge of the bedroom 2 door is rubbing on the carpet making the door stiff to open and close at the time of inspection.

This is noted as a minor defect that you need to be aware of.

A licensed carpenter or general handyman could be engaged to ease the door at the clients discretion.

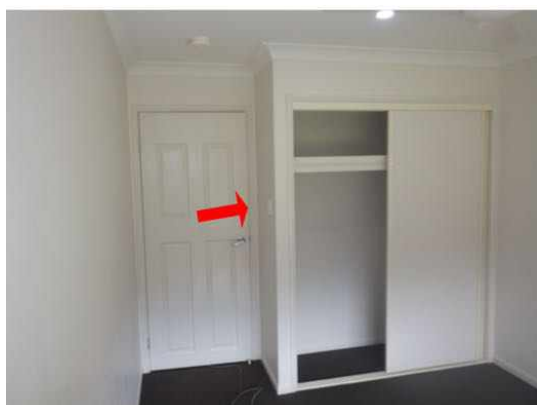
### Finding 3.06

Building:	Main Building
Location:	Bedroom 3 > Front
Finding:	Door - Binding/Jamming
Information:	Binding and/or jamming of the bedroom 3 door on the door frame was evident during standard operation. This defect inhibits the functionality of affected door as well as creating potential for secondary defects to associated building elements, such as damage to the door framing.

A door that binds to the associated door frame or sill may have several causes, such as poor installation of the door or deteriorated hinges.

A qualified carpenter or general handyperson could be appointed to perform minor rectification works at client discretion.

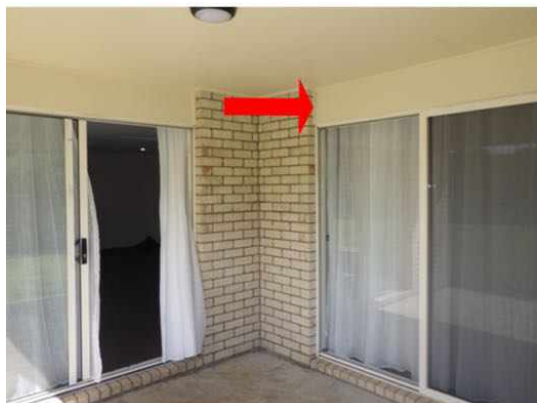
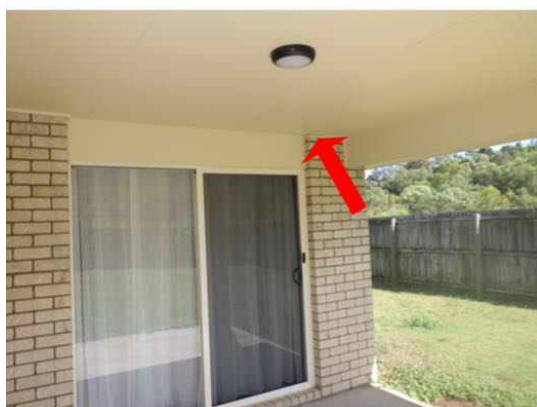
### Finding 3.07

Building:	Main Building
Location:	Alfresco > Centre Left
Finding:	Beading - Loose
Information:	It was noted at the time of inspection that beading in parts of the eaves in the alfresco area is loose..

Beading is important in weatherproofing the surrounding building elements and preventing termite or pest ingress. Furthermore, beading works to protect the joins of building materials, which are more susceptible to deterioration and decay.

Repair of the beading is advised to ensure the protection and longevity of any associated building elements. Such works may be performed by a general handyman.

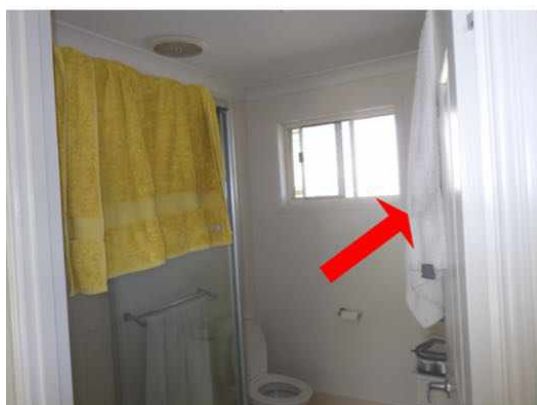
### Finding 3.08

Building:	Main Building
Location:	Ensuite > Centre,Rear
Finding:	Cracking - Wall
Information:	There is cracking to an area of the wall lining in the ensuite area.

The cracking appears minor in nature and is generally only ever an appearance defect. While such cracking may be noticeable in some cases, it is quite common and does not indicate any structural damage.

Cracking of this nature can generally be repaired with minor sanding, filling and/or repainting. Such works should be performed by a qualified painter or a general handyman.

Monitoring of all cracking should be conducted frequently. Always contact a building

inspector should cracks widen, lengthen, or become more numerous.

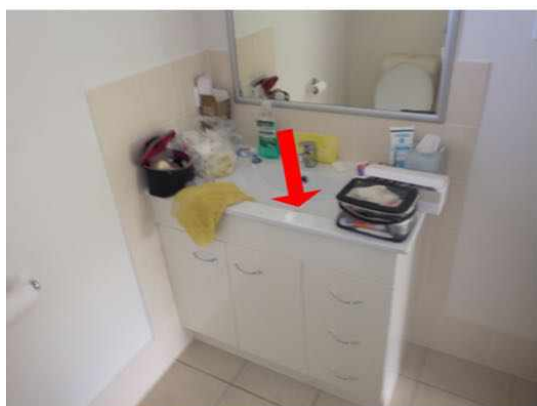
### Finding 3.09

Building: Main Building  
 Location: Ensuite > Rear Right  
 Finding: Basin - Pop up waste.  
 Information: The ensuite basin pop up waste was damaged or broken at the time of inspection. It is advised that maintenance is carried out on the waste so as it functions as intended.

A handyman could be appointed to perform any remedial works where required.

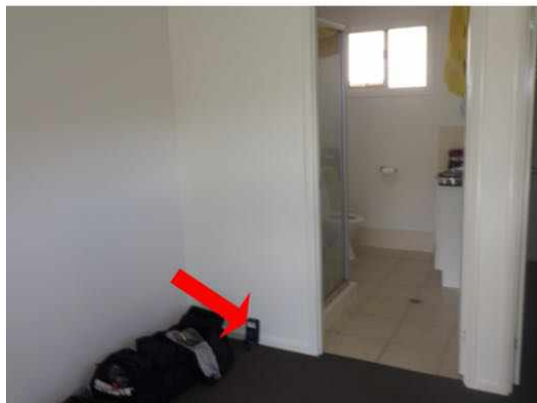
### Finding 3.10

Building: Main Building  
 Location: Ensuite > Front Left  
 Finding: Shower - Monitor  
 Information: Elevated moisture level readings were recorded to the lower 200mm of wall to the ensuite shower alcove at the time of inspection. There was no elevated moisture level readings around the tap area, and no elevated readings transferring to the other side of the wall in the areas where moisture readings were able to be obtained. Both sealant and grout appear in good condition at present.

This defect is quite common, and is suspected to have been caused by moisture permeating or leaching through the grouting and perhaps gaps in the sealant.

Monitoring the area is advised and if any visual signs of excessive moisture appear (peeling paint, mould) then consultation with a qualified plumber or bathroom specialist would be advised to identify the cause of damp and to perform remedial works as required.

Always ensure that sealant and grout is in good condition to prevent any moisture issues occurring in the future.

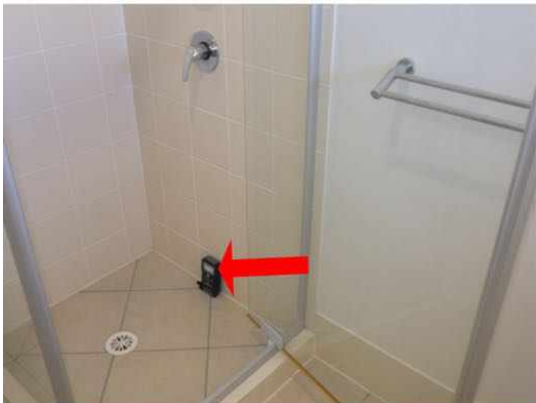
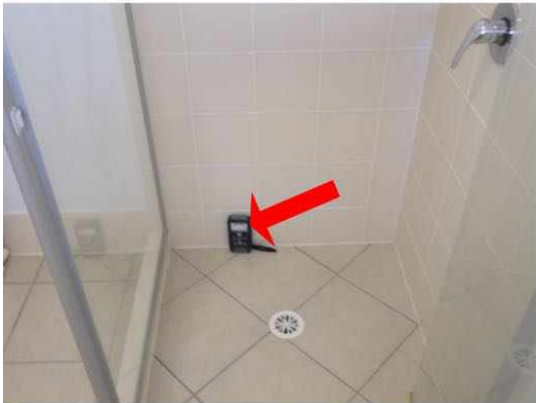
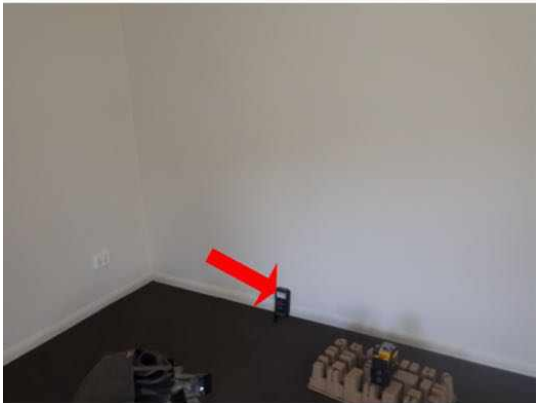
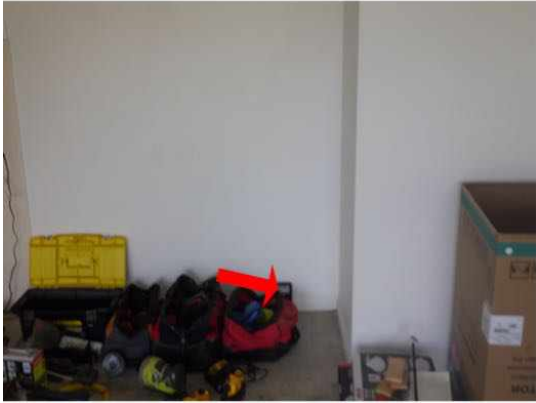
### Finding 3.11

Building: Main Building  
Location: Bathroom > Front Left  
Finding: Shower - Monitor  
Information: Elevated moisture level readings were recorded to the lower 200mm of wall to the bathroom shower alcove at the time of inspection. There was no elevated moisture level readings around the tap area, and no elevated readings transferring to the other side of the wall in the areas where moisture readings were able to be obtained. Both sealant and grout appear in good condition at present.

This defect is quite common, and is suspected to have been caused by moisture permeating or leaching through the grouting and perhaps gaps in the sealant.

Monitoring the area is advised and if any visual signs of excessive moisture appear (peeling paint, mould) then consultation with a qualified plumber or bathroom specialist would be advised to identify the cause of damp and to perform remedial works as required.

Always ensure that sealant and grout is in good condition to prevent any moisture issues occurring in the future.

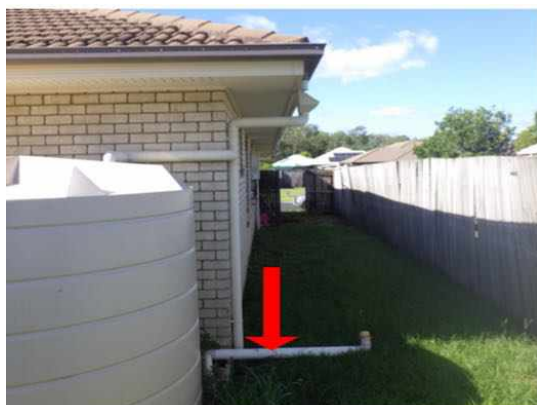
Where roof plumbing doesn't drain adequately, the area at the base perimeter can become excessively damp, potentially creating an environment that is susceptible to rust and corrosion of surrounding building elements, as well as attracting termites and other pests.

It is recommended that a plumber or handyman be appointed to repair or replace the overflow pipe as necessary.

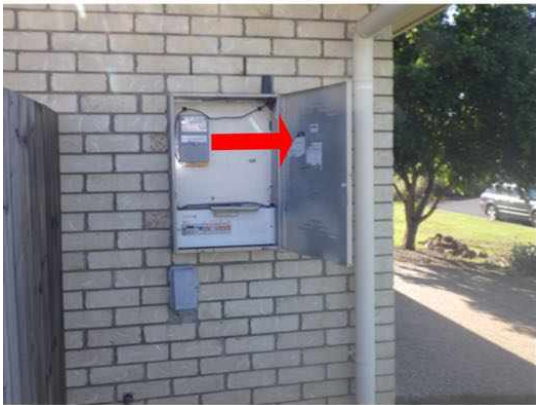
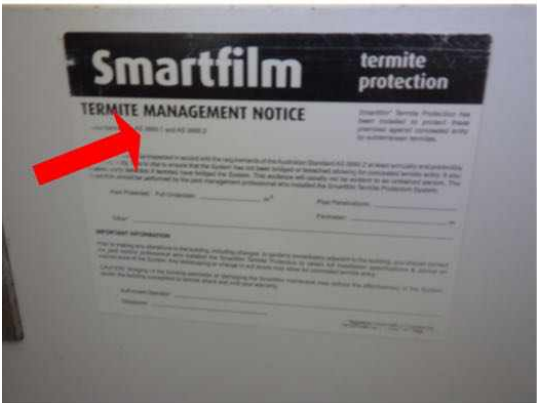
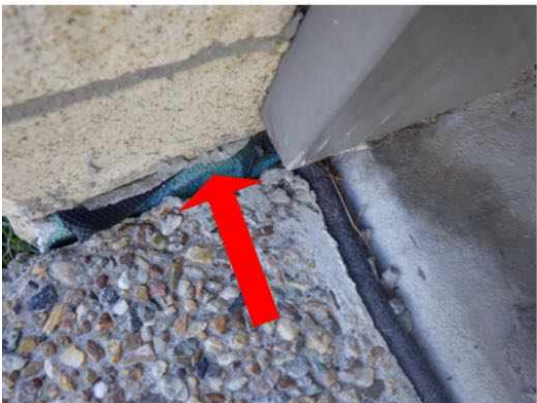
In this instance evidence of a previously installed physical barrier was observed, along with durable notice's inside the electrical meter box and kitchen area under sink cabinetry. This system requires regular annual inspections.

No evidence of regular or annual inspections was found.

Where a Termite Management System has been identified you should refer to the type of barrier date of installation warranty conditions and any documentation provided by the barrier installation company or past owner.
