Building and Timber Pest Inspection Report VR

Inspection Date: Thu, 20 Nov 2025

Property Address: 19 Hill St, Bundanoon NSW 2578,
Australia

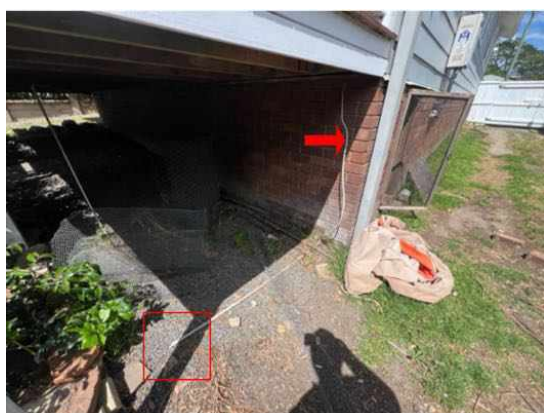
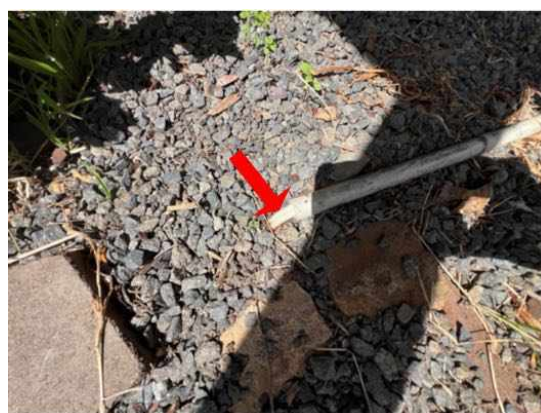
Finding 1.01

Building:	Main Building
Location:	Rear Verandah
Finding:	Electrical wires exposed
Information:	Exposed electrical wiring was identified. Exposed electrical wiring represents a potential safety hazard including for fire and personal contact. Contact a licensed electrician urgently for further inspection investigation and rectification.

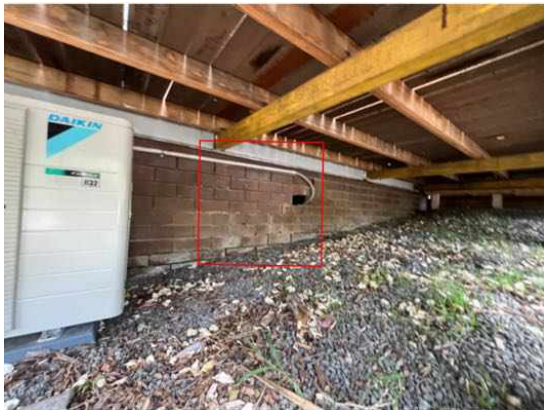
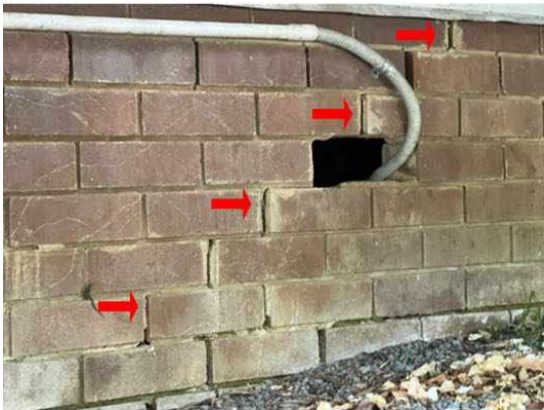
Finding 2.01

Building:	Main Building
Location:	Front Verandah
Finding:	Brickwork - Step cracking
Information:	Step cracking was identified to the brickwork in this area at the time of inspection. Step cracking, which is similar to other forms of cracking, has a variety of possible causes. However, the most common is the subsidence of adjacent footings.

Step cracking is a relatively common defect, and is most likely to occur adjacent to windows, doors and other openings. Mortar failure in the gaps between affected bricks indicates the stresses and tensions affecting the wall.

Where step cracking is extensive or severe, the client is advised to consult a structural engineer. Minor step cracking can be used as a warning sign to address factors causing stress to the wall, which can include the effect of surrounding trees, water leaks, soil erosion, or even the presence of reactive soils in the surrounding area.

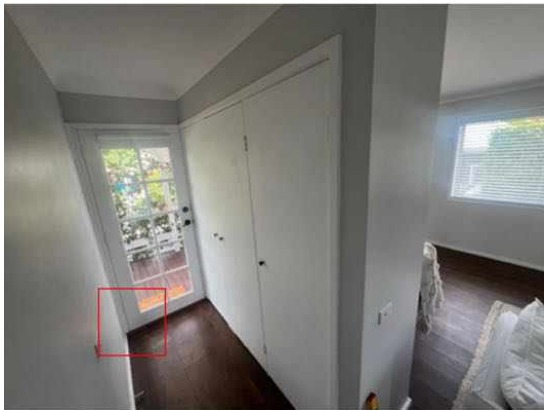
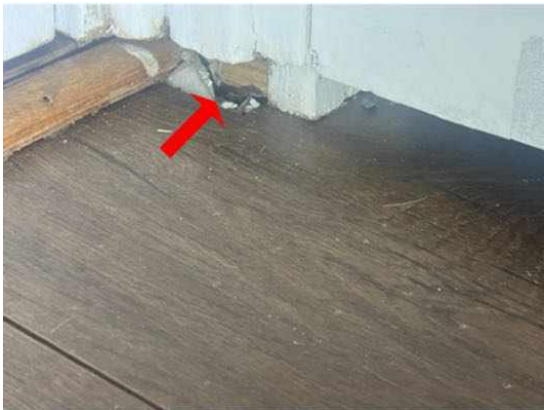
Finding 3.01

Building: Main Building
Location: All Internal Areas
Finding: Flooring Trim - Missing or Unfinished
Information: Sections of flooring were observed without transition or edging trims where the floor meets adjoining surfaces such as sliding doors, walls, tiles, or carpeted areas. Missing or unfinished trims detract from the overall appearance and leave exposed edges susceptible to lifting, moisture ingress, or damage.

A carpenter or flooring installer should be engaged to fit suitable trims or edging to protect exposed areas and provide a neat, durable finish.

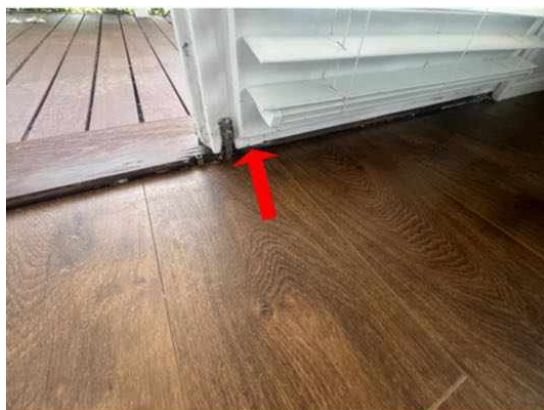
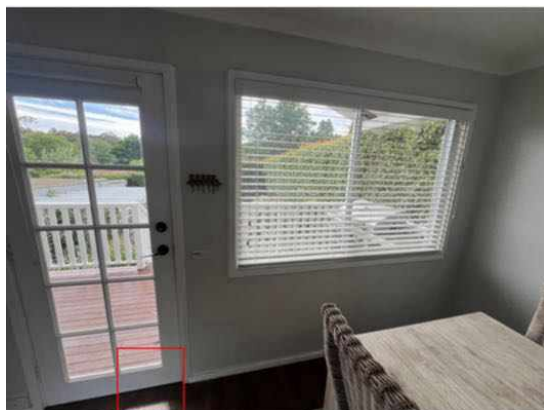
Building: Main Building
Location: Entry (linen), Sitting Room, Bedroom 3 (robe), verandah
Finding: Doors - Binding/Jamming
Information: Binding and/or jamming of several doors throughout the property were evident during standard operation. This defect inhibits the functionality of affected doors as well as creating potential for secondary defects to associated building elements, such as damage to the floor covering.

A door that binds to flooring or to the associated door frame may have several causes, ranging from minor defects, such as poor installation of the door or deteriorated hinges, through to major structural issues, such as damage to subfloor structures.

For minor causes, a qualified carpenter or general handyperson should be appointed to perform minor rectification works at client discretion.

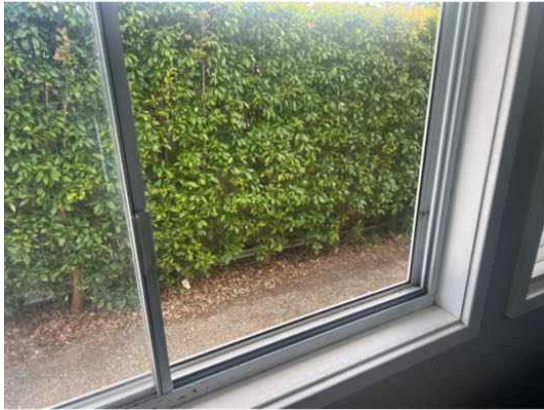
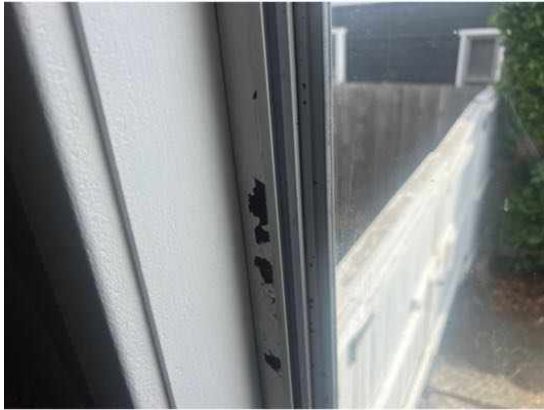
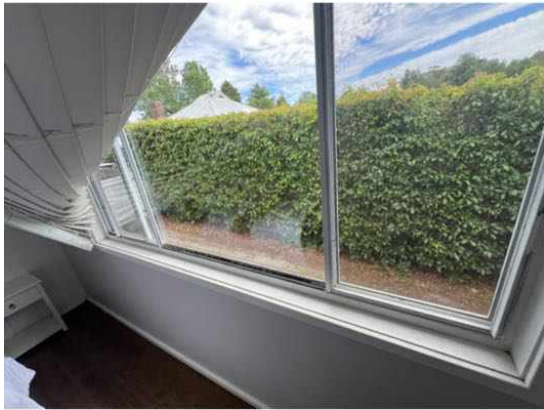
Finding 3.04

Building:	Main Building
Location:	All Internal Areas
Finding:	Painting deteriorated - Window frames throughout
Information:	The paint work in these areas of the property require attention to prepare and re paint. Whilst incomplete or missing paint finish is generally an appearance defect, it can also lead to the development of secondary building defects over time. Incomplete areas of paint finish exposes the area to moisture, potentially accelerating the deterioration of underlying building materials.

Degraded paint finishes should be sanded back, filled, leveled and painted, as applicable. Where inadequate or missing paint protection has led to the deterioration of the associated building element, repair and/or replacement of this building element may be required.

A painting contractor should be appointed at the clients discretion to perform necessary works to aid the appearance of the affected area and to ensure the area is protected against further deterioration. Alternatively, the homeowner following manufacturer instructions may perform these works

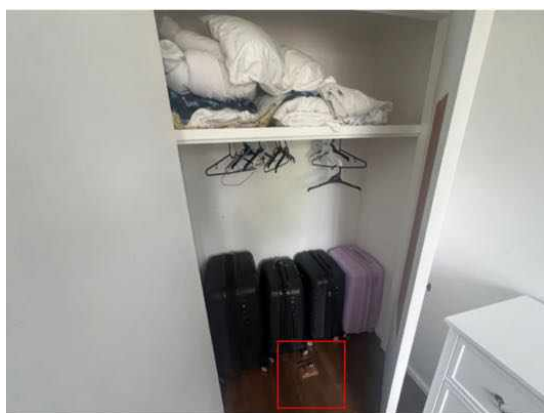
Finding 3.05

Building:	Main Building
Location:	Bedroom 3
Finding:	Building element - Damaged
Information:	Breakage occurs generally when the building materials have either aged and decayed, or as a result of damage (accidental or deliberate).

Repair and/or replacement of broken elements is advised to ensure that additional secondary defects do not arise as a consequence. Such works are necessary, as all building elements play a key role in the operation and function of the overall structure and its performance.

A handy person or carpenter should be appointed to repair or replace the affected building element prior to any subsequent damage being caused.

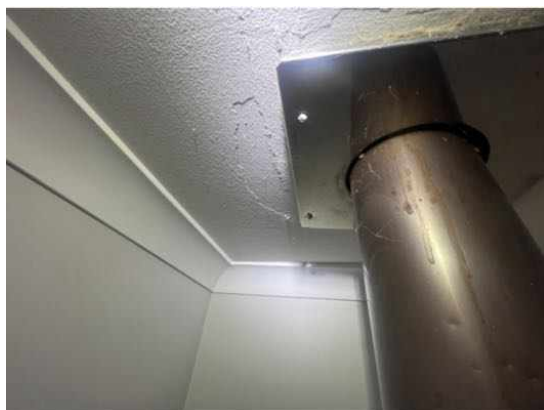
Finding 3.06

Building:	Main Building
Location:	Living Room
Finding:	Ceiling Paint - Flaking
Information:	Flaking paint was identified on the ceiling at the time of inspection. This defect is commonly caused by moisture ingress, poor surface preparation, or the natural ageing and deterioration of paint over time.

Flaking paint not only detracts from the aesthetic appeal of the ceiling but may also expose the underlying surface to further deterioration, including moisture absorption and potential damage.

It is recommended that a qualified painter be engaged to prepare and repaint the affected area to ensure proper adhesion and a durable finish. Investigation into potential underlying causes, such as moisture issues, should also be considered to prevent recurrence.

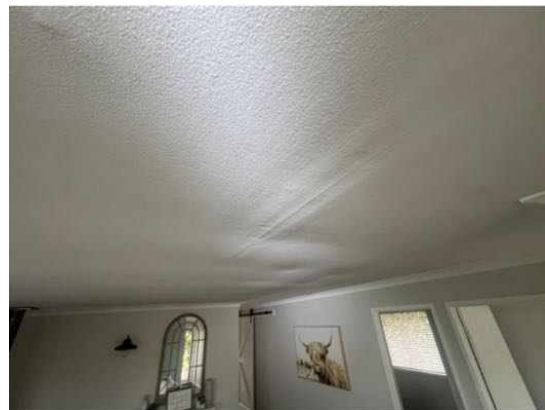
Finding 3.09

Finding: Ceiling - Sagging, Cracking, and Substandard Finishes

Information: The inspection identified several ceiling defects, including localised sagging, cracking, and inconsistent flushing of joint lines. Minor sagging across the ceiling surface suggests that back-blocking may have been omitted or inadequately installed. Cracking and uneven joint treatment were also noted, along with areas of substandard patching where prior repairs have not been completed to an acceptable finish.

These conditions are not considered structural but indicate surface movement and workmanship deficiencies that may worsen if deterioration continues. The affected areas should be assessed by a qualified plasterer to confirm the extent of movement and ensure appropriate repairs are undertaken to restore a uniform ceiling finish.

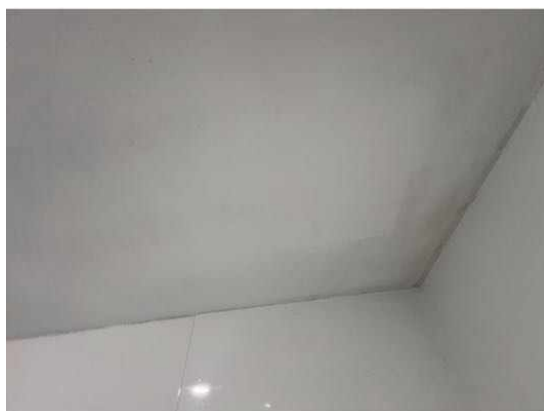
Finding 3.14

Building:	Main Building
Location:	Bathroom
Finding:	Mould - ceiling
Information:	Mould spotting was observed on the ceiling at the time of inspection. This condition is typically indicative of prolonged moisture exposure, which may be caused by water ingress, inadequate ventilation, or condensation buildup.

If left unmanaged, persistent moisture can lead to further mould growth, deterioration of building materials, and potential health concerns.

It is recommended that a licensed plumber or building professional be engaged to investigate the source of moisture and undertake any necessary remedial works. Remediation of the mould-affected areas should also be carried out to prevent further deterioration.

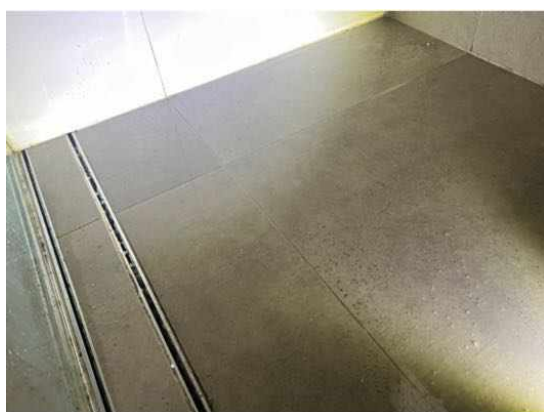
Finding 3.17

Building:	Main Building
Location:	Bathroom
Finding:	Tiles - Cracked or damaged
Information:	Cracking was evident to the tiling in this area at the time of inspection. While the cracking appears to be minor, this area is frequently exposed to water, allowing potential for water penetration into adjoining sections of walls or flooring.

Remedial works may involve some sections of tiling and flooring repair and replacement. A tiling contractor or bathroom specialist should be appointed to provide further advice on reparation options and to perform works as necessary.

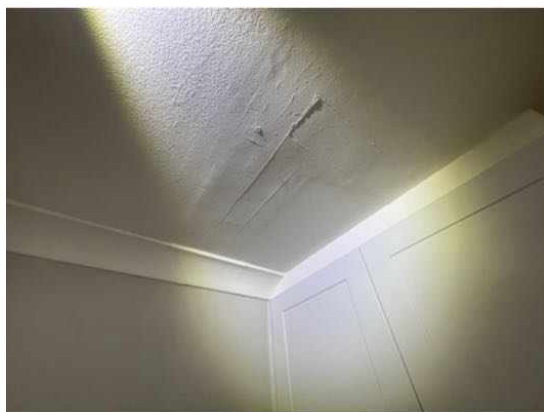
Finding 3.26

Building:	Main Building
Location:	Dining Room
Finding:	Ceiling - Incomplete or substandard works
Information:	The works to this area appear to be incomplete or have been completed to a substandard level.

It is highly recommended that a licensed plasterboard contractor should be appointed to repair the ceiling. To ensure the safety of the area and the longevity of all associated building elements.

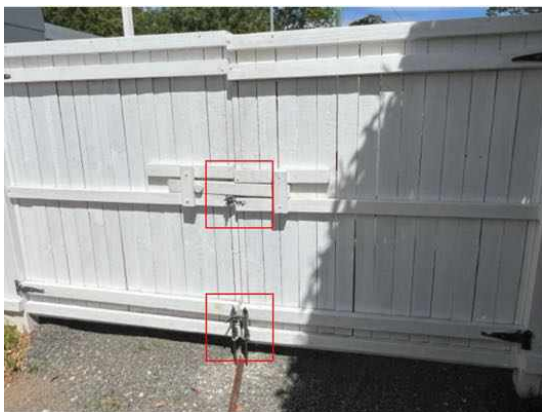
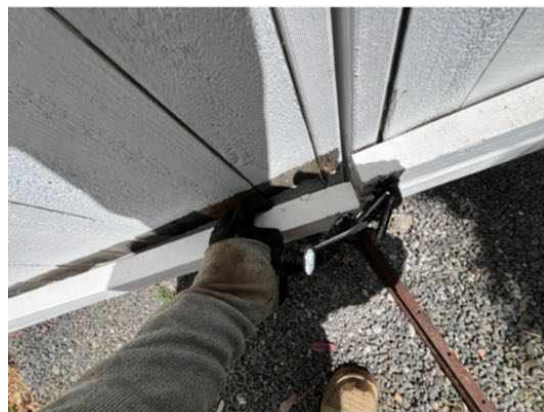
Finding 3.43

Building: Yard
 Location: Yard - Side (left), Front gate
 Finding: Gate Lock - Not working
 Information: The lock in this area was not operational at the time of inspection. Where locks have deteriorated to a point where they are no longer usable, the gates have sagged due to the weight of the timber panelling, or lock installed incorrectly and not functioning, the security of the property is immediately compromised.

Adjustment of gate or of the lock is highly recommended. Consultation with a carpenter or general handyman is required to gain further advice on any added security that may be available for the area and remedial works.

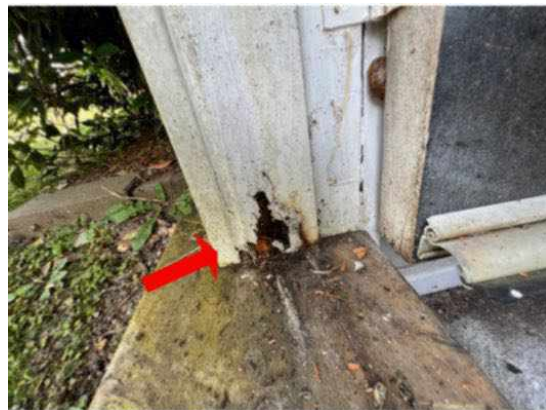
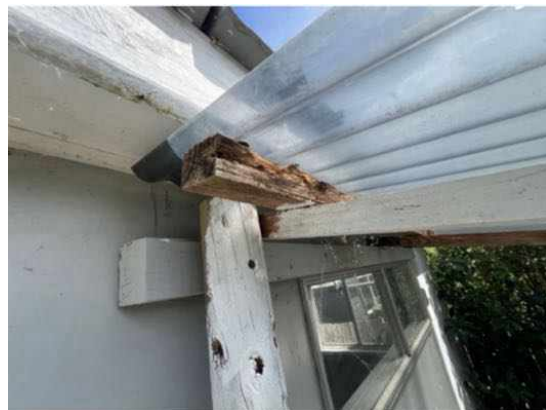
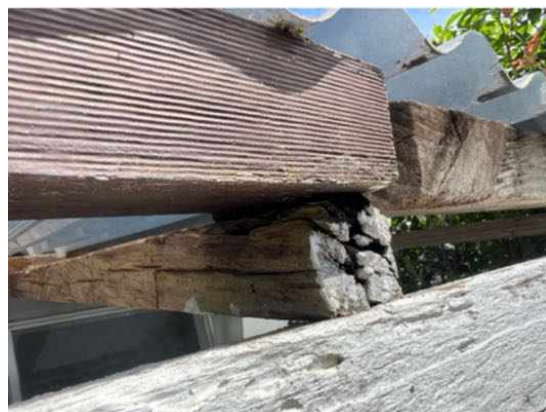
Finding 3.45

Building: Garage
 Location: Garage
 Finding: Wood rot
 Information:

A qualified plumber may be appointed to assess the cause of excessive moisture and to provide advice on any remedial works as required. A qualified carpenter or registered builder may also be required to replace affected building materials.

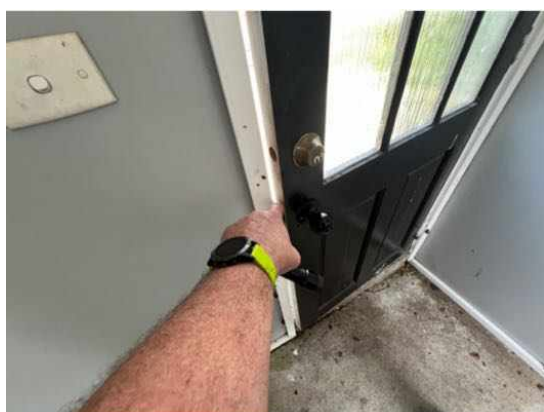
Finding 3.46

Building:	Garage
Location:	Garage
Finding:	Door - Binding/jamming
Information:	Binding and/or jamming of this door is evident during standard operation. This defect inhibits the functionality of the affected door as well as creating potential for secondary defects to associated building elements, such as damage to the floor covering.

For minor causes, a qualified carpenter or general handyperson should be appointed to perform minor rectification works at client discretion.

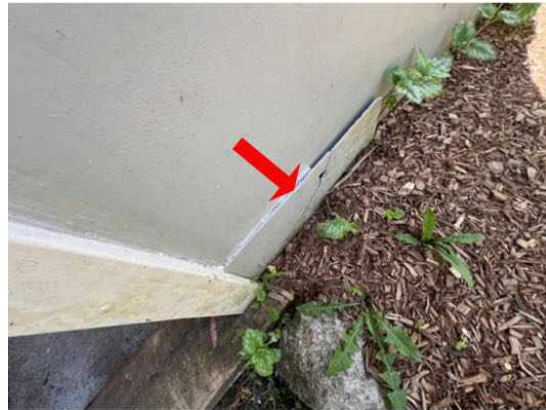
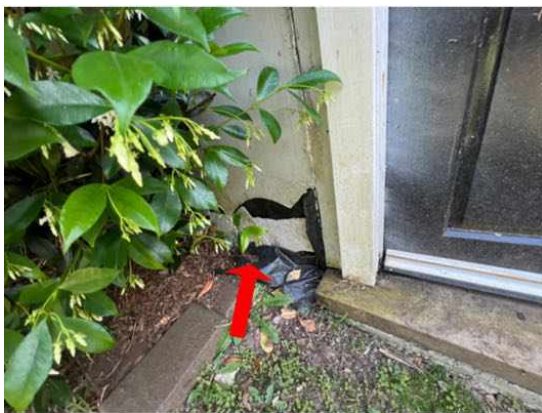
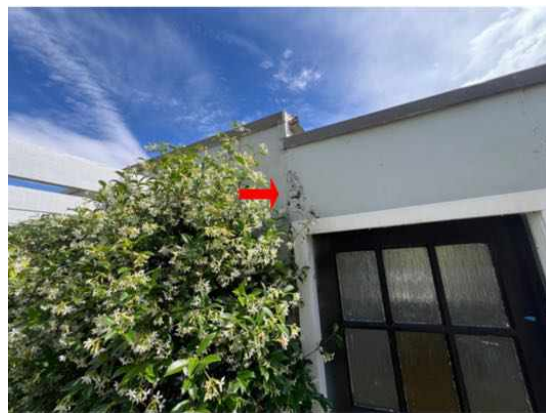
Finding 3.47

Building:	Garage
Location:	Garage
Finding:	Garage external sheeting - Damaged
Information:	Breakage occurs generally when the building materials have either aged and decayed, or as a result of damage (accidental or deliberate).

A licensed carpenter should be appointed to repair or replace the affected building element prior to any subsequent damage being caused.
