Building and Timber Pest Inspection Report

Inspection Date: Tue, 10 Mar 2026

Property Address: 4 Stephen St, Urbenville NSW 2475,
Australia

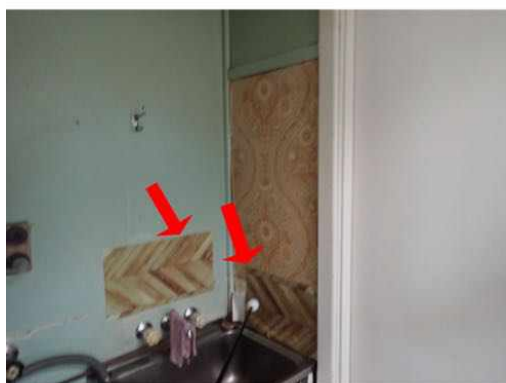
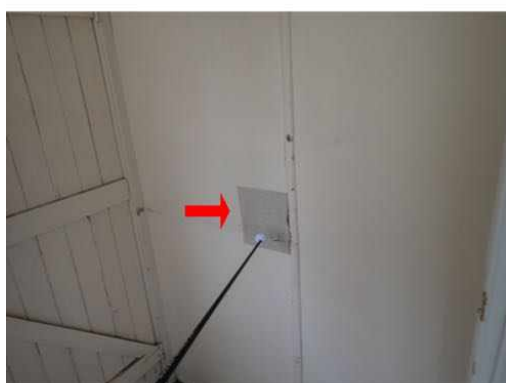
Finding 1.01

Building:	Main Building
Location:	Laundry and bedroom
Finding:	Contact Covering Suspected Holes in Internal Wall Cladding
Information:	Contact material was observed covering suspected holes in the internal wall cladding in the bedroom and laundry at the time of inspection. Covering damaged areas in this manner may conceal defects or damage to the wall lining and prevents a proper assessment of the underlying condition. It should be noted that the wall cladding may contain asbestos due to the age and type of materials used in buildings of this era. Disturbance of asbestos-containing materials can present health risks if fibres become airborne. Asbestos detection and identification is outside the scope of this inspection. It is recommended that the affected areas be further investigated and that any works involving the wall cladding be carried out by suitably qualified professionals. Repairs should be carried out as deemed necessary.

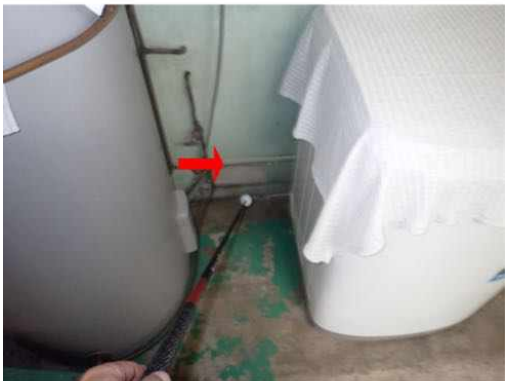
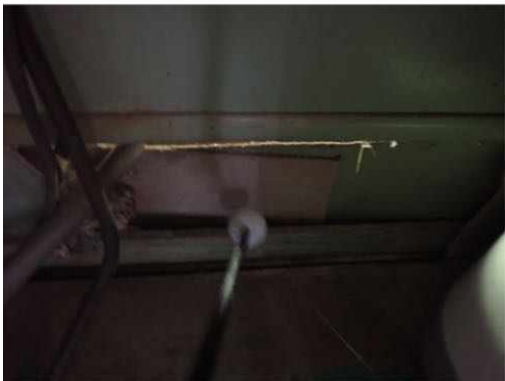
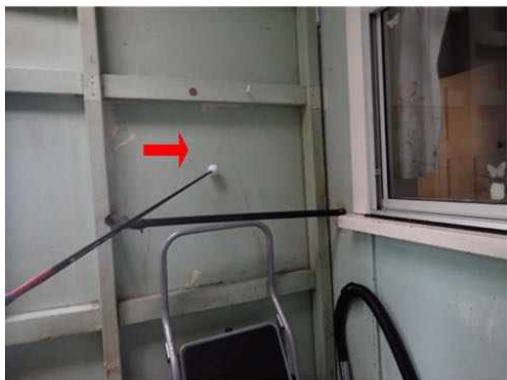
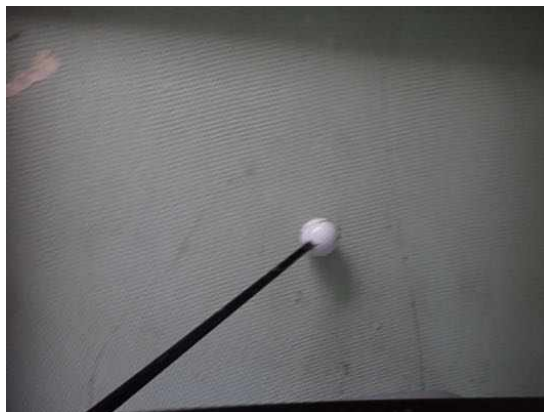
Finding 1.02

Finding: Cracks and Damage to Laundry Wall Cladding – Possible Asbestos Containing Material

Information: Cracks and damage were identified to the laundry wall cladding at the time of inspection. Deterioration of wall cladding may allow further damage if not addressed. The wall cladding may contain asbestos due to the age and type of materials commonly used in buildings of this era. Disturbance of asbestos-containing materials can present health risks if fibres become airborne. Asbestos detection and identification is outside the scope of this inspection. It is recommended that the affected cladding be treated with caution and that any repairs or alterations be carried out by suitably qualified professionals. Repairs should be carried out as soon as possible.

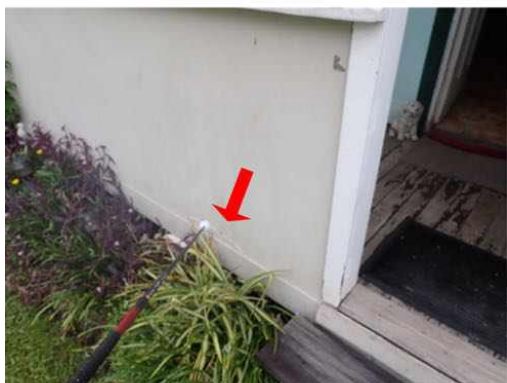
Finding 1.03

Building:	Main Building
Location:	External cladding
Finding:	Damaged External Wall Cladding – Possible Asbestos Containing Material
Information:	Multiple areas of damaged external wall cladding were identified at the time of inspection. Damage to wall cladding may allow moisture ingress and further deterioration of the building fabric if not addressed. Due to the age and type of materials commonly used in buildings of this era, the cladding may contain asbestos. Disturbance of asbestos-containing materials can present health risks if fibres become airborne. Asbestos detection and identification is outside the scope of this inspection. It is recommended that the affected cladding be treated with caution and that any repairs, removal, or alterations be carried out by suitably qualified professionals. Repairs should be carried out as deemed necessary.

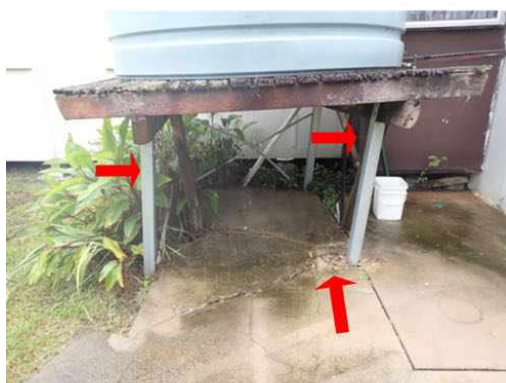
Information: The frame supporting the water tank was observed to be unstable at the time of inspection. An unstable support structure may lead to movement or failure of the frame and could affect the safe support of the water tank if not addressed. This condition may be associated with deterioration of the supporting materials or inadequate construction. It is recommended that a qualified carpenter or suitably experienced tradesperson assess the frame and carry out repairs, strengthening, or replacement as required to ensure the water tank is adequately supported. Repairs

should be carried out as soon as possible.

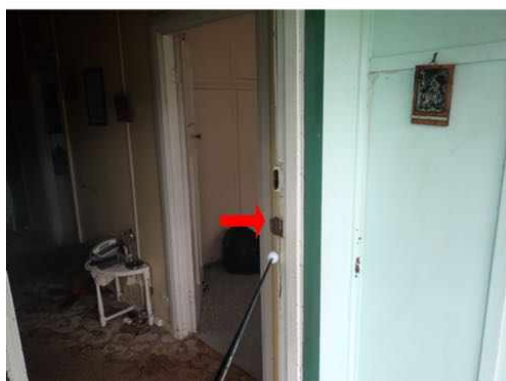
Finding 2.01

Building:	Main Building
Location:	Entry door
Finding:	Front Door Lock Not Secure – Split Door Jamb at Latch
Information:	The front door lock was observed to engage but was not very secure at the time of inspection. A split was identified in the door jamb at the lock latch location which may affect the ability of the door to latch securely. Damage to the door jamb in this area can reduce the effectiveness of the locking mechanism and may worsen over time if not repaired. It is recommended that a qualified carpenter or suitably experienced handyman repair or replace the damaged section of the door jamb and ensure the lock and strike plate are properly secured. Repairs should be carried out as deemed necessary.

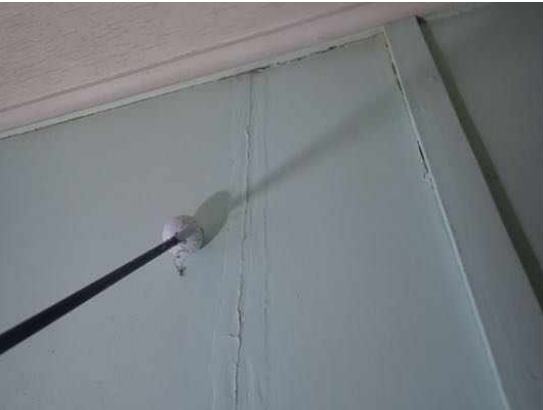
Finding 2.02

Finding: Internal Paintwork in Poor Condition

Information: The internal paintwork was found to be in poor condition at the time of inspection. Areas affected included walls, ceilings, doors, windows, and timber trims such as skirting boards, architraves, and cover strips. Deterioration of painted surfaces can occur over time due to general wear, ageing of coatings, and lack of maintenance. It is recommended that a qualified painter prepare the affected surfaces and carry out repainting as required to restore the protective and cosmetic finish. Repairs and maintenance should be carried out as deemed necessary.

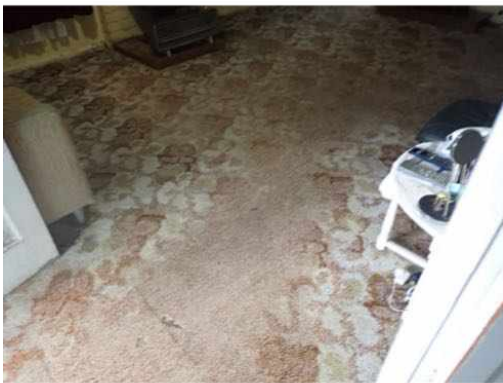
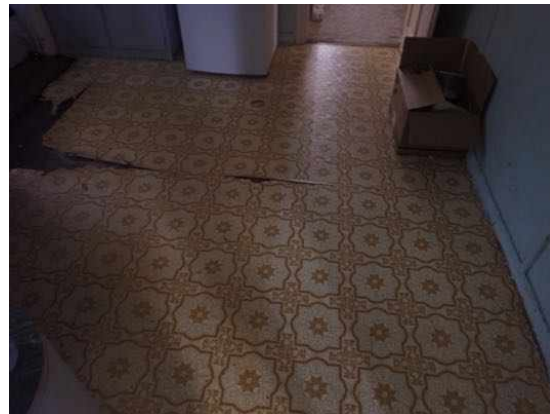
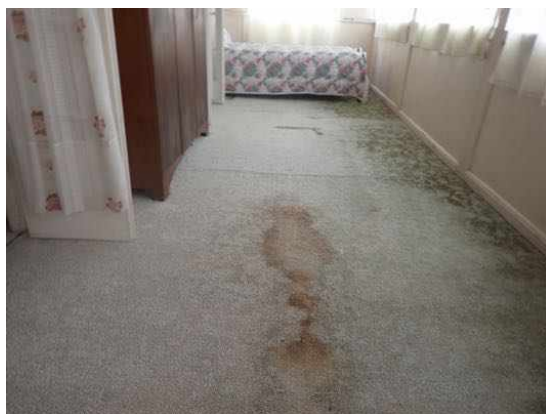
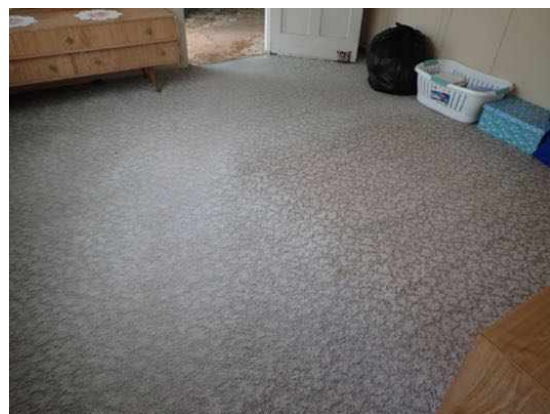
Finding 2.03

Finding: Uneven Timber Flooring and Deteriorated Timber Stumps

Information: The timber flooring throughout the building was observed to be wavy and out of level at the time of inspection. The timber stumps supporting the building were also found to be in poor condition, with defects including wood rot, movement, leaning out of plumb, and signs of sinking. It should be noted that the condition of the stumps below ground level could not be determined during the visual inspection. The external stumps on two sides of the building appeared to have been replaced at some stage. Deterioration of subfloor supports can lead to uneven floors and may indicate ongoing structural movement if not addressed. It is recommended that a qualified builder assess the condition of the timber stumps and subfloor supports and carry out repairs, replacement, or re-levelling of the building as required to prevent further deterioration. Further investigation and rectification works should be carried out as deemed necessary.

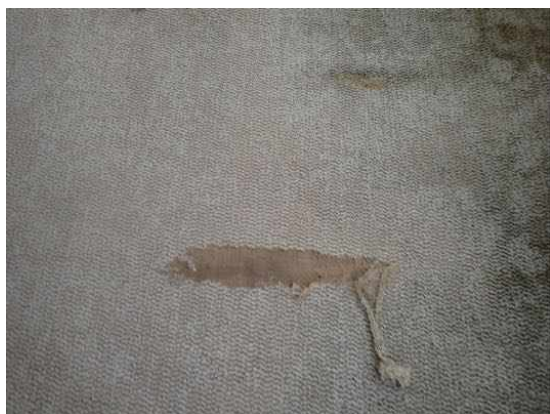
Finding 2.04

Building: Main Building
Location: Floor
Finding: Carpet and Vinyl Flooring in Poor Condition Throughout Building
Information: The carpet and vinyl flooring throughout the building were found to be in poor condition at the time of inspection. Visible wear, deterioration, and general ageing of the floor coverings were noted. Floor coverings of this nature can deteriorate over time due to normal use and ageing of the materials. It is recommended that the affected carpet and vinyl flooring be replaced as required to restore the condition and appearance of the floor surfaces. Replacement should be carried out as deemed necessary.

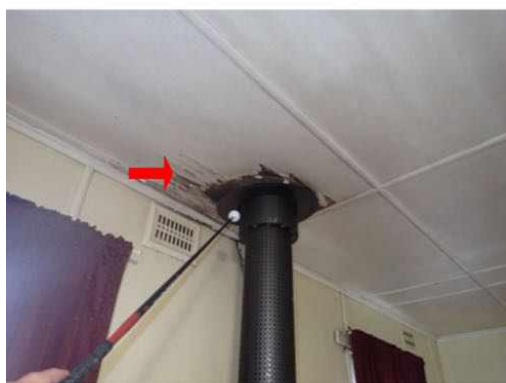
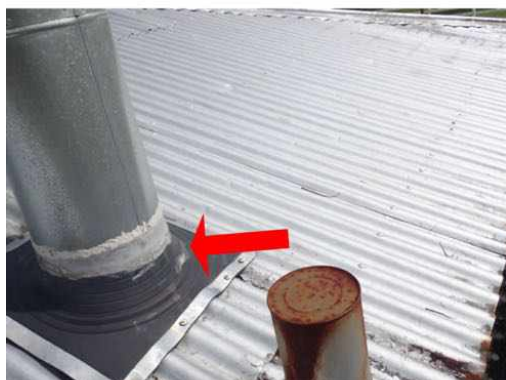
Finding 2.05

Building:	Main Building
Location:	Ceiling living room and roof exterior
Finding:	Active Leak to Fireplace Flue and Ceiling Damage
Information:	An active leak was identified at the fireplace flue, with damage noted to the ceiling around the flue penetration at the time of inspection. Water ingress in this area may lead to further deterioration of the ceiling materials and surrounding building elements if not addressed. This condition may be associated with defects in the roof flashing, sealing around the flue penetration, or deterioration of associated roof components. It is recommended that a qualified roofer or builder assess the flue penetration and carry out repairs as required to stop the leak and repair the damaged ceiling area. Repairs should be carried out as deemed necessary.

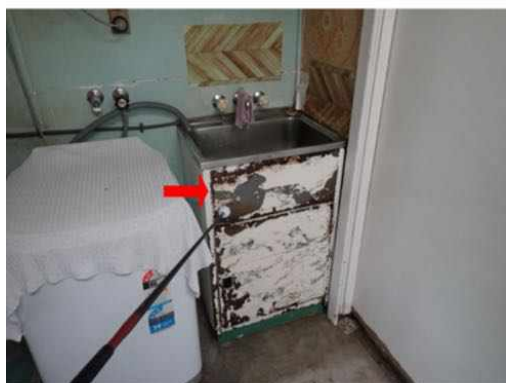
Finding 2.06

Finding: Laundry Tub Cabinet in Poor Condition

Information: The laundry tub cabinet was found to be in poor condition at the time of inspection. Deterioration of cabinets in laundry areas is commonly associated with ongoing moisture exposure, ageing of materials, and general wear over time. Continued deterioration may affect the durability and functionality of the cabinet if not addressed. It is recommended that a suitably experienced handyman repair or replace the cabinet as required to maintain the condition and usability of the laundry area. Repairs or replacement should be carried out as deemed necessary.

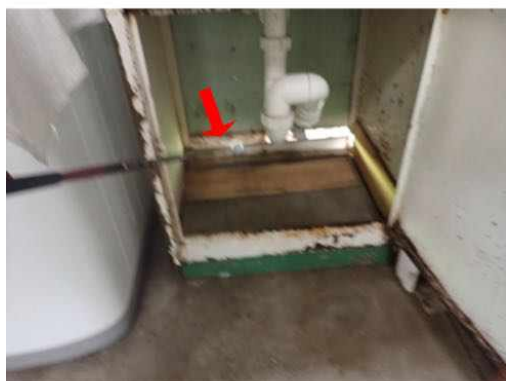
Finding 2.07

Information: A gap was identified in the wall cladding within the laundry tub cabinet at the time of inspection. Openings in wall linings may allow moisture, pests, or debris to enter the wall cavity and may lead to further deterioration of surrounding materials if not addressed. It is recommended that a suitably experienced handyman or qualified tradesperson assess the affected area and carry out appropriate repairs as required.

Repairs should be carried out as deemed necessary.

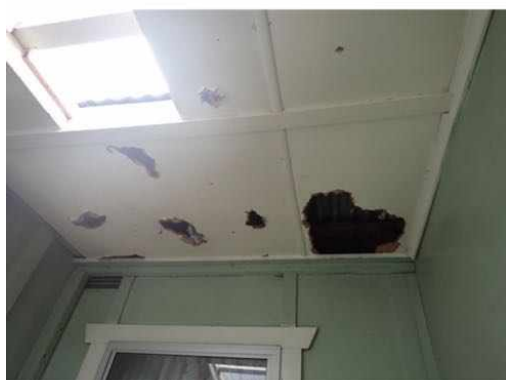
Finding 2.08

Building:	Main Building
Location:	Laundry
Finding:	Impact Damage to Laundry Ceiling
Information:	Impact-related holes were identified in the laundry ceiling at the time of inspection. Damage of this nature may affect the appearance and integrity of the ceiling lining if not repaired. It is recommended that a qualified carpenter or suitably experienced handyman repair the damaged ceiling lining and refinish the surface as required to restore the ceiling finish. Repairs should be carried out as deemed necessary.

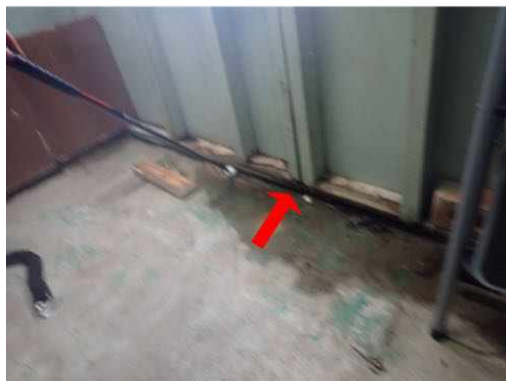
Finding 2.09

Building:	Main Building
Location:	Laundry
Finding:	Wood Rot to Bottom of Laundry Walls
Information:	Wood rot was identified to the bottom sections of the laundry walls at the time of inspection. Deterioration of timber elements in wet areas is commonly associated with prolonged moisture exposure and may worsen if not addressed. Wood rot is also considered a condition conducive to termite attack. Continued decay may affect the integrity of the wall components. It is recommended that a qualified carpenter or

suitably experienced handyman assess the affected areas, identify and rectify the source of the moisture causing the wood rot, and carry out repairs or replacement of the deteriorated timber as required to prevent further deterioration. Repairs should be carried out as deemed necessary.

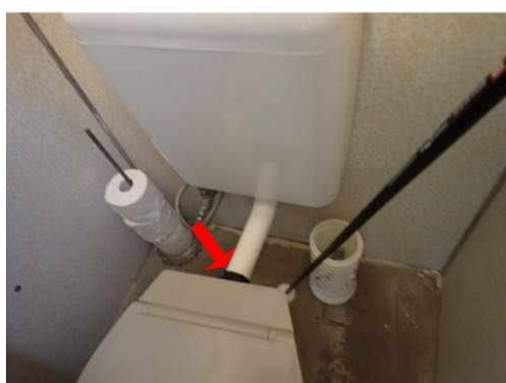
Finding 2.10

Building:	Main Building
Location:	Toilet (WC)
Finding:	Toilet Leaking When Flushed
Information:	The toilet was observed to leak when flushed at the time of inspection. Plumbing leaks can lead to water wastage and moisture-related damage to surrounding building materials if not addressed. The leak may be due to worn seals, faulty fittings, or deterioration of internal cistern or plumbing components. It is recommended that a qualified plumber inspect the toilet and carry out repairs or replacement of defective components as required to ensure the fixture is functioning correctly and to prevent further damage. Repairs should be carried out as deemed necessary.

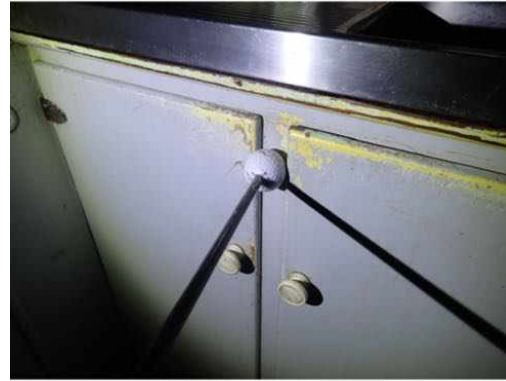
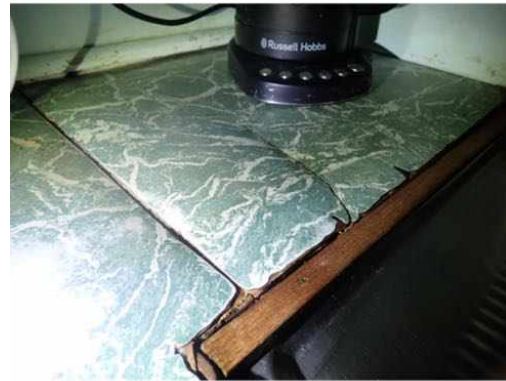
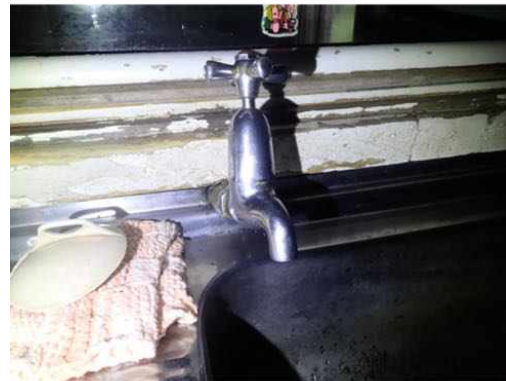
Finding 2.11

Building:	Main Building
Location:	Kitchen
Finding:	Kitchen in Poor Condition

Information: The kitchen was found to be in poor condition at the time of inspection. Deterioration of kitchen components can occur over time due to general wear, ageing of materials, and ongoing use. Continued deterioration may affect the functionality and durability of the kitchen if not addressed. It is recommended that a qualified carpenter, kitchen installer, or suitably experienced handyman assess the kitchen and carry out repairs, maintenance, or replacement of deteriorated components as required. Repairs or replacement should be carried out as deemed necessary.

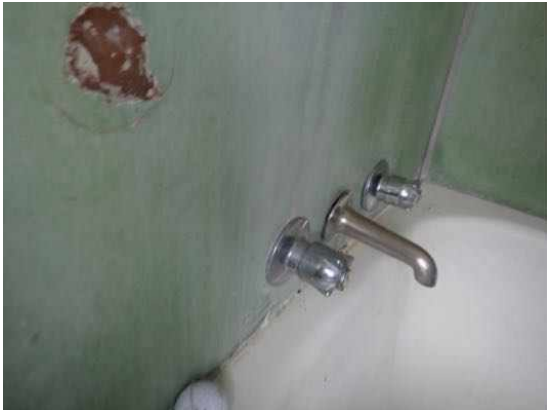
Finding 2.12

Building: Main Building
Location: Bathroom
Finding: Bathroom in Poor Condition

Information: The bathroom was found to be in poor condition at the time of inspection. Defects observed included deteriorated or missing silicone to junctions, the shower rail corner being held together with duct tape, swelling to the vanity cupboard, water damage to the ceiling, and general deterioration of bathroom components. Deterioration of this nature is commonly associated with prolonged moisture exposure and ageing of materials in wet areas. It is recommended that a qualified plumber and suitably experienced tradesperson assess the bathroom and carry out repairs or replacement of the affected components as required to prevent further deterioration. Repairs should be carried out as deemed necessary.

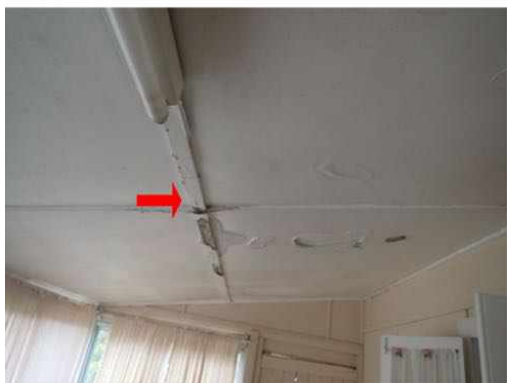
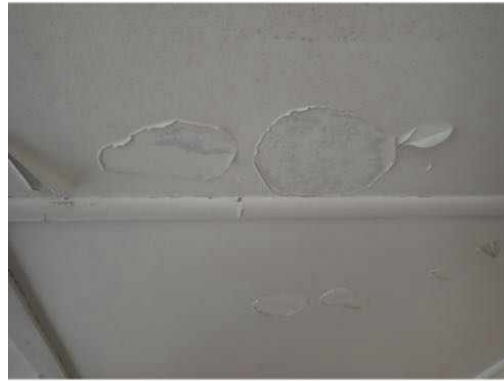
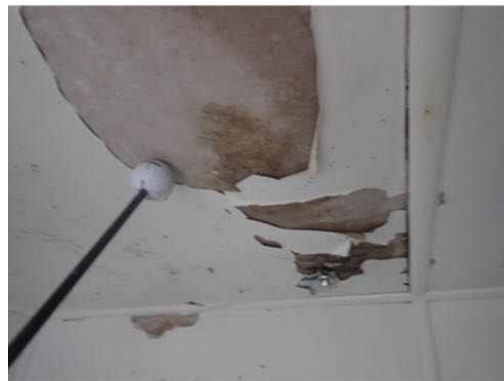
Finding 2.13

Finding: Water Damage to Ceilings in Bathroom and Bedroom

Information: Water damage was identified to the ceilings in the bathroom and bedroom at the time of inspection. Moisture staining and deterioration of ceiling linings can occur due to roof leaks, plumbing leaks, or condensation issues. Continued moisture exposure may lead to further deterioration of the ceiling materials if not addressed. The source of the moisture could not be confirmed during the visual inspection. It is recommended that a qualified builder, roofer or plumber investigate the cause of the moisture and carry out repairs as required, and that the damaged ceiling areas be repaired once the source of the moisture has been rectified. Repairs should be carried out as deemed necessary.

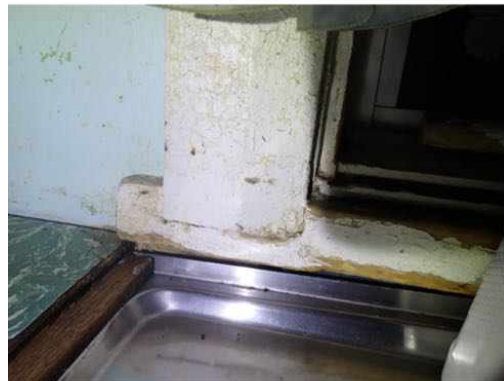
Finding: Doors and Windows in Poor Condition

Information: The majority of the doors and windows throughout the building were found to be in poor condition at the time of inspection. Defects observed included doors catching on door jambs, deteriorated paintwork, damaged doors, worn hardware, and general deterioration of components. Deterioration of doors and windows can occur over time due to ageing of materials, general wear, and lack of maintenance. It is recommended that a qualified carpenter or suitably experienced handyman assess the affected doors and windows and carry out repairs, maintenance, or replacement of deteriorated components as required. Repairs should be carried out as deemed necessary.

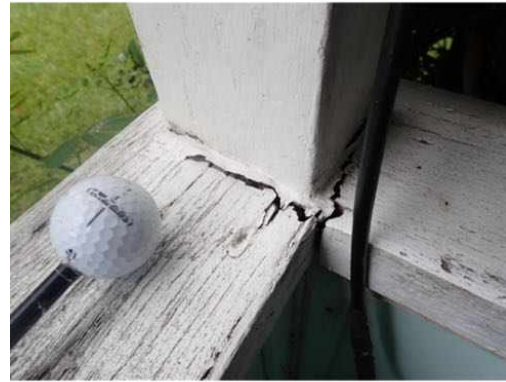
Building: Main Building
Location: Front porch
Finding: Deteriorated Timber Front Porch Handrail
Information: The timber handrail to the front porch was found to be deteriorated at the time of inspection. Deterioration of external timber elements commonly occurs due to prolonged exposure to weather, moisture, and general ageing of the timber. Continued deterioration may affect the durability and safety of the handrail if not addressed. It is recommended that a qualified carpenter assess the handrail and carry out repairs or replacement of the deteriorated timber components as required. Repairs or replacement should be carried out as deemed necessary.

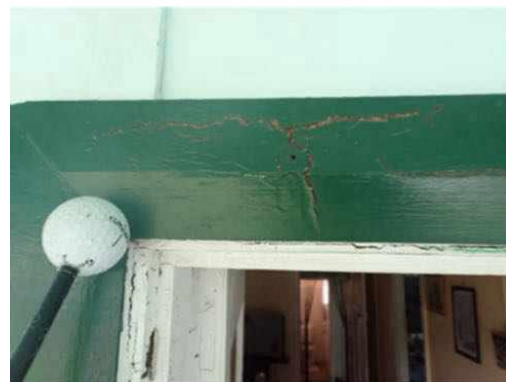
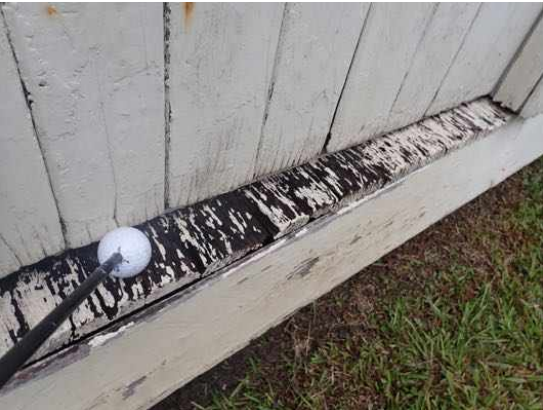
Finding 2.17

Finding: External Doors and Windows in Poor Condition

Information: The majority of the external doors and windows were found to be in poor condition at the time of inspection. Defects observed included wood rot and deteriorated paintwork to several components. Deterioration of external timber doors and windows commonly occurs due to prolonged exposure to weather, moisture, and general ageing of the materials. Continued deterioration may affect the durability and functionality of these elements if not addressed. It is recommended that a qualified carpenter assess the affected doors and windows and carry out repairs or replacement of deteriorated components as required. Repairs should be carried out as soon as possible.

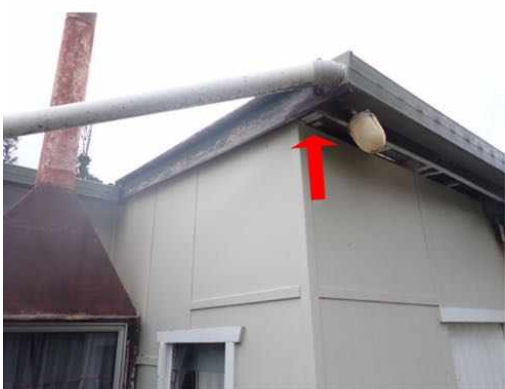
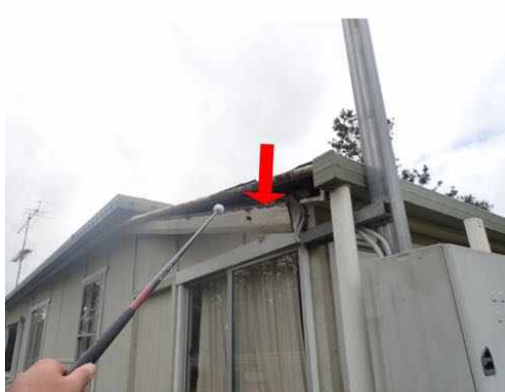
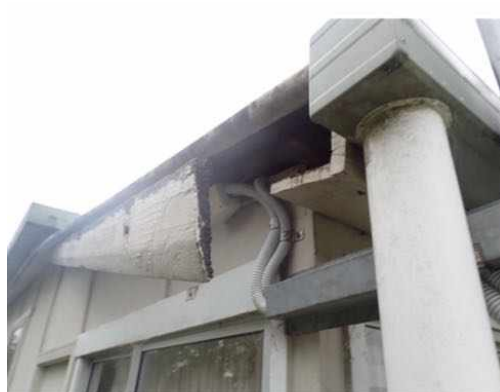
Finding 2.18

Building: Main Building
Location: Eaves and fascia boards
Finding: Eaves and Fascia Boards in Poor Condition
Information: The eaves and fascia boards were found to be in poor condition at the time of inspection. Defects observed included missing sections, deteriorated paintwork, gaps, wood rot, and general wear to several areas. Deterioration of external timber elements commonly occurs due to prolonged exposure to weather, moisture, and ageing of the materials. Continued deterioration may allow moisture or pests to enter roof spaces and may lead to further damage if not addressed. It is recommended that a qualified carpenter assess the affected areas and carry out repairs or replacement of deteriorated components as required. Repairs should be carried out as deemed necessary.

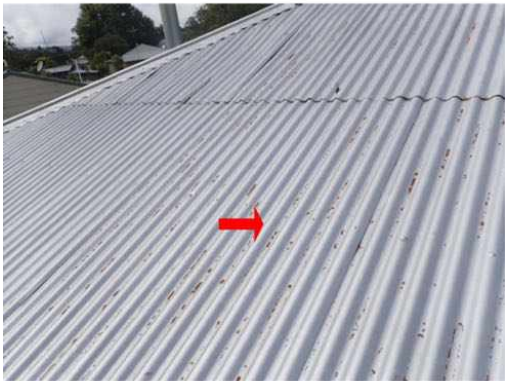
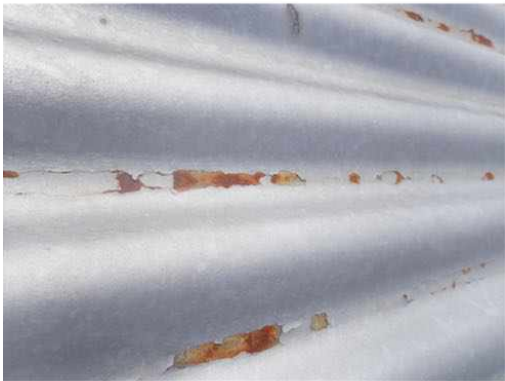
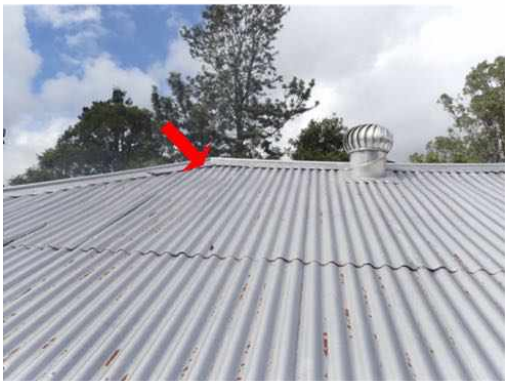
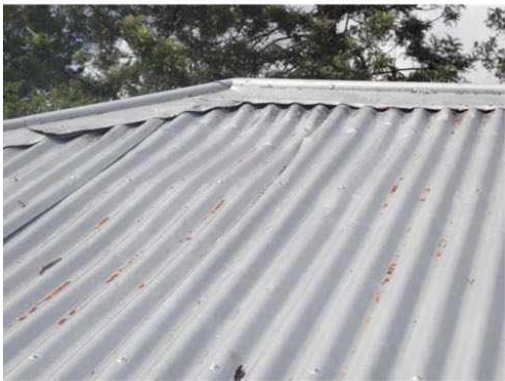
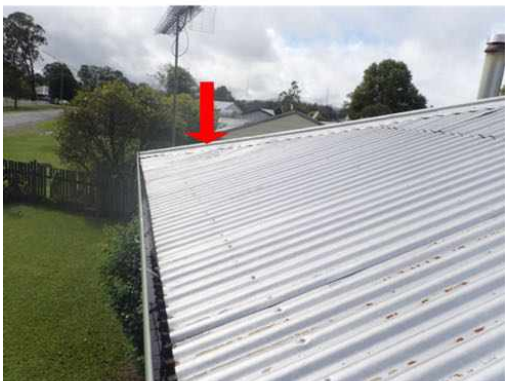
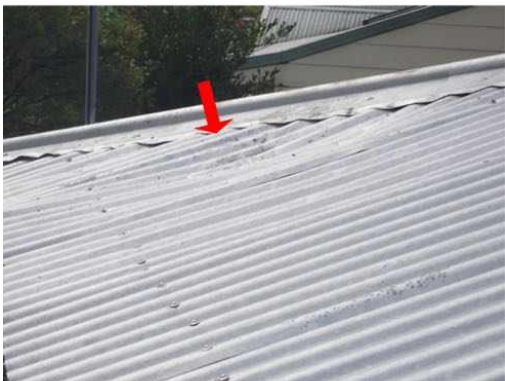
Finding 2.19

Finding: Iron Roof Cladding in Poor Condition

Information: The iron roof cladding was found to be in poor condition, with visible deterioration, corrosion, and general wear consistent with age and prolonged exposure to the elements. In plain terms, the metal roof sheets are worn and rusting in areas and may not provide reliable long-term weather protection. Possible causes include ageing of the material, weather exposure, inadequate maintenance, and deterioration of protective coatings. If not addressed, this condition may allow water ingress and further deterioration of surrounding building components. Preventative measures

include routine roof inspections and maintenance. Repairs or replacement of the affected roof cladding should be carried out by a licensed roofing contractor as soon as possible to prevent further damage to associated building materials.

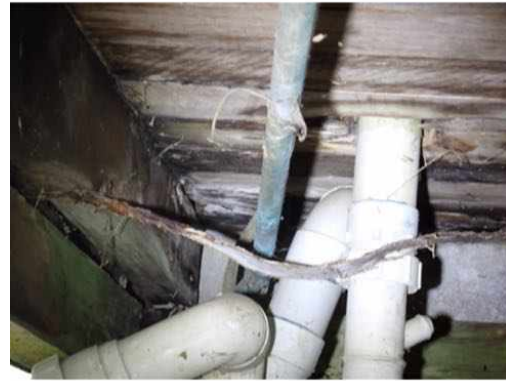
Finding 2.20

Building:	Main Building
Location:	Subfloor
Finding:	Wood Rot Identified to Subfloor Timbers Around Bathroom Area
Information:	Wood rot was identified to subfloor timbers in the area around the bathroom, indicating deterioration of the timber likely associated with prolonged moisture exposure. Possible causes include past or ongoing plumbing leaks, poor ventilation to the subfloor, or moisture penetration from the bathroom area above. Deteriorated and moisture affected timbers are also considered conducive to termite attack. If left unaddressed, the damage may worsen and affect the structural performance of the affected timbers. Preventative measures include ensuring plumbing is watertight, improving subfloor ventilation, and maintaining adequate moisture control. Further assessment and repairs should be carried out by a licensed builder or appropriately qualified contractor as soon as possible to prevent further deterioration of the affected structural timbers.

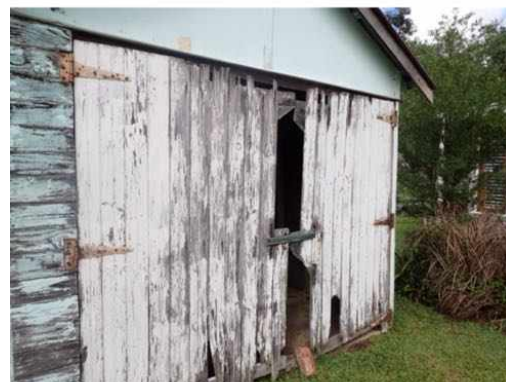
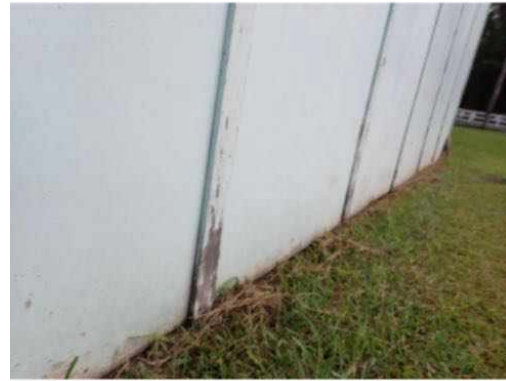
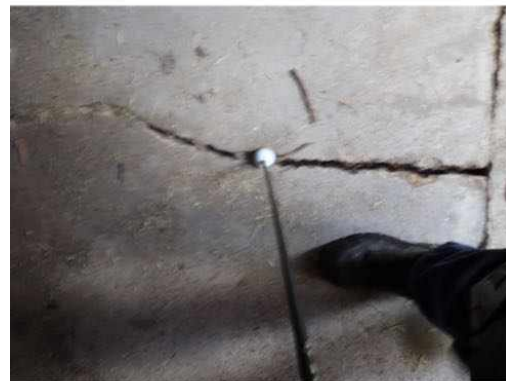
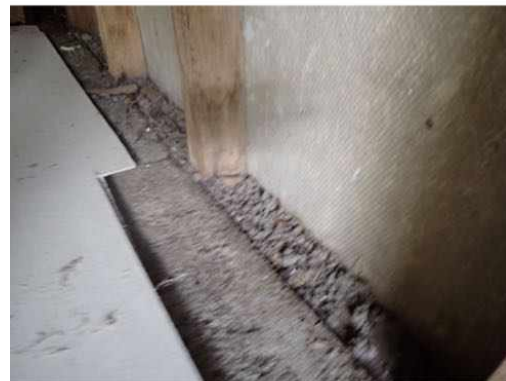
Finding 2.21

Finding: Old Garage in Poor Condition

Information: The old garage was found to be in poor condition overall. Defects identified include deteriorated doors requiring replacement, large structural cracks in the concrete floor, deteriorated external cladding, rust to the roof cladding, and timber framing in direct contact with the ground. Possible causes include age, weather exposure, lack of maintenance, and ground movement contributing to cracking of the concrete slab. Timber elements in contact with the ground are considered conditions conducive to termite attack and timber decay. If left unaddressed, the condition of the structure may continue to deteriorate and could lead to further structural instability and damage to associated building materials. Preventative measures include maintaining adequate ground clearances to timber elements and carrying out routine maintenance to protect exposed materials. Further assessment and rectification works should be carried out by a licensed builder as soon as possible to prevent further deterioration of the structure.

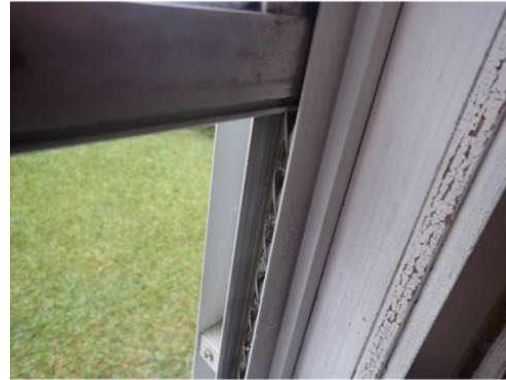
Building:	Main Building
Location:	Windows
Finding:	Aluminium Windows Will Not Stay Open
Information:	The aluminium windows throughout the building were found to be in fair condition at

the time of inspection; however, they would not remain open without being propped. This condition is commonly associated with worn or faulty window winders, hinges, or support mechanisms and is typical with windows of this age and type. It is recommended that a suitably experienced handyman or window specialist inspect the windows and carry out repairs or replacement of worn components as required to restore normal operation. Repairs should be carried out as deemed necessary.

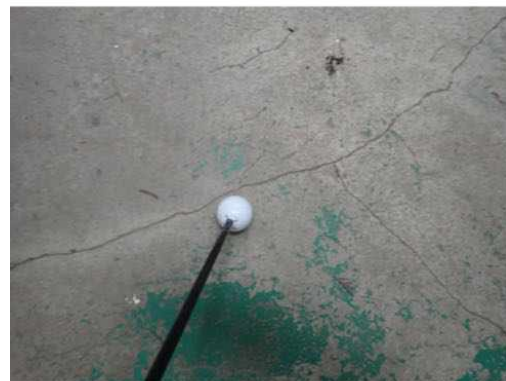
Finding 3.02

Finding: Minor Cracks in Laundry Concrete Floor

Information: Minor cracks were identified in the laundry concrete floor at the time of inspection. Cracking of this nature can occur due to normal shrinkage of the concrete, minor ground movement, or ageing of the slab and is a common defect with concrete of this age. It is recommended that the affected area continue to be monitored and that a suitably experienced tradesperson carry out repairs if the cracking worsens. Repairs should be carried out as deemed necessary.

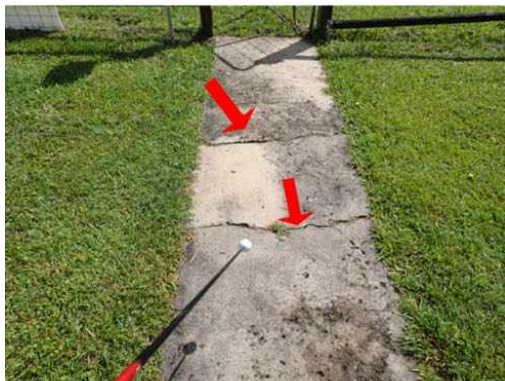
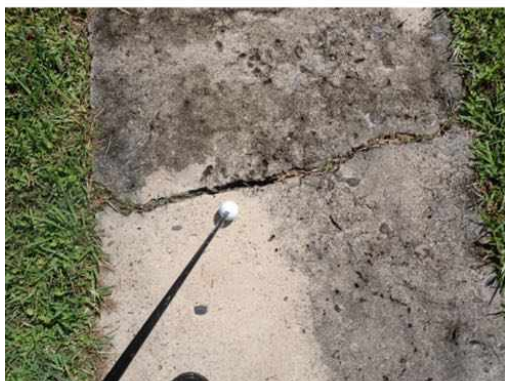
Finding 3.03

Finding: Large Cracks in Front Concrete Path

Information: Large cracks were identified in the front concrete path. Possible causes include ground movement, shrinkage of the concrete over time, tree root movement, or inadequate original construction. Cracking of this nature is a common defect with concrete paths of this age. If left unaddressed, the cracking may worsen and could create a potential trip hazard and allow further deterioration of the concrete. Preventative measures include maintaining stable ground conditions and monitoring surrounding vegetation that may influence ground movement. Assessment and rectification works should be carried out by a licensed concreter or builder as required.

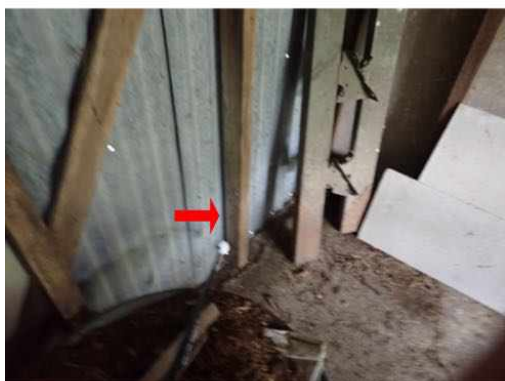
Finding: Minor Termite Damage to Timber Framing Within Old Garage

Information: Minor termite damage was identified to sections of the timber framing within the old

garage. Possible causes include past termite activity and the presence of conditions conducive to termite attack such as timber elements in contact with the ground and general deterioration of building materials. Although the damage appears minor at the time of inspection, concealed areas may contain additional damage that was not visible during the visual inspection. Preventative measures include removing conditions conducive to termite activity and implementing an appropriate termite management system. Further assessment and repairs should be carried out by a licensed builder and a qualified pest management professional as soon as possible to prevent further damage to associated building materials.
