Building and Timber Pest Inspection Report

Inspection Date: Thu, 26 Feb 2026

Property Address: 8A Universal Ave, Dunmore NSW 2529,
Australia

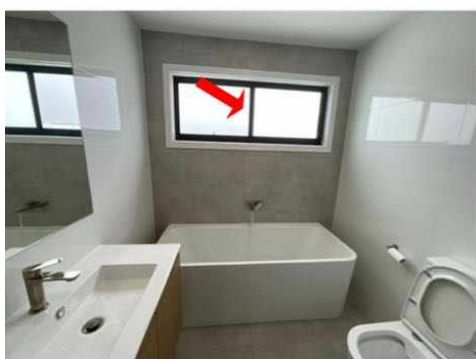
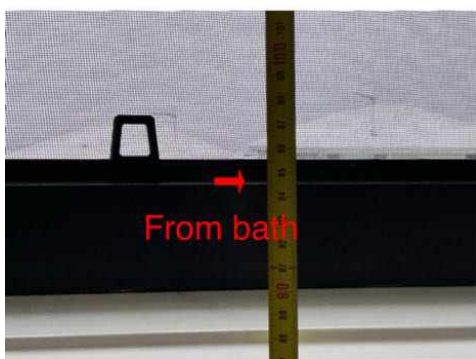
Finding 1.01

Building:	Building 1
Location:	Upstairs bathroom window
Finding:	Window opening restrictors missing.
Information:	The Building Code of Australia rules require all openable windows (where the internal floor is more than 2m above the ground outside) in residential rooms to be fitted with a suitable screen or restrictor. Windows located 1.7m above the floor level do not require protection.

Window restrictors are required where people who are vulnerable to the risk of falling have access to windows. This means all windows above ground level which do not have another fall prevention safety measure in place, such as a balcony or balustrade should have a restrictor. This bathroom allows children to climb on the bath increasing the risk in this area.

There is one safety hazard of the missing bathroom window restrictor.

These need to be added urgently for the safety of all persons.

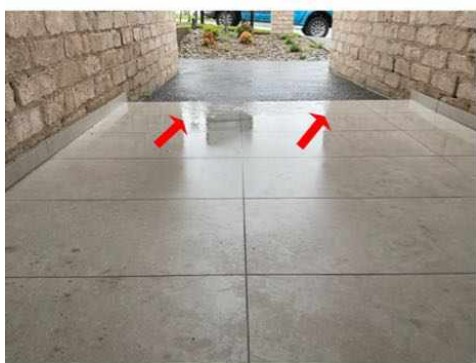
Building: Building 1
Location: Porch
Finding: Fall to balcony tiling
Information: There appears to be insufficient fall in the 3 end porch tiles. This may result in minor pooling of water in the area, creating a possible slip hazard.

This area should be observed after rain to check if water drains away. Adjustment by a tiling contractor may be required (or additional grip added) to prevent slips and falls.

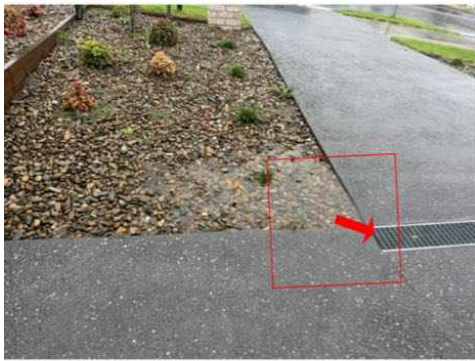
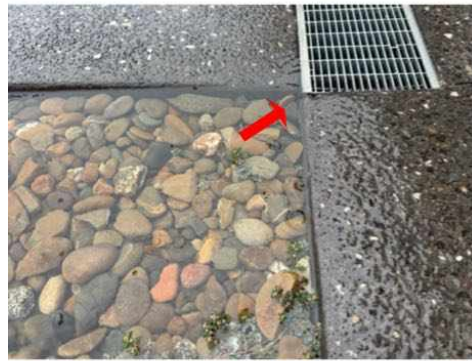
Finding 3.02

Building: Building 1
Location: Front landscaping
Finding: Site drainage - Inadequate
Information: The site drainage in this front area was found to be inadequate at the time of inspection. Water is pooling in this area. It is recommended to drill a hole in the black strip drain to allow water to flow into this drain from the rock bed to prevent possible concrete damage in the long term.

A qualified builder or skilled handyperson can drill this hole to allow water to drain away from this area.

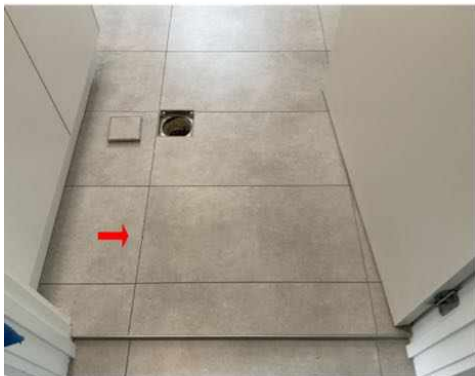
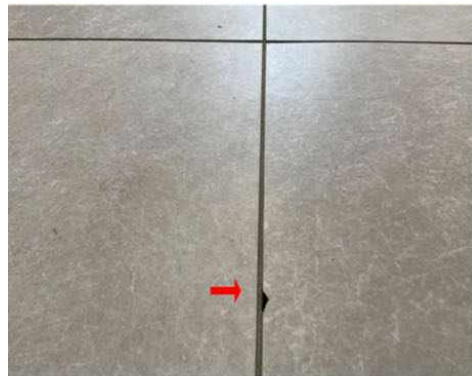
Finding 3.03

Information: One chipped tile was evident in the laundry at the time of inspection. It is suspected that this has occurred as a result of installation damage.

Cracked and chipped tiles detract from the overall appearance of the affected areas. In wet areas of kitchens and bathrooms, it can lead to water damage of adjoining walls and floors.

Replacement of damaged tiles is recommended. A tiling contractor may be appointed to perform these works.

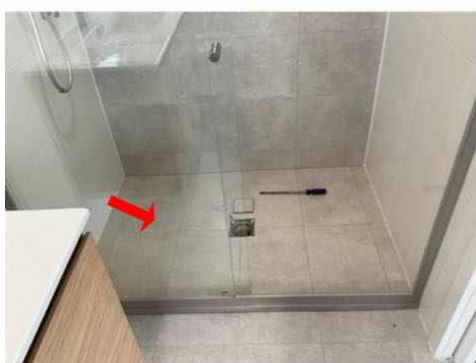
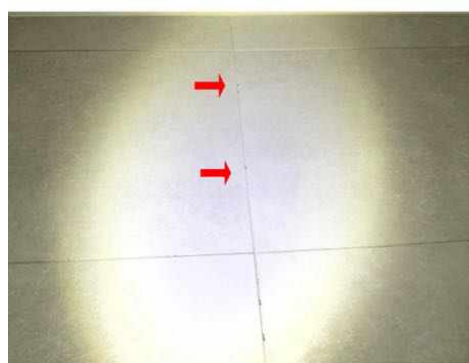
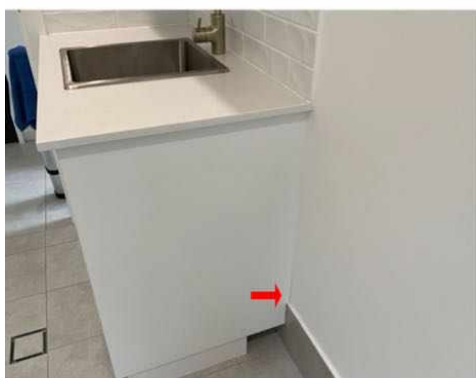
Finding 3.04

Finding: Sealant and grouting - Missing or damaged

Information: It was noted on inspection that a few areas of sealant or grout is degraded to these pictured areas.

Different materials and floor areas move at different rates, generally causing cracking

Flexible and mould resistant materials should be applied to affected areas to prevent any subsequent water damage that is likely to occur. Regular maintenance and replacement of damage or missing or damaged sealant and grout is highly recommended to the wet areas, as this is a regular wear and tear defect. Sealant and grouting in areas that come into regular contact with water should be maintained for the long term care of your property.

A sealant specialist or tiling contractor should be appointed to complete these works as soon as possible

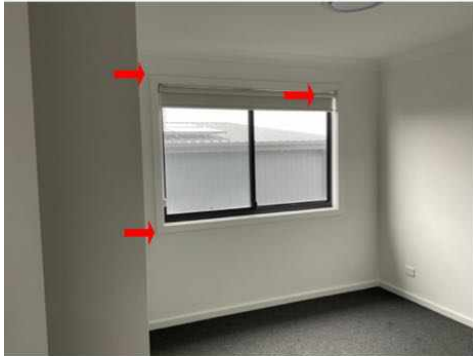
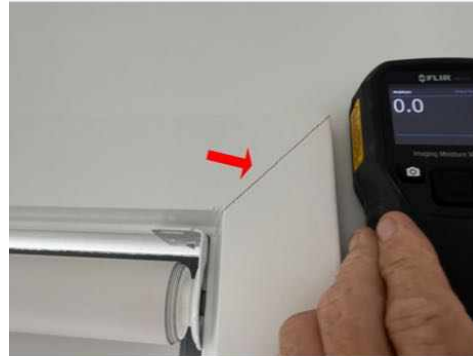
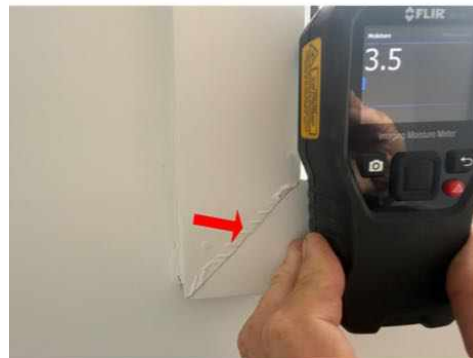
Finding 3.05

Building:	Building 1
Location:	Some architraves
Finding:	Cracking - Damage Category 1 - Fine (up to 1mm)
Information:	Although fine cracks and minor paint damage are quite noticeable, they are often only considered to be an appearance defect, and usually do not indicate any structural damage. Generally, the cause of a fine crack is indicative of a separation between building materials and finishes (e.g. paint, plaster, etc.) along joins.

Cracking of this nature can generally be repaired with minor sanding, filling and/or repainting. Such works should be performed by a qualified painter or a general handyman.

Monitoring of all cracking should be conducted frequently. Always contact a building inspector should cracks widen, lengthen, or become more numerous.

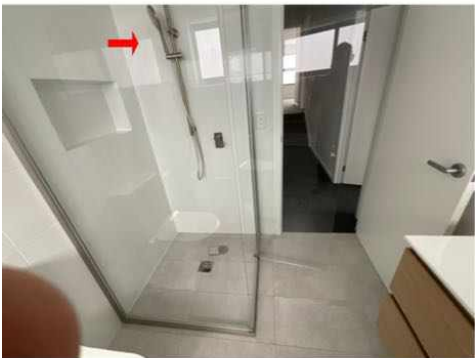
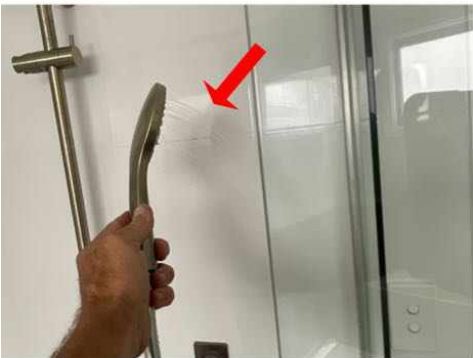
Finding 3.06

Building:	Building 1
Location:	Bathroom
Finding:	Low water pressure to hand held shower
Information:	The hand held shower showed low water pressure on testing all settings, resulting in poor water flow during use. This issue affects normal operation. A licensed plumber is required to investigate and carry out any necessary repairs to restore adequate water pressure to this hand outlet. The overhead shower showed adequate flow.

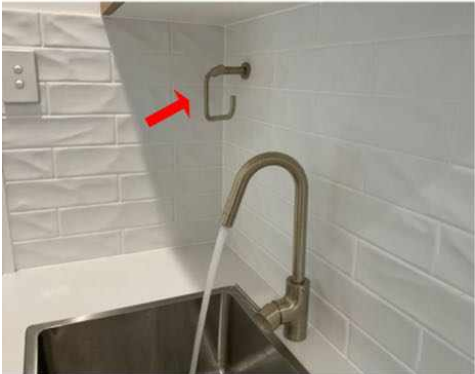
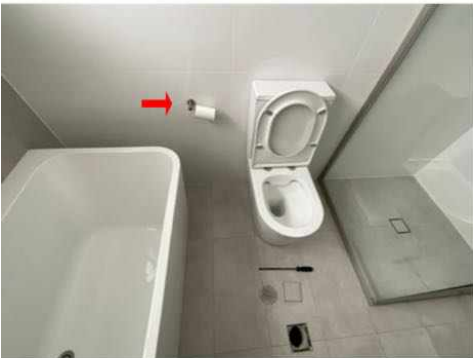
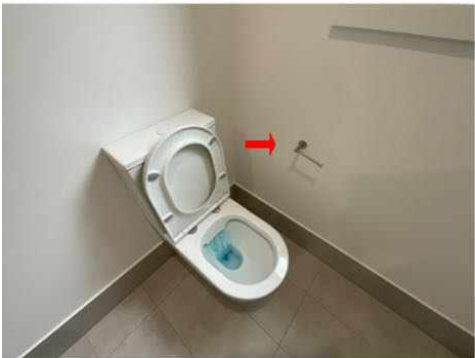
Finding 3.07

Building: Building 1
Location: Wet areas
Finding: Toilet roll and towel holders - Loose
Information: These three fittings were found to be loose at the time of inspection. While not a major operational defect, function can deteriorate if the problem is left unmanaged.

This needs to be brought to the attention of the builder.

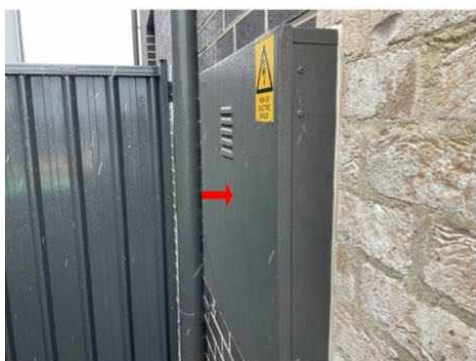
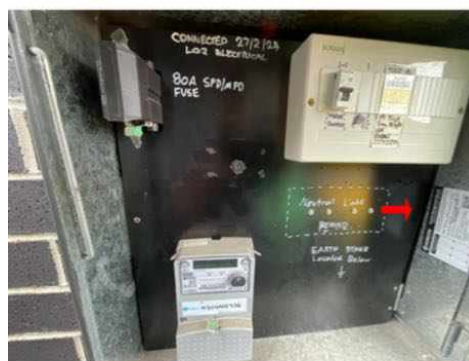
Building: Building 1
 Location: Meter Box
 Finding: Termite Management System - no evidence of a chemical installation
 Information: The application of a post-construction chemical termite barrier is highly recommended for all properties. Such barriers are highly effective in preventing termite attack on any timber building elements throughout the property.

A durable notice should be placed in the switchboard unit to indicate current termite barriers. At the time of inspection, the durable notice was evident and it appeared as though no chemical termite management system has been installed, with no evidence to suggest preventative works taking place since the property was built.

The client may consider gaining further advice from a pest controller as to the costs and procedures involved with a 'chemical' application. It is recommended that obtaining such advice be a short-term priority.

Due to the degree of risk of subterranean termite infestation, we strongly recommend that a full 'chemical' termite management system be installed to the property. Also inspections in accordance with Australian Standards

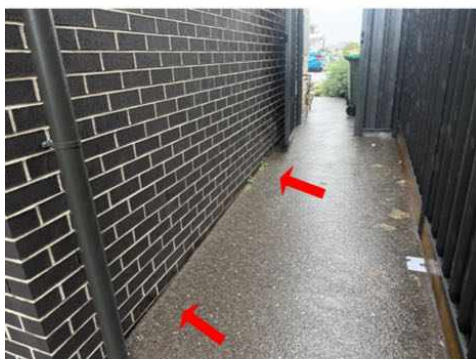
Finding 6.02

If the slab edge is not properly exposed there is a high risk of termite attack. Sometimes, in order to determine the type of slab, a suitably qualified person such as an architect or builder may be required to consult the construction plans.

Where the slab edge cannot be properly inspected, it is highly recommended that termite or timber pest inspections be carried out every 6-12 months to aid protection of the property against infestation.

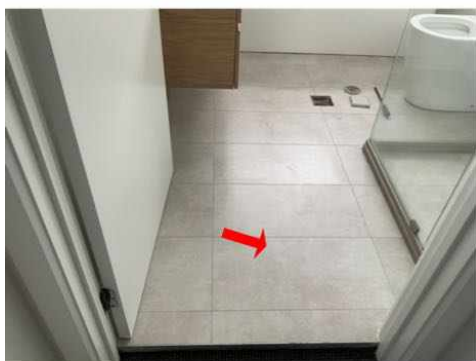
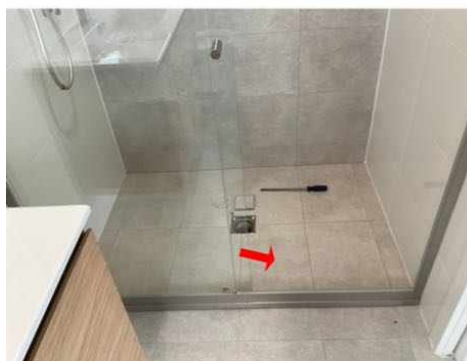
- Membrane used and Manufacturers Specifications. - The Installer and Installation Certification.

With older property's where this information is unavailable all wet areas should be monitored. If any leaks, water staining, peeling or bubbling of the paint become evident to any adjacent walls or ceilings below a licensed builder or waterproofing specialist is recommended to investigate further.
