Building and Timber Pest Inspection Report

Inspection Date: Tue, 7 Apr 2026

Property Address: 45 Charming Street, Hampton East, VIC
3188

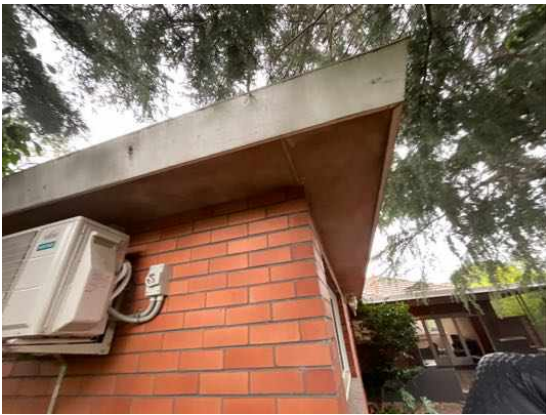
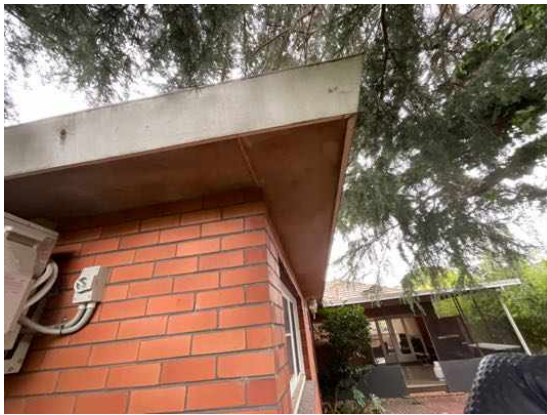
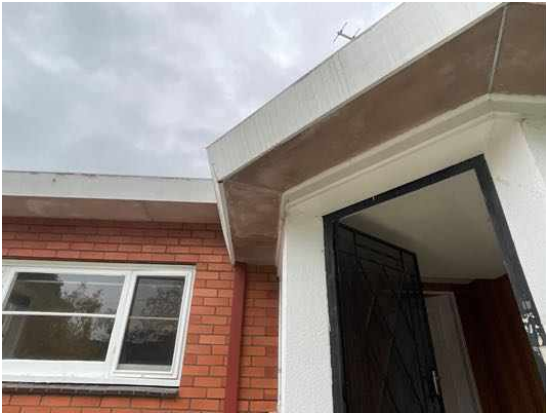
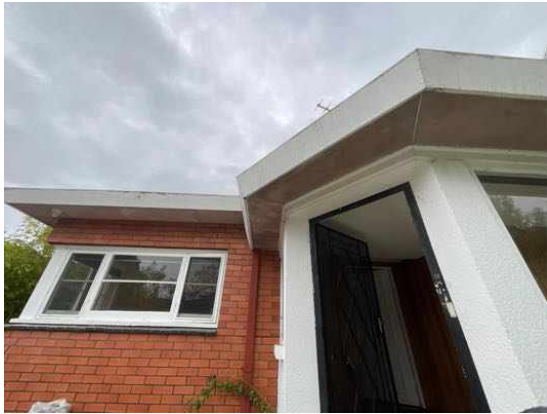
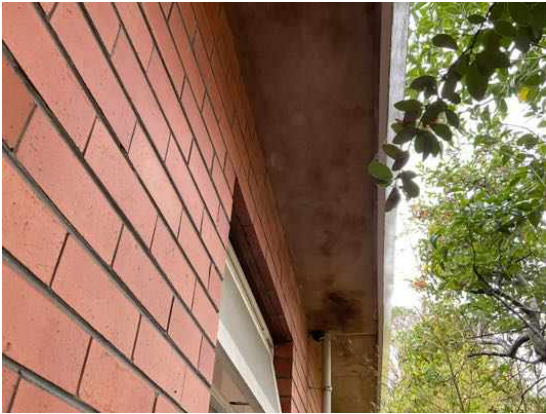
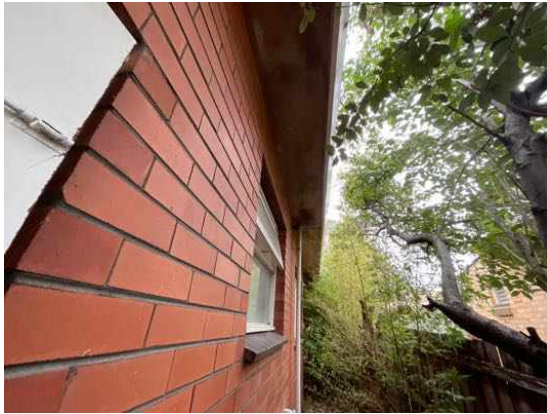
Building:	Main Building
Location:	All External Areas
Finding:	Roof gutter Drainage – Moisture / Moss Growth with Suspected Mould (Potential Major Issue – Must Address ASAP)
Information:	Elevated moisture readings were detected in sections of the roof area using a moisture meter. Moss growth and vegetation overhang were also observed adjacent to the roof and within the gutter system. Suspected mould-like staining was noted to sections of the eaves.

These conditions indicate inadequate drainage performance, including insufficient fall and/or limited downpipe capacity, resulting in water retention and prolonged moisture exposure. Such conditions are conducive to moss growth, mould development, and deterioration of roofing and adjacent building elements over time.

A licensed roof plumber and suitable contractor may need to assess the drainage system and surrounding vegetation as soon as possible. Rectification may include clearing vegetation and debris, improving drainage performance, and addressing moisture-affected areas to prevent further deterioration.

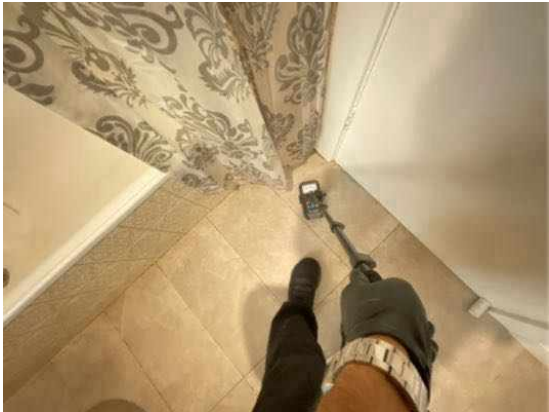
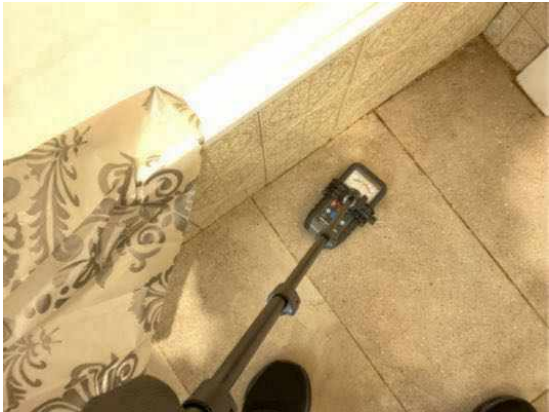
Finding 2.03

Building: Main Building
 Location: All Areas
 Finding: Bathroom – Cracked Tiles with Moisture Detection (Potential Major Issue – Must Address ASAP)

Information: Cracked tiles were observed in a section of the bathroom, and elevated moisture readings were detected using a moisture meter in the surrounding area.

Cracked tiles may allow water to penetrate behind the surface, and the presence of moisture indicates possible leakage or failure of the waterproofing system. Prolonged exposure to moisture may lead to deterioration of underlying materials and concealed

damage.

A licensed plumber and suitable contractor may need to assess the area as soon as possible to identify the source of moisture and carry out necessary repairs, which may include rectification of waterproofing and replacement of affected materials.

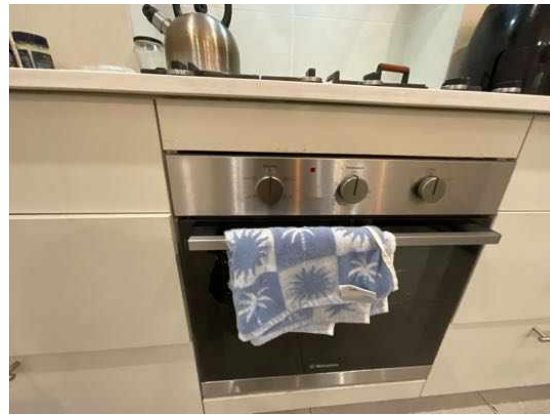
Information: Sections of the cabinetry were noted to be out of alignment, with doors or panels not sitting evenly or closing correctly. This condition may be due to hinge movement, installation tolerances, or normal building movement over time.

If left unrectified, the continued misalignment may lead to wear on hinges, rubbing on adjacent panels, or reduced functionality of the cabinetry.

Rectification should be carried out as soon as practicable by a qualified cabinetmaker or carpenter to adjust the fittings and restore proper alignment.

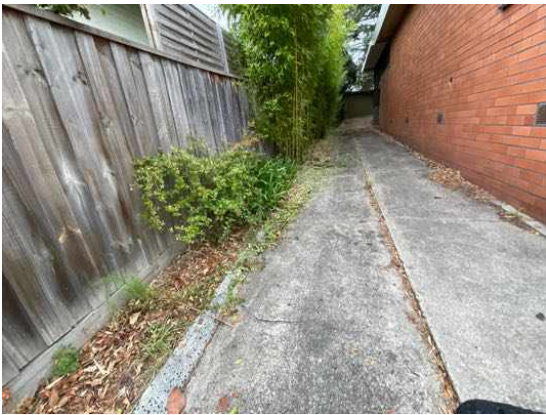
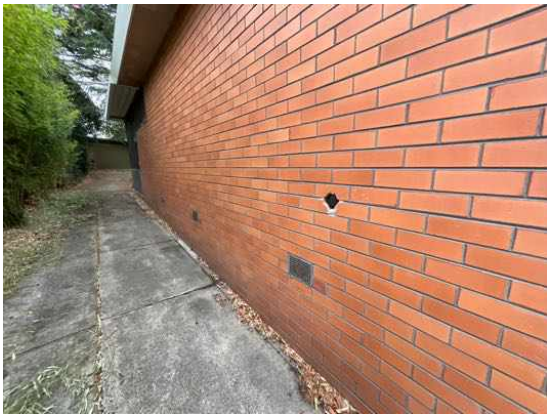
Finding 3.03

Building: Main Building
 Location: All External Areas
 Finding: External Concrete – Cracking Observed (General Movement)
 Information:

Cracking was observed to sections of the external concrete surfaces. The cracks appear consistent with general movement, ageing, or shrinkage of the material.

Concrete cracking of this nature is commonly observed in external areas and may occur due to natural ground movement, environmental conditions, or long-term wear and tear.

A suitable contractor may wish to assess and repair the affected areas as required to maintain surface condition and prevent further deterioration.

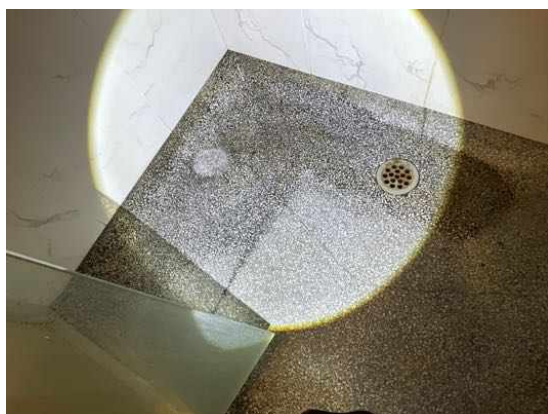
Building: Main Building
 Location: Bathroom
 Finding: Shower Base – Hairline Cracking Observed (General Wear and Tear)
 Information:

Hairline cracking was observed to the shower base surface. The cracks appear minor and limited to the surface finish.

Such cracking may occur due to normal wear, ageing, or minor movement of the substrate. At the time of inspection, no significant failure was evident; however, cracks in wet areas may allow moisture penetration over time if they worsen.

A suitable contractor may wish to monitor and maintain the area, and carry out repairs if deterioration progresses to prevent potential moisture ingress.

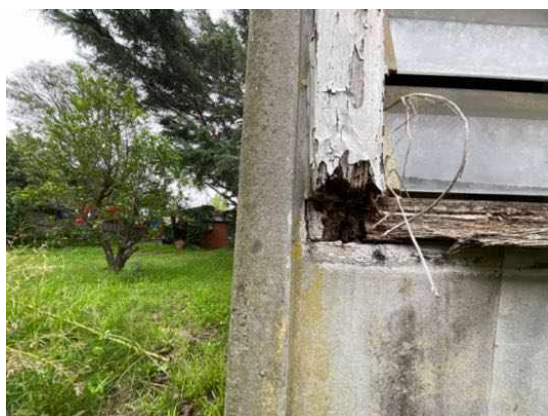
Building: Main Building
 Location: All Areas
 Finding: Fence and Timbers Elements – Suspected Decay and Deterioration

Information: A section of the external timber elements shows signs of possible decay and deterioration. This condition may be related to weathering, inadequate sealing, or moisture exposure affecting the integrity of the timber surfaces.

If not attended to, deterioration may progress and affect the performance of the surrounding building materials. Any moisture in contact with timber is conducive to termite activity, so this matter should be addressed as soon as practicable to avoid further damage.

Rectification should be carried out by a licensed carpenter or builder, who can repair or replace affected sections and ensure all exposed timber is properly sealed and protected. A licensed structural engineer may be required if any structural impact is suspected.

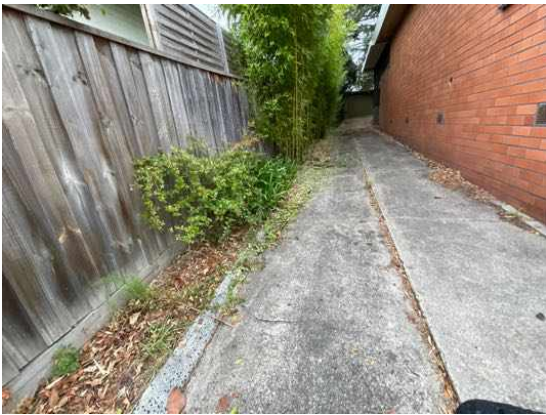
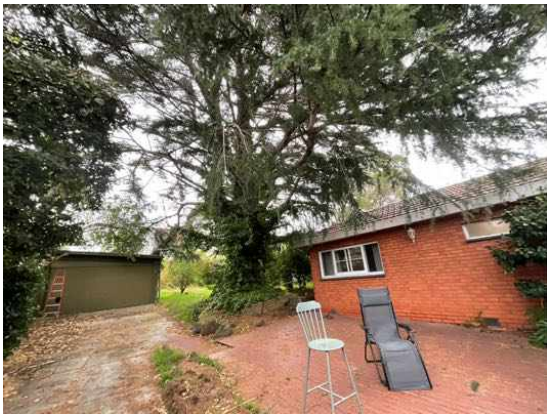
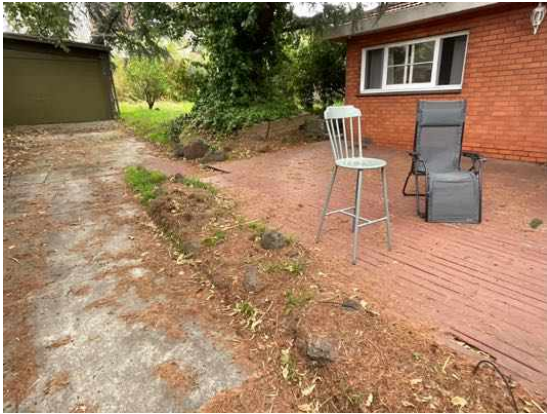
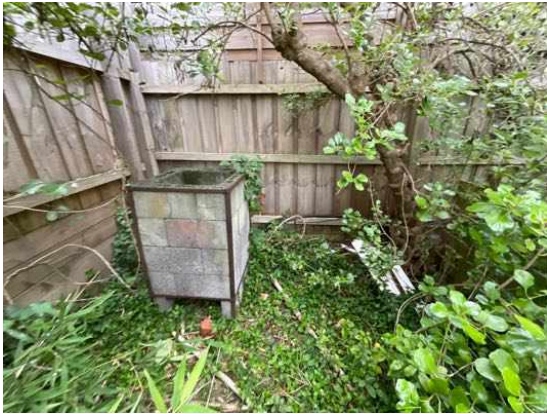
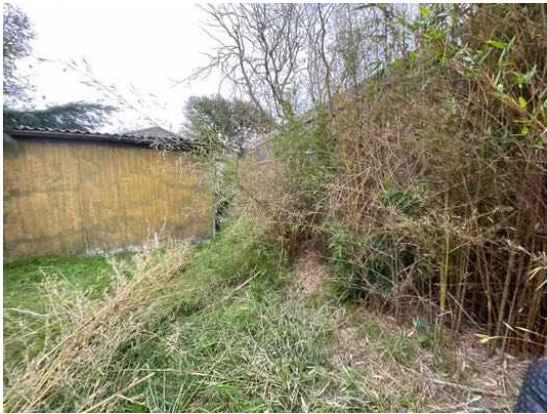
Building: Main Building
Location: All Areas
Finding: Additional Photos - Obstructions and Limitations
Information: These photographs are an indication of the obstructions and limitations which impeded full inspection of the property at the time of inspection. These obstructions can hide an array of defects and should be removed to allow full inspection to be carried out. A re-inspection is recommended once the areas are made accessible.

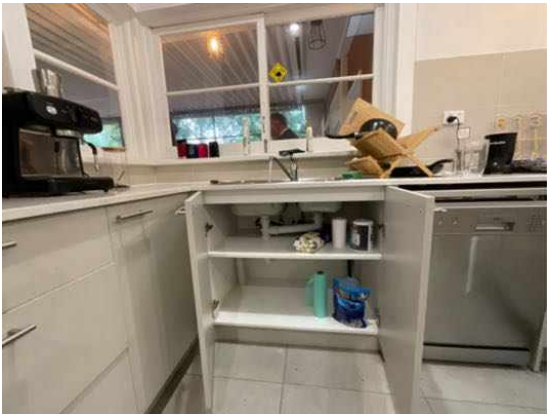
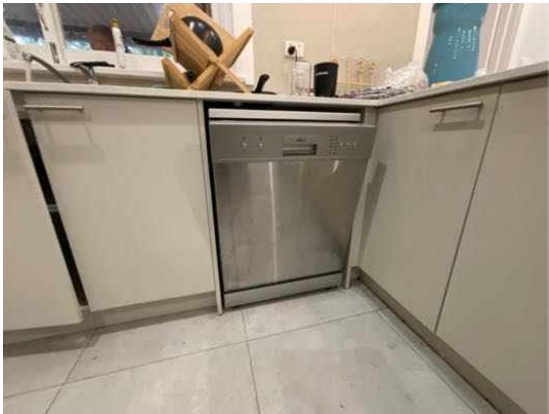
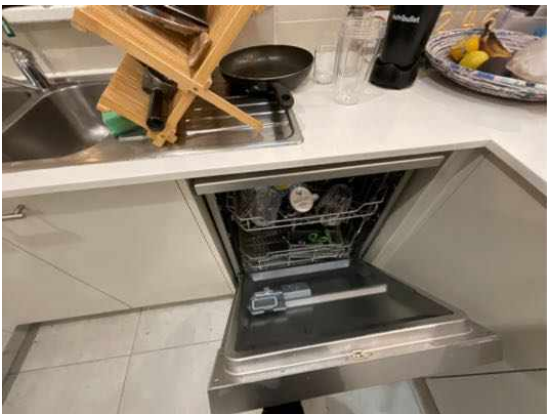
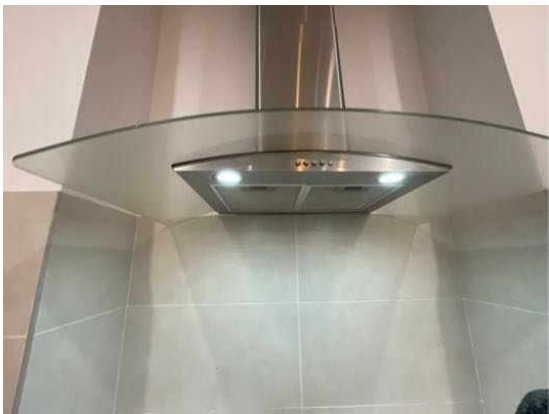
Building: Main Building
Location: All Areas
Finding: Floor Condition – For Information Only
Information: The general condition of the floor surface was observed and noted during the inspection. No major defects were identified, and this is recorded for information purposes only.

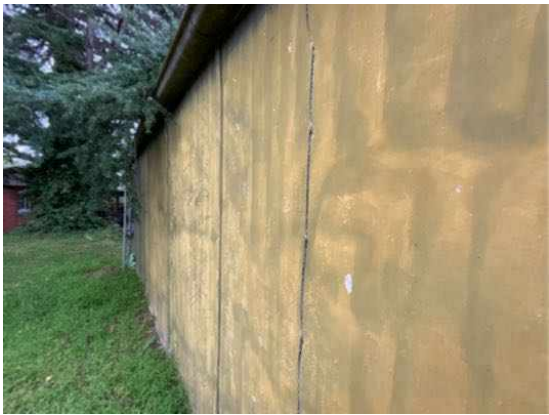
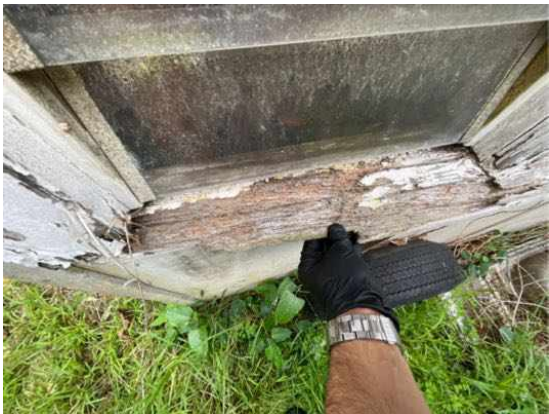
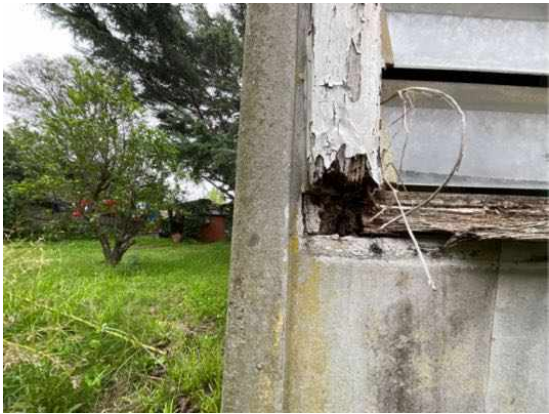
General ageing and deterioration were also observed to the structure, which may affect its overall integrity and pose a safety concern.

An asbestos specialist may need to carry out further investigation, including sampling and laboratory testing, to confirm the presence of asbestos. A suitable contractor may need to assess the structural condition as soon as possible and carry out necessary rectification works to ensure safety.
