Building and Timber Pest Inspection Report

Inspection Date: Tue, 27 Jan 2026

Property Address: 51 Flaxton Dr, Mapleton QLD 4560,
Australia

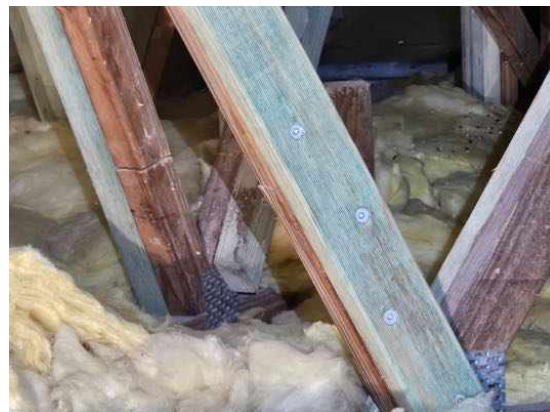
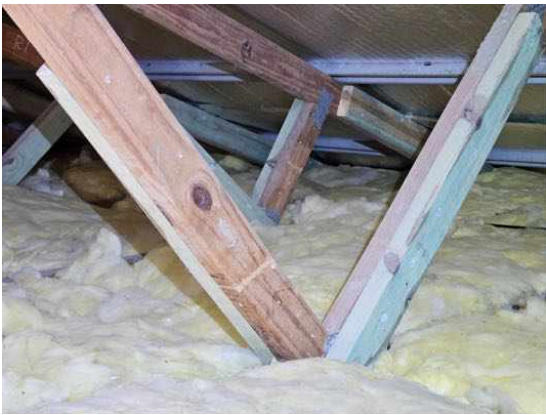
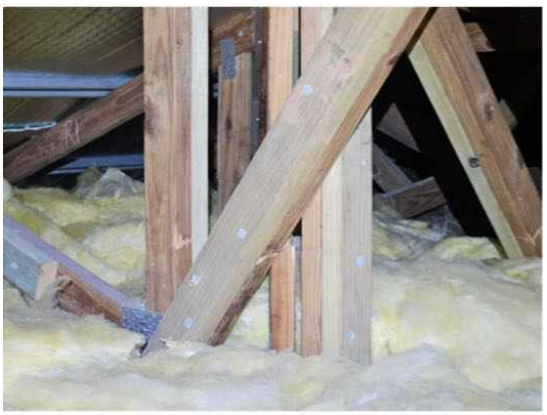
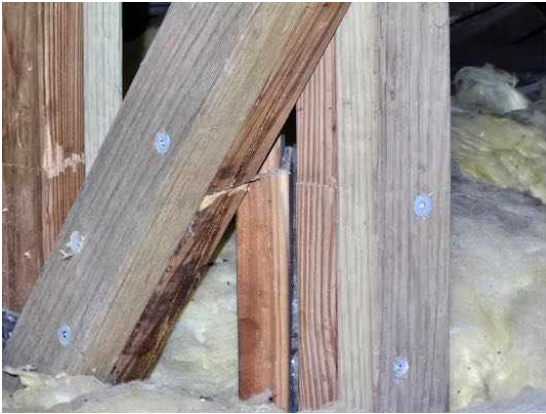
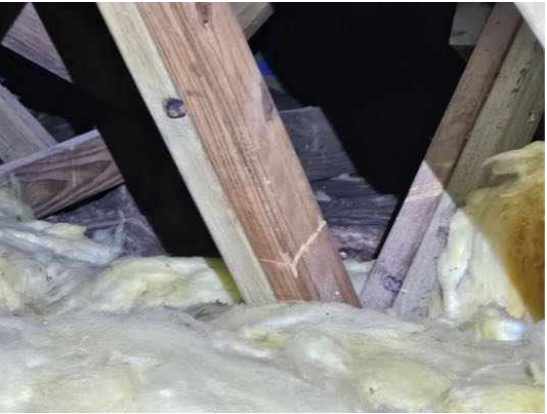
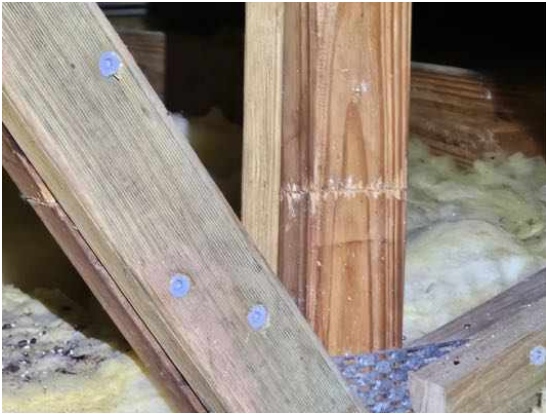
Building:	Main Building
Location:	All areas viewed
Finding:	Roof truss repairs
Information:	On the day of inspection it was noted that repair works had been carried out on the roof trusses above the upper floor rooms above the garage. The majority of trusses in this section of the structure appear to have been cut in various positions. The reason

for this is not determined. Repairs have been carried out.

Certification for this work was not available. It is recommended that the client obtain an engineers or the manufacturers certification the repairs. Given the volume of damaged trusses, if the repairs are not in accordance the correct standards, there is a risk of failure is undue stress is placed on the roof structure. The certifiers certificates were made available for reading; however, there is no mention of this damage, the repairs or certification for the repairs. The original engineering frame design certification is dated 17/11/21, and the frame inspection was carried out on 30/9/22. It is assumed that the damage occurred after these dates.

The remaining section of roof could not be inspected on the day due to the restrictive nature of the framing.

The client is encouraged to seek a copy of the certification for this repair. This will be required to comply with manufacturers warranty conditions.

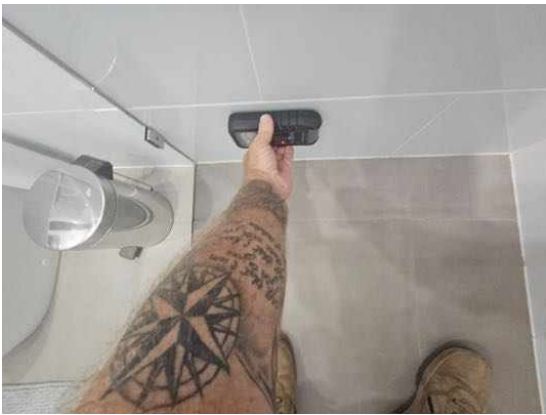
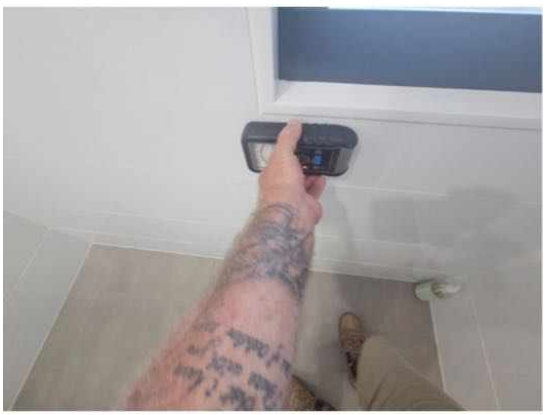
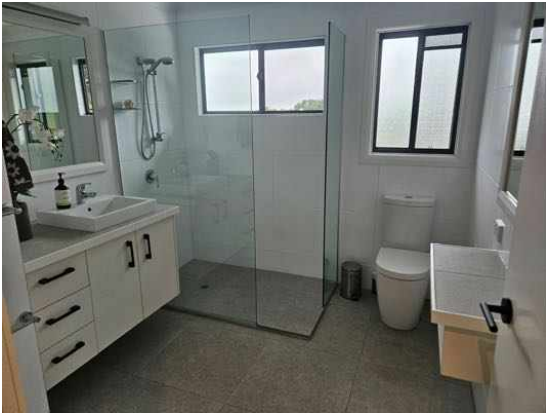
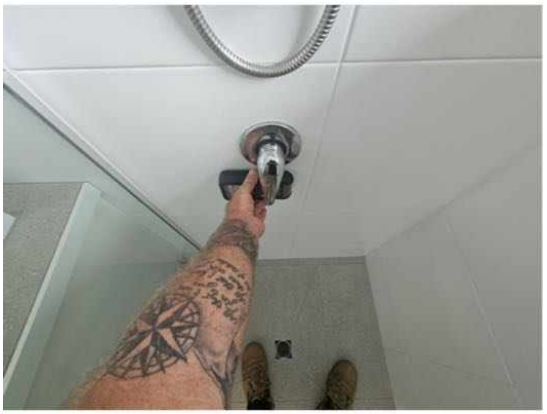
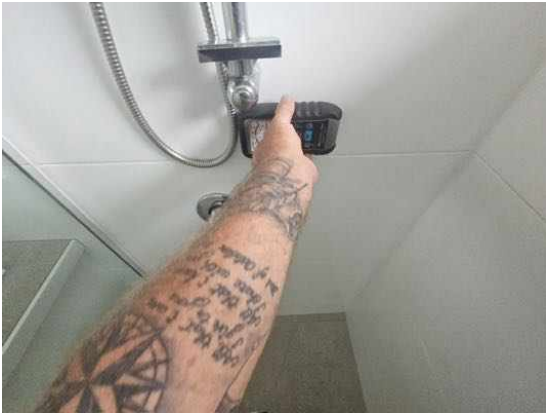
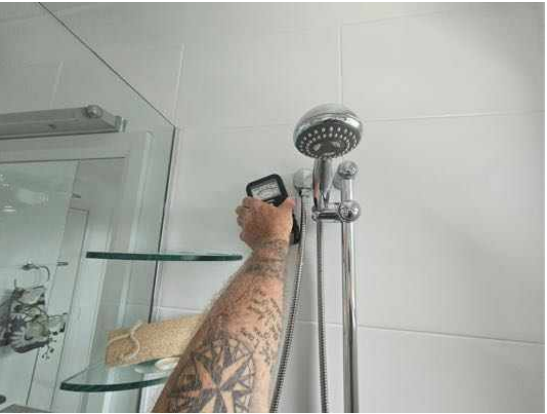
Building: Main Building
Location: Bathrooms
Finding: No moisture detected in bathrooms
Information: On the day of inspection the showers in the bathroom/s are measure for moisture using a "Tramex" moisture meter. During this inspection no moisture was detected in these areas and the tiled / sheeted surfaces appear to be in good order.

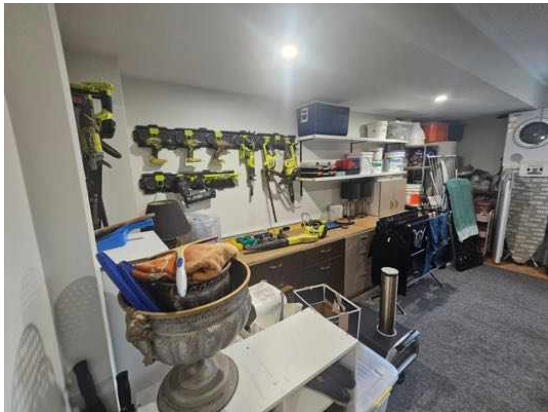
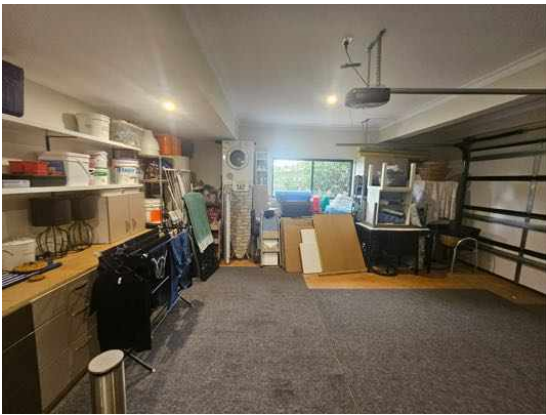
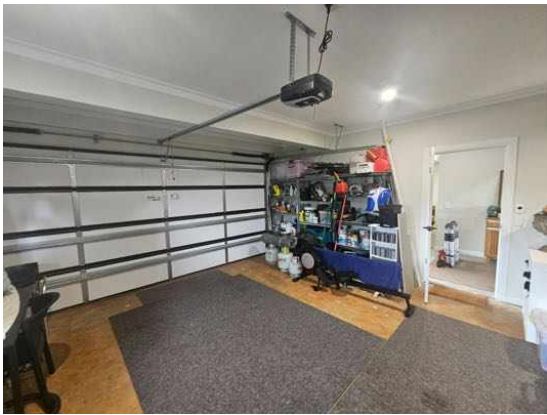
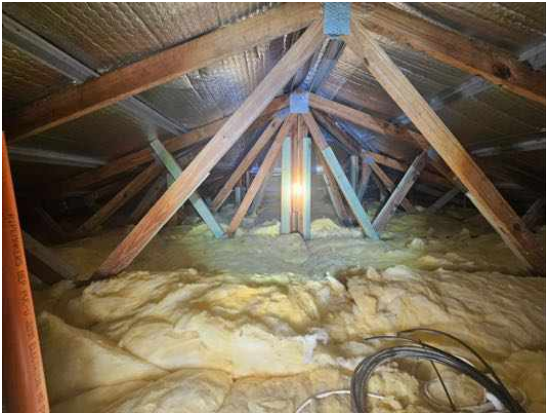
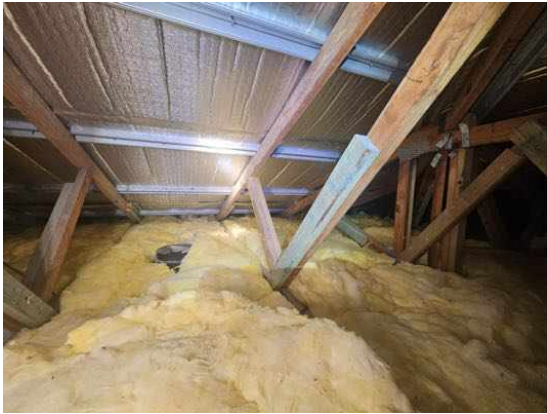
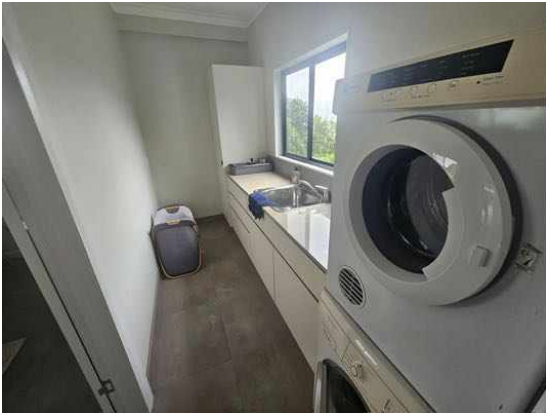
Building: Main Building
Location: All Areas
Finding: Additional Photos - Obstructions and Limitations
Information: These photographs are an indication of the obstructions and limitations which impeded full inspection of the property at the time of inspection. These obstructions can prevent full inspections of the areas shown.
