## Building Inspection Report

Inspection Date: Mon, 9 Mar 2026

Property Address: 2 Sun Valley Dr, Shepparton VIC 3630,  
Australia

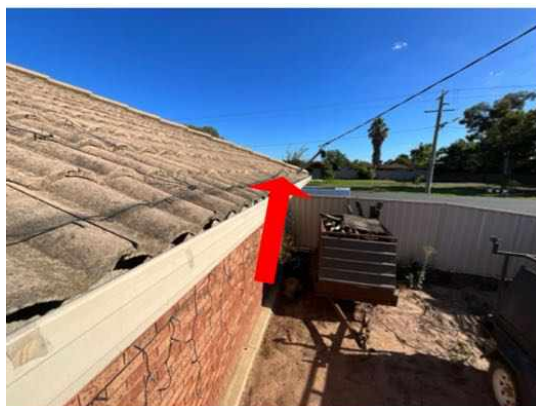
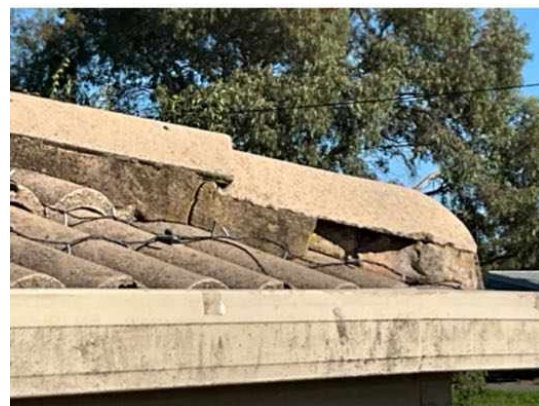
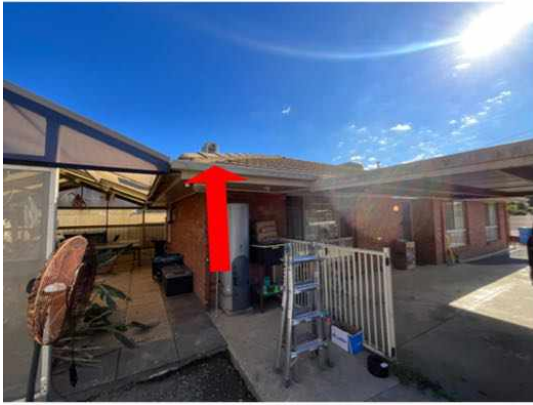
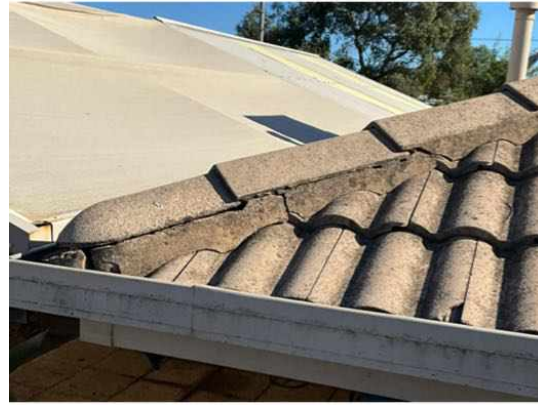
#### Defects 3.01

Building:	Building 1
Location:	Roof Exterior
Finding:	Mortar - Deterioration
Information:	Mortar, or 'bedding', is the material which fills joints and intersections between tiles and other building elements on the exterior roof covering, such as gable ends, hip capping and valleys. Upon inspection of the exterior roof, it was noted that sections of the mortar show varying levels of deterioration.

Mortar generally deteriorates as a result of frequent exposure to weather conditions over a prolonged period of time. Mortar that is deteriorating may allow water ingress into the roof void, putting associated building elements and roofing structures at risk of water damage. Deteriorated mortar also detracts from the functionality of roof tiles and other roofing elements, potentially decreasing weather tightness and roof drainage.

Mortar deterioration can be attended to by a handyperson where areas of deterioration are localised and easily accessible. Otherwise, consultation with a roofing contractor is advised where greater works are required.

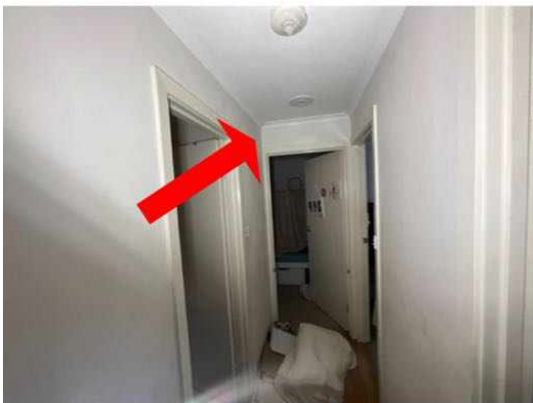
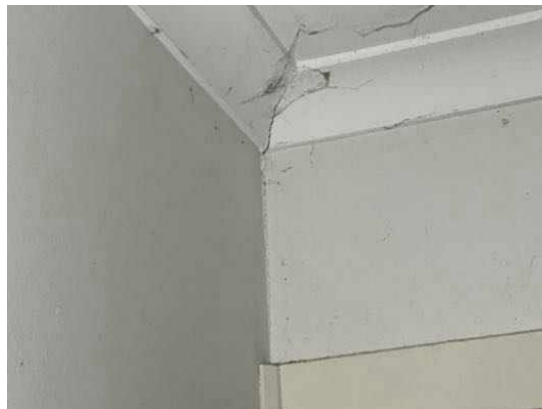
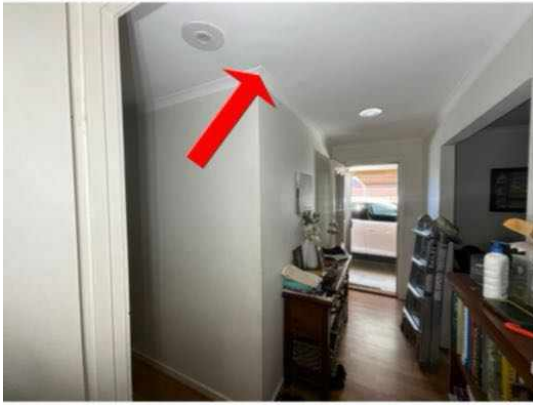
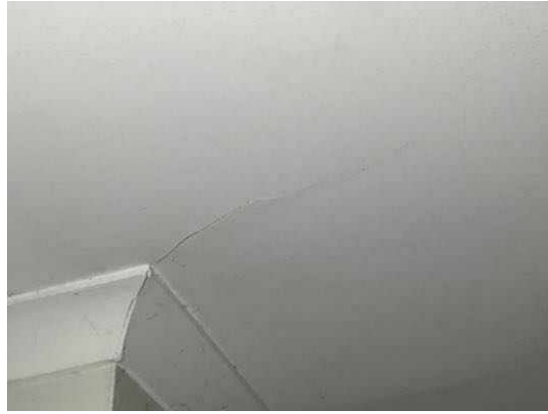
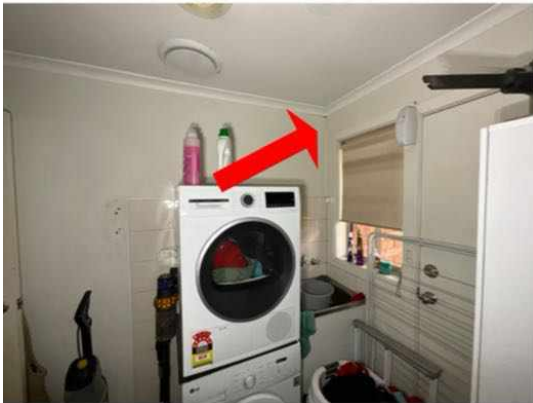
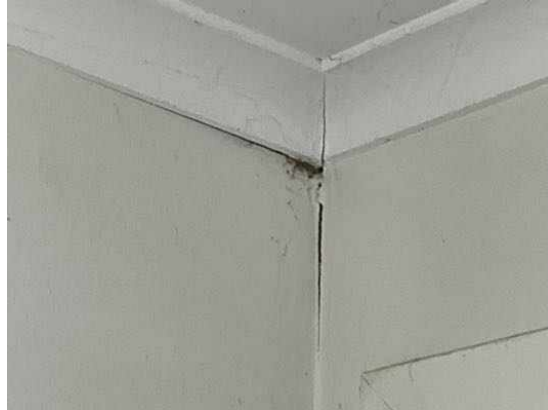
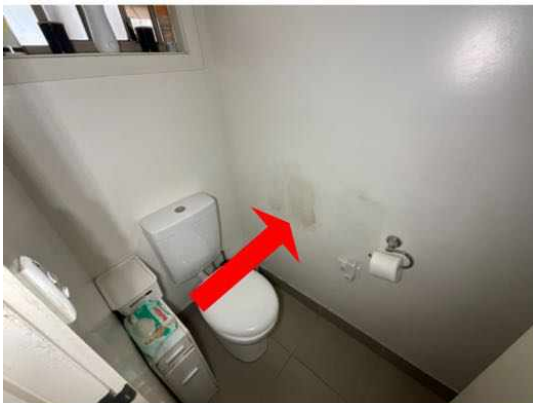
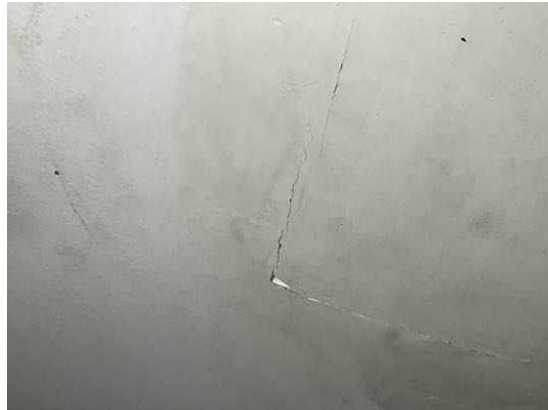
## Defects 3.02

Building:	Building 1
Location:	Hall, laundry, Wc
Finding:	Cracking - Damage Category 1 - Fine (up to 1mm)
Information:	Although fine cracks are quite noticeable, they are often only considered to be an appearance defect, and usually do not indicate any structural damage. Generally, the cause of a fine crack is indicative of a separation between building materials and finishes (e.g. paint, plaster, etc.) along joins.

Cracking of this nature can generally be repaired with minor sanding, filling and/or repainting. Such works should be performed by a qualified painter or a general handyman.

Monitoring of all cracking should be conducted frequently. Always contact a building inspector should cracks widen, lengthen, or become more numerous.

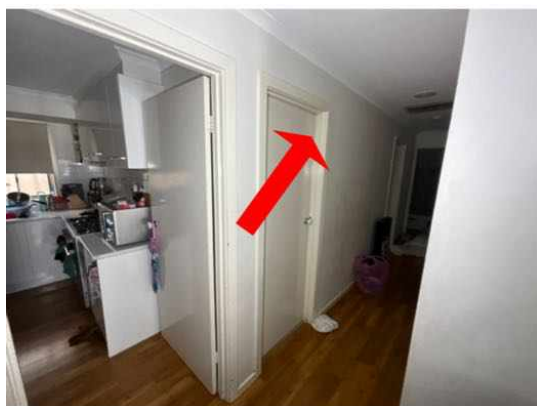
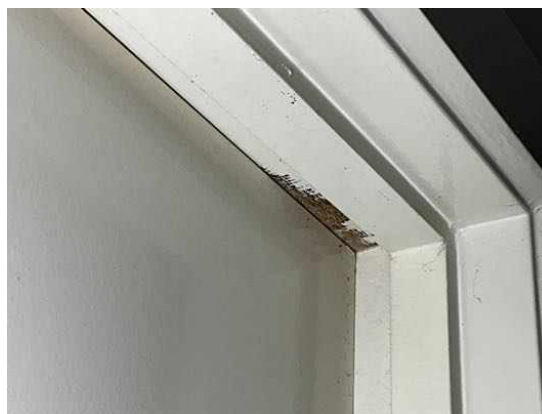
### Defects 3.03

Building: Building 1  
 Location: Laundry  
 Finding: Door- Binding/jamming  
 Information: Binding and/or jamming of this door is evident during standard operation. This defect inhibits the functionality of the affected door as well as creating potential for secondary defects to associated building elements, such as damage to the floor covering.

A qualified carpenter or general handyperson should be appointed to perform minor rectification works at client discretion.

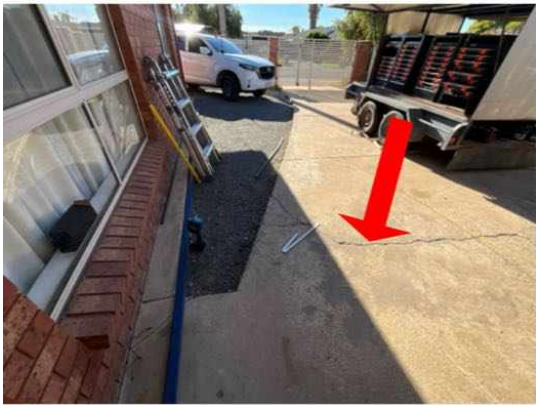
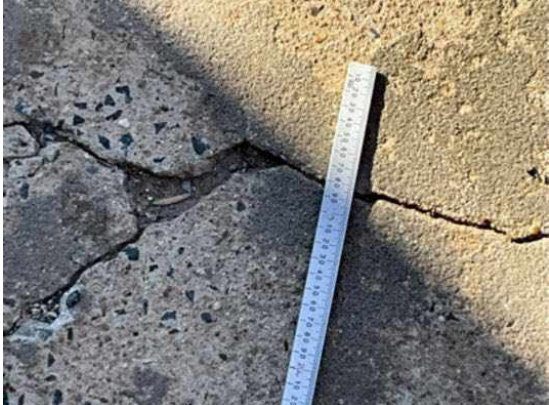
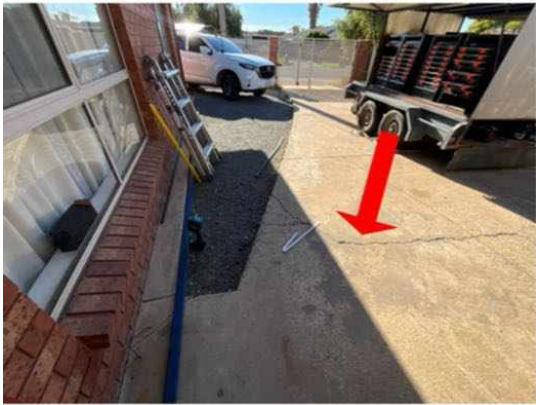
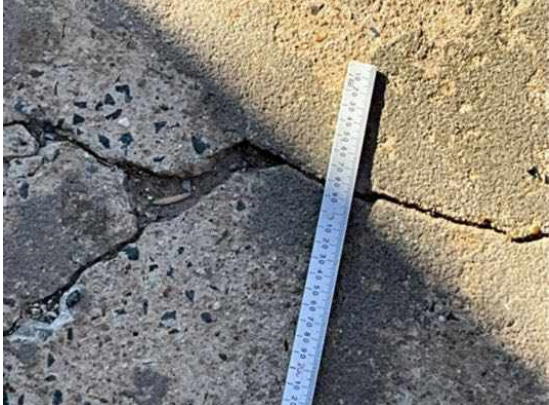
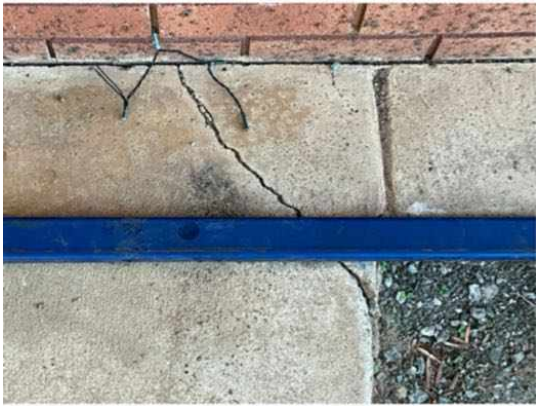
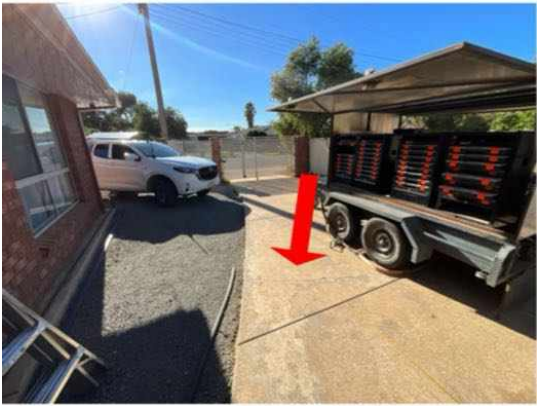
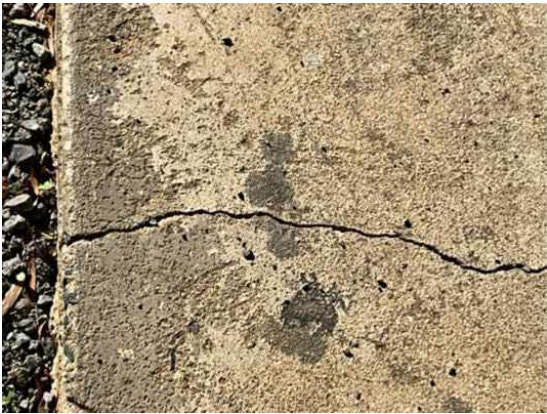
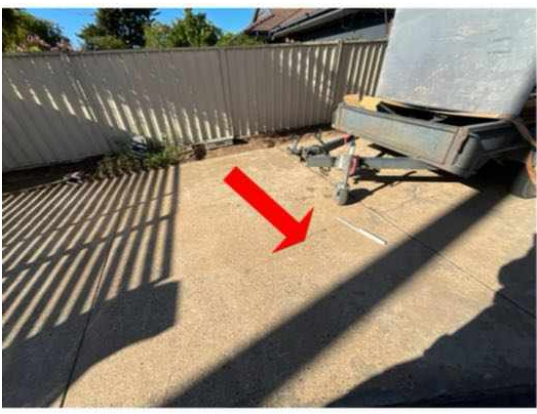
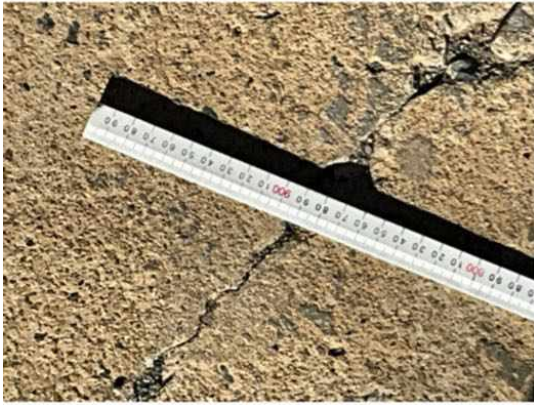
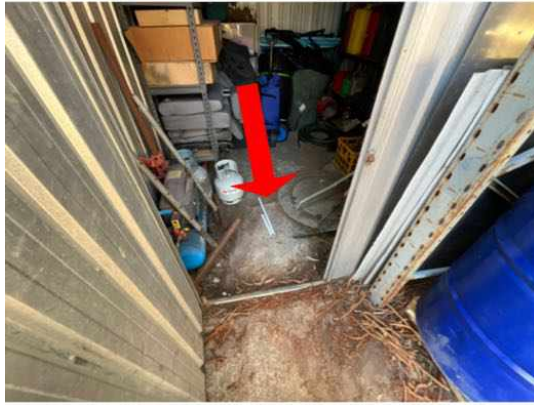
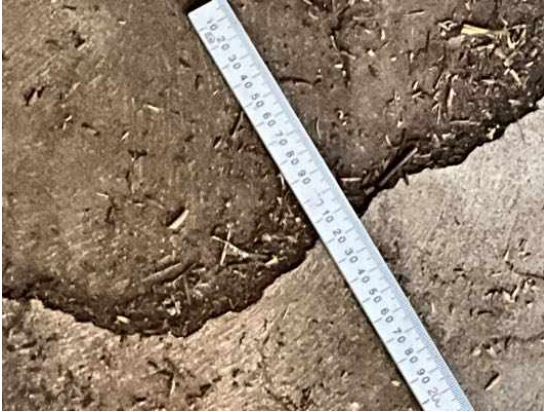
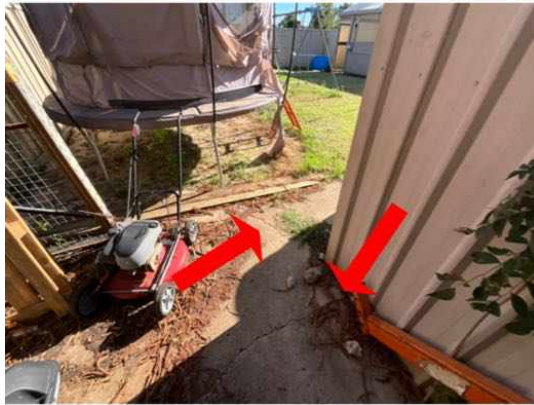
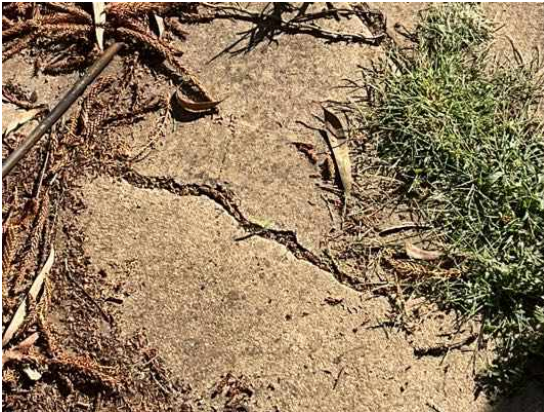
## Defects 3.04

Building:	Building 1
Location:	Driveway, back yard
Finding:	Cracking - External Concrete Paving Damage Category 4 - Gaps in Slab (4mm - 10mm +)
Information:	Gaps in the slab were identified in external concrete paving. Gaps in the slab are significant and are likely to lead to the development of safety hazards and secondary defects if left unmanaged, such as the creation of a trip hazard.

General age and expected deterioration of the paved areas is a common cause of this type of cracking. However, expansion and contraction of the slab may also have occurred due to environmental factors. Such factors include variable moisture and weather conditions, the presence of trees and their roots having a settling or lifting affect on the soil, or the effect of load bearing, e.g. heavy vehicles over a sustained period of time.

Cracking to this degree may also be due to poor original installation of the concrete. Factors such as poor compaction of the sub surface and/or inadequate reinforcing of the slab may create cracking and other secondary defects. Gaps in the concrete paving may also have a more significant structural cause, such as subsidence of soils.

Where gaps in the concrete paving are adjacent to structural elements of the building, the advice of a Structural Engineer is advisable before undertaking repairs. Significant repair and likely replacement of the concrete paving is probable.

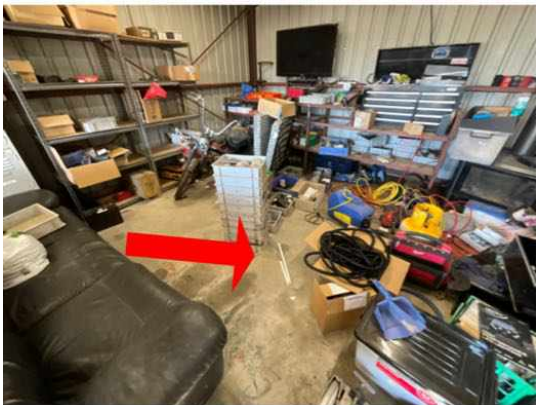
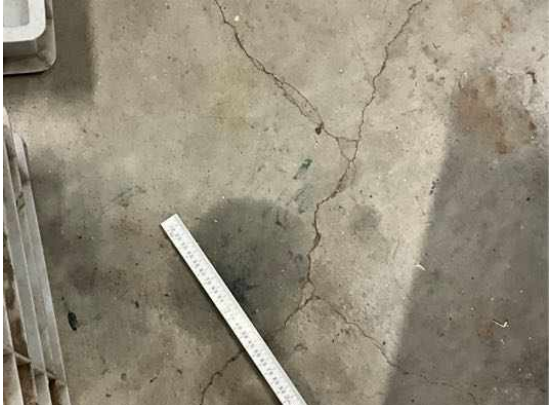
### Defects 3.05

Building: Building 1  
 Location: Garage  
 Finding: Crack in concrete slab - Category 1  
 Information: A crack coded as Category 1 was identified in the slab. A Category 1 crack is described as a fine but noticeable crack, with the slab at an otherwise reasonable level.

To be considered Category 1, the approximate width of the crack is less than 1.0mm, or a less than 10mm change in offset when a 3m straight edge is placed over the defect.

Category 1 cracks should be monitored for a period of 12 months. At the end of the monitoring period, identified cracks that are rated greater than Category 2 are considered defects, and require rectification.

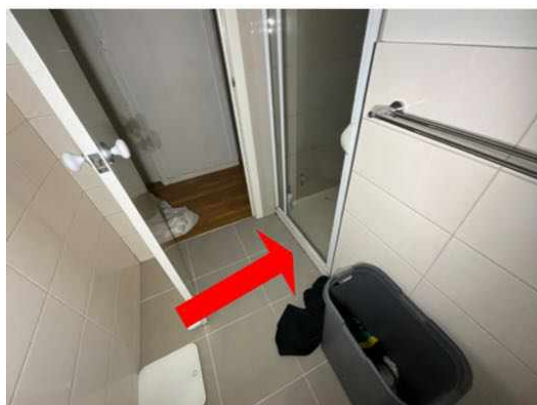
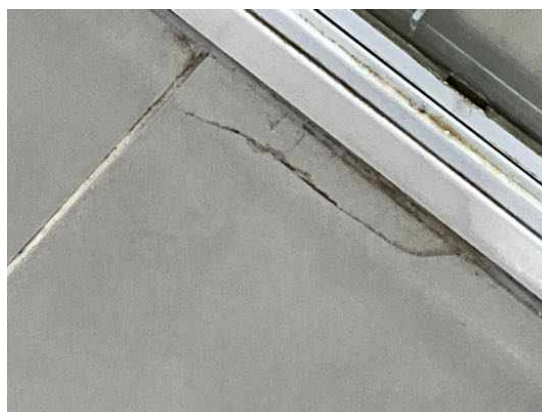
Building: Building 1  
 Location: Bathroom  
 Finding: Cracked floor tiles  
 Information: Cracking in the floor tiles was evident in this area at the time of inspection. It is suspected that this cracking has occurred as a result of minor settlement or impact damage.

Cracked tiles throughout the household detract from the overall appearance of the affected areas however it is unlikely to create or lead to any secondary defects.

While not considered a matter of urgency, replacement of cracked floor tiles is recommended at the clients discretion. A tiling contractor may be appointed to perform these works. Where cracks become more numerous, contact a licensed building inspector for further investigation.

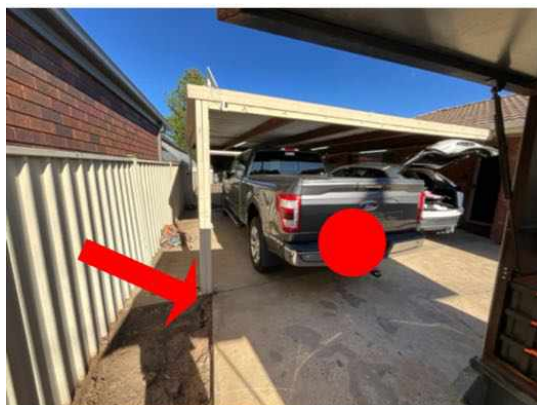
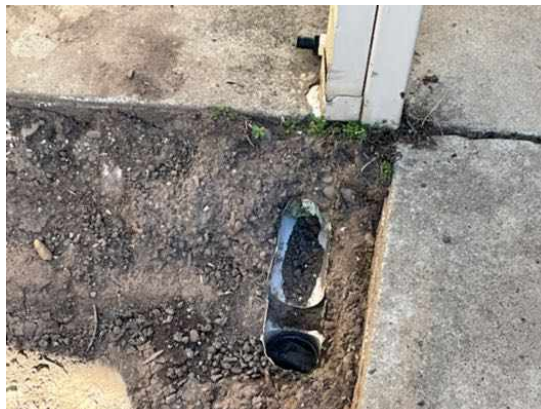
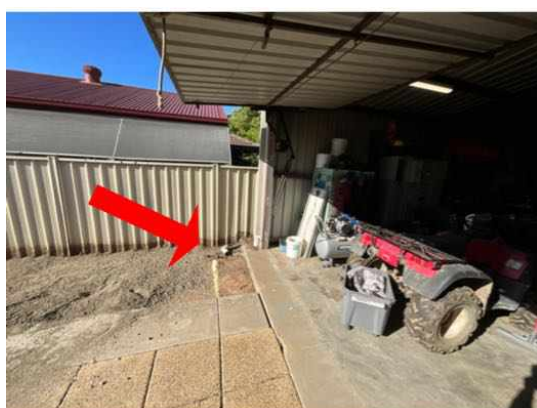
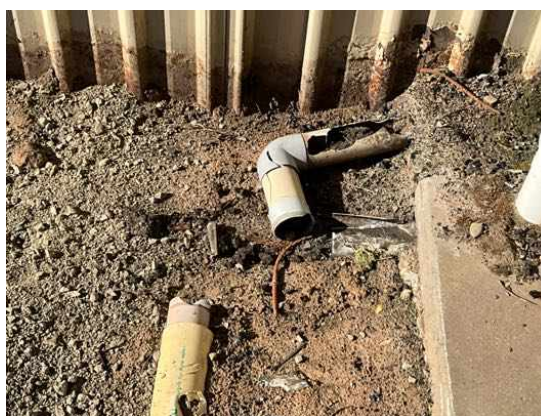
Building: Building 1  
 Location: Carport, garage  
 Finding: Stormwater drain - Not connected  
 Information: The roof plumbing is not adequately connected to stormwater drainage on the site. This disconnection negatively impacts the functional capacity of the roof plumbing.

Where roof plumbing doesn't drain adequately, the area at the base perimeter can become excessively damp, potentially creating an environment that is susceptible to rust and corrosion of surrounding building elements, as well as attracting termites and other pests.

It is highly recommended that a plumber be appointed to further inspect the area and to install adequate drainage equipment where necessary.

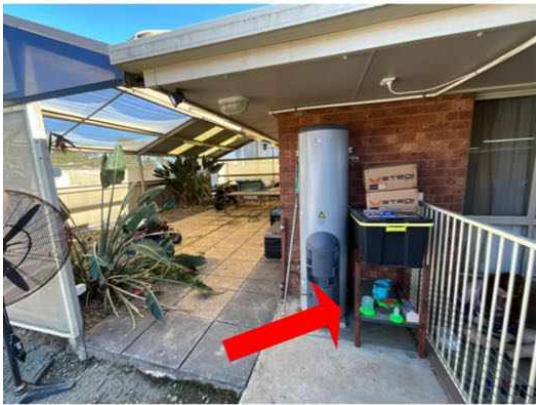
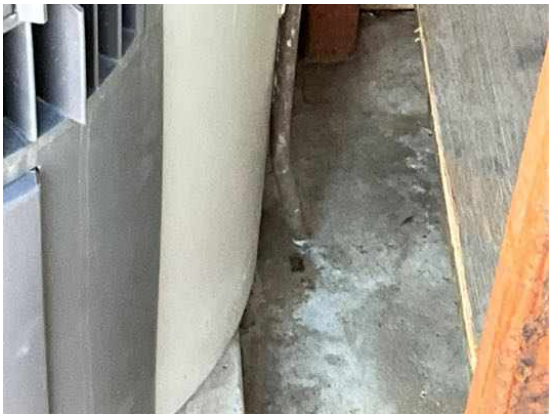
Building:	Building 1
Location:	Carport
Finding:	HWS Overflow - Not Connected
Information:	The Hot Water System (HWS) overflow was found to be disconnected from storm water drainage and is creating excessive moisture in the surrounding area.

These damp conditions can lead to secondary defects such as rot, rust or corrosion of associated building elements, the formation of fungal decay, or even the creation of potential slip hazards. When coupled with poor site drainage, pooling of water may also attract termite activity to this area.

It is highly recommended that a licensed plumber be appointed to connect the HWS overflow in order to prevent such an environment from being created. These minor works should be carried out as soon as possible.
