Building and Timber Pest Inspection Report

Inspection Date: Thu, 5 Feb 2026

Property Address: 24 Travers St, Moorebank NSW 2170,
Australia

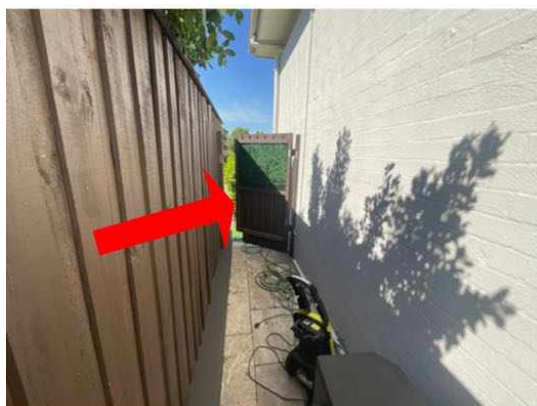
Building:	Main Building
Location:	Pool Area
Finding:	Pool Safety Fence / Gate (Non-Compliant) - Missing
Information:	Location: Side access adjacent to swimming pool

A required pool safety fence and/or self-closing, self-latching gate is missing to the side access path adjacent to the swimming pool. The pool area is therefore not effectively enclosed, allowing direct and uncontrolled access to the pool.

- Absence of a compliant pool safety fence and gate to fully isolate the swimming pool.
- Failure to provide a continuous, child-resistant barrier with controlled access only through a compliant gate.
- Pool access not restricted in accordance with AS 1926.1 Clause 2.1 & 2.2.

This condition presents a serious safety hazard, particularly to young children, due to unrestricted access to the swimming pool.

Install a compliant pool safety fence and self-closing, self-latching gate in accordance with NCC 2022 and AS 1926.1–2012. All works should be carried out by a suitably licensed contractor, and certification by an accredited pool safety inspector is strongly recommended upon completion.

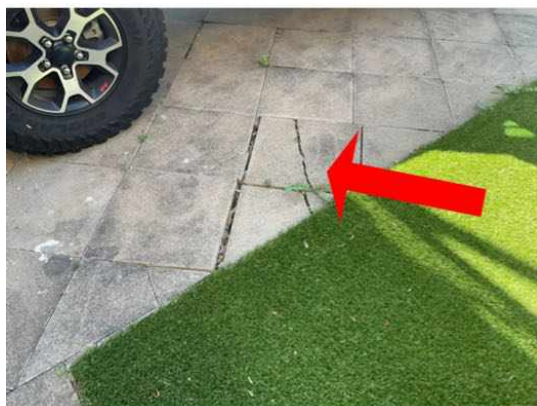
Finding 3.02

Building:	Main Building
Location:	All External Areas
Finding:	Damaged paving
Information:	At the time of inspection, damaged or broken paving were identified. Where this is due to the contractor workmanship or damage occurring during construction it is considered a defect. While being an appearance defect, such damage is expected during construction of a property. A relevant tradesperson should be appointed to perform these rectification works at discretion of the client.

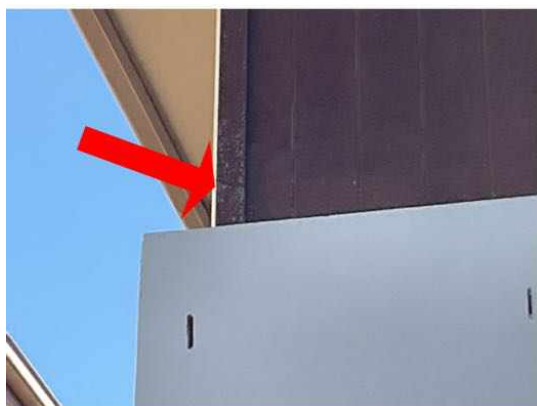
Finding 3.03

Building:	Main Building
Location:	All External Areas
Finding:	External painting deteriorated.
Information:	Much of the external paintwork including but not limited to windows, fascias, guttering, veranda and other external fitments have been neglected and require attention to prepare and re-paint.

Whilst incomplete or missing paint finish is generally an appearance defect, it can also lead to the development of secondary building defects over time. Incomplete areas of paint finish expose the area to moisture, potentially accelerating the deterioration of underlying building materials.

Degraded paint finishes should be sanded back, filled, leveled and painted, as applicable. Where inadequate or missing paint protection has led to the deterioration of the associated building element, repair and/or replacement of this building element may be required.

A painting contractor should be appointed as soon as possible to perform necessary works to aid the appearance of the affected area and to ensure the area is protected against further deterioration. Alternatively, the homeowner following manufacturer instructions may perform these works.

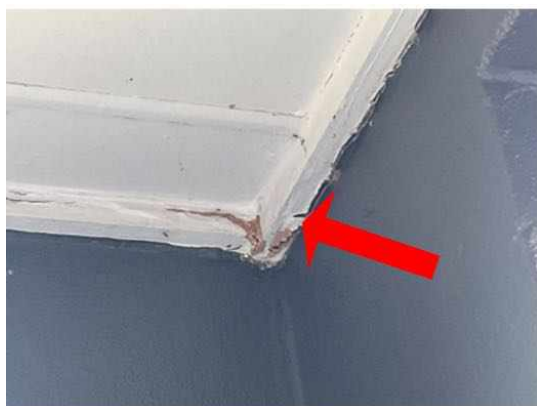
Finding 3.04

Building:	Main Building
Location:	All External Areas
Finding:	Beads - damage
Information:	Where beading (also known as 'quad') are damaged from the eaves It was noted at the time of inspection that beading in this area has deteriorated. Beading is important in weatherproofing the surrounding building elements and preventing termite or pest ingress. Furthermore, beading works to protect the joints of building materials, which are more susceptible to deterioration and decay. Repair or replacement of the beading is advised to ensure the protection and longevity of any associated building elements. Such works may be performed by a general handyperson or qualified carpenter.

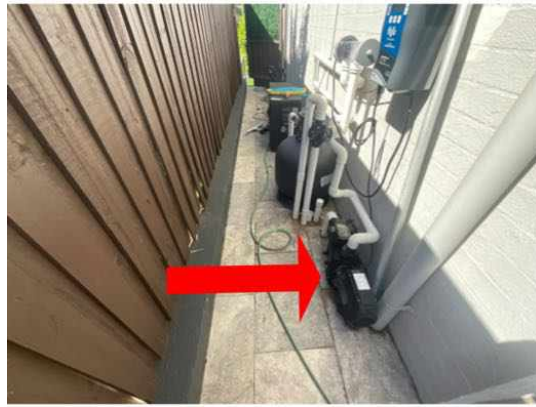
Finding 3.05

Building:	Main Building
Location:	Pool Area
Finding:	Swimming pool circulation pump - leaking
Information:	Water leakage was observed at the swimming pool circulation pump, including around the pump housing and pipe connections.

Ongoing leakage may lead to pump failure, electrical hazards, water loss, and deterioration of surrounding surfaces.

A licensed pool technician or plumber should inspect, repair or replace the leaking pump and associated fittings as required. Any electrical components affected by moisture should also be checked by a licensed electrician.

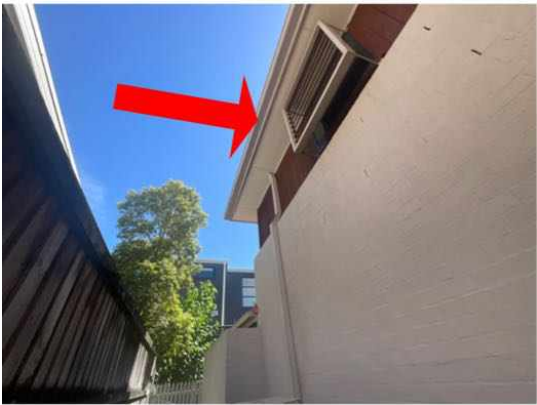
Blocked gutters are likely to lead to high levels of moisture in the affected areas. Such moisture will not only cause rust and decay of the associated building materials, but can also provide conditions that are conducive to termite and timber pest activity. Blockages in gutters should therefore be removed immediately to ensure dry conditions are maintained.

Consult a Licensed Plumber for further specific advice on remedial works that may be required. In the interim, it is highly advised that blocked gutters be removed by the homeowner or a general handyperson as a matter of urgency.

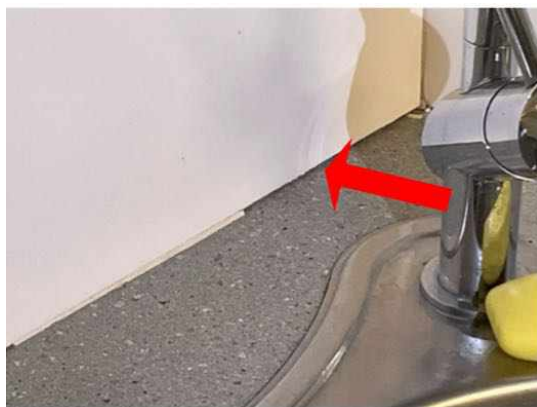
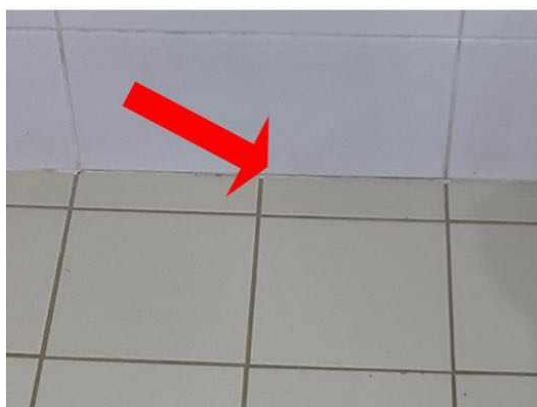
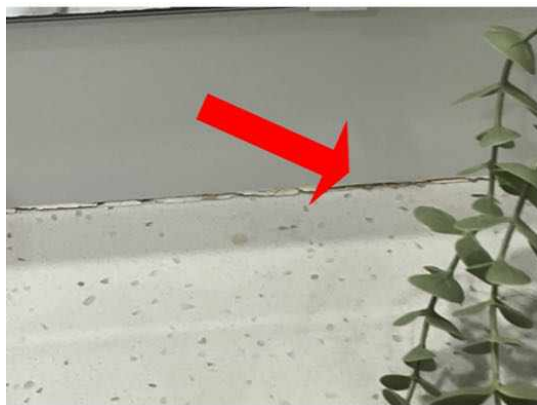
Finding 3.10

Building:	Main Building
Location:	Bathrooms
Finding:	Sealant and grouting - Missing or damaged
Information:	It was noted on inspection that sealant or grout is degraded to the tiled shower alcove and or other areas of the bathroom.

Different materials and floor areas move at different rates, generally causing cracking to grout or sealant at this point. A flexible sealant is required to allow for expected expansion and contraction, while keeping the joint water tight and protective of all associated building materials.

There appears to be excessive mould to the sealant and grout which will likely require scraping out and replacement.

Flexible and mould resistant materials should be applied to affected areas to prevent any subsequent water damage that is likely to occur. Regular maintenance and replacement of damage or missing or damaged sealant and grout is highly recommended to the wet areas, as this is a regular wear and tear defect. Sealant and grouting in areas that come into regular contact with water should be maintained for the long term care of your property.

A sealant specialist or tiling contractor should be appointed to complete these works as soon as possible

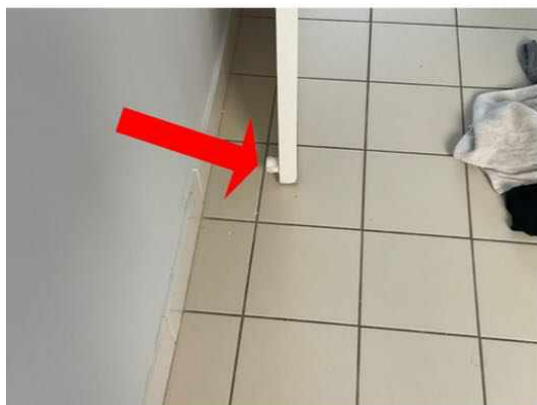
Finding 3.11

Building:	Main Building
Location:	All Internal Areas
Finding:	Door stop - Missing
Information:	The door stop is missing or is inadequate to stop the door handle from damaging the wall. Although some building elements may seem irrelevant or unnecessary, all building elements play a key role in the operation and function of the overall structure and its performance.

Re-installation or replacement of the door stop is advised as soon as possible to prevent any subsequent damage to the door or associated structures. A general handyman may be appointed to perform these works at client discretion.

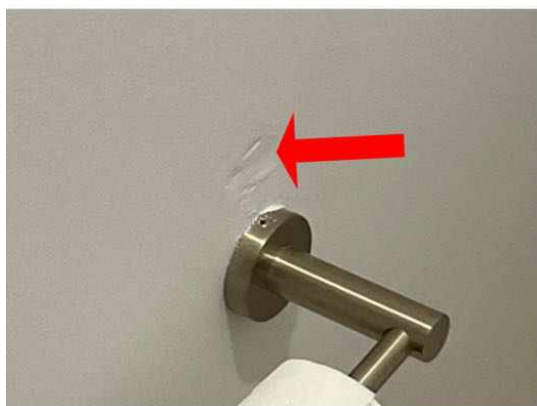
Finding 3.12

Building:	Main Building
Location:	All Internal Areas
Finding:	Paint finish - Substandard, Wear and Tear
Information:	The paint finish in this area was found to have been completed to a substandard level or wear and tear as the normal deterioration of a property from ordinary, everyday use. Exposure to the elements, time, as well as day to day living can cause fair wear and tear.

If this applies, further areas of poor and incomplete finishes could develop over time. Furthermore, substandard, wear and tear paint finishes in areas exposed to moisture, e.g. external areas or wet areas, could lead to deterioration of underlying building materials.

Substandard, wear and tear paint finishes should be sanded back, filled, leveled and repainted, as applicable. Where inadequate paint protection has led to the deterioration of the associated building element, repair and/or replacement of this building element may be required.

A painting contractor should be appointed as soon as possible to perform necessary works to aid the appearance of the affected area and to ensure that the area is protected against further deterioration. Alternatively, the homeowner following manufacturer instructions may be able to provide this service.

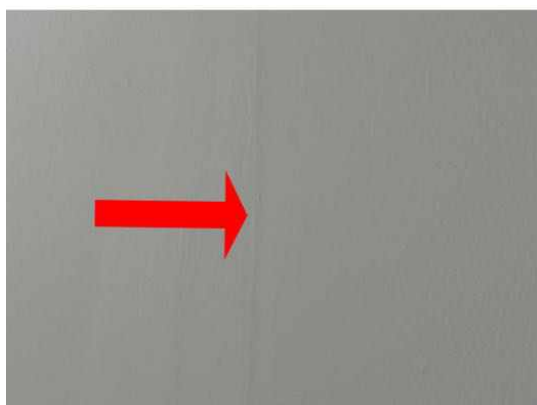
Finding 3.13

Building:	Main Building
Location:	All Internal Areas
Finding:	Cracking - Damage Category 1 - Fine (up to 1mm)
Information:	Although fine cracks are quite noticeable, they are often only considered to be an appearance defect, and usually do not indicate any structural damage. Generally, the cause of a fine crack is indicative of a separation between building materials and finishes (e.g. paint, plaster, etc.) along joins.

Cracking of this nature can generally be repaired with minor sanding, filling and/or repainting. Such works should be performed by a qualified painter or a general handyman.

Monitoring of all cracking should be conducted frequently. Always contact a building inspector should cracks widen, lengthen, or become more numerous.

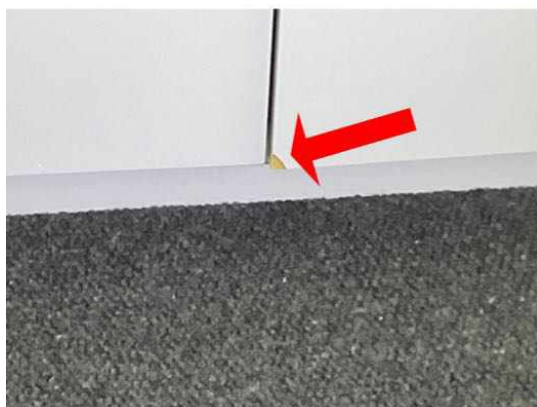
Finding 3.14

Building:	Main Building
Location:	Bedroom
Finding:	Delamination of timbers
Information:	Delamination is one means by which composite materials (e.g. layered timber

composites) may fail over time. In laminated materials, repeated cyclic stresses may lead to the formation of mini-structures of separate layers, with significant loss of mechanical toughness. Water penetration or the presence of excessive moisture also generally contributes to delamination.

Where building materials have become delaminated, they lose their structural strength, and are likely to have a variety of appearance and serviceability defects as a result.

Delamination of timbers may be repaired where the area affected is minor and/or easily accessible, by gluing and screwing layers back together. However, this is an interim repair, and where delamination has occurred, the client should plan for the replacement of affected timbers sooner than would otherwise be expected.

All timber structures affected by delamination should be replaced as soon as possible to avoid any further damage. Repair and replacement estimates should be sought from a registered builder or qualified carpenter.

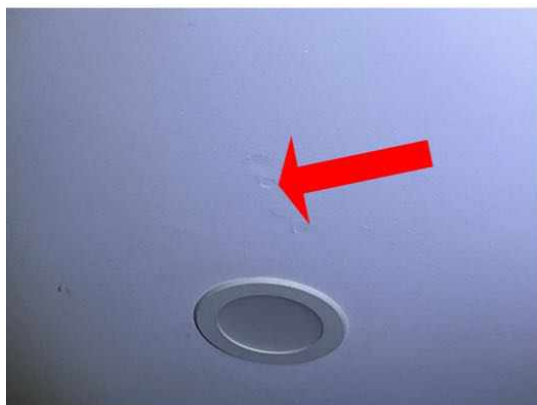
Finding 3.15

Building:	Main Building
Location:	Bedroom - Master
Finding:	Ceiling nails - Popping
Information:	Numerous popped nails were identified in the internal ceiling at the time of inspection. Nails and screws hold simply by the friction between them and the surface they are applied to. Over time, the nails and screws can back out, which is often a result of general ageing and deterioration of the building structure.

If left unmanaged, the ceiling sheets may become loose and unstable, increasing the rate of deterioration of the internal ceiling and creating potential for the development of secondary defects.

Re-fastening of popped nails will help to maintain the stability of the internal ceiling and associated building elements. Such minor works will also help to improve the appearance of the affected area and secure the ceiling sheets, so as to prevent the onset of ceiling sagging. These works should be performed by a qualified carpenter or

plasterer at client discretion.

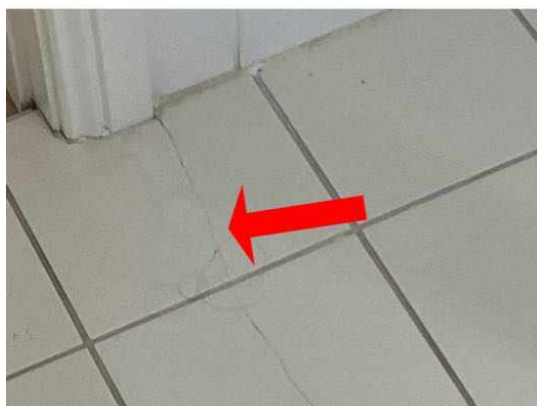
Finding 3.16

Building: Main Building
 Location: Bathroom > Upstairs
 Finding: Tiles - Cracked or damaged
 Information: Cracking was evident to the tiling in this area at the time of inspection. While the cracking appears to be minor, this area is frequently exposed to water, allowing potential for water penetration into adjoining sections of walls or flooring.

If left unmanaged, water penetration to these areas may lead to subsequent water damage, which is likely necessitate repair work to affected building elements.

A tiling contractor should be appointed to ensure that no further water damage occurs. The re-application of silicone and grouting throughout remaining tile work is also advised, to further protect the area against water penetration.

Where water penetration has led to water damage, appointment of a relevant tradesperson may be required to repair damaged building elements.

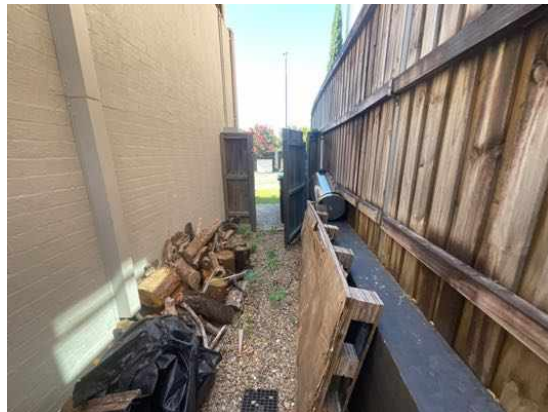
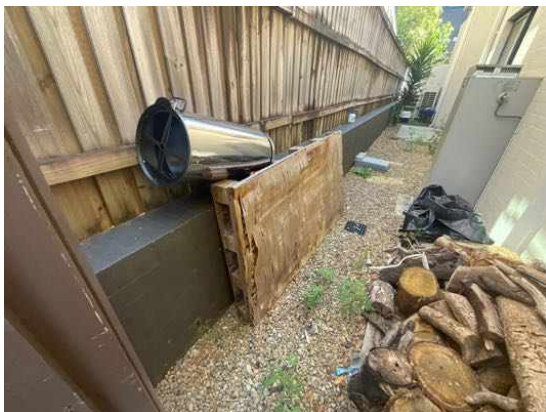
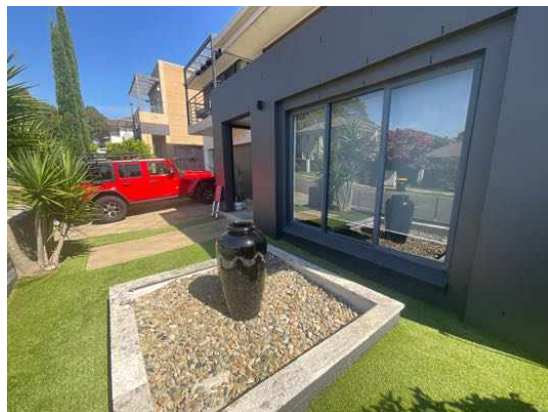
Finding 6.01

Building: Main Building
Location: All Areas
Finding: Garden Beds - Conditions Conducive to Termites
Information: Garden beds were found to be evident in the garden area. These garden beds can include untreated timber, and with a combination of moisture from watering hosing can make conditions conducive to termite activity and termite ingress.
