# Building and Timber Pest Inspection Report

Inspection Date: Sat, 7 Feb 2026

Property Address: 13 Morton St, Parramatta NSW 2150,  
Australia

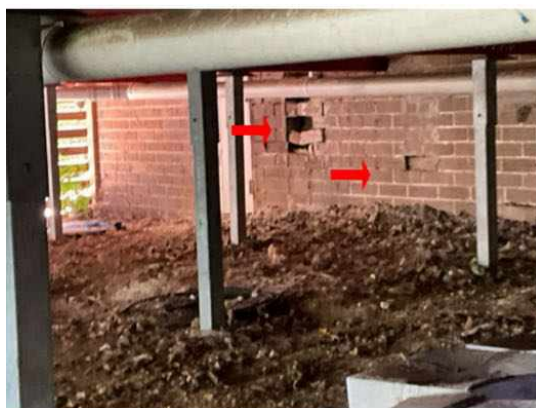
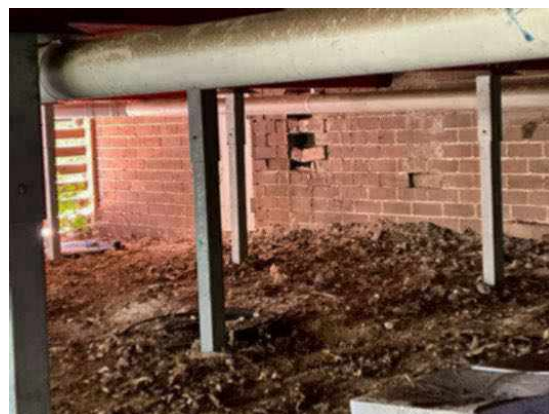
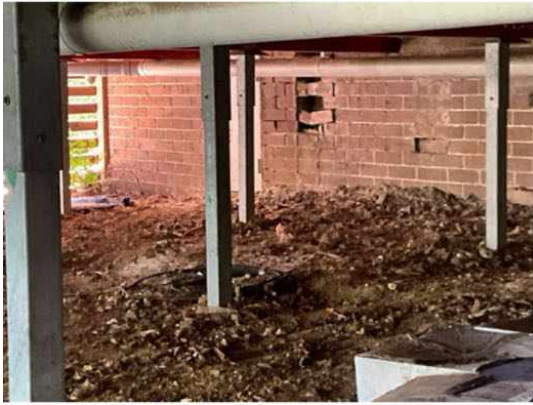
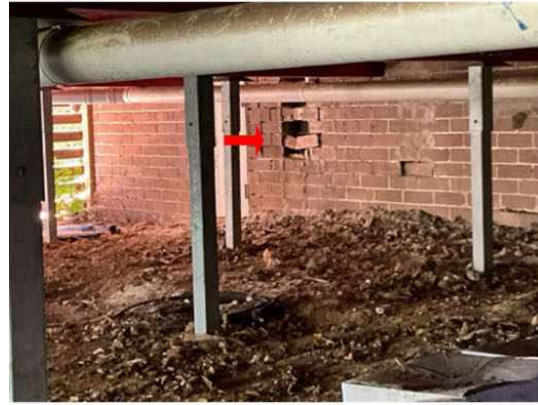
Building: Main Building  
Location: Subfloor  
Finding: Brickwork - Cracking [Repair required]  
Information: cracking was identified to the brickwork in this area. Cracks of this type are likely to have been caused by minor expected movement of building elements, but may also have a structural cause that is more significant.

A crack of this size may be repaired by extensive filling. Additionally, further remedial works to associated building elements, such as eave sheeting or external door frames, is likely to be required.

A qualified bricklayer should be contacted immediately to estimate and perform repair and restoration works. Consultation with a structural engineer may be required where structural instability is found to be the underlying cause of the cracking.

Always contact a building inspector should cracks widen, lengthen, or become more numerous.

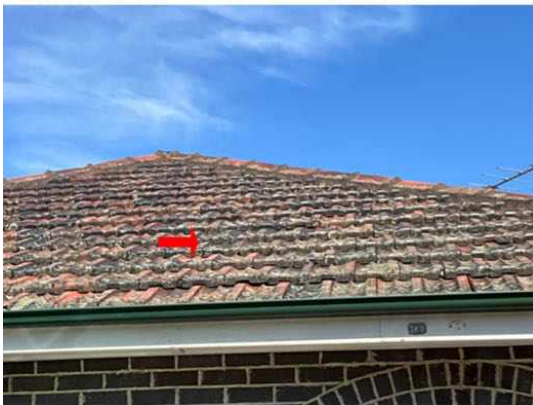
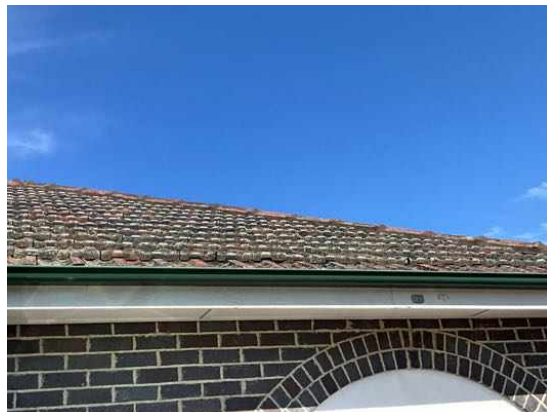
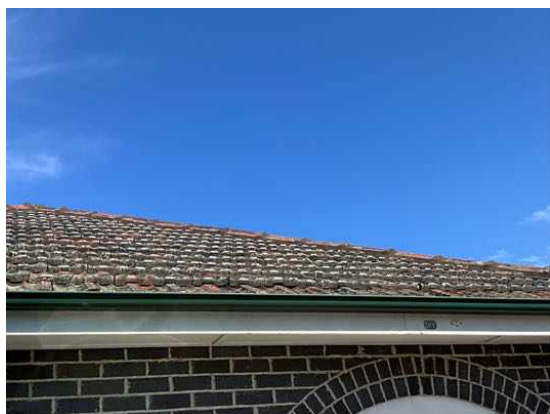
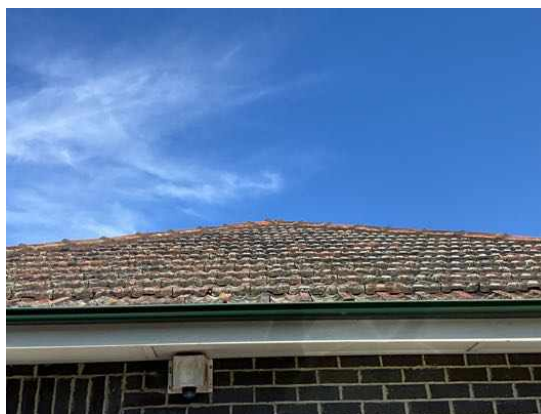
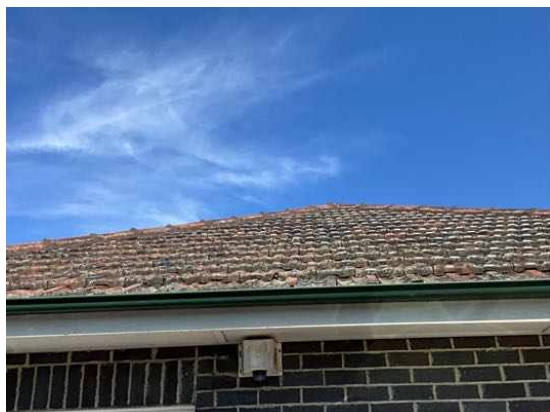
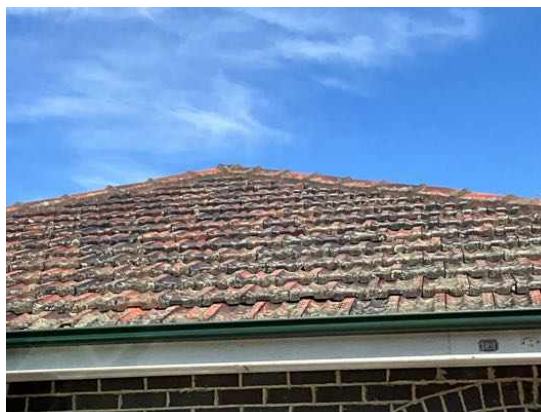
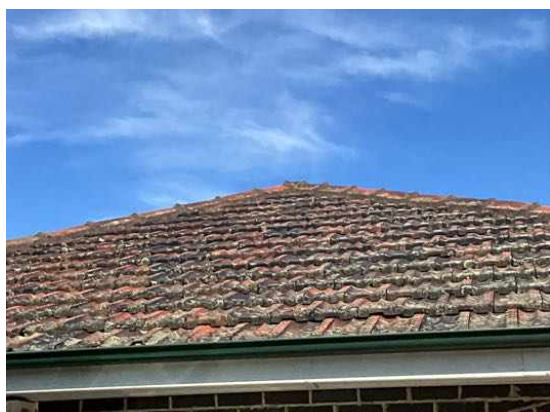
### Finding 3.01

Information: Inspection of the roof revealed widespread weathering to the tiled roof surface. The tiles show loss of surface finish, colour fading, and age-related deterioration typical of older roof coverings. Although no significant cracking was noted, weathering can lead to increased porosity, reduced water-shedding capability, and a higher risk of future cracking or displacement during adverse weather conditions.

A licensed roofer should be engaged to undertake a closer inspection, carry out routine maintenance, and replace any tiles that may be compromised. Ongoing monitoring is recommended due to the age and condition of the roof covering.

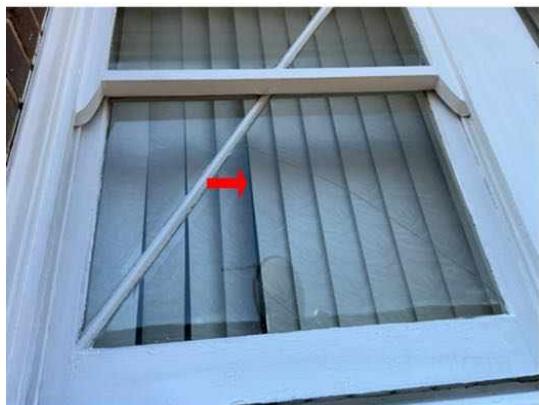
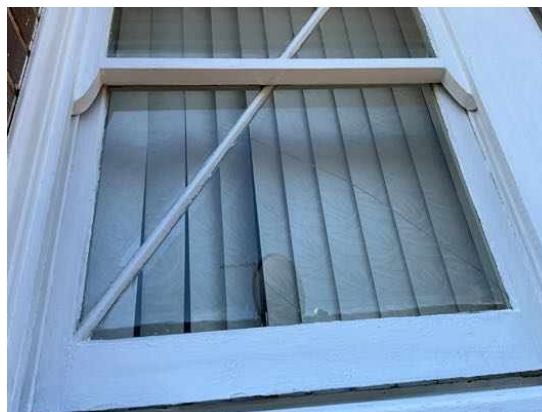
### Finding 3.02

Building:	Main Building
Location:	Exterior walls - right side
Finding:	Cracked Glass
Information:	The glass panel is broken, exhibiting cracks and sharp edges.

Risk: The broken glass poses a safety hazard, increasing the risk of injuries due to cuts or lacerations to individuals in the vicinity. Additionally, it compromises the structural integrity of the surface, potentially leading to further damage or accidents.

A qualified glass repair technician or contractor should be contacted to assess the damage and perform the necessary repairs or replacement of the broken glass panel.

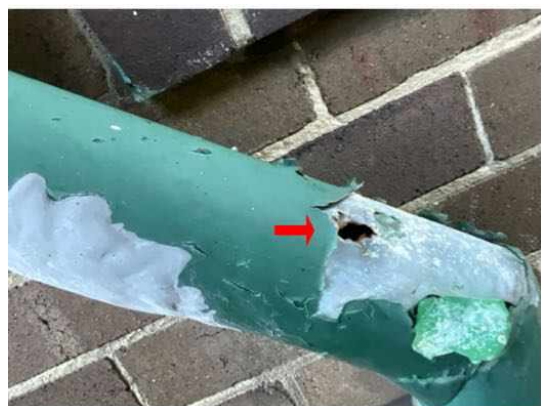
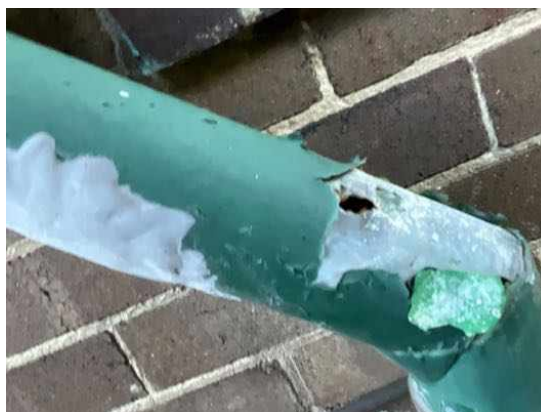
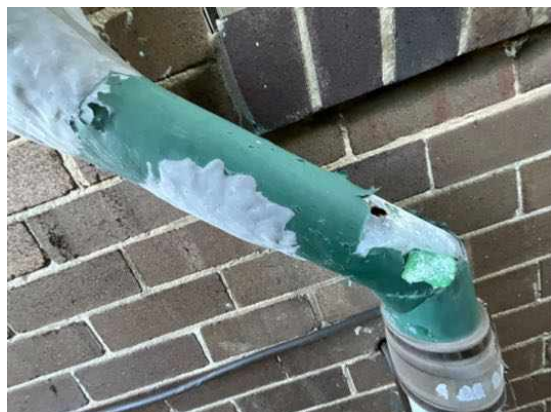
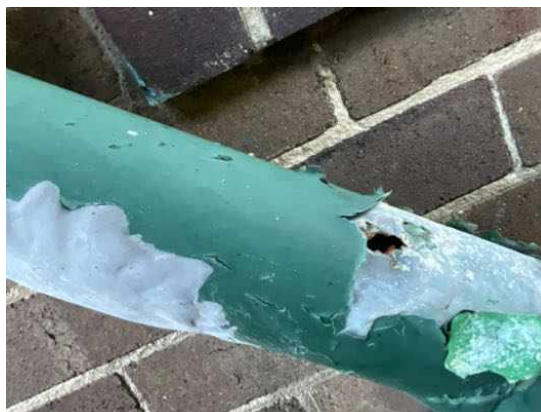
### Finding 3.03

Building:	Main Building
Location:	Exterior walls - left side
Finding:	Downpipes Rusty / leaking
Information:	The downpipes on the property show significant signs of rust and leakage. The rust has weakened the structural integrity of the pipes, and the leaks are causing water to escape, potentially leading to further damage to the building's exterior and foundation.

- **\*\*Water Damage\*\***: Leaking downpipes can cause water to accumulate around the foundation of the building, leading to erosion, foundation damage, and potential structural instability. Additionally, water seeping into walls can cause mold growth, wood rot, and other moisture-related issues.

- **\*\*Structural Deterioration\*\***: The rusting of the downpipes compromises their ability to effectively channel water away from the building, increasing the risk of corrosion spreading to other parts of the drainage system and potentially causing more extensive damage.

A licensed plumber or roofing contractor should be hired to inspect and replace the rusty and leaking downpipes. The new downpipes should be made from rust-resistant materials and properly sealed to prevent future leaks. Regular maintenance checks should also be performed to ensure the drainage system remains in good working order, preventing water damage to the property.

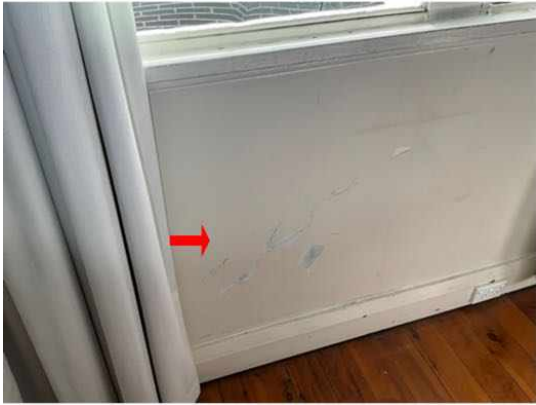
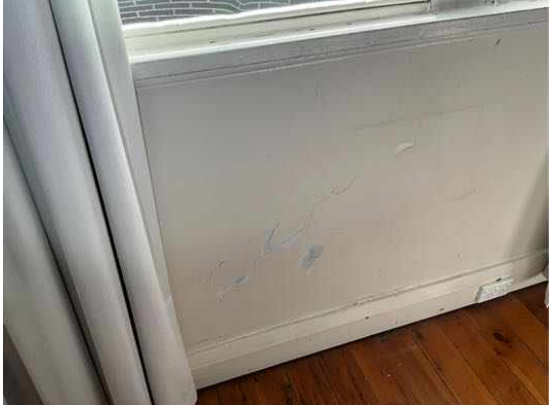
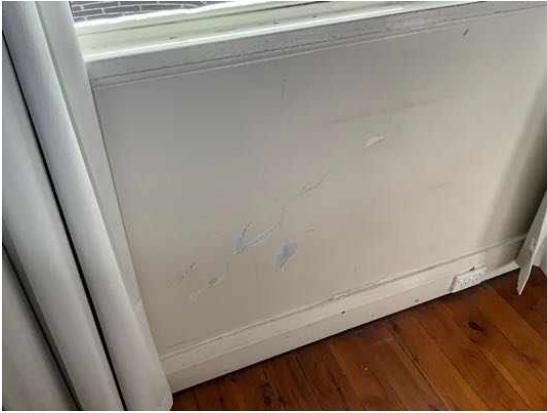
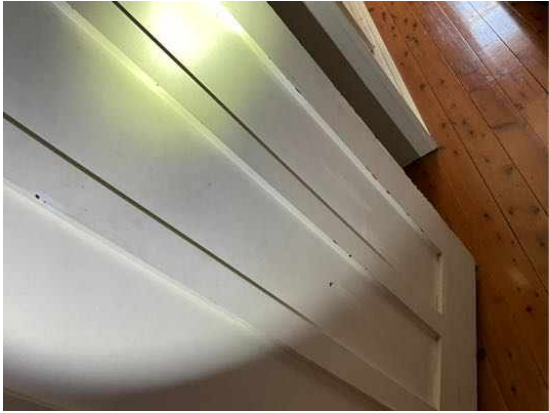
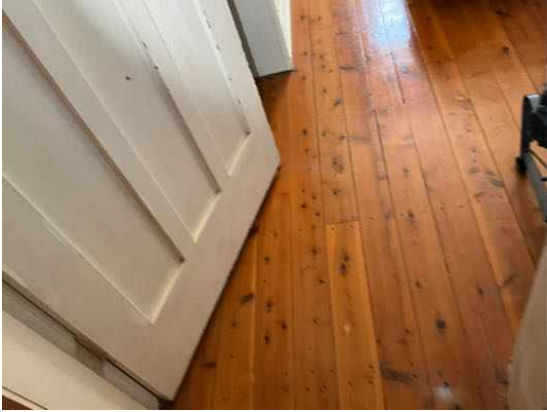
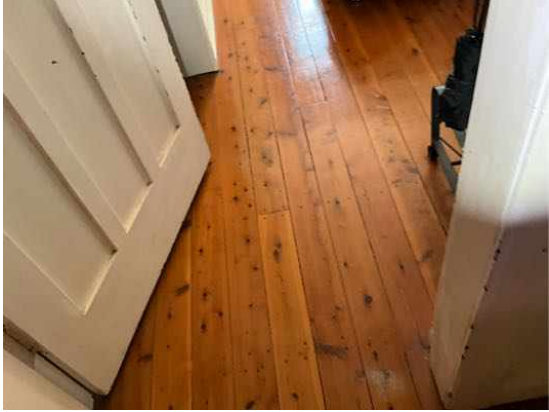
### Finding 3.04

Building:	Main Building
Location:	All Areas
Finding:	Paint surface - Scratches
Information:	Scratches have been identified on the paint surface, detracting from the overall appearance and quality of the painted surface.

1. Aesthetic Degradation: Scratches mar the appearance of the painted surface, diminishing its visual appeal and potentially lowering property value.
2. Corrosion Vulnerability: Exposed areas of bare metal due to scratched paint are susceptible to corrosion, leading to structural damage and compromised durability.
3. Environmental Hazards: Scratched paint can release hazardous chemicals into the environment, posing risks to both human health and the ecosystem.

A qualified painter should address the issue promptly to repair the scratched paint. Depending on the severity of the scratches, repair options may include sanding,

priming, and repainting the affected area to restore the integrity and appearance of the paint surface.

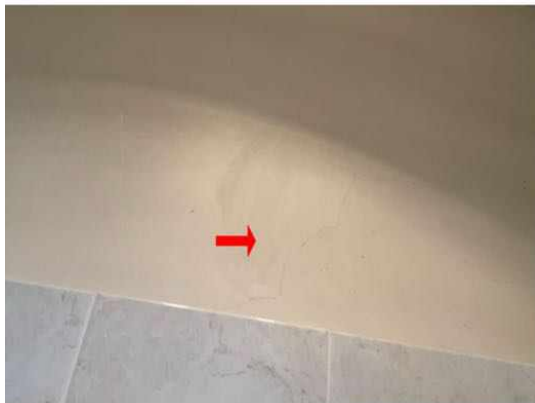
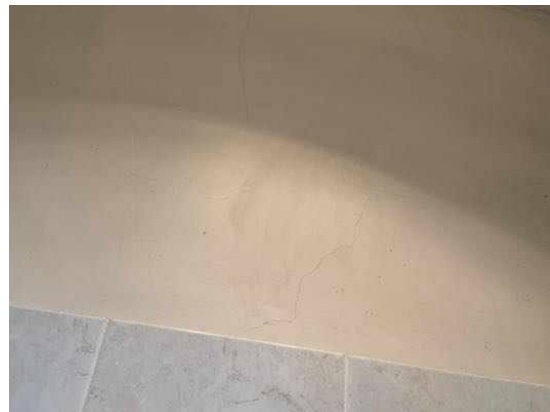
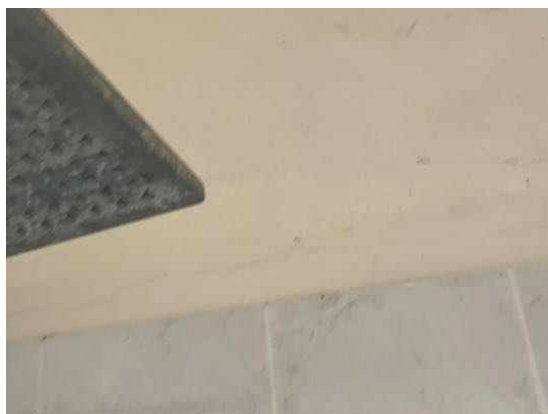
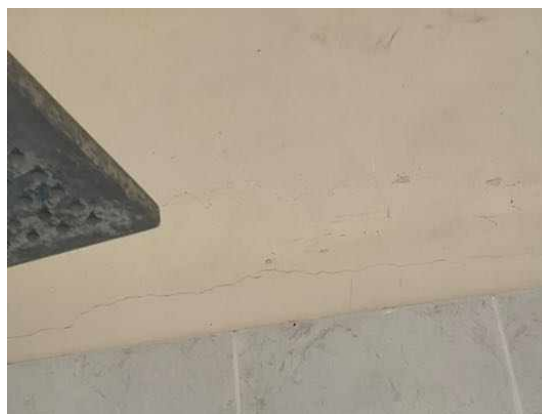
Finding: Brickwork - Cracking [Fine]

Information: Although fine cracks are quite noticeable, they are often only considered to be an appearance defect and usually do not indicate any structural damage. Generally, the cause of a fine crack is indicative of a separation between brickwork and mortar throughout the structure, but single bricks may also show cracks of this nature.

Cracking of this nature can generally be repaired with minor filling and should be conducted by a qualified bricklayer.

Always contact a building inspector should cracks widen lengthen or become more numerous.

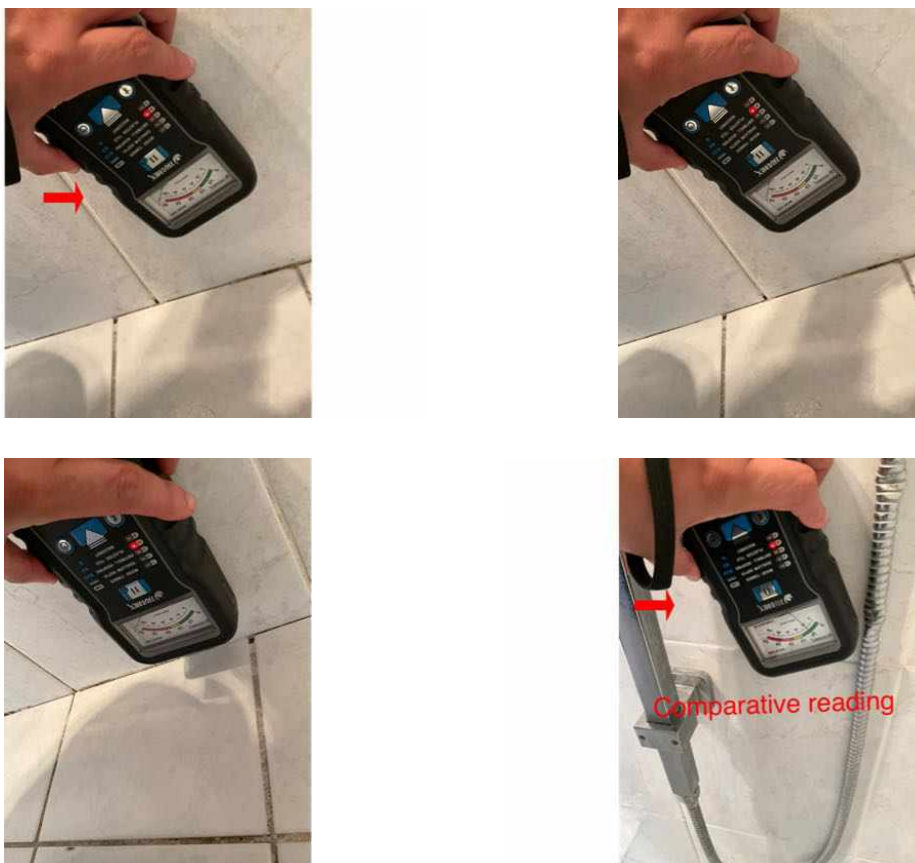
### Finding 3.06

Building:	Main Building
Location:	Ensuite
Finding:	Shower - Damp
Information:	Damp is evident to the lower 300mm of wall to the shower alcove. This defect is quite common, and is suspected to have been caused by moisture permeating through the grouting in this area, which shows evidence of deterioration. Leaking pipes within the adjoining wall is also a possible cause.

Damp (or structural damp) refers to the presence of unwanted moisture in the structure of a building, either as the result of intrusion from outside, or condensation from within the structure. In the shower area, internal water leaks or other sources of excessive moisture are generally the cause of damp.

Unmanaged damp in the shower recess is likely to facilitate the formation and development of mould and fungi growth, decaying associated building materials and compromising their structural integrity. It is important to address damp conditions, as the World Health Organisation notes that excess moisture leads - on almost all indoor materials - to growth of microbes such as moulds, fungi and bacteria, which subsequently emit spores and other matter into the indoor air. Exposure to these contaminants is associated with a wide range of respiratory and other health-related problems.

Consultation with a qualified plumber or bathroom specialist is advised immediately to identify the cause of damp and to perform remedial works as required. Where excessive mould growth is present, further inspection by a specialist environmental health inspector should also be considered.

Always ensure that sealant and grout is in good condition to prevent any moisture issues occurring in the future.

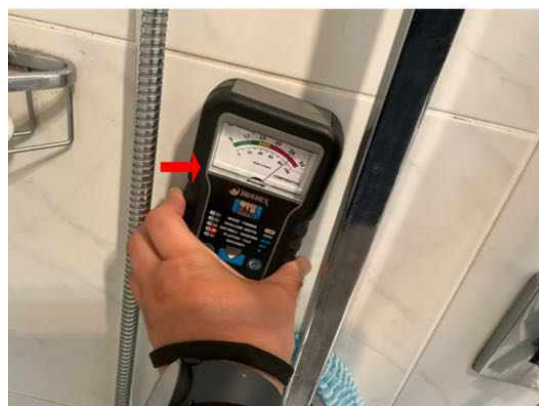
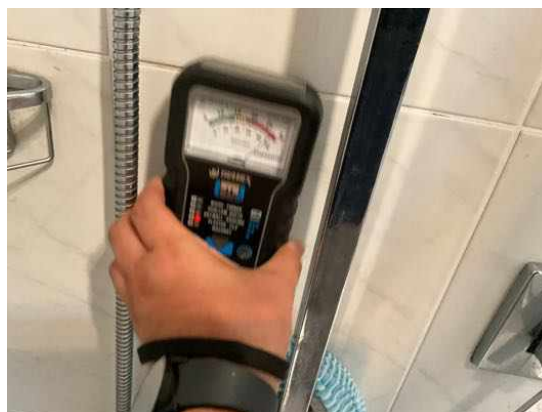
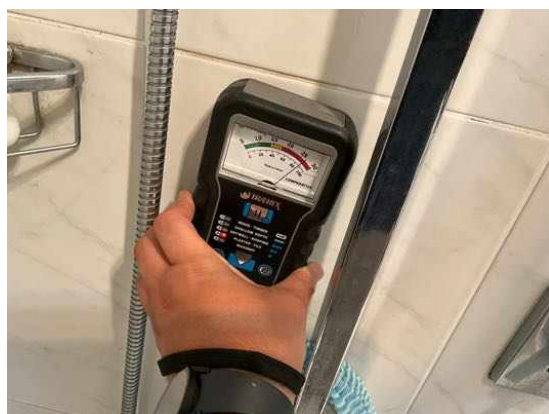
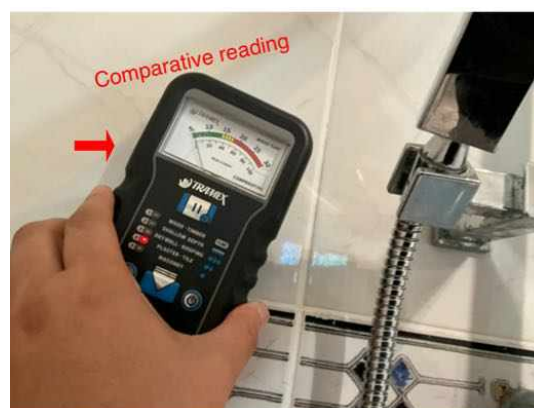
### Finding 3.07

Building:	Main Building
Location:	Bathroom
Finding:	Evidence of excessive moisture was present at the time of inspection
Information:	Excessive moisture is present behind the bathroom tiles, indicating a potential water leakage issue within the wall.

The prolonged presence of moisture can lead to mold growth, deteriorate the structure, and create an environment conducive to health hazards. Additionally, it may compromise the adhesive holding the tiles, leading to their detachment.

A licensed plumber or a qualified contractor specializing in water damage remediation should investigate the source of the moisture, fix any leaks, and address the damage. Additionally, replacing affected tiles and ensuring proper waterproofing are crucial to preventing future issues.

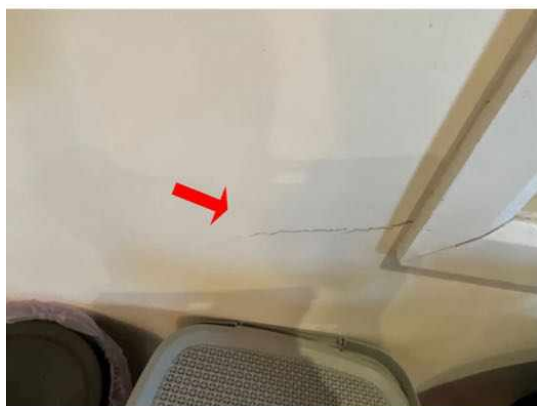
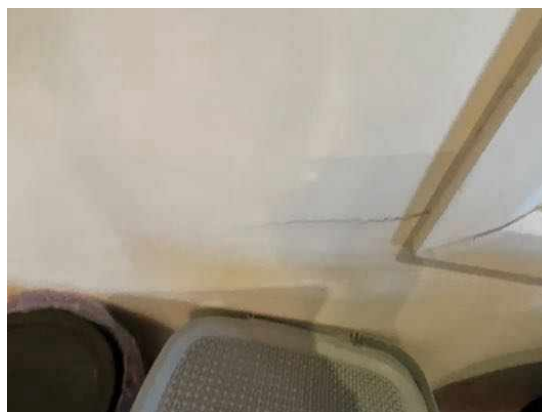
### Finding 3.08

Building:	Main Building
Location:	Kitchen
Finding:	Cracking - Damage Category 2 - Noticeable (up to 5mm)
Information:	Noticeable cracks are a common occurrence as a result of many primary defects. Such causes may include age, general wear and tear, expected building movement, general expansion/contraction of building materials in different weather conditions, and/or minor failings in the installation or application of building materials.

Noticeable cracks may result in minor sticking or jamming of associated doors and windows, which require easement. However, noticeable cracks are easily filled and repaired. A plasterer can be consulted to install an expansion joint at this point to allow for this movement during different weather conditions.

Monitoring of all cracking should be conducted frequently. Always contact a building inspector should cracks widen, lengthen, or become more numerous. Additionally, your building inspector should also be contacted if associated building elements such as doors and windows become more difficult to operate over time.

Relevant tradespeople, such as carpenters, painters and plasterers, should be appointed to perform remedial works, as deemed necessary.

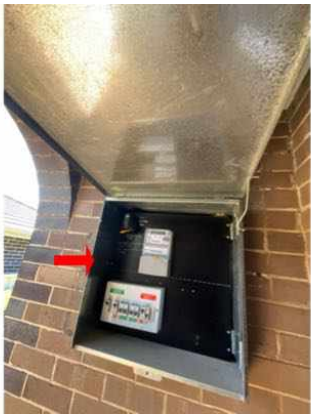
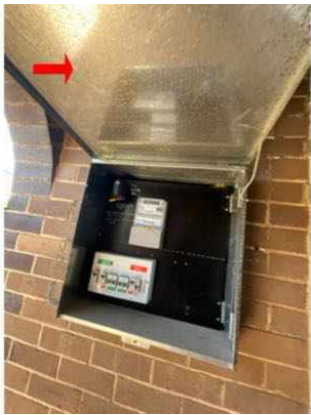
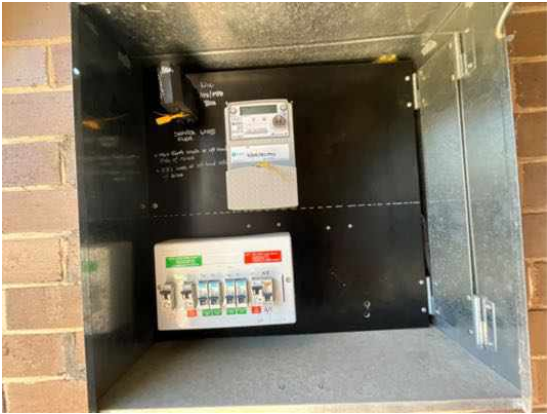
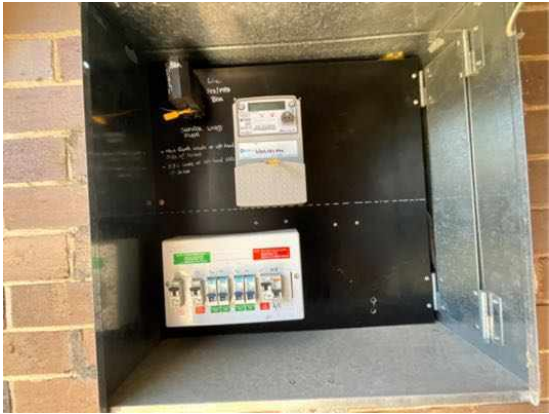
Building: Main Building  
 Location: Front porch  
 Finding: No Evidence of Termite Management System - Durable notice / Legible Sticker  
 Information: The application of a pre & post-construction chemical termite barrier is highly recommended for all properties. Such barriers are highly effective in preventing termite attack on any timber building elements throughout the property.

A durable notice was not placed in the switchboard unit to indicate current termite barriers is legible at the time of inspection.

Client must seek further information from the vendor or real estate agent if the conditions of termite management systems were maintained.

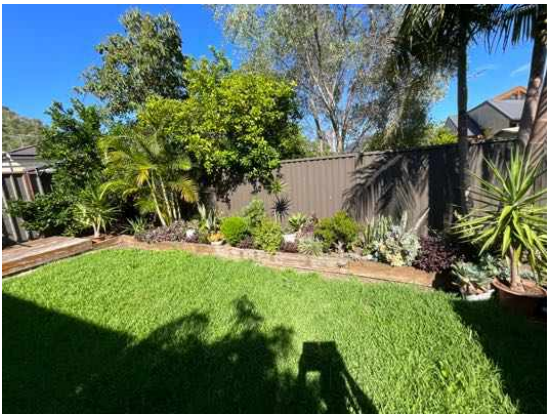
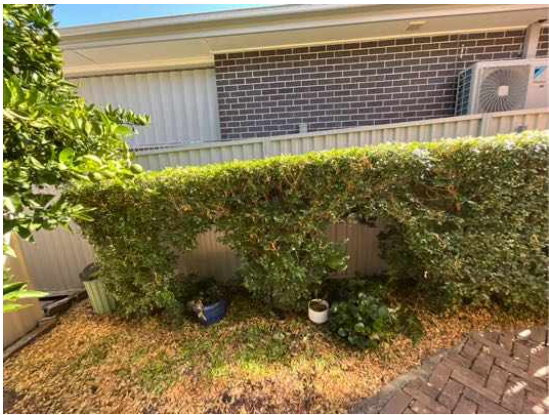
**Finding 6.02**

Building: Main Building  
Location: All Areas  
Finding: vegetation around a property can increase the risk of termite infestation  
Information: The presence of vegetation around a property can increase the risk of termite infestation, as it provides a conducive environment for them. To address this, consider maintaining a clear space between the vegetation and your home. If you suspect a termite issue, it's advisable to consult with a licensed pest control professional for inspection and treatment.

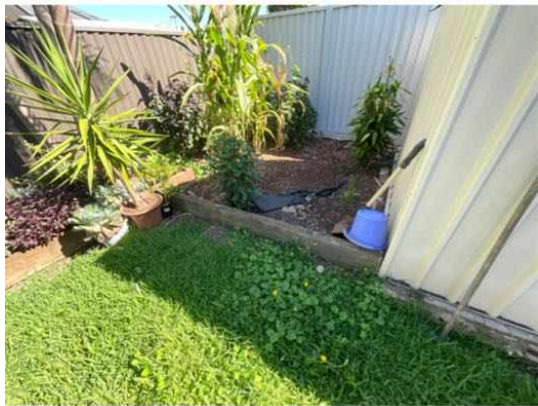
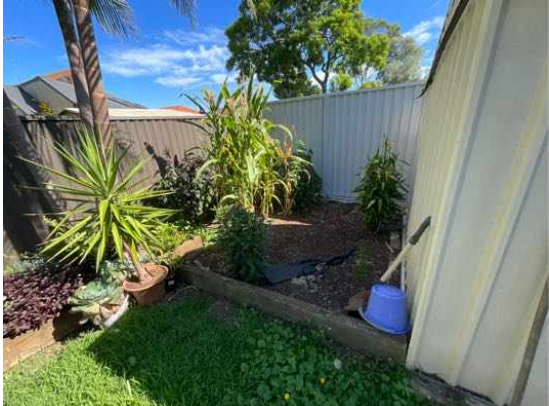
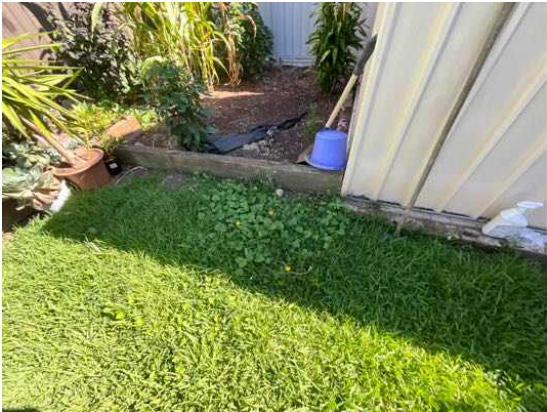
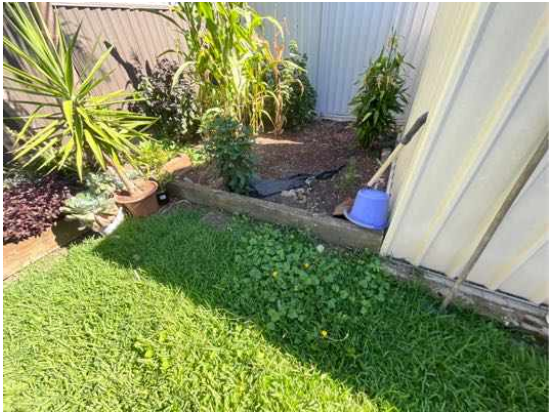
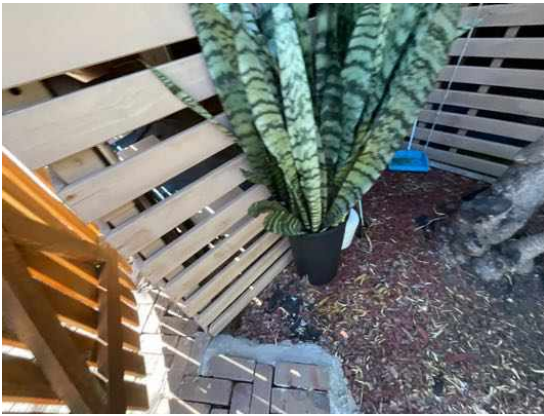
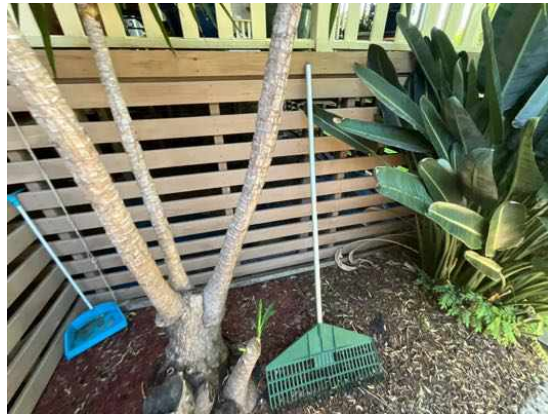
**Finding 6.03**

Building: Main Building  
 Location: All Areas  
 Finding: Timber on ground / conducive conditions to termite damage  
 Information: Timber on the ground is indeed conducive to termite damage. Termites are known to thrive in moist environments, and wood in contact with soil or moisture is more susceptible to infestation.

To prevent this, it's important to keep timber elevated and away from direct ground contact. Regular inspections and proper termite control measures are also essential to protect your wooden structures from termite damage.

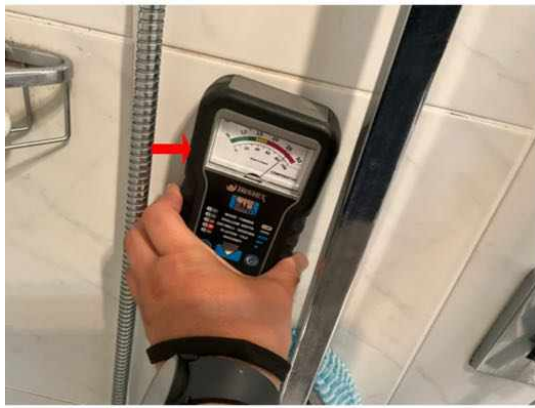
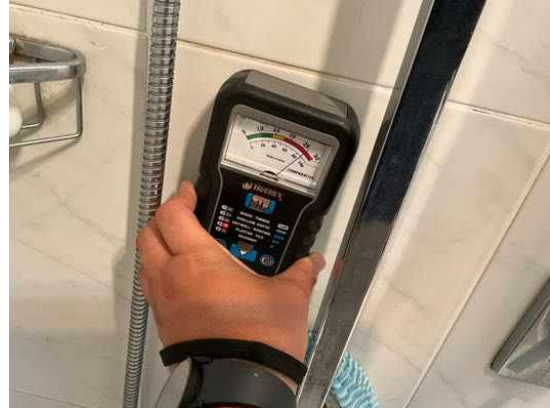
Building:	Main Building
Location:	Bathroom
Finding:	Excessive moisture - Conducive to Timber pest
Information:	Excessive moisture can attract termites and produce conditions that promote fungal growth and wood decay.

Excessive moisture is generally caused by deteriorated inadequate or missing roof drainage leaking plumbing pipes or fixtures poorly plumbed HWS overflows or condenser units and poor site drainage.

Prior to any remedial works being performed a qualified plumber should be appointed to further inspect the property and to identify the cause of the excessive moisture. Works to remove affected building elements may then be necessary and should be performed by an appropriate tradesperson.
