Building and Timber Pest Inspection Report

Inspection Date: Wed, 18 Feb 2026

Property Address: 13 Wickham Rd, Hampton East VIC 3188,
Australia

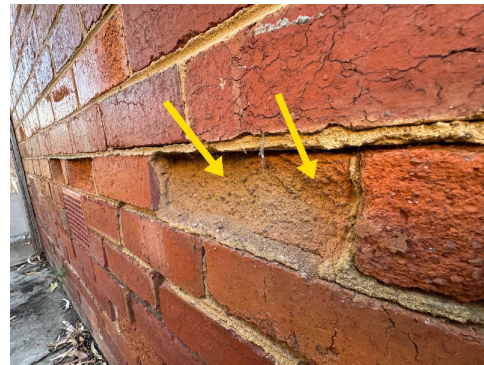
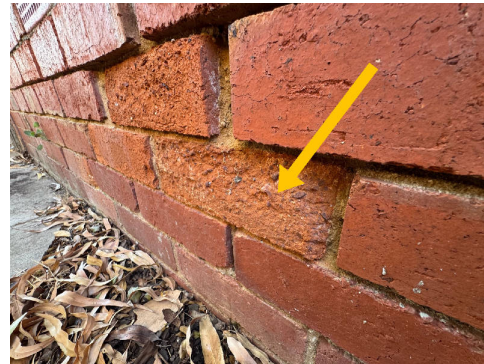
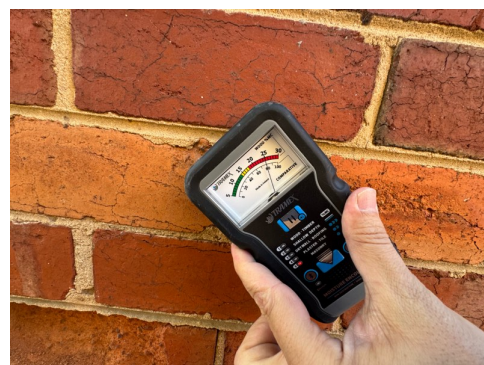
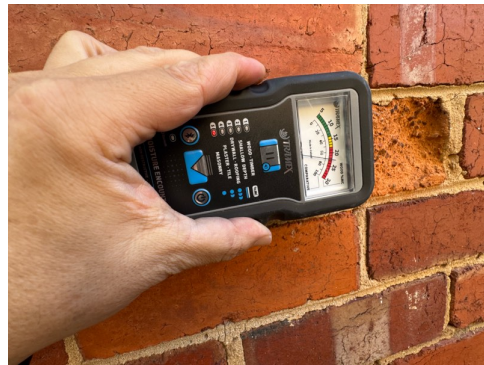
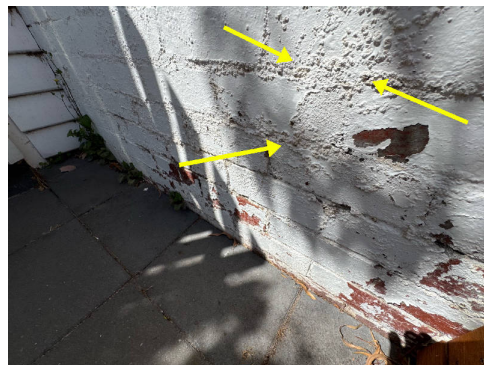
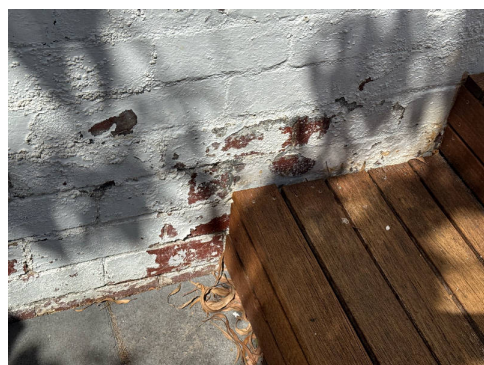
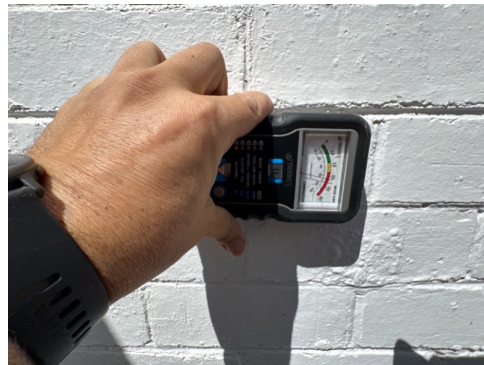
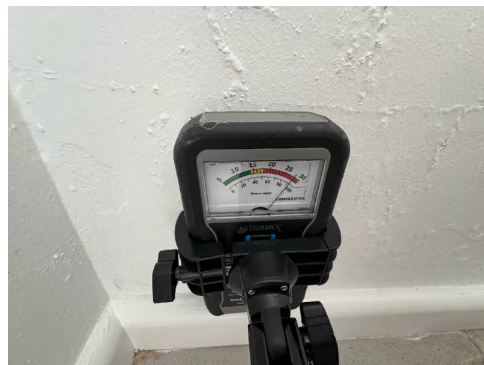
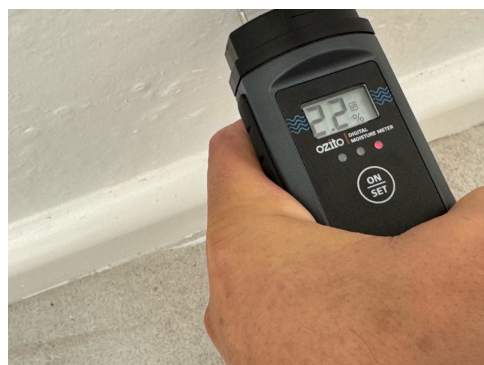
Rising damp is generally managed by the installation of a damp proof course during construction. A Damp Proof Course (DPC) is an impermeable barrier at the base of the wall above ground level. The DPC may have been omitted as a consequence of poor workmanship, or it may have been bridged where materials built up against the side of the house allow moisture ingress above the DPC level.

The first step in addressing rising damp is to diagnose the cause. The identified cause should be addressed first before addressing the appearance and other defects which have resulted from the rising damp. If the original cause is not resolved, further cases of damp are likely to ensue, resulting in secondary defects.

Consultation with a registered builder is advised immediately to identify the cause of the damp and perform remedial works as required.

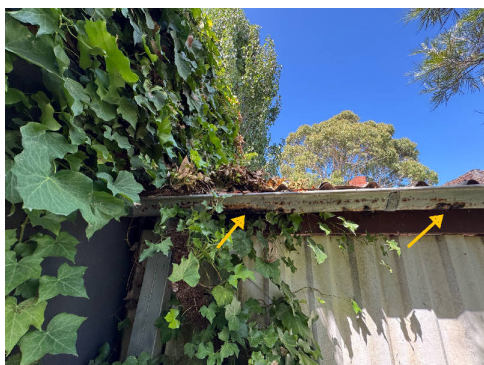
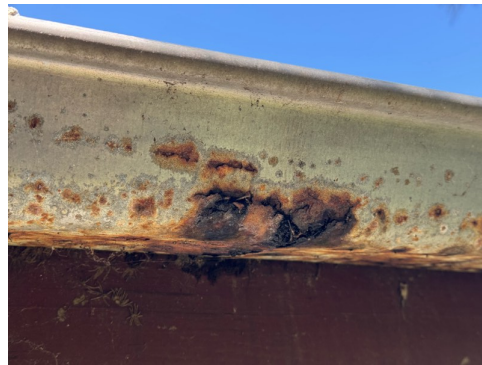
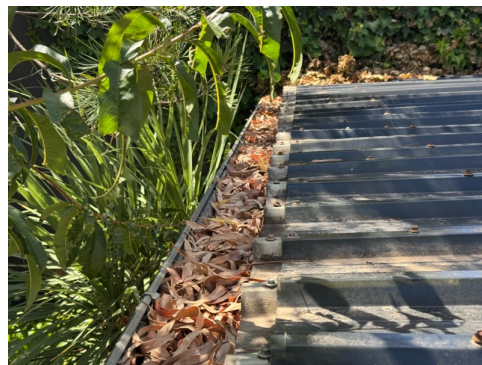
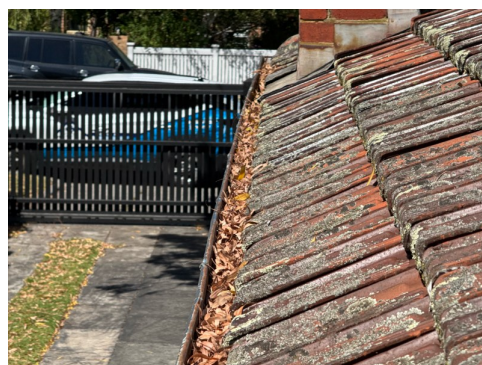
Finding 3.01

Finding: Roof drainage system-poor condition

Information: At the time of inspection, the roof drainage system was found to be in poor condition, particularly to the western elevation of the building. Sections of the gutters are heavily corroded, with perforations and areas of complete material loss, significantly compromising the ability of the guttering to effectively collect and discharge rainwater. In addition, all gutters and roof valleys were blocked with accumulated leaf debris, further restricting stormwater flow and increasing the likelihood of overflow during rainfall events.

Some downpipes were also missing, resulting in uncontrolled discharge of stormwater adjacent to the external walls. This condition is likely to contribute to ongoing moisture exposure to fascia boards, eaves linings, and wall elements, increasing the risk of timber decay, paint failure, and potential foundation movement over time. Blocked gutters and valleys may also accelerate corrosion due to prolonged water retention and organic build-up.

Given the extent of corrosion, blockage, and deterioration observed, localised patch repairs would not be adequate. It is recommended that the affected guttering and associated components be fully replaced by a licensed roofing plumber. The entire roof drainage system should be cleared of debris and assessed for correct falls, secure fixing, and compliant stormwater discharge away from the building.

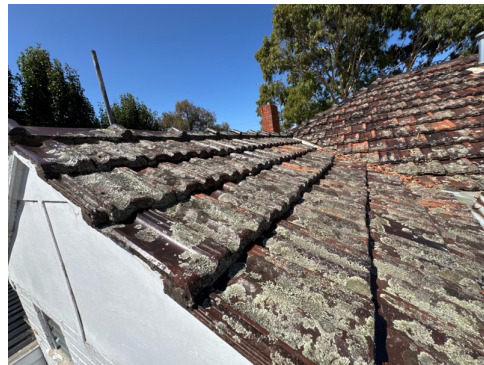
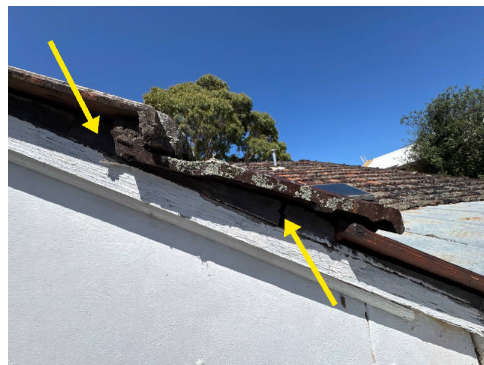
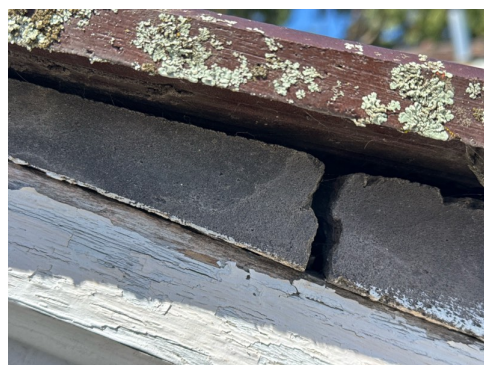
Finding: Roof tiles – fair condition (fretting tiles) and localised mortar bedding deterioration

Information: At the time of inspection, the tiled roof covering was found to be in serviceable condition; however, short-term maintenance works are required. Lichen growth was present across multiple roof tile surfaces, and cleaning is recommended as part of routine roof maintenance. Accumulated organic growth can retain moisture and contribute to accelerated surface deterioration of the tiles over time.

Inspection within the roof void identified several tiles, in accessible areas, affected by fretting. Fretting is characterised by surface erosion and granular breakdown of the tile material, which may reduce long-term durability. Ongoing lichen growth may further accelerate this deterioration process if not addressed.

In addition, localised cracking and deterioration of bedding mortar were identified, particularly to ridge tiles. While the current condition does not require immediate urgent action, comprehensive maintenance is recommended. All cleaning, tile replacement, and renewal of defective bedding mortar should be carried out by a registered roof contractor to ensure compliant and durable rectification works.

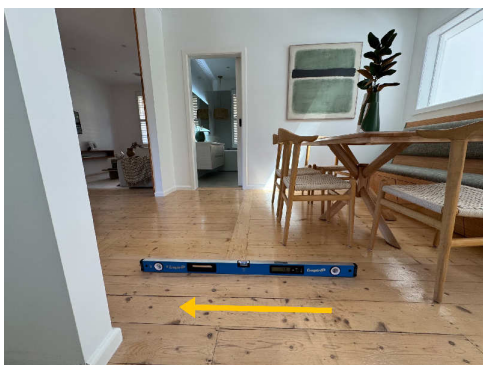
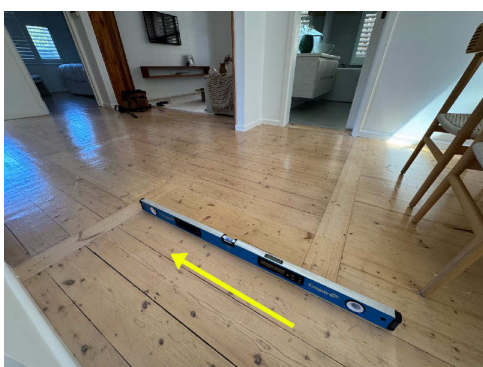
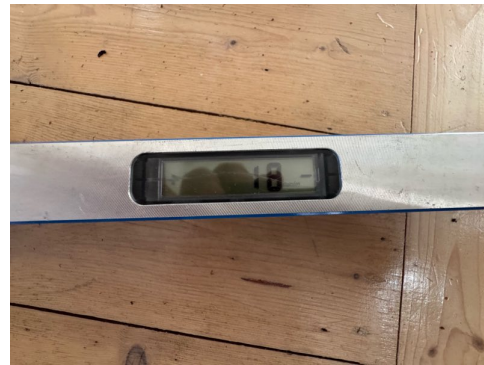
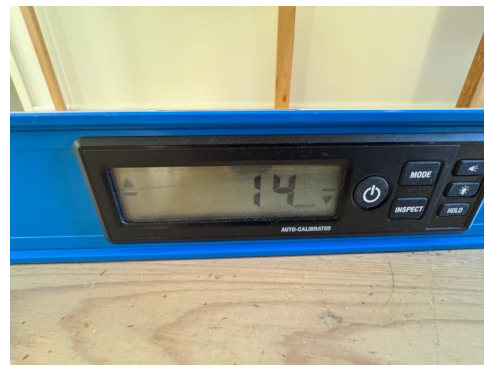
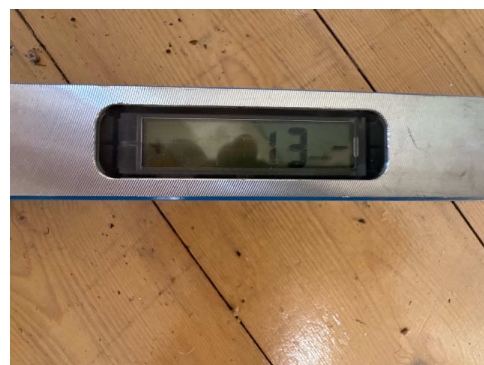
The degree of slope recorded exceeds normal surface tolerances for finished flooring and may be indicative of subfloor movement, stump settlement, bearer or joist deflection, or differential foundation movement.

It is recommended that the subfloor area be monitored. Should further deviation occur, or if doors and windows begin to bind or become difficult to operate, further assessment will be required to determine the underlying cause of the unevenness. If ongoing movement is suspected, engagement of a structural engineer is recommended to undertake a comprehensive assessment and provide rectification recommendations if required.

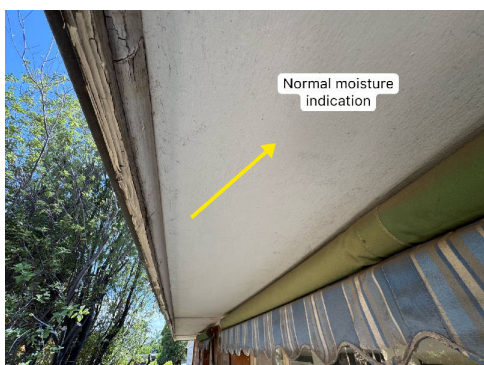
Finding 3.04

Finding: Eave lining - elevated moisture indication and water staining

Information: At the time of inspection, water staining was visible to the eave lining in this area. Moisture meter testing returned elevated readings to the affected section compared to surrounding areas. The condition is consistent with moisture ingress from the roof drainage system. This is likely associated with blocked or overflowing gutters allowing stormwater to back up and track into the eave cavity. Continued moisture exposure may lead to deterioration of the eave lining, decay to concealed timber framing, and potential mould development. It is recommended that the roof drainage system be thoroughly cleaned and assessed to ensure correct discharge.

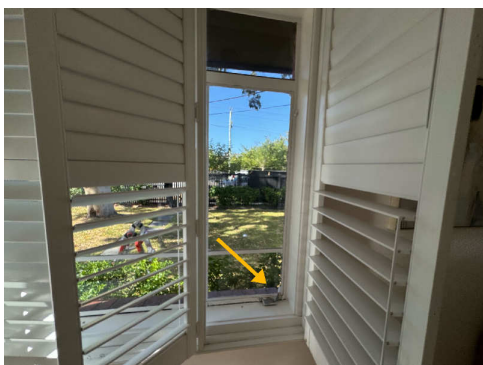
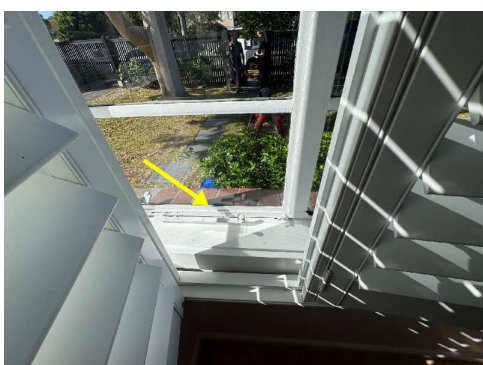
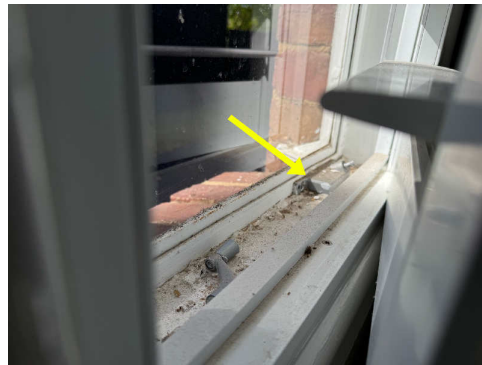
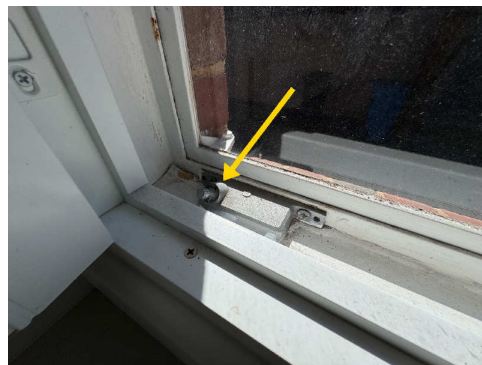
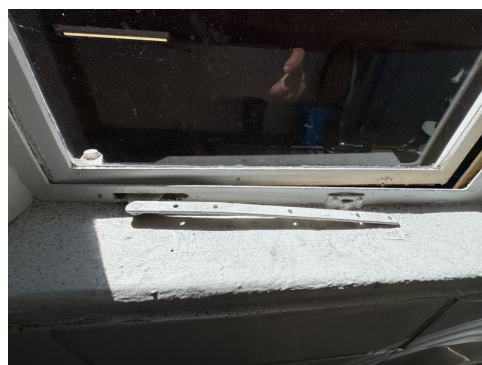
Finding 3.05

Building: Main Building
Location: windows
Finding: Some windows – non-functional

At the time of inspection, it was noted that several windows were not operating as intended and were difficult or unable to be opened and closed properly. The condition impacts natural ventilation and may restrict emergency egress where applicable.

Some window winder mechanisms were found to be defective and not functioning correctly, preventing smooth operation of the window sashes. In addition, certain window sashes were bonded to the window frames due to paint build-up at the junction between the sash and frame, restricting movement and preventing opening.

It is recommended that defective winder mechanisms be repaired or replaced as required and that paint build-up between the sash and frame be carefully removed to restore operation. A qualified handyman or window technician should be engaged to carry out the necessary rectification works.

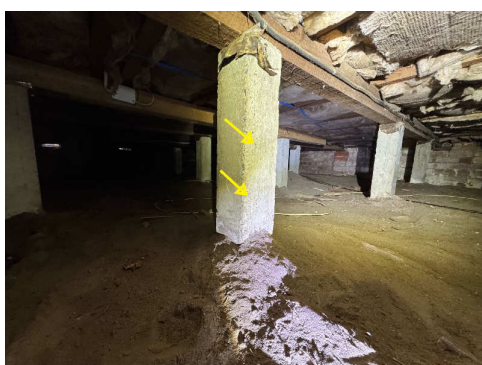
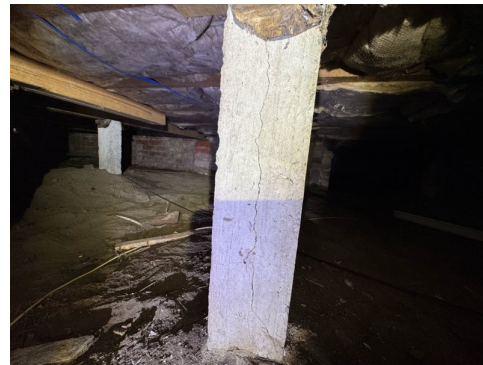
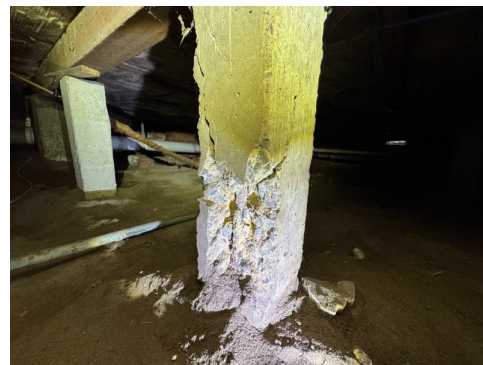
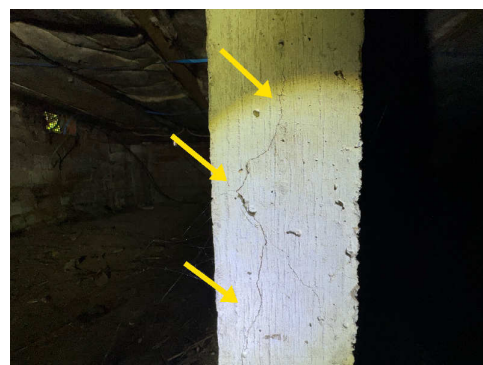
Finding 3.06

Finding: concrete stumps - localised cracking

Information: During the subfloor inspection, some concrete stumps were found to have developed visible cracks along their body. These cracks vary in width and length, indicating potential stress or age-related degradation. While some hairline cracking can occur due to natural shrinkage or suggest that the internal reinforcement may be compromised or the stumps are under uneven loading conditions.

cracks they can allow moisture to penetrate the concrete and reach the internal steel reinforcement. Once moisture enters, the steel can begin to rust and expand—a process known as concrete spalling or "concrete cancer." This expansion exerts internal pressure on the concrete, leading to further cracking and, eventually, a total loss of the stump's structural integrity, which could result in floor subsidence or unlevel surfaces.

It is recommended that this area should be monitored at if cracks width is increasing and more sump has been effected the client should engage a structural engineer to comprehensive assessment a Depending on the severity, these stumps may require remediation or complete replacement to ensure the long-term stability of the building's foundation. In the meantime, the area should be monitored for any increase ing in width of crack and number of stumps has been effected any signs of movement, such as sticking doors or windows in the rooms directly above.

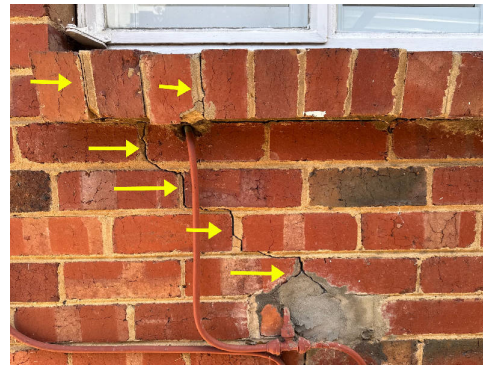
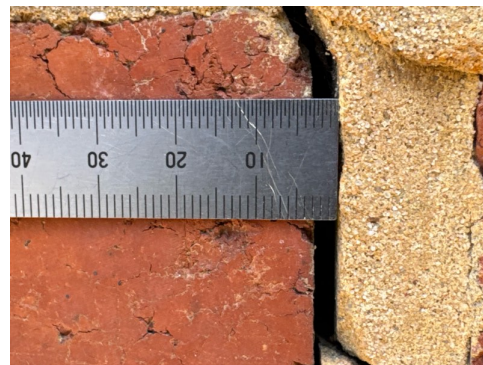
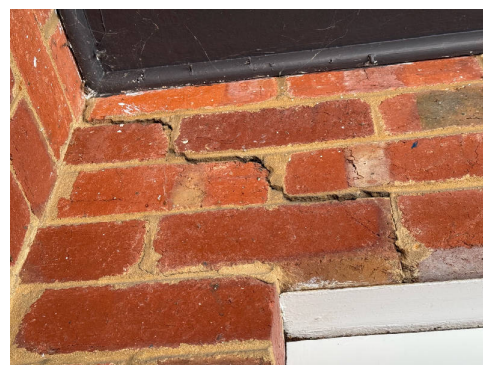
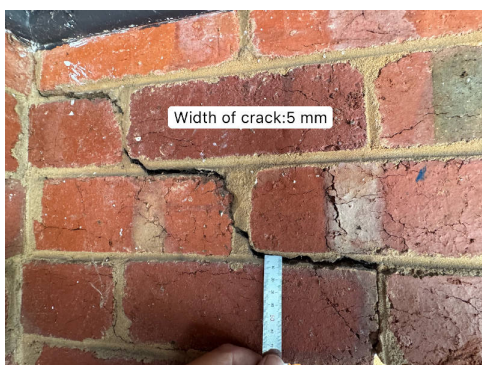
Finding 3.07

Finding: Brickwork - Step cracking(category 3 - noticeable cracking <5 mm)

Information: Step cracking was identified in the exterior walls at the time of inspection. This type of cracking, like other forms, can have various causes, with the most common being the subsidence of adjacent footings. Step cracking is relatively common, particularly near windows, doors, and other openings. The failure of mortar between affected bricks highlights the stresses and tensions impacting the wall. If the step cracking is extensive or severe, it is recommended that a structural engineer be consulted. Minor step cracking, however, can serve as an early warning to address underlying issues such as nearby trees, water leaks, soil erosion, or reactive soils, which may be contributing to the stress on the wall.

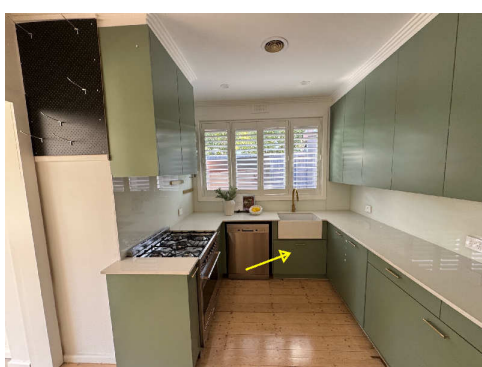
Finding 3.08

Finding: Active leakage beneath kitchen sink

Information: At the time of inspection, active water leakage was identified beneath the kitchen sink from waste connection, with moisture evident to the base of the cabinet.

The leakage is likely associated with the plumbing connections and may lead to deterioration of the vanity unit and surrounding materials if not rectified. Rectification by a licensed plumber is recommended.

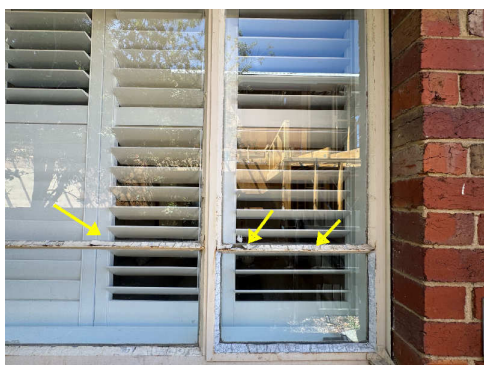
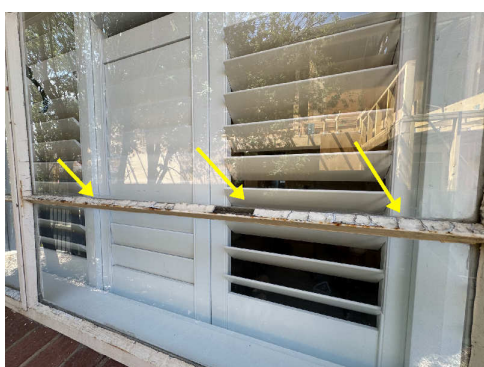
Finding 3.09

Finding: Window seals - deteriorated

Information: The window seals have deteriorated and are in a generally poor condition. Due to frequent exposure to weather conditions and subsequent moisture, deterioration of window seals is expected in a property of this condition and age.

Where window seals have deteriorated, the window is no longer weather-tight; rain penetration and subsequent water damage is therefore likely to ensue. Insulation of the area against external weather conditions will also be compromised.

It is recommended that all deteriorated window seals be replaced by a general handyman or sealant expert to prevent any further damage and to restore the window to a fully functional level.

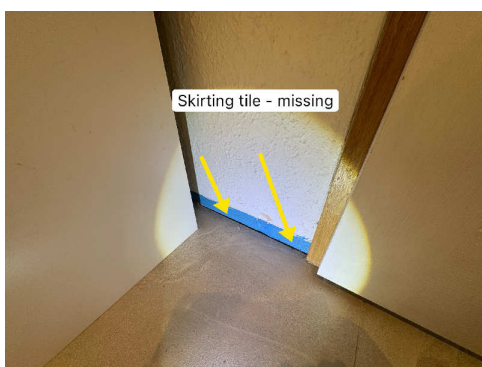
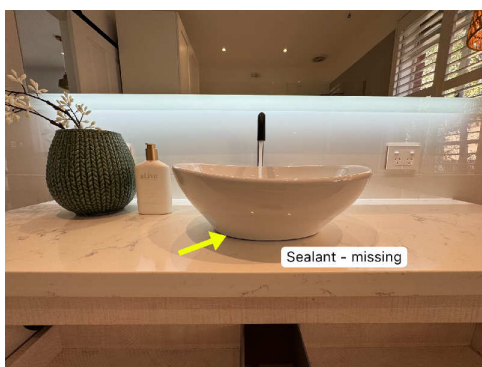
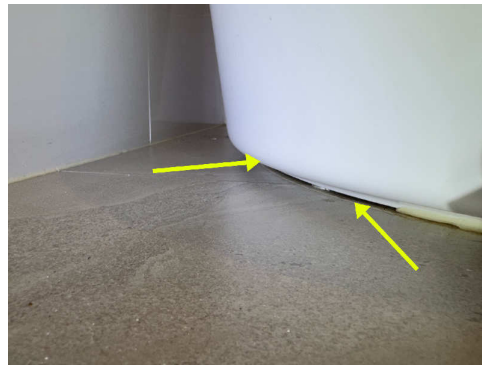
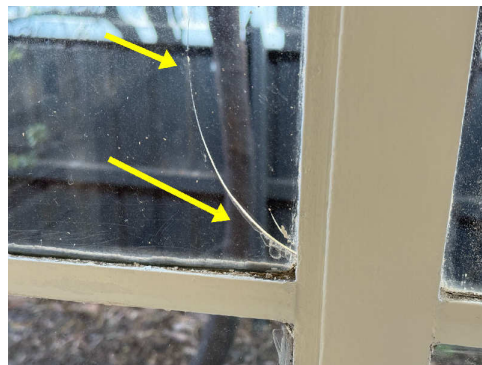
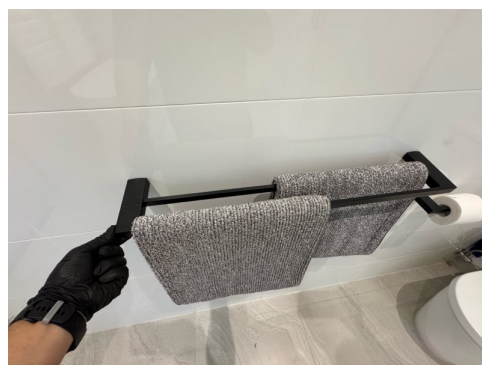
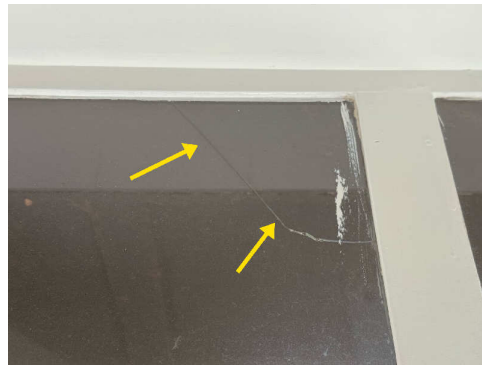
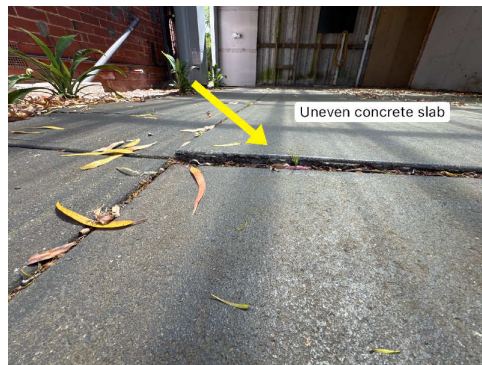
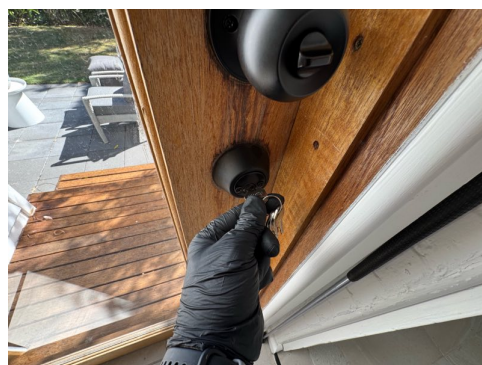
Finding 3.10

Finding: Common Maintenance Defects (Wear and Tear)

Information: In every home, regardless of age, there are maintenance defects or normal wear and tear that occur over time. These issues are completely normal and can be grouped under a broad category of expected wear, which can either be overlooked as part of the home's character or addressed through repairs. Examples of these defects might include hairline cracks in concrete or walls, loose door or window handles, patched sections on walls, and dents or deformities in fences or other building elements. These are all typical issues that arise from the natural aging of a house.

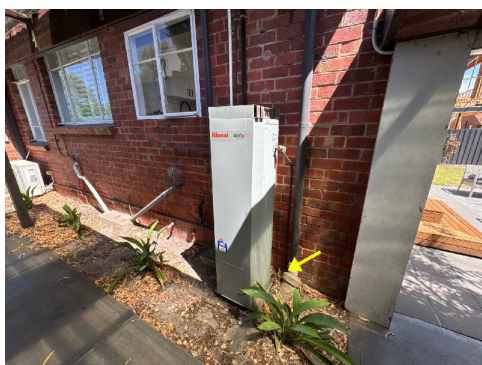
Finding: HWS - Drip tray missing

Information: The drip tray for the Hot Water System unit is missing, allowing leaks from the unit to affect the surrounding building elements. Generally, a drip tray will be installed to catch expected leaks from the unit, and allow them to evaporate without creating excessive moisture in the area.

Without a drip tray, the leaks from the HWS unit are creating conditions in the area that is likely to develop in the rust, corrosion, or wood rot of associated building elements. Additionally, excessive moisture creates an environment that is conducive to termite and timber pest activity, creating potential for further secondary damage.

It is highly advised that a licensed plumber be appointed to install the necessary drip tray in order to prevent any secondary damage.

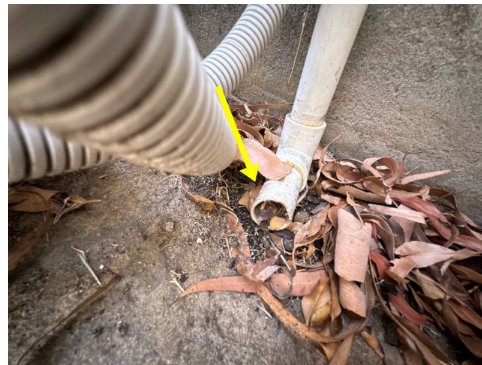
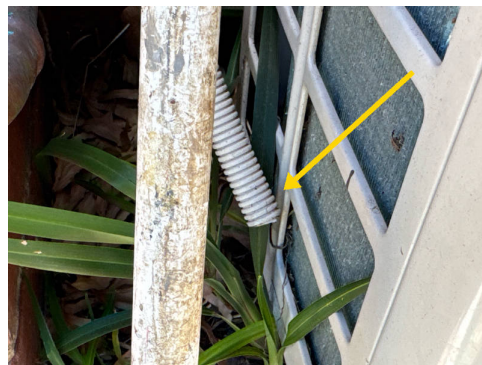
Finding 6.04

Finding: Air conditioner discharge - Not plumbed or drainage

Information: The Air conditioner discharge is not plumbed or connected to suitable drainage, which has resulted in the surrounding area becoming excessively damp. These damp conditions can lead to secondary defects such as rot, rust or corrosion of associated building elements, the formation of fungal decay, or even the creation of potential slip hazards. When coupled with poor site drainage, pooling of water may also attract termite activity to this area. It is highly recommended that a qualified plumber be appointed to install adequate drainage to the overflow. These works will ensure that the area remains dry and free of any secondary defects.

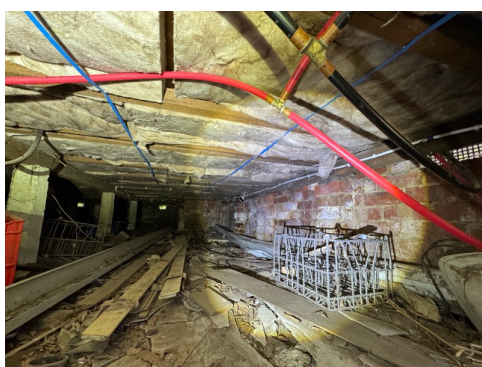
Finding 6.05

An array of debris was found in the subfloor area at the time of inspection. Debris in this area restricts subfloor ventilation and creates potential for concealed pest entry. Stored timbers and other materials may also make the area susceptible to termite activity and wood rot.

A clear and empty subfloor will be better ventilated and easier to maintain in a dry condition. The removal of any timber debris is vital in minimising the risk of termite or wood borer activity.

Debris in the subfloor should be removed as soon as possible. Depending on the location and amount of debris and stored items, the homeowner may elect to undertake this task. Alternatively there are a large number of rubbish removal subcontractors that could undertake these works.

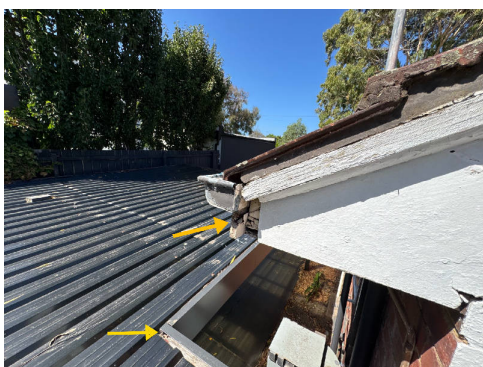
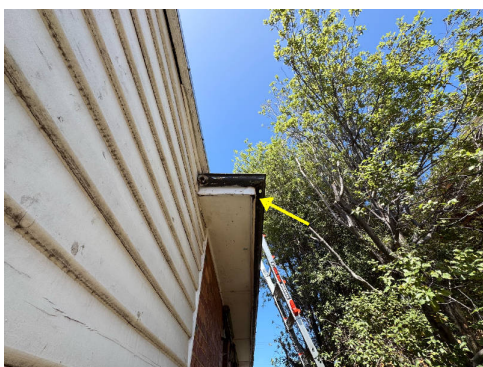
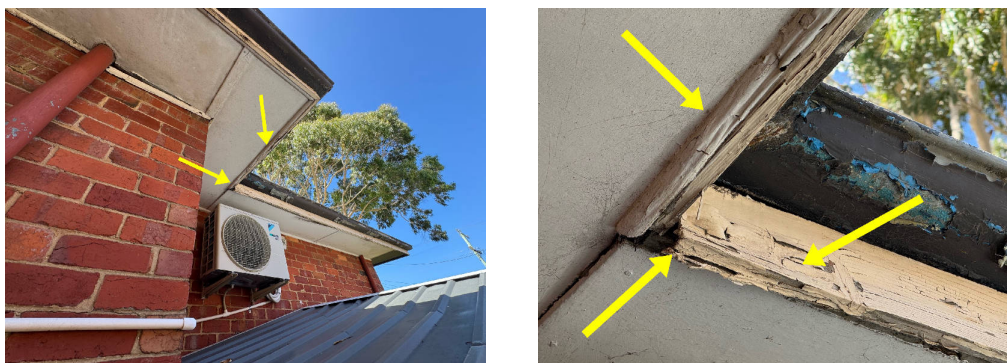
Finding 7.01

Finding: Fascias - Wood rot

Information: Wood rot was found to be affecting fascias in these areas. Wood rot, also known as Fungal Decay, occurs when timbers and other cellulose building materials are exposed to damp conditions on an ongoing basis.

It is likely that this wood rot has developed as a result of faults in the roof plumbing, creating excessive moisture in this areas. Frequent exposure to rain and other weather conditions also make fascias and barges susceptible to accelerated deterioration.

It is advised that a roof plumber be appointed to inspect all roof plumbing and subsequently identify the cause of the wood rot. Replacement of affected fascias and barges may then be a necessary step in protecting surrounding building elements from such deterioration.

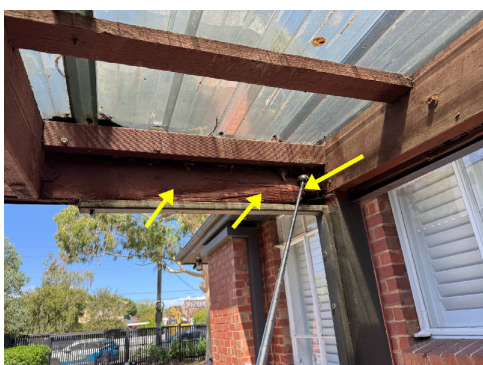
Finding 7.02

Finding: Wood rot

Information: This building element shows evidence of wood rot, also known as fungal decay, which occurs when timbers and other cellulose building materials are exposed to damp conditions on an ongoing basis. This could result from prolonged weather exposure or excessive moisture from adjacent building materials. It's important to note that untreated wood rot can potentially lead to termite infestation or attack, as both termites and fungi in moist environments and compromised wood structures. To mitigate these risks, it is recommended to promptly address the underlying moisture issue causing the wood rot. Solutions may include improving drainage around the affected area, repairing leaks, ensuring proper ventilation to reduce humidity levels, and treating the affected wood with appropriate fungicides or preservatives. Regular inspections and maintenance are also crucial to identify and address wood rot early, preventing further damage and potential pest issues

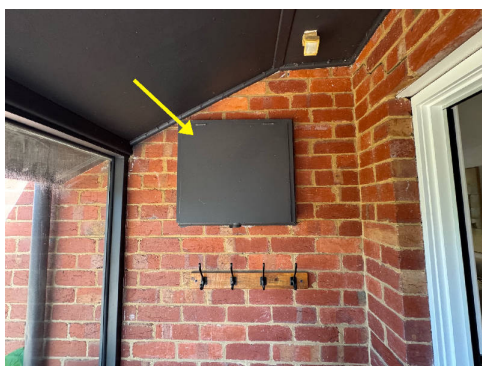
Information: The application of a post-construction chemical termite barrier is highly recommended for all properties, particularly if live termite activity has been found on the site previously. Such barriers are highly effective in preventing termite attack on any timber building elements throughout the property.

A durable notice should be placed in the switchboard unit to indicate current termite barriers. At the time of inspection, it appeared as though no termite management system has been installed, with no evidence to suggest preventative works taking place.

The client may consider gaining further advice from a pest controller as to the costs and procedures involved with this application. It is recommended that obtaining such advice be a short-term priority.

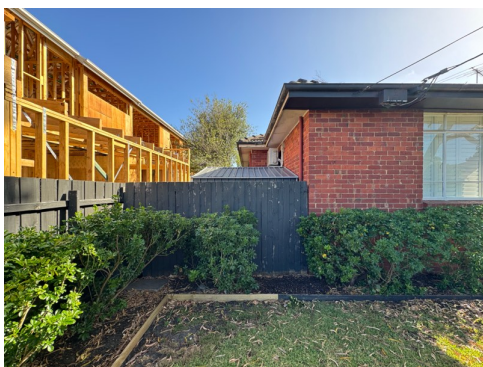
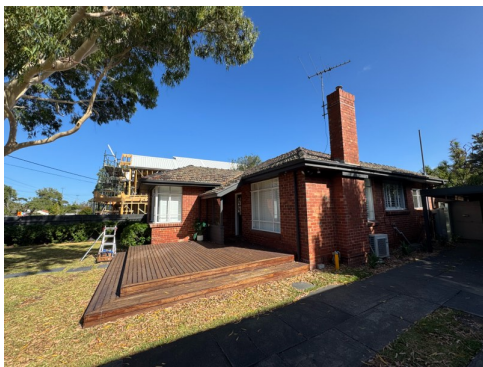
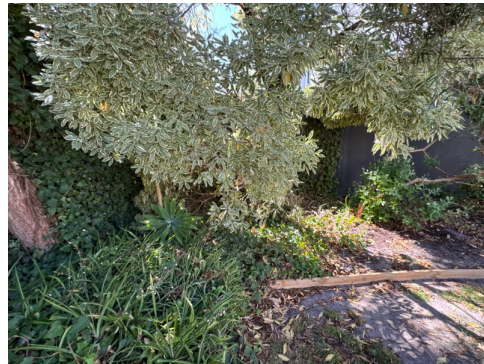
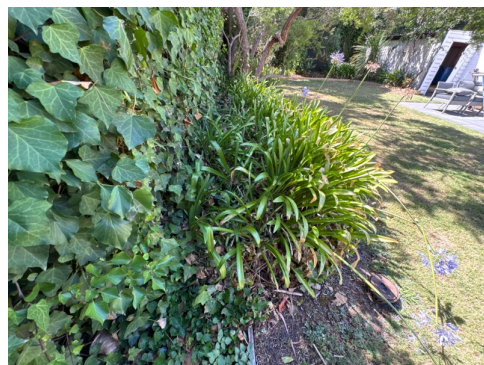
Finding: Obstructions and Limitations - External Areas

Information: These photographs are an indication of the obstructions and limitations which impeded full inspection of the external areas at the time of inspection. These obstructions can hide an array of defects and should be removed to allow full inspection to be carried out. A re-inspection is recommended once the areas are made accessible.

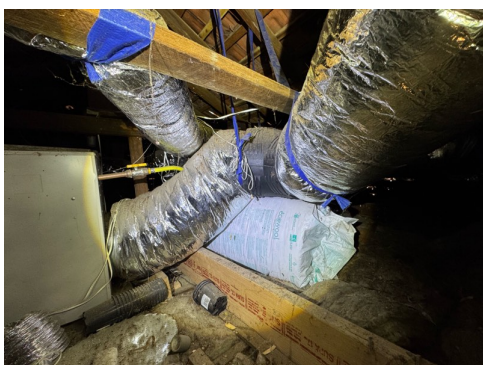
Finding: Obstructions and Limitations - Roof Cavity

Information: These photographs are an indication of the obstructions and limitations that impeded the full inspection of the roof cavity at the time of inspection. Note that the insulation covered nearly all the ceiling joists, which are a major structural element of the ceiling structure; the inspection was also limited to areas with an allowable crawl space of 600mm x 600mm, in particular towards the external walls where the roof line diminishes, it was not accessible. These obstructions and limitations can hide an array of defects and should be removed to allow full inspection to be carried out. A re-inspection is recommended once the areas are made accessible.

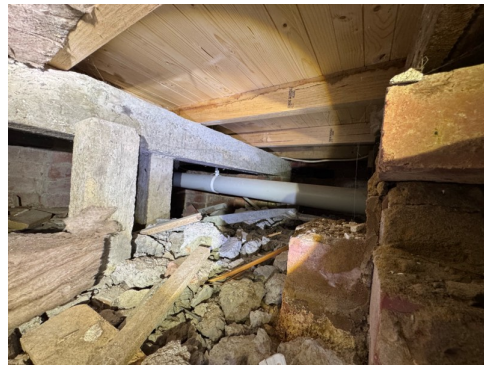
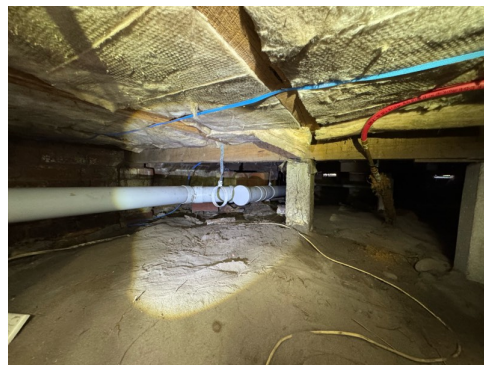
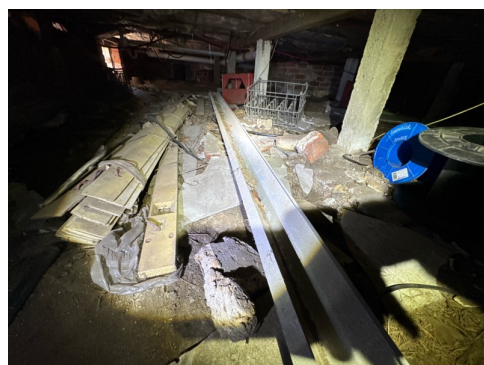
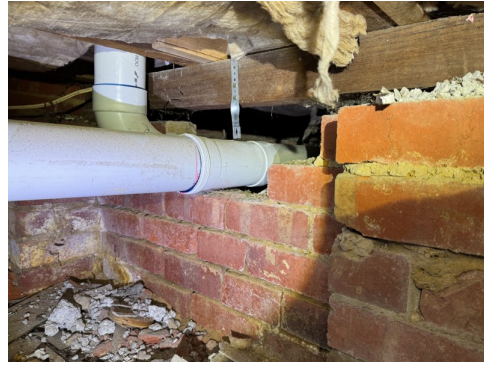
Finding: Obstructions and Limitations – Subfloor

Information: These photographs are an indication of the obstructions and limitations which impeded the full inspection of the subfloor area, including major structural flooring elements, at the time of inspection. These obstructions can hide an array of defects and should be removed to allow full inspection to be carried out. A re-inspection is recommended once the areas are made accessible.
