Building Inspection Report

Inspection Date: Wed, 4 Mar 2026

Property Address: 1 Arabella Pl, Bella Vista NSW 2153,
Australia

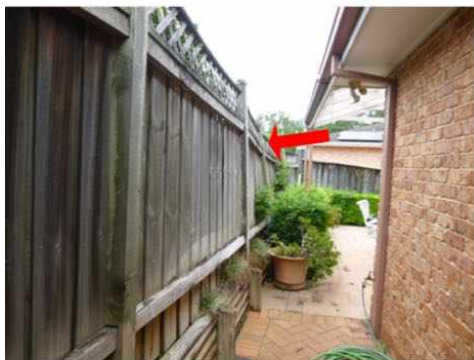
Defects 3.01

Building: Main Building
 Location: Fencing
 Finding: Fencing - Deteriorated
 Information: It was noted at the time of inspection that sections of the fencing of the property have deteriorated. Typically fencing deteriorates due to age and or wear, rot and or rust which is generally expected for a structure of this age, due to prolonged exposure to weather conditions. Sometimes inadequate installation or maintenance can be to blame.

If left unattended, it is likely that further damage will occur. It is suspected that repair of several elements of the fencing may be required however replacement may be a consideration of the client also.

A licensed fencing contractor should be appointed to provide further advice and perform rectification works as necessary.

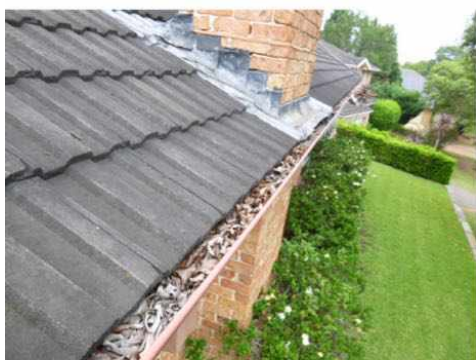
Defects 3.02

Building: Main Building
 Location: Gutters- Front

Finding: Gutters - Blocked

Information: Roof plumbing structures, such as guttering and downpipes, should be free of all debris to prevent blockages. Blockages of the guttering and downpipes will lead to pooling and accumulated water overflows, which is likely to subsequently flood eaves and exterior walls.

Blocked gutters are likely to lead to high levels of moisture in the affected areas. Such moisture will not only cause rust and decay of the associated building materials, but can also provide conditions that are conducive to termite and timber pest activity. Blockages in gutters should therefore be removed immediately to ensure dry conditions are maintained.

Consult a Licensed Plumber for further specific advice on remedial works that may be required. In the interim, it is highly advised that blocked gutters be removed by the homeowner or a general handyperson as a matter of urgency.

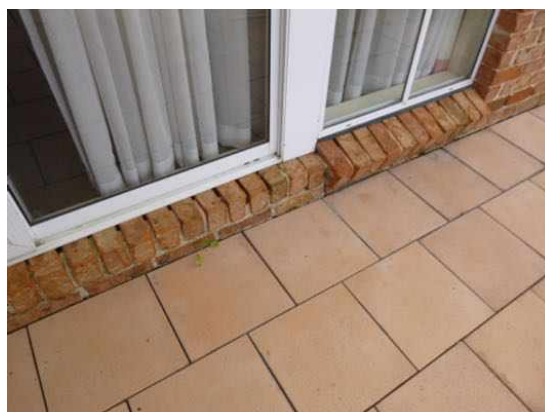
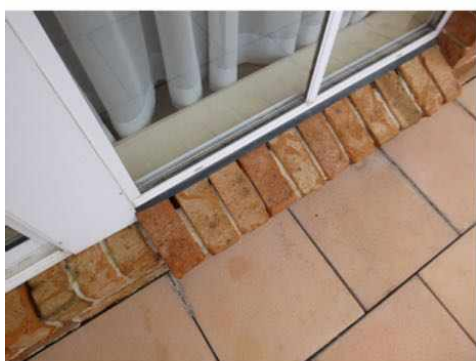
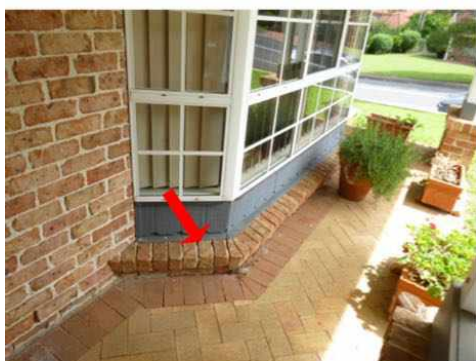
Defects 3.03

Location: Exterior walls - rear

Finding: Brickwork - Deteriorated mortar

Information: Mortar, or 'bedding', is the material which fills joins and intersections between bricks in masonry walls and structures. Sections of mortar in this brickwork were identified as having deteriorated, which is generally expected for a property of this age and condition.

Mortar may deteriorate as a result of age of building materials, minor movement of bricks, or frequent exposure to weathering. Mortar should be replaced to ensure that bricks remain in their intended location and to prevent gaps, which would allow water or moisture ingress and secondary damage as a result.

Mortar deterioration can be addressed by a bricklayer where areas of deterioration are

localised and easily accessible. Alternatively, appointment of a registered builder is advised, to repoint large areas of decaying mortar. Where secondary structural defects have become evident, consultation with a structural engineer may be required.

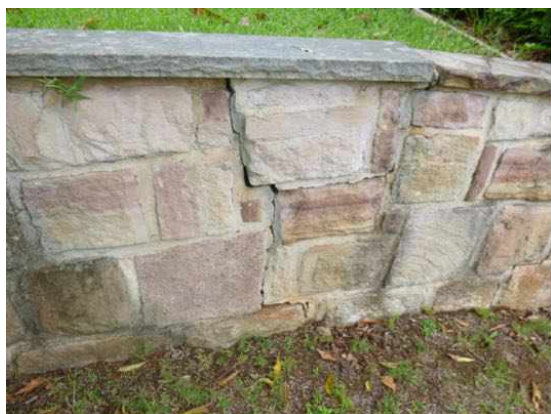
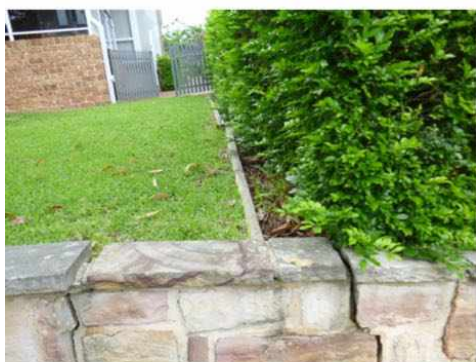
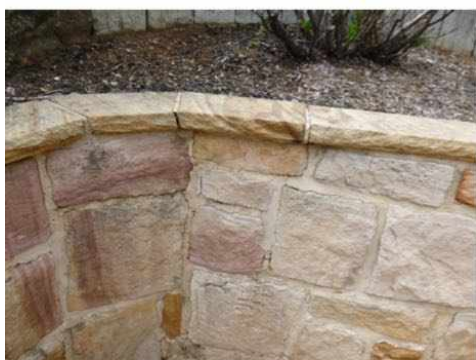
Defects 3.04

Building:	Main Building
Location:	Yard - Front
Finding:	Retaining wall - Defective
Information:	The retaining wall in this area was found to be defective at the time of inspection. Generally, defective retaining walls are caused by poor original design or material use. However, deteriorated retaining walls may also be a result of substandard

construction, poor site drainage or unmanaged stormwater flows.

If left unmanaged, the retaining wall may become a safety hazard if it continues to destabilise. Where retaining walls further rot and decay, an environment is created that is conducive to termite and pest infestation.

Significant repair and replacement should be expected. A landscaper or retaining wall installer may be appointed to repair or replace the wall, at the discretion of the client.

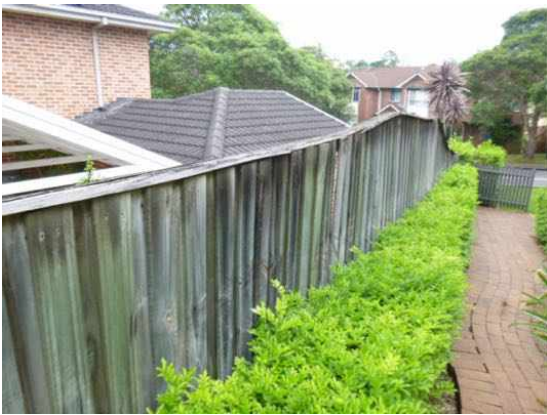
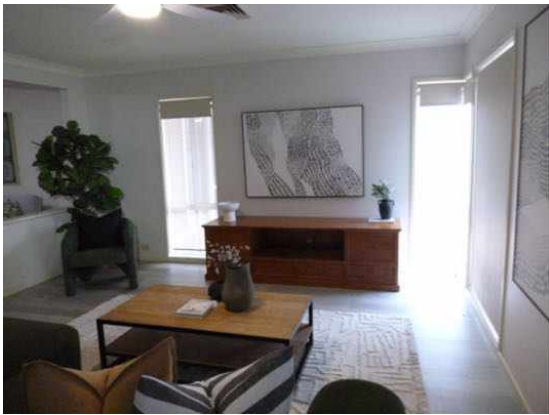
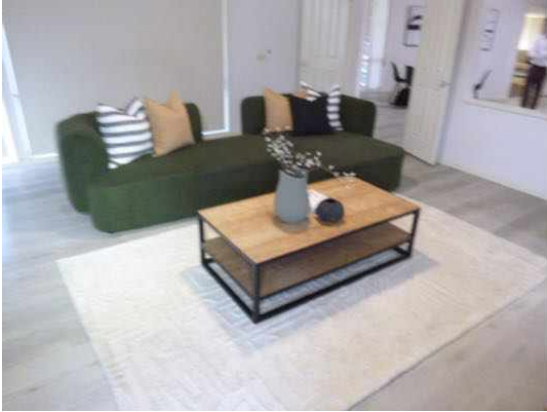
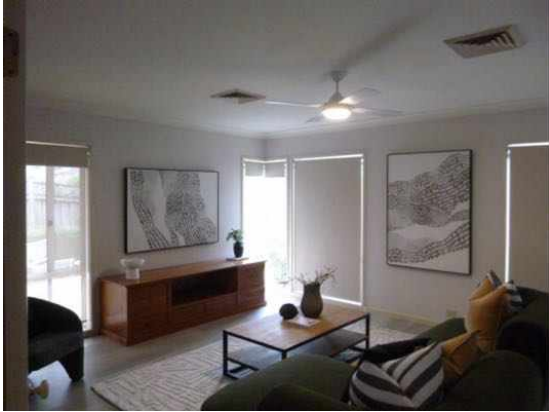
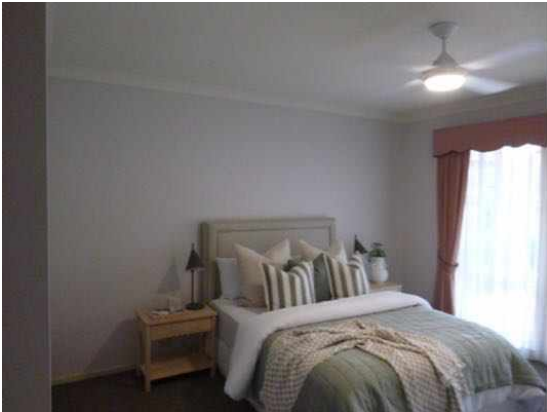
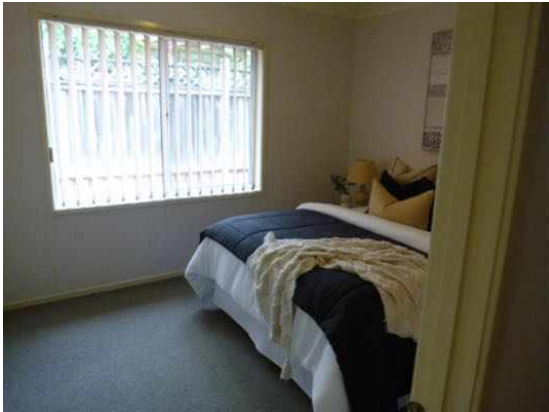
Defects 3.06

Building: Main Building
Location: All Areas
Finding: Additional Photos - Obstructions and Limitations
Information: These photographs are an indication of the obstructions and limitations which impeded full inspection of the property at the time of inspection. These obstructions can hide an array of defects and should be removed to allow full inspection to be carried out. A re-inspection is recommended once the areas are made accessible.

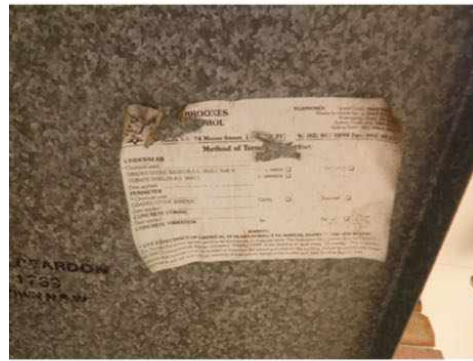
Building:	Main Building
Location:	Meter Box
Finding:	Termite Management System - Evidence of installation
Information:	<p>There are a number of factors which indicate the presence of a previously installed or applied termite barrier. The most common are a durable notice (to the inside of your meter box) observable physical barriers installed to building perimeter and in ground reticulation systems. Where a Termite Management System has been identified you should refer to the type of barrier date of installation warranty conditions and any documentation provided by a builder or past owner. Consult the company who installed the barrier to confirm whether the system is still under warranty.</p> <p>Most chemical termite management systems expire and require replenishment and all physical systems are primarily designed to prevent concealed entry. The client may consider gaining further advice from a pest controller as to the costs and procedures involved with this application. It is recommended that obtaining such advice be a short-term priority.</p>

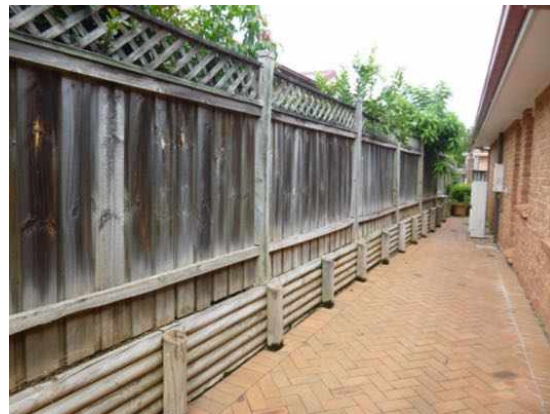
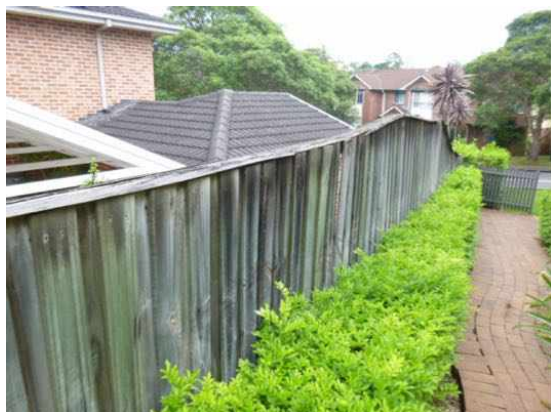
Building: Main Building
 Location: All External Areas
 Finding: Landscaping
 Information: There is no evidence of current termite damage in these timber.

Any timbers in direct ground contact provide opportunity for concealed termite entry and are likely to be subject to premature rot and decay as the soil retains moisture or damp conditions against the timbers. Remove untreated timber that is in direct contact with external grounds. If there is old tree stumps present frequent pest inspections are advised to readily identify any termite activity in these areas. Monitor treated landscape timbers within the garden area, as treated pine breaks down and rots over a period of time causing conducive conditions for termite activity.

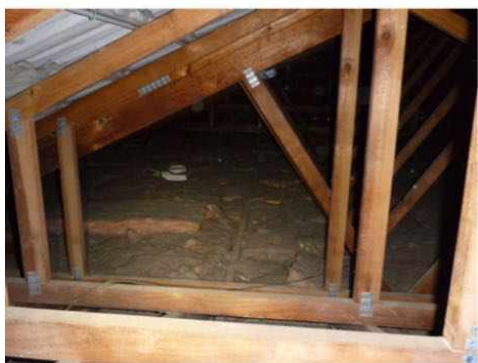
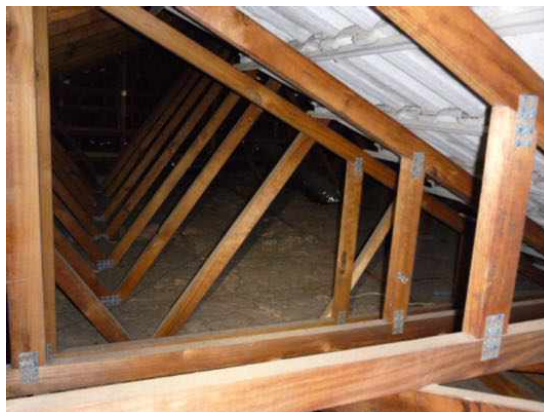
Building:	Main Building
Location:	Roof Void
Finding:	Insulation - adequate
Information:	Upon inspection of the roof void it was noted that there is adequate insulation.

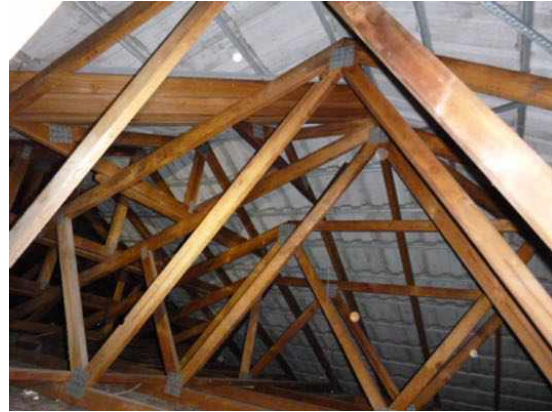
Building:	Main Building
Location:	Roof Void
Finding:	Sarking - Missing
Information:	Sarking is missing under the roof sheeting. Sarking acts as an insulator that helps with noise reduction and protects against water penetration. Sarking plays a key role in the operation and function of the overall roofing structure and its performance.

Although not a requirement at the time of construction, replacement of any missing

building element is advisable (although this can be quite expensive to do after the time of construction). Where sarking is missing, regular inspections of the roof tiles for cracking and potential moisture penetration is required.

Sarking may be retrospectively fitted by a registered builder at the discretion of the client.

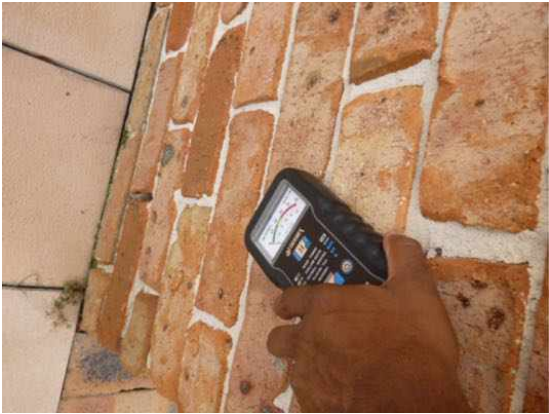
Building: Main Building
Location: All Areas
Finding: No Excessive Moisture
Information: All areas of the dwelling are checked with particular attention paid to wet areas which were closely assessed to check for excessive levels of moisture and temperature anomalies. No evidence of excessive moisture was found inside the house at the time of the inspection.

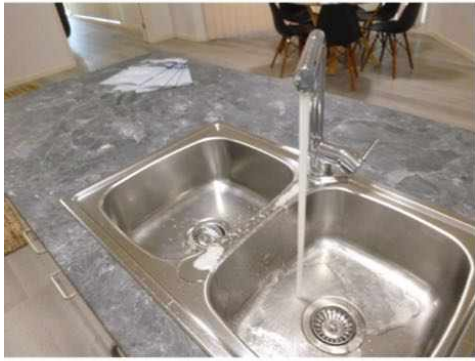
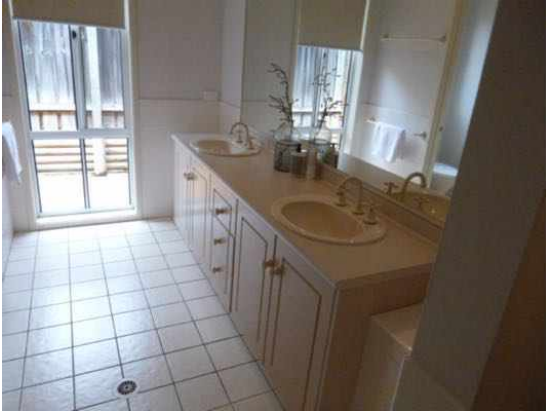
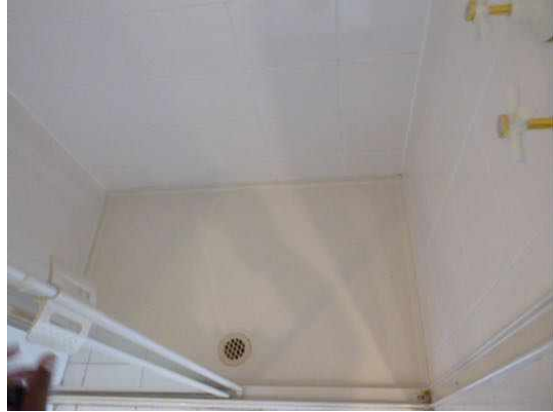
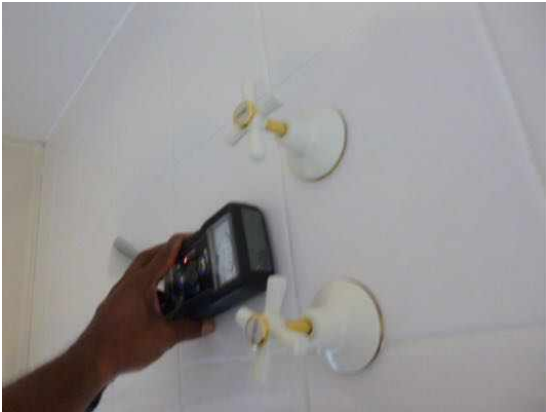
Building:	Main Building
Location:	Bathroom And other wet area
Finding:	No evidence of excessive moisture- Bathroom
Information:	All areas of the dwelling are checked with particular attention paid to wet areas which were closely assessed to check for excessive levels of moisture and temperature anomalies. There was NO evidence of excessive moisture present at the time of inspection in bathrooms.

Regular maintenance and replacement of damage or missing or damaged sealant and grout is highly recommended to the wet areas, as this is a regular wear and tear defect. Sealant and grouting in areas that come into regular contact with water should be maintained for the long term care of your property. Excessive moisture can attract termites and produce conditions that promote termite attack fungal growth and wood decay. It is highly recommended that all plumbing and drainage fixtures and fittings be maintained regularly in order to prevent excessive moisture being present in the external / internal property.

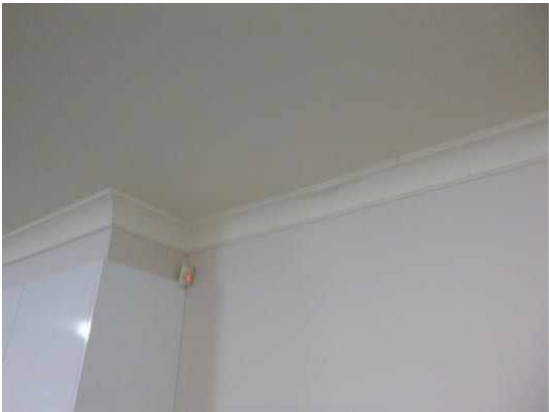
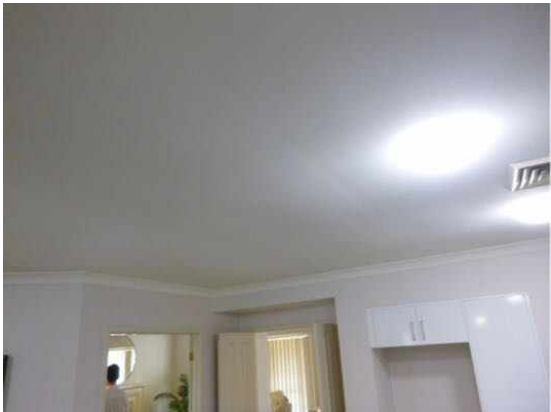
Building: Main Building
 Location: All Areas
 Finding: Ceiling - Sagging
 Information: Sections of the ceiling were found to be sagging at the time of inspection. Sagging to the fixed ceiling structure generally indicates that the building materials have swollen, due to contact with water, or that fixings (e.g. nails or glue) have become loose and require reattachment.

Where minor sagging is evident, comparatively minor works, such as re-gluing of ceiling sheets, may be required. Such works may be performed by relevant tradespeople, such as plasterers and painters. Where excessive moisture has caused

the roofing structure to swell and sag, the source of the water leak should primarily be identified prior to any remedial works being performed.

The appropriate action should be taken by the client as soon as possible to ensure that any potential further damage is limited.

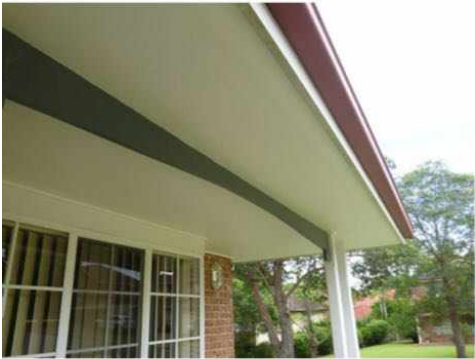
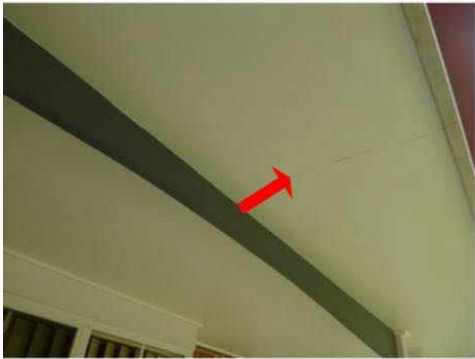
Building:	Main Building
Location:	All Areas
Finding:	Cracking - Damage Category 0 - Hairline (less than 1mm)
Information:	Hairline cracks are very minor in nature and generally are only ever an appearance defect. While such cracking may be noticeable in some cases, it is quite common and does not indicate any structural damage.

Cracking of this nature can generally be repaired with minor sanding, filling and/or repainting. Such works should be performed by a qualified painter or a general handyman.

Monitoring of all cracking should be conducted frequently. Always contact a building inspector should cracks widen, lengthen, or become more numerous.

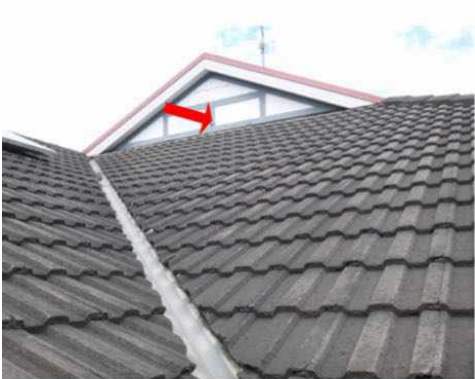
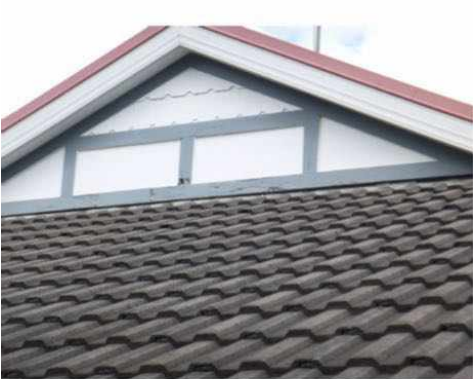
Building:	Main Building
Location:	All External Areas
Finding:	Wood rot
Information:	This building element shows evidence of wood rot. Wood rot, also known as Fungal Decay, occurs when timbers and other cellulose building materials are exposed to damp conditions on an ongoing basis. This could be the result of exposure to weathering over a prolonged period of time, or the attraction of excessive moisture from other abutting building materials. Contributing factors also include poor air ventilation in the area.

Wood rot is often associated with general damp problems and is evidenced by a 'musty' smell or mould and mildew occurring on surfaces. If left unmanaged, damp conditions can lead to further health problems and the decay of timbers will continue.

Early intervention and regular maintenance, particularly of exterior timbers, will prolong the useful life of these building elements. Prior to any works being performed, the cause of the moisture that has created the visible wood rot should be identified and addressed in a suitable manner. Replacement of affected timbers may then be a necessary step in protecting surrounding building elements from such deterioration.

A qualified plumber may be appointed to assess the cause of excessive moisture and to provide advice on any remedial works as required. A qualified carpenter or registered builder may also be required to replace affected building materials.

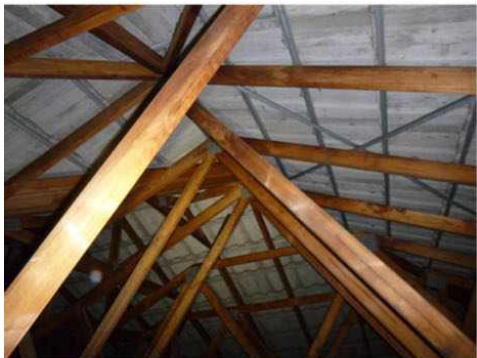
Building:	Main Building
Location:	Roof Exterior/interior
Finding:	Roof tiles
Information:	Upon inspection of the exterior roofing, the majority of roof tiles were considered to be in a good condition. While weathering of the tiles is consistent with the age of the property, maintenance works are required.

Consultation with a roofing contractor is highly advised to gain advice on cost of remedial works that may be required in the short to medium term. Remedial works are likely to increase the longevity of the exterior roofing structure.
