Building and Timber Pest Inspection Report

Inspection Date: Wed, 28 Jan 2026

Property Address: 23 Parkes Cres, Faulconbridge NSW 2776,
Australia

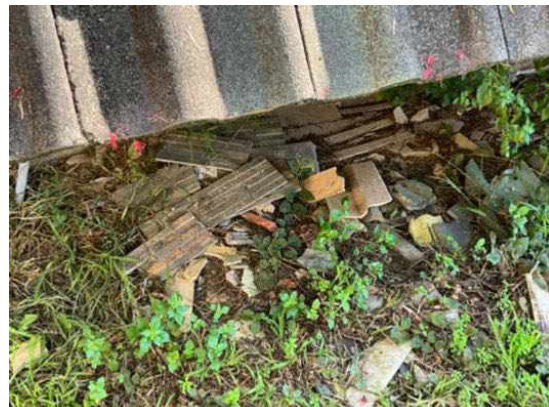
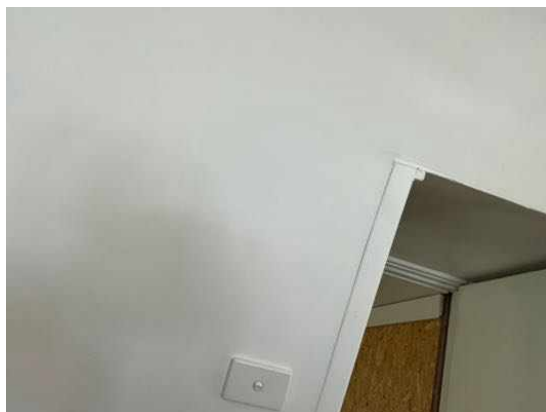
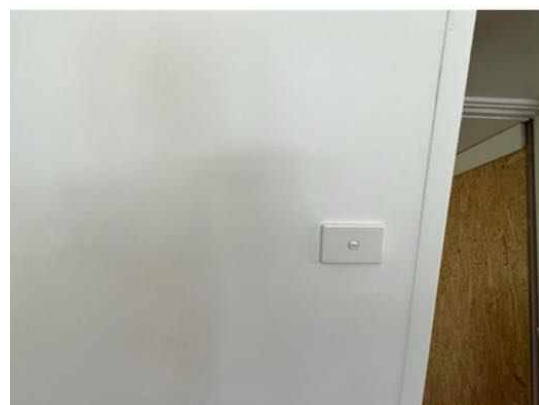
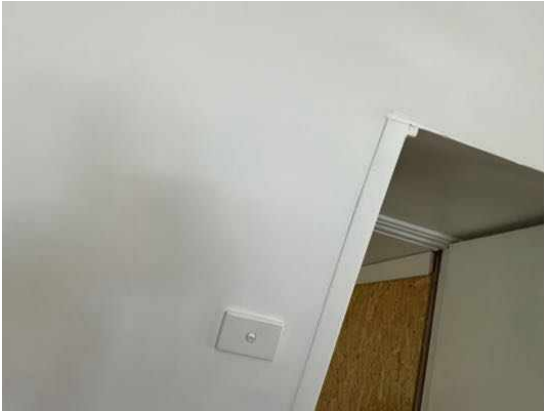
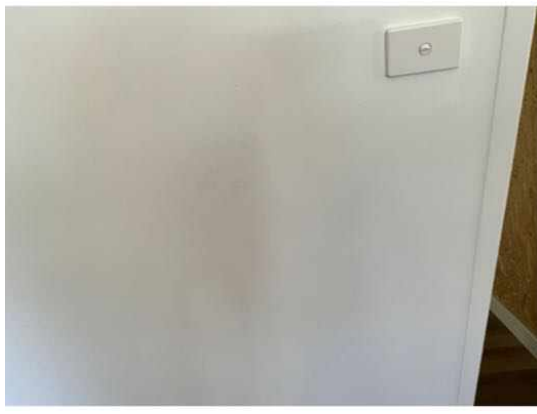
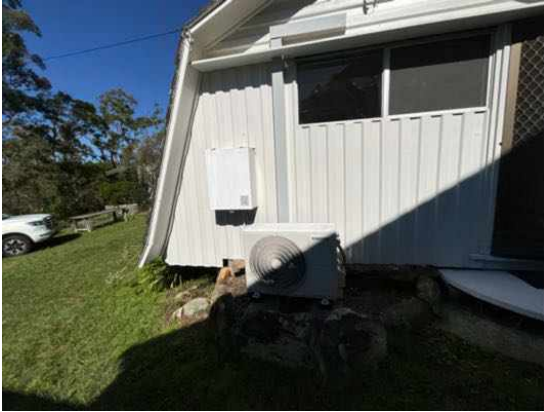
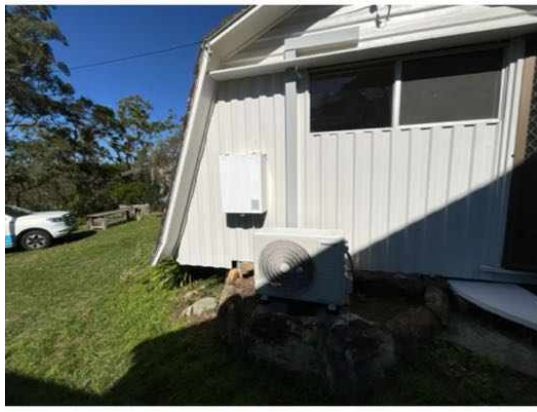
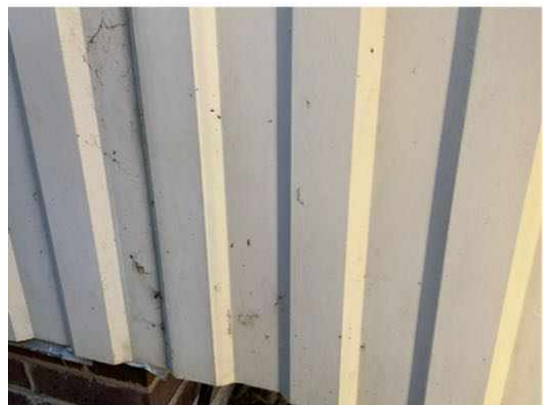
Building:	Main Building
Location:	All Areas
Finding:	Asbestos - Suspected ACM Identified on Site
Information:	Reporting on Asbestos is outside the Scope of this Report. This suspected defect is highlighted as a caution only. We suspect, based on our experience in the building industry, that there is a higher risk of the identified building element containing asbestos.

As Asbestos Reporting is outside the scope of this report, we advise that you consider a separate Asbestos Inspection and Condition Audit, which can include the taking of samples for definitive confirmation of the presence of Asbestos.

In the interim, the client is advised to act with caution, especially when considering any damage to building materials general wear and tear renovations extensions demolition and general maintenance activities due to the suspected presence of Asbestos.

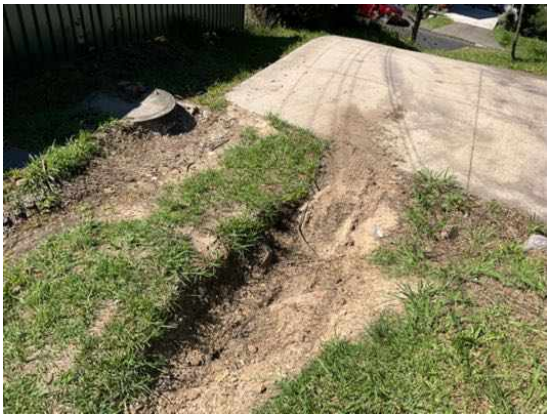
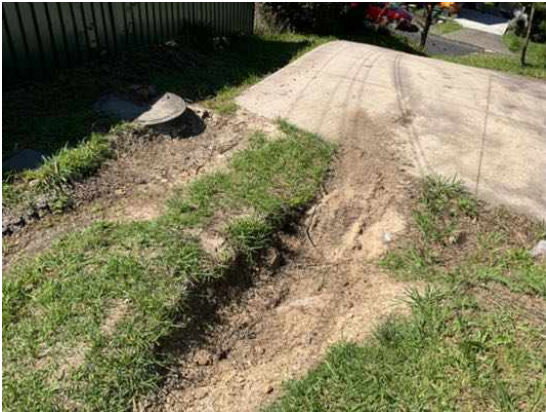
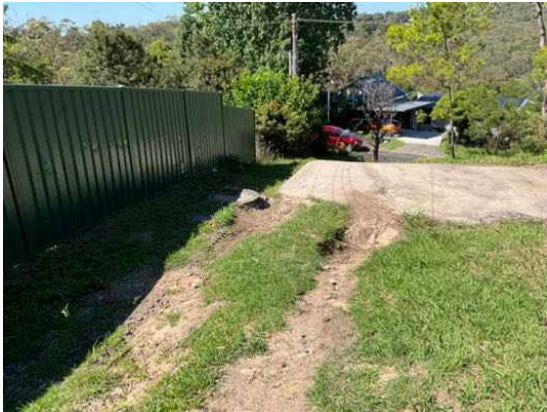
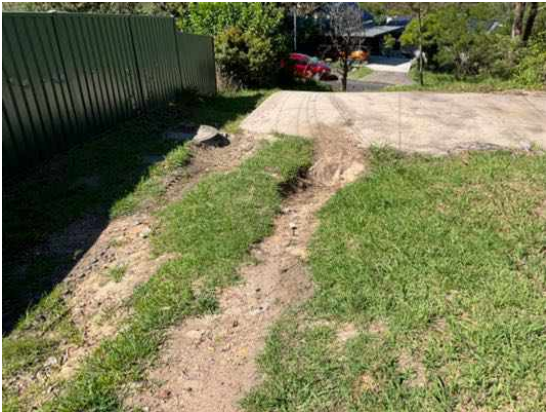
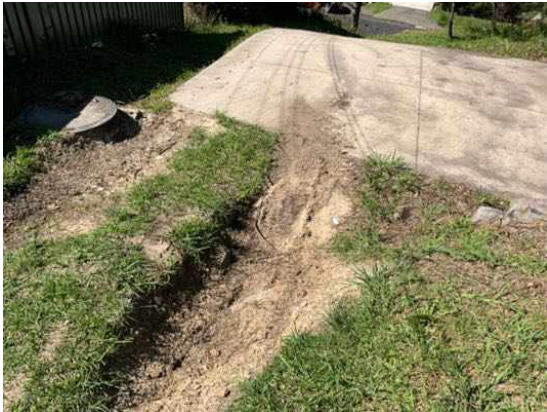
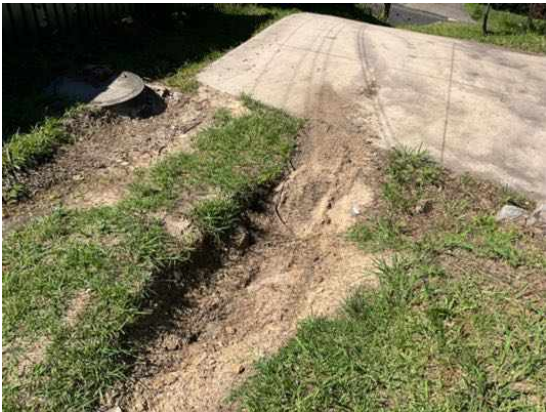
Building: Main Building
Location: Yard - Front
Finding: Uneven Ground
Information: Uneven ground is observed on the property, posing a potential safety hazard and compromising the aesthetic appeal of the landscape.

The uneven ground increases the risk of trips, falls, and injuries for occupants and visitors, and it may contribute to water drainage issues.

Professional landscapers or contractors with expertise in grading and leveling can rectify the uneven ground, ensuring both safety and improved aesthetics of the property.

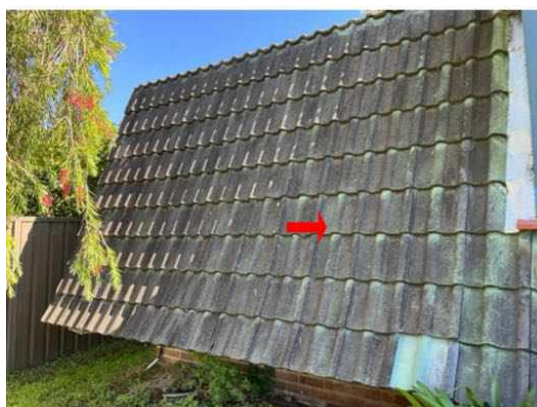
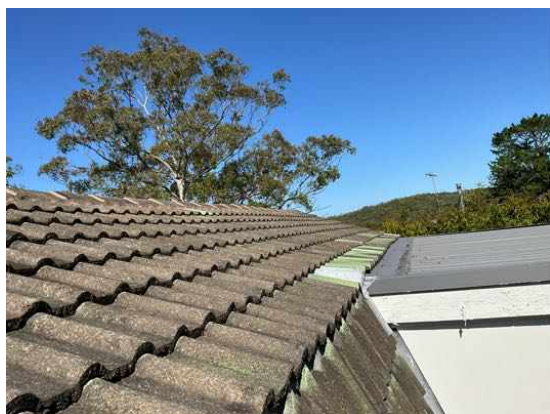
Building:	Main Building
Location:	All Areas
Finding:	Roof Weathered
Information:	Upon inspection of the exterior roofing, the majority of roof was not in a fair condition. While weathering of the roof is consistent with the age of the property, maintenance works are required.

Isolated areas of mortar have come loose in the valleys and minor cracking is also present. Re-pointing and re-sealing the may be considered as an interim solution by the client to help preserve and extend the life span of the tiles.

Where left unmanaged, deteriorating roof are likely to lead to a number of secondary defects, including minor water leaks and weather exposure to internal roofing structures.

Consultation with a roofing contractor is highly advised to gain advice on cost of remedial works that may be required in the short to medium term. Remedial works are likely to increase the longevity of the exterior roofing structure.

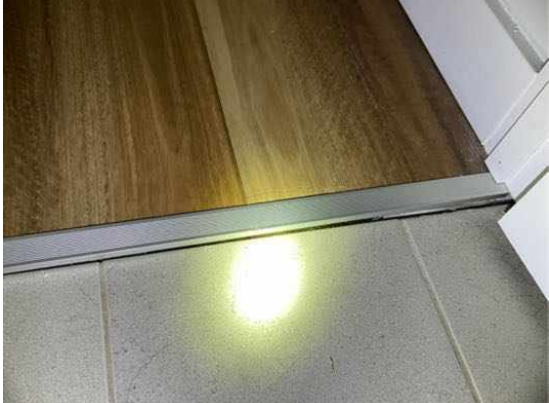
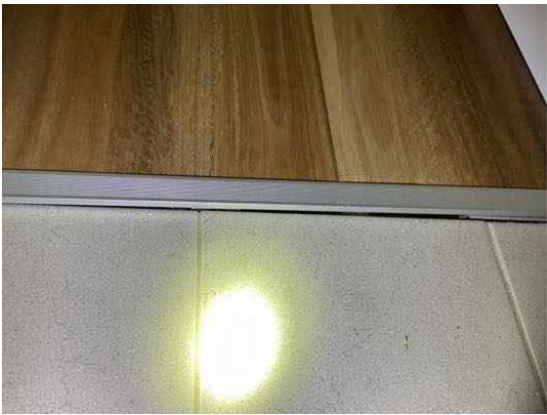
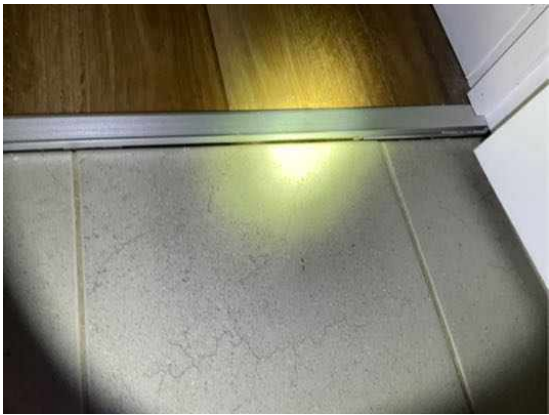
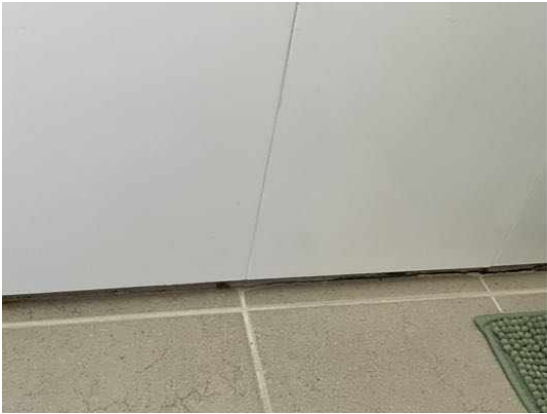
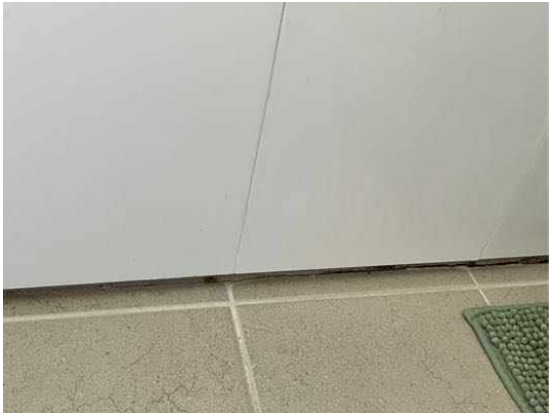
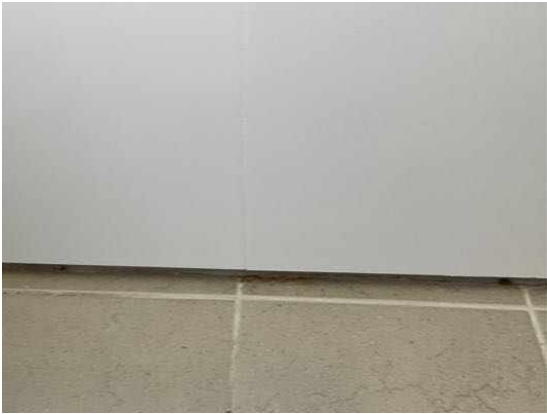
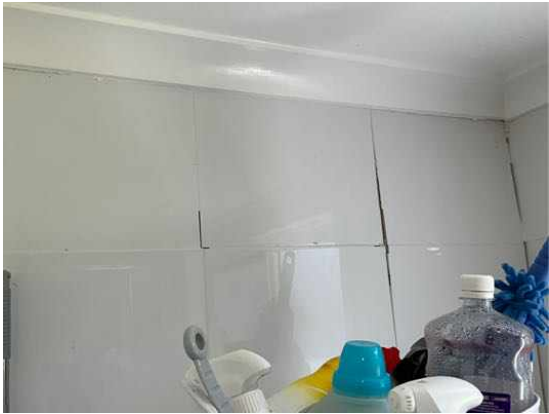
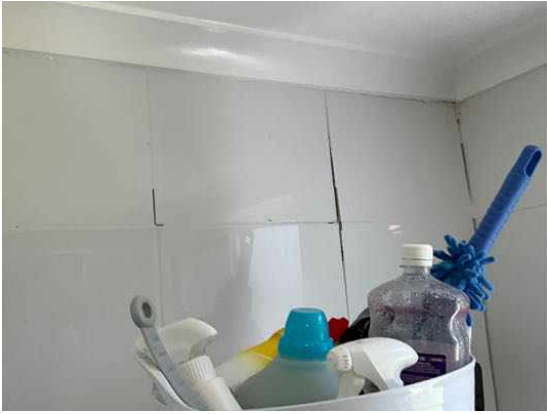
Risk: Poor workmanship poses a range of risks, including compromised structural integrity, potential safety hazards, and a decreased lifespan of the structure. It may also lead to aesthetic and functional issues.

Resolution: A qualified contractor or construction professional should be consulted to assess and address the poor workmanship. They can implement corrective measures to ensure structural soundness, safety, and overall quality of the construction.

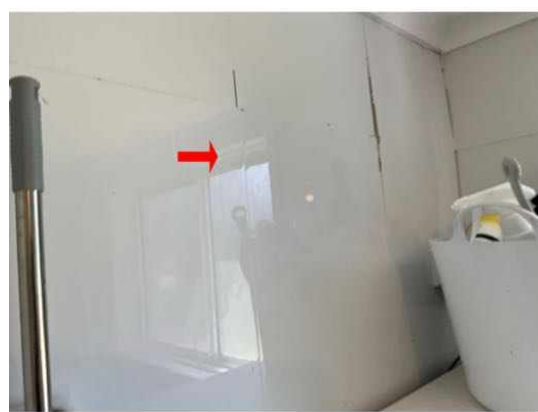
Finding 3.04

Building: Main Building
Location: Bathroom
Finding: Sealant and grouting - Missing or damaged
Information: It was noted on inspection that sealant or grout is degraded to the tiled shower alcove and or other areas of the bathroom.

Different materials and floor areas move at different rates, generally causing cracking to grout or sealant at this point. A flexible sealant is required to allow for expected expansion and contraction, while keeping the joint water tight and protective of all associated building materials.

There appears to be excessive mould to the sealant and grout which will likely require scraping out and replacement.

Flexible and mould resistant materials should be applied to affected areas to prevent any subsequent water damage that is likely to occur. Regular maintenance and replacement of damage or missing or damaged sealant and grout is highly recommended to the wet areas, as this is a regular wear and tear defect. Sealant and grouting in areas that come into regular contact with water should be maintained for the long term care of your property.

A sealant specialist or tiling contractor should be appointed to complete these works as soon as possible

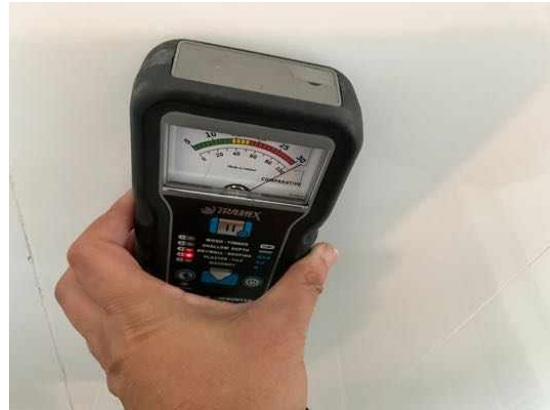
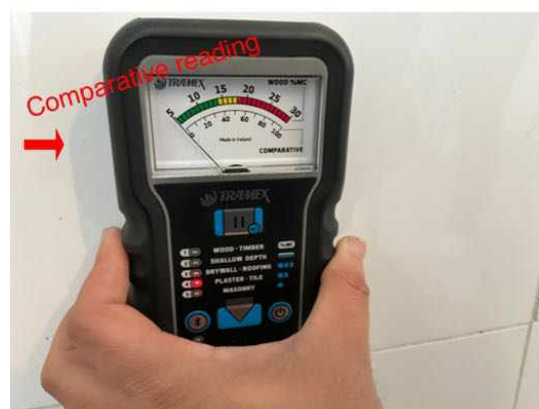
Finding 3.05

Information: Damp is evident to the lower 300mm of wall to the shower alcove. This defect is quite common, and is suspected to have been caused by moisture permeating through the grouting in this area, which shows evidence of deterioration. Leaking pipes within the adjoining wall is also a possible cause.

Damp (or structural damp) refers to the presence of unwanted moisture in the structure of a building, either as the result of intrusion from outside, or condensation from within the structure. In the shower area, internal water leaks or other sources of excessive moisture are generally the cause of damp.

Unmanaged damp in the shower recess is likely to facilitate the formation and development of mould and fungi growth, decaying associated building materials and compromising their structural integrity. It is important to address damp conditions, as the World Health Organisation notes that excess moisture leads - on almost all indoor materials - to growth of microbes such as moulds, fungi and bacteria, which subsequently emit spores and other matter into the indoor air. Exposure to these contaminants is associated with a wide range of respiratory and other health-related problems.

Consultation with a qualified plumber or bathroom specialist is advised immediately to identify the cause of damp and to perform remedial works as required. Where excessive mould growth is present, further inspection by a specialist environmental health inspector should also be considered.

Always ensure that sealant and grout is in good condition to prevent any moisture issues occurring in the future.

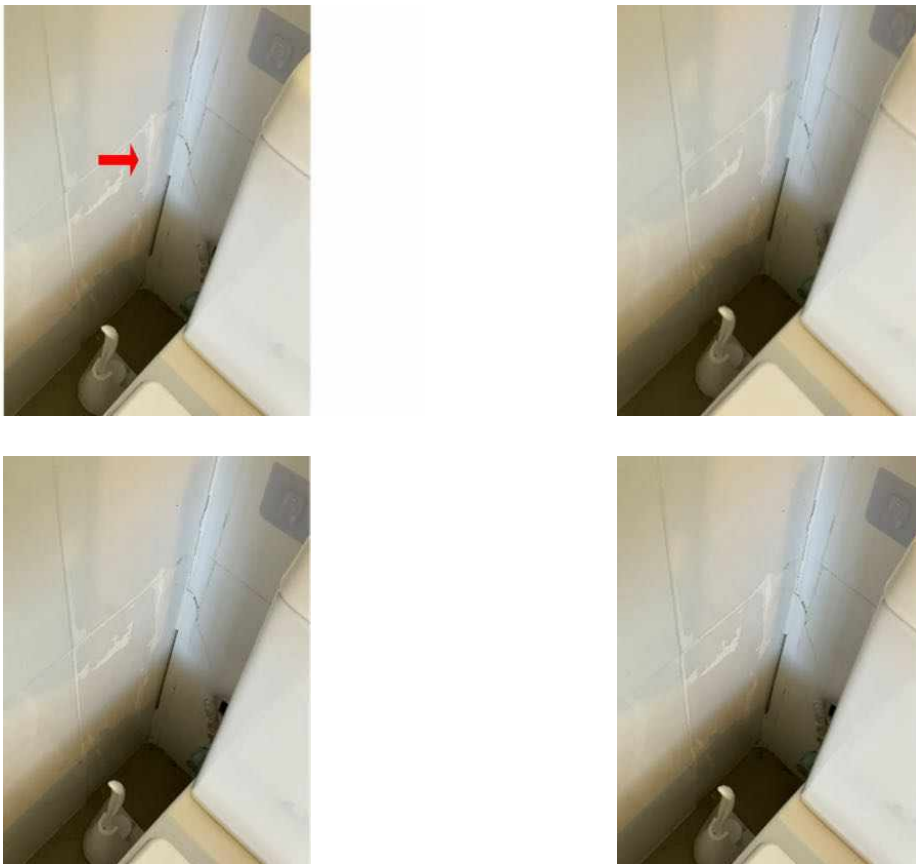
Finding 3.06

Building: Main Building
 Location: Bathroom

Finding: Tiles - Cracked or damaged

Information: Cracking was evident to the tiling in this area at the time of inspection. While the cracking appears to be minor, this area is frequently exposed to water, allowing potential for water penetration into adjoining sections of walls or flooring.

If left unmanaged, water penetration to these areas may lead to subsequent water damage, which is likely necessitate repair work to affected building elements.

A tiling contractor should be appointed to ensure that no further water damage occurs. The re-application of silicone and grouting throughout remaining tile work is also advised, to further protect the area against water penetration.

Where water penetration has led to water damage, appointment of a relevant tradesperson may be required to repair damaged building elements.

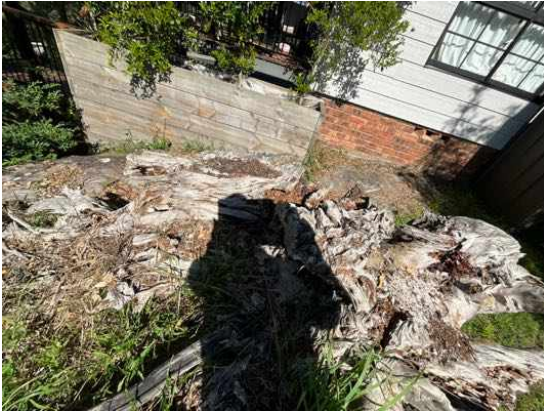
Building:	Main Building
Location:	Yard - Front
Finding:	Suspected - Timber pest damage
Information:	Despite no live termite or timber pest activity being indicated, suspected previous timber pest damage was found to have affected this area. This damage is considered to be inactive at the time of inspection.

It is advised that the area be visually inspected frequently to ensure that the condition of affected building materials does not worsen.

A licensed pest controller must be appointed to provide a further invasive inspection.

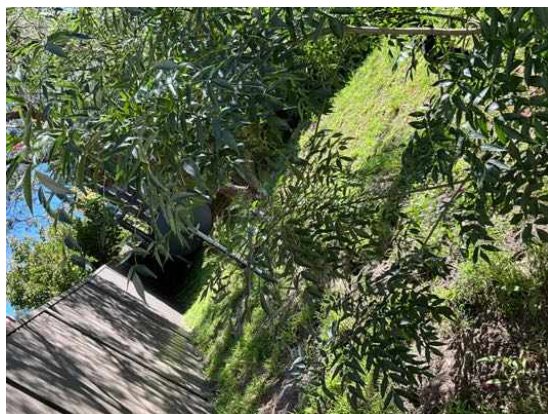
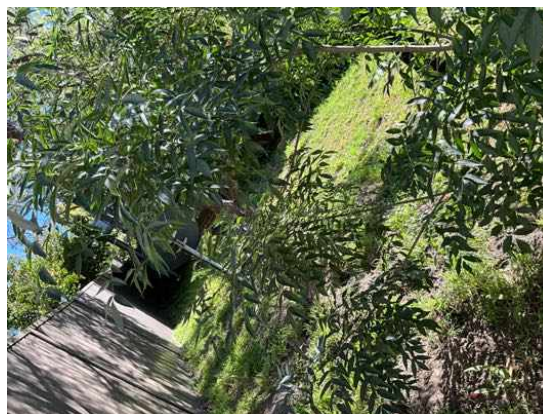
Building:	Main Building
Location:	All Areas
Finding:	Dense vegetation around a property can increase the risk of termite infestation
Information:	The presence of dense vegetation around a property can increase the risk of termite infestation, as it provides a conducive environment for them. To address this, consider maintaining a clear space between the vegetation and your home. If you suspect a termite issue, it's advisable to consult with a licensed pest control professional for inspection and treatment.

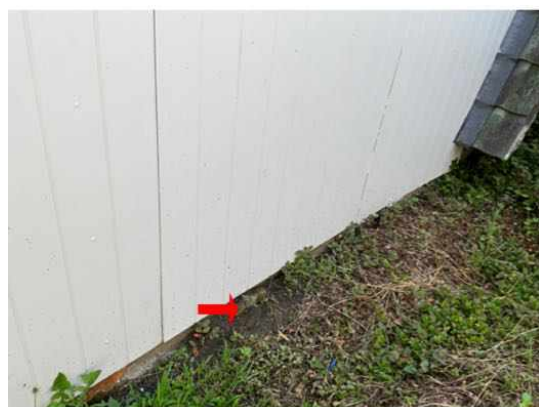
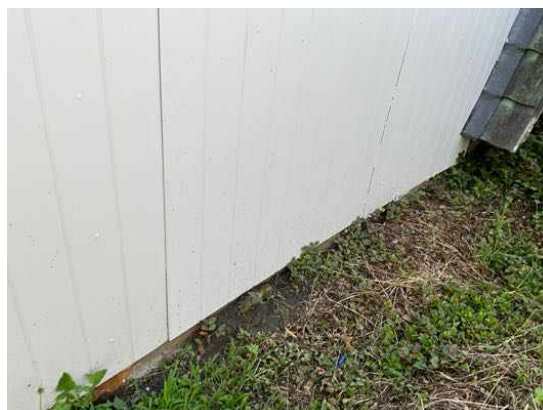
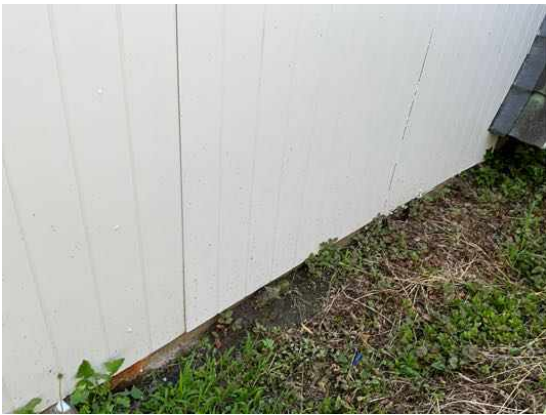
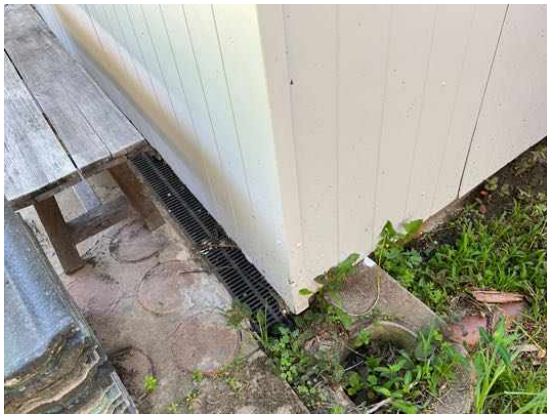
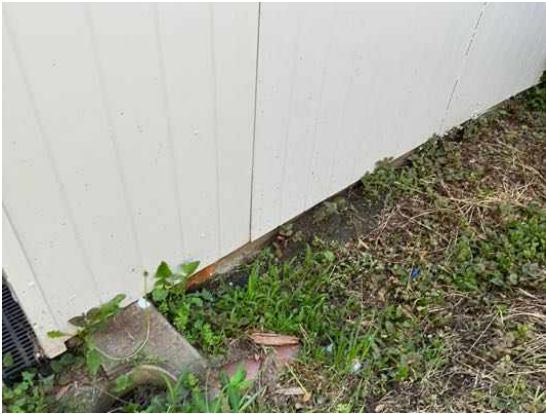
If the slab edge is not properly exposed there is a high risk of termite attack. Sometimes, in order to determine the type of slab, a suitably qualified person such as an architect or builder may be required to consult the construction plans.

Where the slab edge cannot be properly inspected, it is highly recommended that termite or timber pest inspections be carried out every 6-12 months to aid protection of the property against infestation.

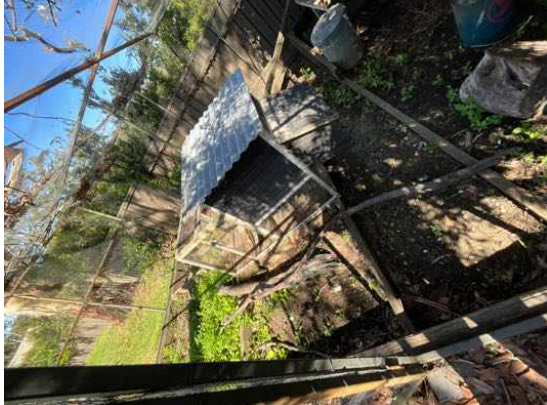
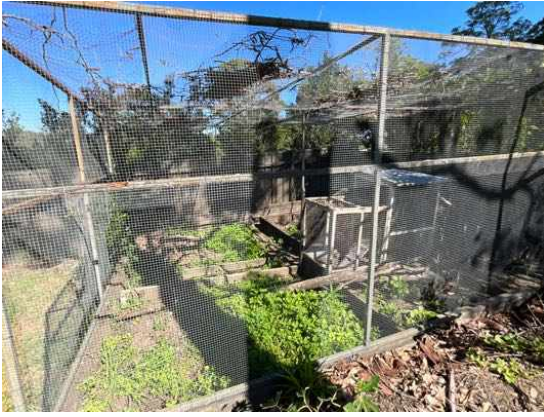
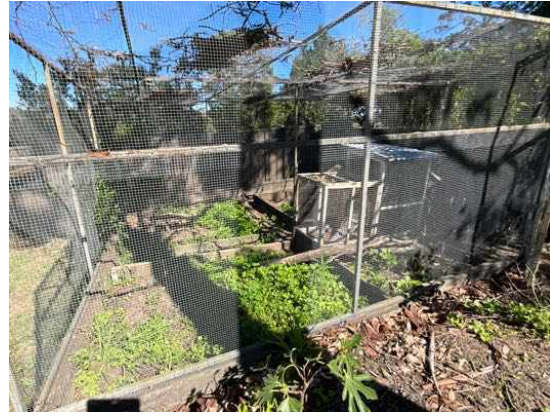
Finding 6.05

Building: Main Building
Location: All Areas
Finding: Timber on ground / conducive conditions to termite damage
Information: Timber on the ground is indeed conducive to termite damage. Termites are known to thrive in moist environments, and wood in contact with soil or moisture is more susceptible to infestation.

To prevent this, it's important to keep timber elevated and away from direct ground contact. Regular inspections and proper termite control measures are also essential to protect your wooden structures from termite damage.

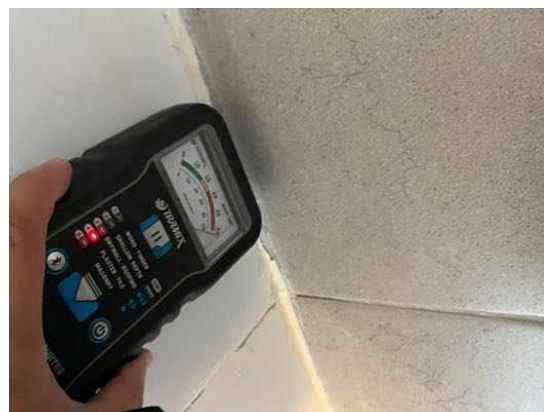
Finding 6.06

Building:	Main Building
Location:	Bathroom
Finding:	Excessive moisture - Conducive to Timber pest
Information:	Excessive moisture can attract termites and produce conditions that promote fungal growth and wood decay.

Excessive moisture is generally caused by deteriorated inadequate or missing roof drainage leaking plumbing pipes or fixtures poorly plumbed HWS overflows or condenser units and poor site drainage.

If mould growth has been found there may be environmental biological or health issues involved. In these cases an appropriately qualified inspector should also be contacted.

Prior to any remedial works being performed a qualified plumber should be appointed to further inspect the property and to identify the cause of the excessive moisture. Works to remove affected building elements may then be necessary and should be performed by an appropriate tradesperson.

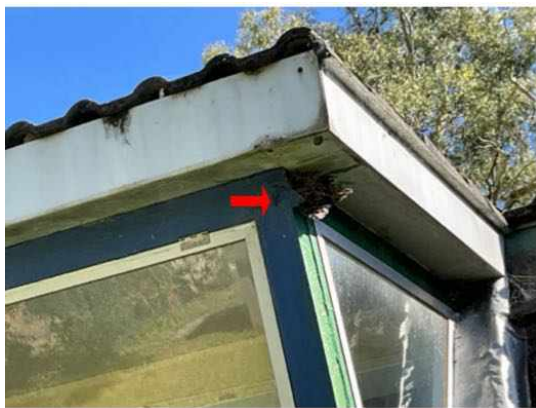
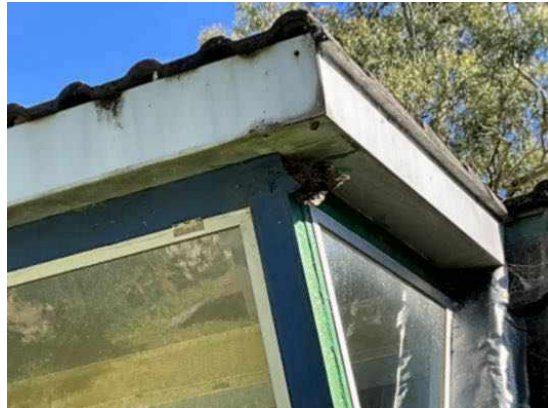
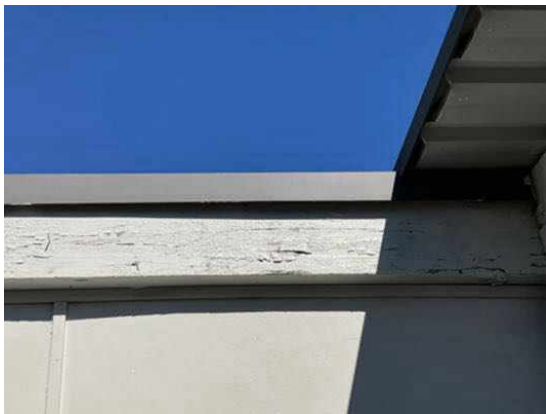
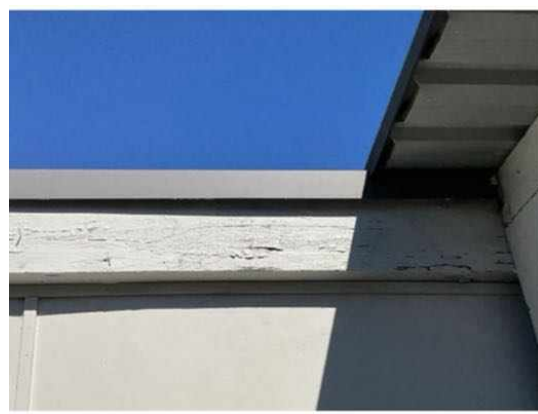
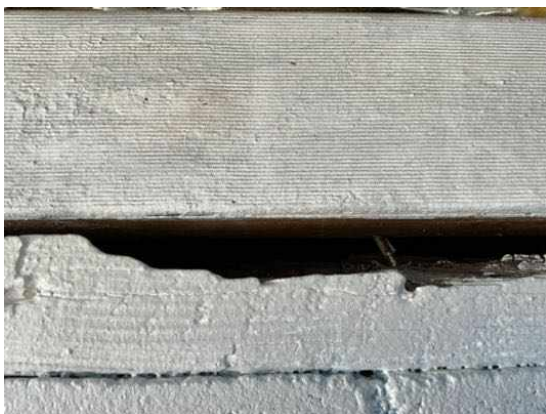
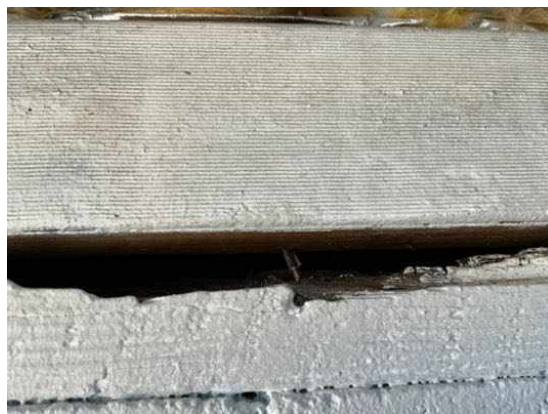
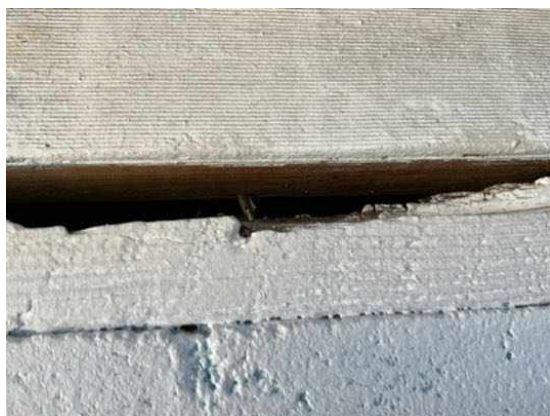
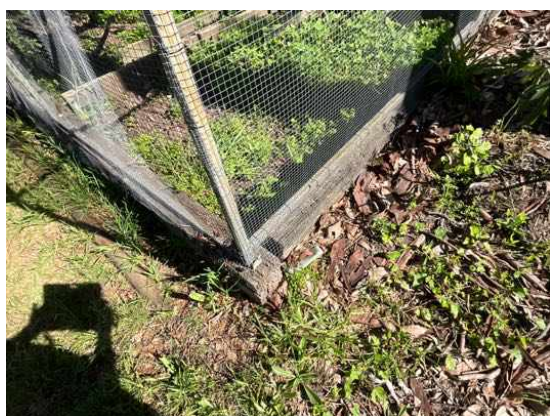
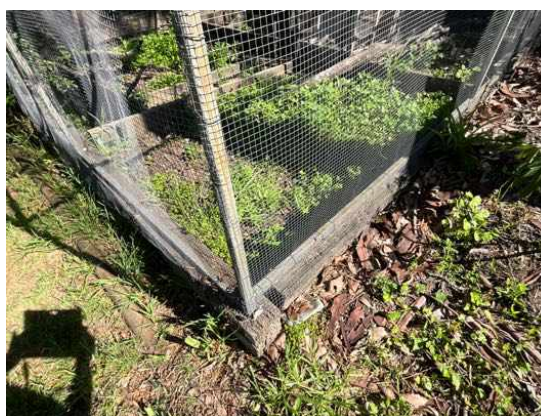
Building: Main Building
 Location: Front Elevation
 Finding: Wood rot
 Information: This building element shows evidence of wood rot. Wood rot, also known as Fungal Decay, occurs when timbers and other cellulose building materials are exposed to damp conditions on an ongoing basis. This could be the result of exposure to weathering over a prolonged period of time, or the attraction of excessive moisture from other abutting building materials. Contributing factors also include poor air ventilation in the area.

Wood rot is often associated with general damp problems and is evidenced by a

'musty' smell or mould and mildew occurring on surfaces. If left unmanaged, damp conditions can lead to further health problems and the decay of timbers will continue.

Early intervention and regular maintenance, particularly of exterior timbers, will prolong the useful life of these building elements. Prior to any works being performed, the cause of the moisture that has created the visible wood rot should be identified and addressed in a suitable manner. Replacement of affected timbers may then be a necessary step in protecting surrounding building elements from such deterioration.

A qualified plumber may be appointed to assess the cause of excessive moisture and to provide advice on any remedial works as required. A qualified carpenter or registered builder may also be required to replace affected building materials.

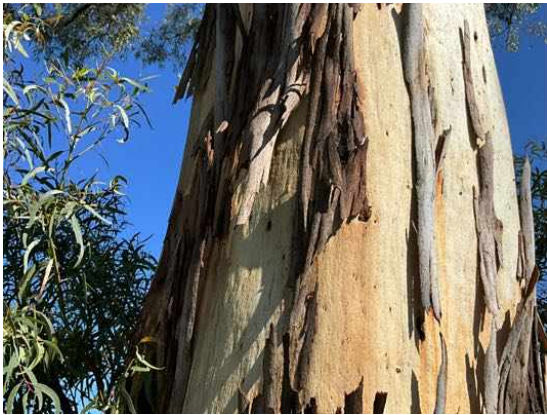
Finding 8.01

Building:	Main Building
Location:	Yard - Back
Finding:	Wood Borer Activity - Trees
Information:	Numerous small to medium-sized exit holes and surface tunnelling marks were noted along the trunk and branches of a dead standing tree. The pattern and shape of the damage are consistent with wood borer infestation. No live activity was observed at the time of inspection, though damage is clearly evident.

- The tree maybe structurally compromised and may pose a fall or safety hazard, especially during wind events.
- Proximity to structures or power lines may increase the risk of damage or injury.
- Although native borers are not typically a threat to treated structural timbers, their presence indicates decay and weakened wood that could attract secondary pests.

- Engage a qualified arborist to assess the structural integrity of the tree and arrange for safe removal if required.
- If the tree is within falling distance of a building, fence, or utility infrastructure, urgent removal is recommended.
- Regular site monitoring is advised for surrounding trees to detect any early signs of similar pest activity.
