Building and Timber Pest Inspection Report

Inspection Date: Thu, 5 Mar 2026

Property Address: 52 Hamilton Ave, Earlwood NSW 2206,
Australia

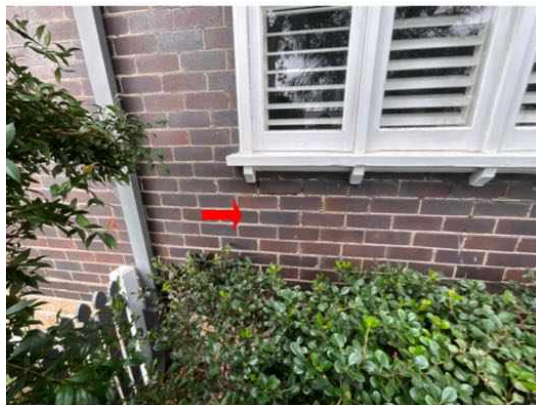
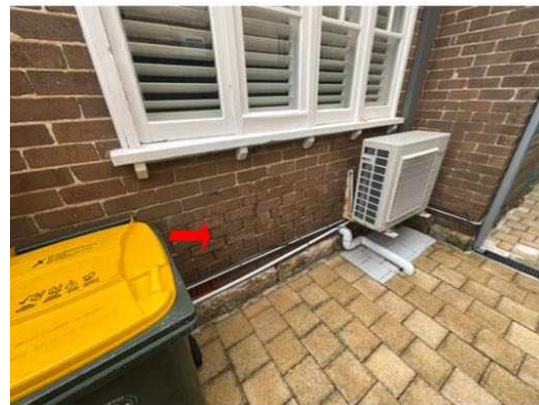
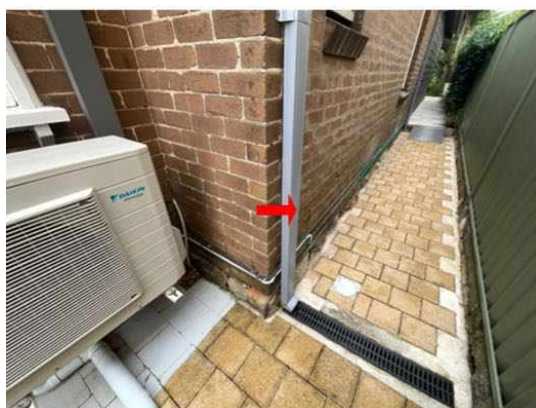
Finding 3.01

Building: Main Building

Location: Exterior walls

Finding: Brickwork - Deteriorated mortar

Information: Mortar, or 'bedding', is the material which fills joints and intersections between bricks in masonry walls and structures. Sections of mortar in this brickwork were identified as having deteriorated.

Mortar deterioration can be addressed by a bricklayer.

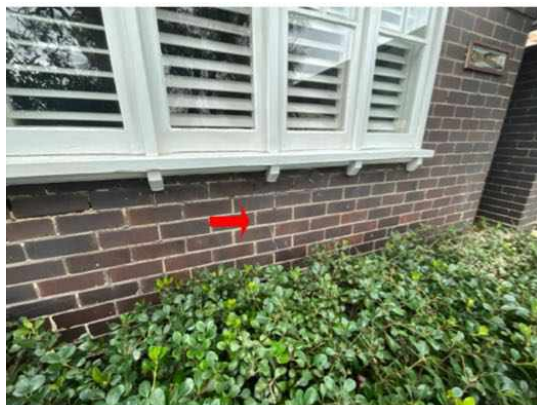
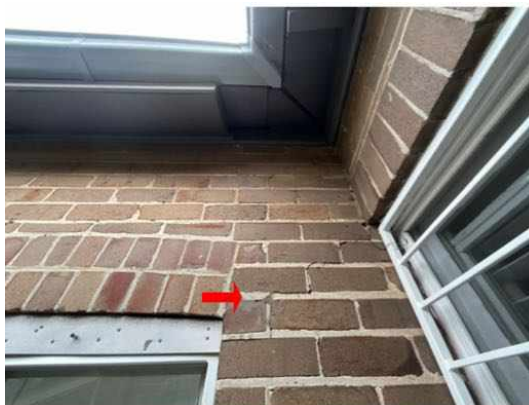
Finding 3.02

Building:	Main Building
Location:	Exterior walls
Finding:	Brickwork - Cracking noticeable
Information:	There were several cracks and or crack repairs evident to external brickwork.

Noticeable cracks are a common occurrence in external brickwork and are a likely result of age expected building movement, general expansion, and/or contraction of building materials in different weather conditions.

It is highly advised that a qualified bricklayer be appointed to provide necessary works to cracked brickwork to prevent any further damage.

Always monitor these cracks and contact a building inspector should cracks widen, lengthen, or become more numerous.

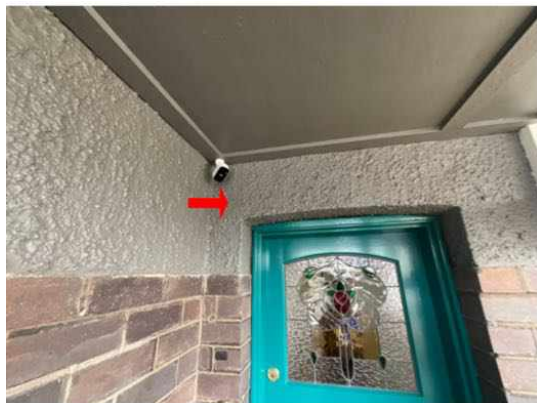
Finding 3.03

Building:	Main Building
Location:	Exterior walls
Finding:	Cracking - Damage Category 2 - Noticeable (up to 5mm)
Information:	Noticeable cracks are a common occurrence as a result of many primary defects. Such causes may include age, general wear and tear, expected building movement, general expansion/contraction of building materials in different weather conditions, and/or minor failings in the installation or application of building materials.

I recommend monitoring and if further cracking is evident appoint a bricklayer to see what works are required.

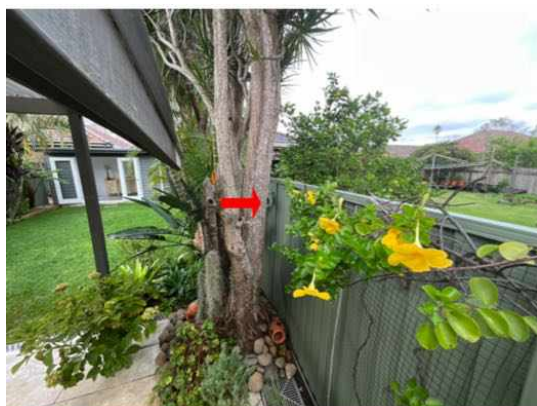
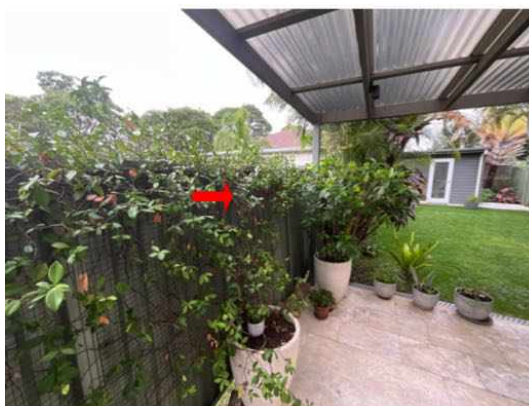
Finding 3.04

Building:	Yard
Location:	Fencing
Finding:	Fencing - Leaning
Information:	It was noted at the time of inspection that sections of the fencing in this area are leaning.

A licensed fencing contractor should be appointed to provide further advice and perform rectification works as necessary.

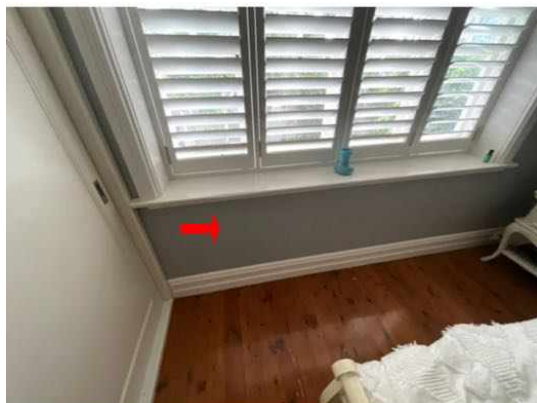
Finding 3.05

Building:	Main Building
Location:	Internal Areas
Finding:	Cracking - Damage Category 2 - Noticeable (up to 5mm)
Information:	Noticeable cracks are a common occurrence as a result of many primary defects. Such causes may include age, general wear and tear, expected building movement, general expansion/contraction of building materials in different weather conditions, and/or minor failings in the installation or application of building materials.

I recommend monitoring and if further cracking is evident appoint a bricklayer to see what works are required.

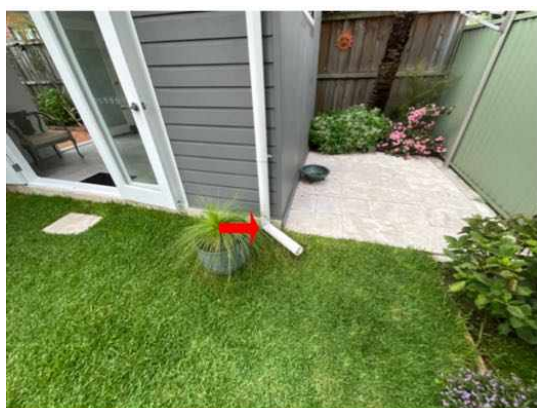
Finding 3.06

Location: Exterior walls

Finding: Stormwater drain - Not connected

Information: The roof plumbing is not adequately connected to stormwater drainage on the site. This disconnection negatively impacts the functional capacity of the roof plumbing.

Where roof plumbing doesn't drain adequately, the area at the base perimeter can become excessively damp, potentially creating an environment that is susceptible to rust and corrosion of surrounding building elements, as well as attracting termites and other pests.

It is highly recommended that a plumber be appointed to further inspect the area and to install adequate drainage equipment where necessary.

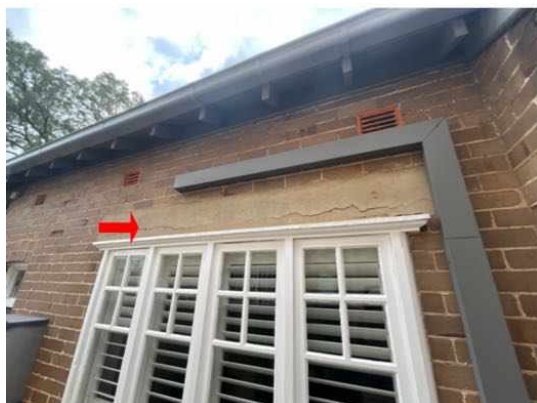
Finding 3.07

Building: Main Building

Location: Exterior walls

Finding: Lintel - Deteriorated

Information: The lintel in this area is showing signs of deterioration.

I recommend appointing a bricklayer to see what necessary works are required.

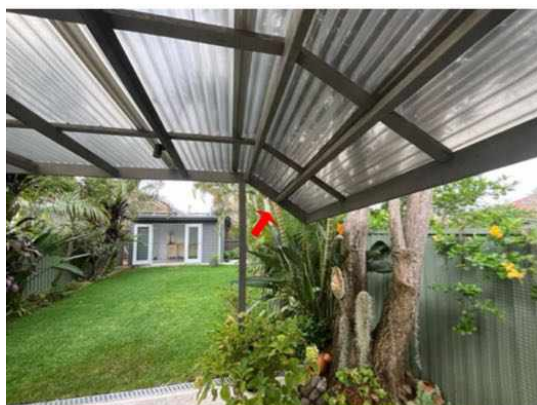
Finding 3.08

Building:	Yard
Location:	Pagola
Finding:	Fitting or fixture - Loose
Information:	The fitting in this area is loose and requires adjustment to tighten.

If left unmanaged, the fitting may further deteriorate, causing potential for the development of other minor secondary defects.

A relevant tradesperson should be appointed to perform these rectification works at discretion of the client.

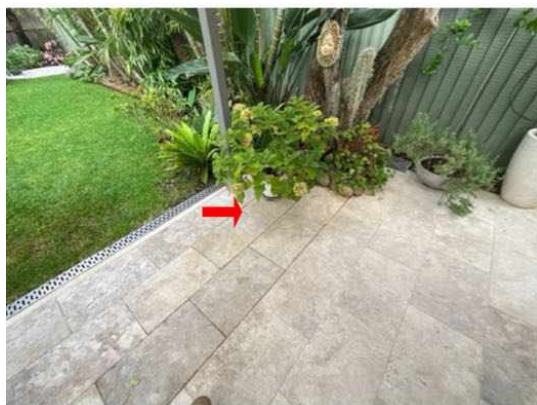
Finding 3.09

Building:	Yard
Location:	Yard - Back
Finding:	Uplifted Yard Tiles Due to Tree Roots
Information:	Tiles in the yard have lifted and become uneven due to pressure from nearby tree

roots.

Movement caused by tree roots may continue over time, leading to further displacement of tiles and creating potential trip hazards.

A landscaper or builder should assess the affected area and carry out repairs to reinstate the tiles. Consideration should also be given to managing or removing the tree roots to prevent further movement.

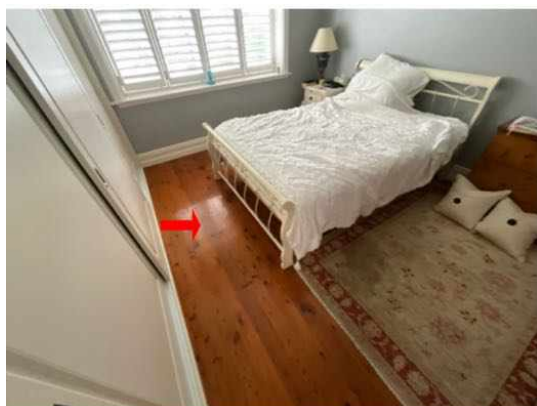
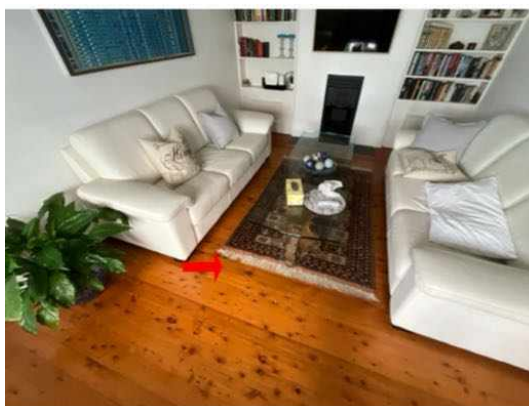
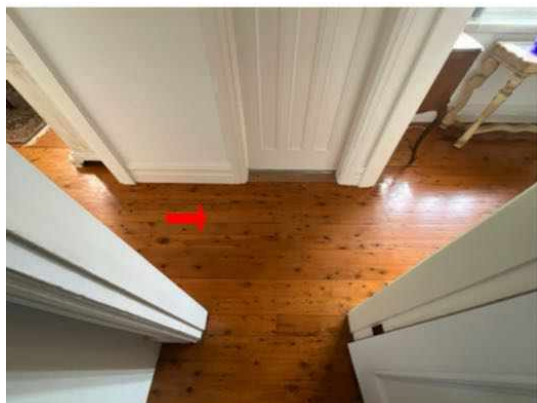
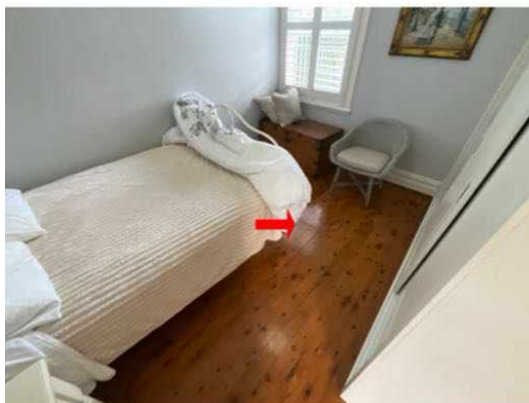
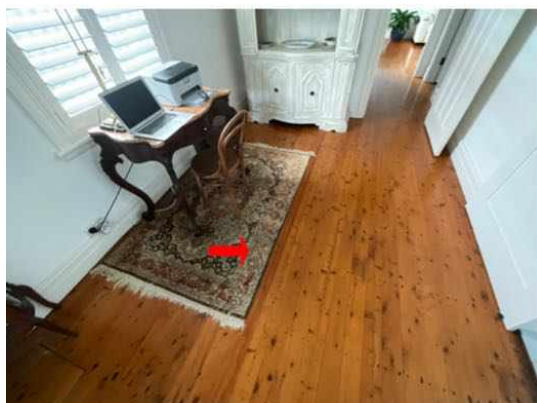
Finding 3.10

Building:	Main Building
Location:	Internal Areas
Finding:	Floors - bouncy
Information:	The internal flooring in this area was identified as being bouncy at the time of inspection. A bouncy floor surface generally presents as a discernible change in level as they are walked across, in noisy or creaking flooring, or in consequent movement of surrounding furniture and fixtures.

Bouncy floors generally indicate that the floorboards or the subfloor structures are coming loose from the joists that they are installed on. Bouncy flooring may also be the result of gaps between flooring and joist structures, which require packing.

The client is advised to seek quotations for required repairs from a Registered Builder.

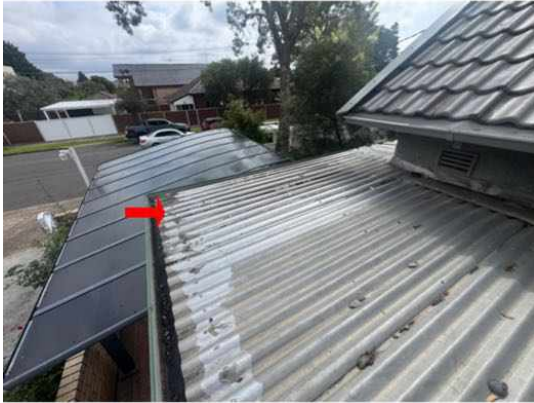
Finding 3.11

Building: Main Building
 Location: Roof Exterior
 Finding: Roof sheets - Deteriorated
 Information:

Upon inspection of the exterior roofing, it was found that the roof sheets show signs of deterioration, with some sheets having come loose from their original fixing. The roofing has sustained an array of issues due to the age of the materials and a lack of general maintenance over time, including loose sheeting, lifting and sagging of sheets, and deterioration of associated building elements.

Loose, deteriorated and damaged roof sheets are susceptible to water penetration, exposing the surrounding associated area to internal roof leaks and water damage.

Re-fixing of all loose roof sheets should be conducted to ensure that no further damage occurs. Depending on the extent of the damage, replacement of sections of roof sheets or associated materials may be required. Engagement of a roofing restoration contractor is highly advised to perform remedial works as necessary.

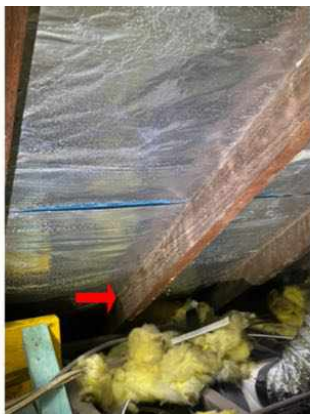
Finding 5.01

Building:	Main Building
Location:	Roof Void
Finding:	Termite - damage identified
Information:	Despite no live termite or timbered pest activity being indicated, termite damage was found to have affected this area.

A building contractor should be appointed to provide a further invasive inspection and to see what necessary works are required.

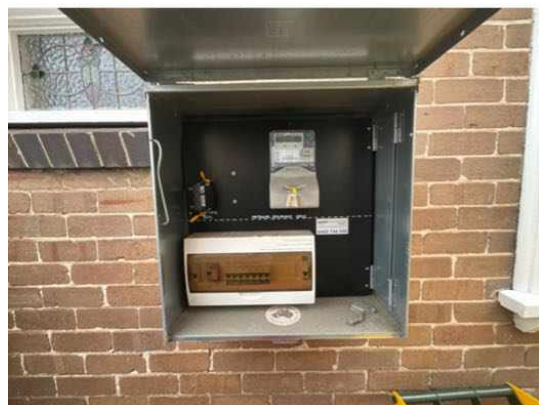
Finding 6.01

Building:	Main Building
Location:	All Areas
Finding:	Termite Management System - no evidence of a chemical installation
Information:	The application of a post-construction chemical termite barrier is highly recommended for all properties, particularly if live termite activity has been found on the site previously. Such barriers are highly effective in preventing termite attack on any timber building elements throughout the property.

A durable notice should be placed in the switchboard unit to indicate current termite barriers. At the time of inspection, it appeared as though no termite management system has been installed, with no evidence to suggest preventative works taking place.

The client may consider gaining further advice from a pest controller as to the costs and procedures involved with this application. It is recommended that obtaining such advice be a short-term priority.

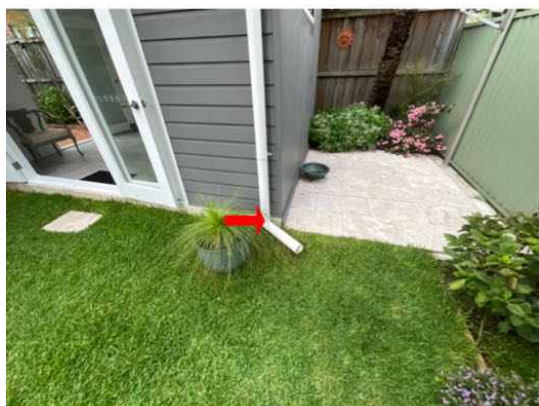
Finding 6.02

Building:	
Location:	Exterior walls
Finding:	Excessive moisture - identified
Information:	Excessive moisture can attract termites and produce conditions that promote fungal growth and wood decay.

Prior to any remedial works being performed a qualified plumber should be appointed to further inspect the property and to identify the cause of the excessive moisture.

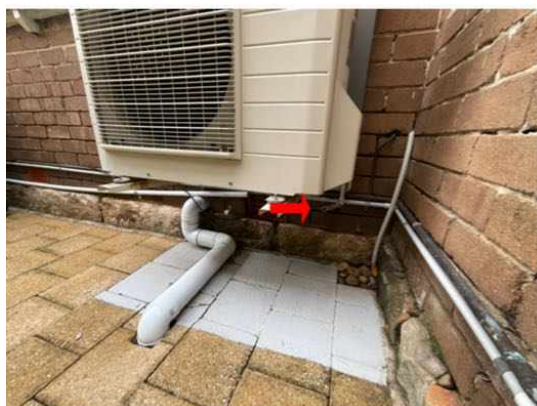
Finding 6.03

Building:	Main Building
Location:	Exterior walls
Finding:	Air conditioner - Disconnected overflow
Information:	The Air Conditioner (A/C) overflow was found to be disconnected from storm water drainage and is creating excessive moisture in the surrounding area.

Such leaking creates an environment which is conducive to an array of defects, including water damage to associated building elements and the attraction of termite or timber pest infestation.

It is highly recommended that a licensed plumber be appointed to connect the A/C overflow in order to prevent such an environment from being created. These minor works should be carried out as soon as possible.

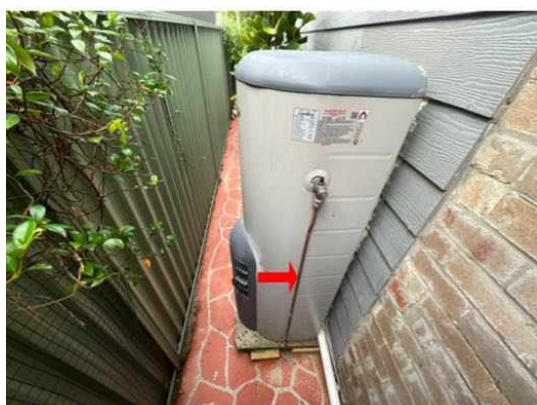
Finding 6.04

Building: Yard
 Location: Yard - Side
 Finding: HWS Overflow - Not Connected
 Information: The Hot Water System (HWS) overflow was found to be disconnected from storm water drainage and is creating excessive moisture in the surrounding area.

It is highly recommended that a licensed plumber be appointed to connect the HWS overflow in order to prevent such an environment from being created.
