# Building and Timber Pest Inspection Report

Inspection Date: Wed, 8 Apr 2026

Property Address: 71a Nicholson Parade, Spring Farm NSW  
2570, Australia

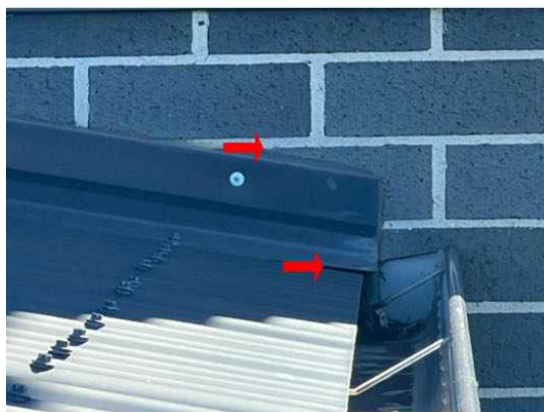
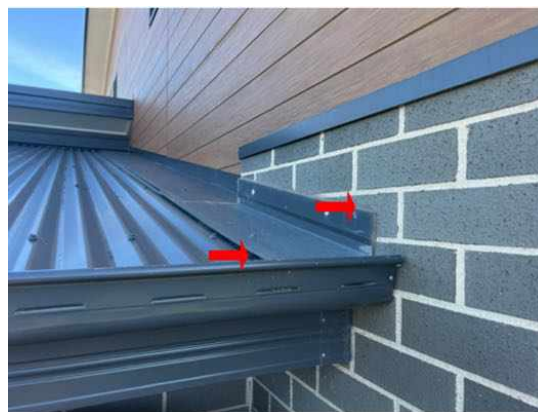
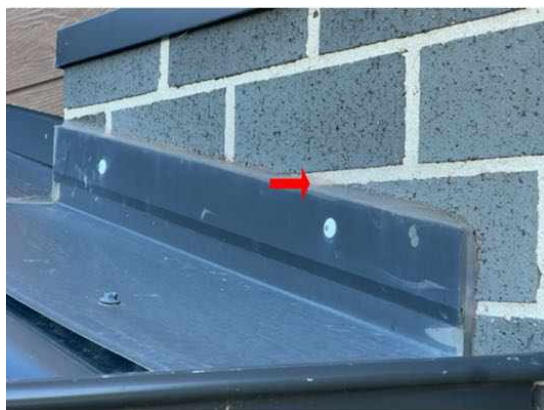
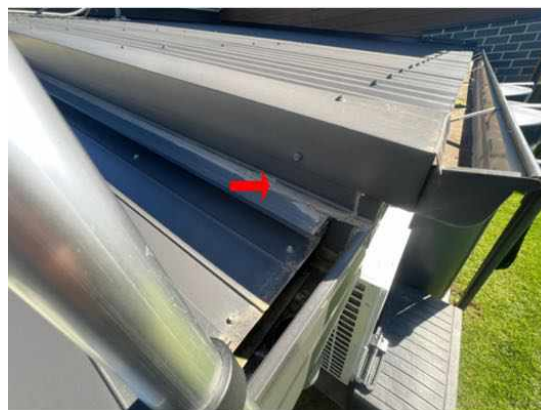
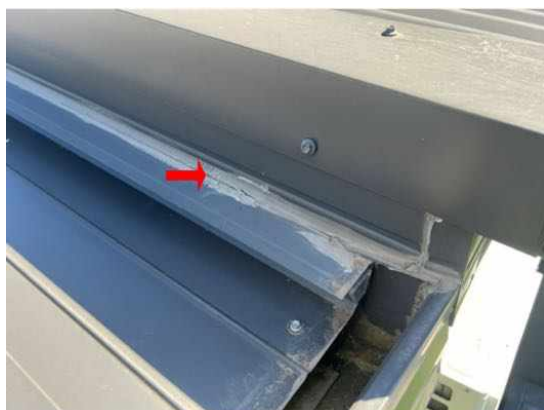
#### Finding 3.01

Building:	Main Building
Location:	Roof Exterior
Finding:	Flashing defective -poor installation
Information:	The metal flashing at the wall junction appears inadequately installed, with visible gaps and lifting and reliance on surface sealant rather than a properly chased and continuous detail. The junction does not appear fully weather-tight, increasing the risk of moisture ingress into the wall cavity or roof structure over time. Defective flashing installation can lead to concealed deterioration if not addressed. Recommend assessment and rectification by a qualified roofing contractor to ensure compliant and effective weatherproofing.

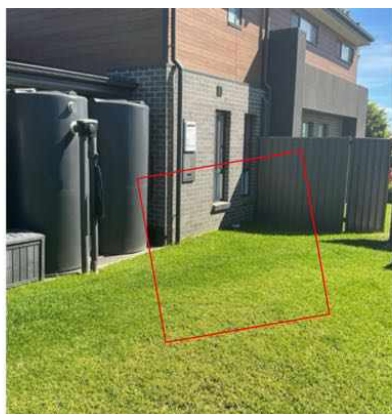
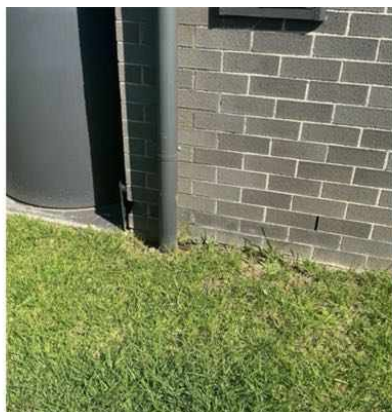
### Finding 3.02

Building:	Main Building
Location:	All External Areas - Rear
Finding:	Site drainage - Inadequate
Information:	The site drainage in this area was found to be inadequate at the time of inspection, creating potential for subsequent water damage to associated building elements.

It is important that water does not lie against the base of walls; surrounding paths and ground levels should be sloped to drain water away from walls. Downpipes should not discharge stormwater onto lower walls or plinths. Stormwater should be carried away by large, regularly cleaned drains. Ground levels may need to be lowered to expose a buried DPC.

Where site drainage is inadequate, installation of an Agricultural (Aggie) Drain may be required. A qualified plumber should be appointed to further inspect the property and perform any remedial works as necessary. Water damage and secondary defects are likely to occur if left unmanaged.

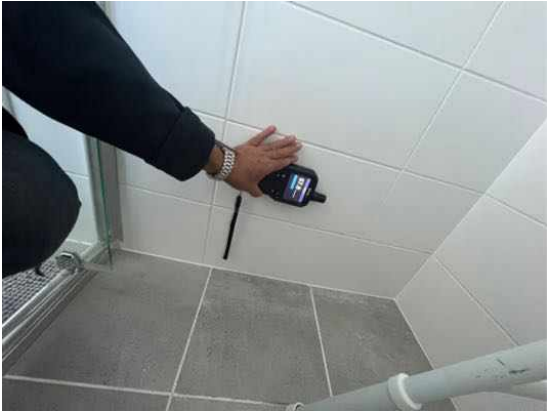
### Finding 3.03

Building:	Main Building
Location:	Bathrooms
Finding:	Elevated Moisture Bathroom (No visible deterioration noted)
Information:	Elevated moisture levels were detected to tiled surfaces in bathroom/shower areas. Persistent moisture ingress can lead to concealed damage, including timber rot and mould growth.

Elevated moisture readings in tiled wet areas can occur from normal shower use, age/deterioration of waterproofing membranes, plumbing leaks or moisture absorption through grout lines. While no damage was visible, elevated readings may indicate moisture retention behind tiles, which can be a conducive condition for future deterioration if not monitored.

Monitor the area over time for signs of drumming, efflorescence, tile movement, or grout deterioration. Further inspection by a licensed waterproofing is recommended (e.g., pressure testing, membrane assessment).

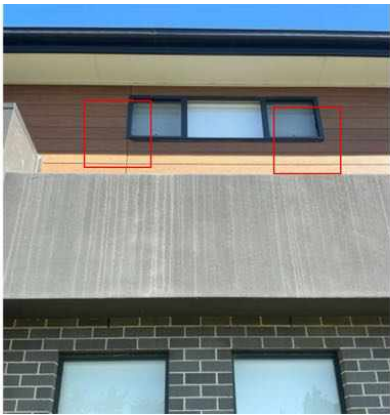
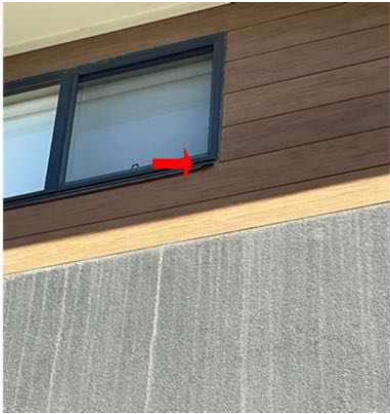
### Finding 3.04

Building:	Main Building
Location:	All External Areas
Finding:	Window seals - deteriorated
Information:	The window seals have deteriorated.

Where window seals have deteriorated, the window is no longer weather-tight; rain penetration and subsequent water damage is therefore likely to ensue. Insulation of the area against external weather conditions will also be compromised.

It is recommended that all deteriorated window seals be replaced by a general handyman or sealant expert to prevent any further damage and to restore the window to a fully functional level.

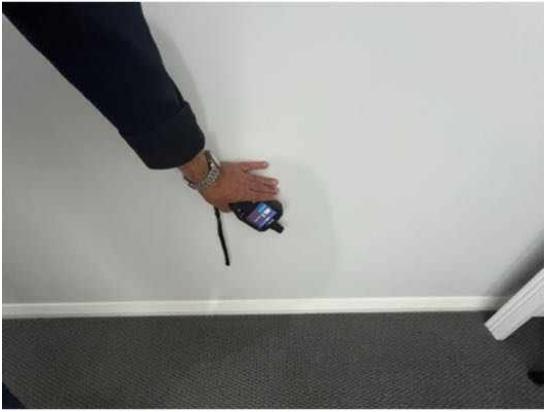
**Finding 3.05**

Finding: Elevated moisture - No visible deterioration

Information: Elevated moisture meter readings were recorded to the tiled floor surfaces , adjacent wall bases and first floor below windows when tested using a non-invasive (pinless) moisture meter. No visual evidence of moisture ingress, tile debonding, grout deterioration, staining, mould growth, or related moisture damage was observed at the time of inspection. Ongoing monitoring is recommended, and further investigation is warranted to check if there are concealed defects developing.

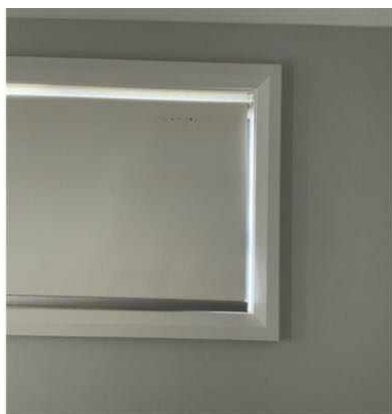
Finding 3.06

Building: Main Building  
Location: All External Areas  
Finding: Walls - Water stained  
Information: Water staining to sections of the walls in this area was evident at the time of inspection. Water staining indicates that surfaces have been exposed to moisture over time. The minerals and other elements in the water lead to staining, which may graduate to corrosion and deterioration if left unmanaged.

While mostly an appearance defect, water staining can be indicative of more serious defects, which may be currently concealed by wall linings.

Where water staining is active, a licensed plumber must be consulted to identify the cause of the staining and to provide advice on any reparation works that may be required. Replacement of any broken or damaged structures is advised.

Conversely, where water staining is old and inactive, affected building materials may be repaired or replaced at client discretion.

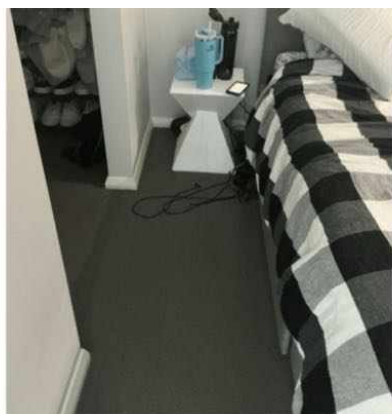
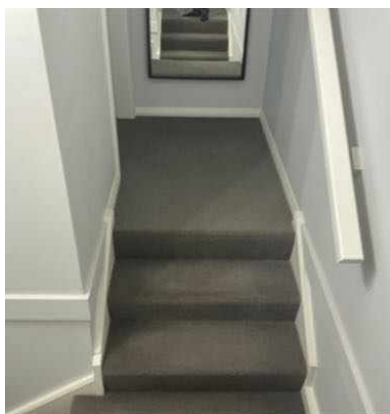
### Finding 3.07

Building:	Main Building
Location:	All Internal Areas
Finding:	Floor Flexing on First Floor - Bouncy Floor to some areas
Information:	Localised floor flexing was noted in isolated areas of the first floor during normal walking conditions. This condition is typical of timber-framed floor systems and may be attributed to minor deflection in floor joists, insufficient subfloor support, or age-related settlement of structural elements.

No visible signs of structural damage or distress were observed at the time of inspection. If the deflection worsens or causes concern, further assessment by a licensed builder or carpenter is recommended. Remedial work may include installation of additional support noggins, blocking, or subfloor stiffening to reduce bounce and improve floor rigidity.

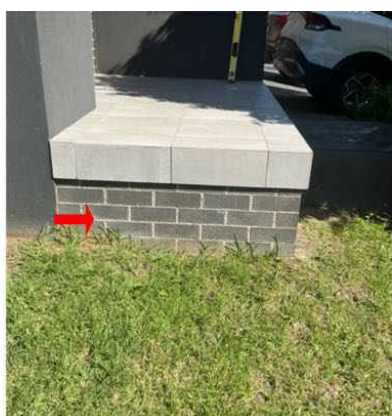
### Finding 3.08

Building:	Main Building
Location:	All External Areas
Finding:	Brickwork - Efflorescence
Information:	Efflorescence appears to be affecting the brickwork, concrete or tiles in this area. Efflorescence typically occurs when excess salts within the concrete or cement mortar is leached to the surface due to water transfer.

It is typically seen as white salt deposits on the surfaces of concrete pavement or mortar between bricks or tiles. While detracting from the overall appearance of the affected area, efflorescence is not likely to develop into secondary damage if left unmanaged.

Generally, soluble salt deposits can be removed by dry brushing with a stiff-bristled brush. Repeated dry brushing is an ideal treatment for eliminating this forming of efflorescence. A cleaning contractor or general handyperson may be appointed to perform these works at the discretion of the client.

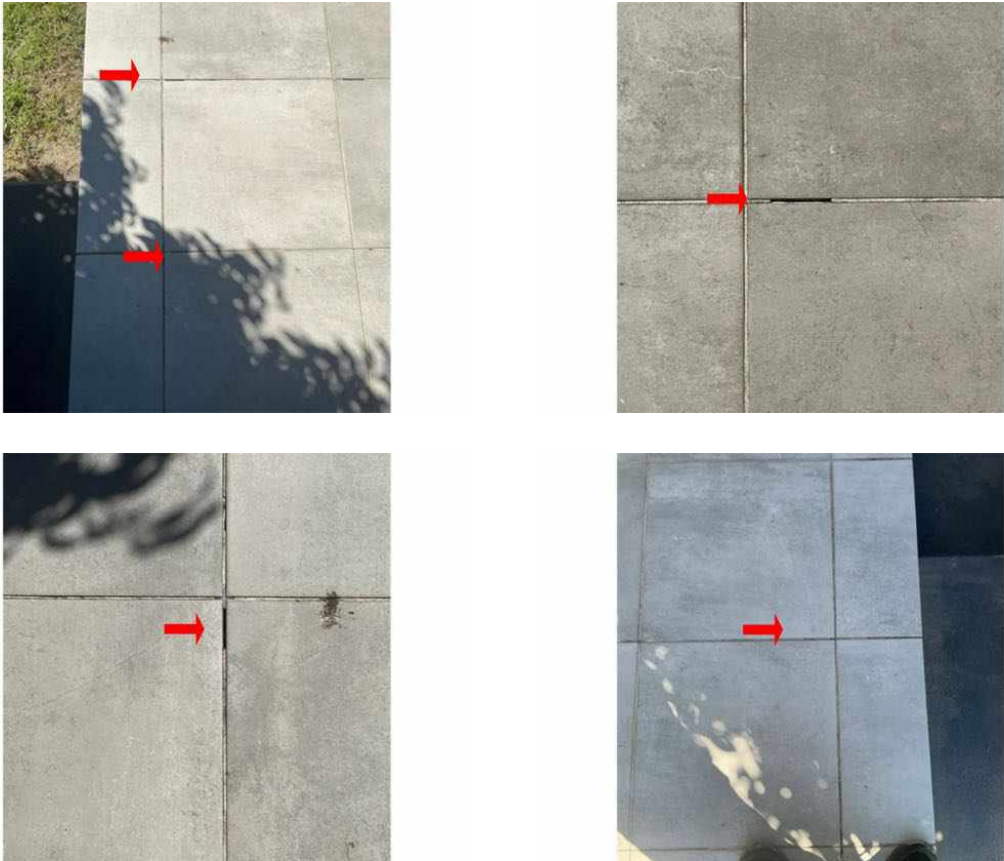
### Finding 3.09

Building:	Main Building
Location:	All External Areas - Front tiles area

Finding: Sealant and grouting - Missing or degraded  
Information: It was noted on inspection that sealant or grout is degraded.

Different materials and floor areas move at different rates, generally causing cracking to grout or sealant at this point. A flexible sealant is required to allow for expected expansion and contraction, while keeping the joint water tight and protective of all associated building materials.

Flexible and mould resistant materials should be applied to affected areas to prevent any subsequent water damage that is likely to occur. Regular maintenance and replacement of damage or missing or damaged sealant and grout is highly recommended to the wet areas, as this is a regular wear and tear defect. Sealant and grouting in areas that come into regular contact with water should be maintained for the long term care of your property.

A sealant specialist or tiling contractor should be appointed to complete these works as soon as possible

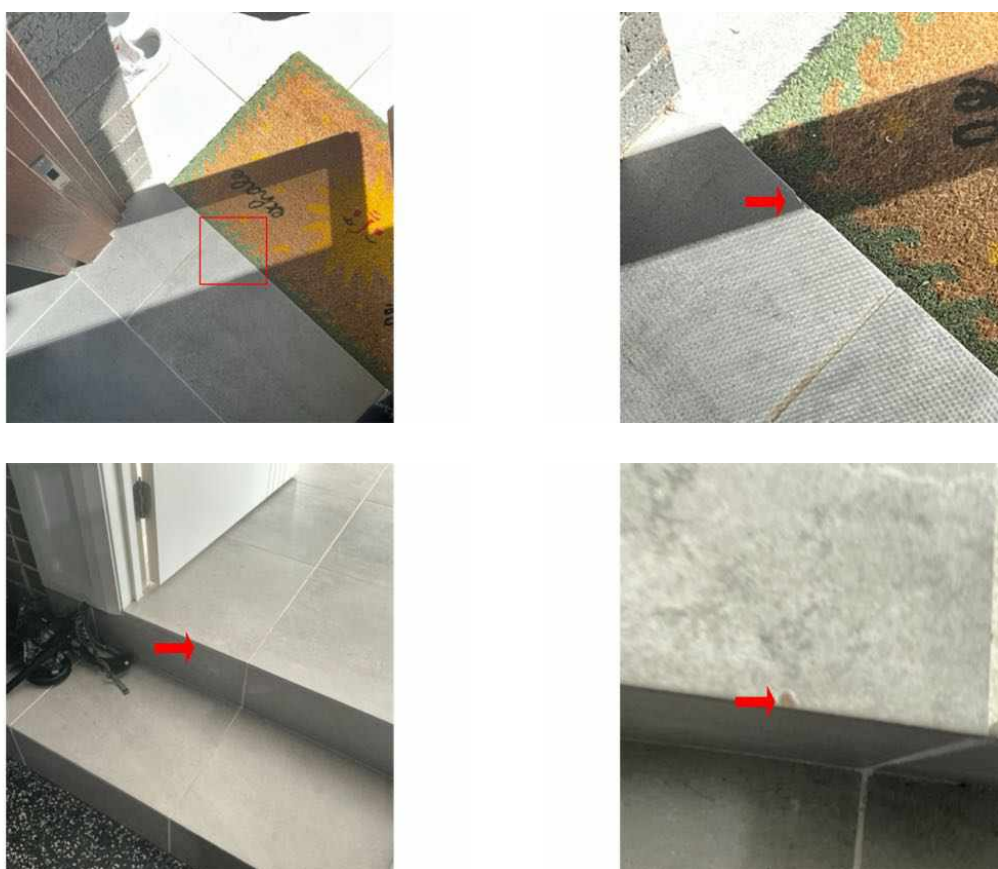
**Finding 3.10**

Building: Main Building  
Location: All Internal Areas - Front , Garage  
Finding: Tiles - Cracked or damaged

Information: Cracking was evident to the tiling in this area at the time of inspection. While the cracking appears to be minor, this area is frequently exposed to water, allowing potential for water penetration into adjoining sections of walls or flooring.

If left unmanaged, water penetration to these areas may lead to subsequent water damage, which is likely necessitate repair work to affected building elements.

A tiling contractor should be appointed to ensure that no further water damage occurs. The re-application of silicone and grouting throughout remaining tile work is also advised, to further protect the area against water penetration.

Where water penetration has led to water damage, appointment of a relevant tradesperson may be required to repair damaged building elements.

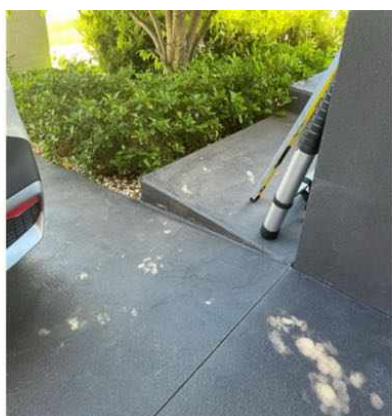
### Finding 3.11

Building: Main Building  
 Location: All External Areas  
 Finding: Cracking - External Concrete Paving Damage Category 2 - Distinct (less than 3mm)  
 Information: Distinct cracks were identified in external concrete paving. Distinct cracks are generally found in older concrete paving, and may also present as a trip hazard as consequence of an uneven or curved surface.

General age and expected deterioration of the paved areas is a common cause of this

type of cracking. However, expansion and contraction of the slab may also have occurred due to environmental factors. Such factors include variable moisture and weather conditions, the presence of trees and their roots having a settling or lifting affect on the soil, or the effect of load bearing, e.g. heavy vehicles over a sustained period of time.

Cracking to this degree may also be due to poor original installation of the concrete. Factors such as poor compaction of the sub surface and/or inadequate reinforcing of the slab may create cracking and other secondary defects.

Repairs are likely to be required to prevent further cracking and to reduce hazards associated with cracking, such as tripping. Monitoring of all cracking should be conducted frequently. Always contact a building inspector should cracks widen, lengthen, or become more numerous.

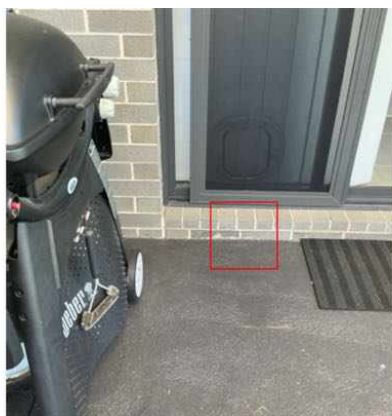
### Finding 3.12

Building:	Main Building
Location:	All External Areas
Finding:	Brickwork - Deteriorated mortar to some areas
Information:	Mortar, or 'bedding', is the material which fills joints and intersections between bricks in masonry walls and structures. Sections of mortar in this brickwork were identified as having deteriorated, which is generally expected for a property of this age and condition.

Mortar may deteriorate as a result of age of building materials, minor movement of bricks, or frequent exposure to weathering. Mortar should be replaced to ensure that bricks remain in their intended location and to prevent gaps, which would allow water or moisture ingress and secondary damage as a result.

Mortar deterioration can be addressed by a bricklayer where areas of deterioration are localised and easily accessible. Alternatively, appointment of a registered builder is advised, to repoint large areas of decaying mortar. Where secondary structural defects have become evident, consultation with a structural engineer may be required.

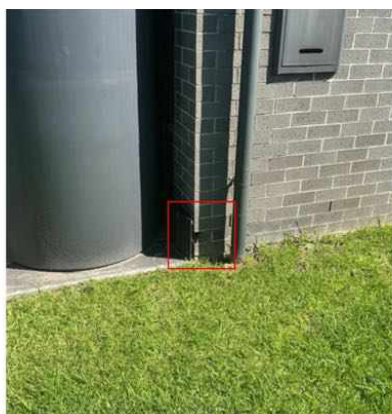
### Finding 3.13

Building:	Main Building
Location:	All External Areas
Finding:	Building element - Damaged - Brick damaged left side
Information:	Breakage occurs generally when the building materials have either aged and decayed, or as a result of damage (accidental or deliberate).

Repair and/or replacement of broken elements is advised to ensure that additional secondary defects do not arise as a consequence. Such works are necessary, as all building elements play a key role in the operation and function of the overall structure and its performance.

A relevant tradesperson should be appointed to repair or replace the affected building element prior to any subsequent damage being caused.

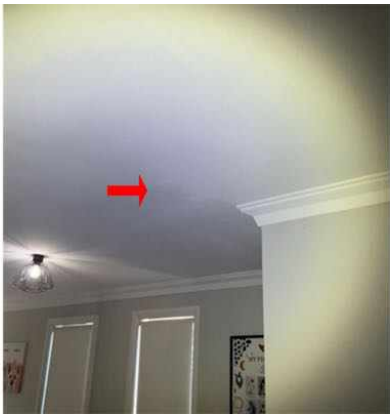
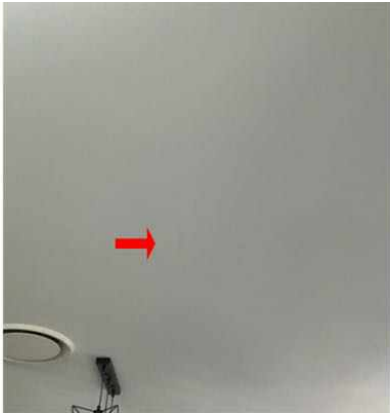
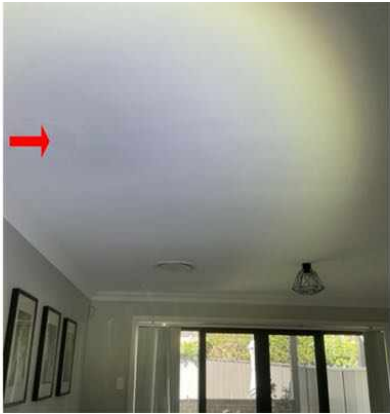
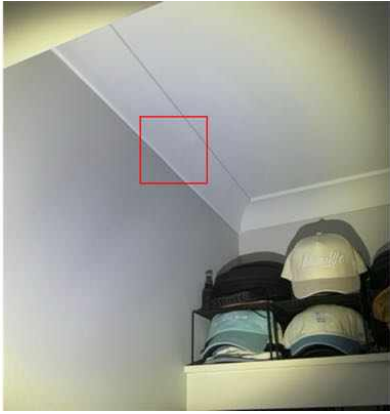
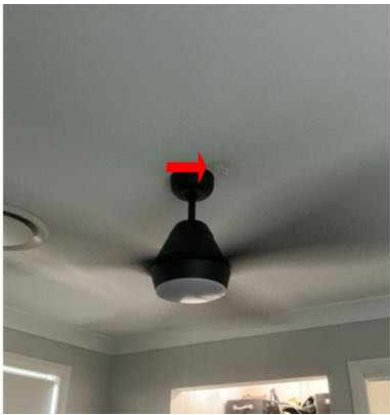
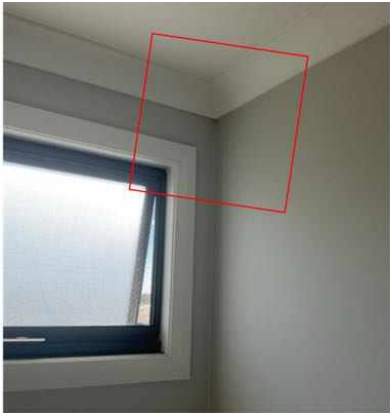
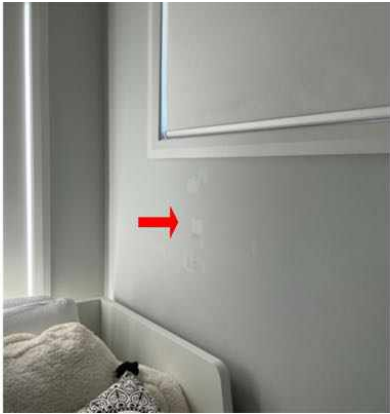
### Finding 3.14

Building:	Main Building
Location:	All Internal Areas
Finding:	Paint Finish & Hairline Cracking - To some areas
Information:	The paint finish in this area was identified as being incomplete at the time of inspection including some hairline minor cracking.

Whilst incomplete or missing paint and minor cracking and imperfections in finish is generally an appearance defect, it can also lead to the development of secondary building defects over time. Incomplete areas of paint finish expose the area to moisture, potentially accelerating the deterioration of underlying building materials.

Incomplete paint finishes should be sanded back, filled, leveled and painted, as applicable. Where inadequate or missing paint protection has led to the deterioration of the associated building element, repair and/or replacement of this building element may be required.

A painting contractor should be appointed as soon as possible to perform necessary works to aid the appearance of the affected area and to ensure the area is protected against further deterioration. Alternatively, the homeowner following manufacturer instructions may perform these works.

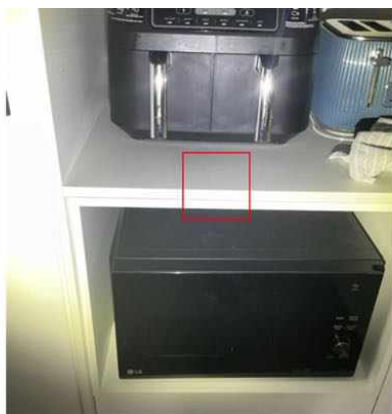
**Finding 3.15**

Building: Main Building  
Location: All Internal Areas  
Finding: Building element - Damaged - Kitchen top chipped  
Information: Breakage occurs generally when the building materials have either aged and decayed, or as a result of damage (accidental or deliberate).

Repair and/or replacement of broken elements is advised to ensure that additional secondary defects do not arise as a consequence. Such works are necessary, as all building elements play a key role in the operation and function of the overall structure and its performance.

A relevant tradesperson should be appointed to repair or replace the affected building element prior to any subsequent damage being caused.

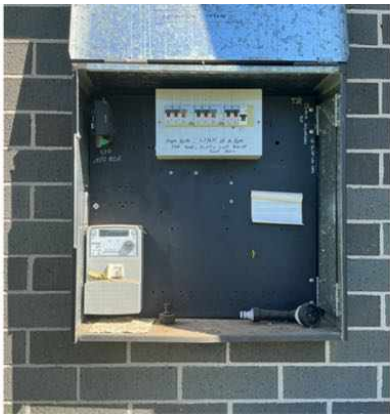
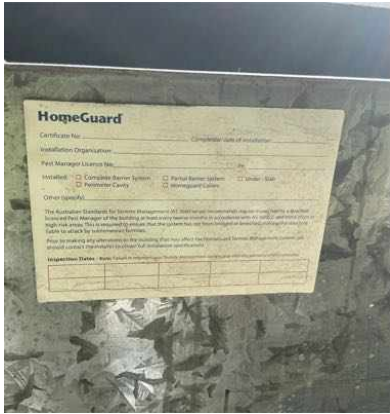
Building:	Main Building
Location:	All External Areas
Finding:	Termite Management System - no evidence of a chemical installation
Information:	The application of a post-construction chemical termite barrier is highly recommended for all properties, particularly if live termite activity has been found on the site previously. Such barriers are highly effective in preventing termite attack on any timber building elements throughout the property.

A durable notice should be placed in the switchboard unit to indicate current termite barriers. At the time of inspection, it appeared as though no termite management system has been installed, with no evidence to suggest preventative works taking place.

The client may consider gaining further advice from a pest controller as to the costs and procedures involved with this application. It is recommended that obtaining such advice be a short-term priority.

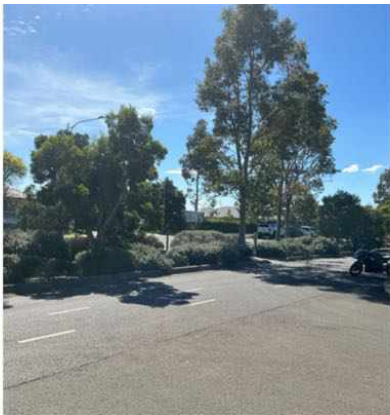
**Finding 6.02**

Building: Main Building  
 Location: All External Areas  
 Finding: Trees within 50m  
 Information: Trees within 50m of the property can be conducive to termite activity. It is recommended to monitor any potential signs of timber pest activity. An invasive inspection of trees with 50m to the property is recommended by a licensed timber pest technician

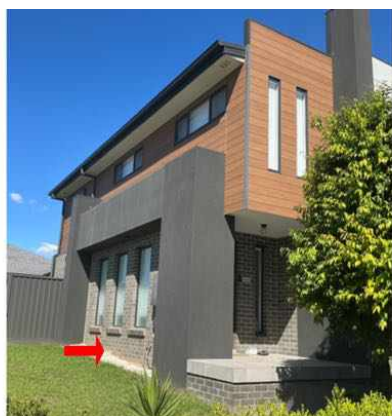
**Finding 6.03**

Building:	Main Building
Location:	All External Areas
Finding:	Slab Edge - Exposure
Information:	An inspection zone of at least 75mm in relation to the exposed slab edge, between the bottom brick and the perimeter pavement, is required. This inspection zone should be maintained in order to force termites into the open where they can be detected more readily during regular inspections. The slab edge should not be concealed by anything that may prevent inspection of the area, including render, landscaping, soil, turf, paving, concrete cladding or other structures.

If the slab edge is not properly exposed there is a high risk of termite attack. Sometimes, in order to determine the type of slab, a suitably qualified person such as an architect or builder may be required to consult the construction plans.

Where the slab edge cannot be properly inspected, it is highly recommended that termite or timber pest inspections be carried out every 6-12 months to aid protection of the property against infestation.

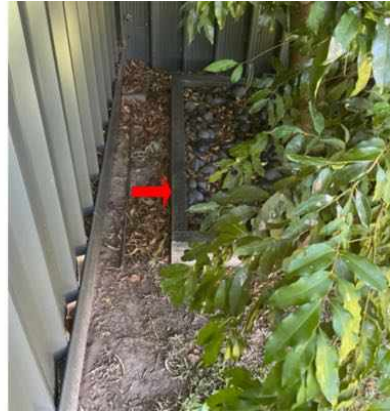
### Finding 6.04

Building:	Main Building
Location:	All External Areas
Finding:	In ground contact - Timber
Information:	Any timbers in direct ground contact provide opportunity for concealed termite entry and are likely to be subject to premature rot and decay as the soil retains moisture or damp conditions against the timbers.

Remove untreated timber that is in direct contact with external grounds. Consider replacement with more durable materials i.e. treated timber or non timber elements. Frequent pest inspections are advised to readily identify any termite activity in these areas.
