Building and Timber Pest Inspection Report

Inspection Date: Fri, 13 Mar 2026

Property Address: 9 Dundee Dr, West Wodonga VIC 3690,
Australia

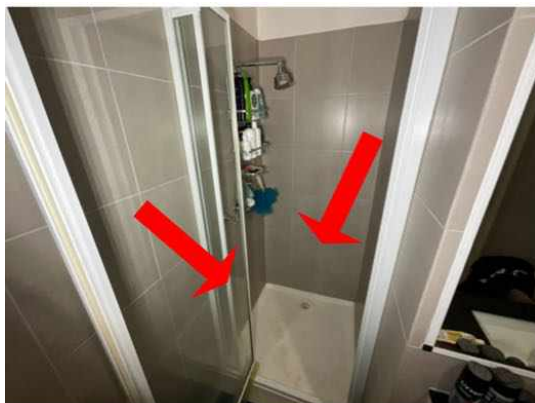
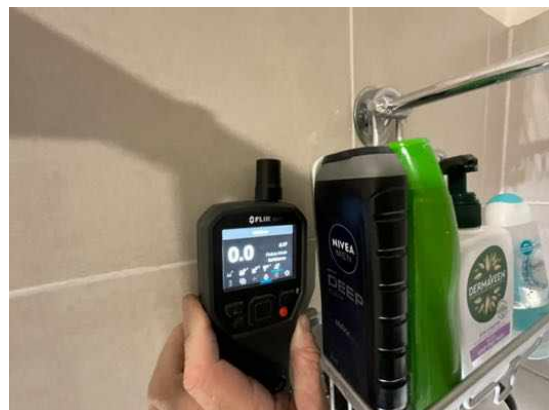
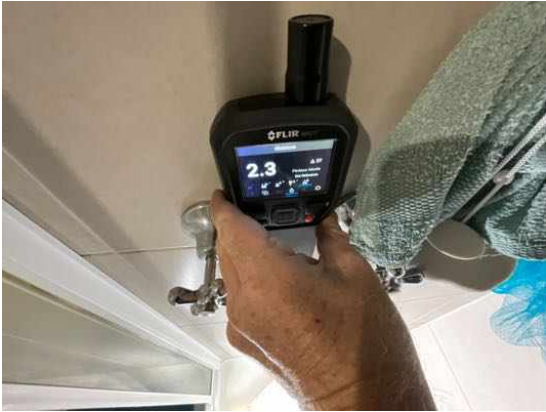
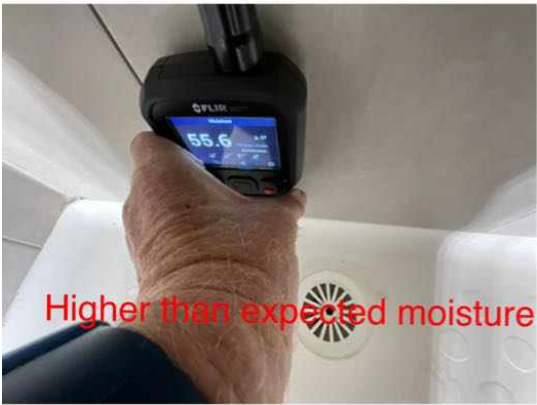
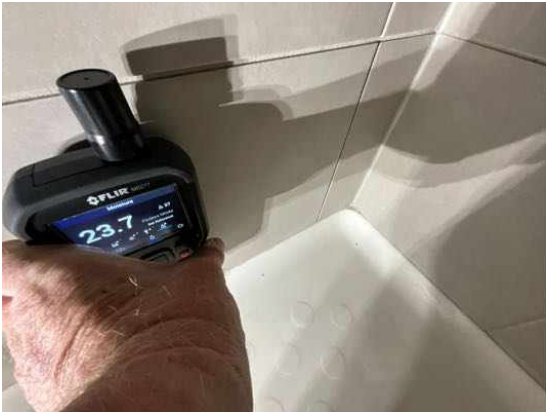
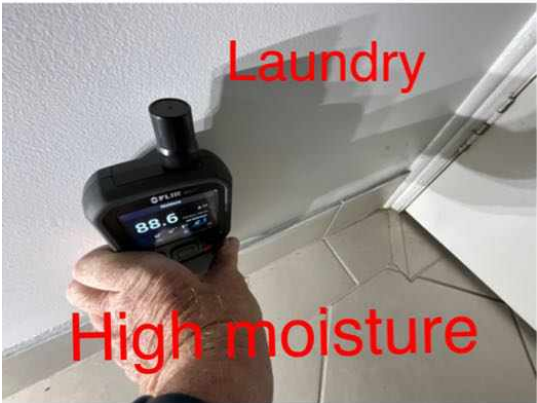
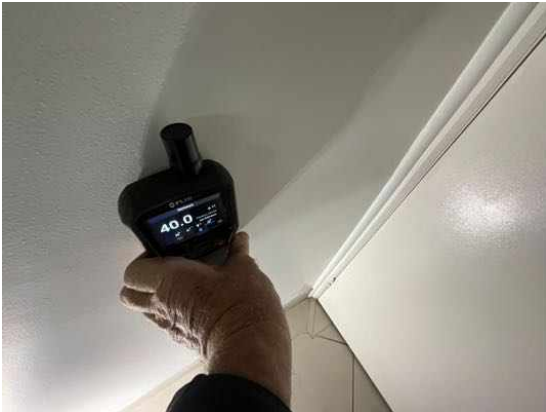
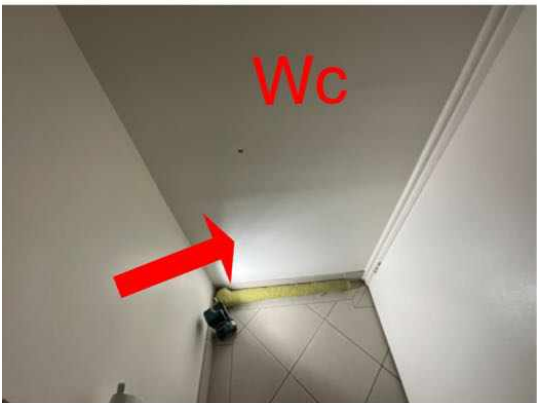
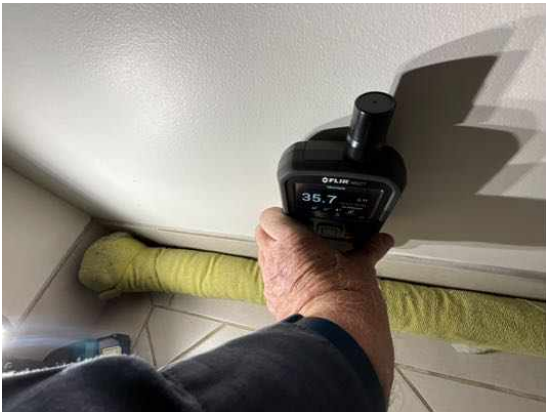
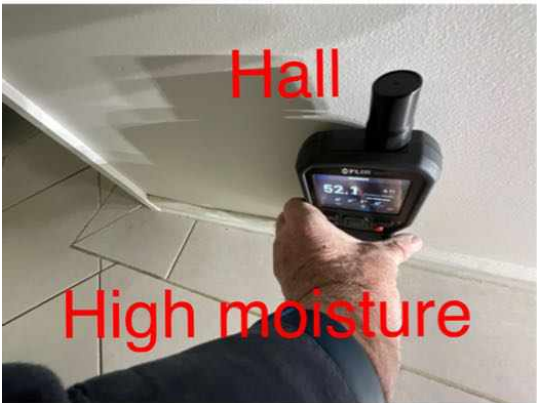
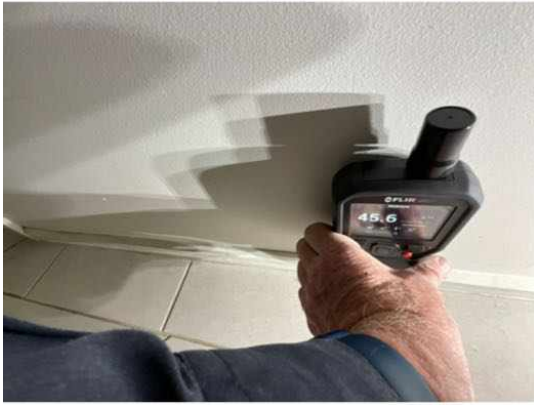
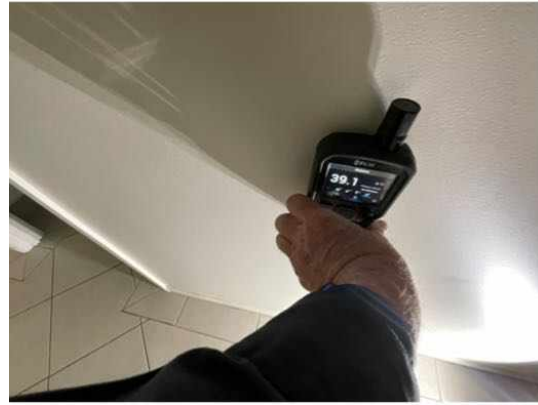
Building: Building 1
Location: Bathroom
Finding: Shower Damp- Major
Information: Damp is evident to the lower 300mm of wall to the Shower Alcove. This is suspected to have been caused by moisture permeating through the grouting in this area, which shows evidence of deterioration.

High levels of moisture were observed on the outside of the shower walls in the opposite wall.

Damp (or structural damp) refers to the presence of unwanted moisture in the structure of the building, either as a result of intrusion from outside, or condensation from within the structure. In the Shower area, internal water leaks or other sources of excessive moisture are generally the cause of damp.

A major defect is noted. The shower alcove shows excessive moisture. A plumber should be contacted first to perform a pressure test and establish whether there is a leak. If no leak, the moisture proof barrier has failed and may need replacement. A bathroom specialist or registered builder should be contacted to perform all needed work and prevent further deterioration.

Consultation with a qualified Plumber or Bathroom Specialist is advised immediately to identify the cause of damp and to perform remedial works as required.

Always ensure that sealant and grout is in good condition to prevent any moisture issues occurring in the future.

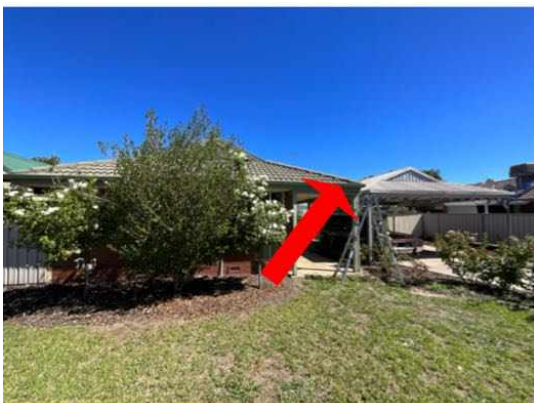
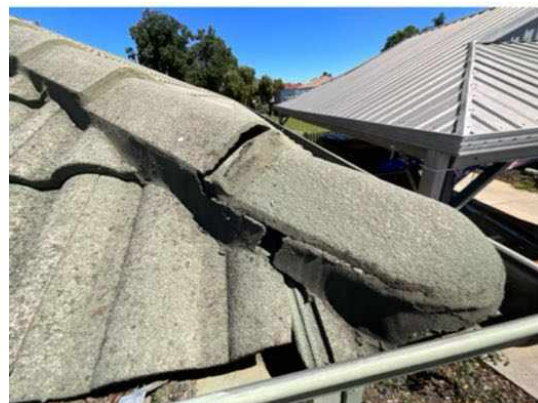
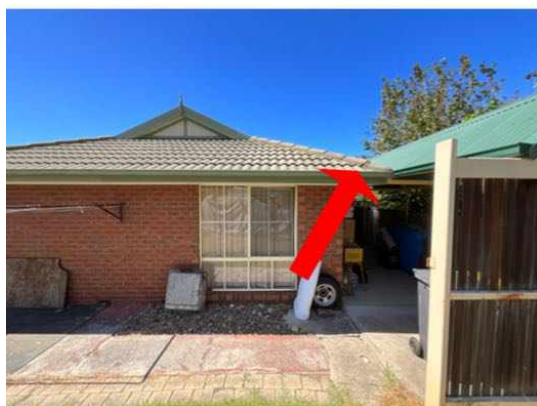
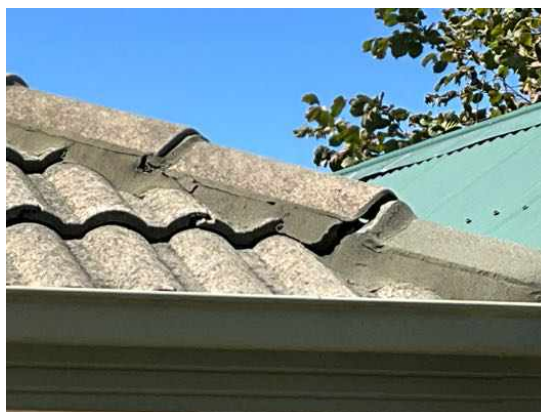
Finding 3.01

| Finding: | Mortar - Deterioration |
| Information: | Mortar, or 'bedding', is the material which fills joints and intersections between tiles and other building elements on the exterior roof covering, such as gable ends, hip capping and valleys. Upon inspection of the exterior roof, it was noted that sections of the mortar show varying levels of deterioration. |

Mortar generally deteriorates as a result of frequent exposure to weather conditions over a prolonged period of time. Mortar that is deteriorating may allow water ingress into the roof void, putting associated building elements and roofing structures at risk of water damage. Deteriorated mortar also detracts from the functionality of roof tiles and other roofing elements, potentially decreasing weather tightness and roof drainage.

Mortar deterioration can be attended to by a handy person where areas of deterioration are localised and easily accessible. Otherwise, consultation with a roofing contractor is advised where greater works are required.

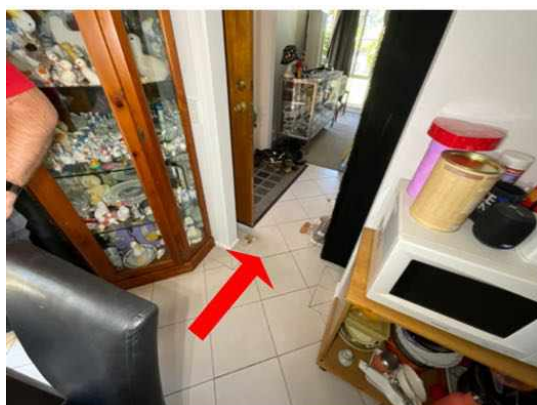
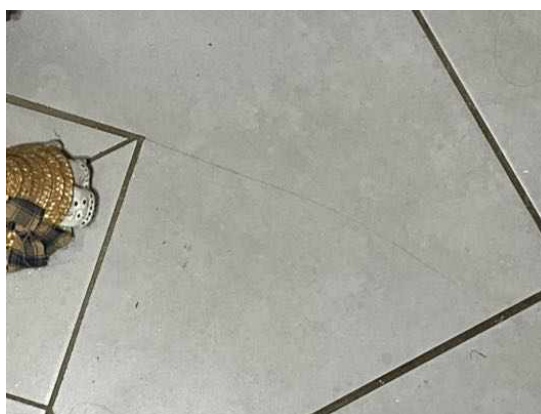
Finding 3.02

| Finding: | Cracked floor tiles |
| Information: | Cracking in the floor tiles was evident in this area at the time of inspection. It is suspected that this cracking has occurred as a result of minor settlement or impact damage. |

Cracked tiles throughout the household detract from the overall appearance of the affected areas however it is unlikely to create or lead to any secondary defects.

While not considered a matter of urgency, replacement of cracked floor tiles is recommended at the clients discretion. A tiling contractor may be appointed to perform these works. Where cracks become more numerous, contact a licensed building inspector for further investigation.

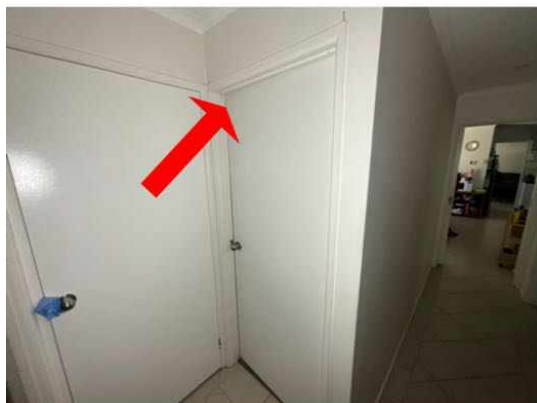
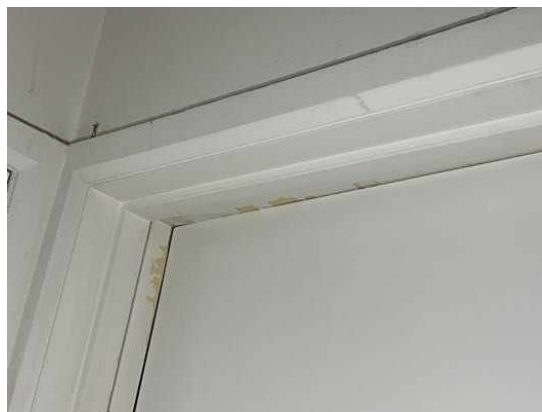
Finding 3.03

| Information: | Binding and/or jamming of this door is evident during standard operation. This defect |

inhibits the functionality of the affected door as well as creating potential for secondary defects to associated building elements, such as damage to the floor covering.

A door that binds to flooring or to the associated door frame may have several causes, ranging from minor defects, such as poor installation of the door or deteriorated hinges, through to major structural issues, such as damage to subfloor structures.

A qualified carpenter or general handyperson should be appointed to perform minor rectification works at client discretion.

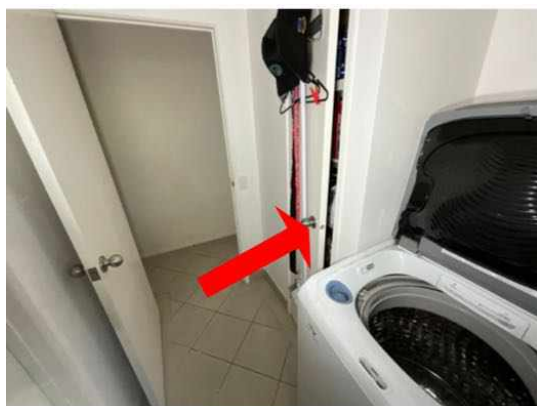
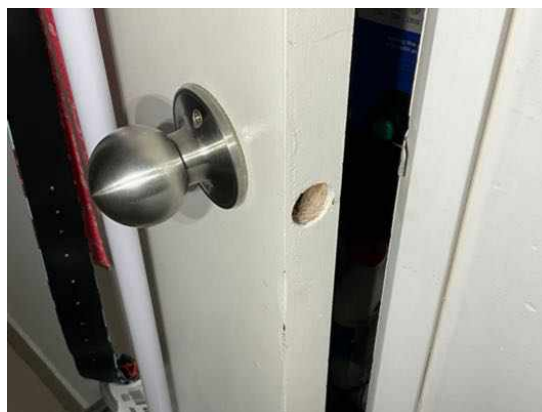
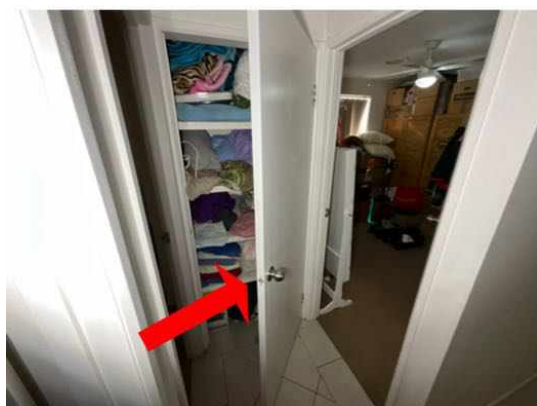
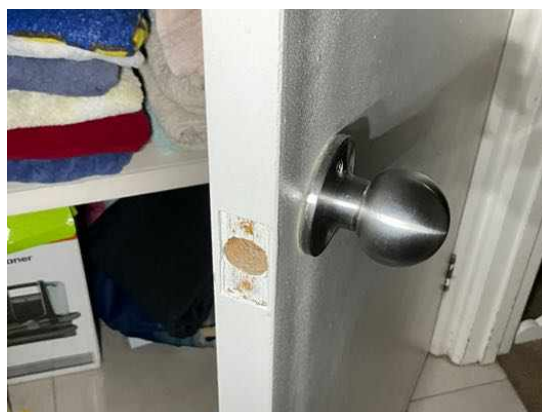
Finding 3.04

| Information: | It was noted that the door in this area was not latching during operation at the time of inspection. |

It is suspected that this defect has occurred due to minor issues with the associated hinges. Such damage is identified as general wear and tear, which is expected for building elements of this age.

A qualified carpenter or general handyperson may be appointed to perform rectification works as necessary, at client discretion.

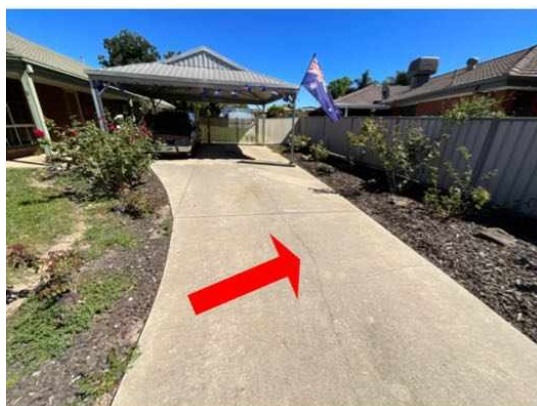
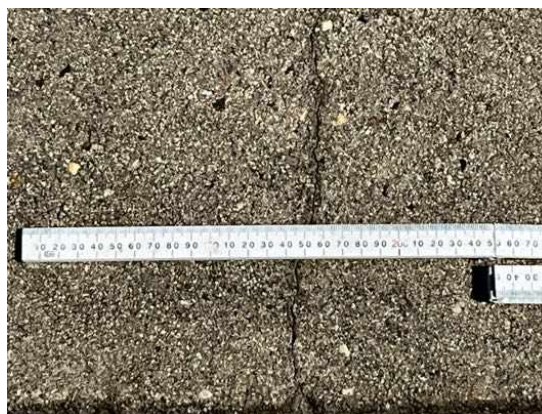
Finding 3.05

| Finding: | Cracking - External Concrete Paving Damage Category 1 - Fine (less than 2mm) |
| Information: | Fine cracks were identified in external concrete paving. Although fine cracks are quite noticeable, they are often only considered to be an appearance defect, and usually do not indicate any structural damage. To be considered a Category 1 or fine crack, the crack is found to be less than 2mm in width. |

Generally the cause of a hairline crack in existing concrete paving such as driveways and pathways is indicative of the expansion and contraction of the concrete. Such causes are generally due to environmental factors, such as moisture levels, weather conditions, root systems of nearby trees or the soil types on which they are laid.

Fine cracks may also be due to poor original installation of the concrete. Factors such as poor compaction of the sub surface and/or inadequate reinforcing of the slab may create cracking and other secondary defects.

Monitoring of all cracking should be conducted frequently. Always contact a building inspector should cracks widen, lengthen, or become more numerous.

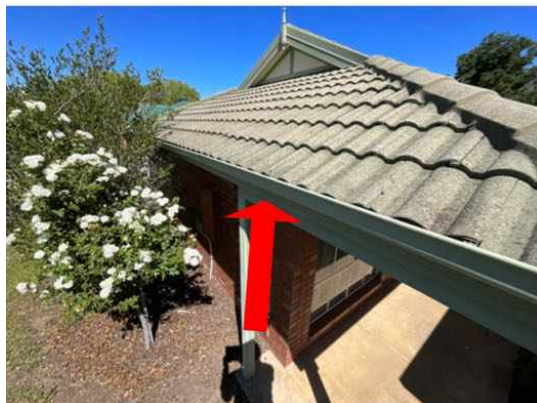
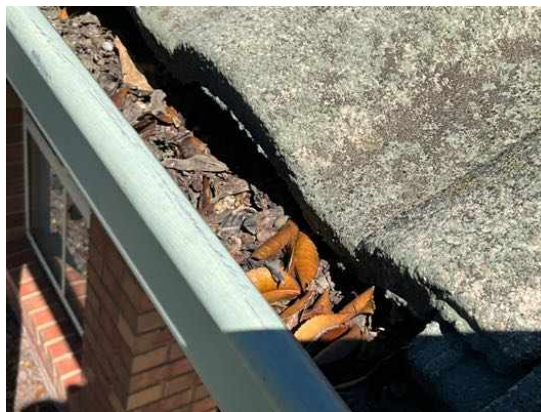
Blocked gutters are likely to lead to high levels of moisture in the affected areas. Such moisture will not only cause rust and decay of the associated building materials, but can also provide conditions that are conducive to termite and timber pest activity. Blockages in gutters should therefore be removed immediately to ensure dry conditions are maintained.

Consult a Licensed Plumber for further specific advice on remedial works that may be required. In the interim, it is highly advised that blocked gutters be removed by the homeowner or a general handyperson as a matter of urgency.

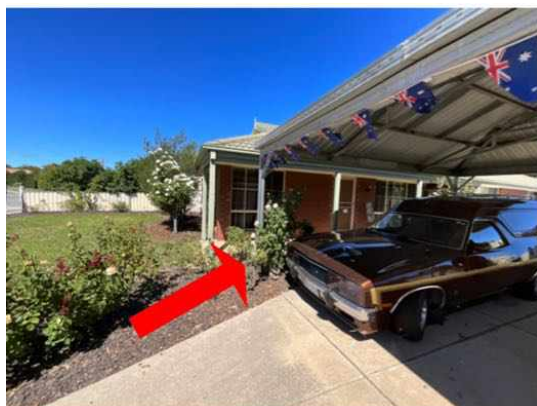
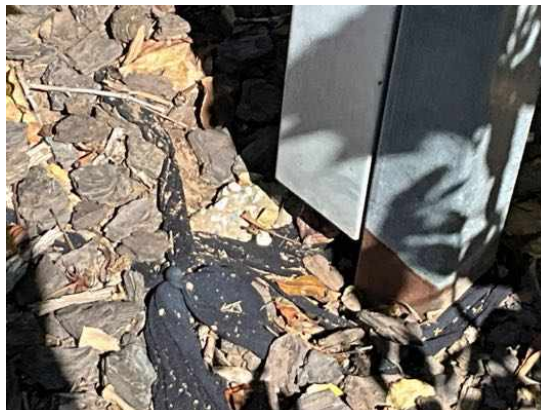
Finding 6.02

Where roof plumbing doesn't drain adequately, the area at the base perimeter can become excessively damp, potentially creating an environment that is susceptible to rust and corrosion of surrounding building elements, as well as attracting termites and other pests.

It is highly recommended that a plumber be appointed to further inspect the area and to install adequate drainage equipment where necessary.

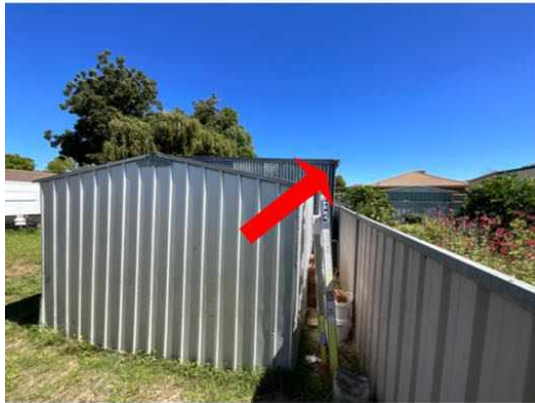
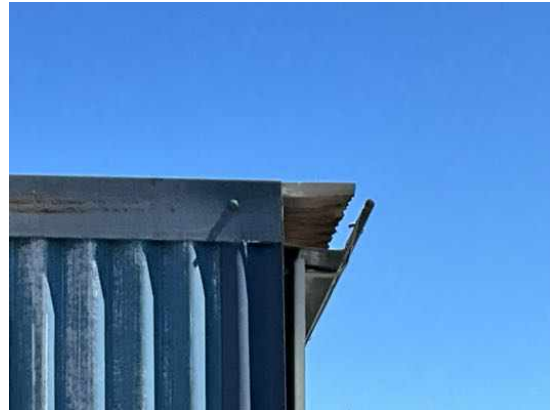
Finding 6.03

Where roof plumbing doesn't drain adequately, the area at the base perimeter can become excessively damp, potentially creating an environment that is susceptible to rust and corrosion of surrounding building elements, as well as attracting termites and other pests.

It is highly recommended that a plumber be appointed to further inspect the area and to install adequate drainage equipment where necessary.

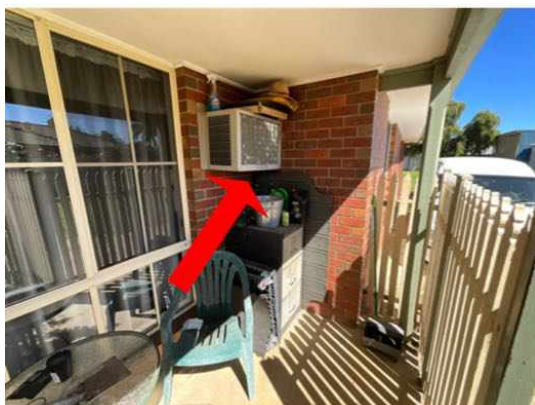
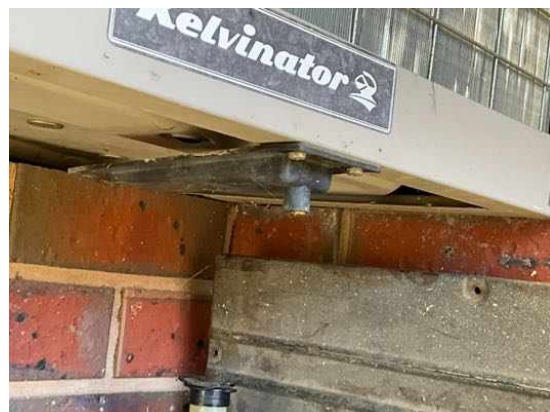
Finding 6.04

| Finding: | Air conditioner - Disconnected overflow |
| Information: | The Air Conditioner (A/C) overflow was found to be disconnected from storm water drainage and is creating excessive moisture in the surrounding area. |

Such leaking creates an environment which is conducive to an array of defects, including water damage to associated building elements and the attraction of termite or timber pest infestation.

It is highly recommended that a licensed plumber be appointed to connect the A/C overflow in order to prevent such an environment from being created. These minor works should be carried out as soon as possible.

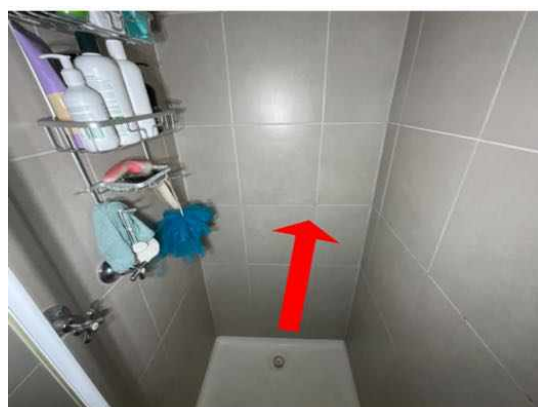
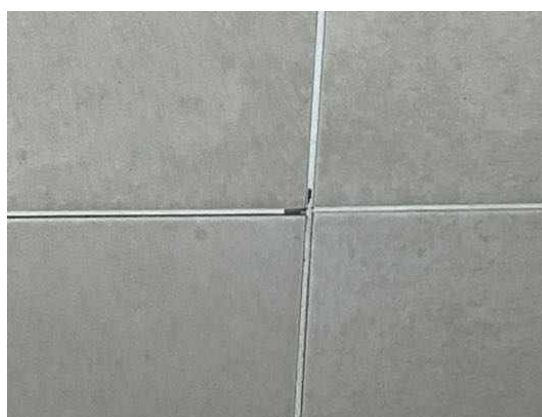
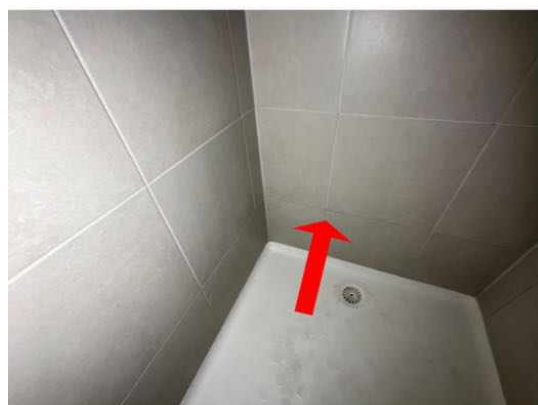
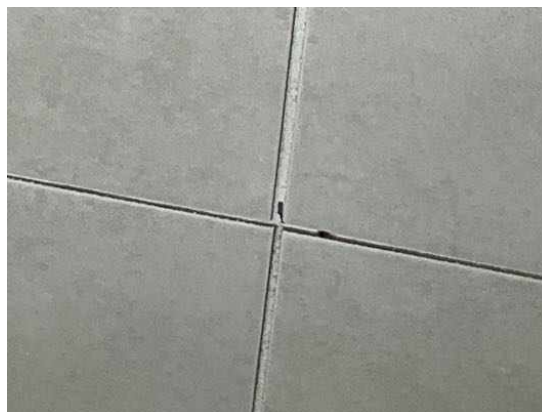
Finding 6.05

Building: Building 1
 Location: Bathroom
 Finding: Inadequate sealant or Grout
 Information: This area has a lack of effective Sealant or Grout. This is allowing the ingress of water to the structure inside the wall.

The presence of water encourages Termite attack, Mould and Fungal Decay.

A Tiler or General Handy person must be contacted as soon as possible to effect repairs and prevent further deterioration.

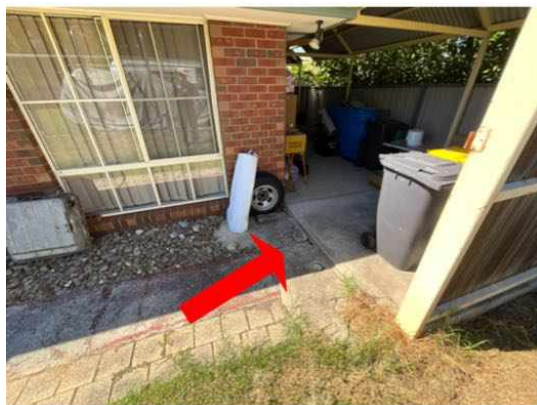
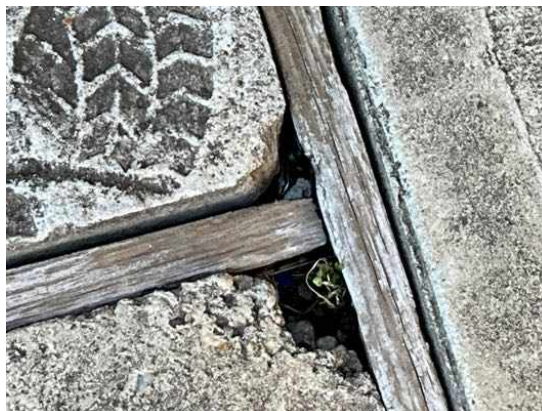
Finding 6.06

Building: Building 1
 Location: Yard - Back
 Finding: Untreated or non-durable timbers in a hazardous environment
 Information: To reduce the risk of timber pest attack it is essential that timber used in a hazardous environment (e.g. in direct contact with the ground or frequently exposed to damp conditions) is of sufficient durability and/or is adequately preservative treated.

rot and/or fungal decay if left unattended creating attraction for subterranean termites to infest the timbers from surrounding areas.

If untreated or non-durable timbers are found to be in a hazardous environment it is highly advised that replacement of these building elements be performed as soon as possible to aid the protection of the property against termite / timber pest attack.

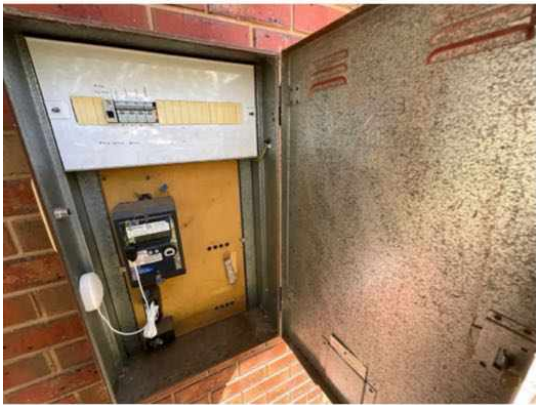
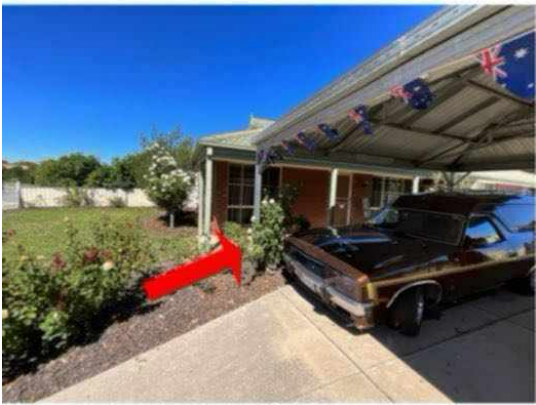
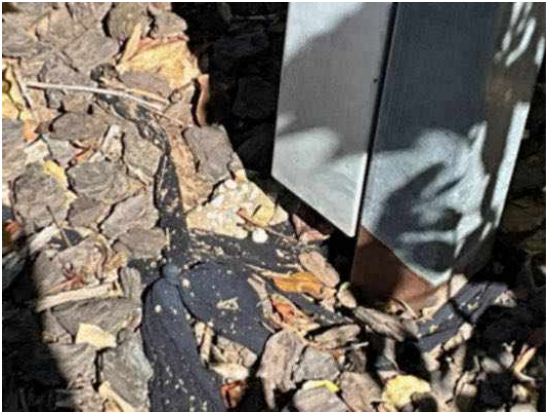
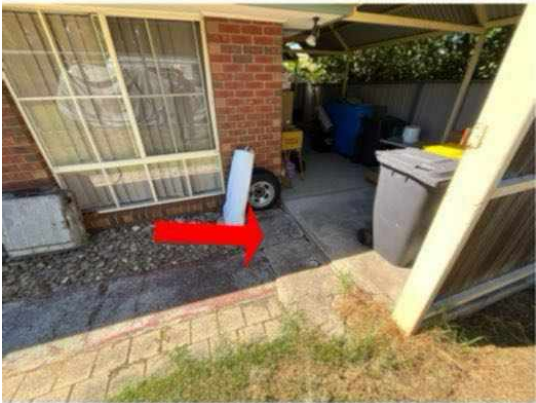
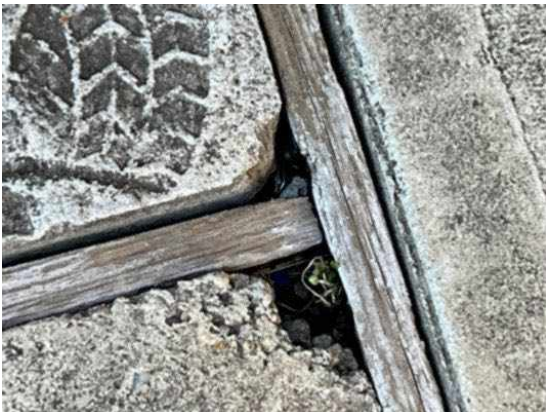
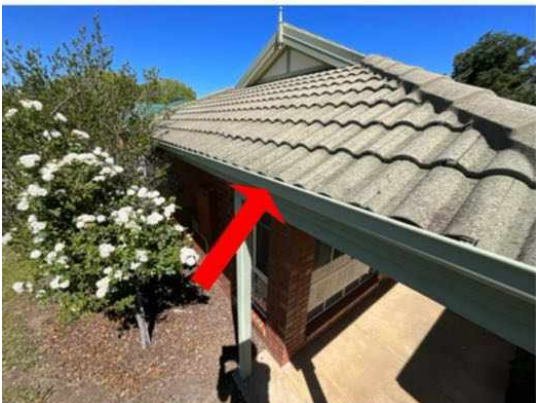
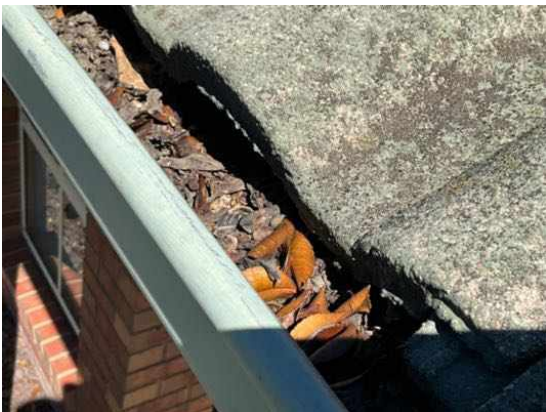
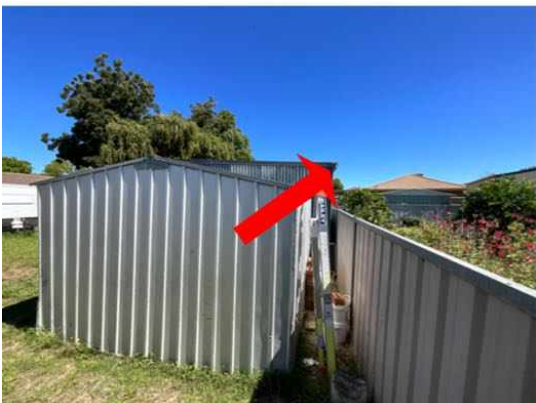
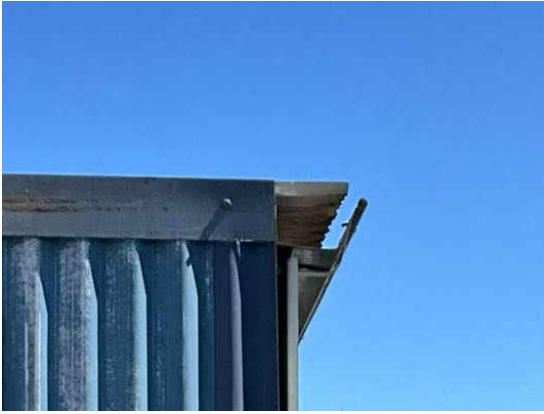
Finding 6.07

| Information: | The application of a post-construction chemical termite barrier is highly recommended for all properties, particularly if live termite activity has been found on the site previously. Such barriers are highly effective in preventing termite attack on any timber building elements throughout the property. |

A durable notice should be placed in the switchboard unit to indicate current termite barriers. At the time of inspection, it appeared as though no termite management system has been installed, with no evidence to suggest preventative works taking place.

There is no evidence of previous Termite Management services. The property has factors that are Conducive to Termite attack. A Licensed Pest controller should be contacted soon to advise on a Termite Management Plan and avoid potentially costly repairs.

The client may consider gaining further advice from a pest controller as to the costs and procedures involved with this application. It is recommended that obtaining such advice be a short-term priority.

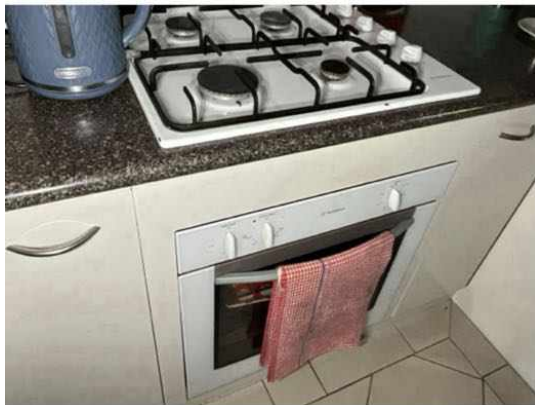
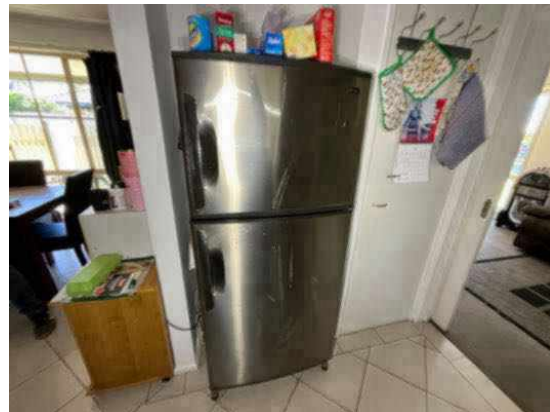
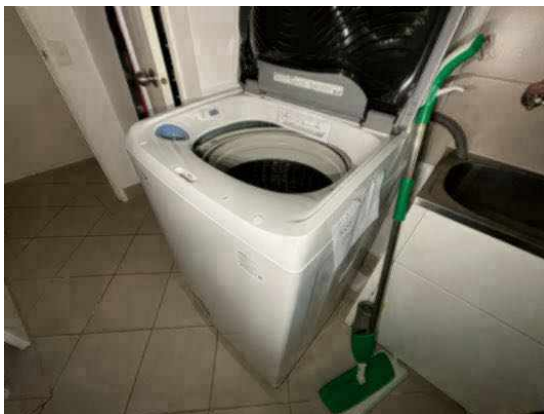
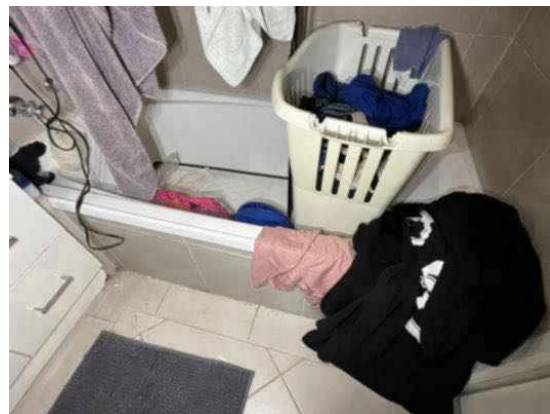
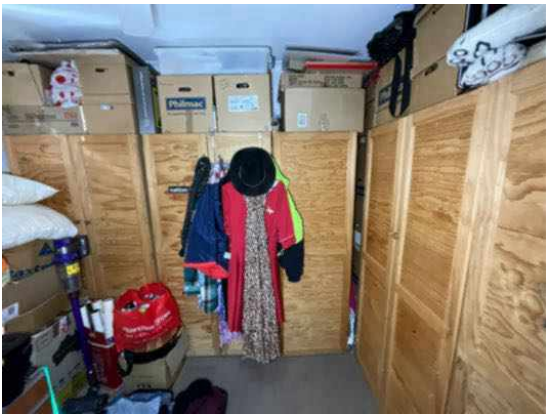
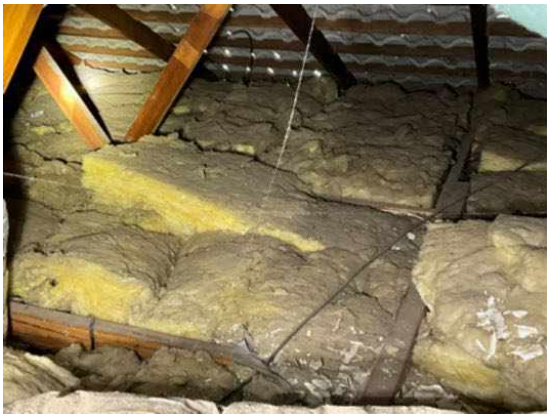
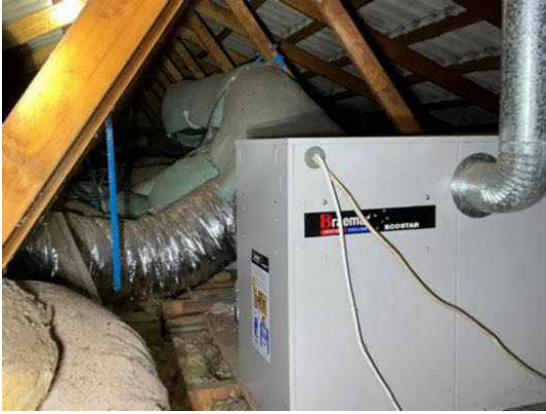
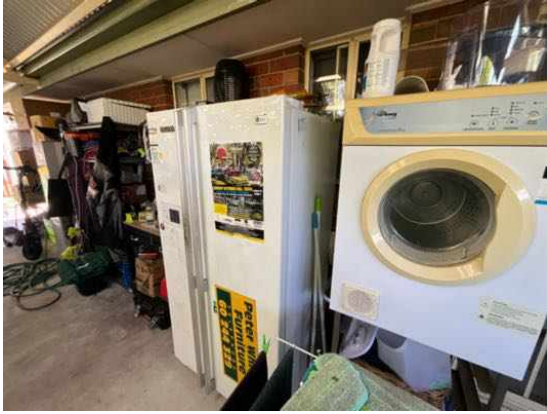
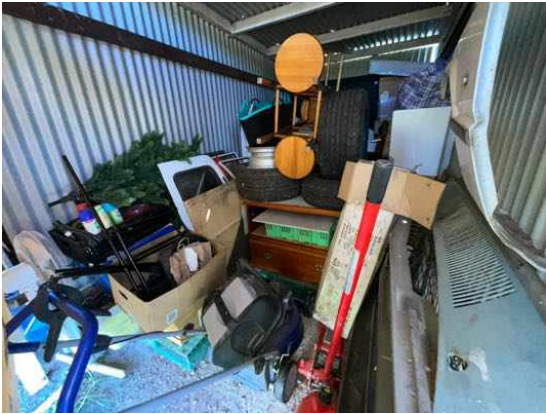
Building: Building 1
Location: All Areas
Finding: Additional Photos - Obstructions and Limitations
Information: These photographs are an indication of the obstructions and limitations which impeded full inspection of the property at the time of inspection. These obstructions can hide an array of defects and should be removed to allow full inspection to be carried out. A re-inspection is recommended once the areas are made accessible.
