Building and Timber Pest Inspection Report

Inspection Date: Wed, 11 Feb 2026

Property Address: 213 Wire Ln, Berry NSW 2535, Australia

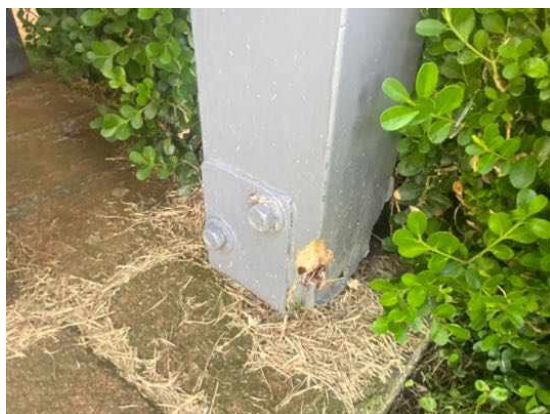
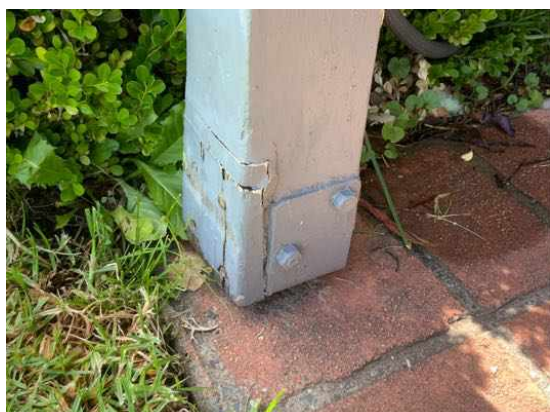
Finding: Wood rot to bottom of posts

Information: This building element shows evidence of wood rot. Wood rot, also known as Fungal Decay, occurs when timbers and other cellulose building materials are exposed to damp conditions on an ongoing basis. This could be the result of exposure to weathering over a prolonged period of time, or the attraction of excessive moisture from other abutting building materials. Contributing factors also include poor air ventilation in the area.

Early intervention and regular maintenance, particularly of exterior timbers, will prolong the useful life of these building elements. Prior to any works being performed, the cause of the moisture that has created the visible wood rot should be identified and addressed in a suitable manner. Replacement of affected timbers may then be a necessary step in protecting surrounding building elements from such deterioration.

A qualified plumber may be appointed to assess the cause of excessive moisture and to provide advice on any remedial works as required. A qualified carpenter or registered builder may also be required to replace affected building materials.

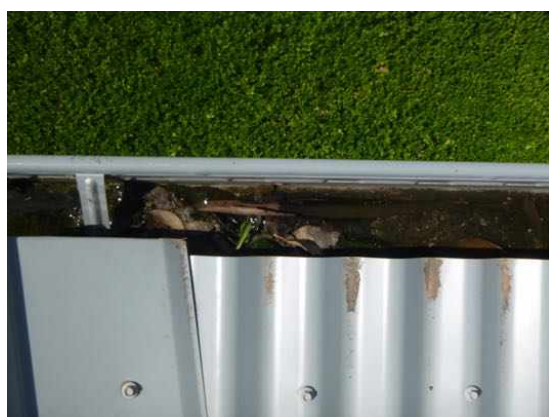
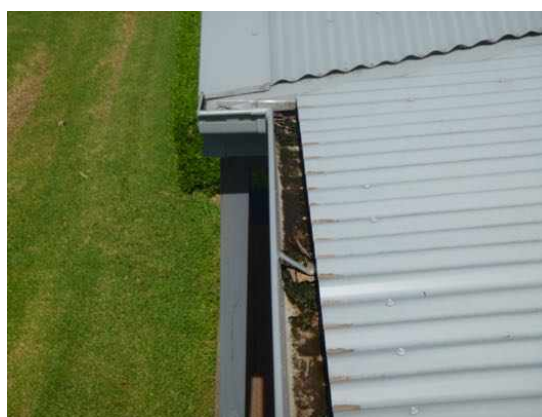
Blocked gutters are likely to lead to high levels of moisture in the affected areas. Such moisture will not only cause rust and decay of the associated building materials, but can also provide conditions that are conducive to termite and timber pest activity. Blockages in gutters should therefore be removed immediately to ensure dry conditions are maintained.

Consult a Licensed Plumber for further specific advice on remedial works that may be required. In the interim, it is highly advised that blocked gutters be removed by the homeowner or a general handyperson as a matter of urgency.

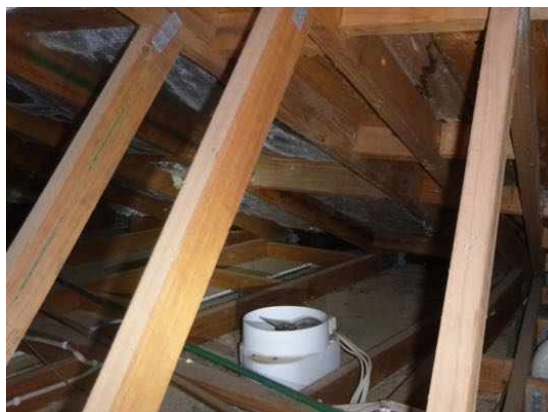
Finding 3.07

Building:	Main Building
Location:	Roof Void
Finding:	Exhaust fans - Sarking on roof (Ducting, Roof Vent or Eave Vents are recommended)
Information:	On inspection of the roof void, it was observed that the exhaust fans to the bathroom and ensuite do not exhaust directly to the outside of the building, which is recommended if sarking has been fitted, as it has in this home.

(B) is covered by roof tiles WITHOUT SARKING or similar materials which would prevent venting through gaps between the tiles.

High levels of moisture in the affected areas can provide conditions that are conducive to termite and timber pest activity. Consult a Licensed Builder or Plumber for further specific advice on remedial works that may be required.

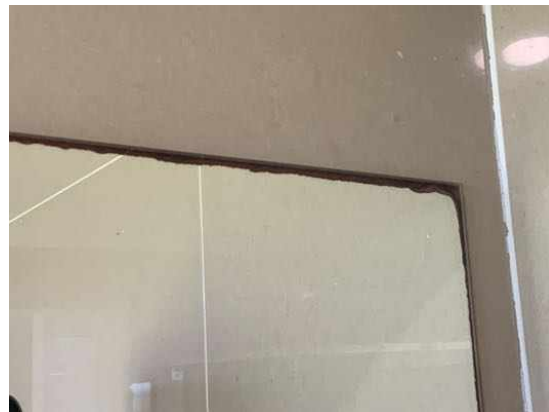
Typically, the layer between the glass and metal becomes separated when the edge of the mirror is regularly exposed to powerful chemicals, most commonly ammonia. Once the separation occurs, any moisture — even just steam from showering can begin to cause the black spots to appear.

In some cases rectification is possible but replacement is generally the best option.

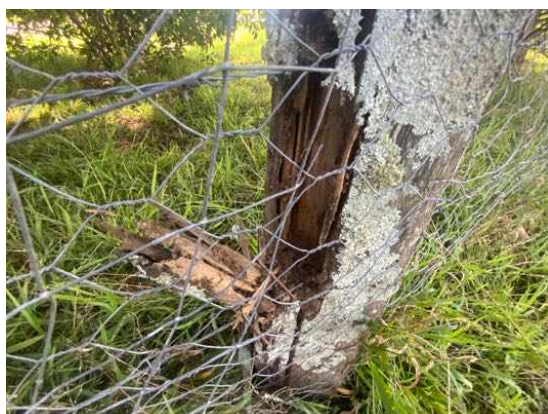
It is advised that the area be visually inspected frequently to ensure that the condition of affected building materials does not worsen. At the time of inspection, damage is not structural and is only considered to be superficial.

A building contractor may be appointed to provide a further invasive inspection if further damage is evident.

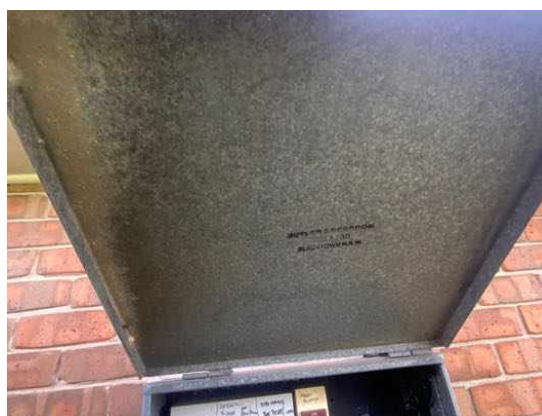
A durable notice should be placed in the switchboard unit to indicate current termite barriers. At the time of inspection, it appeared as though no termite management system has been installed, with no evidence to suggest preventative works taking place.

The client may consider gaining further advice from a pest controller as to the costs and procedures involved with this application. It is recommended that obtaining such advice be a short-term priority.

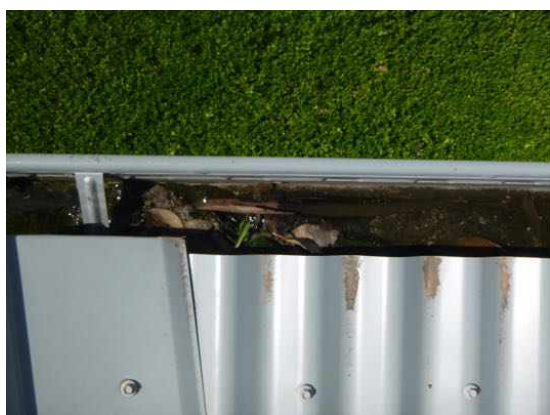
Finding 6.02

Building: Main Building
Location: Roof Exterior
Finding: Gutters - Blocked
Information: Roof plumbing structures, such as guttering and downpipes, should be free of all debris to prevent blockages. Blockages of the guttering and downpipes will lead to pooling and accumulated water overflows, which is likely to subsequently flood eaves and exterior walls.

Consult a Licensed Plumber for further specific advice on remedial works that may be

required. In the interim, it is highly advised that blocked gutters be removed by the homeowner or a general handyperson as a matter of urgency.

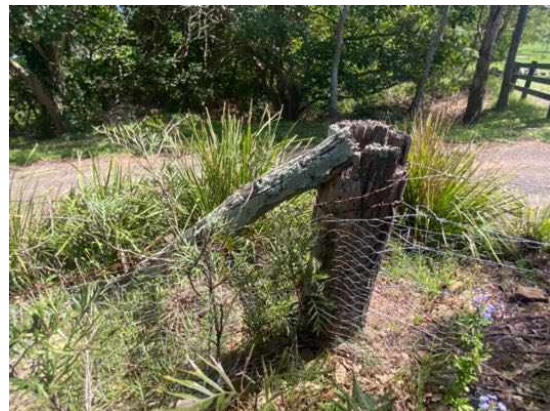
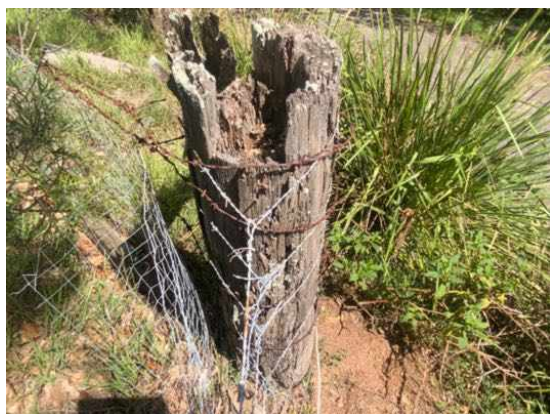
Untreated timbers in direct contact with the ground are likely to develop severe wood rot and/or fungal decay if left unattended creating attraction for subterranean termites to infest the timbers from surrounding areas.

If untreated or non-durable timbers are found to be in a hazardous environment it is highly advised that replacement of these building elements be performed as soon as possible to aid the protection of the property against termite / timber pest attack.

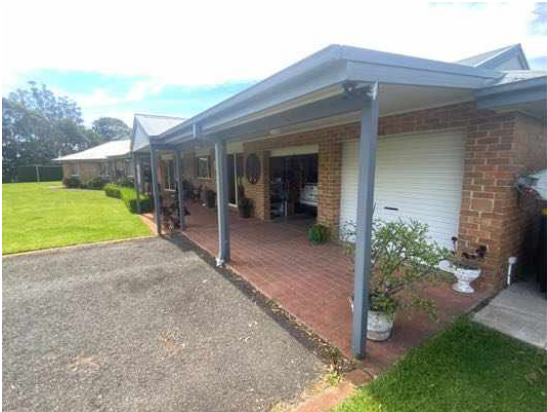
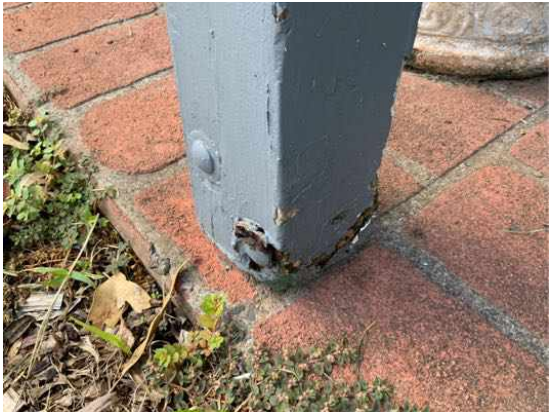
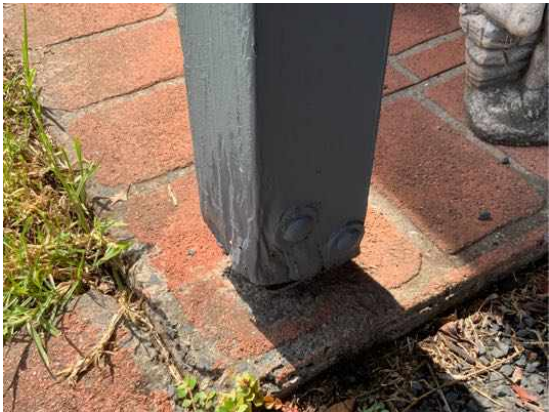
The development of fungal decay is accelerated by temperatures in the range of 5degreeC to 40degreeC as well as the presence of oxygen. Generally fungal decay develops on timber elements that are in use in an external environment which are exposed to rain penetration.

In this case although the affected timber element is in a decaying state the extent of any visible damage appears to be localised to a specific area and is yet to spread to other parts of the building element or affect adjoining structures. The fungal decay is therefore likely to be of a relatively superficial nature with minimal impact on the structural integrity or tensile strength of the timber element.

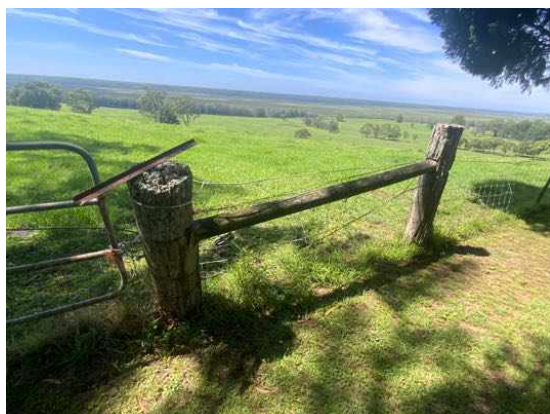
Finding 7.02

Building:	Main Building
Location:	Timber Fencing posts
Finding:	Fungal decay - present (localised)
Information:	Fungal decay also known as wood decay or wood rot generally refers to the deterioration of timber elements when in contact with excessive levels of moisture for a prolonged period of time.

The development of fungal decay is accelerated by temperatures in the range of 5degreeC to 40degreeC as well as the presence of oxygen. Generally fungal decay develops on timber elements that are in use in an external environment which are exposed to rain penetration.

In this case although the affected timber element is in a decaying state the extent of any visible damage appears to be localised to a specific area and is yet to spread to other parts of the building element or affect adjoining structures. The fungal decay is therefore likely to be of a relatively superficial nature with minimal impact on the structural integrity or tensile strength of the timber element.

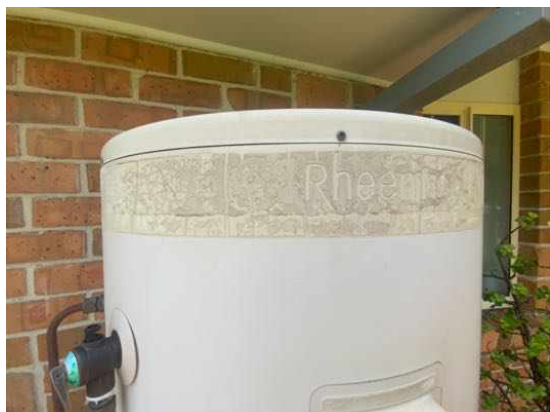
Information: The external hot water unit shows evidence of rust and general deterioration. This rust is likely to have developed due to minor leaks in the unit, providing excess moisture to affected areas. Such damage is expected of a building element of this age and with this level of exposure to excessive moisture.

While the hot water unit is still fully operational, any leaks should be identified and rectified by a licensed plumber as soon as possible. Prevention of further deterioration will delay the need for replacement of the unit in the near future.
