# Building and Timber Pest Inspection Report

Inspection Date: Wed, 25 Feb 2026

Property Address: 61 Cambridge Ave, Bankstown NSW 2200,  
Australia

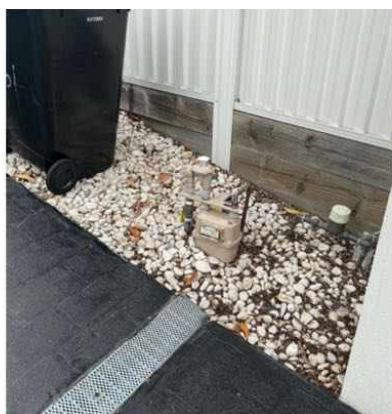
Building: Main Building  
 Location: All External Areas  
 Finding: Gas Installation - Gas Meter - Possible safety hazard  
 Information: It was noted at the time of inspection that the base of the gas meter was sitting on the ground.

Gas meter sitting on the ground could rust and erode causing a potential gas leak as a secondary defect.

It is advised to engage a qualified gas fitter to inspect repair , replace or adjust the meter as required as soon as possible

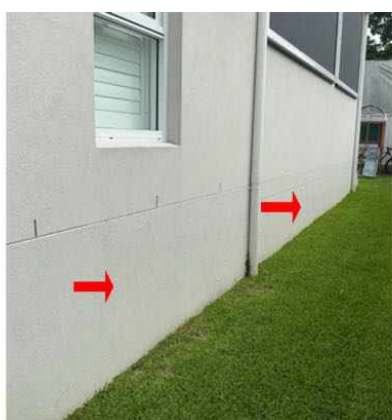
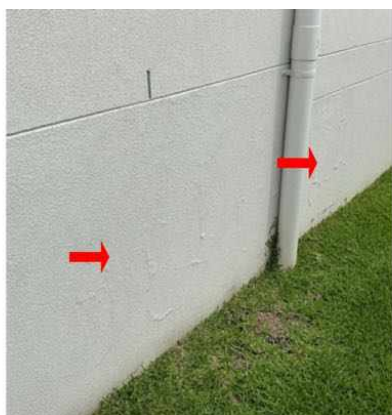
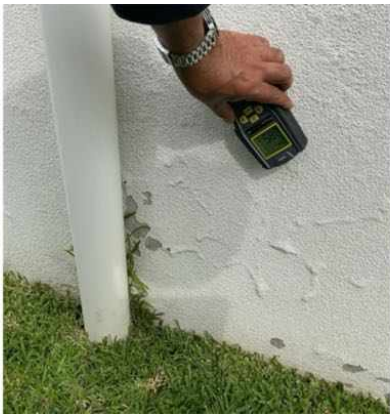
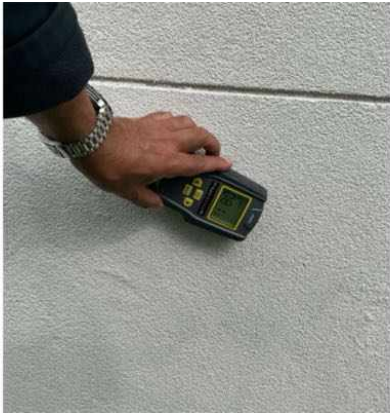
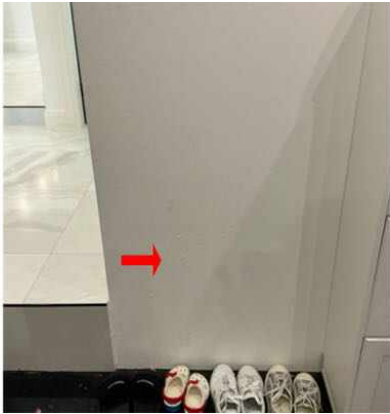
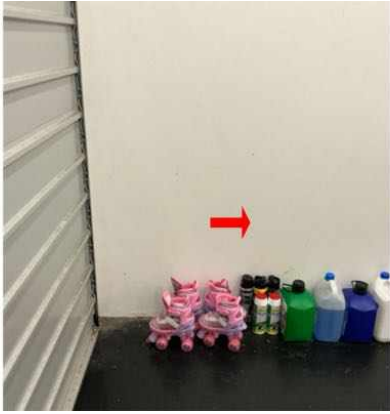
Building: Main Building  
 Location: All External Areas - Right side , Garage  
 Finding: Damp  
 Information: Damp (or structural damp) refers to the presence of unwanted moisture in the structure of a building, either as the result of intrusion from outside, or condensation from within the structure. Generally, structural damp is caused by rain penetration, rising damp, and leaks from plumbing pipes.

Unmanaged damp facilitates the formation and development of mould, fungi growth and wood rot, decaying associated building materials and compromising their structural integrity. Damage to finishes is also likely to occur, including lifting, bubbling, peeling and staining of paint, plaster and wallpaper.

Consultation with a qualified plumber is advised immediately to identify the cause of damp and perform remedial works as required. Where excessive mould growth is present, further inspection by a specialist environmental health inspector should also be considered.

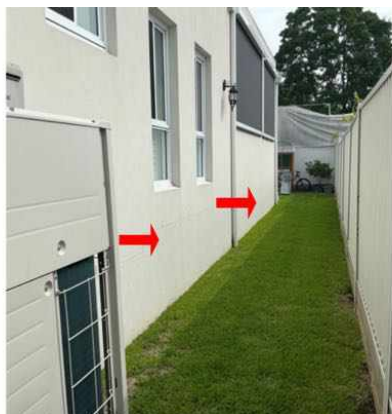
Finding 3.02

Building:	Main Building
Location:	All External Areas
Finding:	Render Finish Covering Damp Membrane
Information:	During the inspection, it was noted that the applied render finish is covering the damp-proof membrane. This is affecting the membrane's ability to prevent moisture movement above it, leading to moisture-related issues over time. It is recommended to consult a qualified builder to ensure the damp-proof membrane is properly exposed, maintaining its effectiveness in preventing moisture ingress.

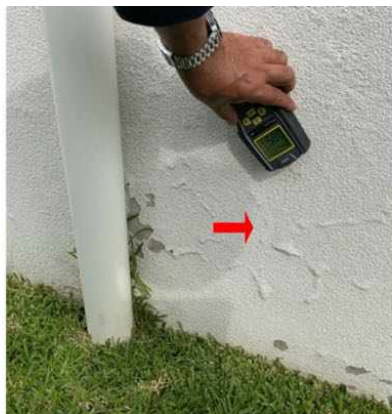
### Finding 3.03

Building:	Main Building
Location:	All External Areas
Finding:	Render - Drummy
Information:	Drummy rendered areas were identified at the time of inspection. The term 'drummy' refers to render that has become detached from its fixing, despite it still being solid. Such defects are generally caused by physical or moisture damage to the area. Drummy render may also be a direct result of poor workmanship during the construction process.

Render may swell and shrink with changes in air humidity if the area has sustained moisture damage. Any exposure to moisture is capable of causing rendered areas to become drummy and/or cracked over a prolonged period of time. Drummy render generally requires chipping off and re-rendering or painting.

Specialist trades are available for these types of services. A registered builder may be required to undertake works if damage is extensive, or if secondary building defects have resulted. Immediate action is recommended to ensure that no further damage is sustained in the affected area.

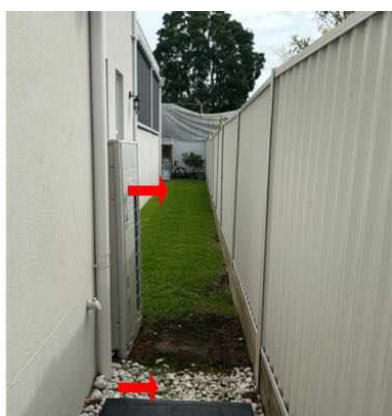
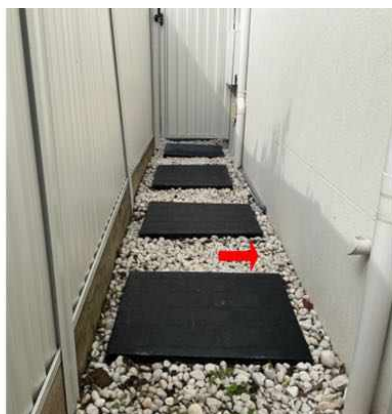
### Finding 3.04

Building:	Main Building
Location:	All External Areas
Finding:	Site drainage - Inadequate
Information:	The site drainage in this area was found to be inadequate at the time of inspection, creating potential for subsequent water damage to associated building elements.

Where site drainage is inadequate, installation of an Agricultural (Aggie) Drain may be required. A qualified plumber should be appointed to further inspect the property and perform any remedial works as necessary. Water damage and secondary defects are likely to occur if left unmanaged.

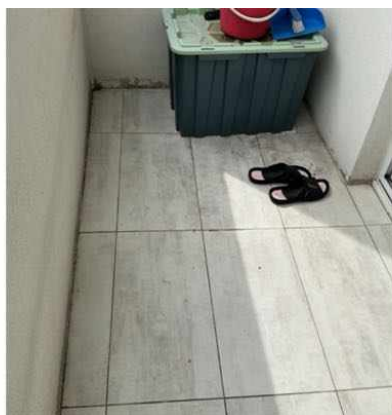
### Finding 3.05

Building:	Main Building
Location:	Balcony - Rear
Finding:	Balcony - No Drainage
Information:	The covered balcony floor is tiled with no visible floor waste, grated drain, or obvious surface drainage point within the area observed. Falls toward a drainage outlet are not clearly identifiable, and the perimeter junctions appear flush without discernible provision for surface runoff. In the absence of a visible drainage arrangement, there is a risk of water ponding during rainfall or cleaning, which may contribute to moisture accumulation at wall-floor junctions and potential waterproofing deterioration over time. Confirmation of compliant falls and drainage outlet location is recommended.

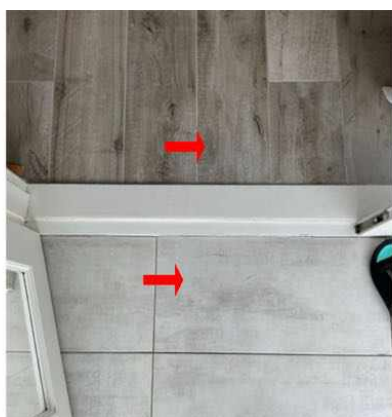
### Finding 3.07

Building:	Main Building
Location:	Balcony
Finding:	Balcony Floor Level Differential
Information:	The balcony finished surface appears to be close to, or at the same level as, the internal floor. Standard construction practice requires a step-down of approximately 50 mm unless a fully engineered threshold drainage system is provided. No such drainage features were visible during inspection. This configuration increases the risk of water ingress. Recommend further investigation by a licensed waterproofing contractor to check for adequate provisions for this arrangement.

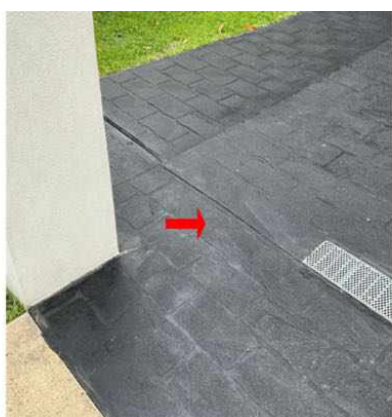
Building: Main Building  
Location: All External Areas  
Finding: Cracking - External Concrete Paving Damage Category 2 - Distinct (less than 3mm)  
Information: Distinct cracks were identified in external concrete paving. Distinct cracks are generally found in older concrete paving, and may also present as a trip hazard as consequence of an uneven or curved surface.

General age and expected deterioration of the paved areas is a common cause of this type of cracking. However, expansion and contraction of the slab may also have

occurred due to environmental factors. Such factors include variable moisture and weather conditions, the presence of trees and their roots having a settling or lifting affect on the soil, or the effect of load bearing, e.g. heavy vehicles over a sustained period of time.

Cracking to this degree may also be due to poor original installation of the concrete. Factors such as poor compaction of the sub surface and/or inadequate reinforcing of the slab may create cracking and other secondary defects.

Repairs are likely to be required to prevent further cracking and to reduce hazards associated with cracking, such as tripping. Monitoring of all cracking should be conducted frequently. Always contact a building inspector should cracks widen, lengthen, or become more numerous.

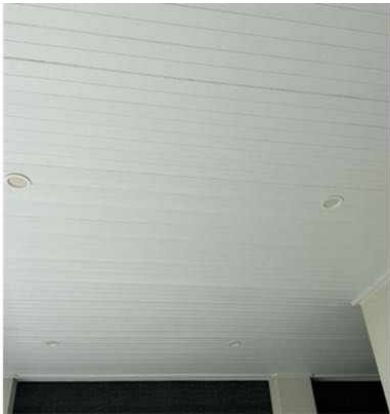
### Finding 3.10

Building:	Main Building
Location:	All External Areas - Rear
Finding:	Water staining
Information:	Water staining was evident in this area at the time of inspection. Water staining indicates that surfaces have been exposed to excessive moisture over time. The minerals and other elements in the water lead to staining, which may graduate to corrosion and deterioration if left unmanaged.

While mostly an appearance defect, water staining can be indicative of more serious defects, which may be currently concealed by other building elements.

Where water staining is active, a licensed plumber must be consulted to identify the cause of the staining and to provide advice on any reparation works that may be required. Replacement of any broken or damaged structures is advised.

Conversely, where water staining is old and inactive, affected building materials may be repaired or replaced at client discretion. A qualified carpenter or registered builder may be appointed to perform these works.

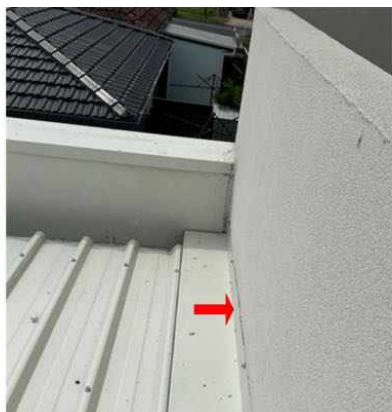
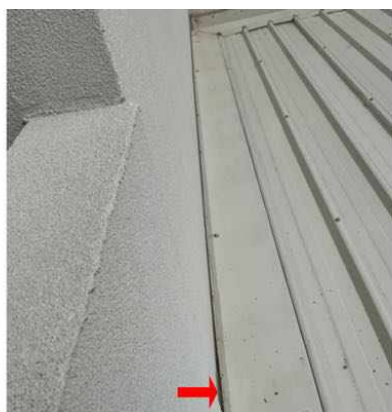
**Finding 3.11**

Building: Main Building  
Location: Roof Exterior  
Finding: Roof plumbing - Loose flashing  
Information: Metal and other material flashings are applied to seals and intersections between roof coverings and building elements. They are designed to aid in weatherproofing of roof joints, and require regular inspection and maintenance as they are more subject to rust-related deterioration.

The flashing in this section of the exterior roofing appears to have come loose from its original fixing. It is suspected that this minor defect has occurred as a result of general

deterioration over time.

Re-fixing and potential replacement of certain areas of flashing is advised to promote adequate roof drainage and protection from water penetration. Failure to perform these works may result in water damage and accelerated deterioration of associated building elements.

A roofing contractor or roofing plumber should be appointed as soon as possible to restore the flashing to a fully operational state and check against NCC standards including upturns.

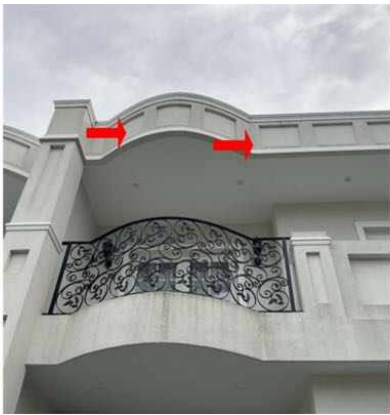
### Finding 3.12

Building:	Main Building
Location:	All External Areas
Finding:	Cracks to render - Category 1 to some areas
Information:	It has been observed that cracking to rendered surfaces has occurred. The degree of damage falls within Category 1, described as fine cracks that do not need repair and which are less than 1.0mm in width limit.

Damage of this category is not considered a defect for rectification. Always contact your building inspector should cracks widen, lengthen, or become more numerous.

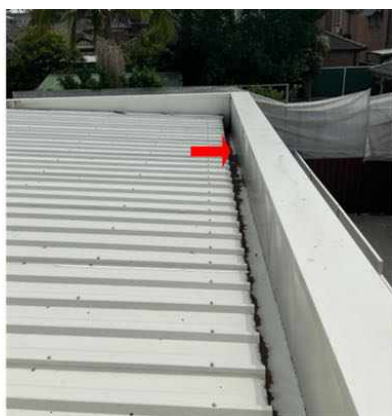
Finding 3.13

Building:	Main Building
Location:	All External Areas
Finding:	Gutters - Blocked
Information:	Roof plumbing structures, such as guttering and downpipes, should be free of all debris to prevent blockages. Blockages of the guttering and downpipes will lead to pooling and accumulated water overflows, which is likely to subsequently flood eaves and exterior walls.

Consult a Licensed Plumber for further specific advice on remedial works that may be required. In the interim, it is highly advised that blocked gutters be removed by the homeowner or a general handyperson as a matter of urgency.

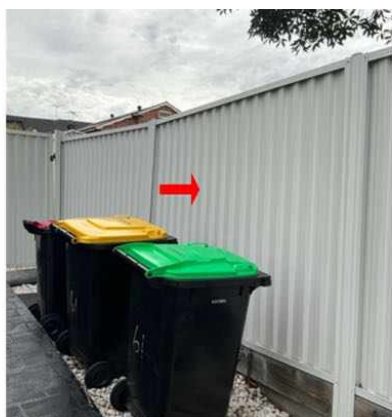
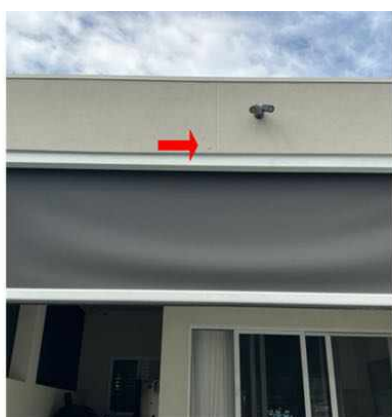
### Finding 3.14

Building:	Main Building
Location:	All External Areas
Finding:	Building element - Damaged - Fence leaning , render damage rear
Information:	Breakage occurs generally when the building materials have either aged and decayed, or as a result of damage (accidental or deliberate).

A relevant tradesperson should be appointed to repair or replace the affected building

element prior to any subsequent damage being caused.

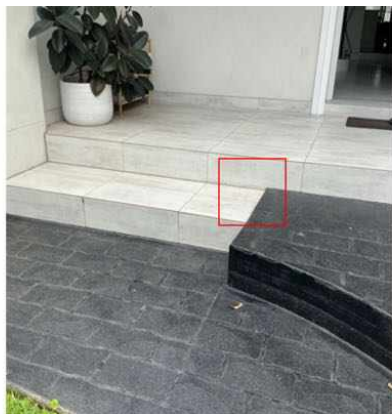
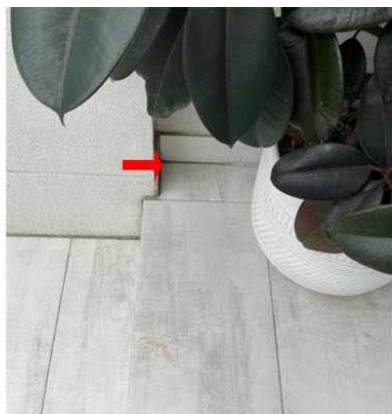
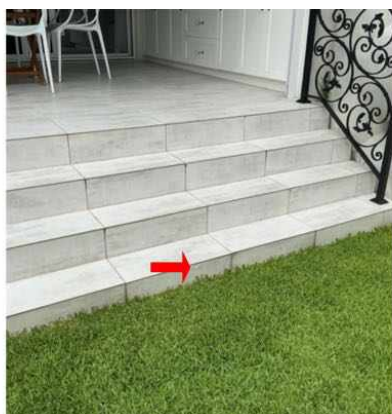
### Finding 3.15

Building:	Main Building
Location:	All External Areas
Finding:	Tiles - Cracked or damaged
Information:	Cracking was evident to the tiling in this area at the time of inspection. While the cracking appears to be minor, this area is frequently exposed to water, allowing potential for water penetration into adjoining sections of walls or flooring.

Where water penetration has led to water damage, appointment of a relevant tradesperson may be required to repair damaged building elements.

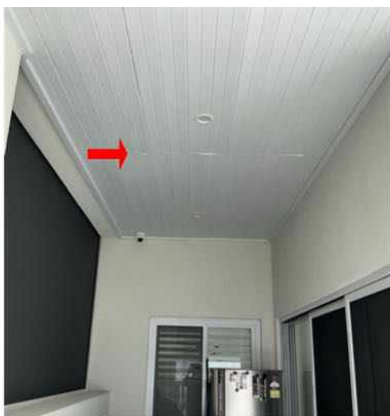
### Finding 3.16

Building:	Main Building
Location:	All External Areas
Finding:	Box Gutter Rainhead
Information:	The rainhead and downpipe installation were visually intact at the time of inspection, however, an overflow provision was not visible and may be concealed. The system's overall performance could not be confirmed without further inspection or testing during rainfall. Regular cleaning and maintenance of rainheads and downpipes are recommended to ensure effective roof drainage. It is recommended to consult with a qualified plumber to ensure it meets NCC requirements

The appropriate action should be taken by the client as soon as possible to ensure that any potential further damage is limited.

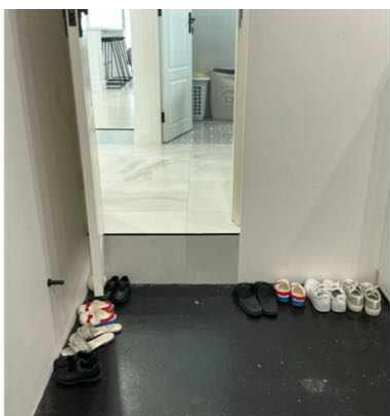
### Finding 3.18

Building: Main Building

Where installation is substandard and/or incomplete, the client should contact the responsible trade to undertake rectification. Unfinished and substandard building works are likely to degrade more quickly and may create potential for secondary defects to associated building elements.

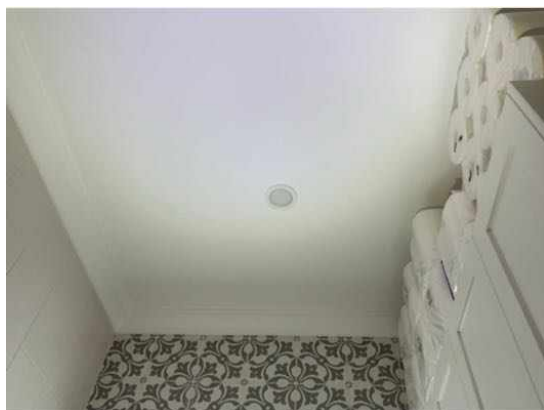
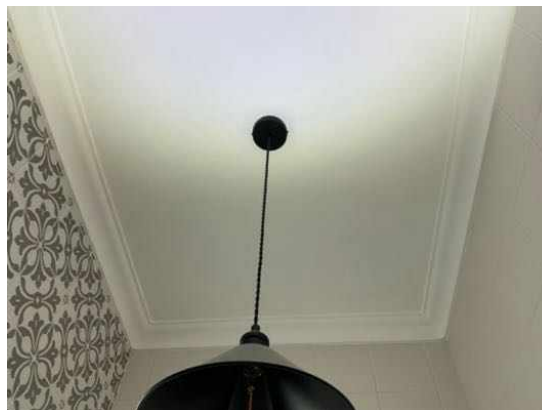
### Finding 3.19

Building: Main Building

The appropriate tradesperson should be appointed as soon as possible to replace the missing building element.

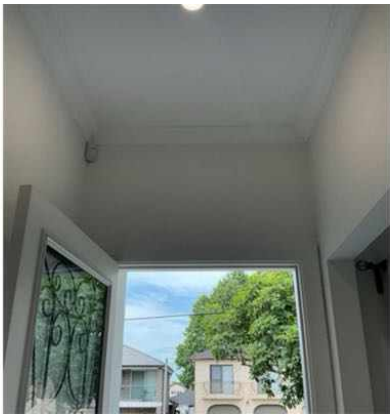
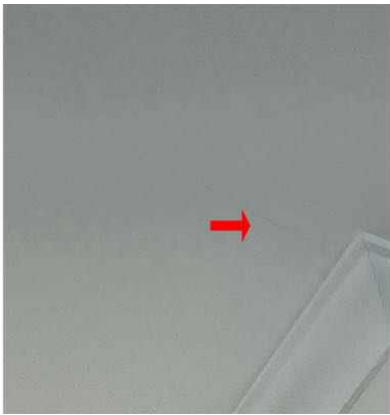
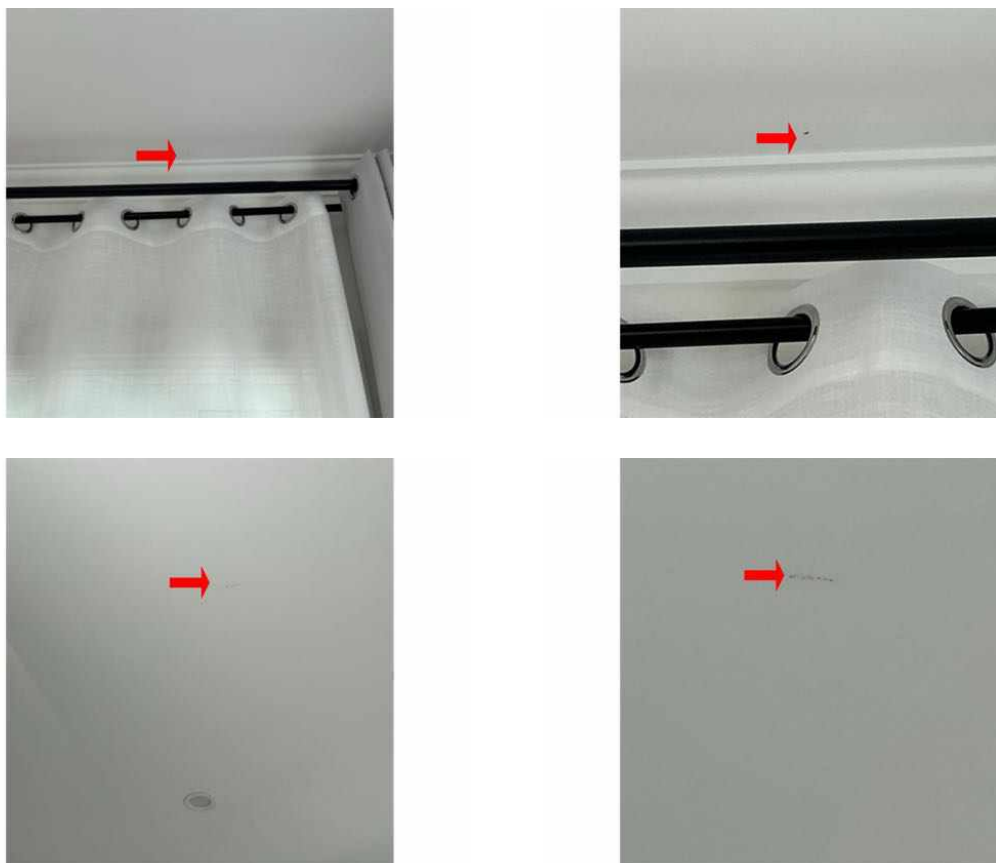
### Finding 3.20

Building:	Main Building
Location:	All Internal Areas
Finding:	Paint Finish & Hairline Cracking - To some areas
Information:	The paint finish in this area was identified as being incomplete or substandard at the time of inspection including some hairline minor cracking/separation. Monitoring is recommended where cracking and separation is evident.

A painting contractor should be appointed as soon as possible to perform necessary works to aid the appearance of the affected area and to ensure the area is protected against further deterioration. Alternatively, the homeowner following manufacturer instructions may perform these works.

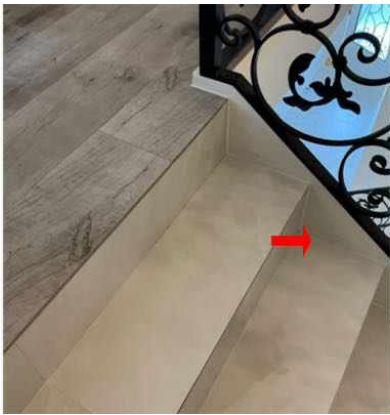
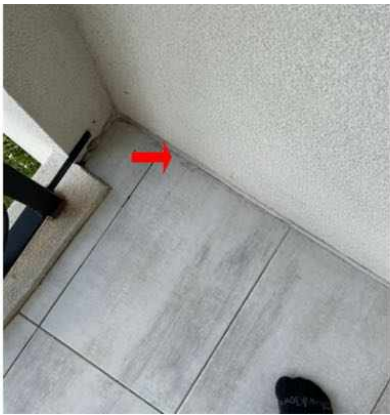
### Finding 3.21

Building:	Main Building
Location:	All Internal Areas
Finding:	Sealant and grouting - Missing or degraded to some areas
Information:	It was noted on inspection that sealant or grout is degraded.

A sealant specialist or tiling contractor should be appointed to complete these works as soon as possible

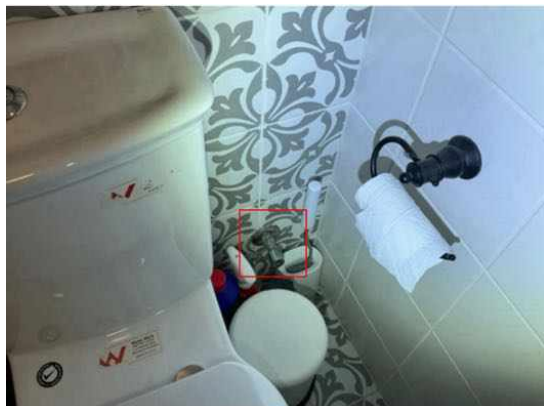
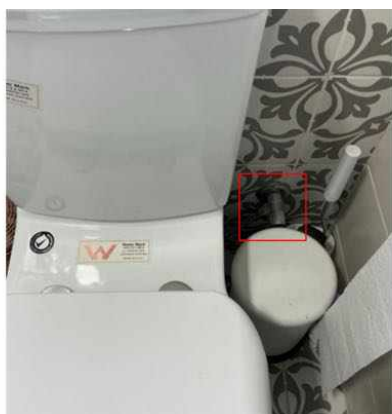
**Finding 3.22**

Building: Main Building  
Location: Bathroom  
Finding: Building element - Rusted or corroded  
Information: This building element shows evidence of rusting and corrosion, which is likely to have developed as a result of excessive exposure to moisture and or inadequate coatings.

Rusting and corrosion should be managed by ideally removing or limiting the affected surface from exposure to moisture. A registered builder may be appointed to replace any building elements that have been severely affected by rust or water damage.

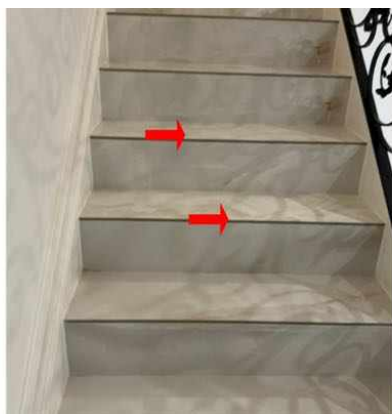
### Finding 3.23

Building:	Main Building
Location:	Stairs - Internal
Finding:	Incomplete or substandard works - No trim or nosing
Information:	The works to this area appear to be incomplete or have been completed to a substandard level.

It is highly recommended that the relevant trades be appointed to complete these works and ensure the safety of the area and the longevity of all associated building elements.

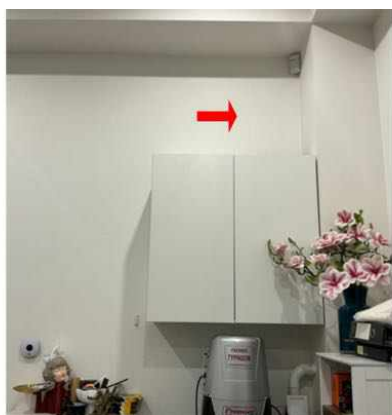
### Finding 3.24

Building:	Main Building
Location:	All Internal Areas
Finding:	Cracks to internal render - Category 1
Information:	It has been observed that cracking to internal rendered surfaces has occurred. The degree of damage falls within Category 1, described as fine cracks that do not need repair and which are less than 1.0mm in width limit.

Damage of this category is not considered a defect for rectification. Always contact your building inspector should cracks widen, lengthen, or become more numerous.

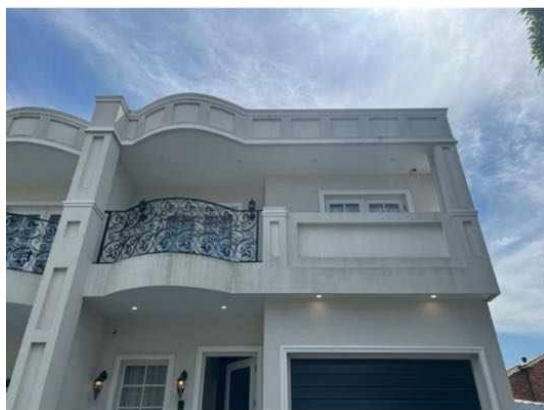
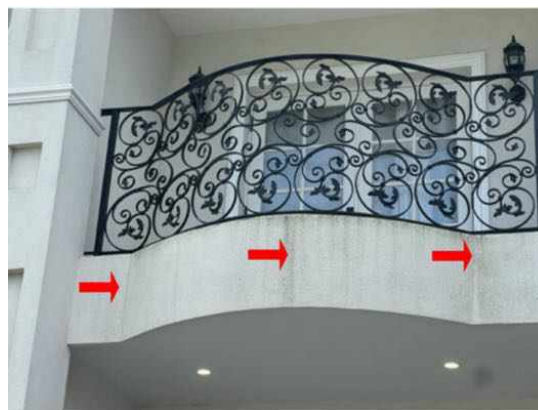
Building:	Main Building
Location:	All External Areas
Finding:	Water Staining - Exterior
Information:	Water staining is evident to the external balcony fascia, indicating ongoing moisture runoff from the area above. The staining appears consistent with repeated exposure to water and may be associated with drainage, overflow, or edge detailing issues. While currently cosmetic, continued moisture exposure may contribute to surface deterioration over time. Further assessment of balcony drainage and waterproofing performance is recommended.

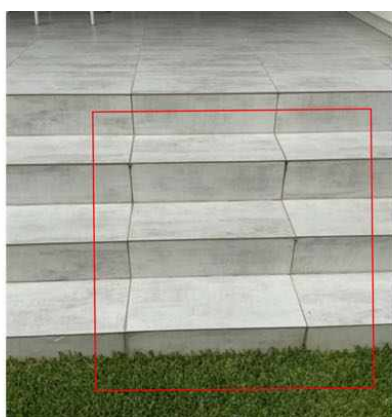
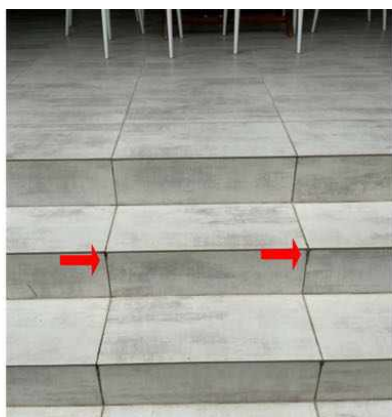
### Finding 3.27

Building:	Main Building
Location:	All External Areas
Finding:	Sealant and grouting - Missing or degraded
Information:	It was noted on inspection that sealant or grout is degraded.

A sealant specialist or tiling contractor should be appointed to complete these works as soon as possible

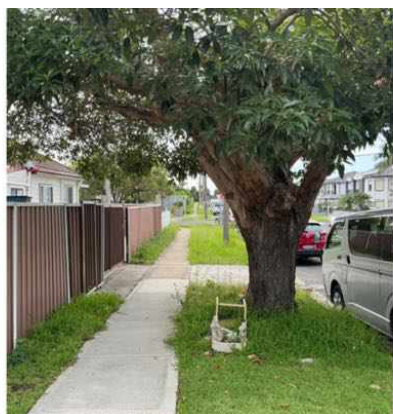
### Finding 6.02

Building:	Main Building
Location:	All External Areas
Finding:	Trees within 50m
Information:	Trees within 50m of the property can be conducive to termite activity. It is recommended an invasive inspection of all trees with 50m to the property be carried out by a qualified pest control expert.

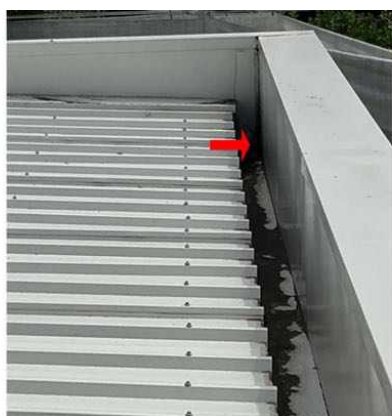
### Finding 6.03

Building:	Main Building
Location:	All External Areas
Finding:	Gutters - Blocked
Information:	Roof plumbing structures, such as guttering and downpipes, should be free of all debris to prevent blockages. Blockages of the guttering and downpipes will lead to pooling and accumulated water overflows, which is likely to subsequently flood eaves and exterior walls.

Consult a Licensed Plumber for further specific advice on remedial works that may be required. In the interim, it is highly advised that blocked gutters be removed by the homeowner or a general handyperson as a matter of urgency.
