Building and Timber Pest Inspection Report

Inspection Date: Fri, 13 Feb 2026

Property Address: 91 Fairmont Boulevard, HAMLYN
TERRACE 2259

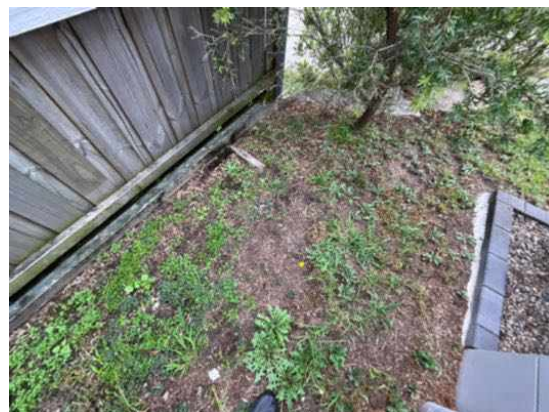
Building: Main Building
 Location: Yard - Side
 Finding: Perimeter - Insufficient Fall
 Information: The perimeter ground levels were found to have an inadequate slope away from the adjoining building structure, creating potential for water pooling in this area.

Perimeter is required to fall from the building by a minimum of 25mm in the first metre and bare ground should fall away from the house by 50mm in the first meter. This standard ensures that excessive moisture does not pool around the base of building structures, which creates potential for water and structural damage, as well as making the area susceptible to termite and timber pest activity.

Where ground levels do not have adequate fall, a licensed paving contractor should be appointed to install or remove and re-level pavement.

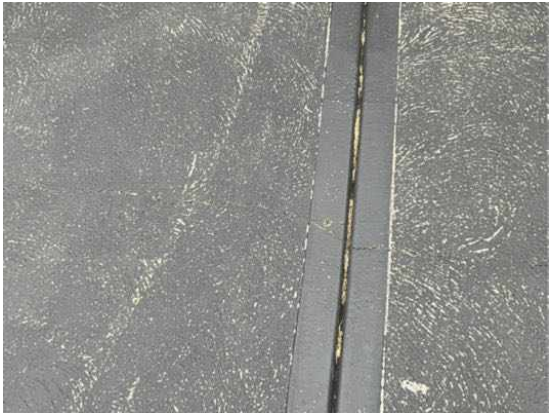
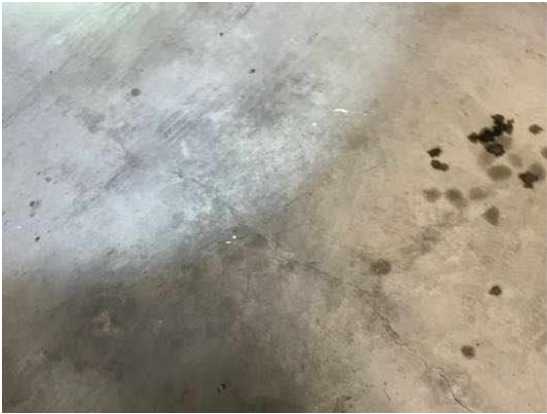
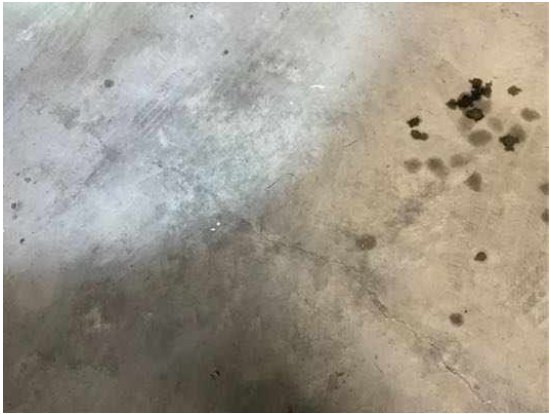
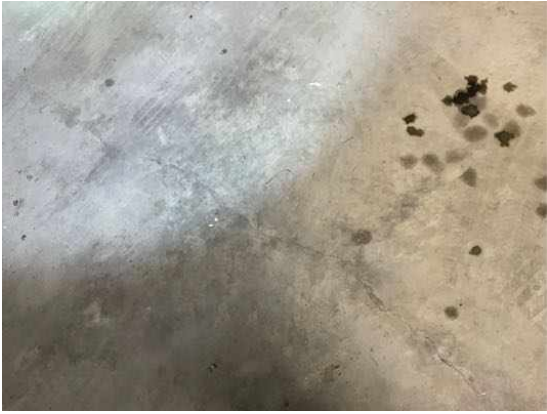
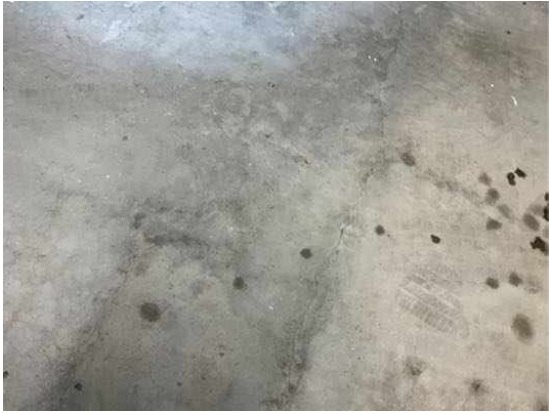
Finding: Crack in concrete slab - Category 0

Information: A crack coded as Category 0 was identified in the slab. A Category 0 crack is described as a hairline crack, representing insignificant movement of slab from level.

The approximate width of the crack to be considered Category 0 is 0.3mm, or change in offset of less than 8mm when a 3m straight edge is placed over the defect.

No rectification is required at this time. However, all cracking should be monitored over a 12 month period to identify any further damage in the area.

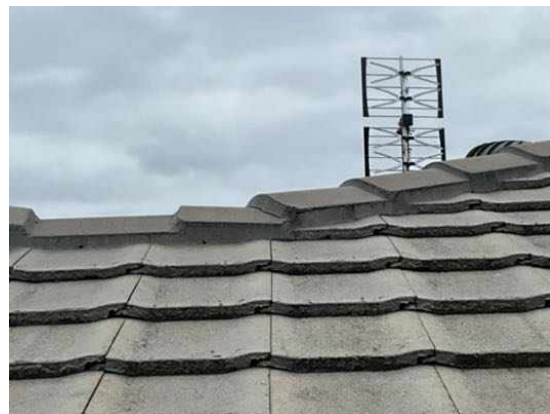
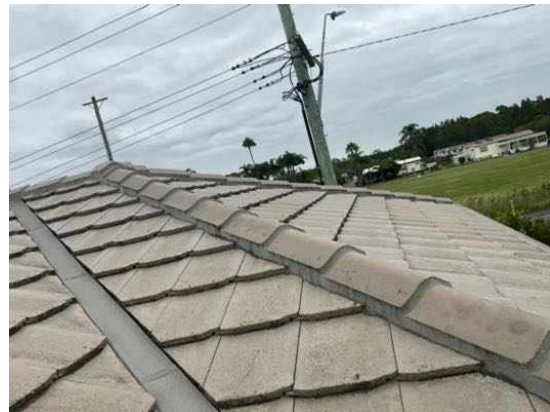
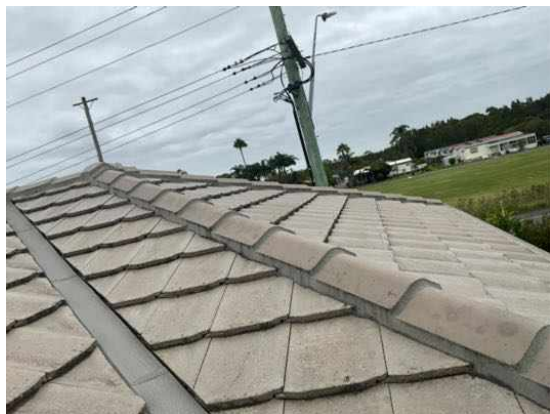
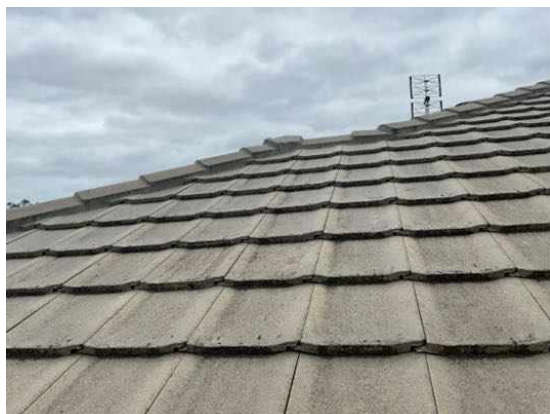
Finding 3.03

Building: Main Building
Location: All Areas
Finding: Roof Weathered
Information:

Inspection of the roof revealed widespread weathering to the tiled roof surface. The tiles show loss of surface finish, colour fading, and age-related deterioration typical of older roof coverings. Although no significant cracking was noted, weathering can lead to increased porosity, reduced water-shedding capability, and a higher risk of future cracking or displacement during adverse weather conditions.

A licensed roofer should be engaged to undertake a closer inspection, carry out routine maintenance, and replace any tiles that may be compromised. Ongoing monitoring is recommended due to the age and condition of the roof covering.

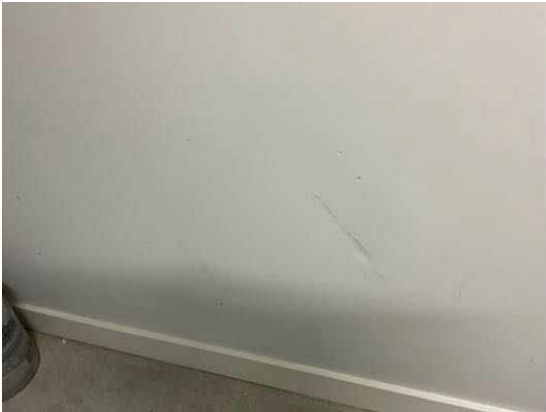
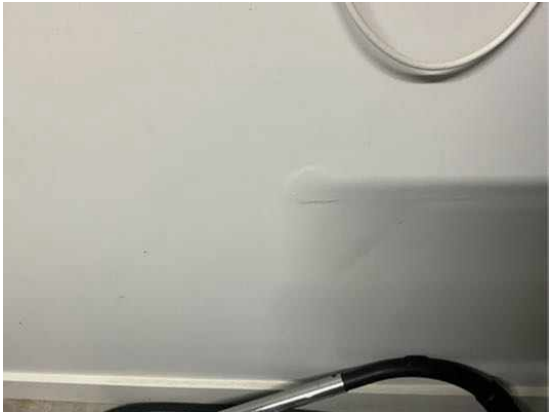
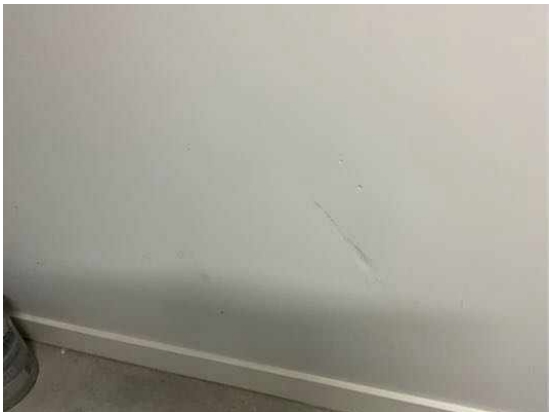
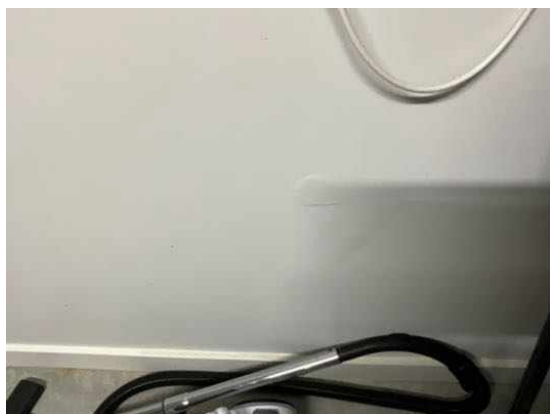
1. Aesthetic Degradation: Scratches mar the appearance of the painted surface, diminishing its visual appeal and potentially lowering property value.
2. Corrosion Vulnerability: Exposed areas of bare metal due to scratched paint are susceptible to corrosion, leading to structural damage and compromised durability.
3. Environmental Hazards: Scratched paint can release hazardous chemicals into the environment, posing risks to both human health and the ecosystem.

A qualified painter should address the issue promptly to repair the scratched paint. Depending on the severity of the scratches, repair options may include sanding, priming, and repainting the affected area to restore the integrity and appearance of the paint surface.

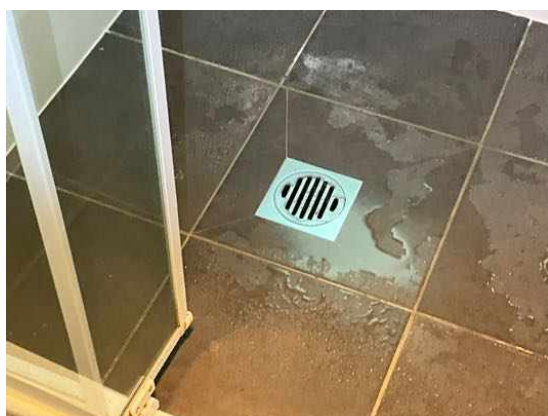
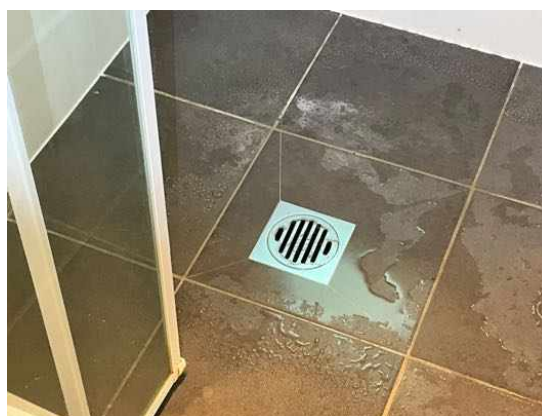
Finding: Shower base - Water pooling
Information: Evidence of water pooling around the floor waste in the shower recess was noticed at the time of inspection. It is suspected that this excessive moisture is attributed to insufficient fall in the shower floor tiles.

This pooling is minor overall but is still considered unsatisfactory, as standard tiling practices would not permit this situation to occur. Pooling water around floor wastes can create a slip hazard in extreme cases and create conditions that are conducive to mould growth over time. Where left unmanaged, the degradation of sealant and grouting is also likely to occur, possibly necessitating further repair works.

Remedial works may involve some sections of tiling and flooring repair and replacement. A tiling contractor or bathroom specialist should be appointed to provide further advice on reparation options and to perform works as necessary.

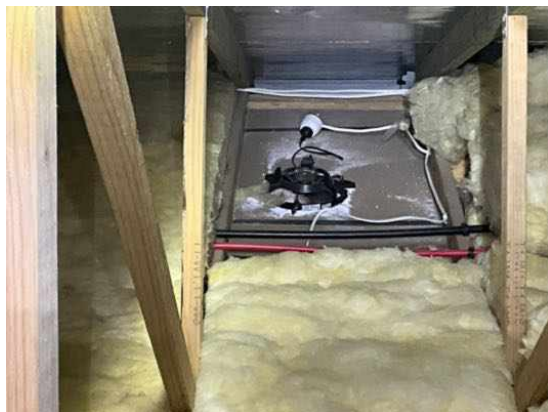
Finding 3.08

Building: Main Building
Location: Roof Void
Finding: Exhaust fan not vented out
Information: The exhaust fan located within the roof void is not appropriately ducted to the external atmosphere and is currently discharging moist air directly into the roof space. This is considered a defect under AS 4349.1, as it does not meet the minimum standard of

This condition may lead to excessive condensation within the roof void, increasing the risk of mould growth, deterioration of insulation, timber decay, and overall reduced durability of building elements. It may also result in poor indoor air quality, potentially affecting occupant health.

It is recommended that the exhaust fan be modified by a licensed HVAC contractor or qualified builder, ensuring it is properly ducted to discharge externally in accordance with manufacturer specifications, the National Construction Code (NCC), and applicable Australian Standards.

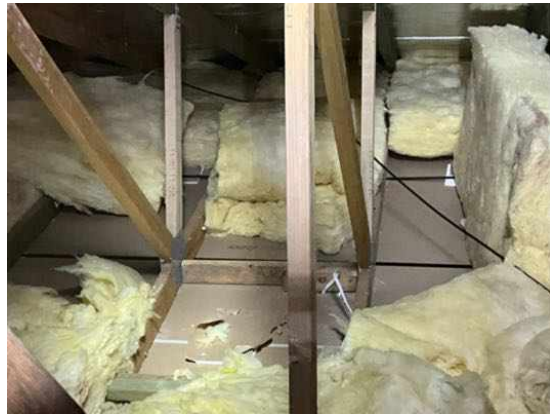
Finding 3.09

Building:	Main Building
Location:	Roof Void
Finding:	Insulation poorly placed
Information:	During the roof void inspection, it was observed that multiple insulation batts have been dislodged or are poorly placed, leaving significant gaps in coverage. This compromises the thermal performance of the ceiling insulation system.

- Reduced Energy Efficiency: Exposed areas without insulation can lead to increased heating and cooling costs as they allow for thermal bridging.
- Increased Moisture Risk: Uneven insulation may lead to condensation issues, especially in colder climates, potentially affecting timber framing and ceiling materials.
-

- Qualified Insulation Installer – A licensed insulation contractor should be engaged to reposition or replace the insulation batts, ensuring consistent and complete coverage across the ceiling.

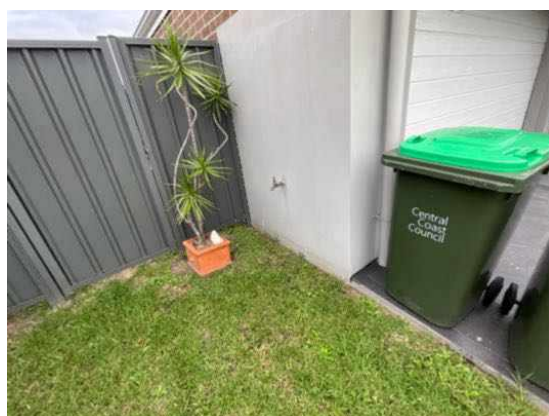
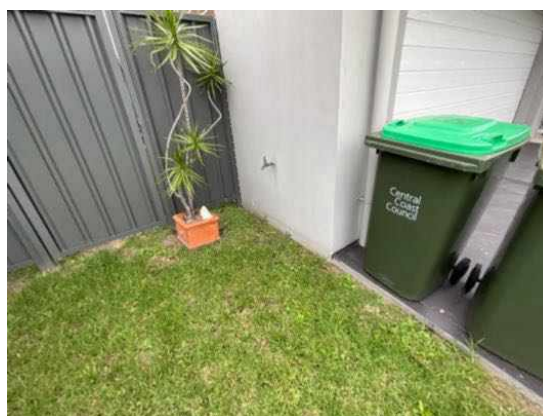
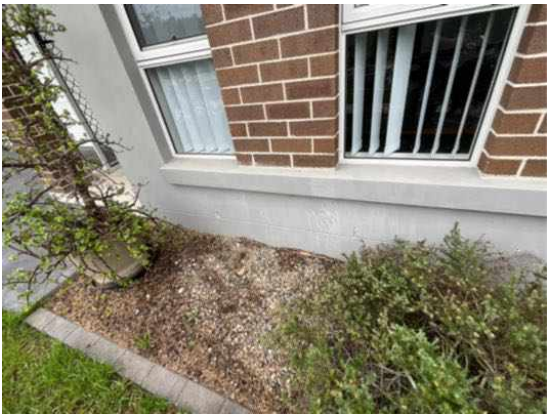
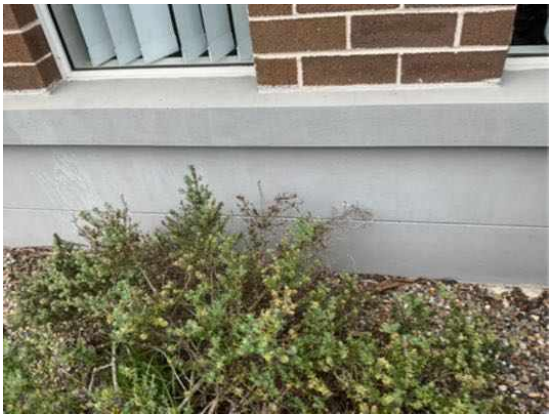
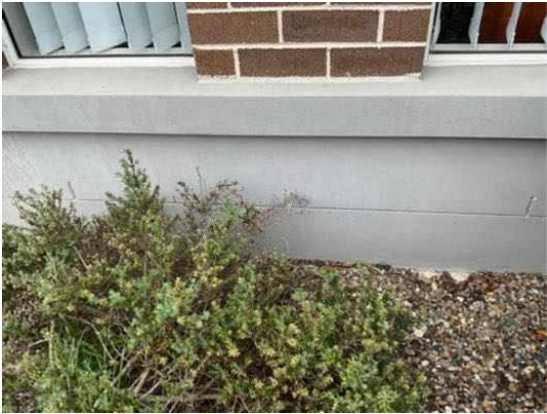
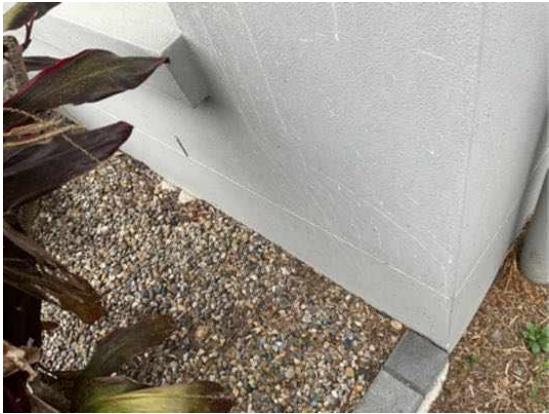
If the slab edge is not properly exposed there is a high risk of termite attack. Sometimes, in order to determine the type of slab, a suitably qualified person such as an architect or builder may be required to consult the construction plans.

Where the slab edge cannot be properly inspected, it is highly recommended that termite or timber pest inspections be carried out every 6-12 months to aid protection of the property against infestation.

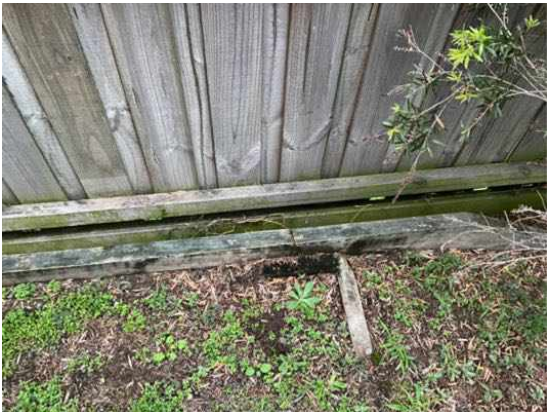
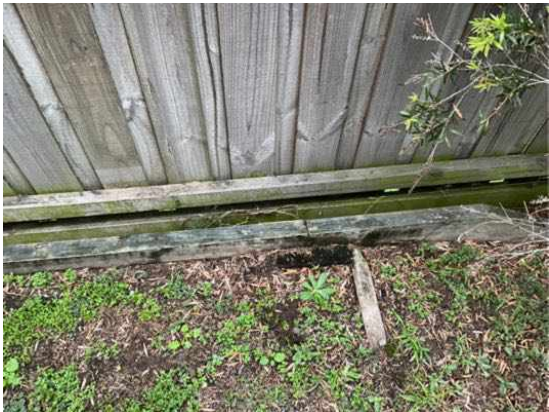
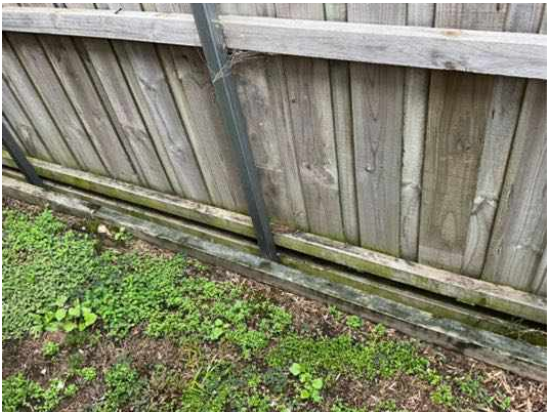
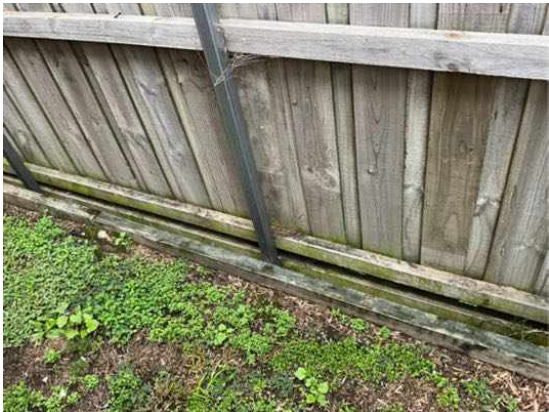
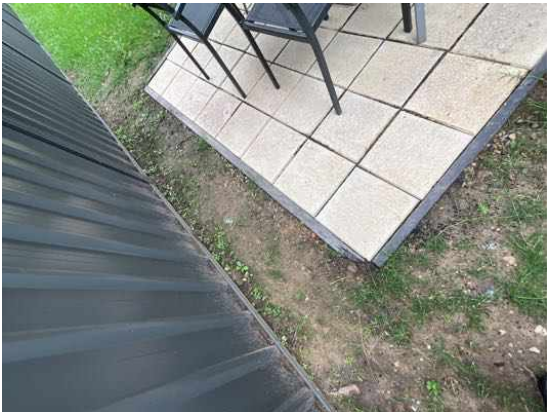
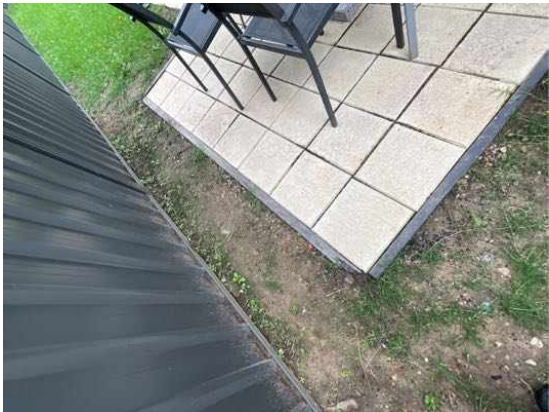
Finding 6.02

Building: Main Building
Location: All Areas
Finding: Timber on ground / conducive conditions to termite damage
Information: Timber on the ground is indeed conducive to termite damage. Termites are known to thrive in moist environments, and wood in contact with soil or moisture is more susceptible to infestation.

To prevent this, it's important to keep timber elevated and away from direct ground contact. Regular inspections and proper termite control measures are also essential to protect your wooden structures from termite damage.

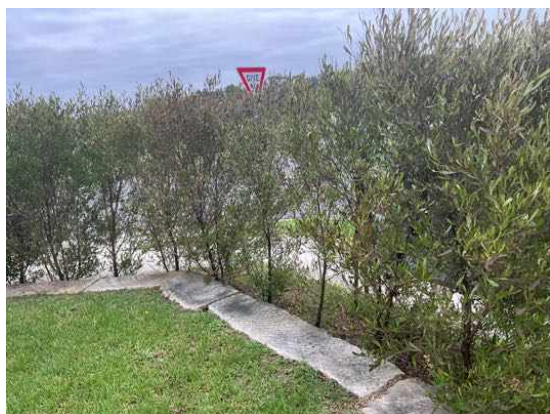
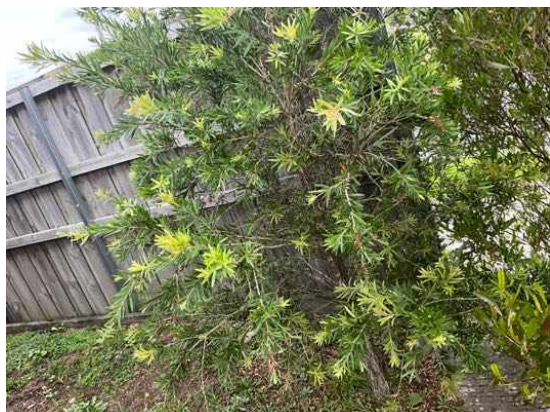
Finding 6.03

Building: Main Building
Location: All Areas
Finding: Dense vegetation around a property can increase the risk of termite infestation
Information: The presence of dense vegetation around a property can increase the risk of termite infestation, as it provides a conducive environment for them. To address this, consider maintaining a clear space between the vegetation and your home. If you suspect a termite issue, it's advisable to consult with a licensed pest control professional for inspection and treatment.

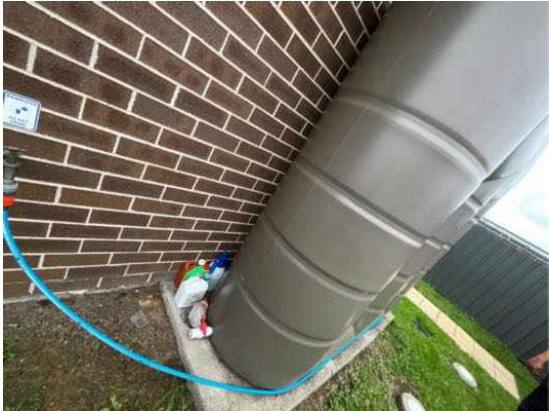
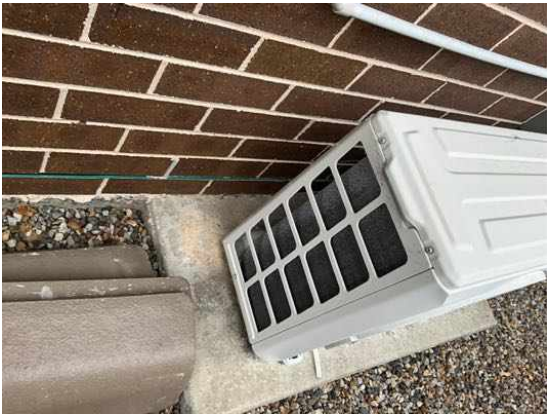
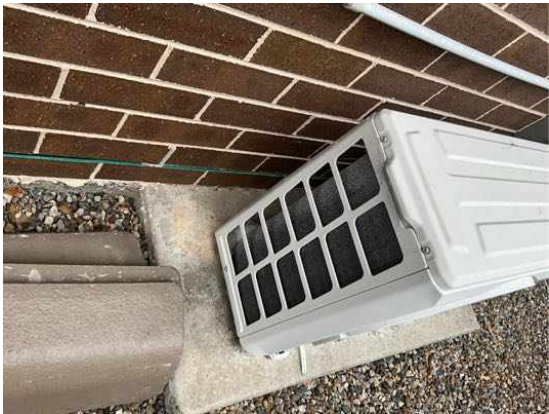
Where bridging has occurred full inspection is prevented and termites may enter a property in a concealed or undetected manner.

Recommended moving obstructions away from the external walls for further and future inspections.

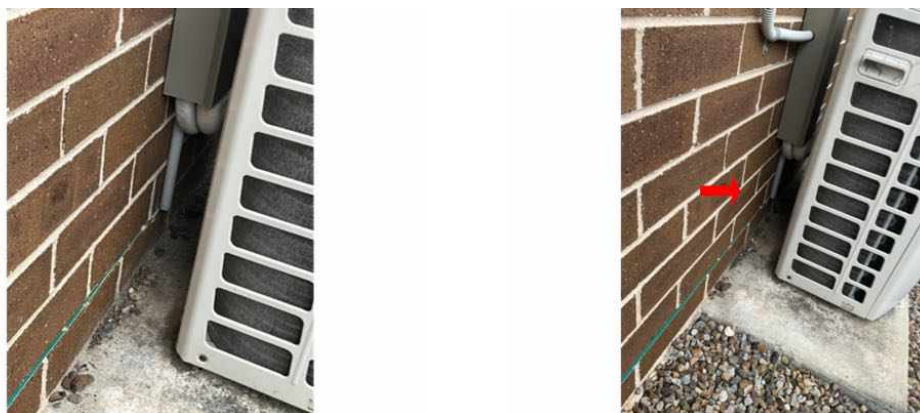
Finding 6.06

Building: Main Building
 Location: Exterior walls - right side
 Finding: Aircon - Excessive moisture conducive condition near Air-conditioner
 Information: Excessive moisture near an air conditioner can indeed create conducive conditions for termites. Termites are attracted to damp and decaying wood, which can be found in areas with high moisture levels. To fix this issue:

1. Fix Leaks: Check for any leaks or condensation around your air conditioning unit. Repair any damaged pipes, drains, or insulation

2. Proper Drainage: Ensure that your air conditioner has proper drainage. Make sure the condensate drain line is clear and directed

5. Please consult a HVAC Technician: HVAC (Heating, Ventilation, and Air Conditioning) technicians are trained to diagnose and

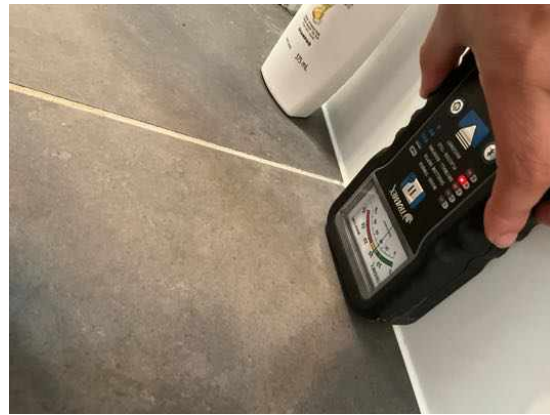
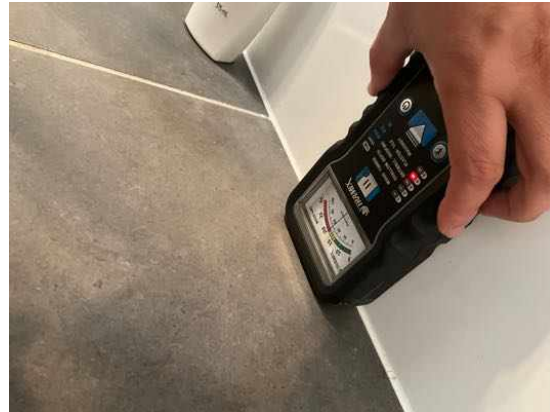
Finding 6.07

Building:	Main Building
Location:	Ensuite
Finding:	Excessive moisture - Conducive to Timber pest
Information:	Excessive moisture can attract termites and produce conditions that promote fungal growth and wood decay.

Excessive moisture is generally caused by deteriorated inadequate or missing roof drainage leaking plumbing pipes or fixtures poorly plumbed HWS overflows or condenser units and poor site drainage.

Prior to any remedial works being performed a qualified plumber should be appointed to further inspect the property and to identify the cause of the excessive moisture. Works to remove affected building elements may then be necessary and should be performed by an appropriate tradesperson.
