# Building and Timber Pest Inspection Report

Inspection Date: Thu, 19 Mar 2026

Property Address: 81 Kane Dr, St Leonards VIC 3223, Australia

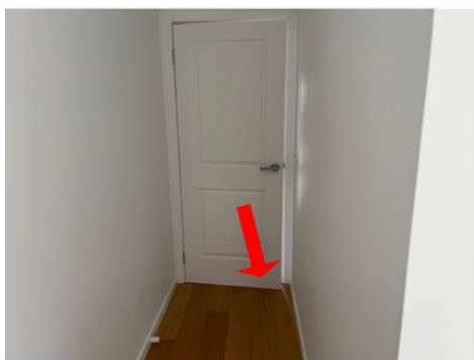
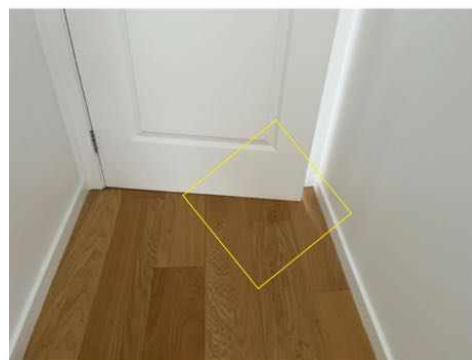
#### Finding 3.01

Building: Main Building  
 Location: Bedroom 2 (Downstairs)  
 Finding: Door - Binding/jamming or rubbing at the bottom.  
 Information: Binding and/or jamming of this door is evident during standard operation.

This door rubs slightly across the flooring surface, which will cause the material to become scratched in time.

This minor defect barely inhibits the functionality of the affected door but if left unattended it is likely to worsen.

A simple adjustment to the hinge should rectify the issue.

For minor causes, a general handyperson should be appointed to perform rectification or a shower screen installer should be appointed at the clients discretion.

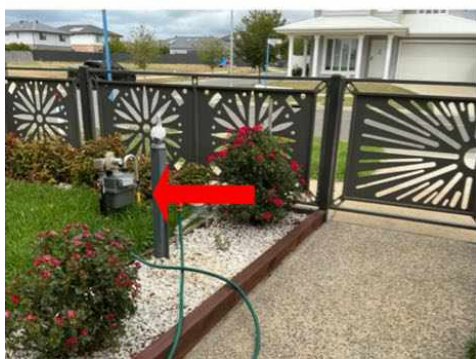
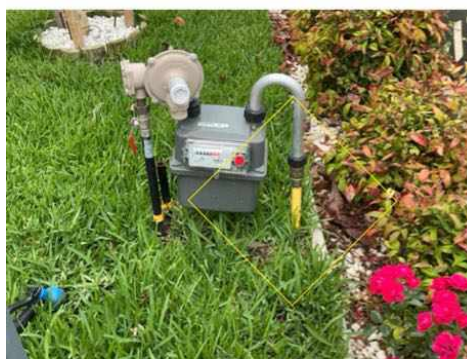
#### Finding 3.02

Building: Main Building  
 Location: Gas meter - yellow pipe

**Finding:** Yellow gas pipe - Not UV protected

**Information:** The yellow (I-plex gas pipe is designed to be installed inside walls or roof voids away from direct sunlight. Where the pipe is exposed the Ultra. Inlet light causes the gas pipe to degrade and become brittle. This can (in rare cases) result in the pipe shattering if it is damaged.

To protect the pipe a sleeve or other form of protection should be applied - such as silver duct tape.

This simple rectification can provide a protective layer and extend the life of the pipe.

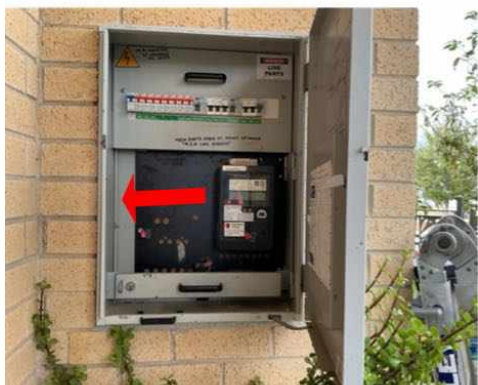
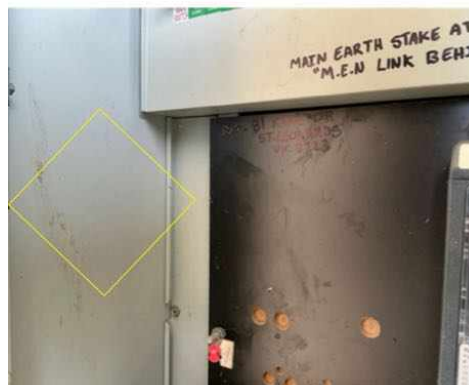
### Finding 6.01

**Building:** Main Building

**Location:** Meter Box

**Finding:** Termite Management System - no evidence of a chemical installation

A durable notice should be placed in the switchboard unit to indicate current termite barriers. At the time of inspection, it appeared as though no termite management

system has been installed, with no evidence to suggest preventative works taking place.

The client may consider gaining further advice from a pest controller as to the costs and procedures involved with this application. It is recommended that obtaining such advice be a short-term priority.

A termite treatment is recommended as a practical step to prevent potential termite infestation. A termite barrier system provides the optimum protection to the asset, against termite infestation.

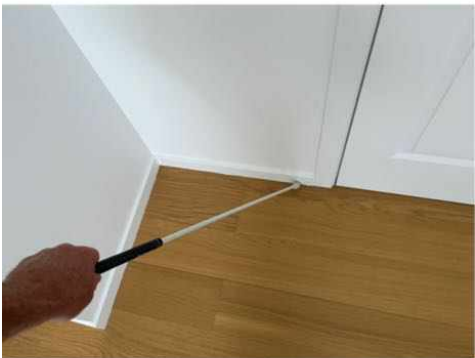
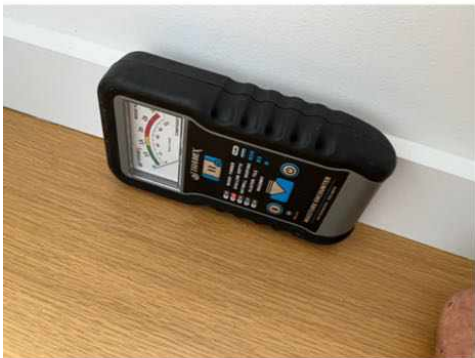
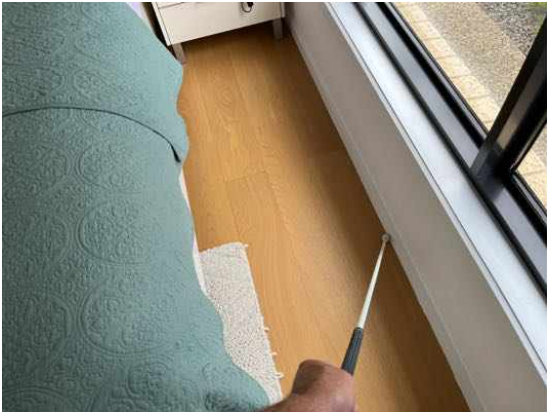
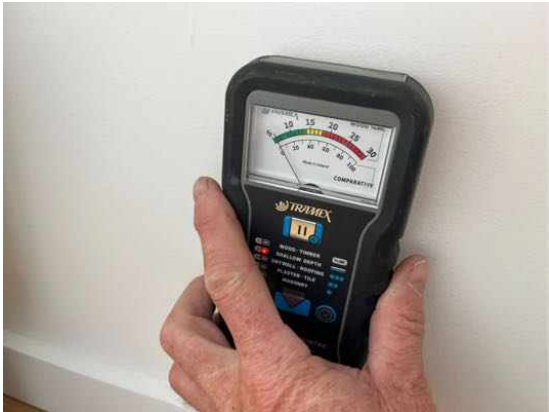
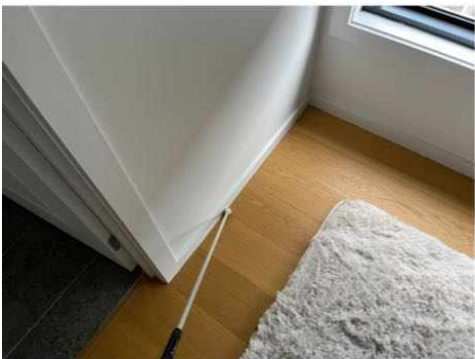
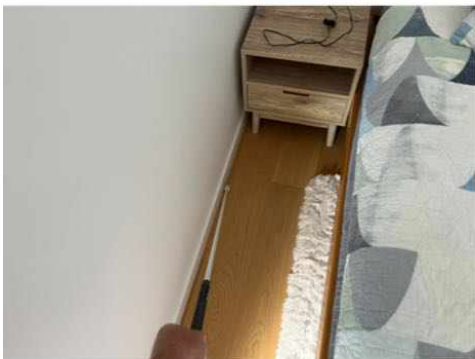
## Finding 6.02

Building:	Main Building
Location:	All Areas
Finding:	Termite Techniques
Information:	All areas of the dwelling are checked with particular attention paid to wet areas which were closely assessed to check for excessive levels of moisture and temperature anomalies.

No evidence of termite activity was found inside the house at the time of the inspection.

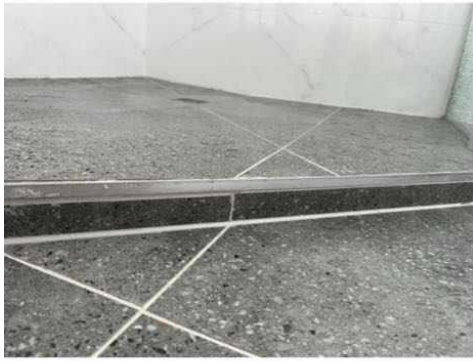
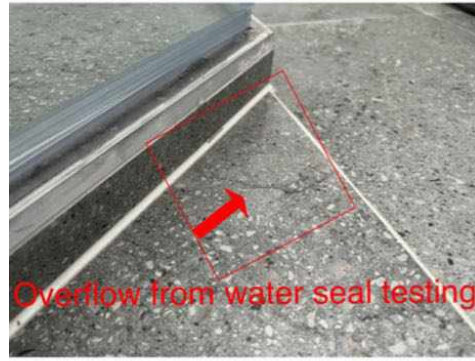
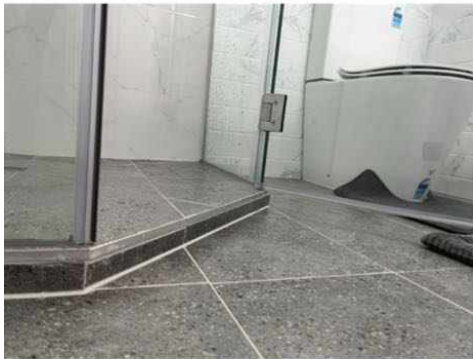
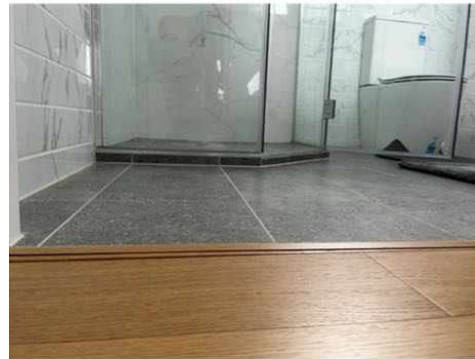
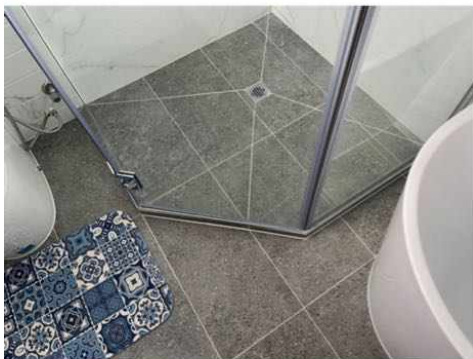
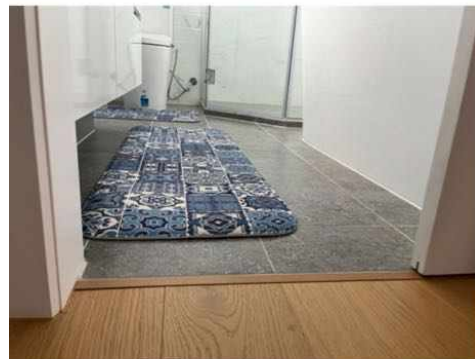
#### Noted Item

Building: Main Building  
 Location: Upstairs Bathroom  
 Finding: Risk of water damage  
 Information: The upstairs Ensuite shower and upstairs bathroom showers, may overflow under certain conditions. However the shower appears to be functional and not considered defective.

2) The water pressure at the property appears to be very strong and the owners currently throttle back the water pressure at the water metre by half closing the shut off valve.

3) The showers are raised above the bathroom floors, which is not considered an issue as there is adequate fall towards the waste drain.

Increasing the water pressure may result in too much water flow and the drain may not cope.

any obstruction of the drain, may result in the water flowing out of the shower onto the floor and possibly out the wet area.

4) There is no additional floor drains in the upstairs (or ground floor) bathrooms.

5) Water stops are present across but there is no lippage that would hold back water from flowing into the adjoins room.

Recommend a plumber be engaged to install a water restrictor or similar device to limit the water pressure.

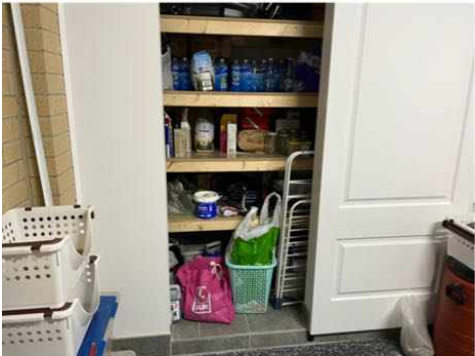
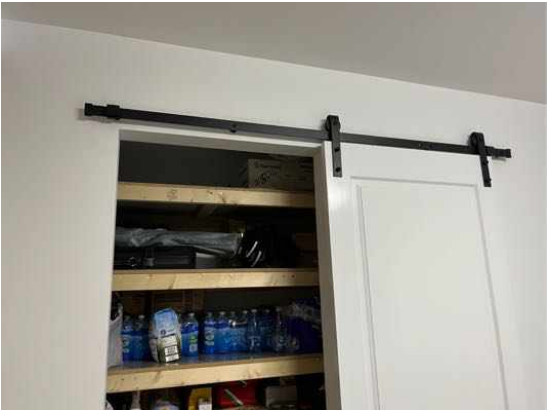
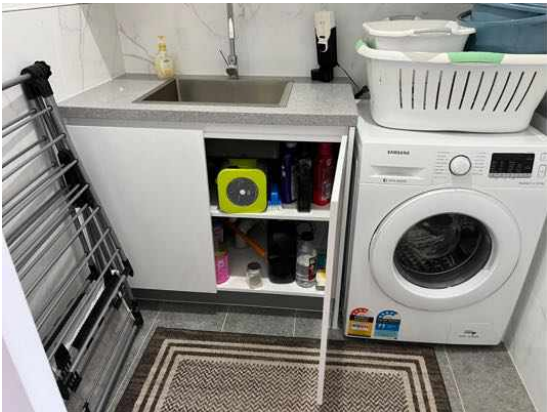
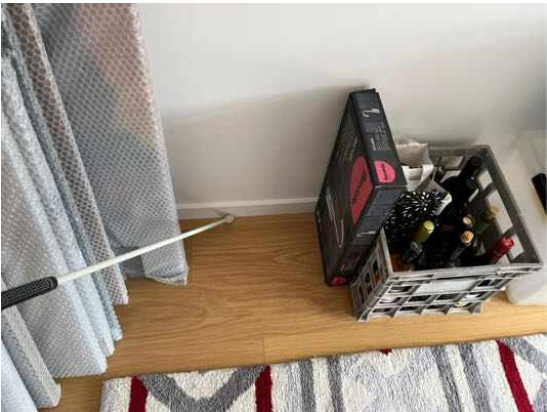
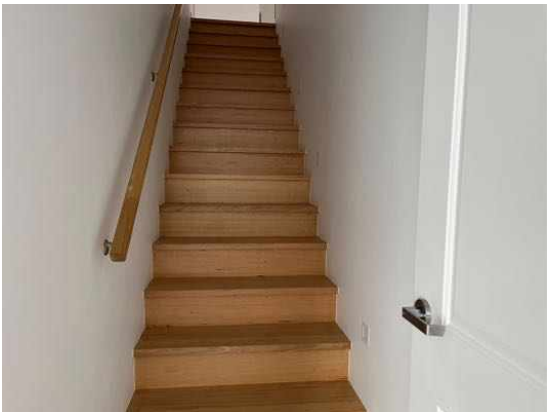
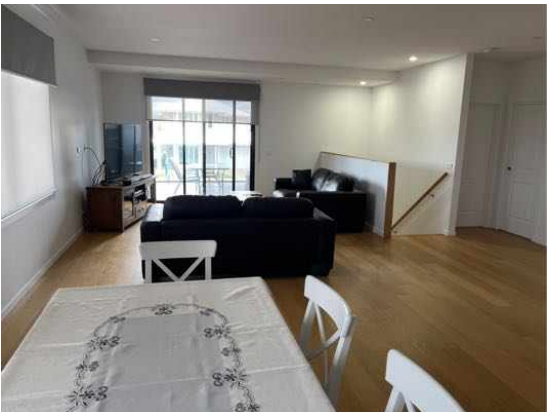
### Noted Item

Building: Main Building  
Location: All Areas  
Finding: Additional Photos - Obstructions and Limitations  
Information: The Vendor was working from the house at the time of the inspection.

The dishwasher power point was being used at the time, therefore the appliance could not be checked.

These obstructions can hide an array of defects and should be removed to allow full inspection to be carried out. A re-inspection is recommended once the areas are made accessible.
