# Building and Timber Pest Inspection Report

Inspection Date: Mon, 23 Feb 2026

Property Address: 9 Stanger Ct, Wodonga VIC 3690, Australia

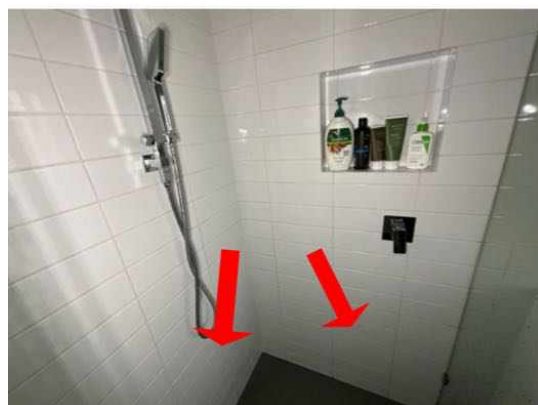
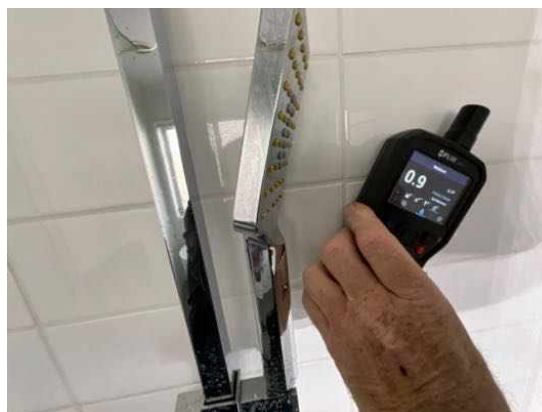
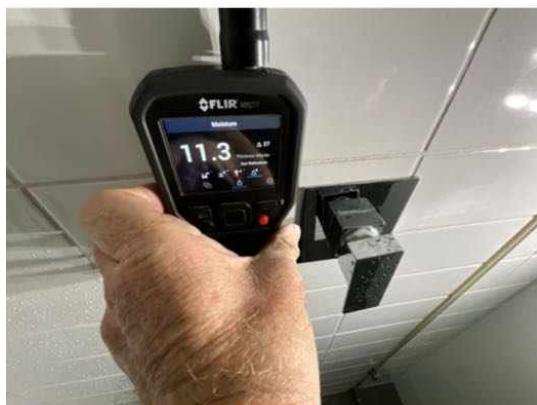
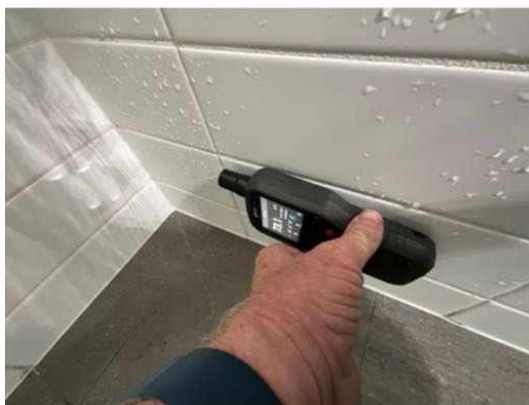
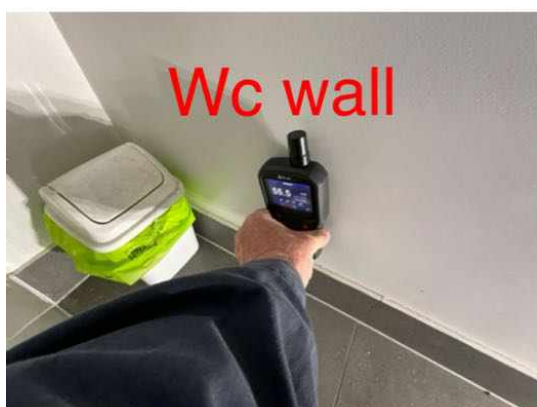
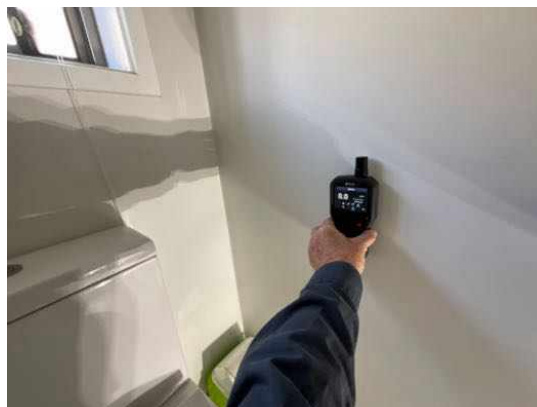
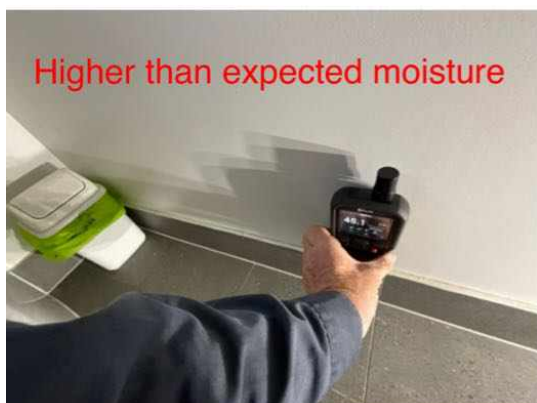
#### Finding 3.01

Building: Building 1  
Location: Bathroom  
Finding: Shower Damp- Major  
Information: Damp is evident to the lower 300mm of wall to the Shower Alcove. This is suspected to have been caused by moisture permeating through the grouting in this area, which shows evidence of deterioration.

High levels of moisture were observed on the outside of the shower walls in the opposite wall.

Damp (or structural damp) refers to the presence of unwanted moisture in the structure of the building, either as a result of intrusion from outside, or condensation from within the structure. In the Shower area, internal water leaks or other sources of excessive moisture are generally the cause of damp.

Consultation with a qualified Plumber or Bathroom Specialist is advised immediately to identify the cause of damp and to perform remedial works as required.

Always ensure that sealant and grout is in good condition to prevent any moisture issues occurring in the future.

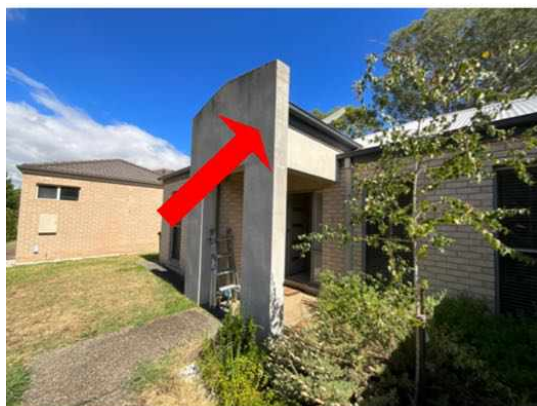
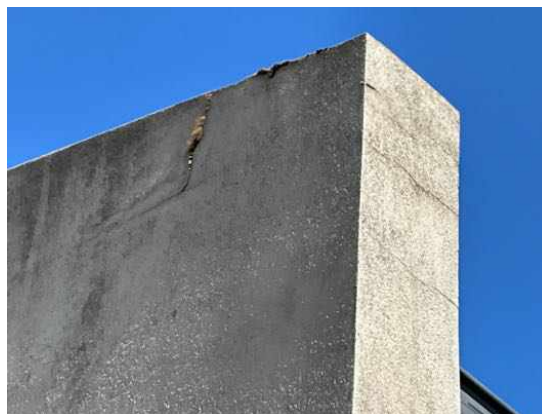
### Finding 3.02

Building:	Building 1
Location:	Entry
Finding:	External Render- deterioration
Information:	The external rendered surfaces show signs of deterioration. This can be seen in the sections of render cracking/flaking away from the substrate. This can be caused by initial poor quality installation work or excessive moisture over time.

A Renderer should be contacted soon to consult on the best method of restoration. Repairs will prevent further deterioration of the render and underlying structure.

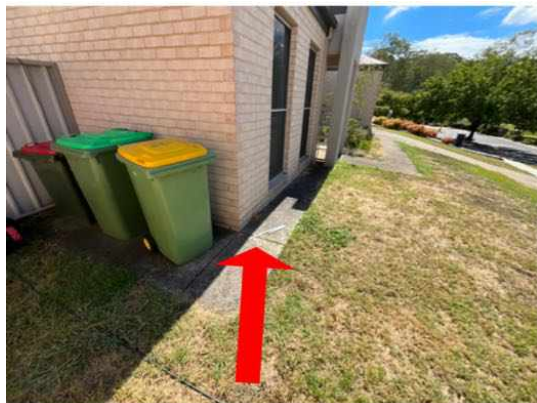
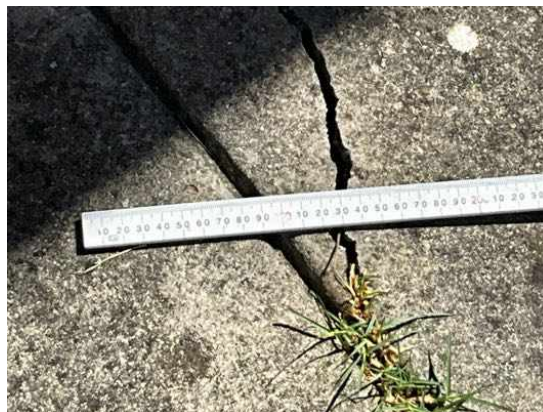
### Finding 3.03

Building:	Building 1
Location:	Yard - Front
Finding:	Cracking - External Concrete Paving Damage Category 3 - Wide Cracks (2mm - 4mm)
Information:	Wide cracks were identified in external concrete paving Wide cracks are significant and are likely to lead to the development of safety hazards and secondary defects if left unmanaged.

General age and expected deterioration of the paved areas is a common cause of this type of cracking. However, expansion and contraction of the slab may also have occurred due to environmental factors. Such factors include variable moisture and weather conditions, the presence of trees and their roots having a settling or lifting affect on the soil, or the effect of load bearing, e.g. heavy vehicles over a sustained period of time.

Cracking to this degree may also be due to poor original installation of the concrete. Factors such as poor compaction of the sub surface and/or inadequate reinforcing of the slab may create cracking and other secondary defects. Wide cracks may also have a more significant structural cause, such as subsidence of soils.

Where the crack is located adjacent to structural elements of the building, the advice of a Structural Engineer is advisable before undertaking repairs. Significant repair and likely replacement of the concrete paving is probable.

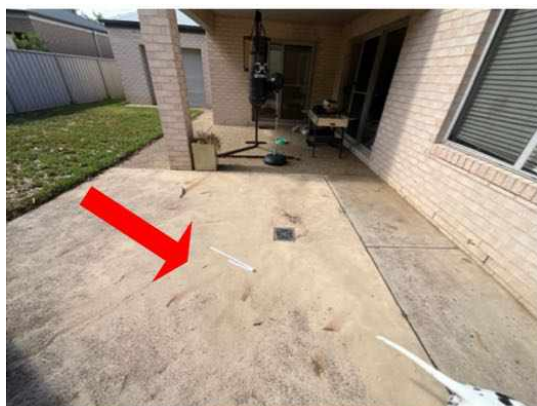
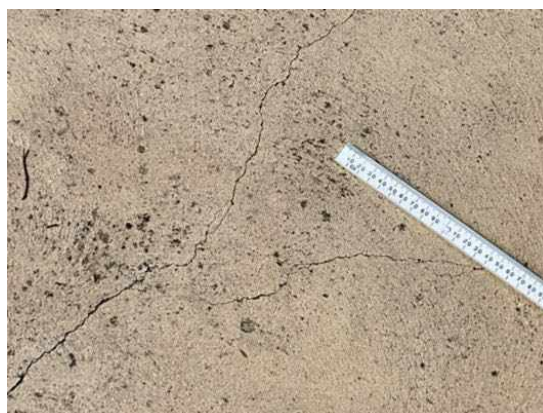
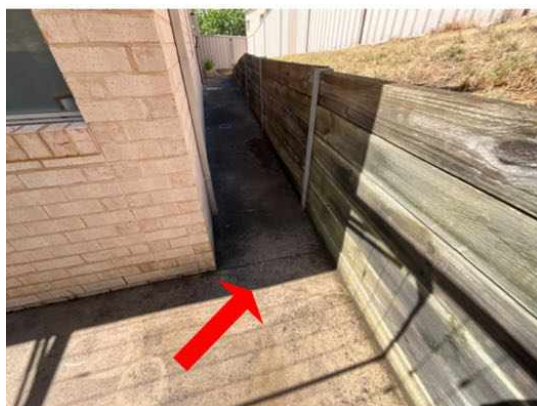
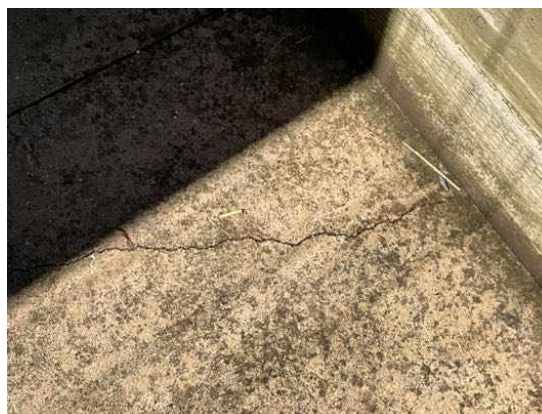
### Finding 3.04

Building:	Building 1
Location:	Yard - Back
Finding:	Cracking - External Concrete Paving Damage Category 1 - Fine (less than 2mm)
Information:	Fine cracks were identified in external concrete paving. Although fine cracks are quite noticeable, they are often only considered to be an appearance defect, and usually do not indicate any structural damage. To be considered a Category 1 or fine crack, the crack is found to be less than 2mm in width.

Generally the cause of a hairline crack in existing concrete paving such as driveways and pathways is indicative of the expansion and contraction of the concrete. Such causes are generally due to environmental factors, such as moisture levels, weather conditions, root systems of nearby trees or the soil types on which they are laid.

Fine cracks may also be due to poor original installation of the concrete. Factors such as poor compaction of the sub surface and/or inadequate reinforcing of the slab may create cracking and other secondary defects.

Monitoring of all cracking should be conducted frequently. Always contact a building inspector should cracks widen, lengthen, or become more numerous.

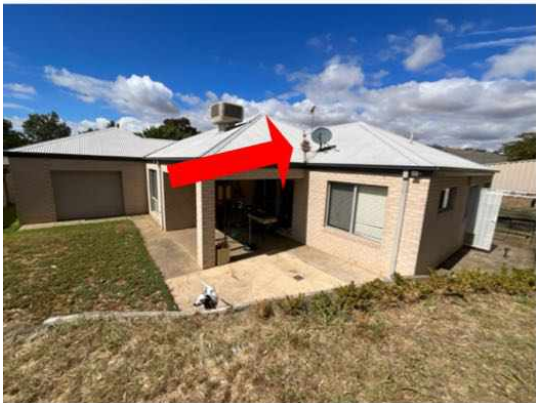
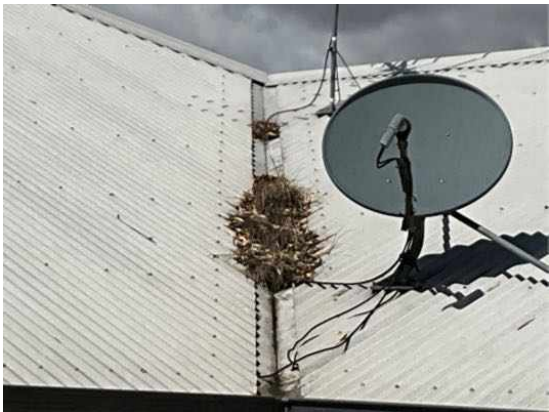
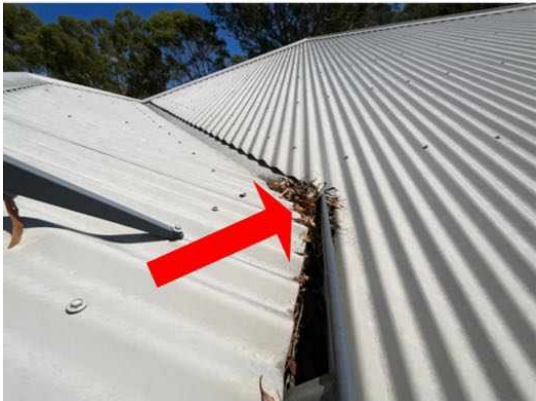
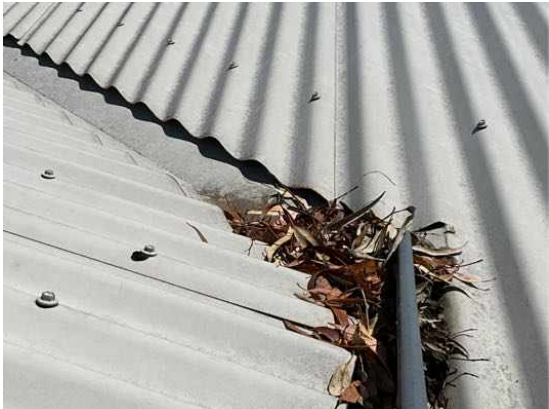
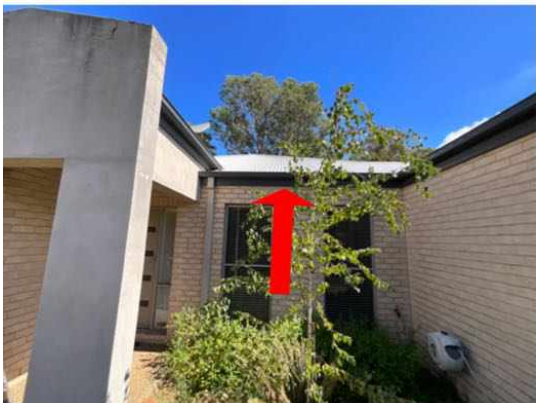
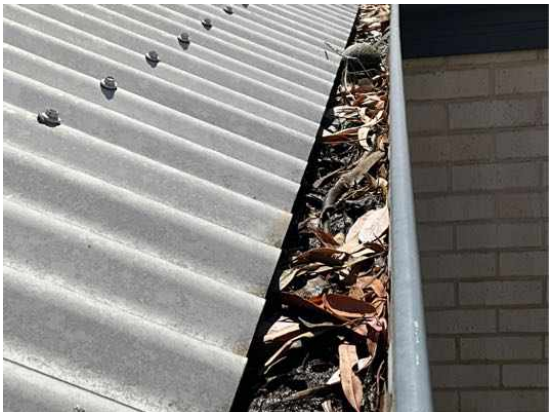
### Finding 6.01

Building:	Building 1
Location:	Roof Exterior
Finding:	Gutters- Blocked
Information:	Roof plumbing structures, such as guttering and downpipes, should be free of all debris to prevent blockages. Blockages of the guttering and downpipes will lead to pooling and accumulated water overflows, which is likely to subsequently flood eaves and exterior walls.

Blocked gutters are likely to lead to high levels of moisture in the affected areas. Such moisture will not only cause rust and decay of the associated building materials, but can also provide conditions that are conducive to termite and timber pest activity. Blockages in gutters should therefore be removed immediately to ensure dry conditions are maintained.

Consult a Licensed Plumber for further specific advice on remedial works that may be required. In the interim, it is highly advised that blocked gutters be removed by the homeowner or a general handyperson as a matter of urgency.

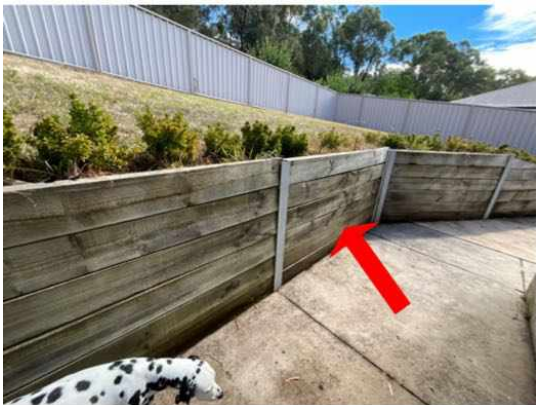
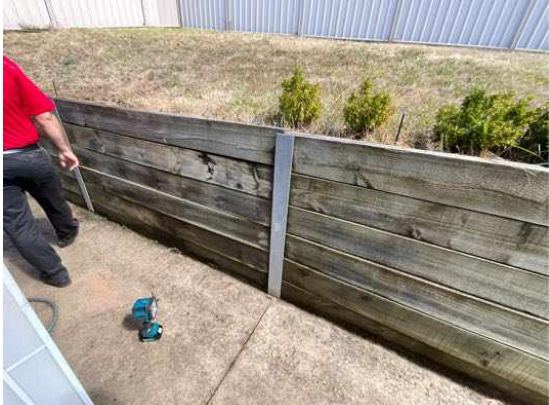
**Finding 6.02**

Building: Building 1  
 Location: Yard - Back  
 Finding: Untreated or non-durable timbers in a hazardous environment  
 Information: To reduce the risk of timber pest attack it is essential that timber used in a hazardous environment (e.g. in direct contact with the ground or frequently exposed to damp conditions) is of sufficient durability and/or is adequately preservative treated.

Untreated timbers in direct contact with the ground are likely to develop severe wood rot and/or fungal decay if left unattended creating attraction for subterranean termites to infest the timbers from surrounding areas.

If untreated or non-durable timbers are found to be in a hazardous environment it is highly advised that replacement of these building elements be performed as soon as possible to aid the protection of the property against termite / timber pest attack.

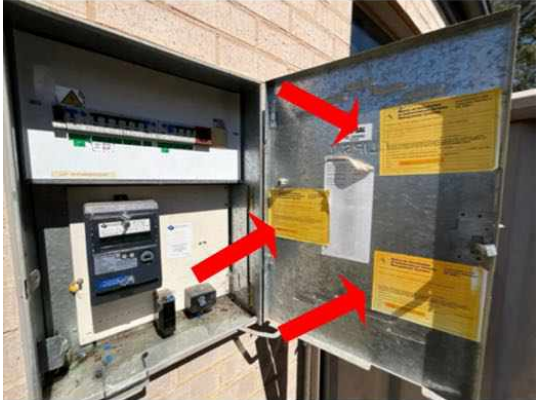
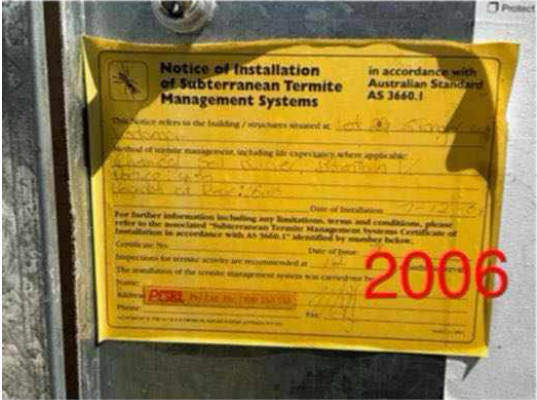
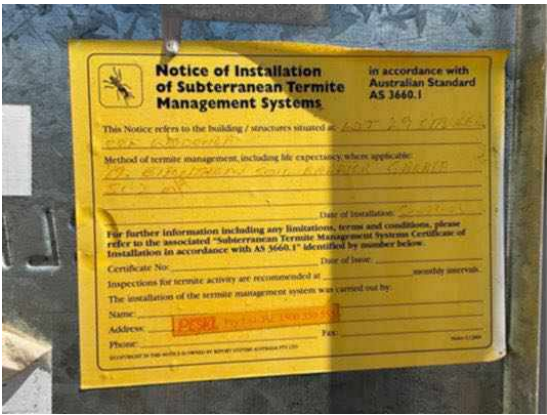
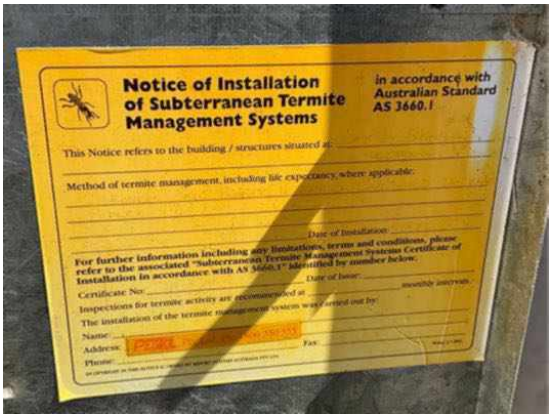
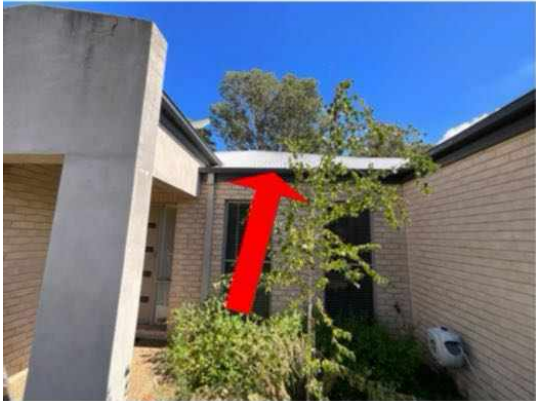
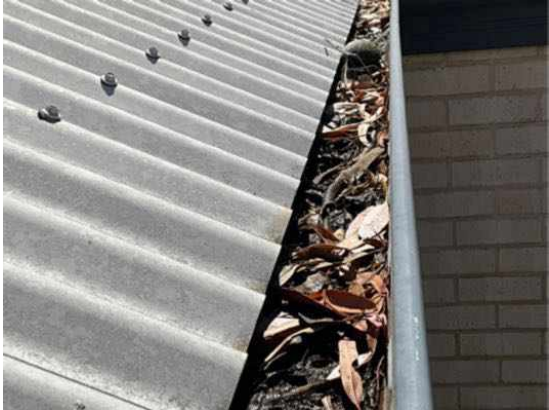
Finding 6.03

Building: Building 1  
 Location: All External Areas  
 Finding: Termite Management System - no evidence of a chemical installation  
 Information: The application of a post-construction chemical termite barrier is highly recommended for all properties, particularly if live termite activity has been found on the site previously. Such barriers are highly effective in preventing termite attack on any timber building elements throughout the property.

A durable notice should be placed in the switchboard unit to indicate current termite barriers. At the time of inspection, it appeared as though no termite management system has been installed, with no evidence to suggest preventative works taking place.

The client may consider gaining further advice from a pest controller as to the costs and procedures involved with this application. It is recommended that obtaining such advice be a short-term priority.

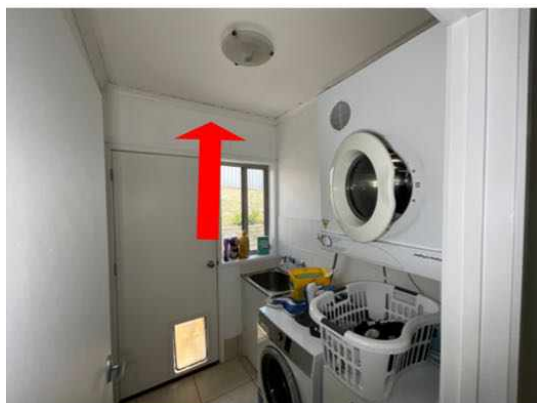
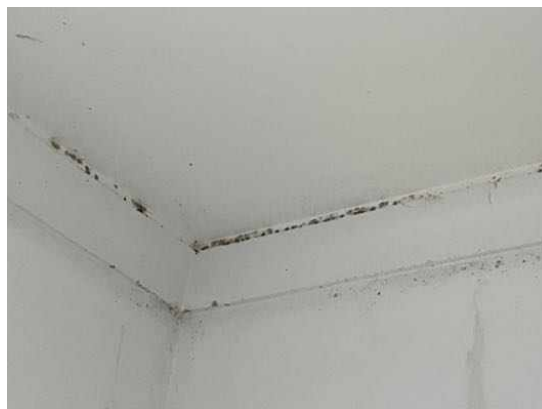
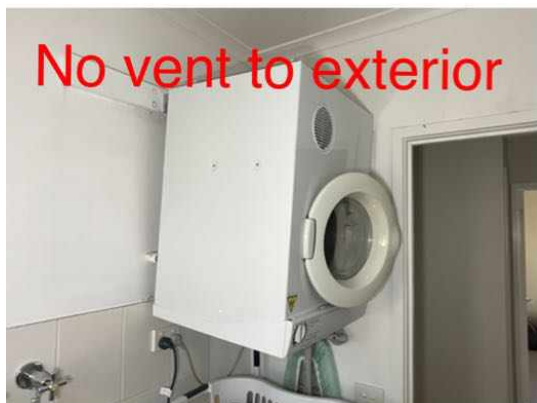
Building: Building 1  
Location: Laundry  
Finding: Mould - Present  
Information: Where evidence of mould growth was noted, there may be environmental, biological or health issues associated with the report. A specialist inspection by a suitably qualified environmental health inspector is warranted, where mould is extensive or where any queries regarding air quality spores or other related issues apply.

Generally, the client is advised to ensure that the general environment is free of moisture and humidity to aid in the prevention of mould formation and development. Any mould found during the inspection should be cleaned immediately by a cleaning contractor or the homeowner as applicable.

Please note that severely affected building elements may require replacement by a registered builder or qualified carpenter.

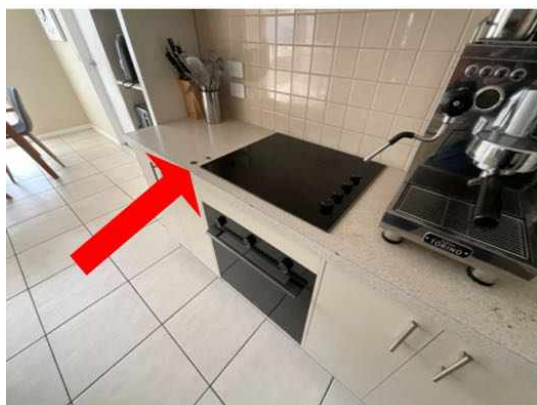
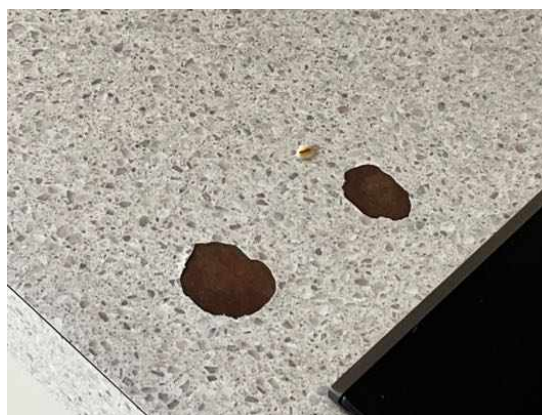
Building: Building 1  
 Location: Kitchen  
 Finding: Kitchen Bench -Damaged  
 Information: The surface of the kitchen bench shows cracking and obvious marks. These marks are not structural and would be considered more than fair wear and tear for building of this age.

Excessive pressure or weight may be the cause.

If restoration is required, the services of a cabinetmaker or Kitchen specialist should be sought to restore the Bench to original standard.

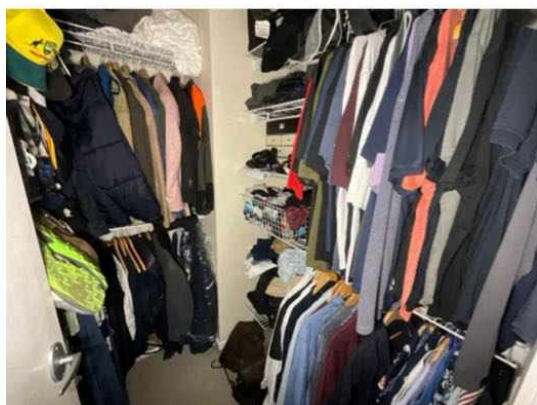
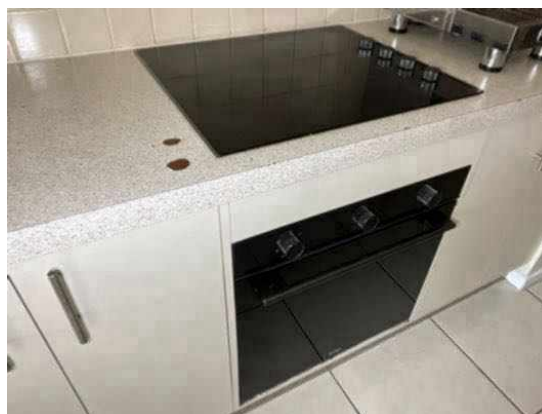
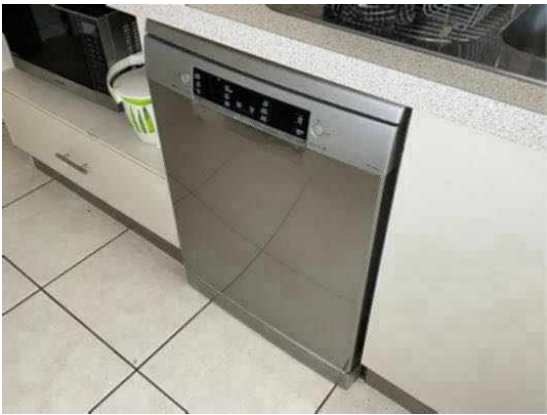
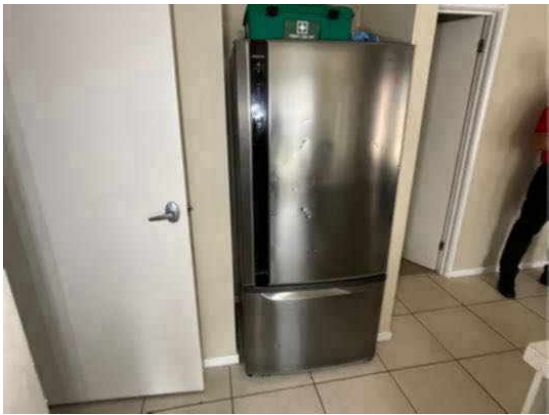
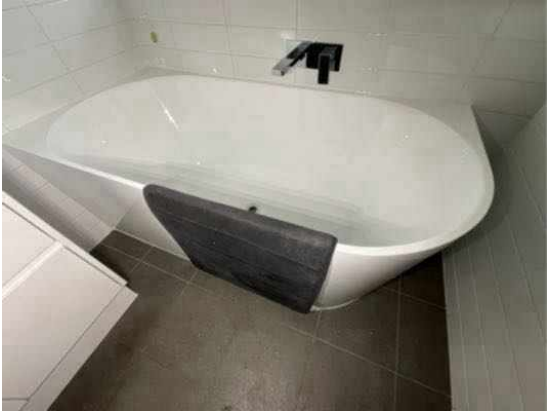
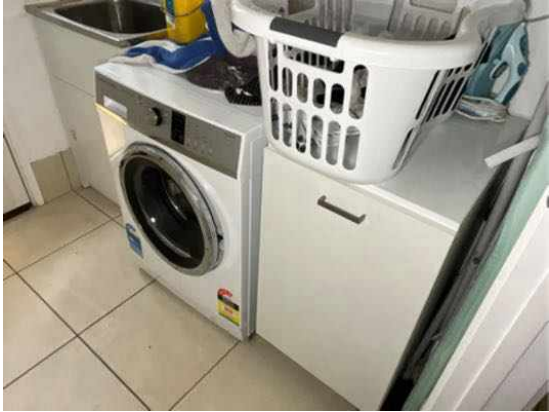
Building: Building 1  
 Location: All Areas  
 Finding: Additional Photos - Obstructions and Limitations  
 Information: These photographs are an indication of the obstructions and limitations which impeded full inspection of the property at the time of inspection. These obstructions can hide an array of defects and should be removed to allow full inspection to be carried out. A re-inspection is recommended once the areas are made accessible.
