Building and Timber Pest Inspection Report

Inspection Date: Thu, 9 Apr 2026

Property Address: 27 Old Tatura Rd, Rushworth VIC 3612,
Australia

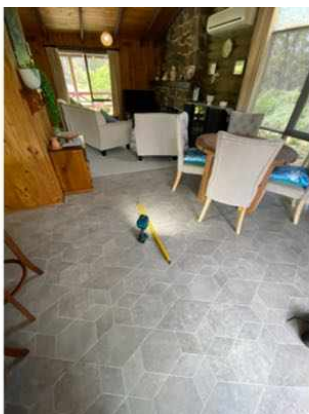
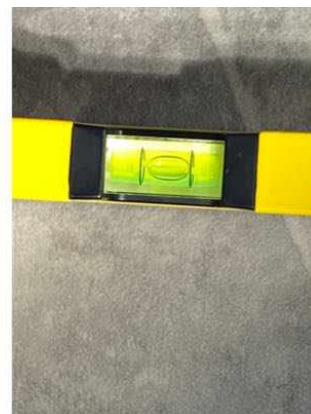
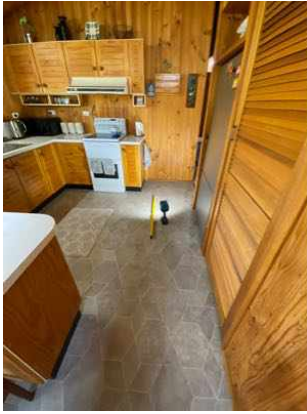
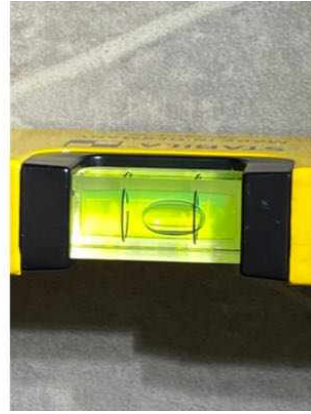
Finding 3.01

Building: Building 1
Location: All Internal Areas
Finding: Flooring - Uneven
Information: The internal flooring in this area is out of level and uneven. Uneven flooring is likely to indicate minor defects such as expected movement of the foundations of the property, but may also indicate subsidence of the associated subfloor stumps.

It is advised that the flooring be closely monitored to identify any further movement. Where flooring remains relatively unchanged for an extended period of time (i.e. several months), it is likely that this defect has been caused by expected movement of the foundations of the property.

However, where flooring is uneven further, potentially invasive inspection of the subfloor structures and stumps in this area is required. In this case, works to repair are likely to be required, and would be carried out by a registered builder specialising in re-stumping.

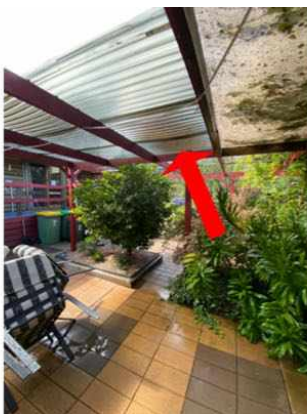
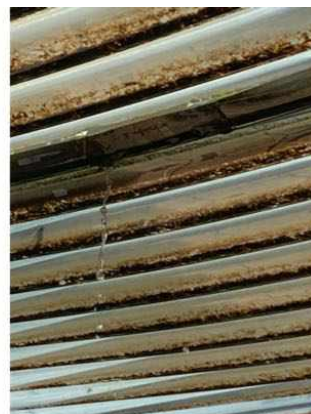
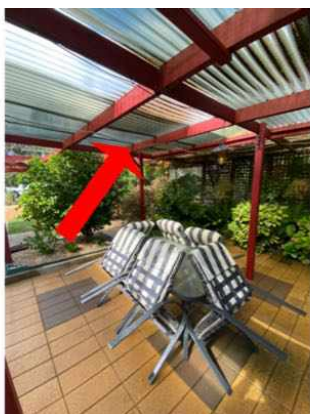
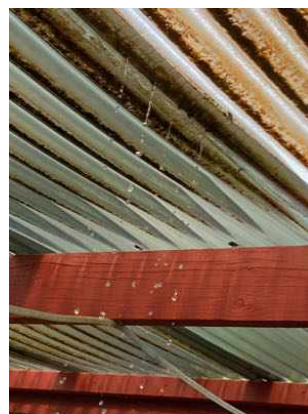
Finding 3.02

Building:	Building 1
Location:	Alfresco
Finding:	Exterior roof- Leaking
Information:	Active roof leaks were evident at the time of inspection. Roof leaks can have a number of causes, including damage to roof coverings, deterioration of roof fixtures and fittings, or loosely associated materials (fascias etc.).

Where water leaks are active, rain penetration is likely to cause water damage to associated structures and building elements in this area, which can have a range of implications. If left unmanaged, the development of major structural damage to the roofing and associated structures may occur.

In this case, it may be that the grade of the roofing sheets should be increased and re attached. This will improve the structure and drainage of the alfresco area. A roofing plumber or handyman should be contacted soon to complete these works. Improvements will prevent further deterioration.

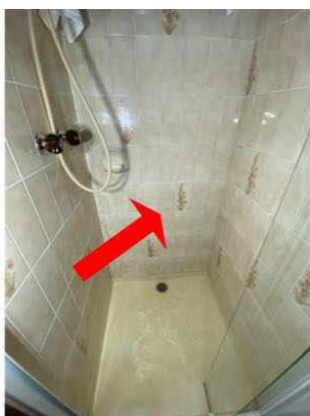
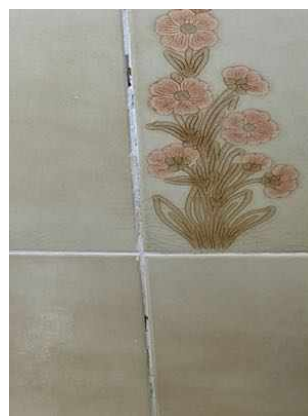
Finding 3.03

Building:	Building 1
Location:	Bathroom
Finding:	Inadequate sealant or Grout
Information:	This area has a lack of effective Sealant or Grout. This is allowing the ingress of water to the structure inside the wall.

The presence of water encourages Termite attack, Mould and Fungal Decay.

A Tiler or General Handy person must be contacted as soon as possible to effect repairs and prevent further deterioration.

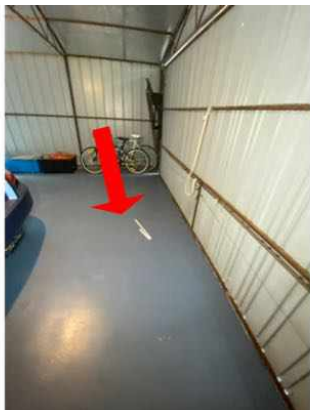
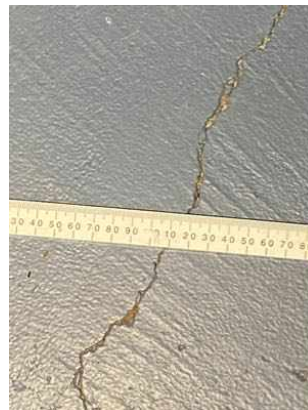
Finding 3.04

Building:	Building 1
Location:	Garage
Finding:	Crack in concrete slab - Category 1
Information:	A crack coded as Category 1 was identified in the slab. A Category 1 crack is described as a fine but noticeable crack, with the slab at an otherwise reasonable level.

To be considered Category 1, the approximate width of the crack is less than 1.0mm, or a less than 10mm change in offset when a 3m straight edge is placed over the

defect.

Category 1 cracks should be monitored for a period of 12 months. At the end of the monitoring period, identified cracks that are rated greater than Category 2 are considered defects, and require rectification.

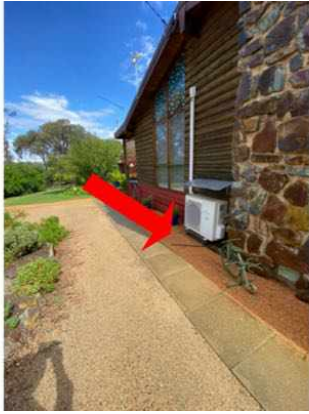
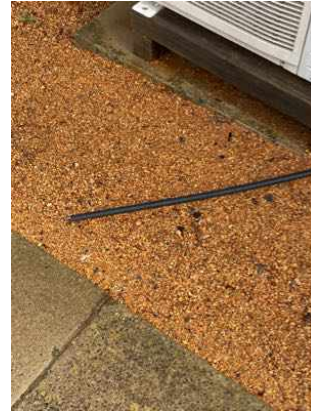
Finding 6.01

Building: Building 1
 Location: Yard - Side
 Finding: Air conditioner - Disconnected overflow
 Information: The Air Conditioner (A/C) overflow was found to be disconnected from storm water drainage and is creating excessive moisture in the surrounding area.

Such leaking creates an environment which is conducive to an array of defects, including water damage to associated building elements and the attraction of termite or timber pest infestation.

It is highly recommended that a licensed plumber be appointed to connect the A/C overflow in order to prevent such an environment from being created. These minor works should be carried out as soon as possible.

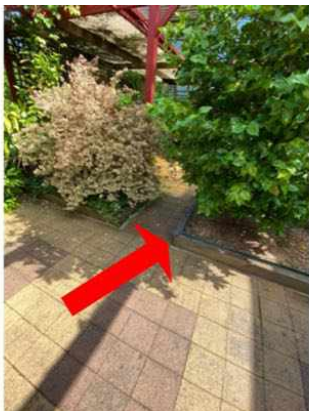
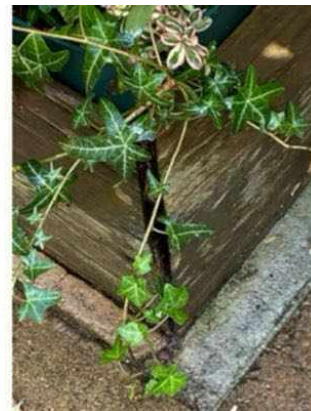
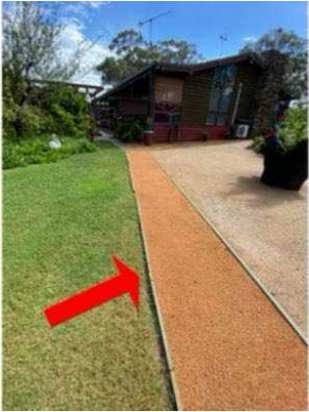
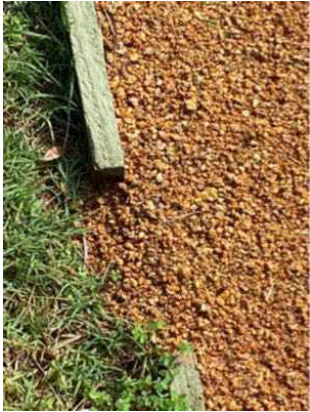
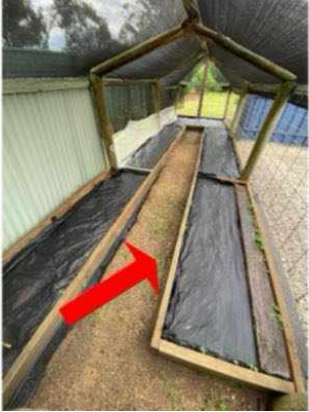
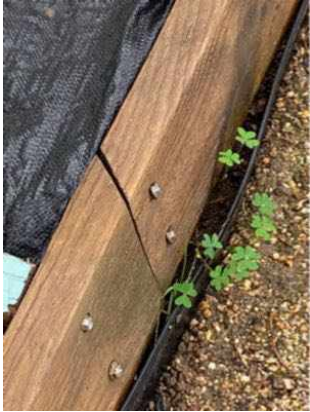
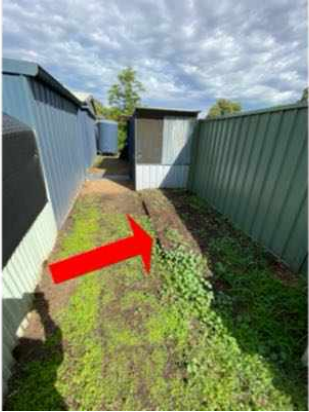
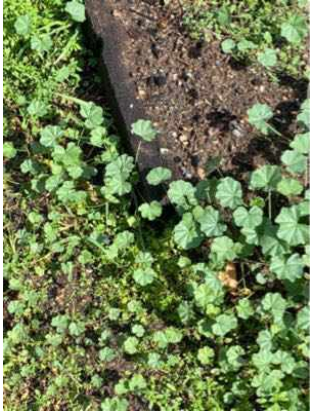
Finding 6.02

Building:	Building 1
Location:	Yard- back, front, side
Finding:	Untreated or non-durable timbers in a hazardous environment
Information:	To reduce the risk of timber pest attack it is essential that timber used in a hazardous environment (e.g. in direct contact with the ground or frequently exposed to damp conditions) is of sufficient durability and/or is adequately preservative treated.

Untreated timbers in direct contact with the ground are likely to develop severe wood rot and/or fungal decay if left unattended creating attraction for subterranean termites to infest the timbers from surrounding areas.

If untreated or non-durable timbers are found to be in a hazardous environment it is highly advised that replacement of these building elements be performed as soon as possible to aid the protection of the property against termite / timber pest attack.

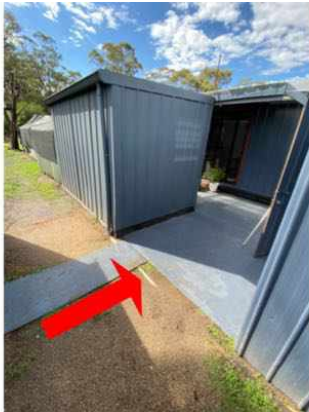
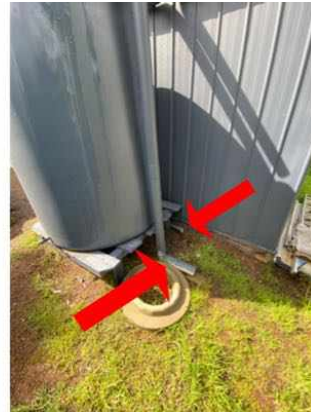
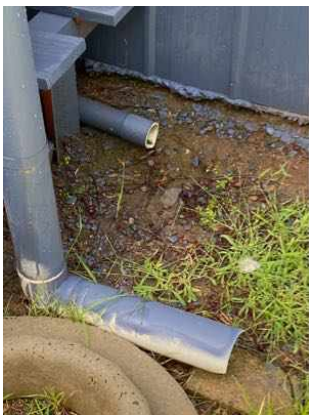
Finding 6.03

Building: Building 1
 Location: Garage area
 Finding: Stormwater drain - Not connected
 Information: The roof plumbing is not adequately connected to stormwater drainage on the site. This disconnection negatively impacts the functional capacity of the roof plumbing.

Where roof plumbing doesn't drain adequately, the area at the base perimeter can become excessively damp, potentially creating an environment that is susceptible to rust and corrosion of surrounding building elements, as well as attracting termites and other pests.

It is highly recommended that a plumber be appointed to further inspect the area and to install adequate drainage equipment where necessary.

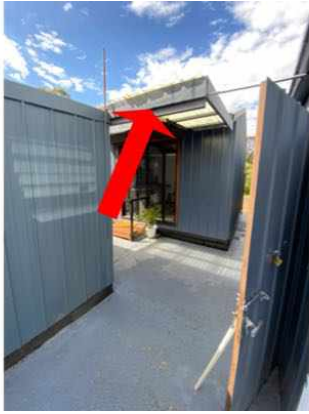
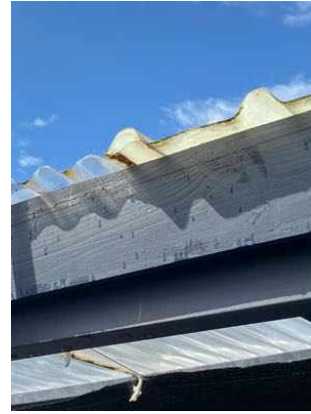
Finding 6.04

Building:	Building 1
Location:	Bungalow
Finding:	Guttering Missing
Information:	The Guttering in this area was missing at the time of inspection. Guttering, Downpipes and Stormwater drainage are vital to protect the integrity of the structure and to prevent an environment conducive to Timber Pest attack.

A Plumber should be contacted as soon as possible to replace and connect to drainage the missing Guttering.

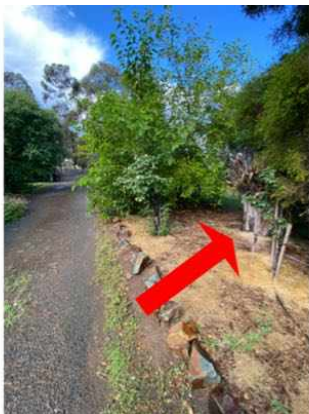
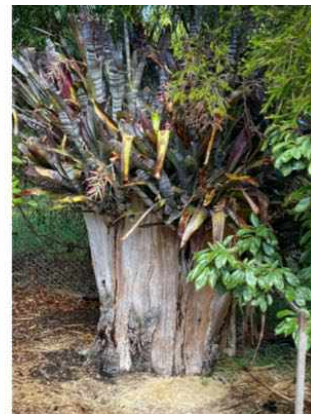
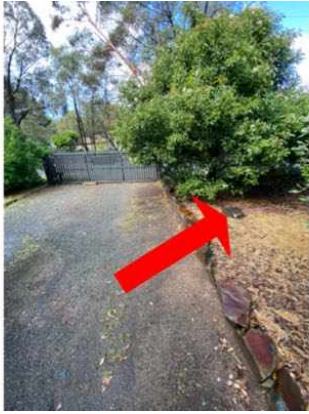
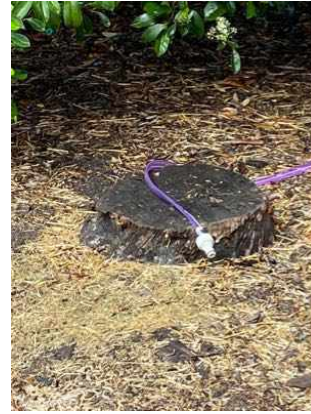
Finding 6.05

Finding: Tree Stump in Ground

Information: Any tree stumps in the yard not removed during the tree removal process provides the opportunity for Termite infestation and is likely to be subject to decay from damp conditions against the stump.

All tree stumps should be removed by professional tree removal services where possible. Meanwhile regular inspections are advised to identify any termite activity in the areas identified.

Services for tree stump removal should be contacted as soon as possible to reduce the risk of timber pest attack.

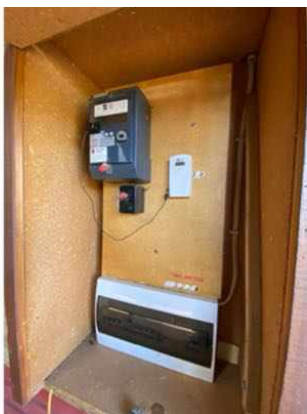
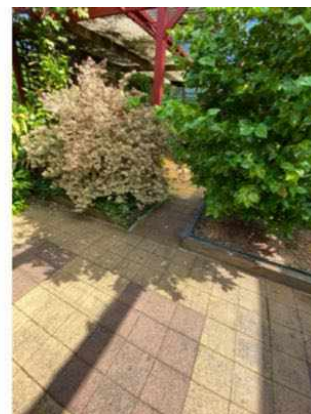
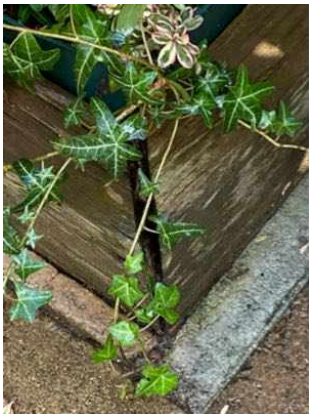
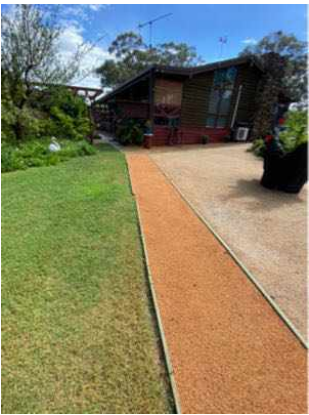
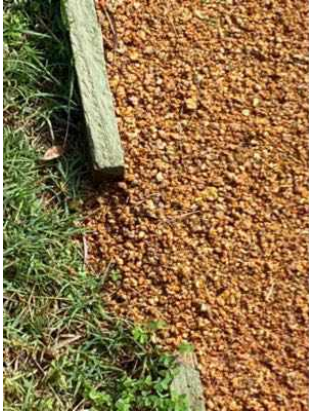
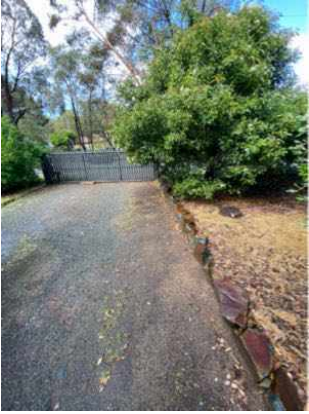
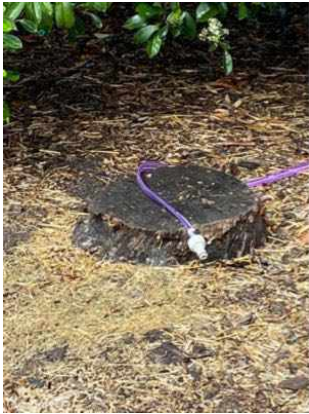
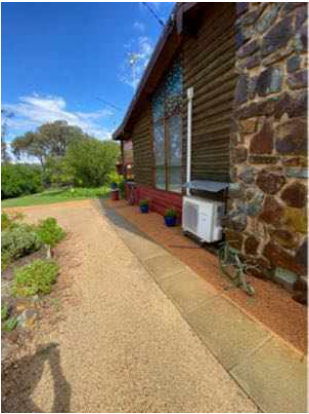
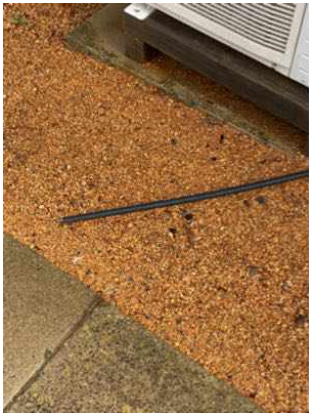
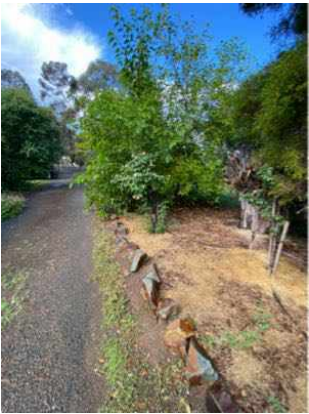
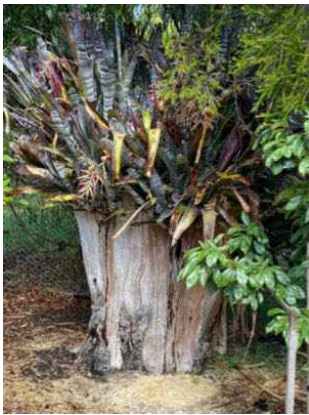
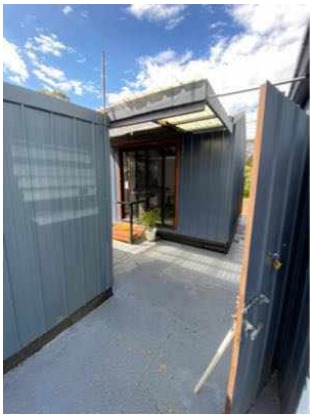
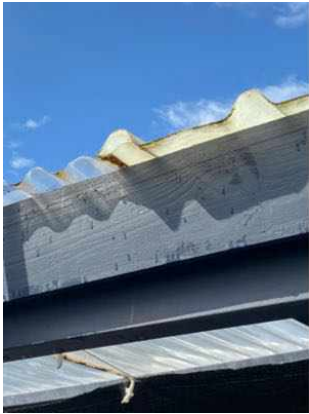
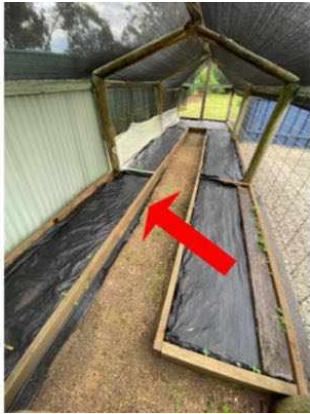
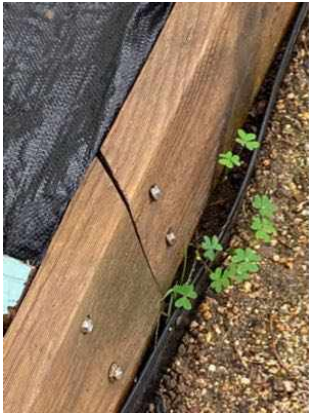
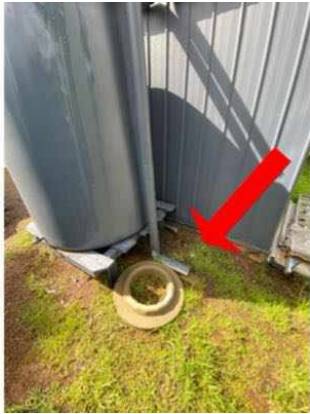
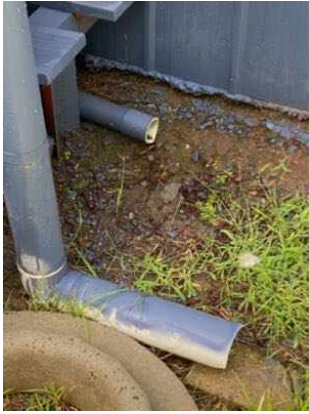
Finding 6.06

Building:	Building 1
Location:	All External Areas
Finding:	Termite Management System - no evidence of a chemical installation
Information:	The application of a post-construction chemical termite barrier is highly recommended for all properties, particularly if live termite activity has been found on the site previously. Such barriers are highly effective in preventing termite attack on any timber building elements throughout the property.

A durable notice should be placed in the switchboard unit to indicate current termite barriers. At the time of inspection, it appeared as though no termite management system has been installed, with no evidence to suggest preventative works taking place.

The client may consider gaining further advice from a pest controller as to the costs and procedures involved with this application. It is recommended that obtaining such advice be a short-term priority.

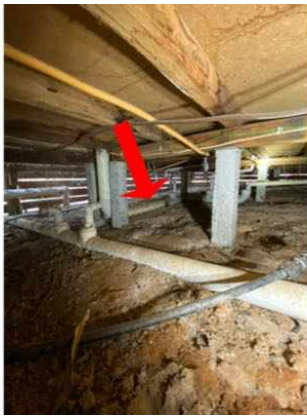
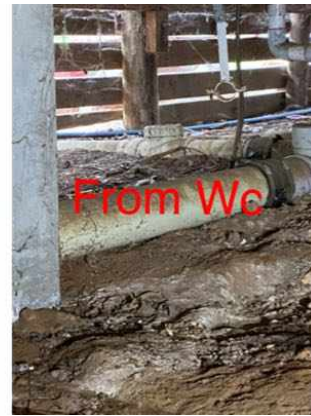
Building: Building 1
 Location: Subfloor
 Finding: Wc drain
 Information: This plumbing element appears to be running up hill. The grade is sloping back toward the Wc pan.

No action is needed at this point. If blockage or any toilet drainage problems occur, a plumber should be contacted to improve the drain and bring the element back to compliance.

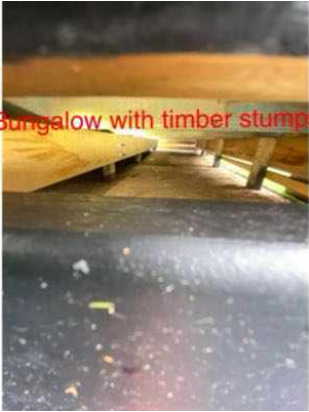
Bungalow with timber stumps

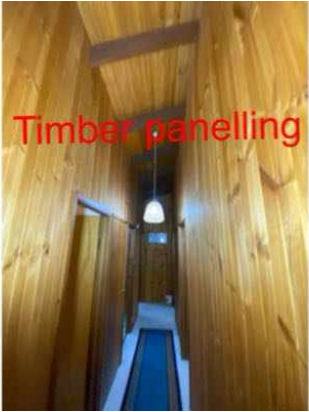
Timber panelling
