# Building and Timber Pest Inspection Report

Inspection Date: Thu, 15 Jan 2026

Property Address: 10 Yarrow Ct, Redbank Plains QLD 4301,  
Australia

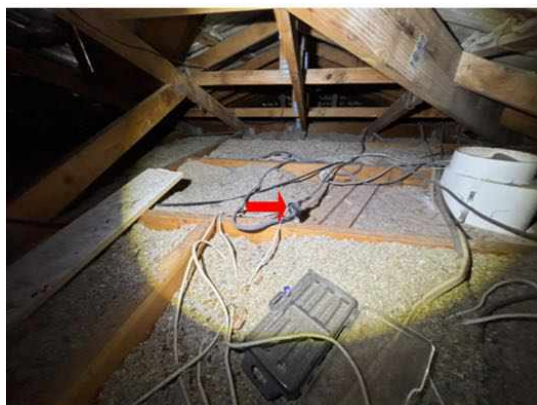
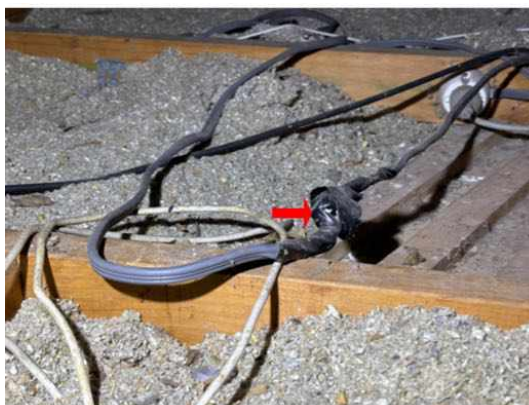
#### Finding 1.01

Building:	Main Building
Location:	Roof Void
Finding:	Electrical junction box - Missing
Information:	At the time of the inspection, it was noted that an electrical cable in the roof void near the manhole has not been terminated in a junction box.

It could not be determined if the wire is live at the time of the inspection, and as such should be treated as if it is live. Junction boxes provide a second insulation barrier to adequately seal off and protect the wires, increasing the safety of the immediate environment and ensuring that the wiring is not damaged.

The absence of junction boxes poses as an electrical safety hazard, providing risk of electrocution. It appears as though wiring in this area has been completed to a substandard level of workmanship, evidenced by the lack of adequate wiring protection.

An electrical cable join in the roof void is not encased in a junction box.

Appointment of a licensed electrician is highly advised to provide additional information on the risks of unprotected wiring and to install junction boxes and any other elements as required. Such works should be carried out as a matter of urgency; until this time, any persons within this area should exercise a high level of caution.

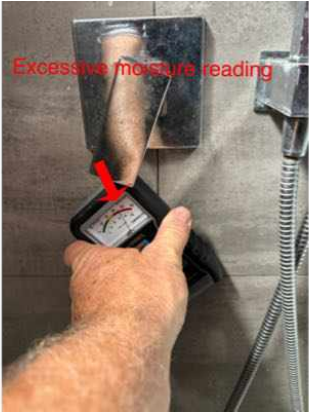
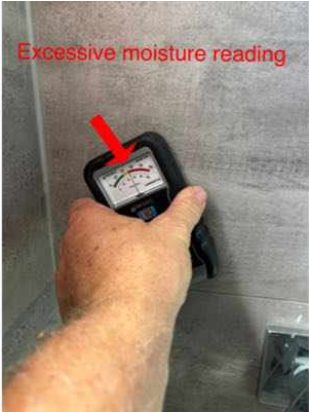
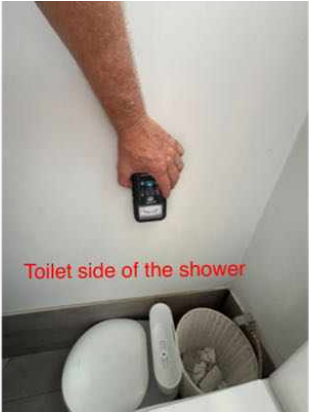
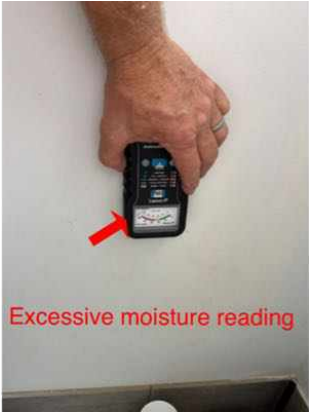
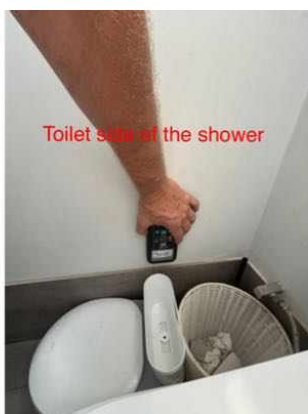
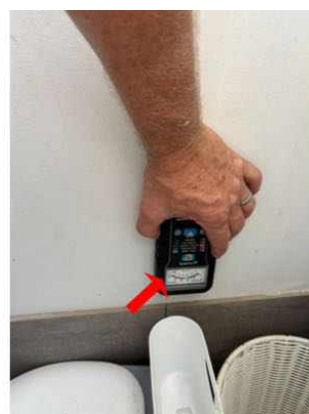
#### Finding 2.01

Building:	Main Building
Location:	Bathroom

Finding: Bathroom - excessive moisture readings

Information: At the time of the inspection, it was noted that excessive moisture readings were recorded on the shower wall and on the toilet side of the shower wall. The evidence suggests that there may be an issue with the water proofing membrane which may be allowing moisture to enter the wall cavity.

Moisture in the wall cavities can create a conducive environment for termite activity and can cause undetected deterioration of the associated building materials. An invasive inspection, may be required in order to confirm the source of the excessive moisture readings and to determine if any damage has occurred in the wall cavity.

Excessive moisture levels were recorded on the shower wall and on the toilet side of the shower wall. This indicates a failure of the waterproofing membrane. A bathroom specialist needs to address this as a matter of urgency.

A bathroom specialist should be engaged to assess the shower and provide a solution for this issue. A repair may include replacing the grout and sealing the wall and floor tiles in the shower cubicle. This should be done as a matter of urgency.

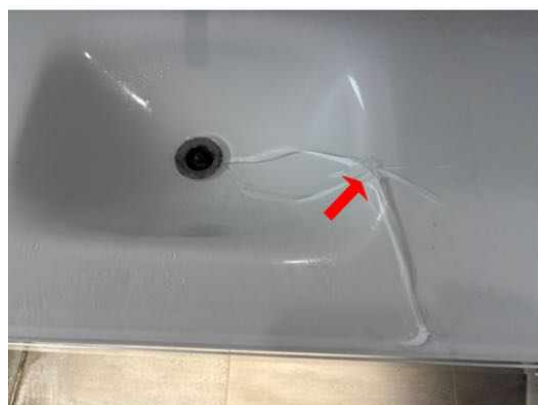
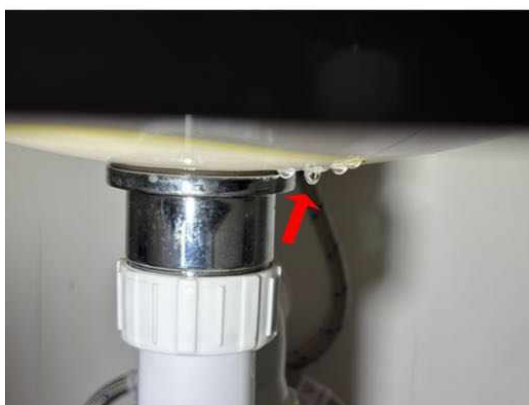
### Finding 3.01

Building: Main Building  
 Location: Bathroom  
 Finding: Bathroom - glass vanity top cracked  
 Information: At the time of the inspection, it was noted that there was a crack to the glass vanity top. Water is leaking through this crack into the body of the vanity cabinet. This appears to be impact damage.

If left unaddressed, damage will occur to the vanity cabinet.

A bathroom specialist should be engaged to replace the glass vanity top. This should be done as a matter of urgency.

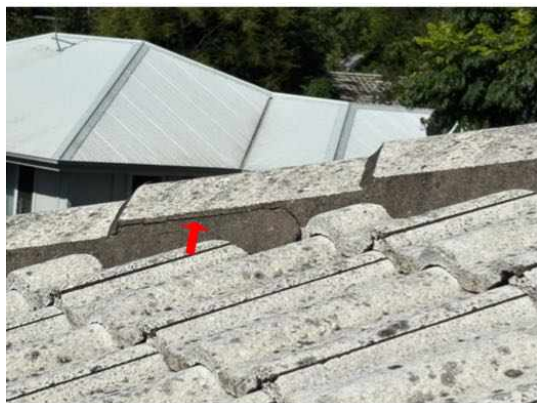
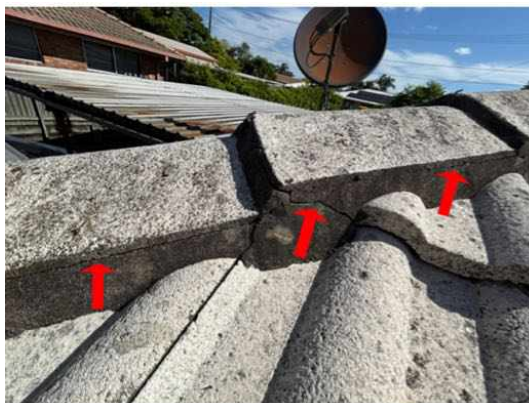
### Finding 3.02

Building: Main Building  
 Location: Roof Exterior  
 Finding: Roof tiles - Weathered  
 Information: Upon inspection of the exterior roofing, the majority of roof tiles were considered to be

in a fair condition. While weathering of the tiles is consistent with the age of the property, maintenance works may be required.

Minor cracking was noted to some sections of the ridge cap mortar.

Where left unmanaged, deteriorating roof tiles are likely to lead to a number of secondary defects, including minor water leaks and weather exposure to internal roofing structures.

Re-pointing and re-sealing the may be considered as an interim solution by the client to help preserve and extend the life span of the tiles.

Consultation with a roofing contractor is highly advised to gain advice on cost of remedial works that may be required in the short to medium term. Remedial works are likely to increase the longevity of the exterior roofing structure.

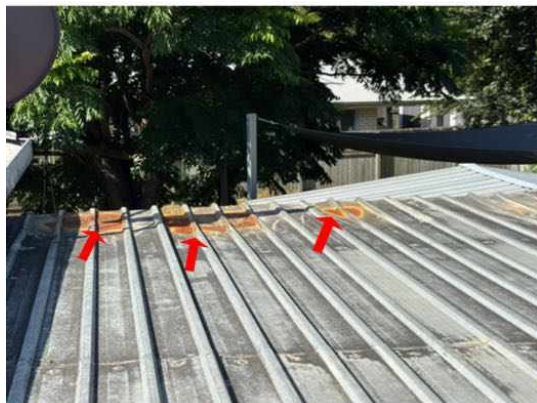
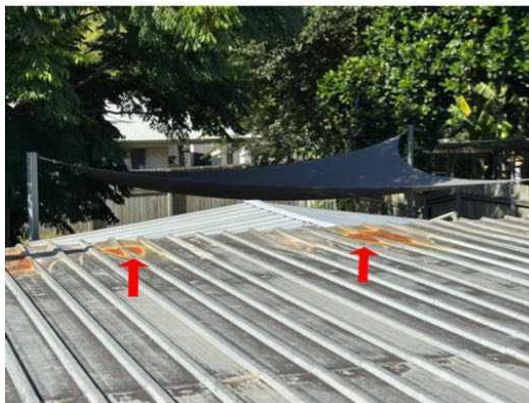
### Finding 3.03

Building:	Main Building
Location:	Carport roof
Finding:	Carport - metal roof rusting
Information:	At the time of the inspection, it was noted that there were several areas of rust on the metal carport roof. The rust has caused holes in the carport roof which appear to have had sealant applied to them.

A roofing contractor could be engaged to replace the carport roof. This can be done at the clients discretion.

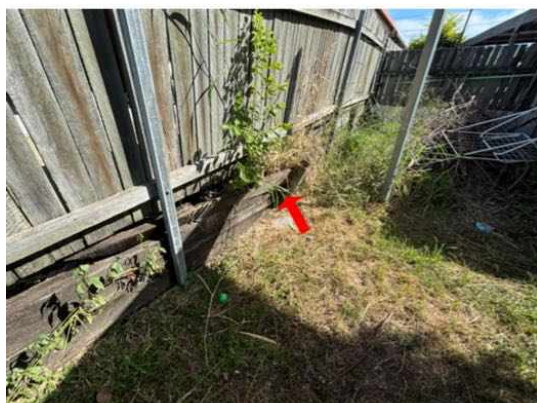
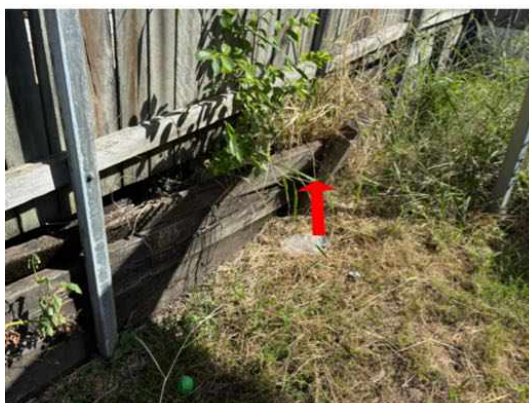
### Finding 3.04

Building: Main Building  
 Location: Side yard  
 Finding: Side yard - retaining wall deterioration  
 Information: At the time of the inspection, it was noted that the small retaining wall on the right hand side of the dwelling has deteriorated and as a result is leaning over.

A retaining wall specialist could be engaged to replace this retaining wall. This can be done at the clients discretion.

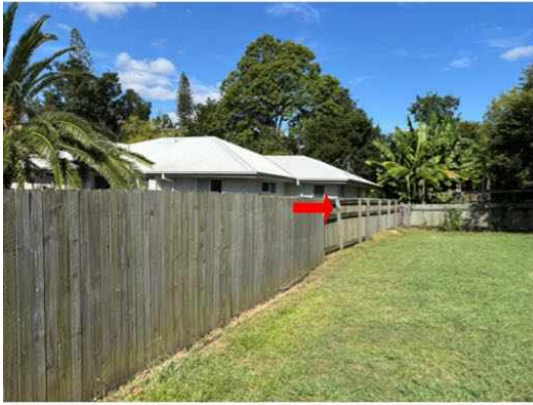
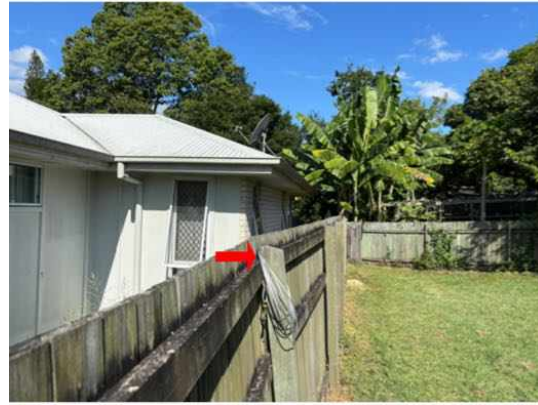
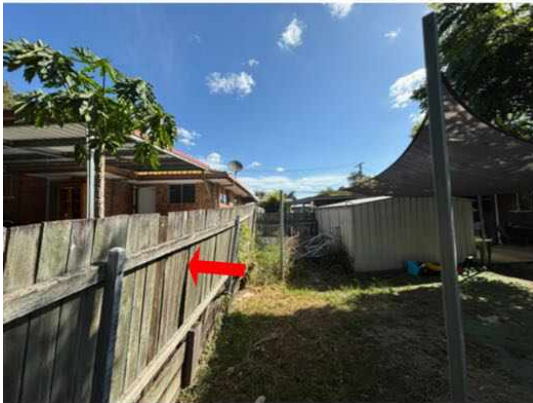
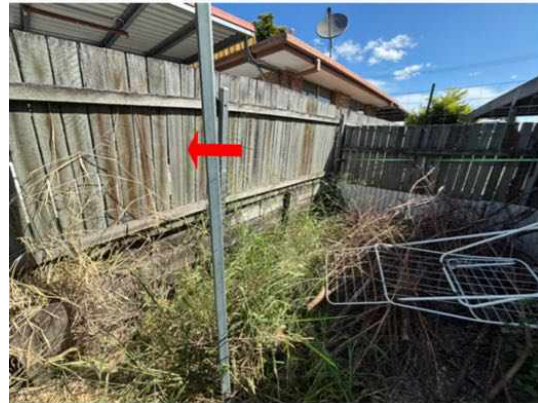
### Finding 3.05

Building: Main Building  
 Location: Back yard  
 Finding: Boundary fences - deteriorating  
 Information: At the time of the inspection, it was noted that the side and rear timber boundary fences were deteriorating. The rear fence is leaning into the neighbours yard. A section of the right hand side is leaning into the yard. The fences are currently upright.

A fencing contractor should be engaged to assess the fences and provide a solution to rectify this issue. This can be done at the clients discretion.

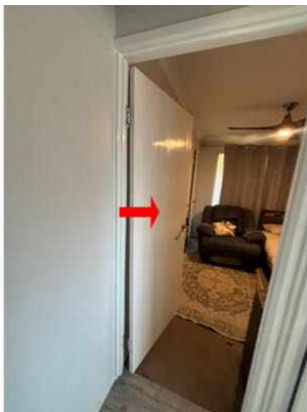
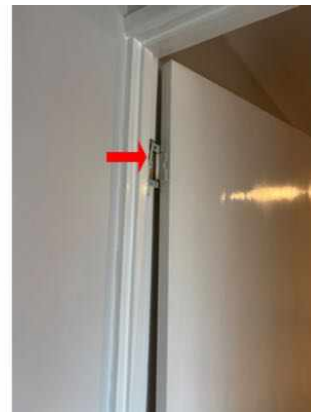
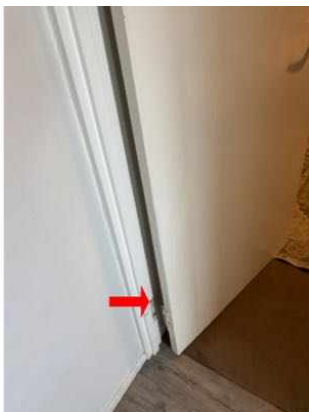
### Finding 3.06

Building: Main Building

Location: Bedroom 1

Finding: Bedroom 1 - door loose

Information: At the time of the inspection, it was noted that the hinged door to bedroom 1 was not secured to the door frame. Screws are missing from the hinges. The functionality of the door is affected.

A building maintenance professional could be engaged to re-attach the door. This can be done at the clients discretion.

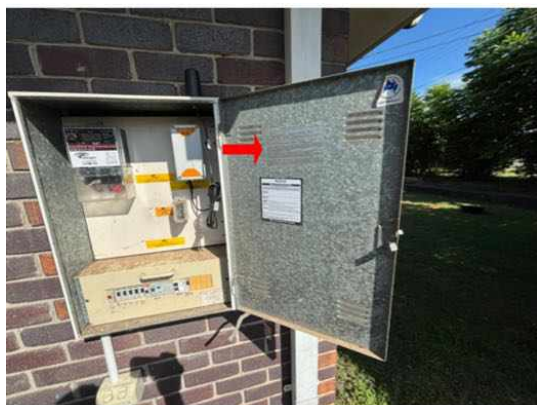
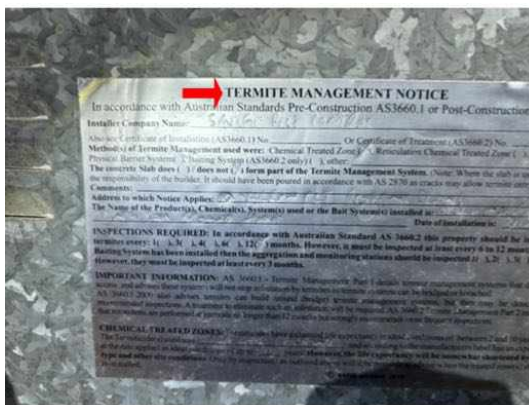
### Finding 6.01

Building:	Main Building
Location:	All External Areas
Finding:	Termite Management System - no evidence of a current chemical installation
Information:	At the time of the inspection, no evidence of a current chemical termite management system was found. There is a durable notice in the meter box showing a chemical treatment was carried out on the 31/01/2014 with an expected lifespan of 5-8 years. This treatment will no longer be effective.

A durable notice should be placed in the switchboard unit to indicate current termite barriers. At the time of inspection, it appeared as though no termite management system has been installed, with no evidence to suggest preventative works taking place.

Evidence of a past chemical termite treatment system was found during the inspection. A durable notice was found in the meter box. A chemical termite barrier was installed to the perimeter of the dwelling. The durable notice is dated the 31/01/2014. This treatment had an expected lifespan of 5-8 years and will no longer be effective. The chemical barrier is a drill and inject and trench installation. No record of annual termite inspections having been carried out was found onsite.

The application of a post-construction chemical termite barrier is highly recommended for all properties, particularly if live termite activity has been found on the site previously. Such barriers are highly effective in preventing termite attack on any timber building elements throughout the property.

The client may consider gaining further advice from a pest controller as to the costs and procedures involved with this application. It is recommended that obtaining such advice be a short-term priority.

A termite treatment system and annual termite inspections are an important part of an ongoing termite management plan.

A termite and timber pest technician must be engaged to provide a suitable termite treatment system to suit this style of building. This needs to be done as a matter of urgency.

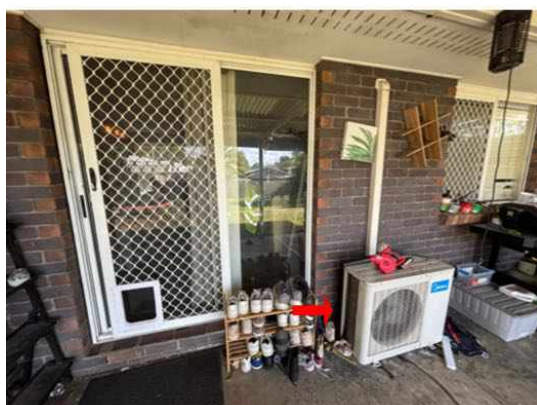
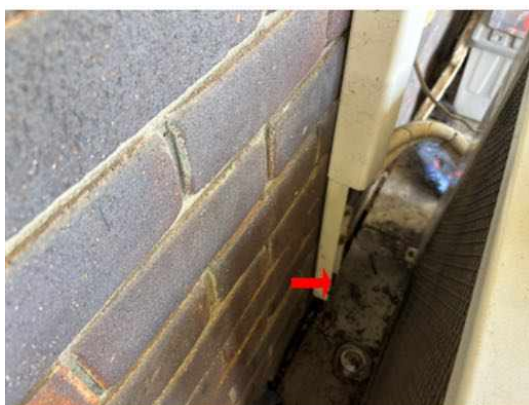
### Finding 6.02

Building: Main Building  
 Location: Rear elevation  
 Finding: Air conditioner - Disconnected overflows  
 Information: At the time of the inspection, it was noted that the air conditioner drain overflows to the unit at the rear of the dwelling was not connected to the storm water drainage and as a result are draining next to the foundations of the dwelling.

Air conditioning overflows that are not connected to the storm water drainage and are draining near the foundation can create excessive moisture in the surrounding area.

Such leaking creates an environment which is conducive to an array of defects, including water damage to associated building elements and the attraction of termite or timber pest infestation.

It is highly recommended that a licensed plumber be appointed to connect the A/C overflow in order to prevent such an environment from being created. These minor works should be carried out as soon as possible.

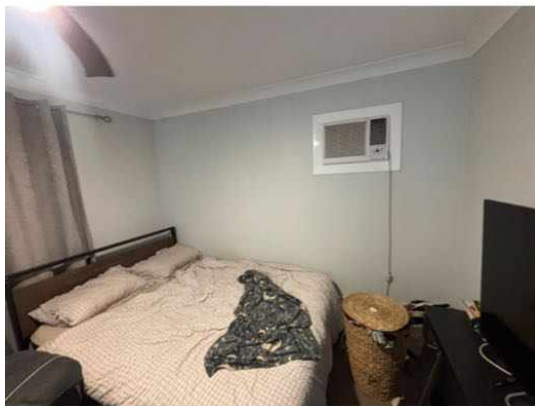
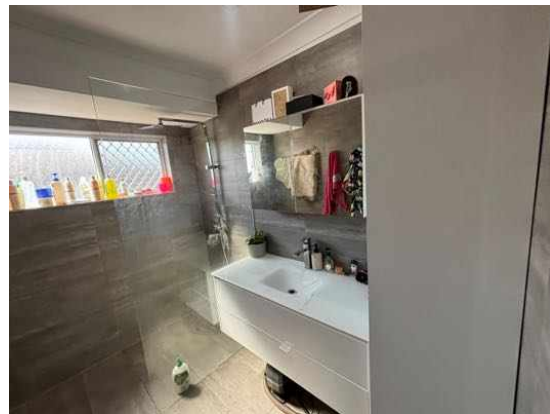
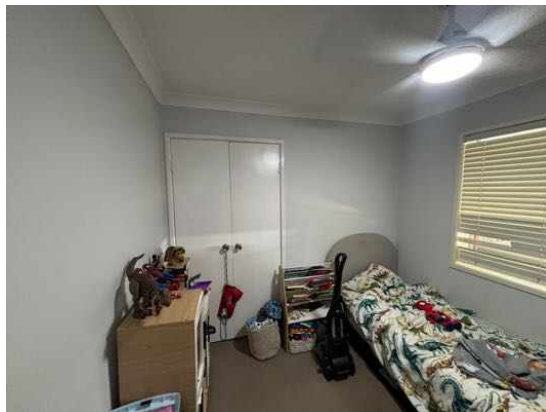
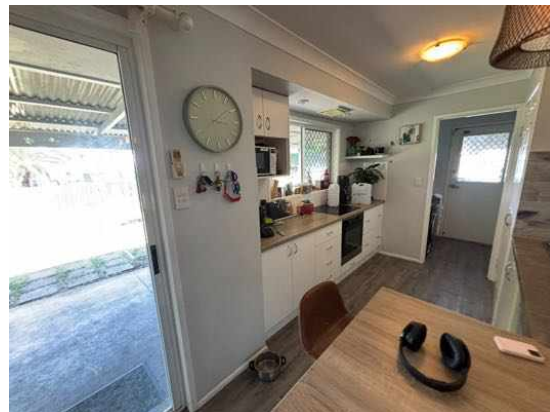
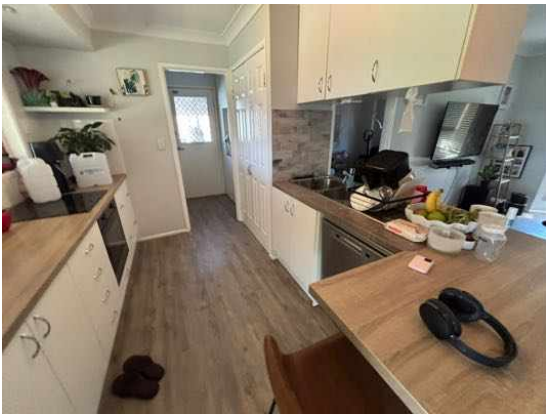
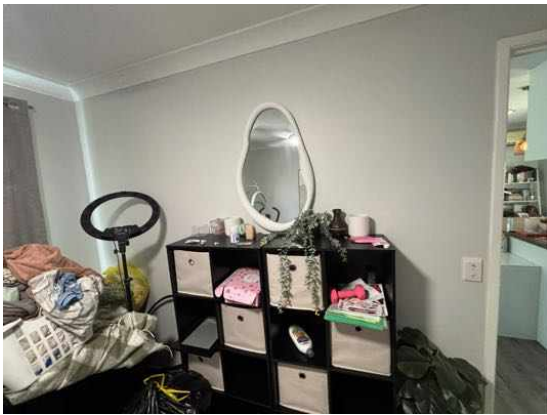
#### Noted Item

Building: Main Building  
Location: All Internal Areas  
Finding: Obstructions and Limitations - Internal areas  
Information: These photographs are an indication of the obstructions and limitations which impeded full inspection of the property of the internal areas at the time of inspection. These obstructions can hide an array of defects and should be removed to allow full inspection to be carried out. A re-inspection is recommended once the areas are made accessible.

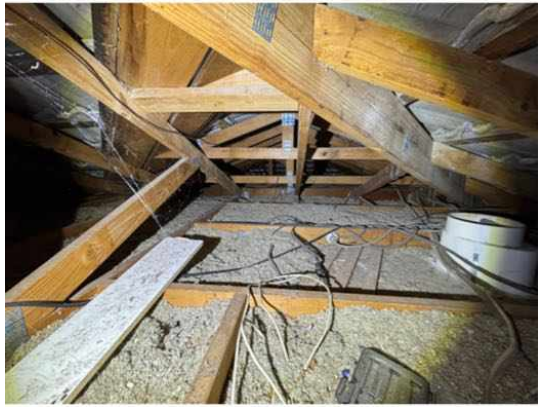
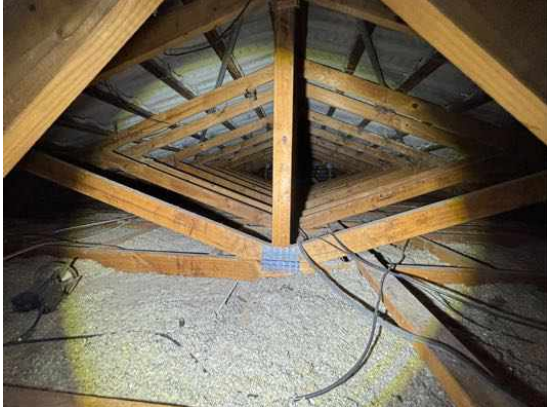
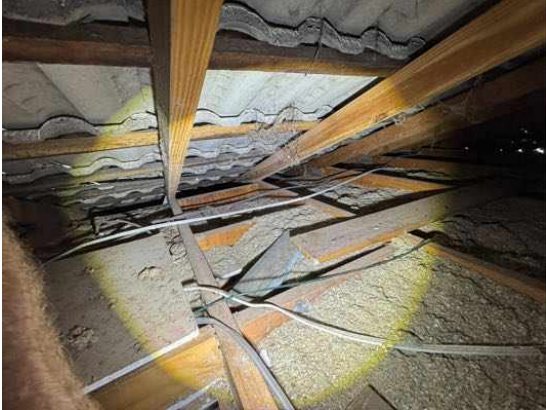
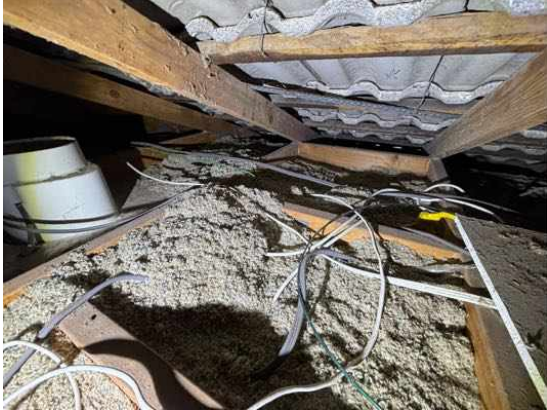
**Noted Item**

Building: Main Building  
Location: Roof Void  
Finding: Obstructions and Limitations - Roof cavity  
Information: These photographs are an indication of the obstructions and limitations which impeded full inspection of the property of the roof cavity

at the time of inspection. These obstructions can hide an array of defects and should be removed to allow full inspection to be carried out. A re-inspection is recommended once the areas are made accessible.
