Building and Timber Pest Inspection Report

Inspection Date: Thu, 15 Jan 2026

Property Address: 4/16 Baudin Ave, Shell Cove NSW 2529, Australia

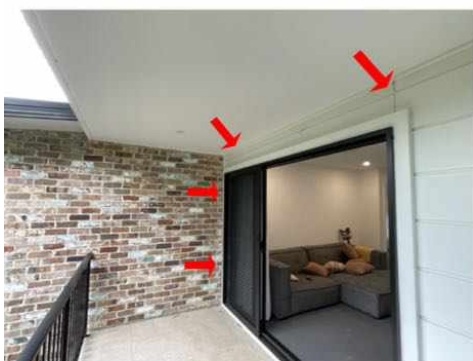
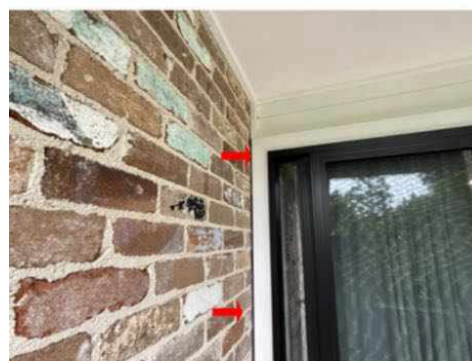
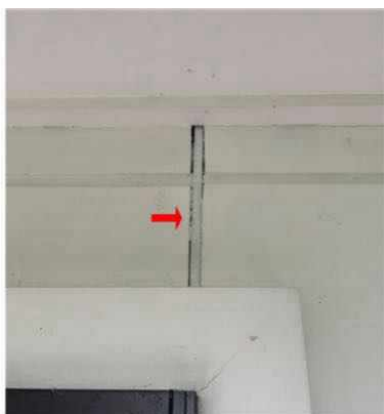
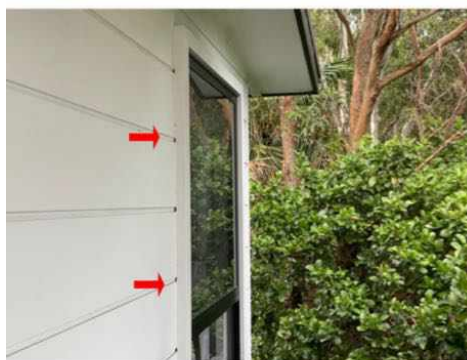
Building: Building 1
Location: Exterior rear walls
Finding: Sealant (external) - missing
Information: It was noted on inspection that areas of external sealant was missing to small areas of the external walls.

Flexible sealants should be applied to these affected areas to prevent any subsequent water damage that is likely to occur.

A sealant specialist or skilled handy person should be appointed to complete these works as soon as possible

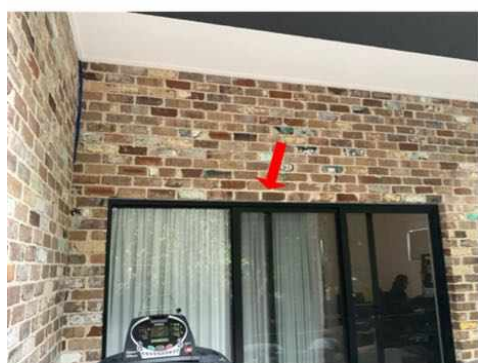
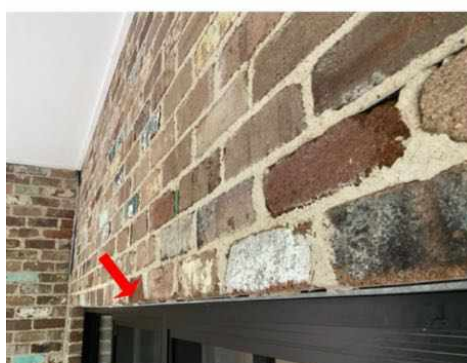
Finding 3.02

Building:	Building 1
Location:	Rear verandah lintel
Finding:	Door lintel with minor bowing
Information:	This lintel shows very minor bowing. Horizontal bowing is caused by lack of resistance to vertical pressures from upper floors and brickwork walls.

This lintel should be monitored annually for any further bowing or movement. If further bowing occurs, a registered builder should be appointed to perform remedial works.

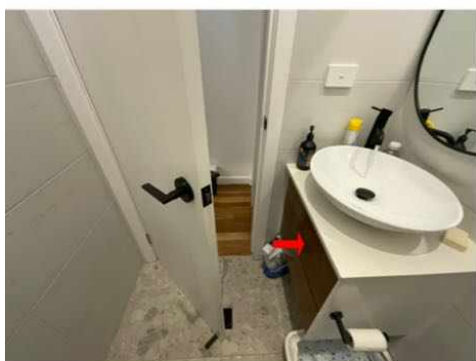
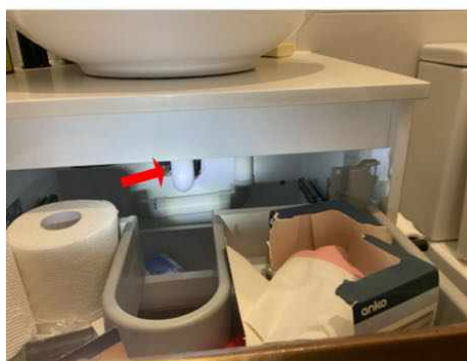
Finding 3.03

Building:	Building 1
Location:	Bathroom, laundry, toilet
Finding:	Waterproofing membranes
Information:	No waterproofing membrane was evident behind the lower toilet vanity pipes. The Aust standard AS3740 state "Penetrations (e.g., toilet pan screws, pipe penetrations) must be fully sealed". A sealant expert or licensed plumber should seal around these vanity pipes in the near future.

With older property's where this information is unavailable all wet areas should be monitored. If any leaks, water staining, peeling or bubbling of the paint become evident to any adjacent walls or ceilings below a licensed builder or waterproofing specialist is recommended to investigate further.

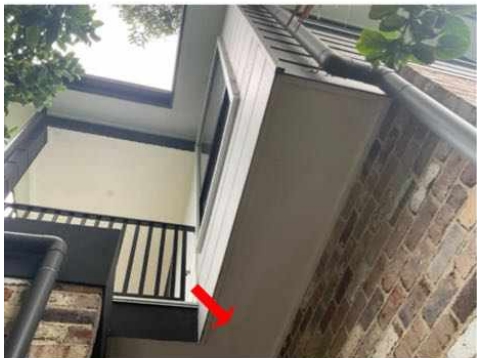
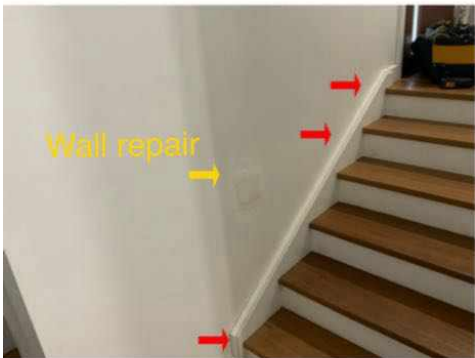
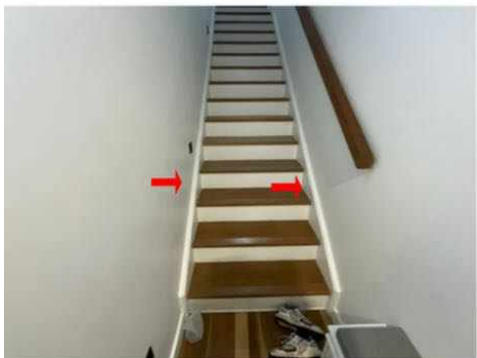
Finding 3.04

Building:	Building 1
Location:	Rear verandah, stairs and other small areas
Finding:	Cracking - Damage Category 1 - Fine (up to 1mm)
Information:	Although fine cracks are quite noticeable, they are often only considered to be an appearance defect, and usually do not indicate any structural damage. Generally, the cause of a fine crack is indicative of a separation between building materials and finishes (e.g. paint, plaster, etc.) along joints.

Cracking of this nature can generally be repaired with minor sanding, filling and/or repainting. Such works should be performed by a qualified painter or a general handyman.

Monitoring of all cracking should be conducted frequently. Always contact a building inspector should cracks widen, lengthen, or become more numerous.

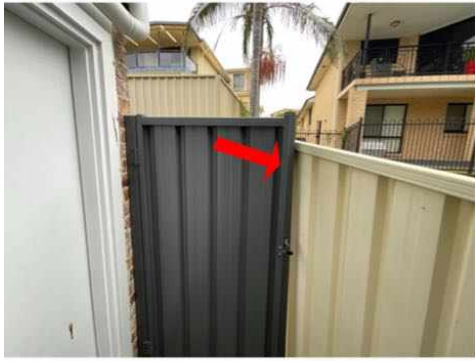
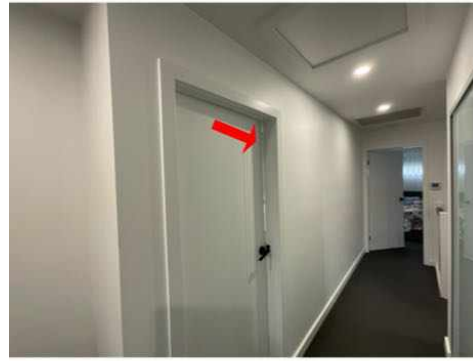
Finding 3.05

Building: Building 1
Location: Rear of house and upper middle bedroom
Finding: Gate and door - Binding/jamming
Information: Binding of this gate and door was evident during standard operation. This defect inhibits the functionality of these areas making them hard to operate.

A gate or door that binds usually occurs as a result of minor movement of the post/fence or deteriorated hinges.

A qualified carpenter or general handyperson should be appointed to perform rectification works at client discretion.

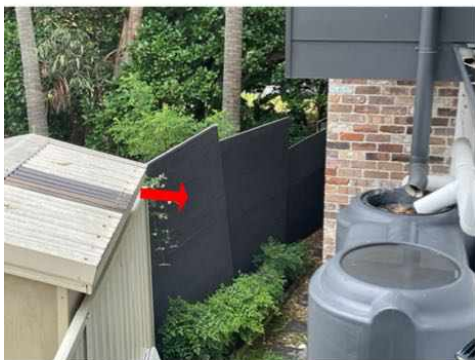
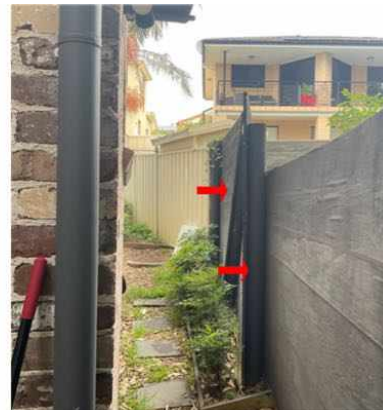
Finding 3.06

Building:	Building 1
Location:	Rear of house
Finding:	Fence damaged - leaning
Information:	Evidence of damage to the fence was identified at the time of the inspection. The likely cause is not enough concrete used in the post footings.

If left unmanaged this fence may deteriorate further. It is suggest a licensed builder or fencer be engaged for rectification when convenient.

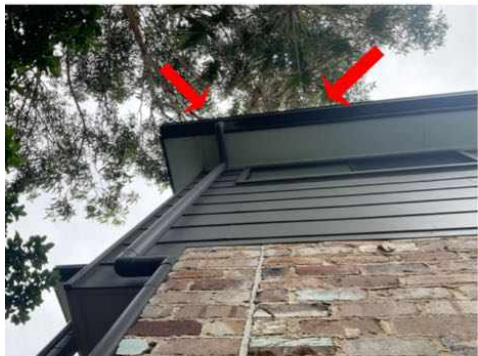
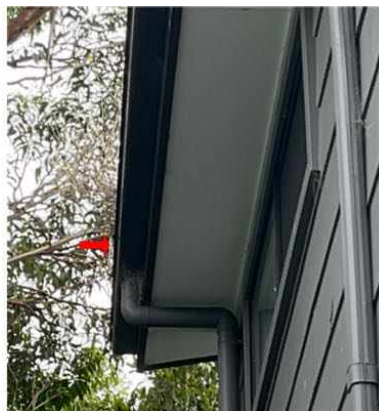
Finding 3.07

Building:	Building 1
Location:	Roof exterior
Finding:	Gutters - Full and blocked
Information:	The guttering on around the roof was found to be blocked at the time of the inspection. Roof plumbing structures, such as guttering and downpipes, should be free of all debris to prevent blockages. Blockages of the guttering and downpipes will lead to pooling and accumulated water overflows, which is likely to subsequently flood eaves and exterior walls.

Blocked gutters are likely to lead to high levels of moisture in the affected areas which

can cause rust and decay of the gutters and downpipes and wood rot to adjoining timber areas. Blockages in gutters should therefore be removed immediately to ensure dry conditions are maintained.

It is highly advised that gutters be cleaned by the homeowner or a general handyperson as a matter of urgency.

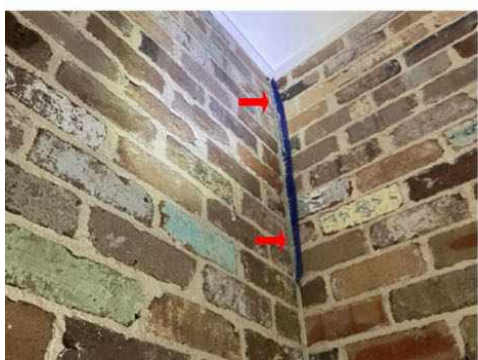
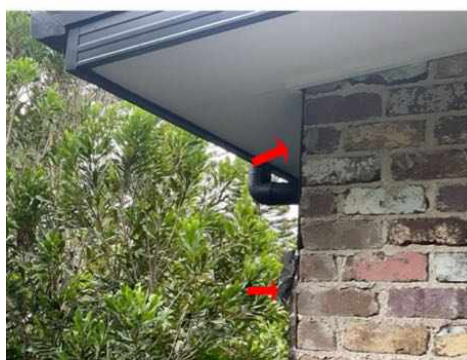
Finding 3.08

Building: Building 1
 Location: Rear verandah and lower toilet window areas
 Finding: Unfinished construction
 Information: The construction of the rear walls and lower toilet window appears to be incomplete. These external areas of flashing need to be trimmed (unless the blue material is a termite barrier which are normally only installed horizontally). The internal toilet upper window paintwork requires finishing.

A Registered Builder or carpenter should be appointed to trim off this material and complete this construction process.

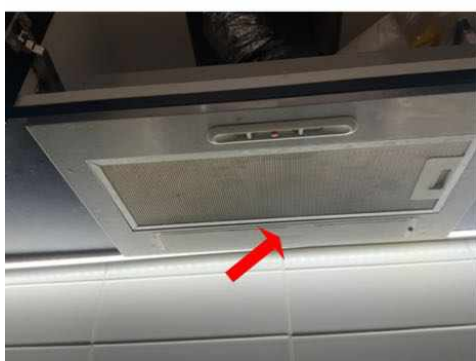
Finding 3.09

Building:	Building 1
Location:	Kitchen
Finding:	Rangehood - Light not working
Information:	While the range hood appears to be working at a satisfactory level, the light to the appliance was not working at the time of inspection.

A licensed electrician should be appointed to replace the light on the range hood to restore it to a fully operational state.

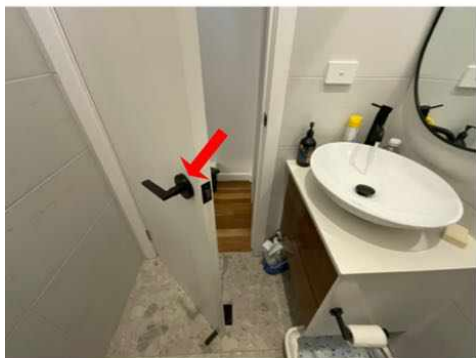
Finding 3.10

Building:	Building 1
Location:	Toilet (WC)
Finding:	Lock - Not working
Information:	The lock in this area was not operational at the time of inspection. Repair or replacement of the lock is highly recommended. Consultation with a locksmith or general handyman is required to gain further advice on any added security that may be available for the area.

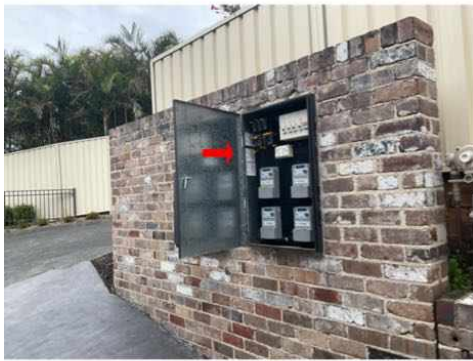
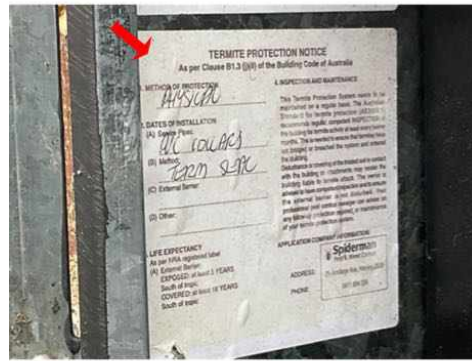
Building:	Building 1
Location:	Meter Box
Finding:	Termite Management System - no evidence of a chemical installation
Information:	The application of a post-construction chemical termite barrier is highly recommended for all properties. Such barriers are highly effective in preventing termite attack on any timber building elements throughout the property.

A durable notice should be placed in the switchboard unit to indicate current termite barriers. At the time of inspection, the durable notice was evident and it appeared as though a physical barrier has been installed, but no chemical termite management system has been installed, with no evidence to suggest preventative works taking place since the property was built.

The client may consider gaining further advice from a pest controller as to the costs and procedures involved with a 'chemical' application. It is recommended that obtaining such advice be a short-term priority.

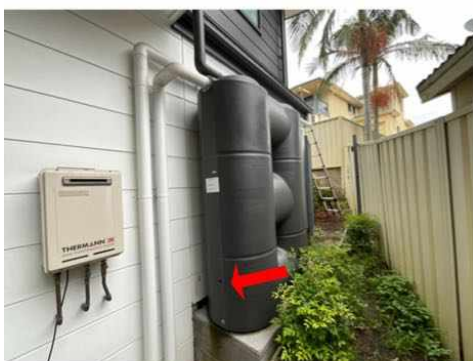
Finding 6.02

Building:	Building 1
Location:	Left walls
Finding:	Bridging - Landscaping
Information:	Where landscaping material obstructs inspection of building elements, also known as bridging as it provides a bridging point for the access of termites, full inspection can not be achieved. Consequently moisture or dampness may be present and the areas becomes conducive to termite activity. Landscaping against or very close to buildings provide cover, shade and can provide an environment that is attractive to termite infestation.

The removal of landscaping material that provide "cover" will assist greatly in preventing Bridging from occurring.

The removal of this material should be carried out if possible and then a reinspection taken place to minimize the risk of termite attack.

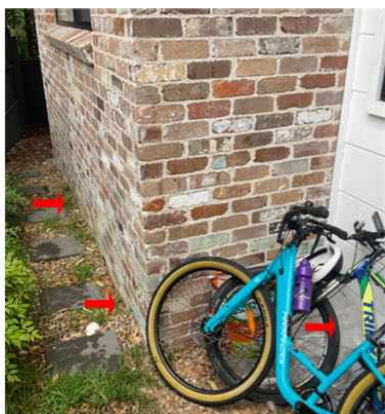
Finding 6.03

Building:	Building 1
Location:	Exterior walls
Finding:	Slab Edge - Exposure

Information: An inspection zone of at least 75mm in relation to the exposed slab is highly recommended. This inspection zone should be maintained in order to force termites into the open where they can be detected more readily during regular inspections. The slab edge should not be concealed by anything that may prevent inspection of the area, including render, landscaping, soil, turf, paving, concrete cladding or other structures.

If the slab edge is not properly exposed there is a high risk of termite attack. Sometimes, in order to determine the type of slab, a suitably qualified person such as an architect or builder may be required to consult the construction plans.

Where the slab edge cannot be properly inspected, it is highly recommended that termite or timber pest inspections be carried out every 6-12 months to aid protection of the property against infestation.

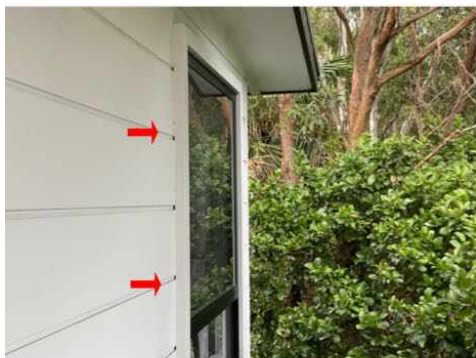
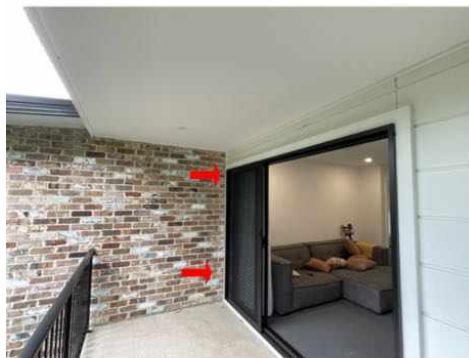
Finding 6.04

Building: Building 1
 Location: Pictured rear area
 Finding: Sealant (external) - missing and attractive to termites
 Information: It was noted on inspection that areas of external sealant was missing to small areas of the external walls. A flexible sealant or flashing is required to protect the associated building materials from rainwater ingress. Any moisture ingress into the property is very attractive to termites. Flexible sealants or flashing should be applied to these affected areas to prevent termite activity.

A sealant specialist or skilled handy person should be appointed to complete these works as soon as possible.

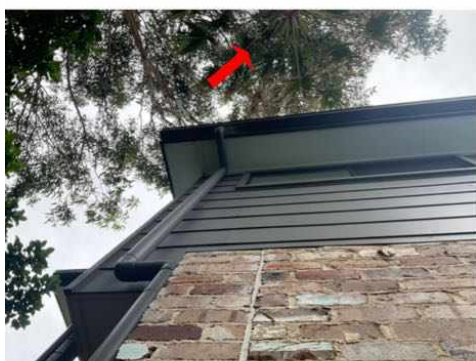
Finding 6.05

Building: Building 1
Location: Roof areas
Finding: Trees - Overhanging and filling gutters
Information: Overhanging trees often result in excessive amounts of leaf debris accumulating in gutters. There are plants now growing in this gutter.

Gutters are a critical part of the building's management of storm water and rain. It is therefore important that they be kept clear to prevent secondary damage to associated building elements, including exterior and interior walls, ceiling linings and any adjoining building elements. Where gutters are blocked, pooling of rainwater is likely to occur, fast-tracking rust and corrosion of the roof plumbing elements.

It is highly advised that all overhanging tree branches be removed as soon as possible to prevent any further damage. Such works should be performed by the homeowner; however, appointment of a landscape contractor or an arborist may be required.

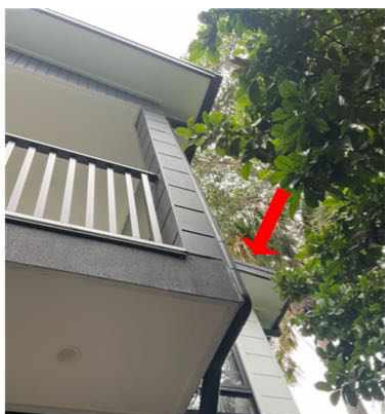
Finding 6.06

Building: Building 1
Location: Roof exterior
Finding: Gutters - Full and blocked

Information: The guttering on around the roof was found to be blocked at the time of the inspection. Roof plumbing structures, such as guttering and downpipes, should be free of all debris to prevent blockages. Blockages of the guttering and downpipes will lead to pooling and accumulated water overflows, which is likely to subsequently flood eaves and exterior walls.

Blocked gutters are likely to lead to high levels of moisture in the affected areas. Such moisture will not only cause rust and decay of the associated building materials, but can also provide conditions that are conducive to termite and timber pest activity. Blockages in gutters should therefore be removed immediately to ensure dry conditions are maintained.

It is highly advised that gutters be cleaned by the homeowner or a general handyperson as a matter of urgency.
