Building Inspection Report

Inspection Date: Wed, 1 Apr 2026

Property Address: 1/14 Milton Ave, Clayton South VIC 3169,
Australia

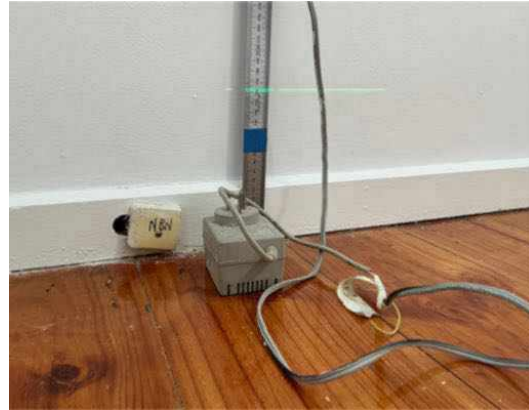
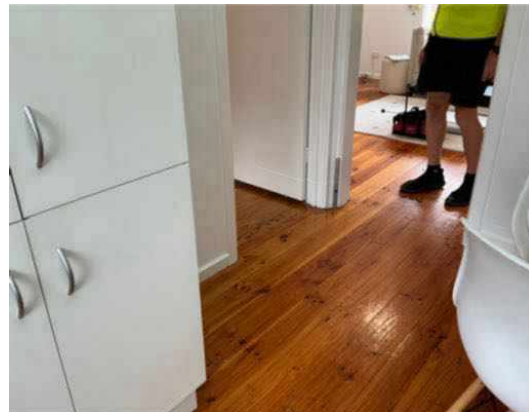
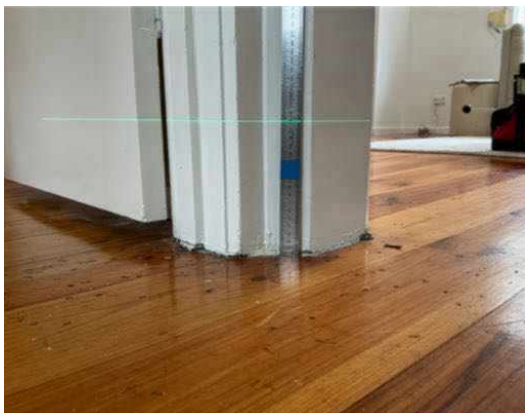
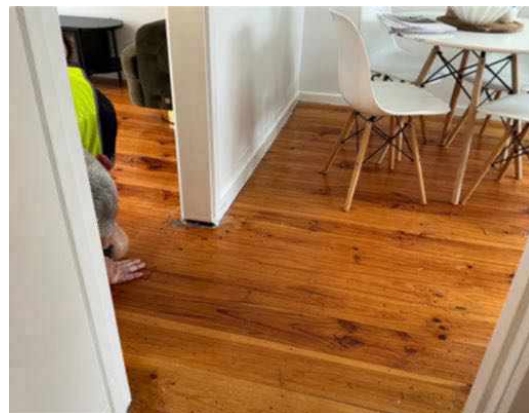
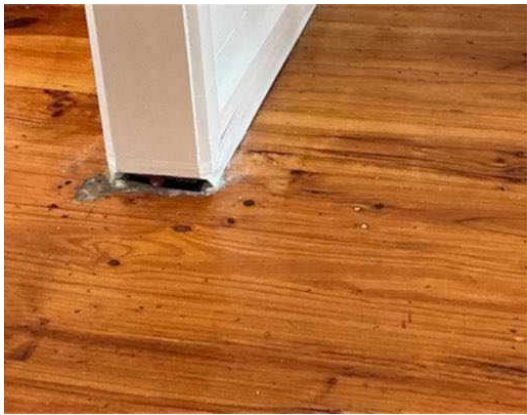
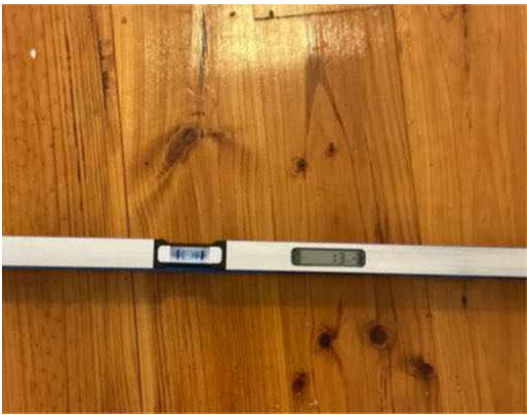
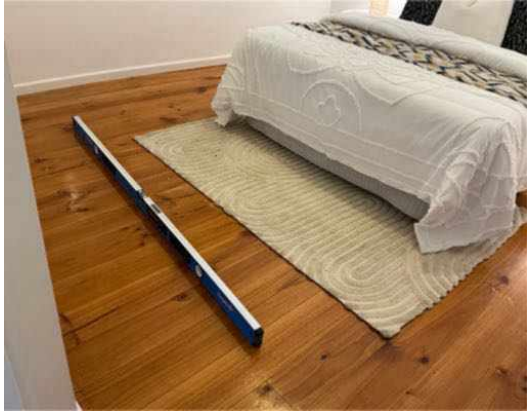
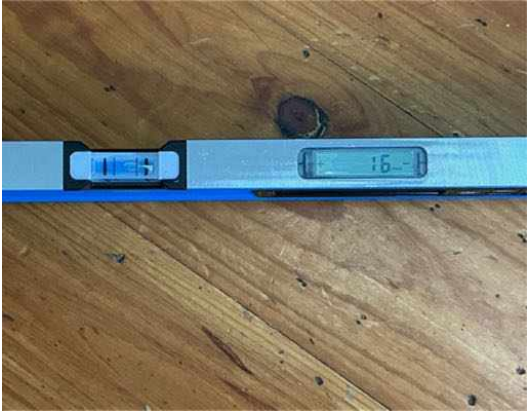
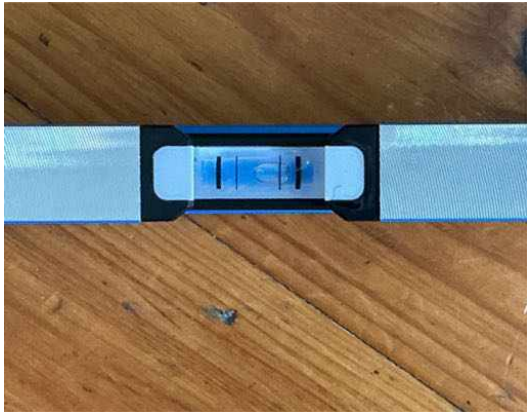
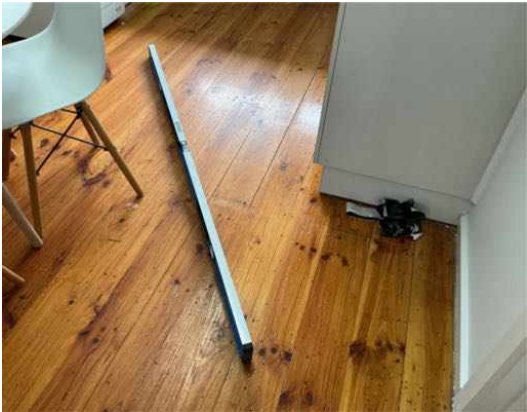
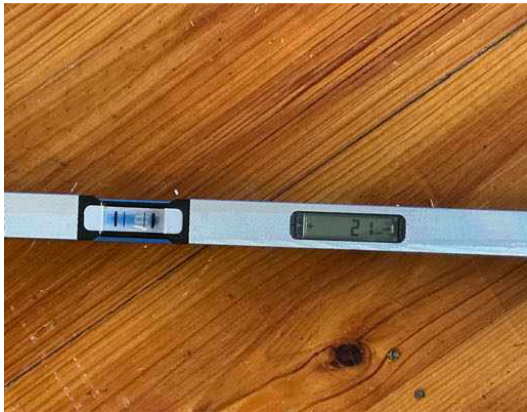
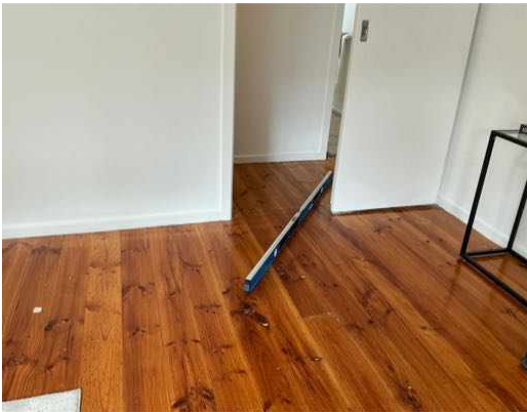
Defects 2.01

Building:	Main Building
Location:	All Areas
Finding:	Flooring - Uneven
Information:	The internal flooring in this area is out of level and uneven. Uneven flooring is likely to indicate minor defects such as expected movement of the foundations of the property, but may also indicate subsidence of the associated subfloor stumps.

Uneven and bouncy floors were found throughout, with binding doors and gaps to door frames and skirting.

It is advised that the flooring be closely monitored to identify any further movement. Where flooring remains relatively unchanged for an extended period of time (i.e. several months), it is likely that this defect has been caused by expected movement of the foundations of the property.

However, where flooring is uneven further, potentially invasive inspection of the subfloor structures and stumps in this area is required. In this case, works to repair are likely to be required, and would be carried out by a registered builder specialising in re-stumping.

Restumping/stabilization as well as underpinning works will be required in the short term. Access to the subfloor area was extremely limited, full inspection of the subfloor is not possible. It is recommended that a specialist in Restumping and underpinning be contracted to perform and advise on remedial works.

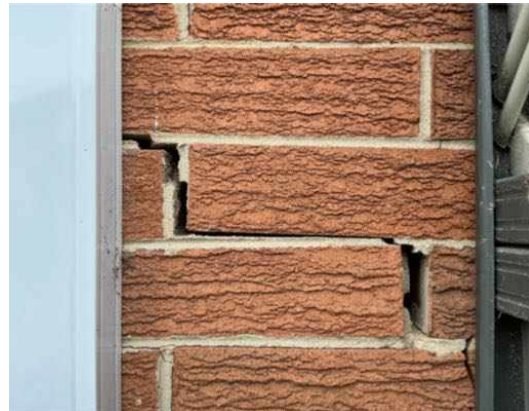
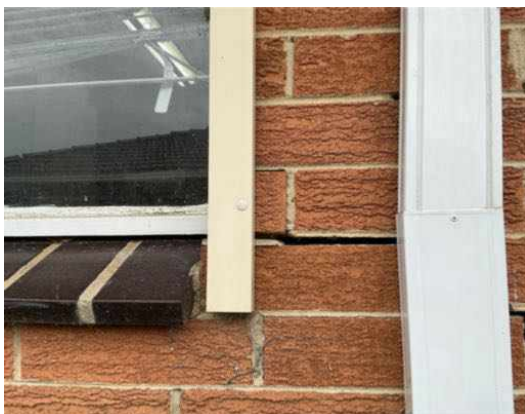
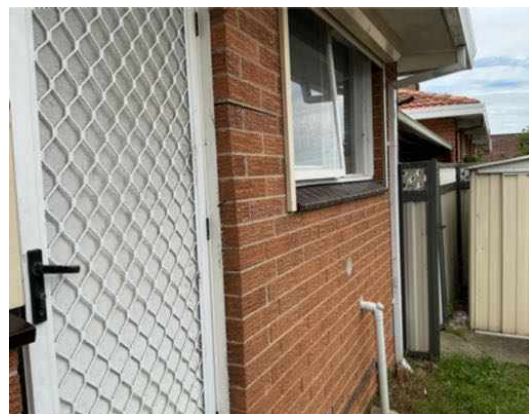
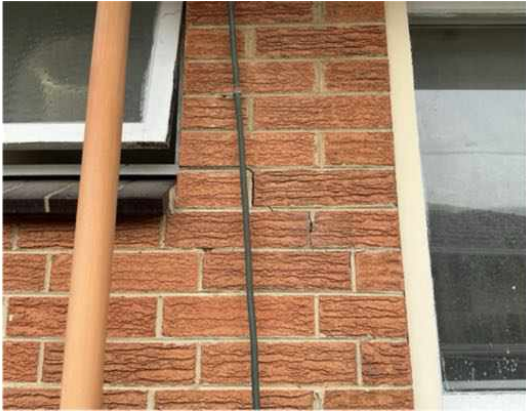
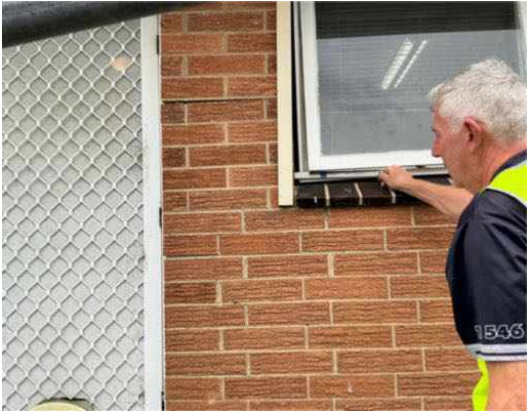
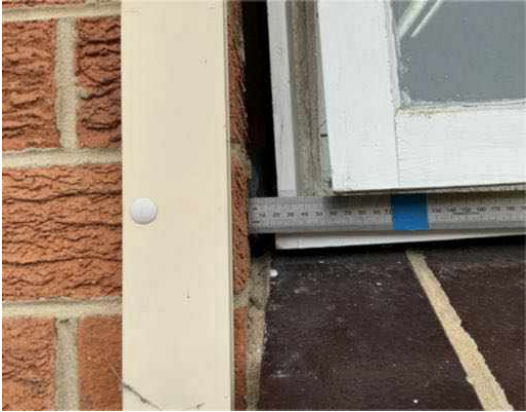
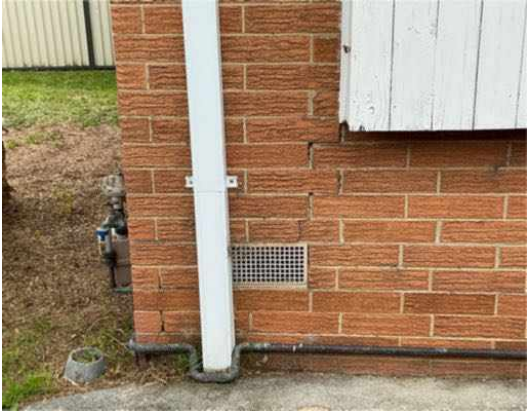
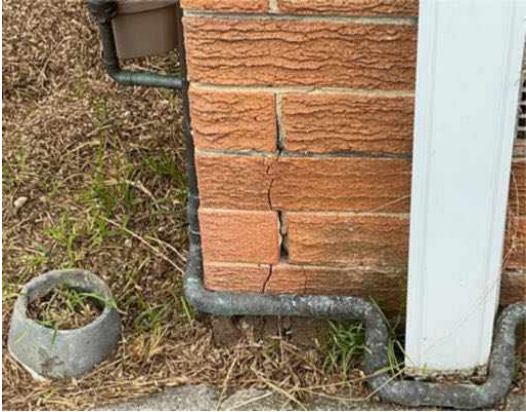
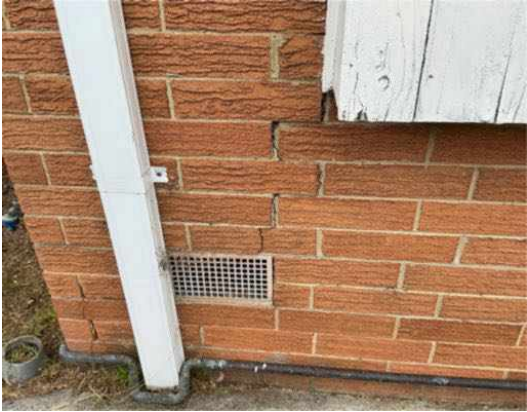
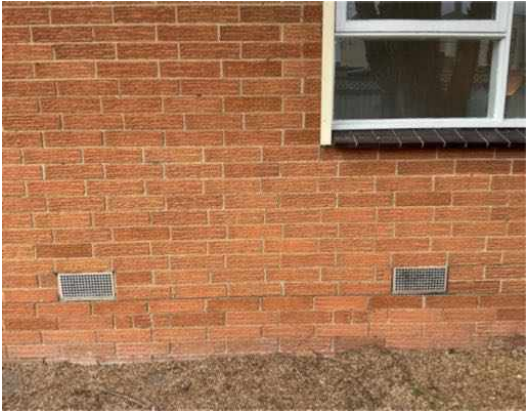
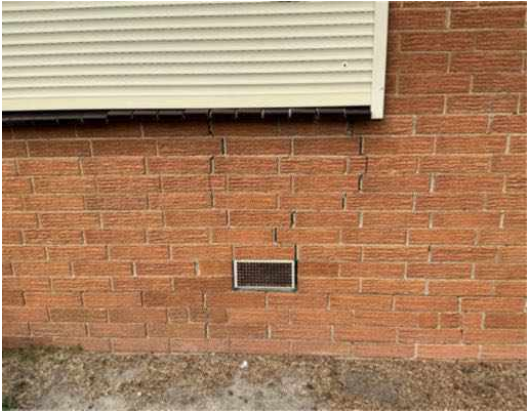
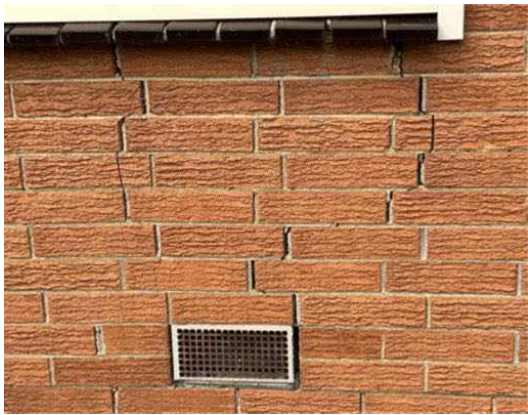
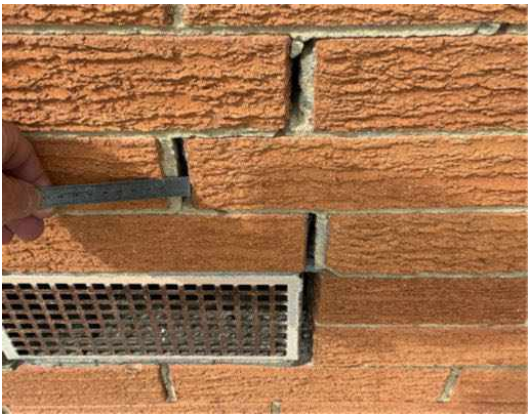
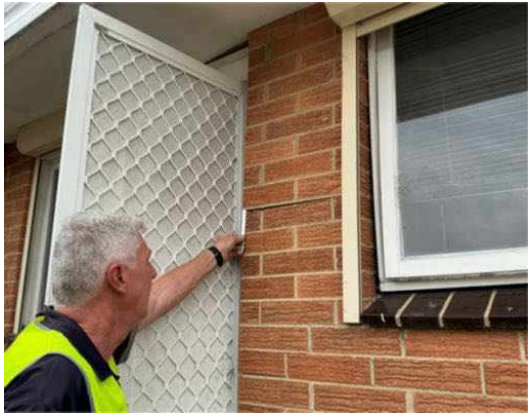
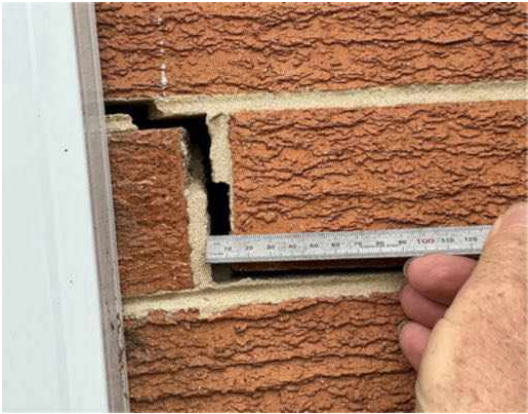
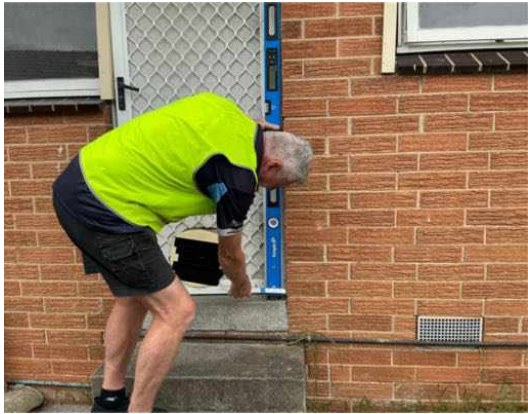
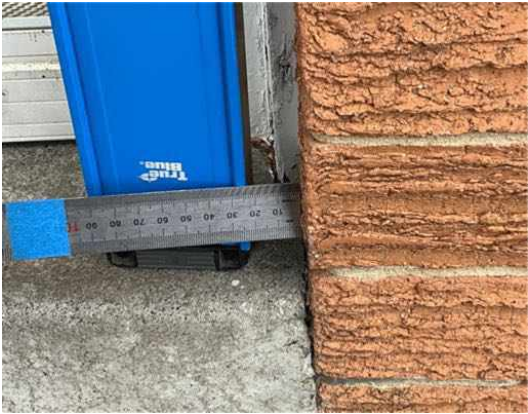
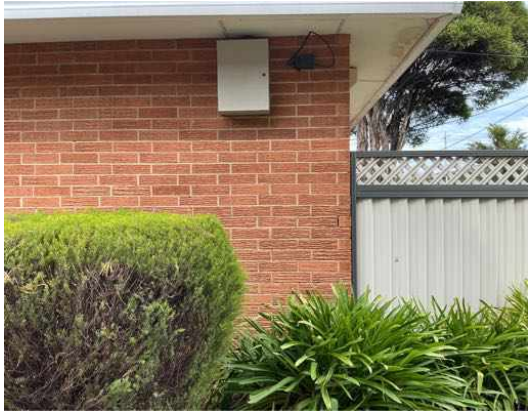
Defects 2.02

Building: Main Building
Location: All Areas
Finding: Brickwork cracking major and minor
Information: There are several minor cracks evident throughout the exterior of the dwelling. These cracks are commonly less than 5mm in width and are expected in a property of this age and can be easily filled and monitored in the future.

There are also several larger more noticeable major cracks and crack repairs evident to the dwelling. These cracks usually coincide with openings (windows and doors) however they can present in other areas also. Cracks of this type are likely to have been caused by minor expected movement of building elements, but may also have a structural cause that is more significant.

Noticeable cracks in brickwork may develop if left unattended with the potential of necessitating remedial works or replacement of sections of brickwork. Always monitor these cracks and contact a building inspector should cracks widen lengthen or become more numerous.

A qualified bricklayer should be contacted immediately to estimate and perform repair and restoration works. Consultation with a structural engineer may be required where structural instability is found to be the underlying cause of the cracking.

A qualified Bricklayer will be required to advise on and quote all brickwork repairs.

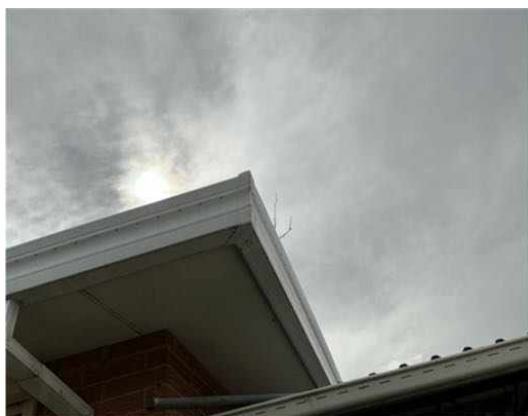
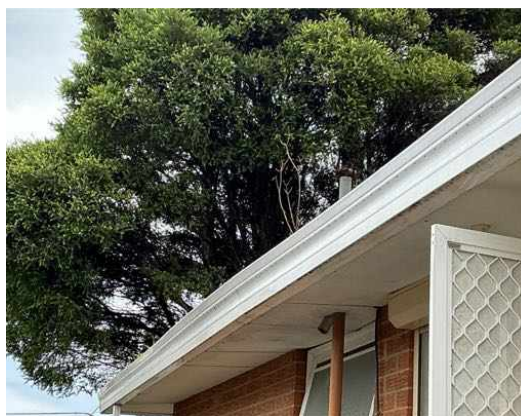
Defects 3.02

Building:	Main Building
Location:	Gutters
Finding:	Gutters - Blocked
Information:	Roof plumbing structures, such as guttering and downpipes, should be free of all debris to prevent blockages. Blockages of the guttering and downpipes will lead to pooling and accumulated water overflows, which is likely to subsequently flood eaves and exterior walls.

Blocked gutters are likely to lead to high levels of moisture in the affected areas. Such moisture will not only cause rust and decay of the associated building materials, but can also provide conditions that are conducive to termite and timber pest activity. Blockages in gutters should therefore be removed immediately to ensure dry conditions are maintained.

Consult a Licensed Plumber for further specific advice on remedial works that may be required. In the interim, it is highly advised that blocked gutters be removed by the homeowner or a general handyperson as a matter of urgency.

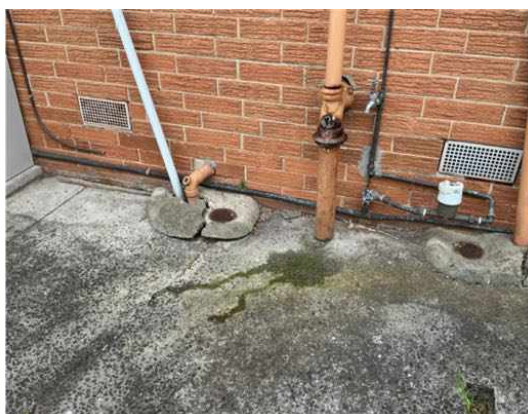
Defects 3.03

Building:	Main Building
Location:	Toilet plumbing
Finding:	Toilet - Leaking
Information:	At the time of inspection, the toilet showed evidence of leaking during operation.

Although common, internal water leaks can be detrimental to surrounding building elements. Rust, corrosion, decay and water damage are all potential outcomes of a water leak that is left unattended, which are then likely to develop into more serious defects and may necessitate major repair works. Additionally, internal water leaks may significantly increase the water usage within the property.

It is highly advised that internal water leak be addressed by a licensed plumber as soon as possible. Use of the leaking toilet should be minimised until such time.

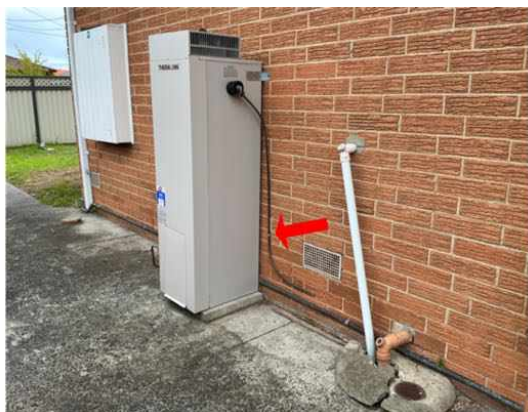
Defects 3.04

Building:	Main Building
Location:	Rear Elevation
Finding:	HWS Overflow - Not Connected
Information:	The Hot Water System (HWS) overflow was found to be disconnected from storm water drainage and is creating excessive moisture in the surrounding area.

These damp conditions can lead to secondary defects such as rot, rust or corrosion of associated building elements, the formation of fungal decay, or even the creation of potential slip hazards. When coupled with poor site drainage, pooling of water may also attract termite activity to this area.

It is highly recommended that a licensed plumber be appointed to connect the HWS overflow in order to prevent such an environment from being created. These minor works should be carried out as soon as possible.

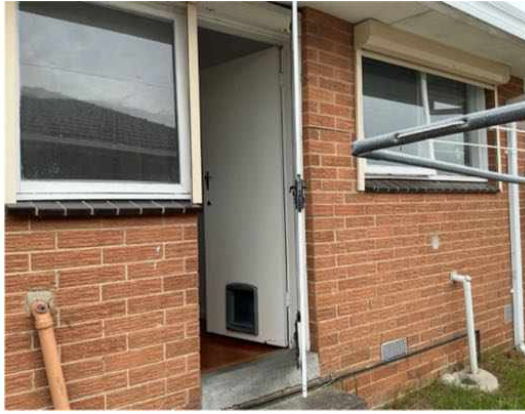
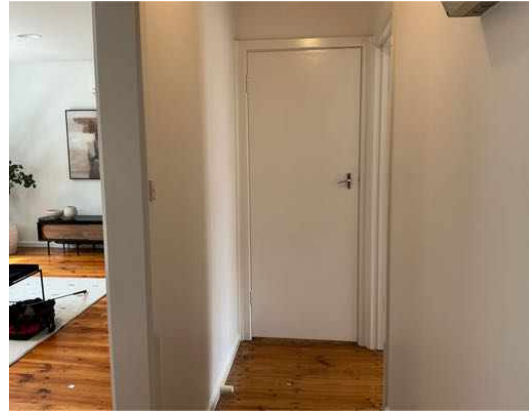
Defects 3.05

Building:	Main Building
Location:	All Areas
Finding:	Door - Binding/jamming
Information:	Binding and/or jamming of this door is evident during standard operation. This defect inhibits the functionality of the affected door as well as creating potential for secondary defects to associated building elements, such as damage to the floor covering.

A door that binds to flooring or to the associated door frame may have several causes, ranging from minor defects, such as poor installation of the door or deteriorated hinges, through to major structural issues, such as damage to subfloor structures.

Where door binding/jamming appears to indicate major structural issues, a registered builder specialising in re-stumping should be appointed to provide an estimate on the cost of rectification.

For minor causes, a qualified carpenter or general handyperson should be appointed to perform minor rectification works at client discretion.

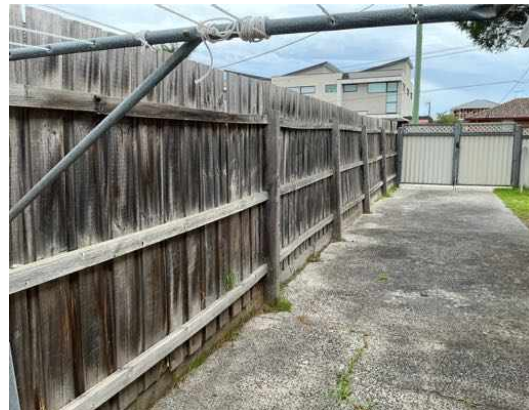
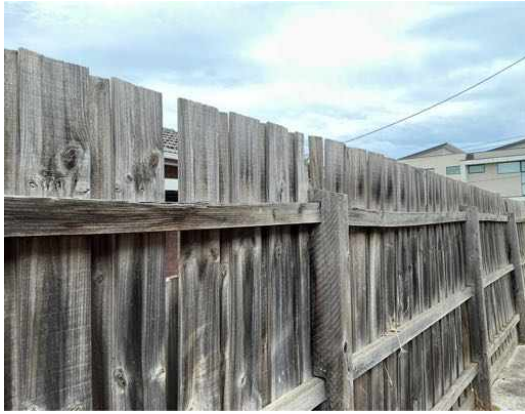
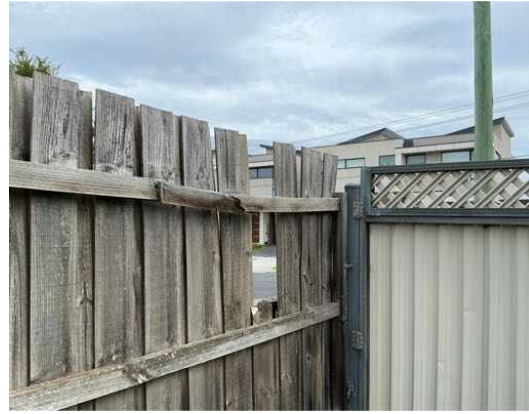
Defects 3.06

Finding: Fencing - Deteriorated

Information: It was noted at the time of inspection that sections of the fencing throughout the property have deteriorated. Typically fencing deteriorates due to age and or wear, rot and or rust which is generally expected for a structure of this age, due to prolonged exposure to weather conditions. Sometimes inadequate installation or maintenance can be to blame.

If left unattended, it is likely that further damage will occur. It is suspected that repair of several elements of the fencing may be required however replacement may be a consideration of the client also.

A licensed fencing contractor should be appointed to provide further advice and perform rectification works as necessary.

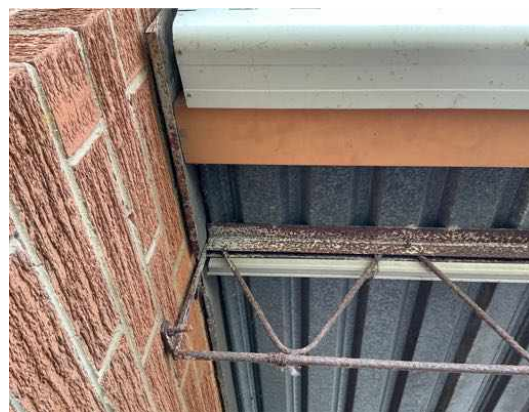
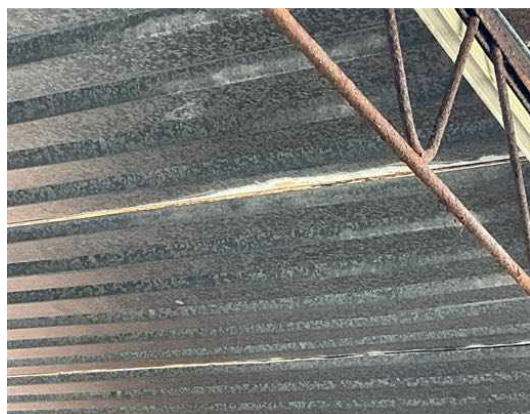
Defects 3.07

Building:	Main Building
Location:	Carport
Finding:	Roof sheets - Rusted
Information:	Metal roofs generally comprise numerous individual sheets, which join and overlap. These intersections are particularly prone to lift at the edge and consequently rust at these points.

Upon inspection of the exterior roofing structure, evidence of rust to these sections was identified. If left unmanaged, these degrading joints can allow water ingress to the internal roofing structures, potentially leading to secondary damage of building elements. Accelerated deterioration of the roofing sheets and any associated building elements is also likely to occur.

A roofing contractor should be appointed immediately to assess the damage to the roofing sheets and to perform remedial works as necessary. Works may include replacement of severely affected roofing sheets or minor works such as the application of rust-retardant surface protectors.

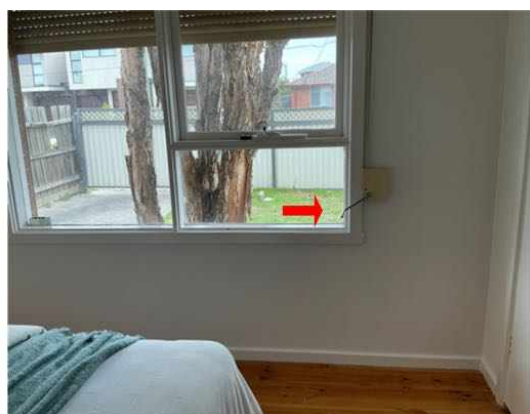
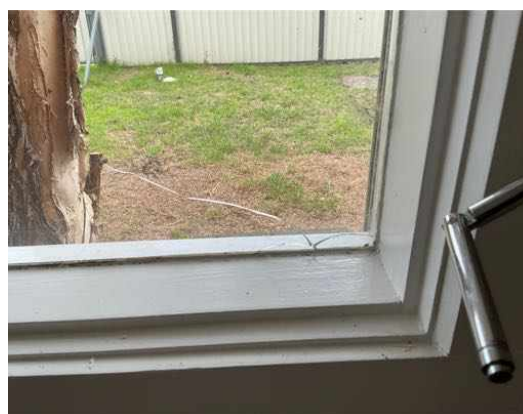
Defects 3.08

Building:	Main Building
Location:	Bedroom
Finding:	Window - Cracked
Information:	Cracks were identified in the window in this area. Cracking in windows is generally the result of impact damage, and is likely to develop further when left unmanaged.

The likelihood of this windowpane further cracking and shattering is increased exponentially, providing a safety hazard in the area. The cracked window also impairs the weather tightness of the building, creating potential for minor water leaks.

A qualified glazier is required to repair the window as soon as possible. Depending on the extent of the cracking, replacement of the window may be required. Please be advised that any persons coming into contact with the cracked window should do so with due caution to avoid any personal injury that may ensue.

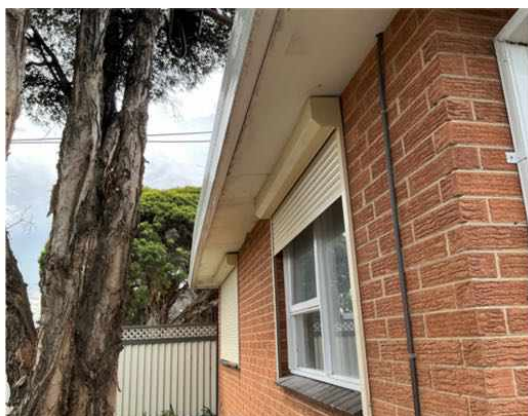
Defects 3.09

Building:	Main Building
Location:	Eaves
Finding:	Eaves - Sagging
Information:	Sagging to the eaves was evident in this area at the time of inspection. This type of

defect is generally consistent with older properties, where the eave sheeting has worn over time.

Sagging eaves are susceptible to the attraction of excessive moisture, and are therefore considered non-functional. This defect also detracts from the overall appearance and condition of the roofing structure and any associated structures.

A roofing plumber or general handyman is recommended to perform rectification works as soon as possible. Subsequent water damage is likely to result over time if left unattended.

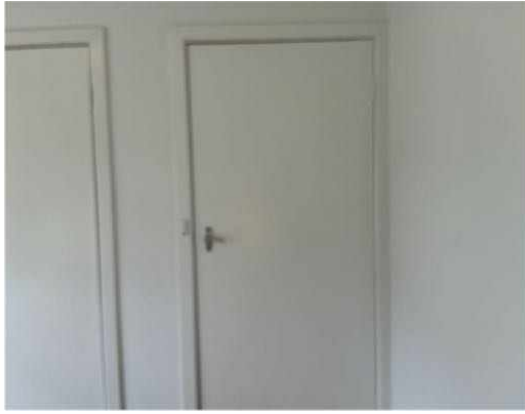
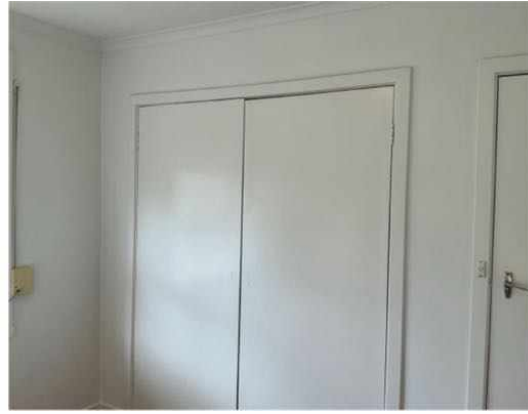
Defects 3.10

Building:	Main Building
Location:	All Areas
Finding:	Door - Gap
Information:	A significant gap was identified between the door and door frame in this area. Where large gaps to the head or foot of door frames appear, it may indicate a variety of defects, ranging from uneven framework, sagging hinges or uneven flooring.

A gap to the head of the door may also indicate movement of the foundation of the property, which is a common occurrence and does not indicate structural damage.

A qualified carpenter should be appointed to perform remedial works to restore the door to a fully operational level.

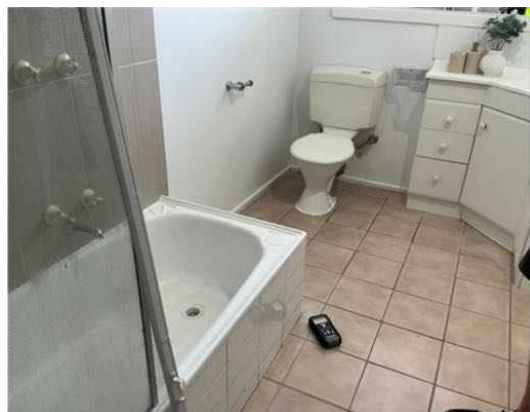
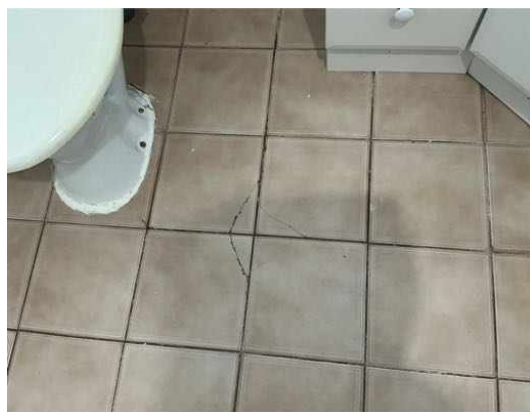
Defects 3.11

Finding: Cracked floor tiles

Information: Cracking in the floor tiles was evident in this area at the time of inspection. It is suspected that this cracking has occurred as a result of minor settlement or shrinkage of the slab.

Cracked tiles throughout the household detract from the overall appearance of the affected areas however it is unlikely to create or lead to any secondary defects.

While not considered a matter of urgency, replacement of cracked floor tiles is

recommended at the clients discretion. A tiling contractor may be appointed to perform these works. Where cracks become more numerous, contact a licensed building inspector for further investigation.

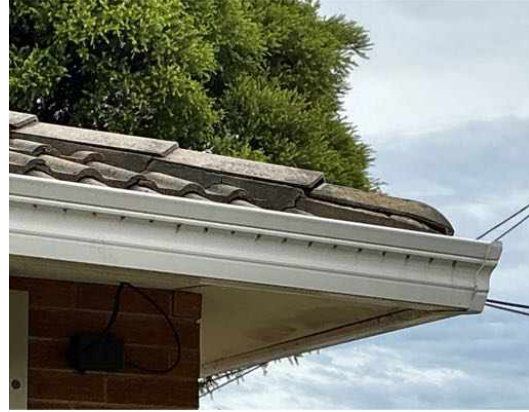
Defects 3.12

Building:	Main Building
Location:	Roof Exterior
Finding:	Roof tiles - Weathered
Information:	Upon inspection of the exterior roofing, the majority of roof tiles were considered to be in a fair condition. While weathering of the tiles is consistent with the age of the property, maintenance works are required.

Isolated areas of mortar have come loose in the valleys and minor cracking is also present. Re-pointing and re-sealing the may be considered as an interim solution by the client to help preserve and extend the life span of the tiles.

Where left unmanaged, deteriorating roof tiles are likely to lead to a number of secondary defects, including minor water leaks and weather exposure to internal roofing structures.

Consultation with a roofing contractor is highly advised to gain advice on cost of remedial works that may be required in the short to medium term. Remedial works are likely to increase the longevity of the exterior roofing structure.

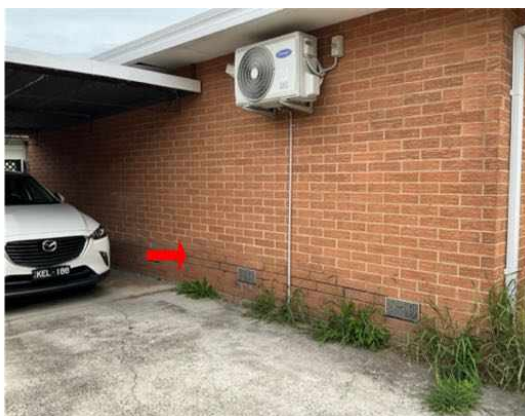
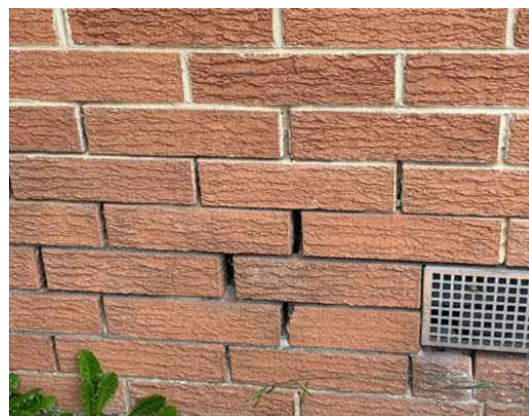
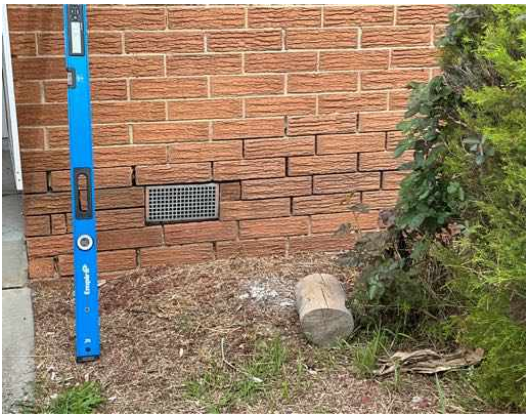
Defects 3.13

Building:	Main Building
Location:	All Areas
Finding:	Brickwork - Deteriorated mortar
Information:	Mortar, or 'bedding', is the material which fills joins and intersections between bricks in masonry walls and structures. Sections of mortar in this brickwork were identified as having deteriorated, which is generally expected for a property of this age and condition.

Mortar may deteriorate as a result of age of building materials, minor movement of bricks, or frequent exposure to weathering. Mortar should be replaced to ensure that bricks remain in their intended location and to prevent gaps, which would allow water or moisture ingress and secondary damage as a result.

Mortar deterioration can be addressed by a bricklayer where areas of deterioration are localised and easily accessible. Alternatively, appointment of a registered builder is advised, to repoint large areas of decaying mortar. Where secondary structural defects have become evident, consultation with a structural engineer may be required.

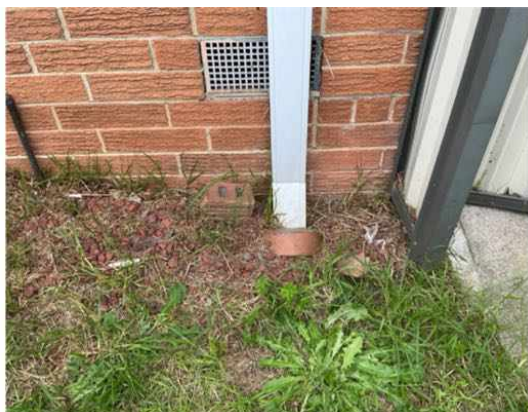
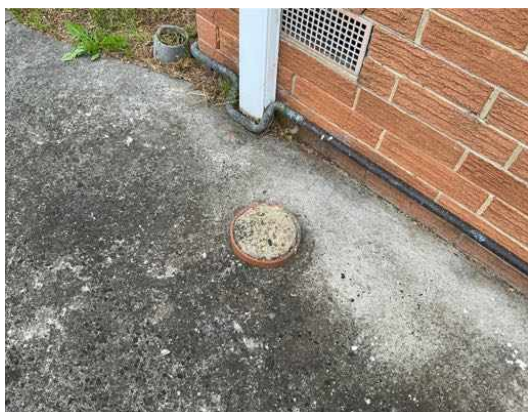
Noted Item

Building: Main Building
 Location: All Areas
 Finding: Terracotta pipes
 Information: Terracotta drainage pipes (sometimes referred to as clay or vitrified clay pipes) have been used for many many years. The use of clay drainage pipes dates back to the Romans, who used the clay pipe system as it was easy to manufacture, straightforward to lay and, for the most part, reliable. However, due to the rigid and brittle nature of clay or terracotta pipes problems can begin to occur over time. Even if they're functioning fine now, clay pipes will need replacing eventually.

The average lifespan of a clay pipe sewer system is 60 years — which means an upgrade is decades overdue for many homes. For your peace of mind you may wish to have your sewer pipes inspected and replaced before a major problem occurs

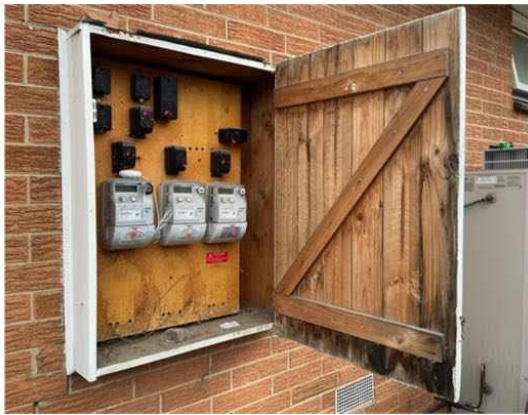
Noted Item

Building:	Main Building
Location:	Electrical Switchboard
Finding:	Termite Management System - no evidence of a chemical installation
Information:	The application of a post-construction chemical termite barrier is highly recommended for all properties, particularly if live termite activity has been found on the site previously. Such barriers are highly effective in preventing termite attack on any timber building elements throughout the property.

A durable notice should be placed in the switchboard unit to indicate current termite barriers. At the time of inspection, it appeared as though no termite management system has been installed, with no evidence to suggest preventative works taking place.

The client may consider gaining further advice from a pest controller as to the costs and procedures involved with this application. It is recommended that obtaining such advice be a short-term priority.

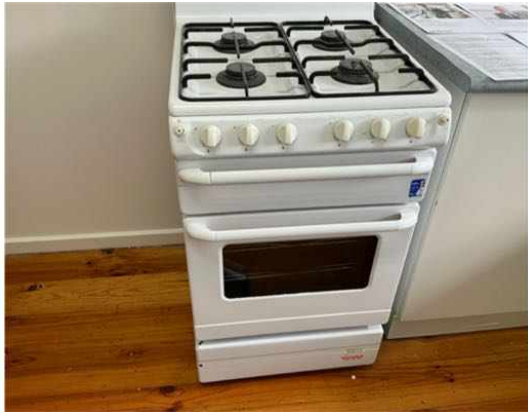
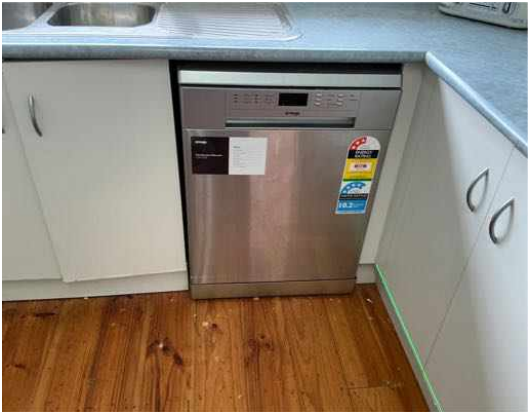
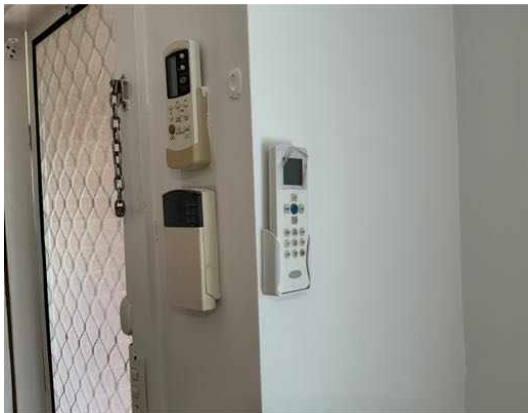
Noted Item

Building: Main Building
Location: Appliances
Finding: Warranty - Expired
Information: Where appliances are beyond their warranty period, the owner should be prepared to meet the cost of replacement or repair of the item at any time. The operation of the appliance can not be guaranteed and further inspection by an appropriately qualified tradesperson may be required.
