# Building and Timber Pest Inspection Report

Inspection Date: Wed, 14 Jan 2026

Property Address: 180 Ryde Rd, West Pymble NSW 2073,  
Australia

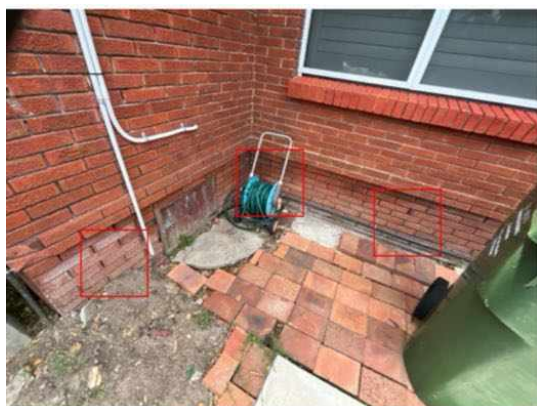
Building:	Main Building
Location:	Multiple areas
Finding:	Brick and Mortar - Deteriorated (Erosion)
Information:	The masonry in this area was found to be deteriorated. Mortar, or 'bedding', is the material which fills joins and intersections between bricks in masonry walls and structures.

Commonly referred to as corrosion or erosion, the bricks and mortar are aged and likely to have been affected by a variety of factors, including moisture, salt-based deterioration, and more.

Mortar and brickwork should be replaced to ensure the structure remains in their intended location and to prevent gaps, which would allow water or moisture ingress and secondary damage as a result.

This can be addressed by a licensed bricklayer where areas of deterioration are localised and easily accessible.

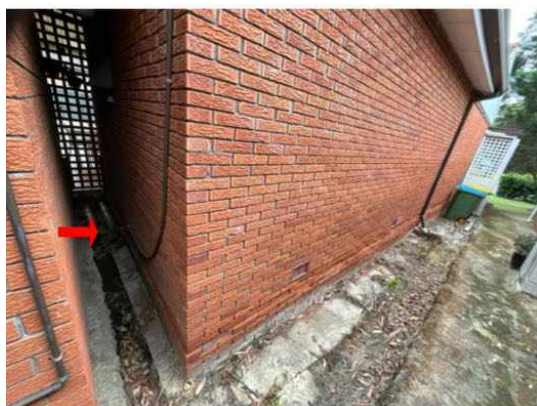
### Finding 2.03

Building:	Main Building
Location:	Multiple areas
Finding:	Site drainage— Inadequate
Information:	The site drainage in this area was found to be inadequate at the time of inspection, creating potential for subsequent water damage to associated building elements. This is additionally conducive to termite activity.

It is important that water does not lie against the base of walls; surrounding paths and ground levels should be sloped to drain water away from walls. Downpipes should not discharge stormwater onto lower walls or plinths. Stormwater should be carried away by large, regularly cleaned drains. Ground levels may need to be lowered to expose a buried DPC.

Where site drainage is inadequate, installation of an Agricultural (Aggie) Drain may be required. A licensed plumber should be appointed to further inspect the property and perform any remedial works as necessary. Water damage and secondary defects are likely to occur if left unmanaged.

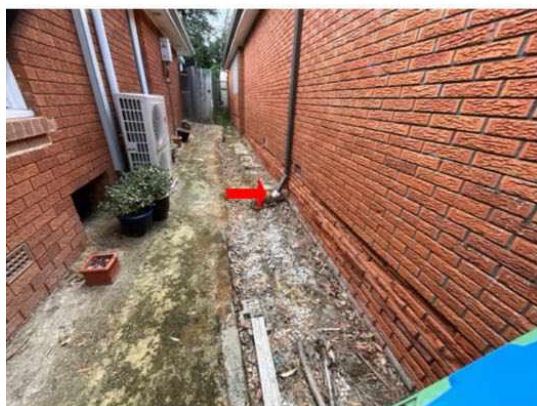
Building:	Main Building
Location:	Multiple areas
Finding:	Plumbing - Point of connection non-compliant
Information:	At the time of inspection it was noted that connections between above ground pipe work and below ground sewer/storm water systems were incomplete.

Additionally, where sewer pipes are concerned, gases can escape from unsealed connections which can pose a serious health risk.

Engagement of a certified plumber is strongly recommended to ensure all connection points are sealed in accordance with the plumbing construction guidelines.

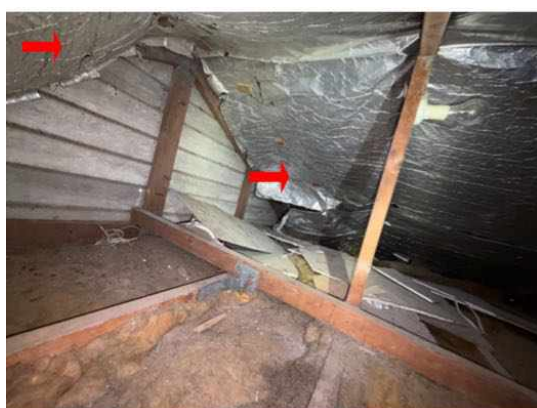
Building:	Main Building
Location:	Roof Void
Finding:	Sarking - Damaged
Information:	Sarking, a laminated aluminium foil applied to the interior of the roof covering, assists in insulating the property and acting as a vapour-barrier to the roof void and, subsequently, to the household.

Where sarking is damaged, both insulation and moisture protection of the property are inhibited. This creates a loss of energy and thus negatively impacts the energy efficiency of the property, allowing potential for moisture ingress from condensation or leaking roof tiles.

It is important to repair any holes or damaged sections of sarking to ensure that the building material is fully functional. A registered builder or qualified carpenter should be consulted to provide further advice on this defect and to perform rectification works at client discretion.

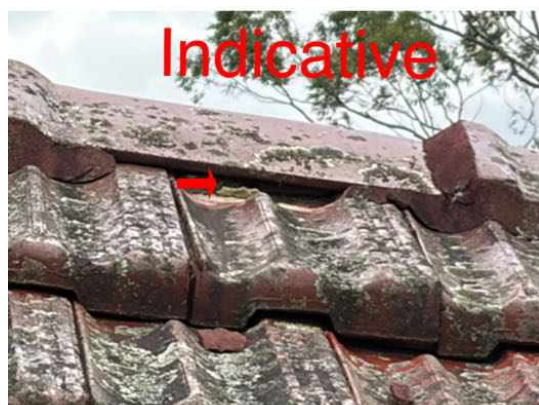
Upon inspection of the exterior roofing, the majority of roof tiles were considered to be in a fair condition. While weathering of the tiles is consistent with the age of the property, maintenance works are required.

Isolated areas of mortar have come loose and minor cracking is also present. Re-pointing and re-sealing the may be considered as an interim solution by the client to help preserve and extend the life span of the tiles.

Where left unmanaged, deteriorating roof tiles are likely to lead to a number of secondary defects, including minor water leaks and weather exposure to internal roofing structures.

Consultation with a licensed roofing contractor is highly advised to gain advice on cost of remedial works that may be required in the short to medium term. Remedial works are likely to increase the longevity of the exterior roofing structure.

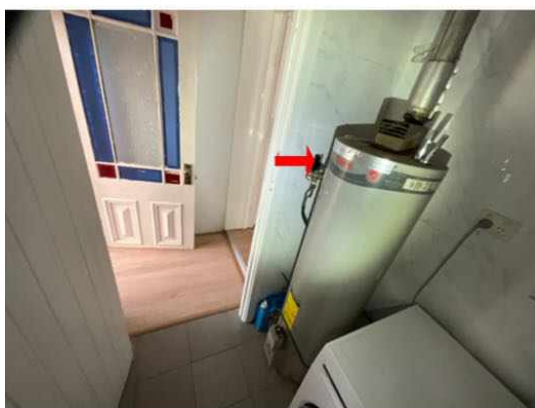
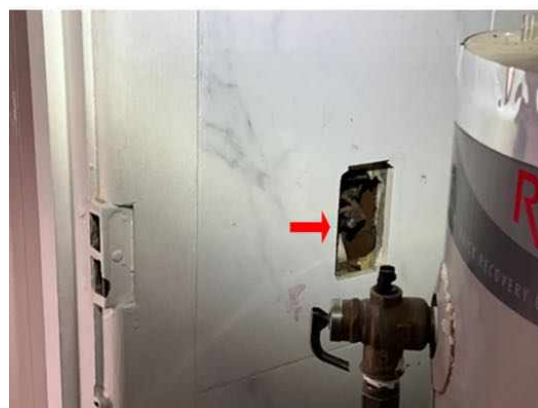
Works that have not been completed to a satisfactory level create potential for the development of building defects and may impede on the safety and integrity of the overall structure.

It is highly recommended that the relevant trades be appointed to complete these works and ensure the safety of the area and the longevity of all associated building elements.

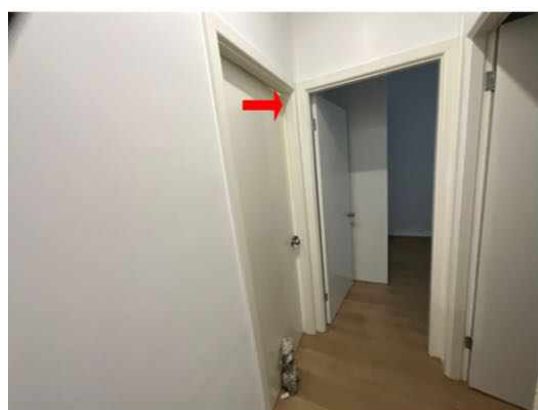
A door that binds to flooring or to the associated door frame may have several causes, ranging from minor defects, such as poor installation of the door or deteriorated hinges.

A licensed carpenter should be appointed to perform minor rectification works at client discretion.

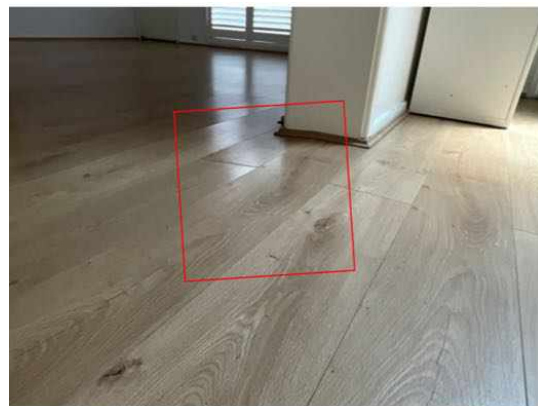
Building: Main Building  
 Location: Dining to living  
 Finding: Flooring - Uneven  
 Information: The internal flooring in this area is out of level and uneven. This is believed to be substandard workmanship to the flooring due to level difference between dining and living rooms.

If flooring becomes uneven further, an invasive inspection must be carried out by a licensed builder.

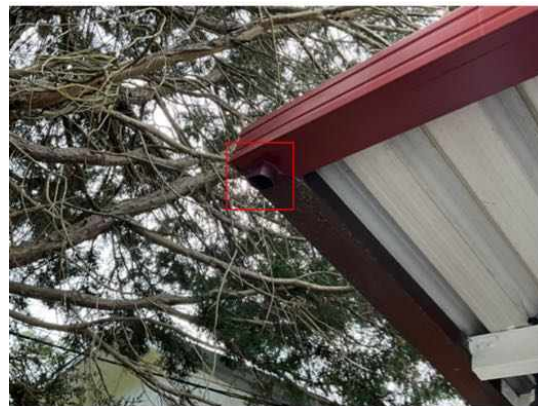
Where roof plumbing doesn't drain adequately, the area at the base perimeter can become excessively damp, potentially creating an environment that is susceptible to rust and corrosion of surrounding building elements, as well as attracting termites and other pests.

It is highly recommended that a plumber be appointed to further inspect the area and to install adequate drainage equipment where necessary.

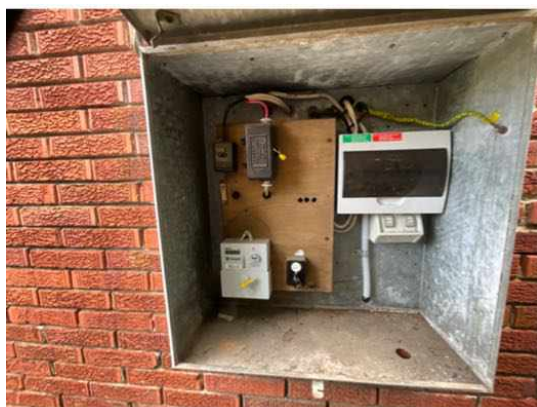
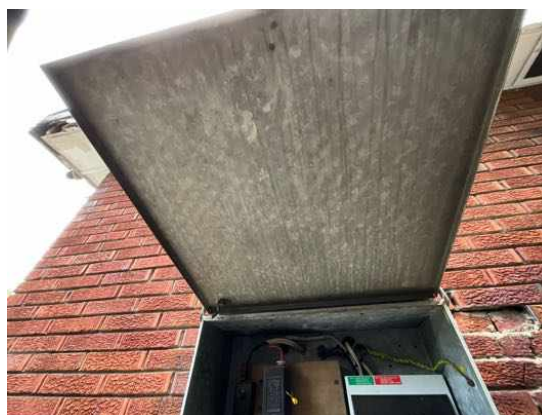
### Finding 6.05

Building:	Main Building
Location:	Meterbox
Finding:	Termite Management System - no evidence of installation
Information:	The application of a post-construction chemical termite barrier is highly recommended for all properties, particularly if live termite activity has been found on the site previously. Such barriers are highly effective in preventing termite attack on any timber building elements throughout the property.

A durable notice should be placed in the switchboard unit to indicate current termite barriers. At the time of inspection, it appeared as though no termite management system has been installed, with no evidence to suggest preventative works taking place.

The client may consider gaining further advice from a pest controller as to the costs and procedures involved with this application. It is recommended that obtaining such advice be a short-term priority.

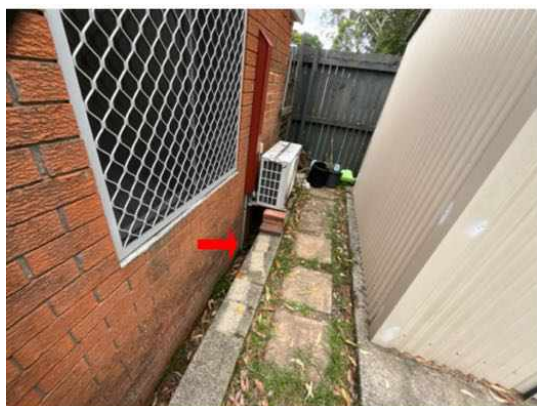
### Finding 6.06

Building:	Main Building
Location:	Yard - Side
Finding:	Overflow - Not plumbed for drainage
Information:	The overflow is not plumbed or connected to suitable drainage, which can result in the surrounding area becoming excessively damp.

These damp conditions can lead to secondary defects such as rot, rust or corrosion of associated building elements, the formation of fungal decay, or even the creation of potential slip hazards. When coupled with poor site drainage, pooling of water may also attract termite activity to this area.

It is highly recommended that a licensed plumber be appointed to install adequate drainage to the overflow. These works will ensure that the area remains dry and free of any secondary defects.

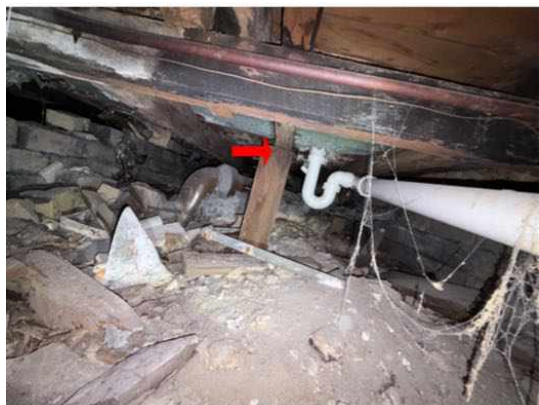
### Finding 6.07

Building:	Main Building
Location:	Subfloor
Finding:	Formwork timbers - left in situ
Information:	Formwork timber appears to have been left on site and in situ after concrete construction. Formwork timber is used to support and shape the concrete while pouring during the construction process. Leaving formwork timbers in the subfloor space or around the exterior of the property increases the risk of termite activity being present. As they are likely to come into contact with weather conditions or excessive moisture wood rot is likely to develop on timbers that are not treated. It is highly recommended that any formwork timbers be immediately removed from areas in

which they may attract any termite/timber pest attack. Minimisation of risk/prevention of termite attack is far more adequate than dealing with the presence of termite activity.

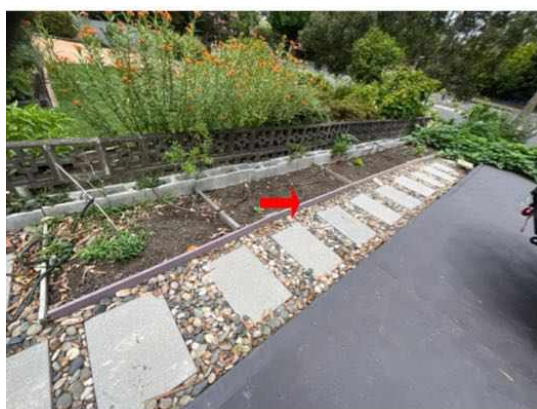
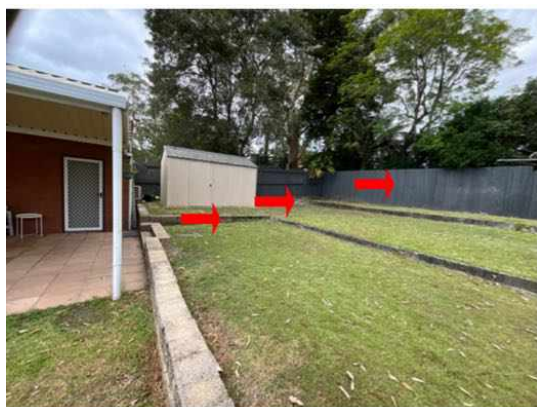
When met with excessive moisture timber begins to decay and develop wood rot. Any timbers that are in direct contact with external grounds especially if left untreated or non-durable also provide ingress for subterranean termites into that particular element.

The removal of any such materials that may be conducive to termite activity should be removed as soon as possible to minimise the risk of termite attack.

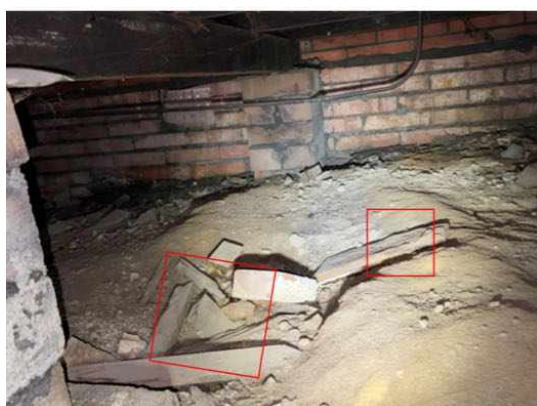
### Finding 6.10

Building: Main Building  
 Location: Yard, subfloor  
 Finding: Stored timbers - subfloor space or external area  
 Information: The storing of timbers in the subfloor space or around the external property increases the risk of termite activity being present. As they are likely to come into contact with weather conditions or excessive moisture wood rot is likely to develop on timbers that are not treated.

It is highly recommended that any stored timbers be immediately removed from areas in which they may attract any termite / timber pest attack. Minimisation of risk / prevention of termite attack is far more adequate than dealing with the presence of termite activity.

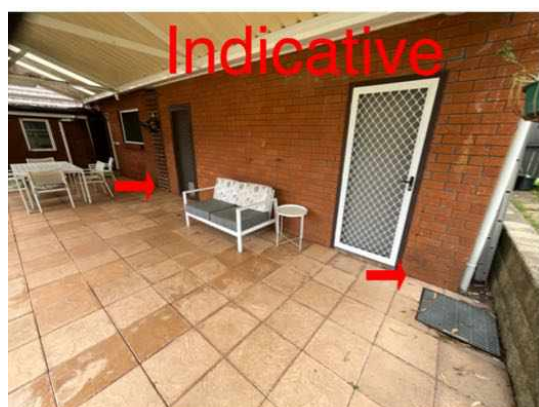
Building:	Main Building
Location:	Extensions
Finding:	Slab Edge - Exposure
Information:	Slab Edge Exposure: Where external concrete slab edges are not exposed there is a high risk of concealed termite entry. In some buildings built since July 1995 the edge of the slab forms part of the termite shield system. In these buildings an inspection zone of at least 75mm should be maintained to permit detection of termite entry. The concrete edge should not be concealed by render, tiles, cladding, flashings, adjoining structures, paving, soil, turf or landscaping etc. Where this is the case you should arrange to have the slab edge exposed for inspection. Concealed termite entry may already be taking place but could not be detected at the time of the inspection. This may have resulted in concealed timber damage. Does the slab edge inspection zone fully comply?

Not able to comment. A very high proportion of termite attacks are over the edge of both Infill and other concrete slabs types. Covering the edge of a concrete slab makes concealed termite entry easy. Infill slab type construction has an even higher risk of concealed termite ingress as the slab edge is concealed due to the construction design and cannot be exposed. The type of slab may only be determined by assessment of the construction plans by a qualified person e.g. Builder, Architect. Construction Plans may be obtainable by your local Council or Builder. Termite activity and or damage may be present in concealed timbers of the building. We strongly recommend frequent regular inspections in accordance with AS 3660.2. Where the slab edge is not fully exposed or the slab is an infill slab or the slab type cannot be determined then we strongly recommend inspections every 3 to 6 months in accordance with AS 3660.2 or AS 4349.3.
