Building and Timber Pest Inspection Report

Inspection Date: Mon, 19 Jan 2026

Property Address: 43 Red Gum Ave, Hazelbrook NSW 2779,
Australia

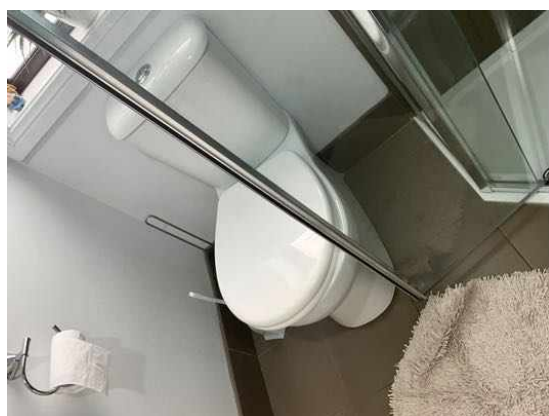
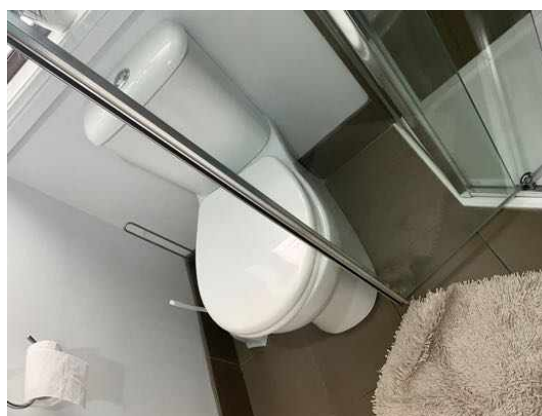
Building:	Main Building
Location:	Bathroom / Laundry
Finding:	Shower screen - Hitting toilet
Information:	A safety hazard was identified in the bathroom of the property. The issue pertains to the shower screen, which, when fully opened, makes contact with the adjacent toilet. This situation poses an immediate risk to the safety and well-being of occupants due to the potential for accidents and injuries.

Collision between the shower screen and the toilet can cause injury to individuals using the bathroom, particularly if the shower screen shatters upon impact. The

repeated contact between the shower screen and the toilet can also result in damage to both fixtures, leading to costly repairs or replacements.

This is to be addressed prior to handover.

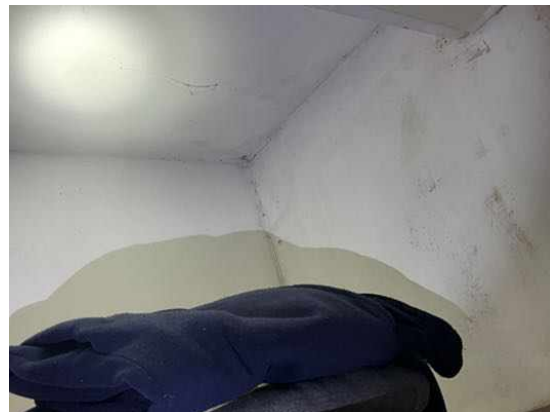
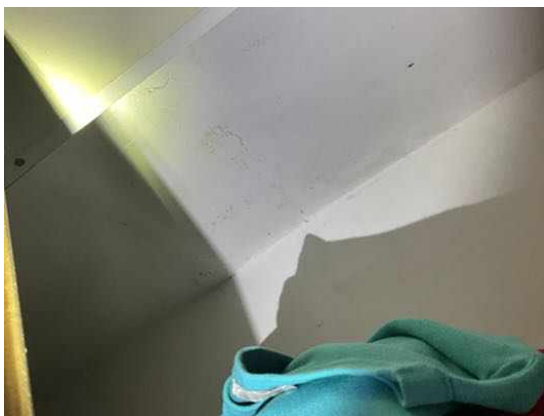
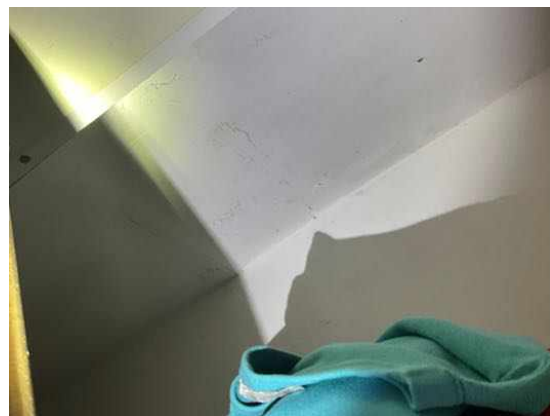
Finding 1.03

Building: Main Building
 Location: Bedroom 2
 Finding: Mould - Present
 Information: Mold growth is present throughout the property, primarily due to inadequate ventilation. Poor airflow and moisture accumulation within the house have created ideal conditions for mold to thrive.

- ****Health Hazards****: Mold growth can pose serious health risks to occupants, particularly those with allergies, asthma, or other respiratory conditions. Prolonged exposure to mold spores can cause respiratory issues, skin irritation, and other allergic reactions.
- ****Structural Damage****: Mold can degrade building materials over time, leading to rot and weakening of the structural components such as timber, drywall, and insulation, which can result in costly repairs.

- ****Decreased Property Value****: The presence of mold can significantly reduce the value of the property, as it indicates underlying moisture and ventilation issues that need addressing.

A licensed mold remediation specialist should be engaged to remove the mold and treat affected areas. In addition, a ventilation expert or builder should assess and improve the house's ventilation system, possibly installing exhaust fans, vents, or mechanical ventilation systems to ensure adequate airflow and prevent future mold growth.

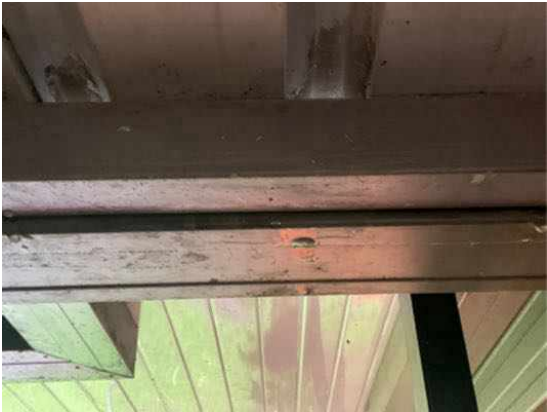
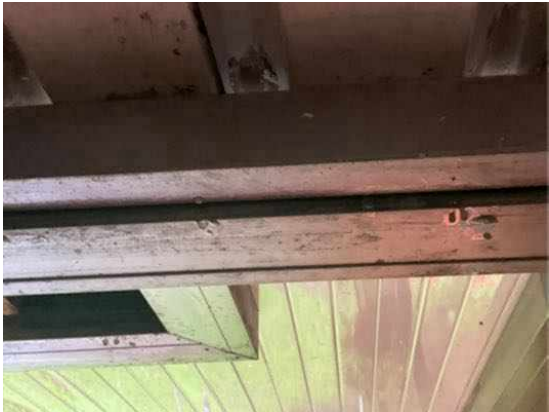
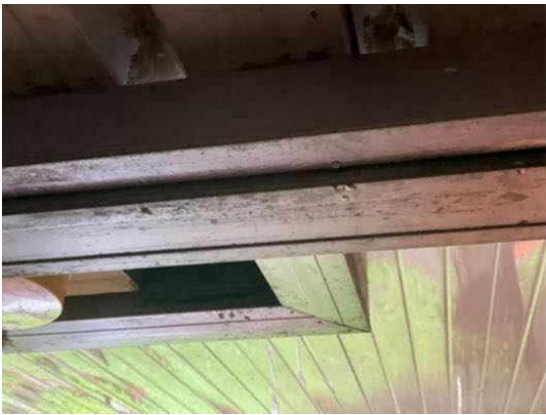
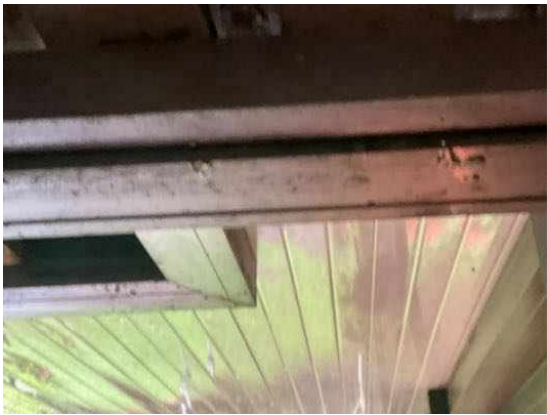
Finding 2.01

Building:	Main Building
Location:	Carport
Finding:	Roof covering - Leaking
Information:	An active leak was identified to the roof covering, indicated by water ingress.

Where water leaks are active, rain penetration is likely to cause water damage to

associated structures and building elements in this area, which can have a range of implications. If left unmanaged, the development of major structural damage to the roofing and associated structures may occur.

A roofing contractor should be appointed as soon as possible to primarily identify the cause of the leak, and to provide subsequent repair works as necessary. Depending on the extent of the damage, replacement of sections of the roof covering and/or roofing structures may be required.

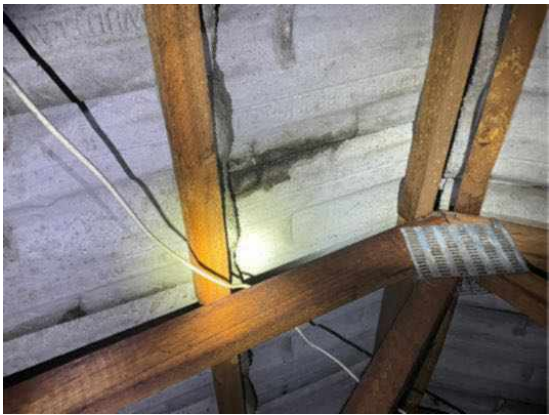
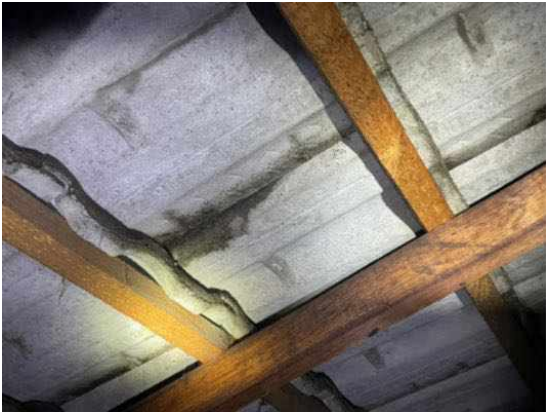
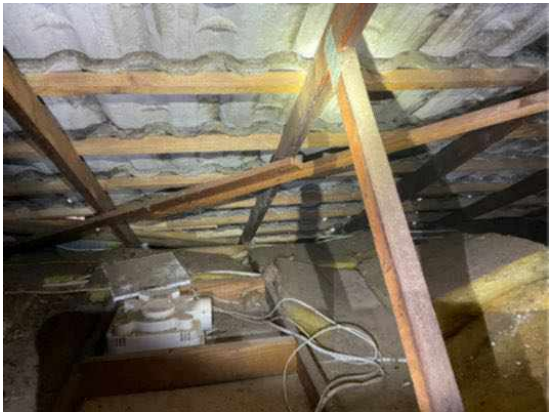
Finding 2.02

Building: Main Building
Location: Roof Void
Finding: Roof Leaks
Information: The roof has developed leaks, allowing water to penetrate the building envelope. These leaks may be due to damaged or missing shingles/tiles, deteriorated flashing, clogged gutters, or other roof system failures.

1. Structural Damage: Continuous water ingress can weaken the structural integrity of the roof and supporting structures, leading to potential collapse or costly repairs.

2. Mold and Mildew Growth: Persistent moisture promotes mold and mildew growth, which can cause health issues for occupants, including respiratory problems and allergic reactions.

3. Electrical Hazards: Water infiltration can come into contact with electrical wiring and fixtures, increasing the risk of short circuits, electrical fires, or electrocution.

4. Insulation Damage: Wet insulation loses its effectiveness, leading to reduced energy efficiency and higher heating and cooling costs.
5. Interior Damage: Leaks can cause staining, peeling paint, and damage to interior ceilings, walls, and personal property.

6. Pest Infestation: Moist environments can attract pests such as termites, ants, and rodents, which can further damage the property.

A licensed roofing contractor or qualified roofer should be contacted to inspect and repair the roof leaks. They will:

- Identify the source of the leaks and assess the extent of the damage.
- Repair or replace damaged shingles, tiles, flashing, or other roofing materials.
- Ensure proper sealing around roof penetrations, such as vents, chimneys, and skylights.
- Clean and maintain gutters and downspouts to ensure proper drainage.
- Provide recommendations for any additional necessary repairs or preventive measures to avoid future leaks.

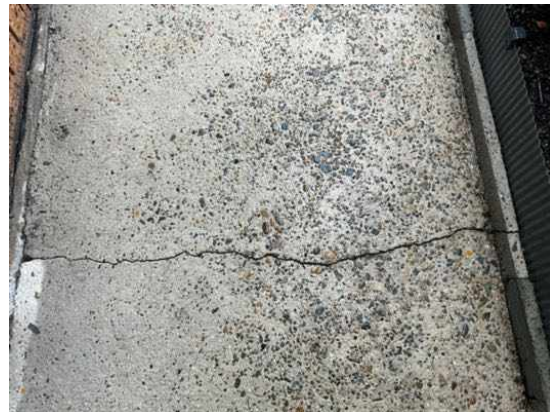
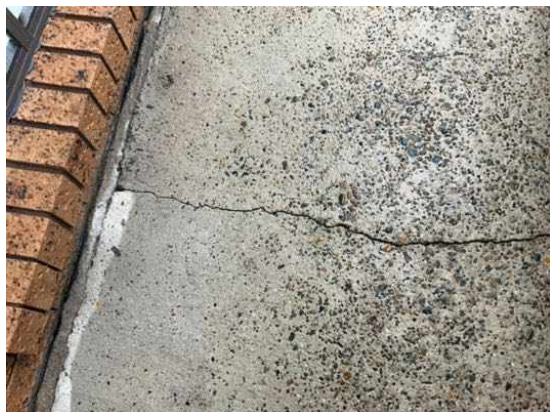
Building: Main Building
Location: All Areas
Finding: Noticeable Cracking in Concrete Slab
Information: Noticeable cracking has been observed in the concrete slab, failing to meet the required construction and quality standards.

- Cracks are visible on the surface and may extend through the depth of the slab.

- Evidence of improper curing or inadequate reinforcement leading to cracking.

The presence of noticeable cracks in the concrete slab can result in:

- Compromised structural integrity of the slab, potentially leading to failure under load.
- Water ingress through cracks, causing corrosion of reinforcement and further weakening the structure.
- Potential trip hazards and aesthetic issues, reducing the overall value and safety of the property.
- Increased maintenance and repair costs due to ongoing deterioration.

- A structural engineer should be engaged to assess the extent of the cracking and recommend appropriate repair methods.
- A licensed contractor or concrete repair specialist should carry out the recommended repairs under the guidance of the structural engineer.

A detailed inspection should be conducted post-repair to confirm compliance with the required standards and to ensure that the structural integrity of the concrete slab has been restored.

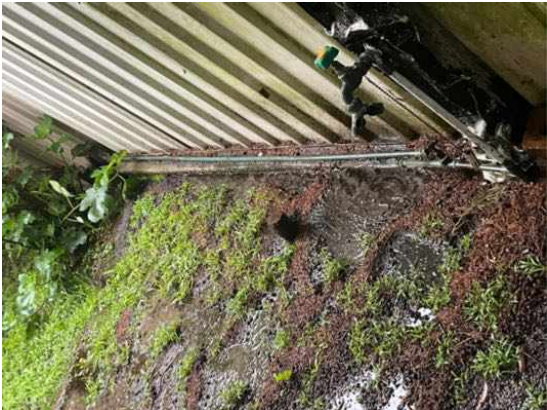
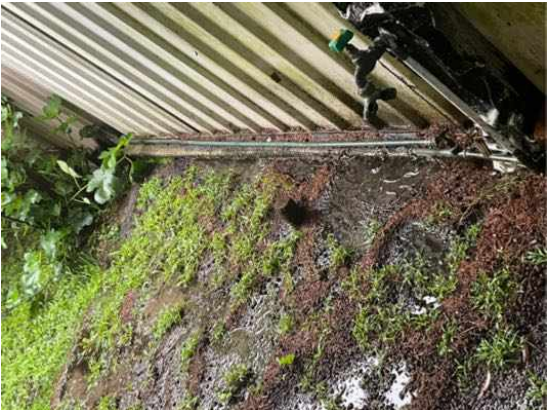
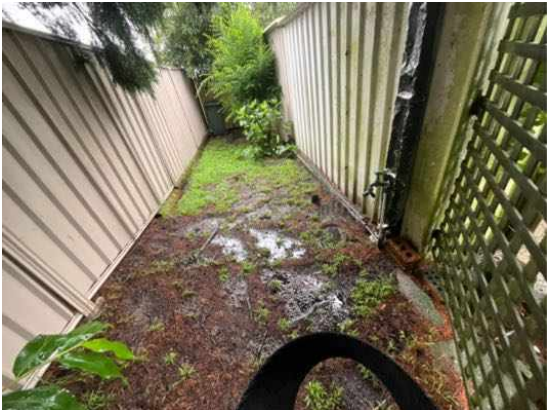
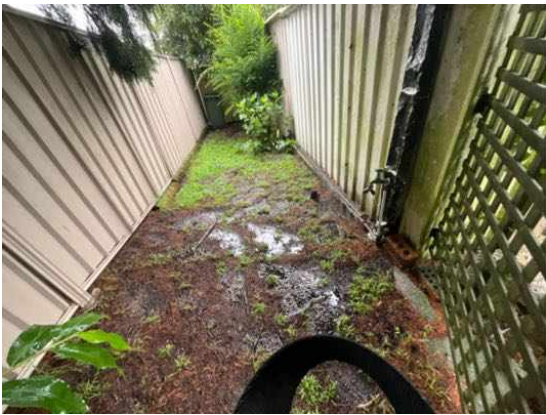
Finding 3.03

Building:	Main Building
Location:	All Areas
Finding:	Perimeter - Insufficient Fall
Information:	The perimeter ground levels were found to have an inadequate slope away from the adjoining building structure, creating potential for water pooling in this area.

Perimeter is required to fall from the building by a minimum of 25mm in the first metre and bare ground should fall away from the house by 50mm in the first meter. This standard ensures that excessive moisture does not pool around the base of building structures, which creates potential for water and structural damage, as well as making the area susceptible to termite and timber pest activity.

Surface water drainage is defective if it is not in accordance with the requirements of the Building Code of Australia.

Such water pooling also increases the risk of termite activity and the development of fungal decay in the area.

Consult a Licensed Plumber regarding the cost of potential site drainage rectification works.

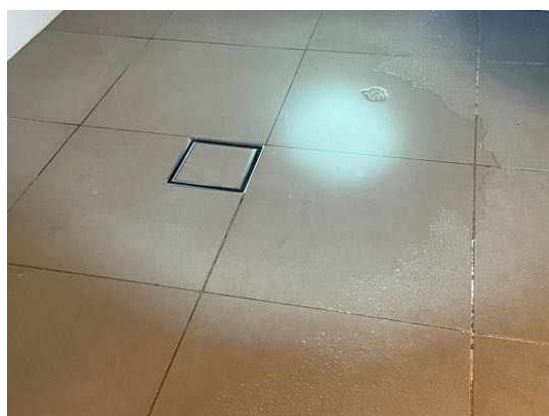
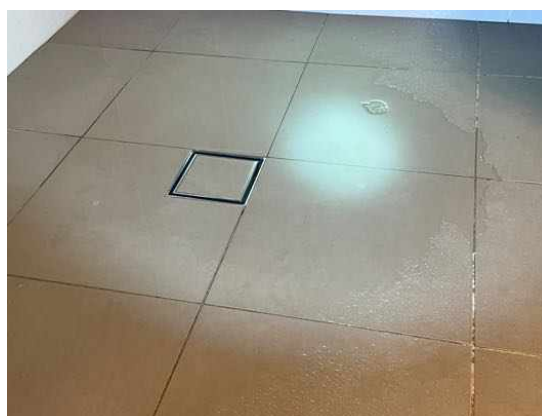
Building:	Main Building
Location:	Bathroom
Finding:	Shower base - Water pooling
Information:	Evidence of water pooling around the floor waste in the shower recess was noticed at the time of inspection. It is suspected that this excessive moisture is attributed to insufficient fall in the shower floor tiles.

This pooling is minor overall but is still considered unsatisfactory, as standard tiling practices would not permit this situation to occur. Pooling water around floor wastes can create a slip hazard in extreme cases and create conditions that are conducive to mould growth over time. Where left unmanaged, the degradation of sealant and grouting is also likely to occur, possibly necessitating further repair works.

Remedial works may involve some sections of tiling and flooring repair and replacement. A tiling contractor or bathroom specialist should be appointed to provide further advice on reparation options and to perform works as necessary.

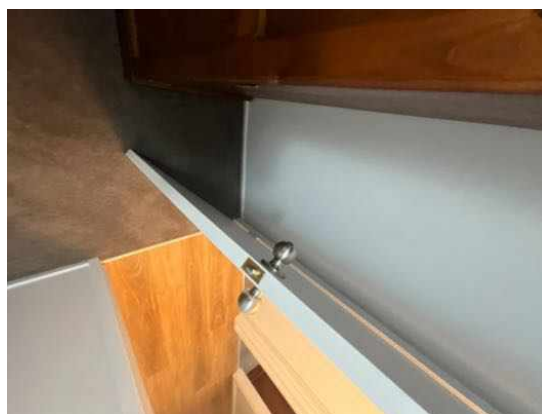
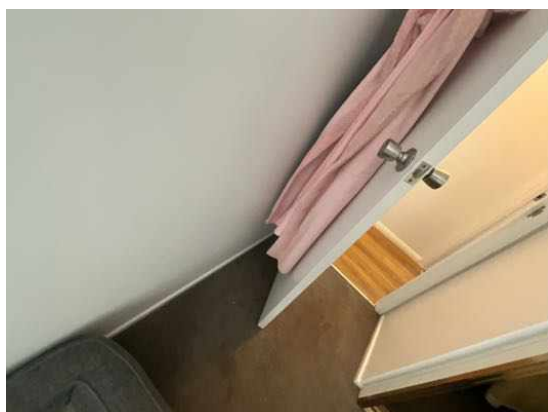
Finding 3.09

Building:	Main Building
Location:	All Areas
Finding:	Missing Door Stopper
Information:	The door lacks a stopper, which is essential to prevent the door from swinging too far

and potentially damaging the wall or the door handle. The absence of a door stopper increases the likelihood of impact damage to both the door and surrounding surfaces over time.

- **Damage Risk:** Moderate risk of damage to the door handle, wall, or door itself from repeated impacts when the door is opened forcefully or by a gust of wind.
- **Wear and Tear Risk:** Increased wear on door hardware and hinges due to the potential for abrupt stops without a dedicated stopper.

- **Engage a Handyperson or Carpenter:** A handyperson or carpenter should install a suitable door stopper to prevent excessive door movement. This could be a floor-mounted or wall-mounted stopper depending on the space and door design.

This issue is a minor defect but should be addressed to prevent potential damage and maintain the integrity of the door and surrounding areas.

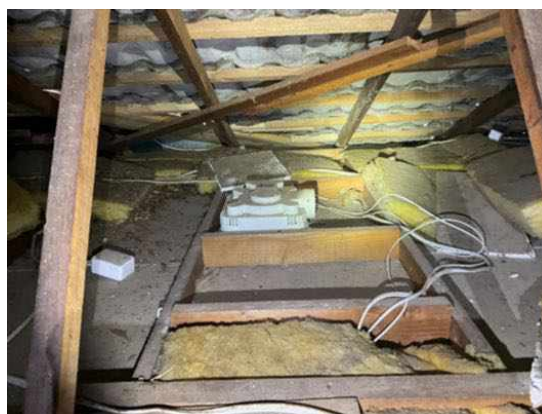
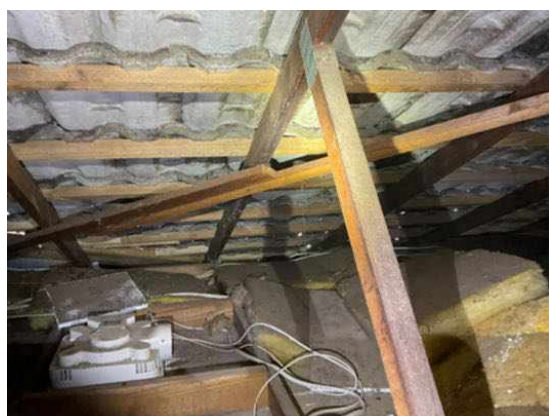
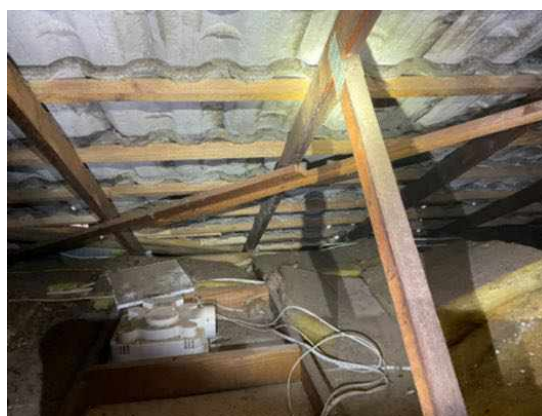
Finding 3.10

Location: Roof Void
Finding: Exhaust fan not vented out
Information: The exhaust fan located within the roof void is not appropriately ducted to the external atmosphere and is currently discharging moist air directly into the roof space. This is considered a defect under AS 4349.1, as it does not meet the minimum standard of residential building performance expected under normal residential building practices.

This condition may lead to excessive condensation within the roof void, increasing the risk of mould growth, deterioration of insulation, timber decay, and overall reduced durability of building elements. It may also result in poor indoor air quality, potentially affecting occupant health.

It is recommended that the exhaust fan be modified by a licensed HVAC contractor or qualified builder, ensuring it is properly ducted to discharge externally in accordance with manufacturer specifications, the National Construction Code (NCC), and applicable Australian Standards.

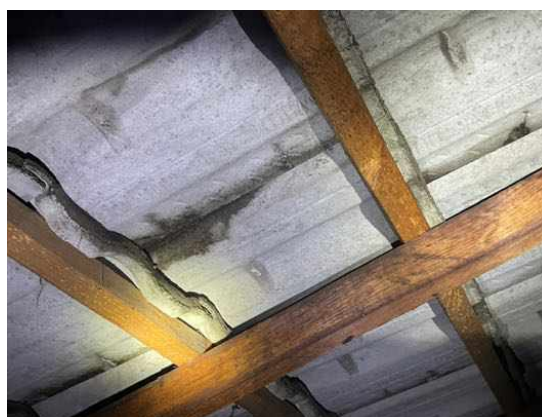
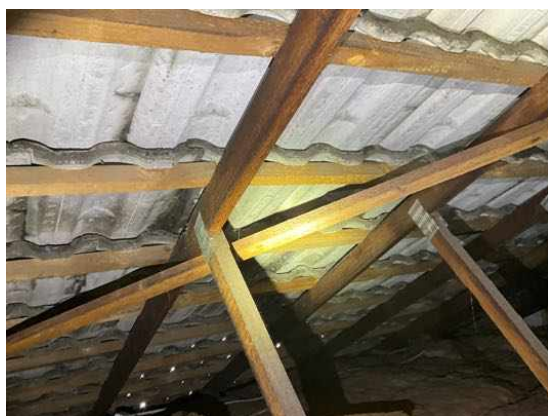
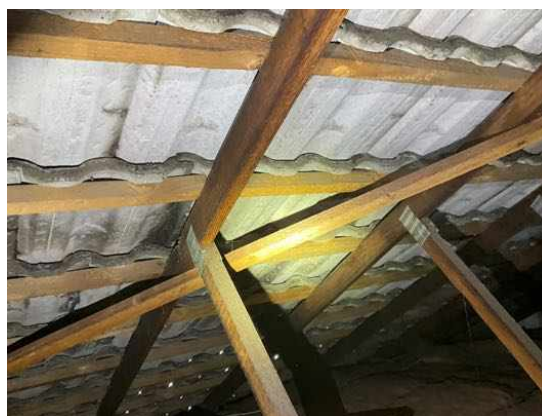
Finding 3.11

Location: Roof Void
Finding: Sarking - Missing
Information: Sarking is missing under the roof sheeting. Sarking acts as an insulator that helps with noise reduction and protects against water penetration. Sarking plays a key role in the operation and function of the overall roofing structure and its performance.

Although not a requirement at the time of construction, replacement of any missing building element is advisable (although this can be quite expensive to do after the time of construction). Where sarking is missing, regular inspections of the roof tiles for cracking and potential moisture penetration is required.

Sarking may be retrospectively fitted by a registered builder at the discretion of the client.

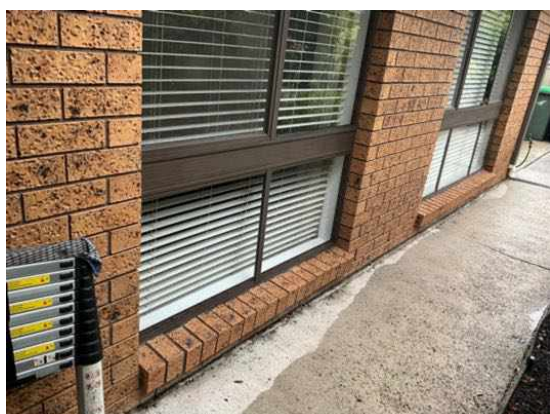
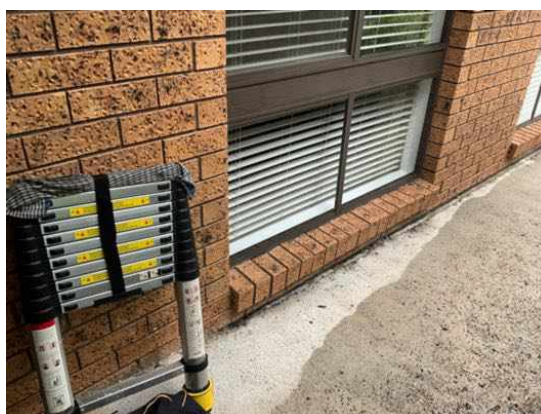
If the slab edge is not properly exposed there is a high risk of termite attack. Sometimes, in order to determine the type of slab, a suitably qualified person such as an architect or builder may be required to consult the construction plans.

Where the slab edge cannot be properly inspected, it is highly recommended that termite or timber pest inspections be carried out every 6-12 months to aid protection of the property against infestation.

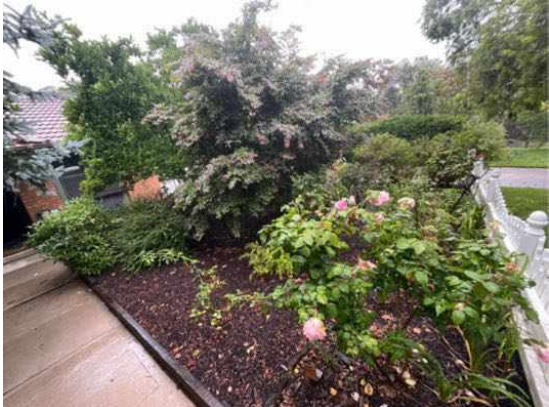
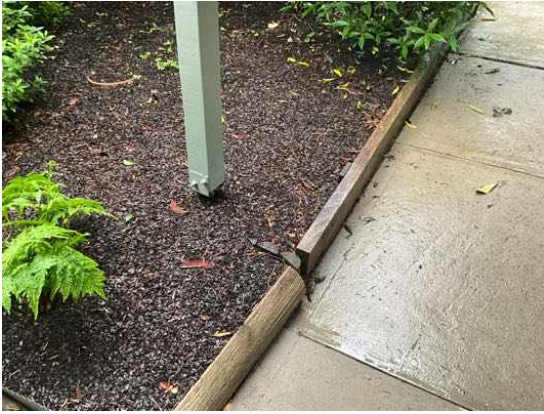
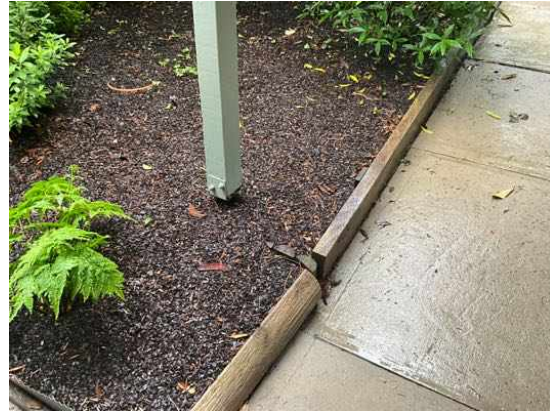
Finding 6.03

Building: Main Building
Location: All Areas
Finding: Timber on ground / conducive conditions to termite damage
Information: Timber on the ground is indeed conducive to termite damage. Termites are known to thrive in moist environments, and wood in contact with soil or moisture is more susceptible to infestation.

To prevent this, it's important to keep timber elevated and away from direct ground contact. Regular inspections and proper termite control measures are also essential to protect your wooden structures from termite damage.

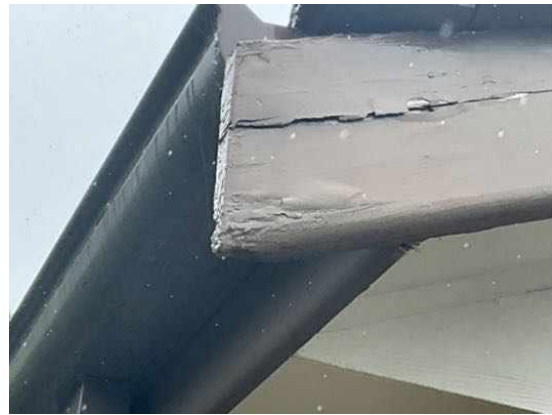
Building:	Main Building
Location:	All Areas
Finding:	Wood rot
Information:	This building element shows evidence of wood rot. Wood rot, also known as Fungal Decay, occurs when timbers and other cellulose building materials are exposed to damp conditions on an ongoing basis. This could be the result of exposure to weathering over a prolonged period of time, or the attraction of excessive moisture from other abutting building materials. Contributing factors also include poor air ventilation in the area.

Wood rot is often associated with general damp problems and is evidenced by a 'musty' smell or mould and mildew occurring on surfaces. If left unmanaged, damp conditions can lead to further health problems and the decay of timbers will continue.

Early intervention and regular maintenance, particularly of exterior timbers, will prolong the useful life of these building elements. Prior to any works being performed, the cause of the moisture that has created the visible wood rot should be identified and addressed in a suitable manner. Replacement of affected timbers may then be a necessary step in protecting surrounding building elements from such deterioration.

A qualified plumber may be appointed to assess the cause of excessive moisture and to provide advice on any remedial works as required. A qualified carpenter or registered builder may also be required to replace affected building materials.

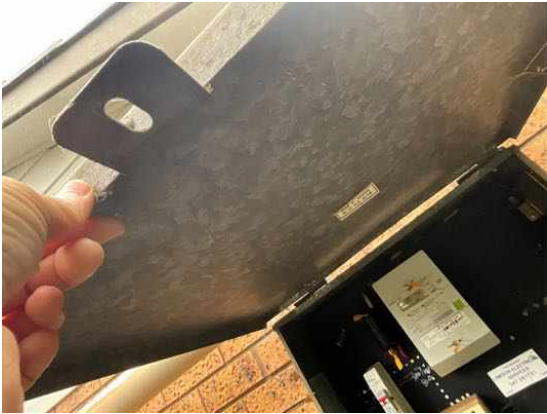
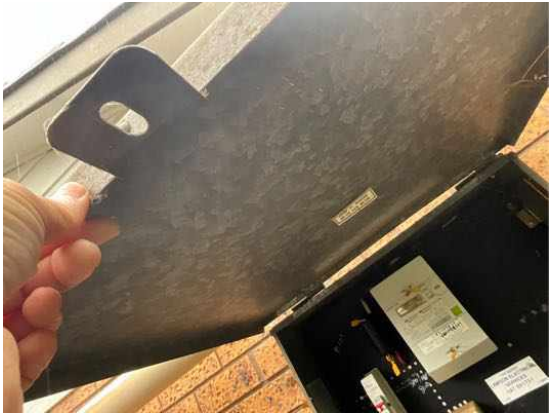
A durable notice placed in the switchboard unit to indicate termite barriers at the time of inspection.

Client must seek further information from the vendor or real estate agent if the conditions of termite management systems were maintained as per the label or seek advise from licensed pest controller.
