Building and Timber Pest Inspection Report

Inspection Date: Mon, 12 Jan 2026

Property Address: 20 Grandview Ave, Rye VIC 3941, Australia

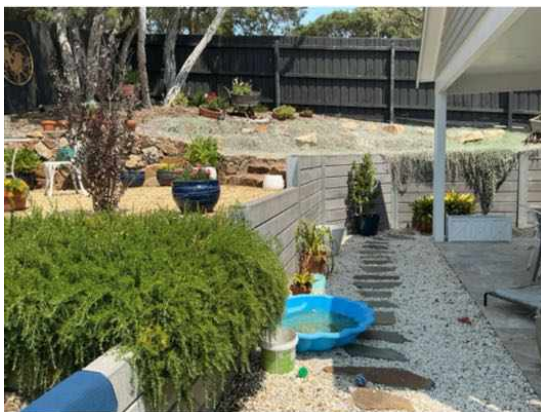
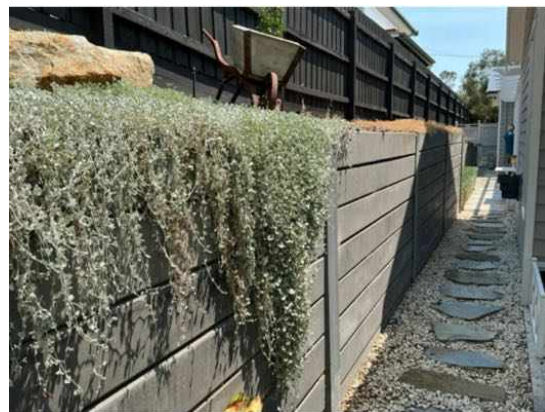
Finding 1.01

Building:	Main Building
Location:	Yard - Back
Finding:	Balustrade missing Non-Compliance
Information:	The balustrades to the rear retaining walls is missing, creating a potential fall hazard particularly for children.

Some changes to the building regulations are made to ensure the safety of all inhabitants and balustrades are definitely one of those crucial regulations.

This defect creates a potential safety hazard and should be rectified as soon as possible to ensure the safety of the area and to meet present building standards and regulations.

A registered builder should be contacted to discuss possible rectification solutions.

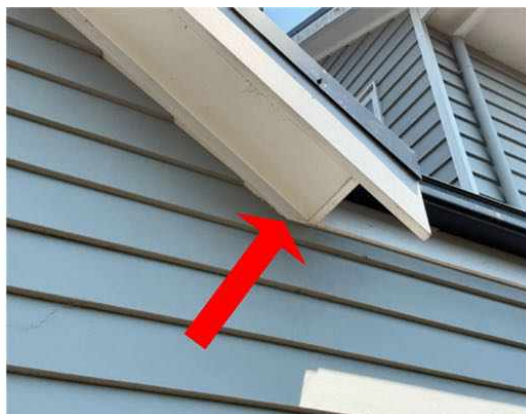
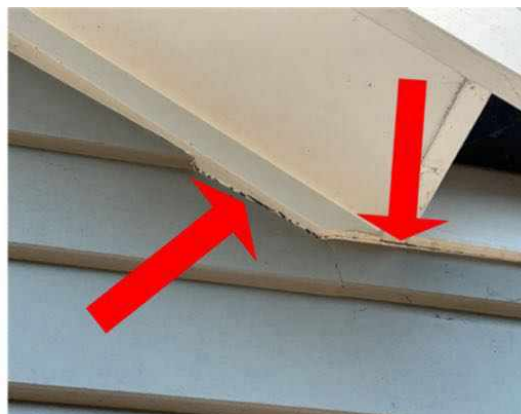
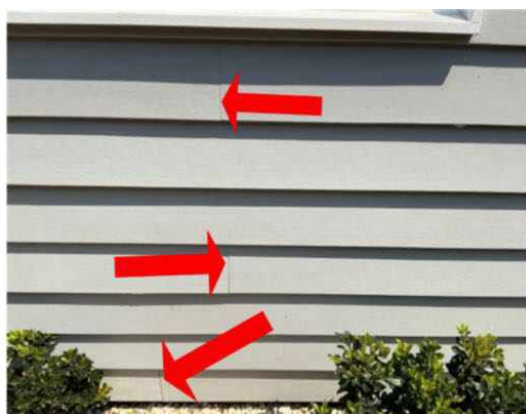
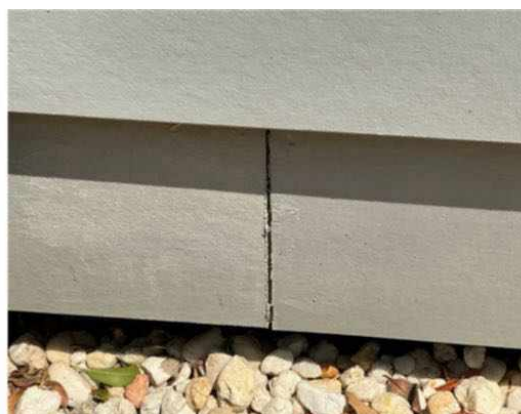
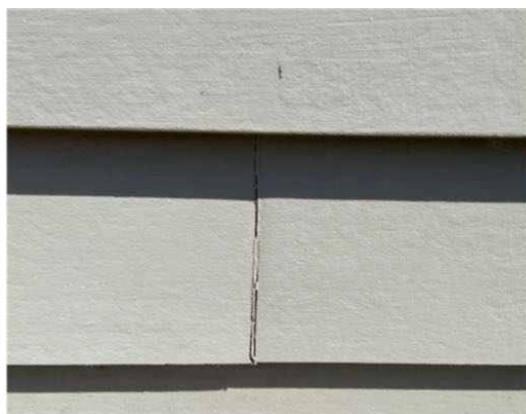
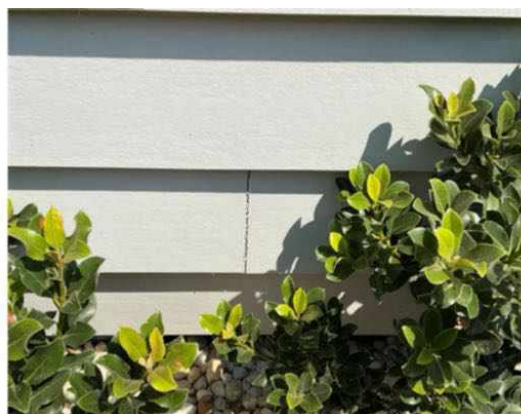
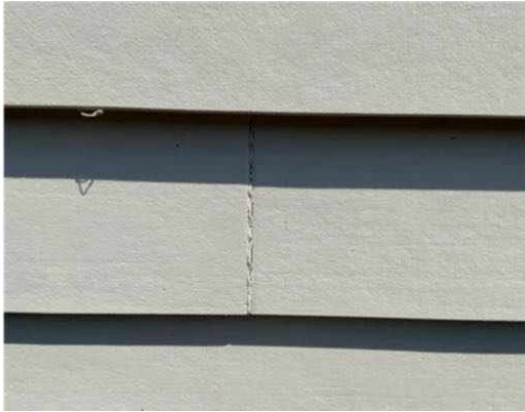
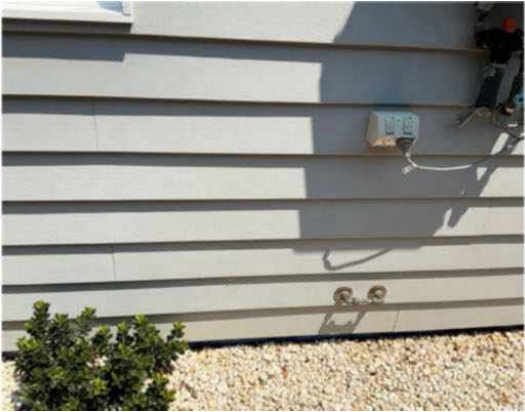
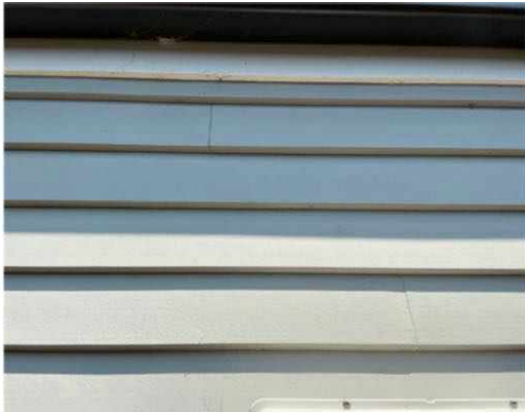
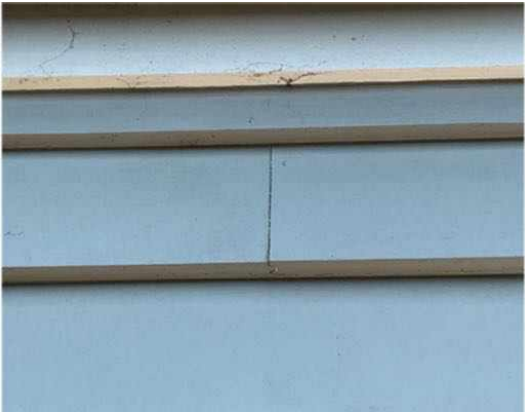
Finding 3.01

Building: Main Building
Location: Exterior walls - left side
Finding: A few gaps to the exterior walls
Information: A few gaps were noticed to some of the exterior walls to the building. These gaps can let in water, drafts, and pests. Overtime moisture ingress may cause damage to internal walls, mould growth, or structural issues. Gaps also reduce the energy efficiency of the property. Recommend engaging a painter to seal gaps to reduce the risk of pest/water penetration to the building at the owners discretion.

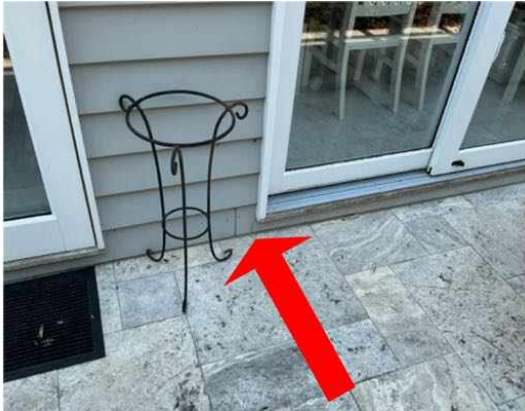
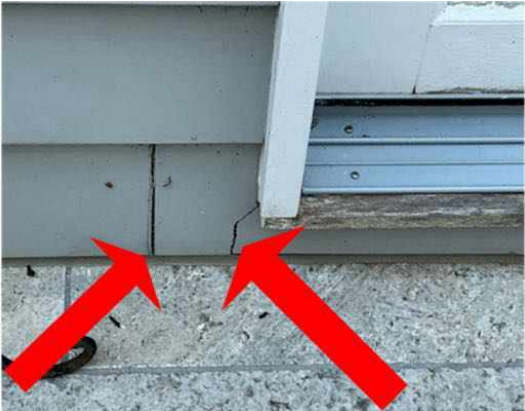
Finding 3.02

Building: Main Building
 Location: Exterior walls - right side
 Finding: A couple of gaps to the exterior wall
 Information: A couple of gaps was noticed to the right hand side of the building. These gaps can let in water, drafts, and pests. Overtime moisture ingress may cause damage to internal walls, mould growth, or structural issues. Gaps also reduce the energy efficiency of the property. Recommend engaging a painter to seal gaps to reduce the risk of pest/water penetration to the building at the owners discretion.

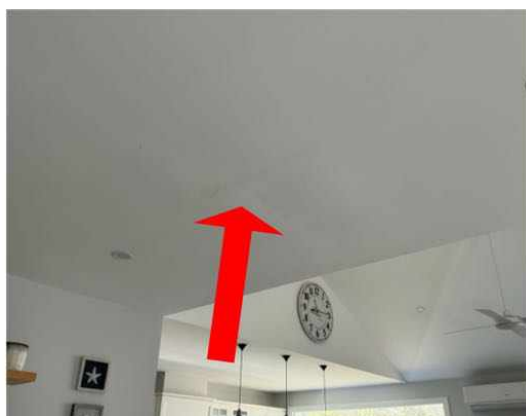
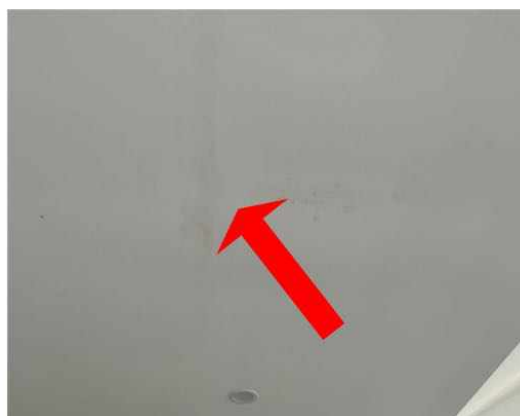
Finding 3.03

Building:	Main Building
Location:	Living Room
Finding:	Living room Evidence of moisture stains but tested dry
Information:	Evidence of moisture stains was found to the living room ceiling but tested dry using a moisture meter and thermal camera. Recommend monitoring and if further moisture staining is noticed contact a registered plumber straight away to rectify. Excessive moisture can attract termites and produce conditions that promote termite attack, fungal growth and wood decay. Excessive moisture is generally caused by deteriorated, inadequate or missing roof drainage, leaking plumbing pipes or fixtures, poorly plumbed HWS overflows or condenser units and poor site drainage. It is highly recommended that all plumbing and drainage fixtures and fittings be maintained regularly in order to prevent excessive moisture being present in the external / internal property.

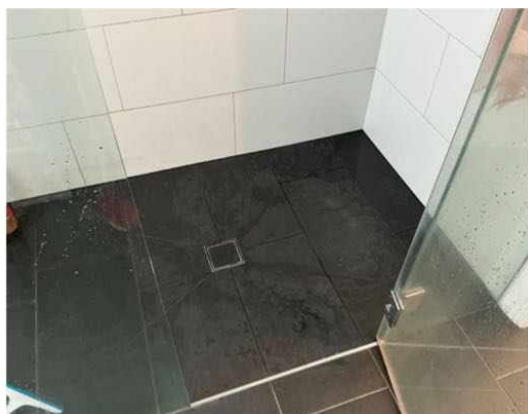
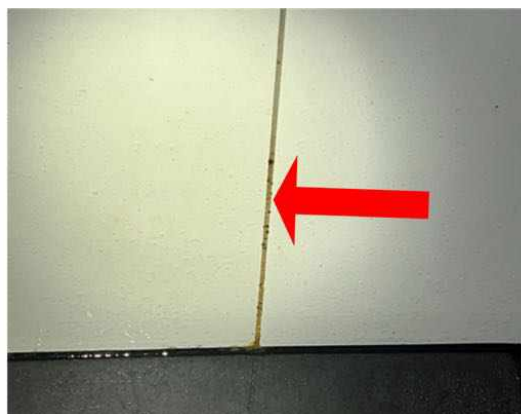
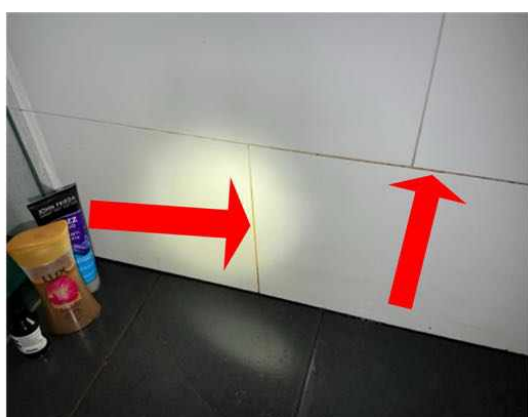
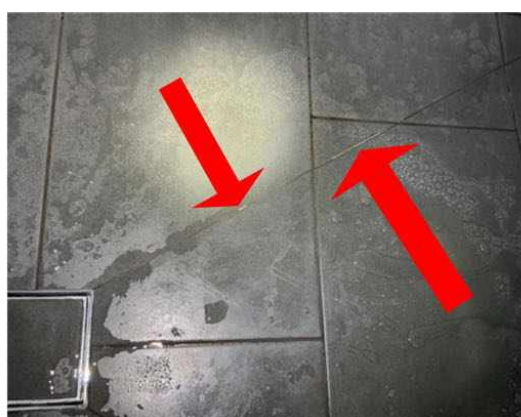
Finding 3.04

Building:	Main Building
Location:	Ensuite - Master
Finding:	Bathroom Sealant grouting - Missing or damaged degraded
Information:	It was noted on inspection that sealant or grout is degraded/missing or damaged to the tiled shower alcoves and or other areas of the bathrooms.

Different materials and floor areas move at different rates, generally causing cracking to grout or sealant at this point. A flexible sealant is required to allow for expected expansion and contraction, while keeping the joint water tight and protective of all associated building materials.

Flexible and mould resistant materials should be applied to affected areas to prevent any subsequent water damage that is likely to occur. Regular maintenance and replacement of damage or missing or damaged sealant and grout is highly recommended to the wet areas, as this is a regular wear and tear defect. Sealant and grouting in areas that come into regular contact with water should be maintained for the long term care of your property.

A sealant specialist or tiling contractor should be appointed to complete these works as soon as possible

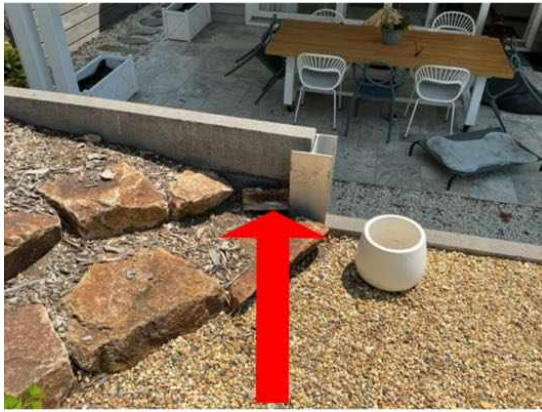
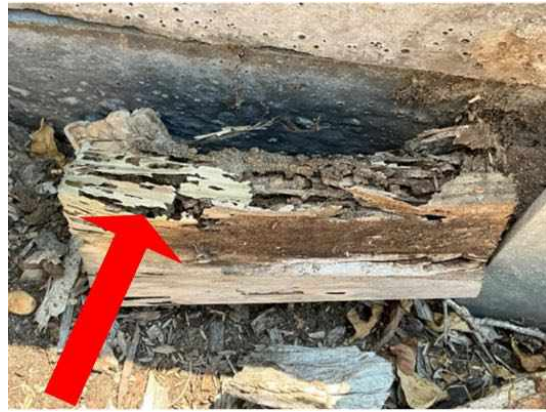
Finding 5.01

Building:	Main Building
Location:	Yard - Back
Finding:	Evidence of termite damage
Information:	Despite no live termite or timber pest activity being indicated, previous termite damage was found to have effected the timber in the rear yard. This damage is considered to be inactive and is minor in nature.

It is advised that the timber be removed or the area be visually inspected frequently to ensure that the condition of the materials does not worsen. At the time of inspection, damage is only considered to be superficial.

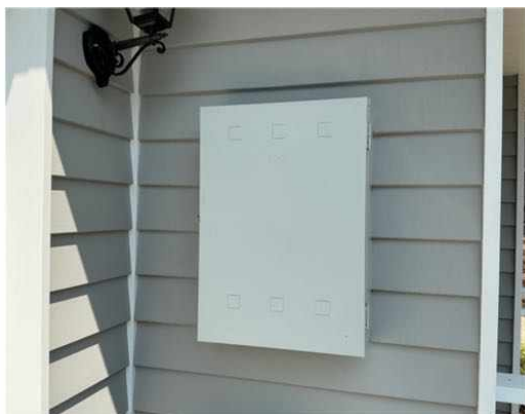
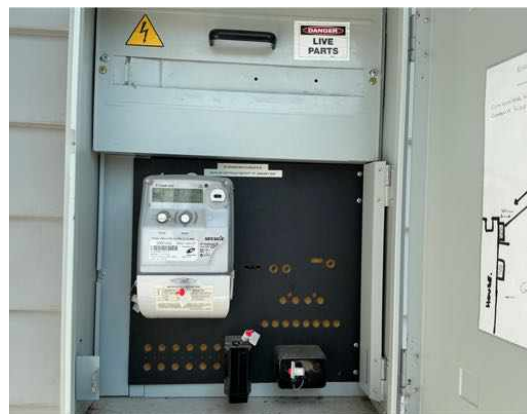
Finding 6.01

Building:	Main Building
Location:	All External Areas
Finding:	No Termite Management System - no evidence of a chemical installation
Information:	The application of a post-construction chemical termite barrier is highly recommended for all properties, particularly if live termite activity has been found on the site previously. Such barriers are highly effective in preventing termite attack on any timber building elements throughout the property.

A durable notice should be placed in the switchboard unit to indicate current termite barriers. At the time of inspection, it appeared as though no termite management system has been installed, with no evidence to suggest preventative works taking place.

The client may consider gaining further advice from a pest controller as to the costs and procedures involved with this application. It is recommended that obtaining such advice be a short-term priority.

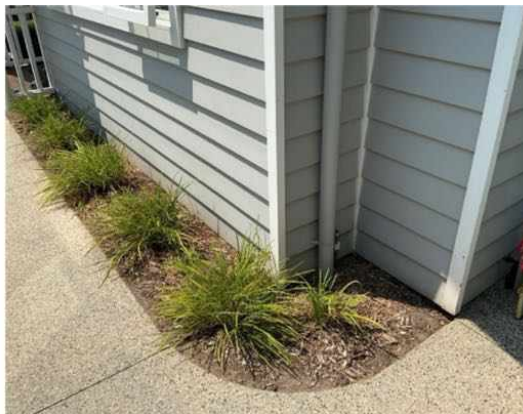
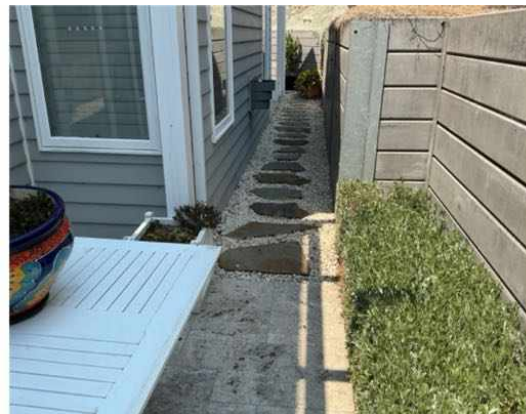
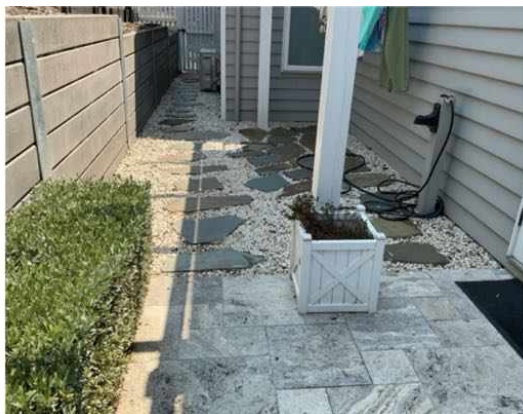
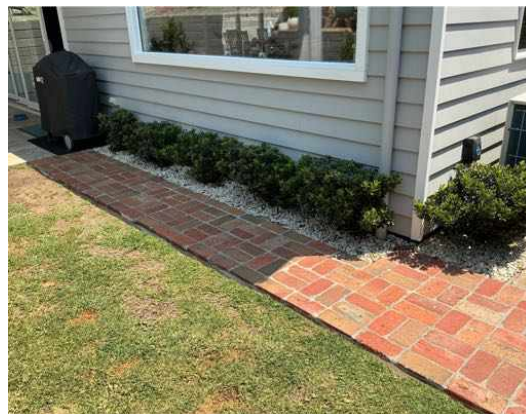
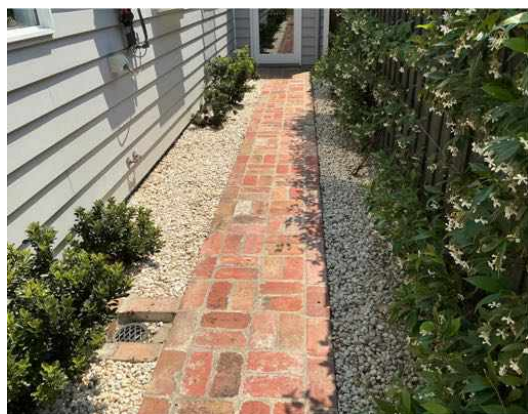
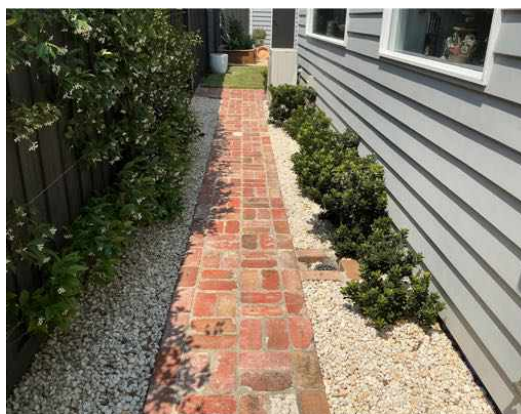
Finding 6.02

Building: Main Building
Location: Yards
Finding: Site drainage - poor/inadequate
Information: The site drainage to parts of the yards was found to be inadequate at the time of inspection, creating potential for subsequent water damage to associated building elements. Excessive moisture will attract termites.

It is important that water does not lie against the base of walls; surrounding paths and ground levels should be sloped to drain water away from walls. Downpipes should not discharge stormwater onto lower walls or plinths. Stormwater should be carried away by large, regularly cleaned drains. Ground levels may need to be lowered to expose a buried DPC.

Where site drainage is inadequate, installation of an Agricultural (Aggie) Drain may be required. A qualified plumber should be appointed to further inspect the property and perform any remedial works as necessary. Water damage and secondary defects are likely to occur if left unmanaged.

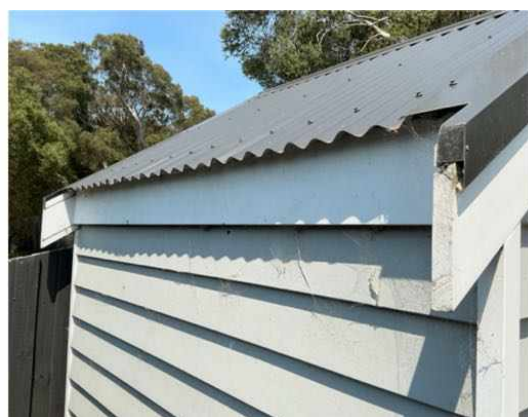
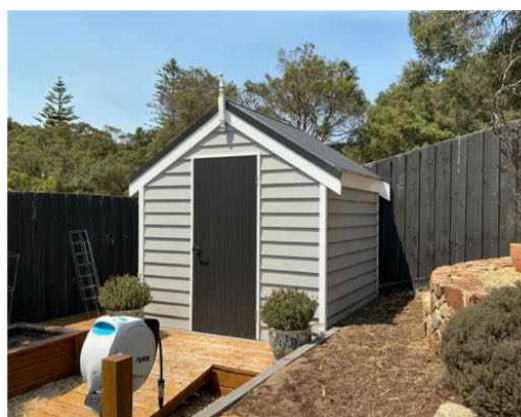
Finding 6.03

Building:	Main Building
Location:	Yard - Back
Finding:	Shed No gutters or down pipes installed
Information:	No gutters or down pipes installed on the shed. Where plumbing doesn't drain adequately, the area at the base perimeter can become excessively damp, potentially creating an environment that is susceptible to rust and corrosion of surrounding building elements, as well as attracting termites and other pests. .Recommend engaging a plumber to install gutters and down pipes to reduce the risk of footing movement and other moisture related issues as soon as possible.

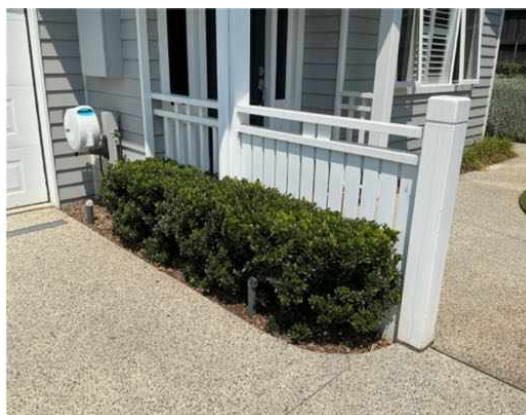
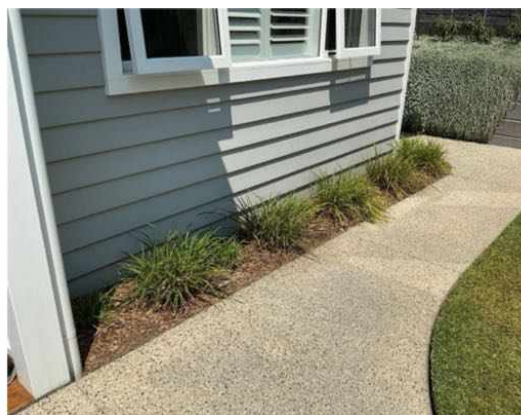
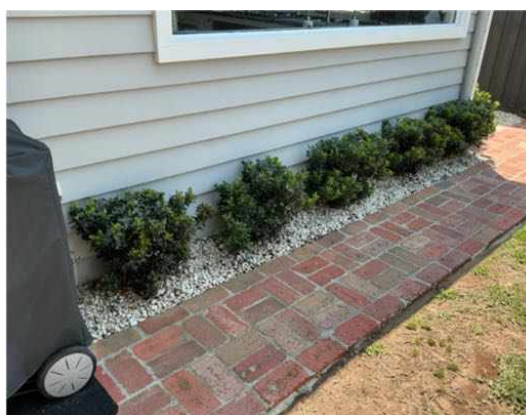
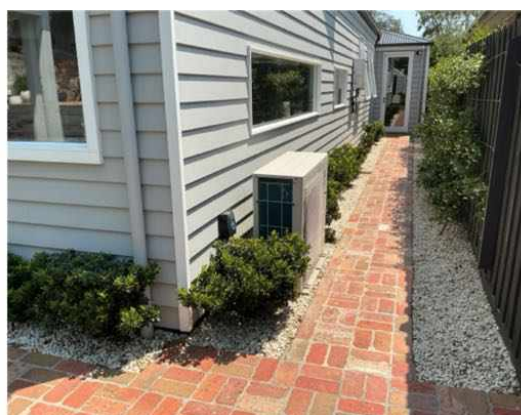
Finding 6.04

Building:	Main Building
Location:	Yards
Finding:	Garden Beds Conditions Conducive to Termites
Information:	Garden beds were found to be evident in close proximity to the building. Garden beds immediately adjacent to the perimeter of the building block the visual inspection of these areas, providing a concealed termite entry point.

These garden beds can include untreated timber, and with a combination of moisture from watering/hosing can make conditions conducive to termite activity and termite

ingress.

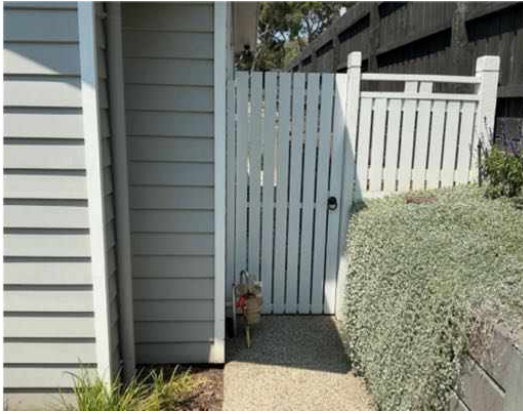
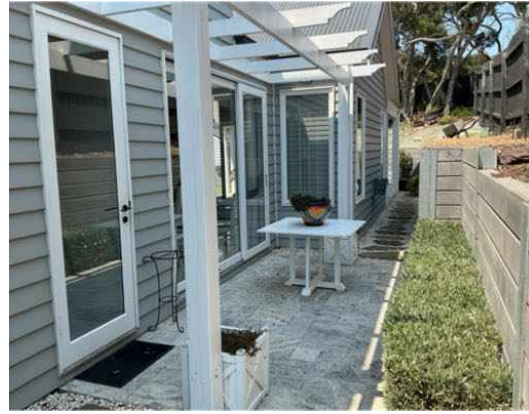
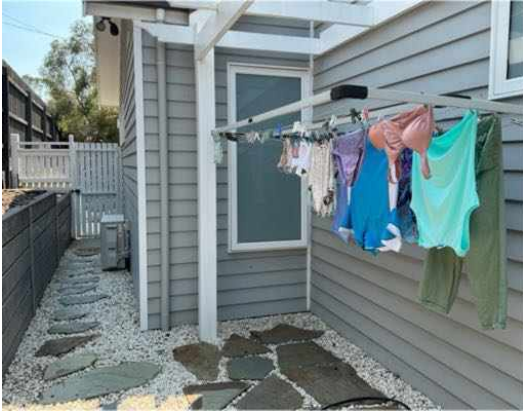
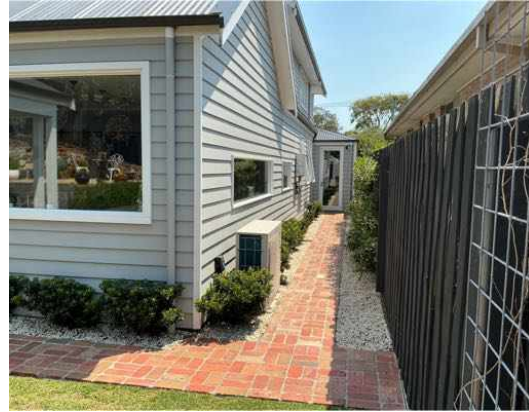
Finding 6.05

Building:	Main Building
Location:	Various parts of the building
Finding:	Bridging attachments to buildings
Information:	Bridging occurs when items against a building provide a concealed entry point for termites into the building or by passing around a termite management system.

Where any part of an attachment to a building is not isolated and is not provided with a clear gap of not less than 25mm from building, bridging occurs. Attachments to buildings such as hot water services, downpipes, verandahs, decks, steps, fences, service conduits and the like provide the opportunity for concealed entry.

Building attachments of this nature need to be frequently inspected for termite activity by a qualified inspector.

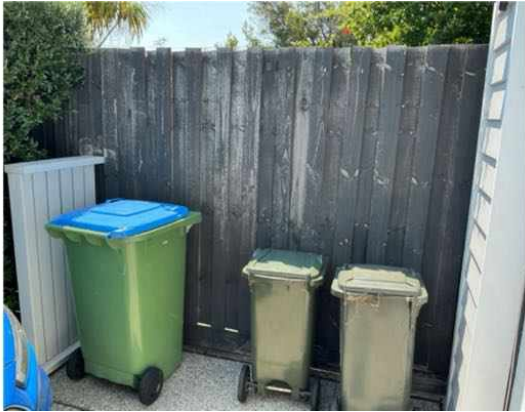
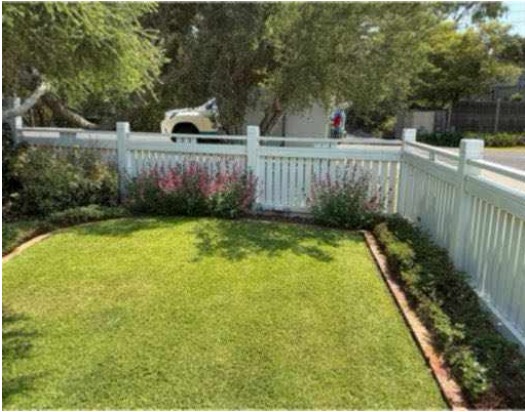
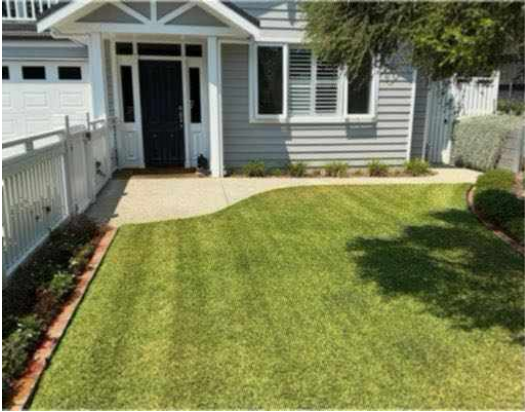
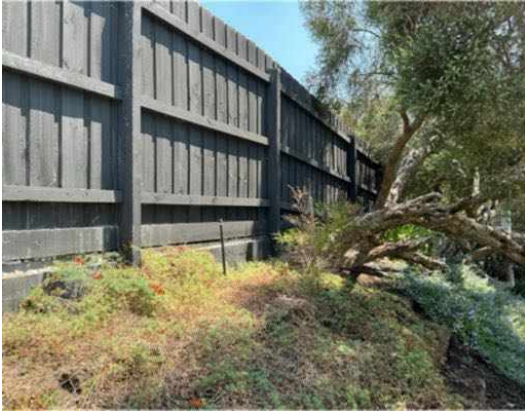
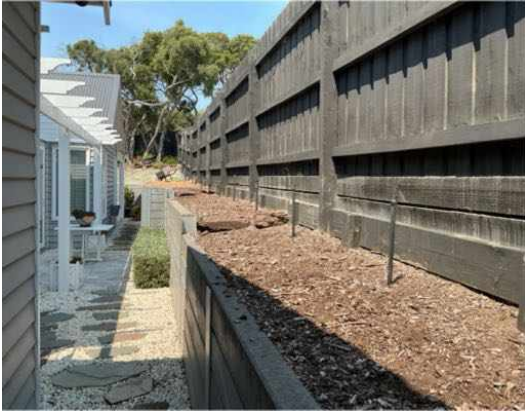
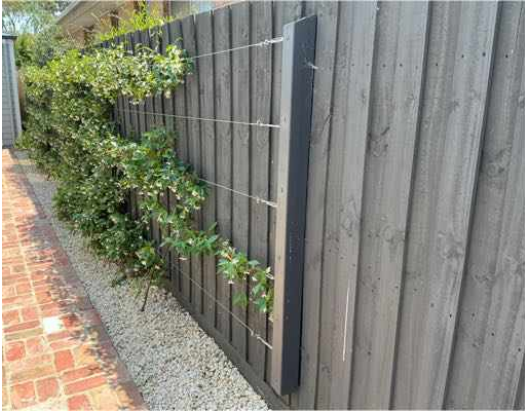
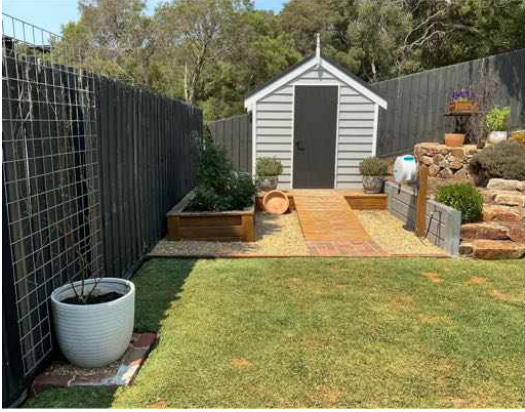
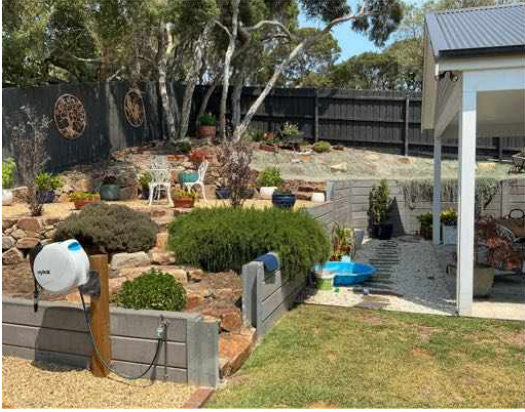
Finding 6.06

Building:	Main Building
Location:	Various parts of the building
Finding:	In ground contact
Information:	Any timbers in direct ground contact provide opportunity for concealed termite entry and are likely to be subject to premature rot and decay as the soil retains moisture or damp conditions against the timbers.

Remove untreated timber that is in direct contact with external grounds. Consider replacement with more durable materials i.e. treated timber or non timber elements. Frequent pest inspections are advised to readily identify any termite activity in these areas.

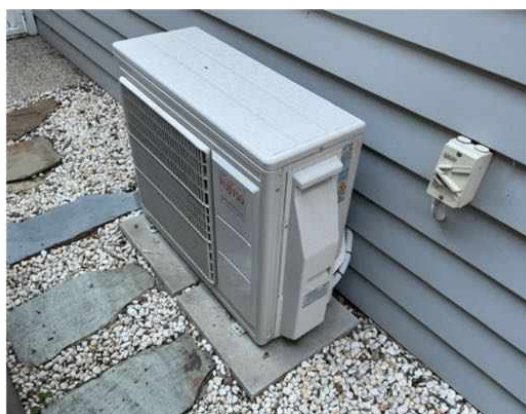
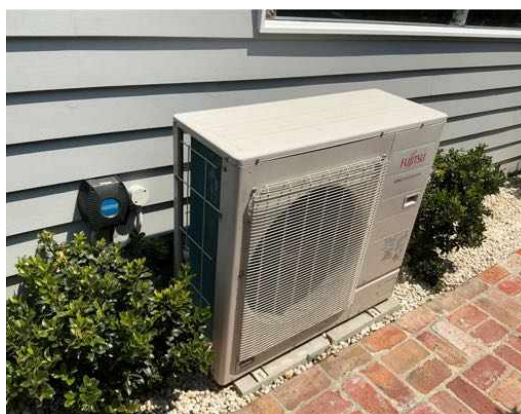
Finding 6.07

Building: Main Building
Location: Yard - Back
Finding: Air conditioning unit overflow -Not plumbed for drainage
Information: The overflow to the air conditioning unit is not plumbed or connected to suitable drainage, which has resulted in the surrounding area becoming excessively damp. These damp conditions can lead to secondary defects such as rot, rust or corrosion of associated building elements, the formation of fungal decay, or even the creation of potential slip hazards. When coupled with poor site drainage, pooling of water may also attract termite activity to this area. It is highly recommended that a qualified plumber be appointed to install adequate drainage to the overflow. These works will ensure that the area remains dry and free of any secondary defects.
