Building and Timber Pest Inspection Report

Inspection Date: Tue, 27 Jan 2026

Property Address: 71 Peartree Cct, WERRINGTON, NSW,
2747, Australia

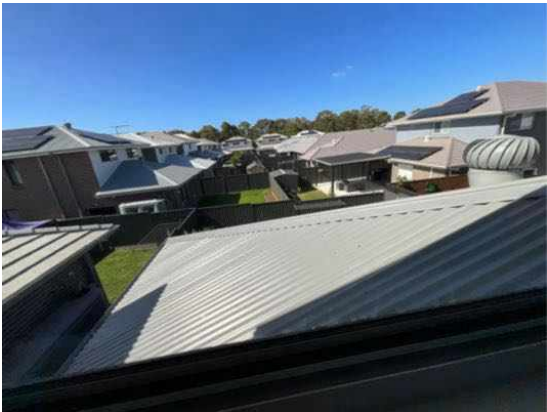
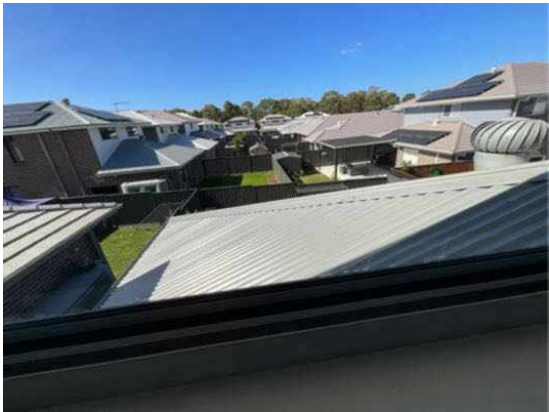
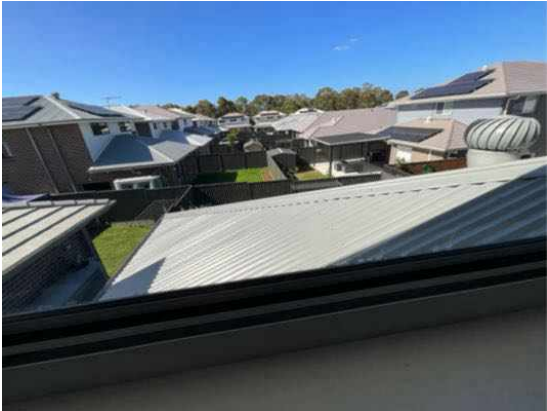
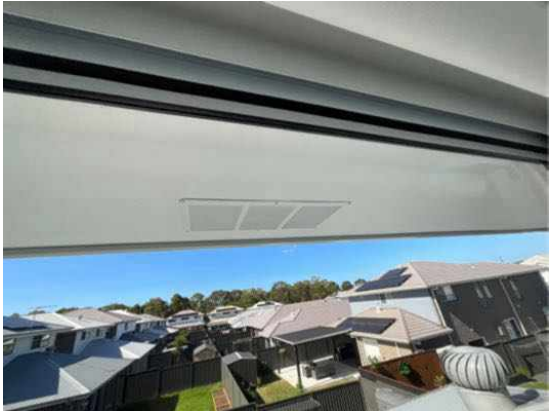
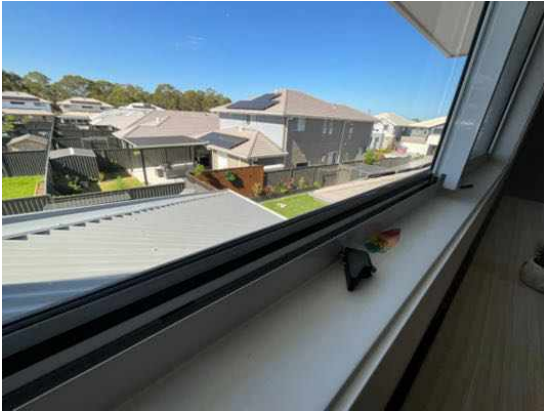
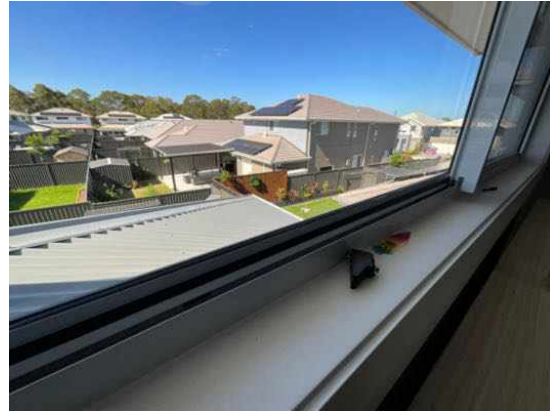
Finding 1.02

Building: Main Building
Location: All Areas
Finding: Window child lock missing
Information: The window in question lacks a child lock mechanism, which poses a potential safety risk to young occupants in the premises. As per Australian Standards windows accessible to children should be equipped with appropriate child safety locks to prevent accidental opening, reducing the risk of falls and ensuring compliance with safety regulations.

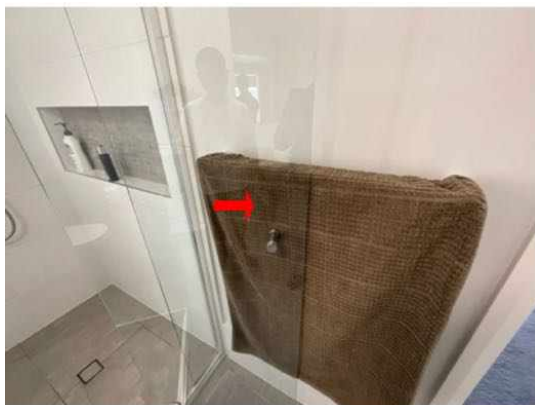
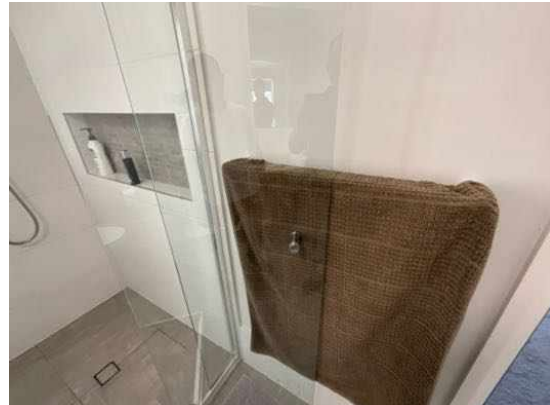
Finding 1.03

Building: Main Building
 Location: Ensuite
 Finding: shower screen door hitting fixed towel rail/bar
 Information: The shower screen door was found to make contact with the fixed towel rail/bar upon opening. This indicates poor placement or alignment of fittings.

This condition is considered a potential safety hazard. Ongoing impact may lead to loosening of fittings or damage to the shower glass, which carries a risk of glass breakage and injury to occupants.

Recommendation:

It is recommended that a licensed glazier or bathroom renovator further evaluate and rectify this issue. Adjustment of the shower screen door alignment or relocation of the towel rail is required to prevent contact and ensure safe operation.

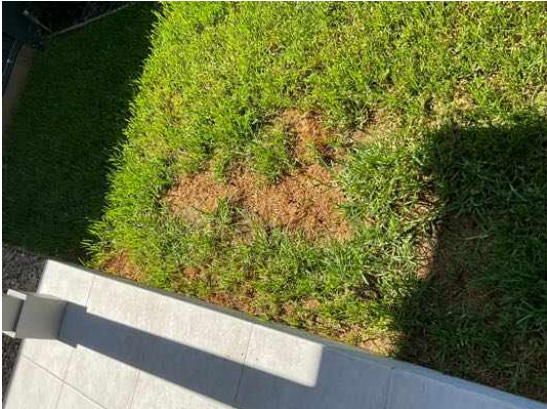
Surface water drainage is defective if it is not in accordance with the requirements of the Building Code of Australia.

Such water pooling also increases the risk of termite activity and the development of fungal decay in the area.

Consult a Licensed Plumber regarding the cost of potential site drainage rectification works.

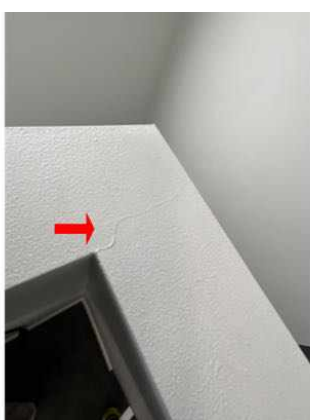
Finding 3.02

Building: Main Building
 Location: Upstairs
 Finding: Cracking - Damage Category 0 - Hairline (less than 1mm)
 Information: Hairline cracks are very minor in nature and generally are only ever an appearance defect. While such cracking may be noticeable in some cases, it is quite common and does not indicate any structural damage.

Cracking of this nature can generally be repaired with minor sanding, filling and/or repainting. Such works should be performed by a qualified painter or a general handyman.

Monitoring of all cracking should be conducted frequently. Always contact a building inspector should cracks widen, lengthen, or become more numerous.

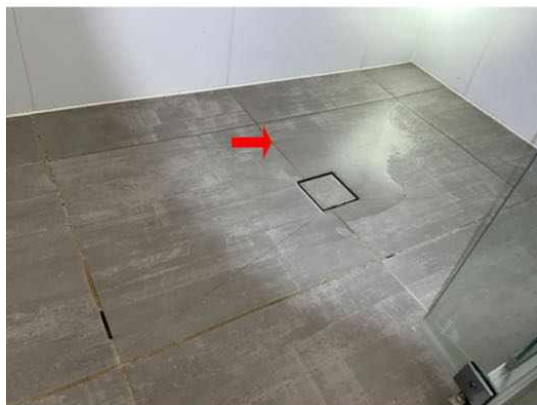
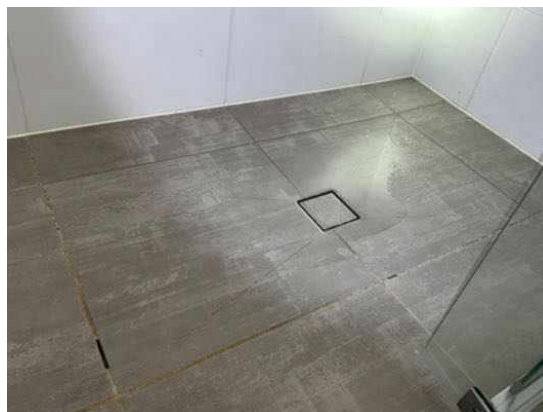
Building:	Main Building
Location:	Bathroom
Finding:	Shower base - Water pooling
Information:	Evidence of water pooling around the floor waste in the shower recess was noticed at the time of inspection. It is suspected that this excessive moisture is attributed to insufficient fall in the shower floor tiles.

This pooling is minor overall but is still considered unsatisfactory, as standard tiling practices would not permit this situation to occur. Pooling water around floor wastes can create a slip hazard in extreme cases and create conditions that are conducive to mould growth over time. Where left unmanaged, the degradation of sealant and grouting is also likely to occur, possibly necessitating further repair works.

Remedial works may involve some sections of tiling and flooring repair and replacement. A tiling contractor or bathroom specialist should be appointed to provide further advice on reparation options and to perform works as necessary.

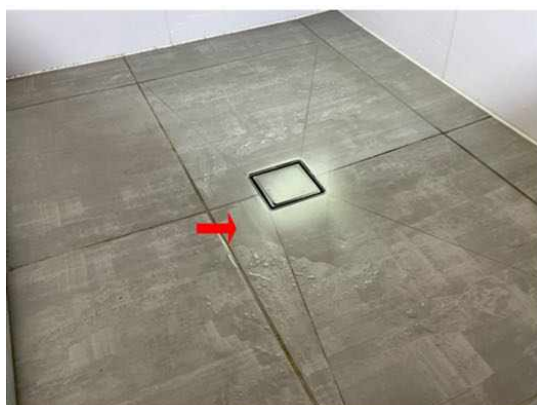
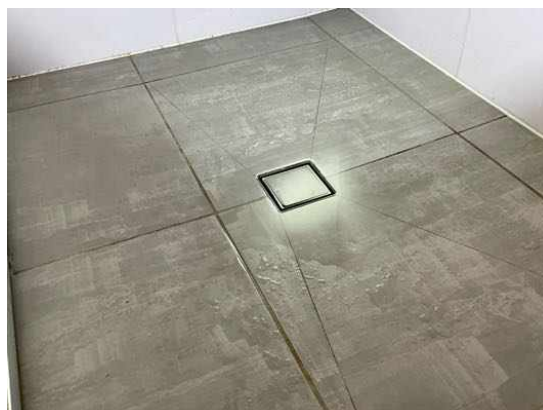
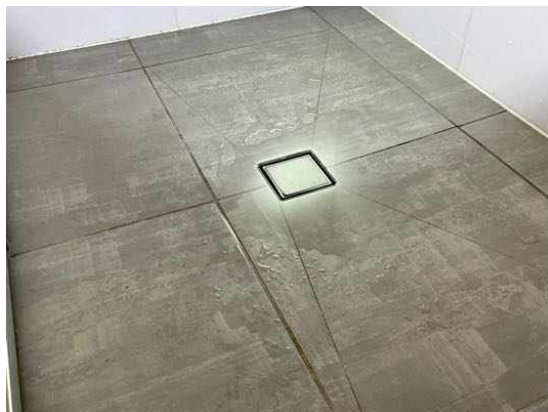
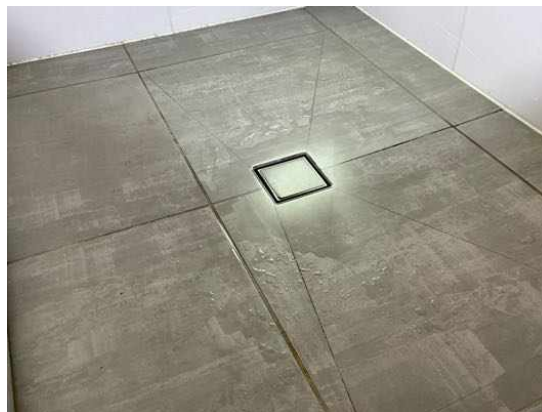
Finding 3.05

Information: Evidence of water pooling around the floor waste in the shower recess was noticed at the time of inspection. It is suspected that this excessive moisture is attributed to insufficient fall in the shower floor tiles.

This pooling is minor overall but is still considered unsatisfactory, as standard tiling practices would not permit this situation to occur. Pooling water around floor wastes can create a slip hazard in extreme cases and create conditions that are conducive to mould growth over time. Where left unmanaged, the degradation of sealant and grouting is also likely to occur, possibly necessitating further repair works.

Remedial works may involve some sections of tiling and flooring repair and replacement. A tiling contractor or bathroom specialist should be appointed to provide further advice on reparation options and to perform works as necessary.

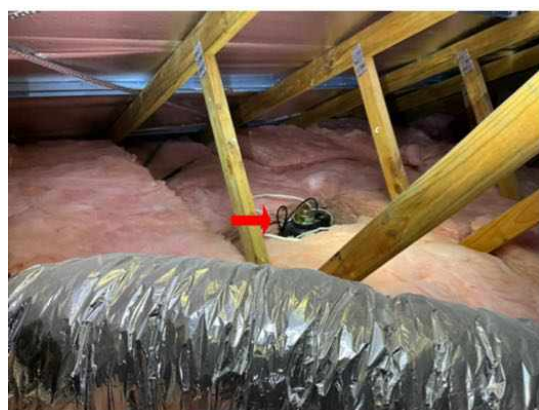
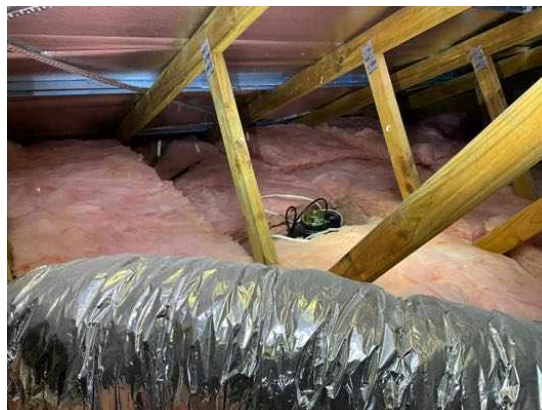
Finding 3.06

Information: The exhaust fan located within the roof void is not appropriately ducted to the external atmosphere and is currently discharging moist air directly into the roof space. This is considered a defect under AS 4349.1, as it does not meet the minimum standard of residential building performance expected under normal residential building practices.

This condition may lead to excessive condensation within the roof void, increasing the risk of mould growth, deterioration of insulation, timber decay, and overall reduced durability of building elements. It may also result in poor indoor air quality, potentially affecting occupant health.

Recommended Action:

It is recommended that the exhaust fan be modified by a licensed HVAC contractor or qualified builder, ensuring it is properly ducted to discharge externally in accordance with manufacturer specifications, the National Construction Code (NCC), and applicable Australian Standards.

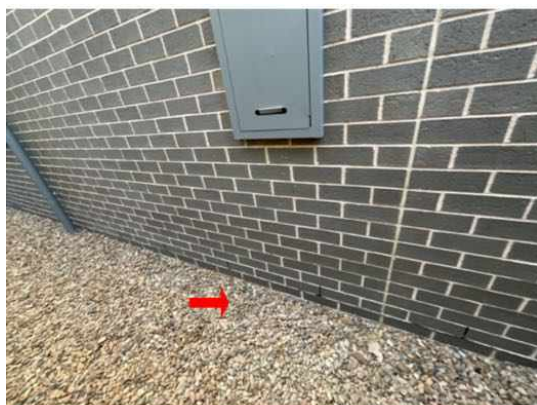
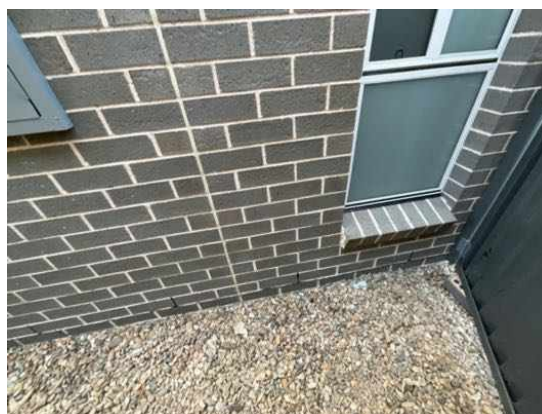
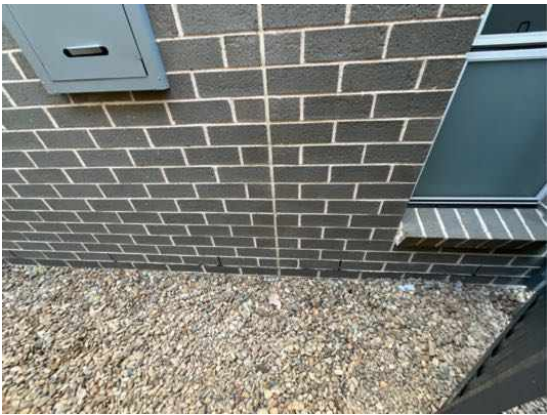
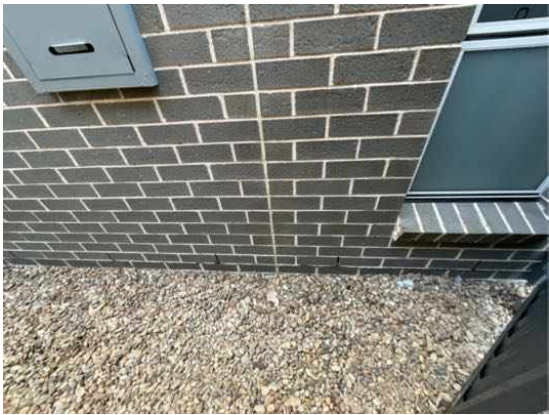
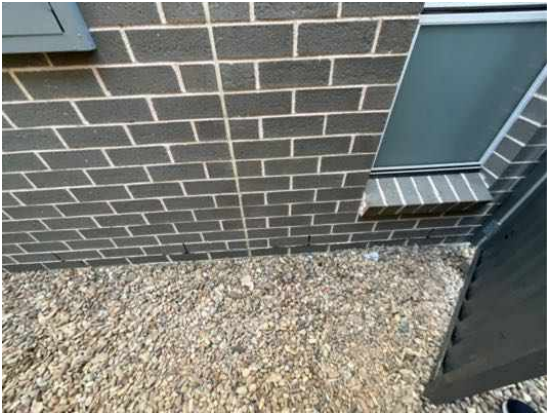
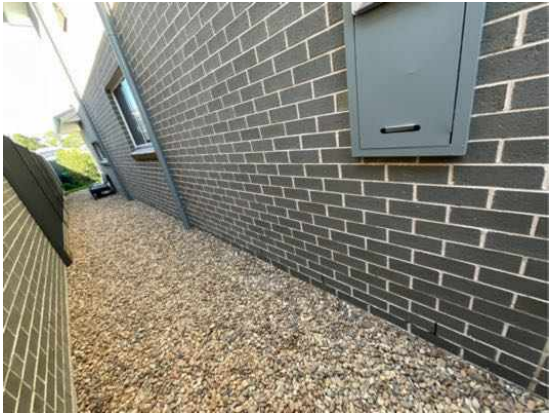
If the slab edge is not properly exposed there is a high risk of termite attack. Sometimes, in order to determine the type of slab, a suitably qualified person such as an architect or builder may be required to consult the construction plans.

Where the slab edge cannot be properly inspected, it is highly recommended that termite or timber pest inspections be carried out every 6-12 months to aid protection of the property against infestation.

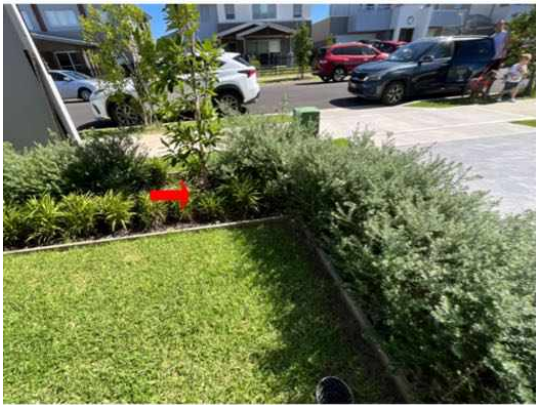
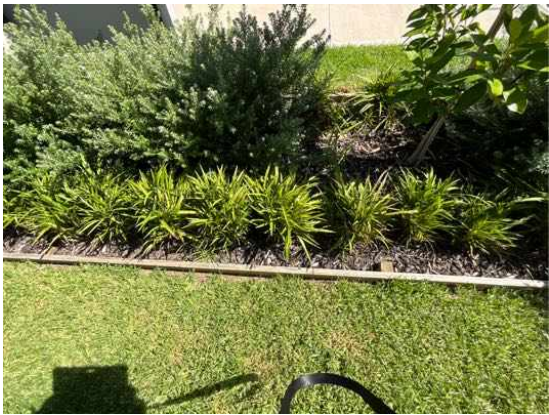
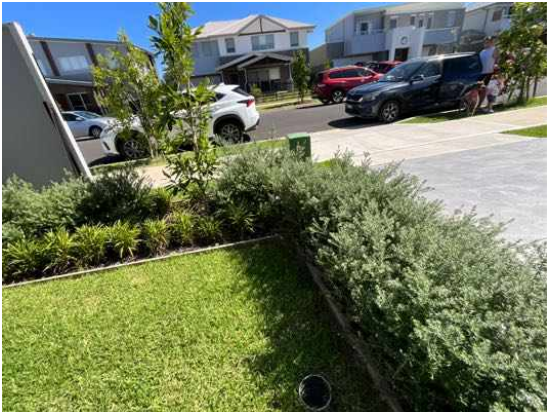
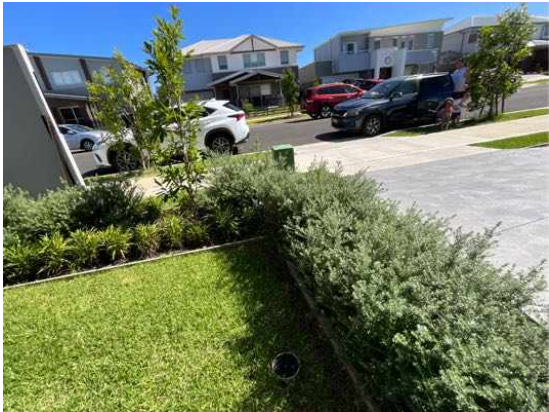
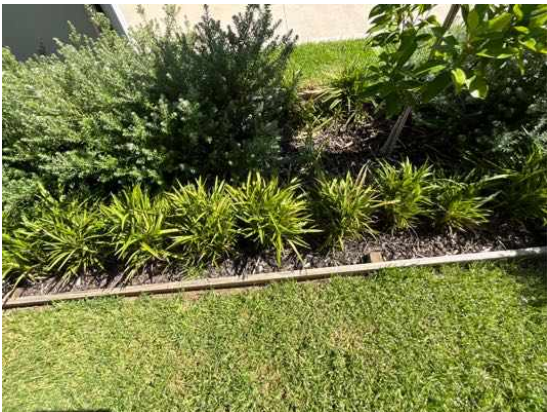
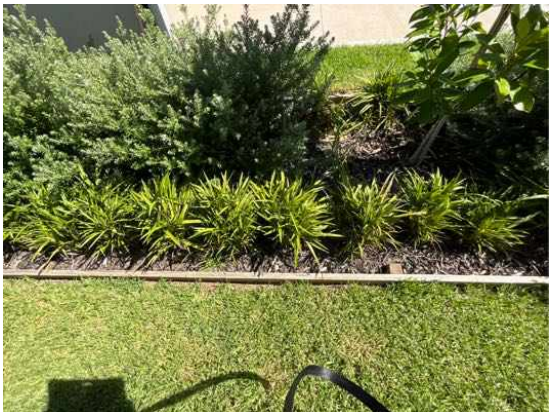
Finding 6.02

Building:	Main Building
Location:	All Areas
Finding:	vegetation around a property can increase the risk of termite infestation
Information:	The presence of vegetation around a property can increase the risk of termite infestation, as it provides a conducive environment for them. To address this, consider maintaining a clear space between the vegetation and your home. If you suspect a termite issue, it's advisable to consult with a licensed pest control professional for inspection and treatment.

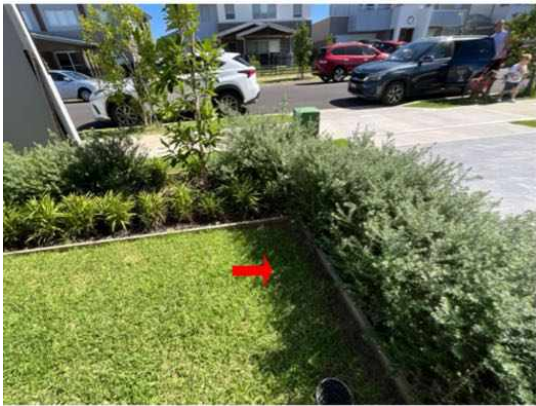
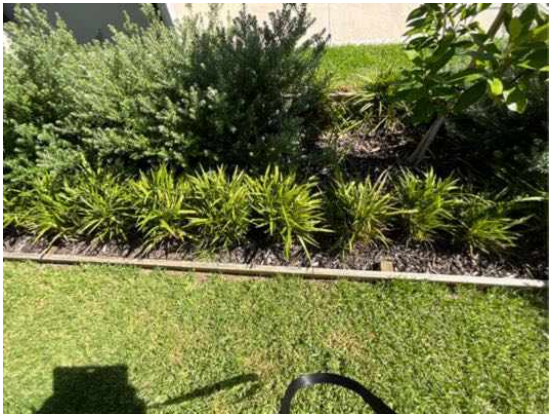
Finding 6.03

Building: Main Building
Location: All Areas
Finding: Timber on ground / conducive conditions to termite damage
Information: Timber on the ground is indeed conducive to termite damage. Termites are known to thrive in moist environments, and wood in contact with soil or moisture is more susceptible to infestation.

To prevent this, it's important to keep timber elevated and away from direct ground contact. Regular inspections and proper termite control measures are also essential to protect your wooden structures from termite damage.

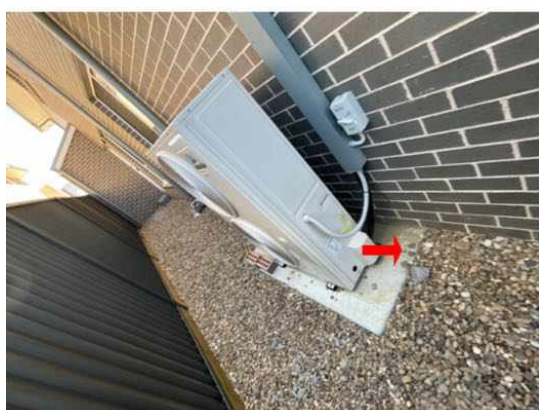
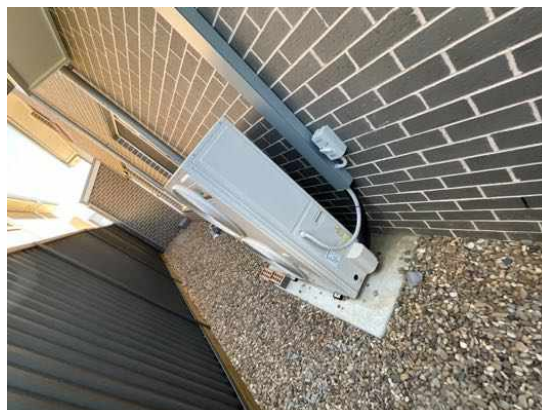
Where bridging has occurred full inspection is prevented and termites may enter a property in a concealed or undetected manner.

Recommended moving obstructions away from the external walls for further and future inspections.

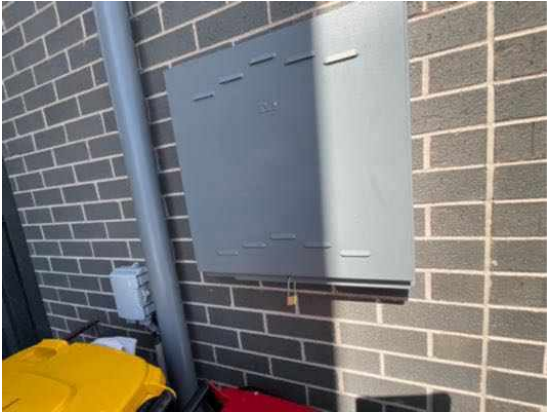
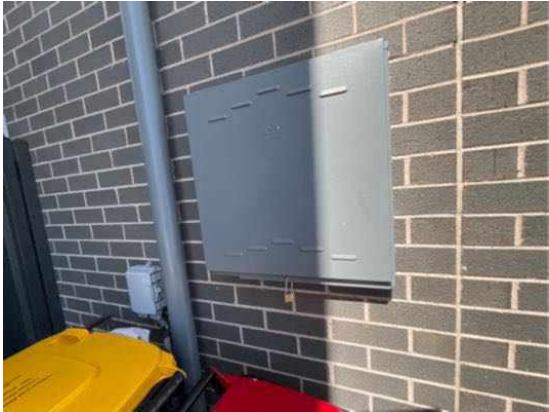
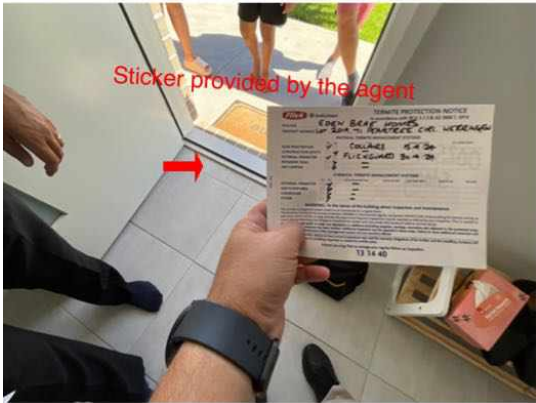
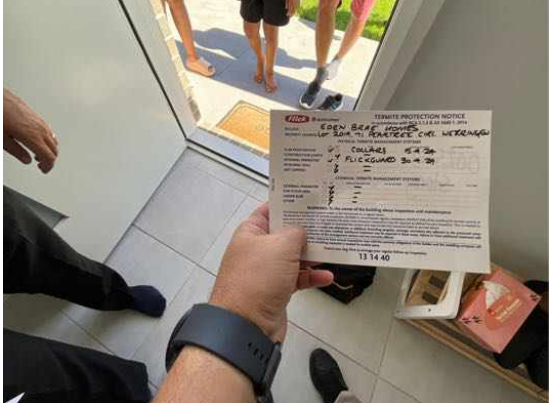
- Building: Main Building
- Location: Exterior walls - left side
- Finding: Evidence of Termite Management System - Durable notice / Legible Sticker - seek further information
- Information: The application of a pre & post-construction chemical termite barrier is highly recommended for all properties. Such barriers are highly effective in preventing termite

A durable notice was not sighted in the switchboard unit to indicate termite barriers however agent showed a copy at the time of inspection.

Client must seek further information from the vendor or real estate agent if the conditions of termite management systems were maintained as per the label or seek advise from licensed pest controller.
