Building and Timber Pest Inspection Report

Inspection Date: Tue, 3 Feb 2026

Property Address: 48 Panorama Dr, Farmborough Heights
NSW 2526, Australia

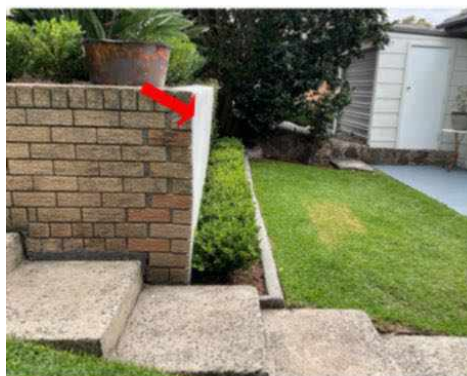
Building:	Building 1
Location:	Front retaining walls
Finding:	Retaining wall - Defective
Information:	The retaining wall in this left area was found to be defective at the time of inspection. It is leaning toward the house. Generally, defective retaining walls are caused by poor original design or material use. Retaining walls are normally constructed in blockwork or timber with adequate drainage installed. However, deteriorated retaining walls may also be a result of substandard construction, poor site drainage or unmanaged stormwater flows. No drainage was evident and it cannot be determined if any drainage exits behind these retaining wall areas.

The owner on request provided a page from the building inspection undertaken in June 2022, see below, indicating it appears this wall had some damage over 3 years ago.

“12.1. Brick retaining walls to the front property areas generally appear in a fair/functional condition with some,movement/rotation/cracking

apparent to accessible/visible sections at the time of this inspection. Brick walls were not designed to act as a retaining wall and could crack/fail at any time. Observe brickwork for any significant/further/future cracking/failure etc. We recommend you engage a structural engineer to reassess/investigate further &/or provide further advice with

regards any maintenance/rectification options/requirements”

If left unmanaged, the retaining wall may continue to move. Significant repair and replacement should be expected at some time in the future, It is recommended to seek advice from a structural engineer regarding repair of both front retaining walls.

A landscaper or retaining wall installer may the be appointed to repair or replace the wall, at the discretion of the client.

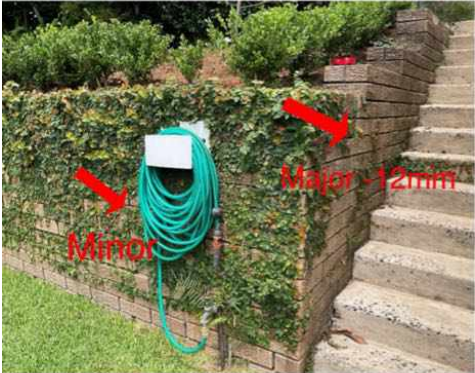
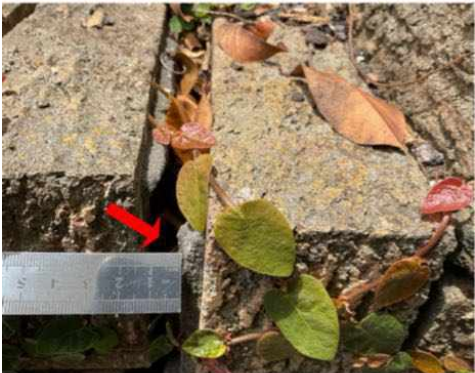
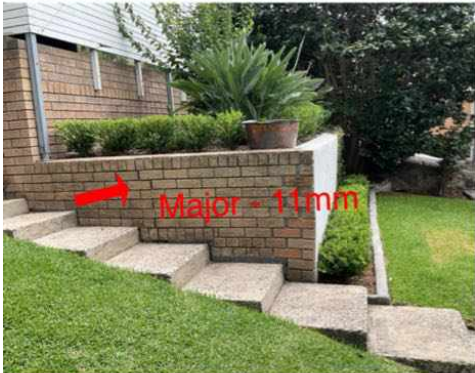
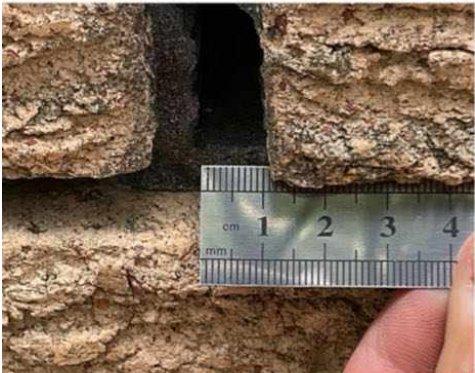
Finding 2.02

Building:	Building 1
Location:	Exterior front walls around stairs
Finding:	Step cracking to brickwork major
Information:	Step cracking was identified to the brickwork in the front external wall areas at the time of inspection.

The NSW Standards and Tolerances 2017 states cracks over 5mm in width are a major defect requiring rectification work. This applies to the two brick walls either side of the front stairs that show step cracking of 11mm and 12mm. Other very small cracks under 3mm were found under the vines on the right side wall.

Step cracking, which is similar to other forms of cracking, has a variety of possible causes. However, the most common is the subsidence of adjacent footings.

Step cracking is a relatively common defect. Mortar failure in the gaps between affected bricks indicates the stresses and tensions affecting the wall.

Where step cracking is extensive or severe, the client is advised to consult a structural engineer. Minor step cracking can be used as a warning sign to address factors causing stress to the wall, which can include the effect of surrounding trees, water

leaks, soil erosion, or even the presence of reactive soils in the surrounding area.

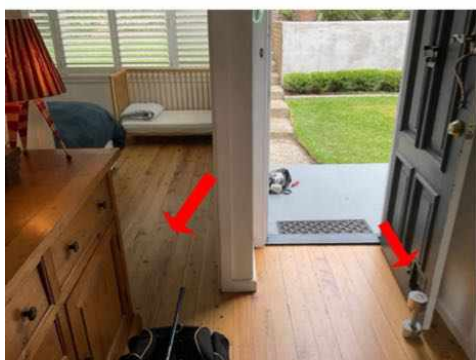
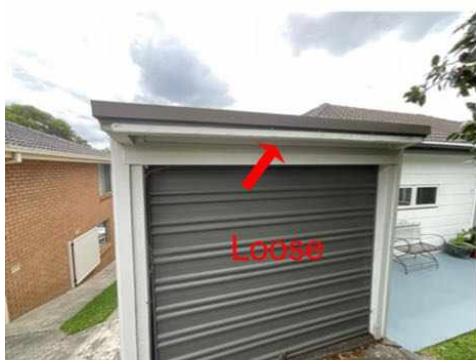
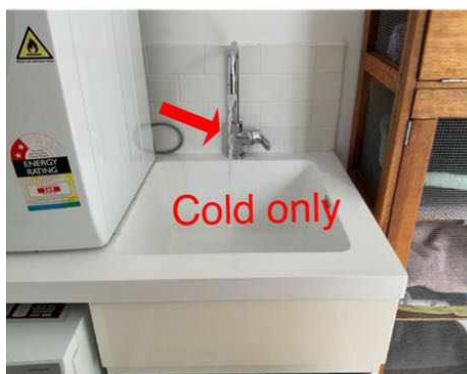
Building: Building 1
 Location: Pictured external areas
 Finding: Building elements - Damaged or missing
 Information: Evidence of minor missing or damaged areas was identified at the time of the inspection. These include -

1. One bedroom is missing a door and the front doggy door flap is also missing.
2. The bathroom door needs a doorstop to stop the shower screen breaking from impacts.
3. The front garage timber is very loose requiring refixing in place.
4. The laundry tap only had cold water, all other taps worked normally.

A carpenter would be the trade responsible for rectification of most of these areas when convenient.

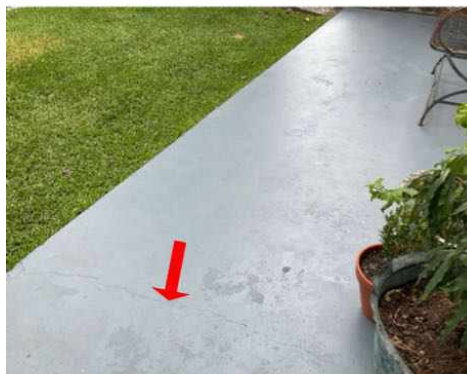
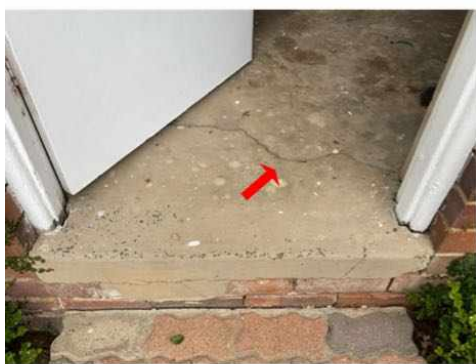
Finding 3.02

Building:	Building 1
Location:	Slabs front & rear
Finding:	Crack in concrete slabs - Category 1
Information:	Cracks coded as Category 1 was identified in these pictured slabs. A Category 1 crack is described as a fine but noticeable crack, with the slab at an otherwise reasonable level. To be considered Category 1, the approximate width of the crack is less than 1.0mm, or a less than 10mm change in offset when a 3m straight edge is placed over the defect.

Category 1 cracks should be monitored for a period of 12 months. At the end of the

monitoring period, identified cracks that are rated greater than Category 2 are considered defects, and require rectification.

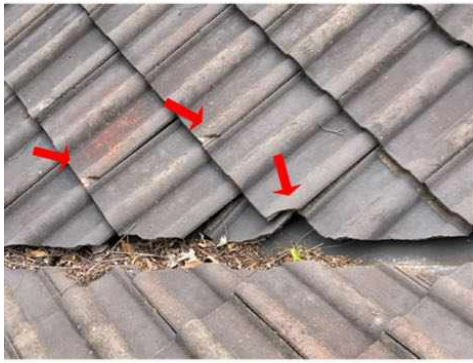
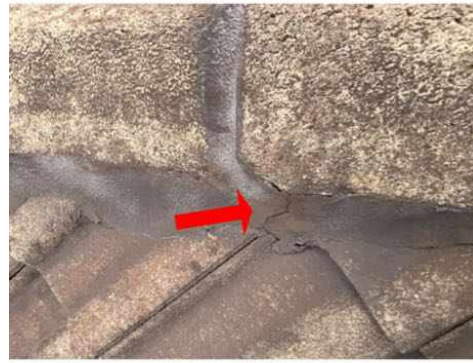
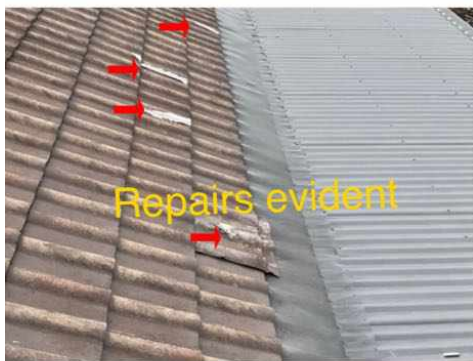
Finding 3.03

Building:	Building 1
Location:	Roof Exterior
Finding:	Roof tiles - Weathered
Information:	Upon inspection of the exterior roofing, the majority of roof tiles were considered to be in fair - good with some chipped tiles and a few rear patched areas found.

While weathering of the tiles is consistent with the age of the property, maintenance works are required. Isolated areas of mortar show minor cracking is also present.

Where left unmanaged, deteriorating roof tiles are likely to lead to a number of secondary defects, including minor water leaks and weather exposure to internal roofing structures.

Consultation with a roofing contractor is highly advised to gain advice on cost of remedial works that may be required in the short to medium term. Remedial works are likely to increase the longevity of the exterior roofing structure.

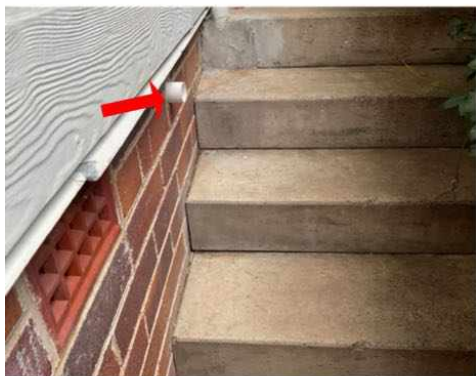
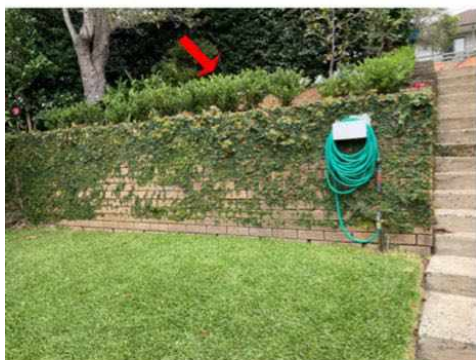
Finding 3.04

Building:	Building 1
Location:	Retaining and house wall areas
Finding:	Site drainage - Inadequate
Information:	The site drainage in these areas appears to be inadequate with no visible AG drains evident at the time of inspection.

Where site drainage is inadequate, installation of an Agricultural (Aggie) Drain may be required. A qualified plumber should be appointed to further inspect the property and perform any remedial works as necessary. Secondary defects are likely to occur if left unmanaged.

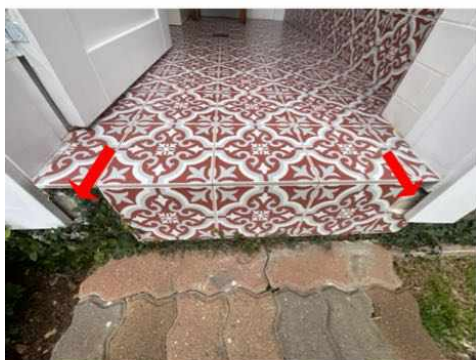
Finding 3.05

Finding: Tiles cracked

Information: A few damaged tiles were evident in these pictured areas at the time of inspection. It is suspected that this cracking has occurred as a result of minor settlement or impact damage. Cracked tiles throughout the household detract from the overall appearance of the affected areas.

Replacement of cracked tiles is recommended. A tiling contractor may be appointed to perform these works. Where cracks become more numerous, contact a licensed building inspector for further investigation.

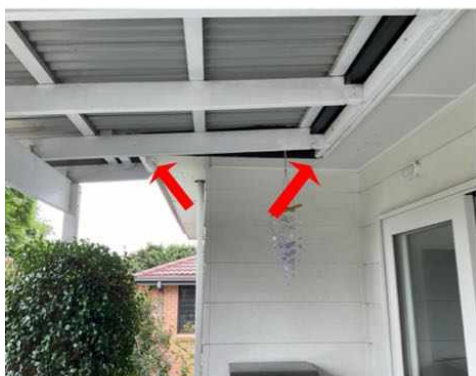
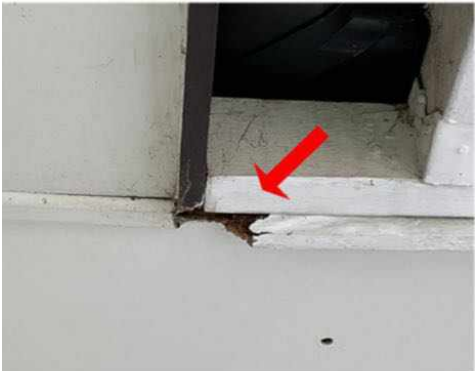
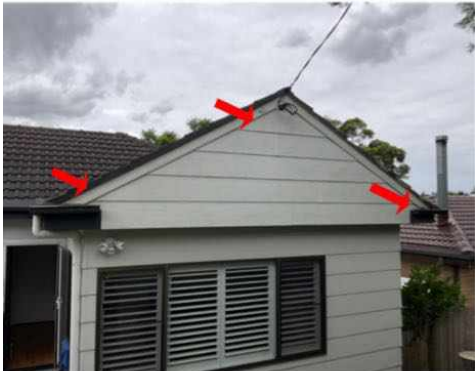
Finding 3.06

Finding: Wood rot

Information: The building shows evidence of wood rot, common to timber roof areas lacking paint. Wood rot, also known as Fungal Decay, occurs when timbers and other cellulose building materials are exposed to damp conditions on an ongoing basis. This could be the result of exposure to weathering over a prolonged period of time, or the attraction of excessive moisture from other abutting building materials.

Early intervention and regular maintenance, particularly of exterior timbers, will prolong the useful life of these building elements. Prior to any works being performed, the cause of the moisture that has created the visible wood rot should be identified and addressed in a suitable manner. Replacement of affected timbers may then be a necessary step in protecting surrounding building elements from such deterioration.

A qualified carpenter or registered builder may also be required to replace affected building materials.

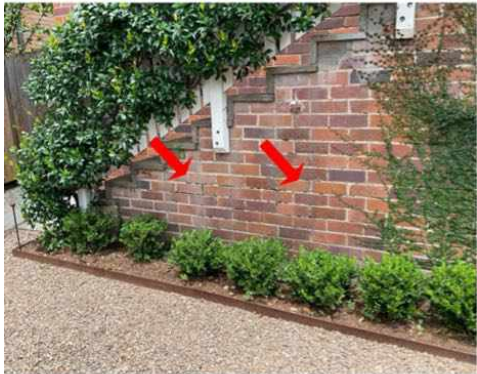
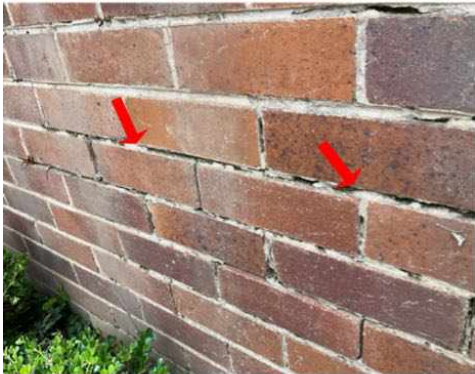
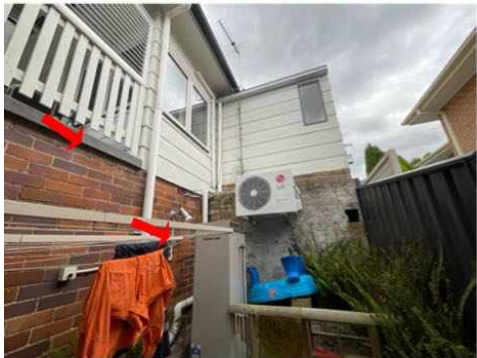
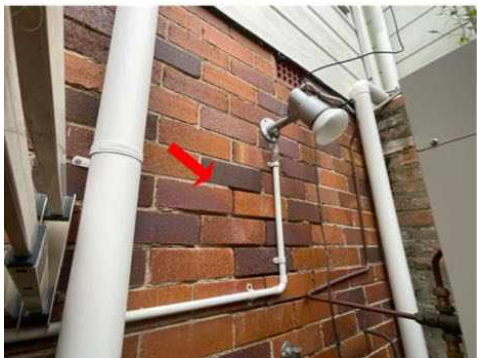
Location: Pictured external areas
Finding: Brickwork mortar missing in small areas
Information: Small areas of mortar was found to be missing at the time of the inspection. Mortar, or 'bedding', is the material which fills joints and intersections between bricks.

Mortar that is missing may allow water ingress into these areas, putting associated building elements at risk of water damage.

Missing mortar can be attended to by bricklayer as soon as possible.

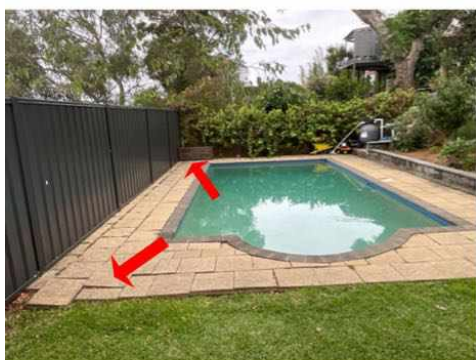
Finding 3.09

Building:	Building 1
Location:	Pool Area
Finding:	Subsidence Monitor
Information:	It appears that the pool paving has been affected by movement of the foundations, often referred to as sinking or subsidence. General subsidence is usually initiated by changes in soil moisture content. The most critical factor is identifying the specific causes, and identifying if this is a recurring or ongoing problem, or one that has been resolved by previous works in the past.

Subsidence can have complex and varying causes, which will influence the required remedial works. At this point it is recommended to contain storm water flows, ensure paving flows away from the pool to lessen any excessive wetting and drying effects. A landscaping contractor can be contacted for rectification.

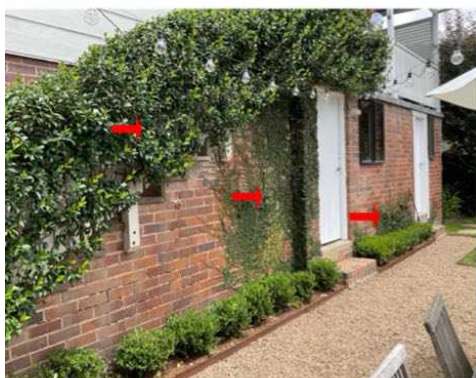
Building:	Building 1
Location:	Walls - rear
Finding:	Bridging - Vegetation
Information:	Where vegetation obstructs inspection of building elements, also known as bridging as it provides a bridging point for the access of termites, full inspection can not be achieved. Consequently moisture or dampness may be present and the areas becomes conducive to termite activity. Plants against or very close to buildings provide cover, shade and can provide an environment that is attractive to termite infestation.

The removal and replanting of species that do not provide "cover" or cutting back of existing vegetation will assist greatly in preventing Bridging from occurring.

The removal of any such materials that may be conducive to termite activity should be carried out as soon as possible and arrange re inspection to minimize the risk of termite attack.

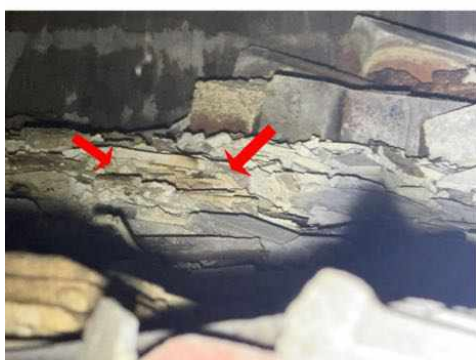
Building:	Building 1
Location:	Subfloor
Finding:	Mould - Present in subfloor
Information:	Where evidence of mould growth was noted, there may be environmental, biological or health issues associated with the report. A specialist inspection by a suitably qualified environmental health inspector is warranted, where mould is extensive or where any queries regarding air quality spores or other related issues apply.

Subfloor mould is generally caused by moisture ingress, lack of external drainage, lack of adequate ventilation and subfloor debris present. These issues need rectification

Generally, the client is advised to ensure that the general environment is free of moisture and humidity to aid in the prevention of mould formation and development.

to stop mould development. Any mould found during the inspection should be cleaned immediately by a cleaning contractor or the homeowner as applicable.

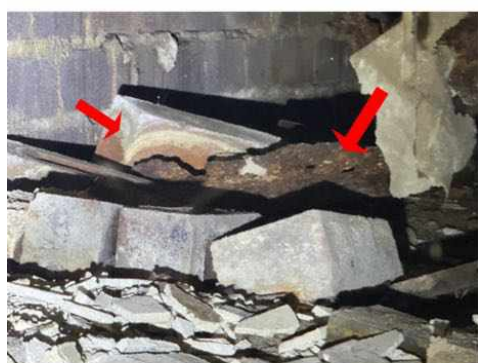
Finding 6.07

Building:	Building 1
Location:	Subfloor
Finding:	Subfloor - Debris

Information: An array of debris was found in the subfloor area at the time of inspection. Debris in this area restricts subfloor ventilation and creates potential for concealed pest entry. Stored timbers and other materials may also make the area susceptible to termite activity and wood rot.

A clear and empty subfloor will be better ventilated and easier to maintain in a dry condition. The removal of any timber debris is vital in minimising the risk of termite or wood borer activity.

Debris in the subfloor should be removed as soon as possible. Depending on the location and amount of debris and stored items, the homeowner may elect to undertake this task. Alternatively there are a large number of rubbish removal subcontractors that could undertake these works.

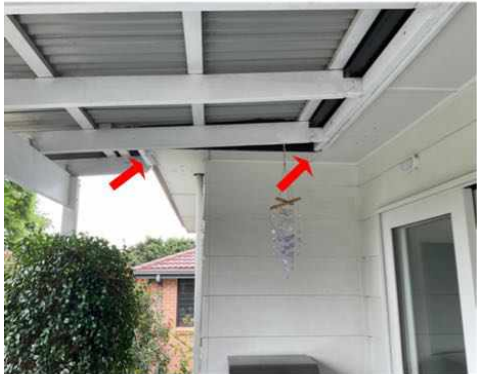
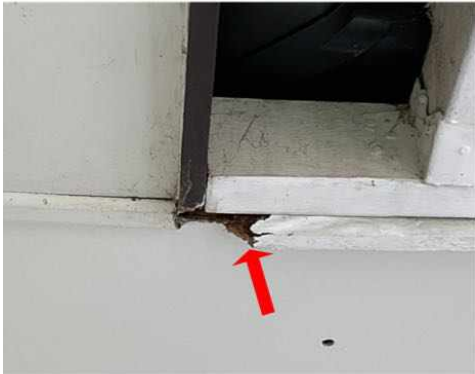
Finding 7.01

Building: Building 1
Location: Verandah
Finding: Fungal decay - present (localised)
Information: Fungal decay also known as wood decay or wood rot generally refers to the deterioration of timber elements when in contact with excessive levels of moisture for a prolonged period of time.

The development of fungal decay is accelerated by temperatures from 5degreeC to 40degreeC as well as the presence of oxygen. Generally fungal decay develops on timber elements that are in use in an external environment which are exposed to rain penetration.

Note - See ALL wood rot photos in building defects above, all these show fungal

decay.

In this case, the affected timber element is in a decaying state and will need replacement by a carpenter or licensed builder.

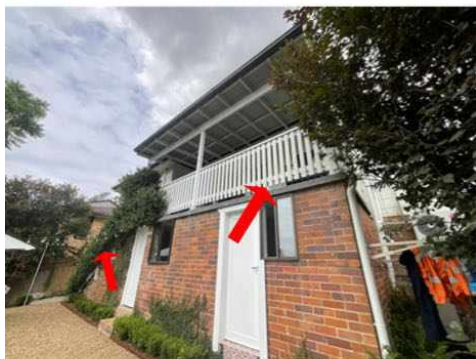
Building: Building 1
 Location: Rear deck
 Finding: Elevated structure inspections
 Information: While this deck had no obvious structural defects, where any elevated Structure (deck, balcony, verandah etc) is present, and this elevated structure is designed to accommodate people, you MUST have this structure checked by an engineer or other suitably qualified person.

Nothing contained in this report should be taken as an indicator that an assessment has been made, on any elevated structure, as suitable for any specific number of people or purpose. This can only be done by a qualified engineer. For the purpose of this report, the Structure includes the elevated rear deck, handrails and stairs some of which is overgrown.

You should also arrange annual inspections of the structure by an engineer or other suitably qualified person to ensure any maintenance, that may become necessary, is identified. Care must be taken not to overload the structure.
