Building and Timber Pest Inspection Report

Inspection Date: Tue, 17 Feb 2026

Property Address: 3/75 Collins St, Corrimal NSW 2518,
Australia

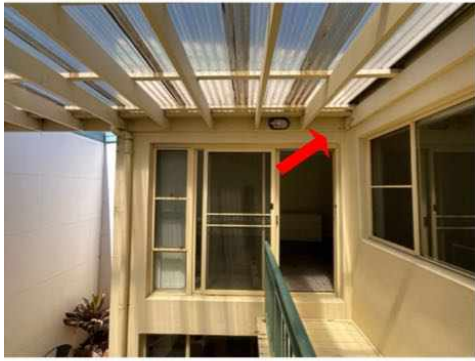
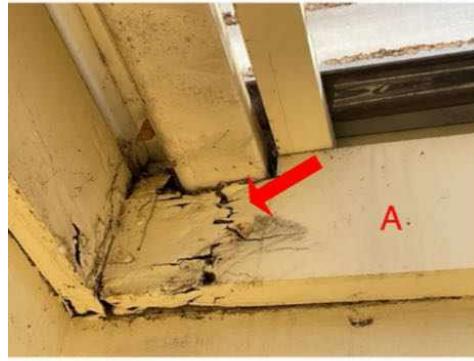
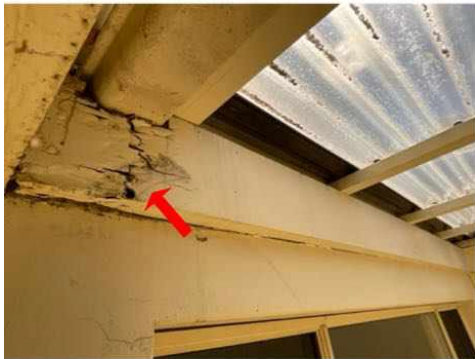
Building:	Building 1
Location:	Courtyard
Finding:	Wood rot
Information:	This area of the pergola shows evidence of severe wood rot to both intersecting beams. There is now no support for 1.5 metres of the beam marked A.

Wood rot, also known as Fungal Decay, occurs when timbers and other cellulose building materials are exposed to damp conditions on an ongoing basis. This could be the result of exposure to weathering over a prolonged period of time, or the attraction of excessive moisture from other abutting building materials. Contributing factors also include poor air ventilation in the area.

A qualified plumber may be appointed to assess the cause of excessive moisture (appears to be a leaking gutter) and to provide advice on any remedial works as required.

A qualified carpenter or registered builder will be required to replace affected timbers to support this lightweight roof. This may be up to strata in this area.

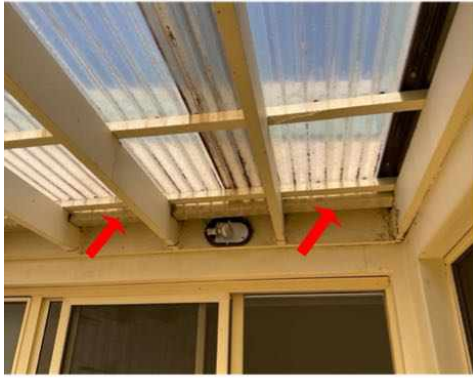
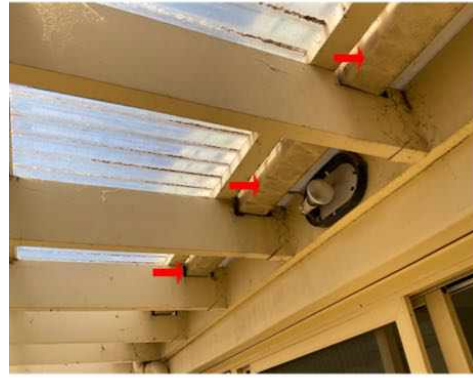
Finding 3.01

Building: Building 1
Location: Courtyard gutter
Finding: Additional fixings required
Information: Evidence of insufficient fixings were evident on the pictured gutter which is very loose. This may be the primary cause if the leak causing the wood rot.

This gutter needs additional fixings to ensure its longevity and to stop leaks.

A carpenter or plumber would be able to add additional fixings to these areas.

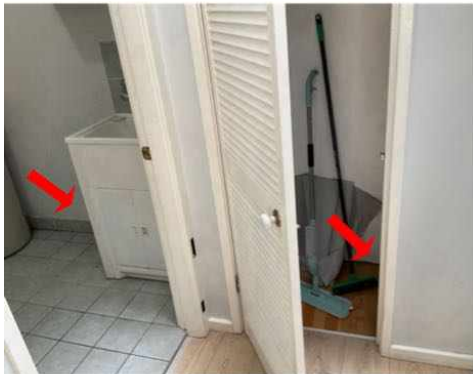
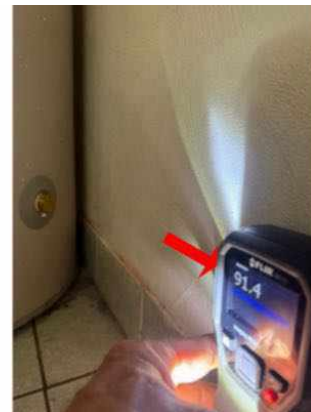
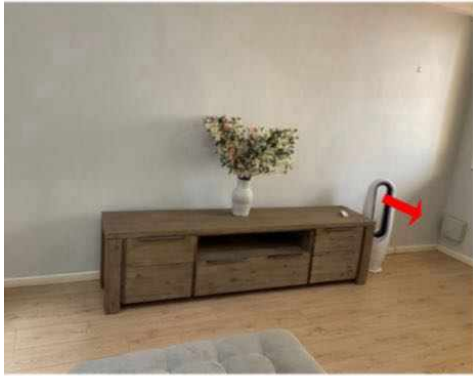
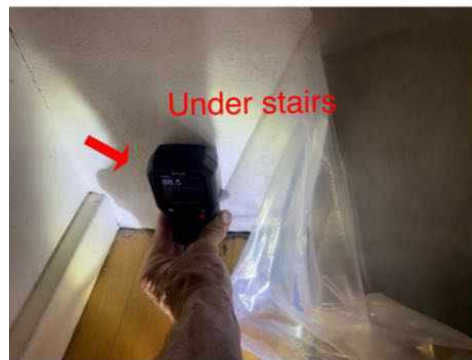
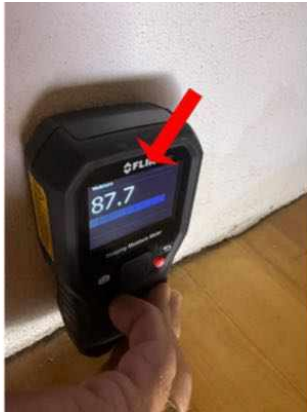
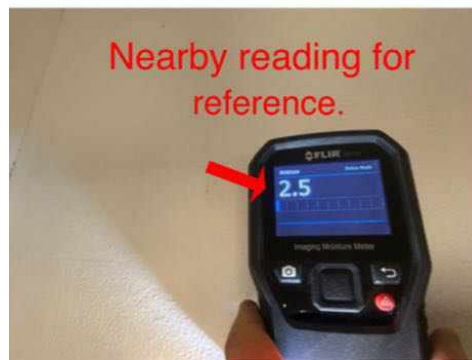
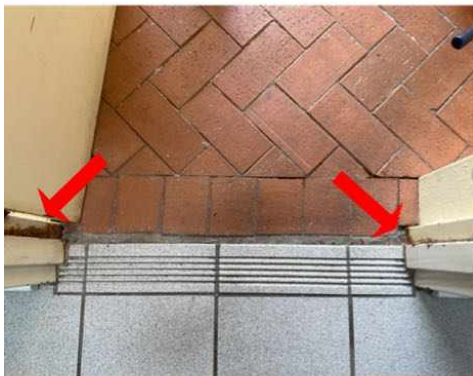
Finding 3.02

Building:	Main Building
Location:	Lower west and north walls
Finding:	Evidence of excessive moisture was present at the time of inspection
Information:	Excessive moisture was found in the internal lower west and north walls and in the courtyard corner. High readings of up to 91.4 were recorded.

This is thought to be caused by rising damp as further areas higher up these pictured walls were tested with no significant moisture found (ie readings of under 10).

The rust to the entry door frame also supports this finding.

A licensed plumber is required to investigate further.

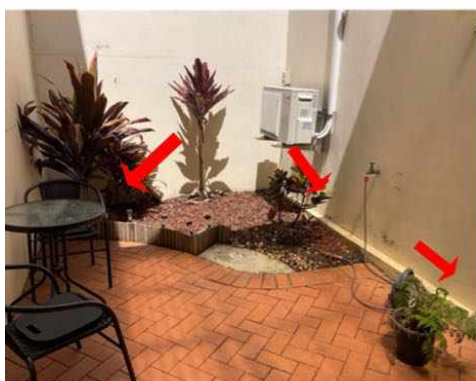
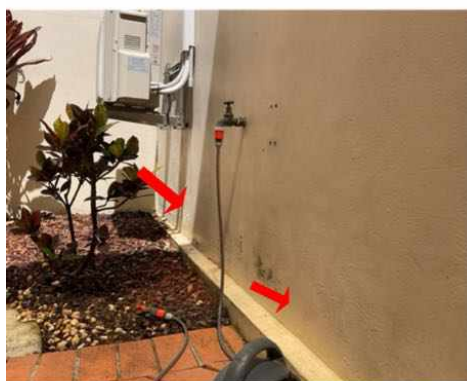
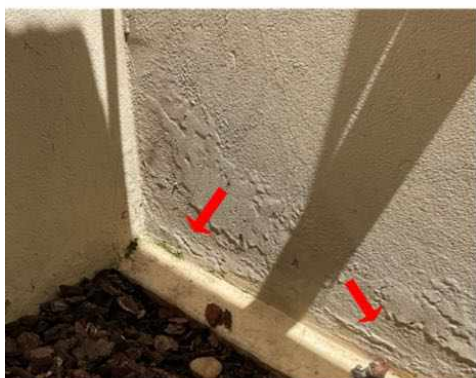
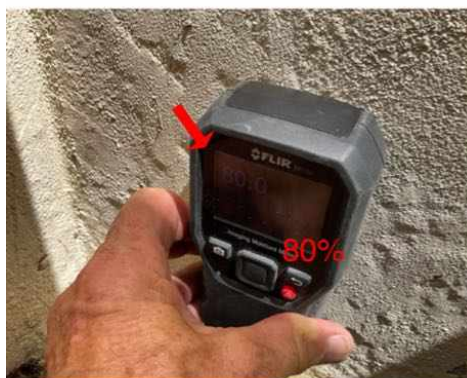
Finding 3.03

Building:	Building 1
Location:	Courtyard
Finding:	Damp - Rising
Information:	Rising damp describes the upward movement of water in low sections of building elements (e.g. walls) by capillary action - the movement of water through porous materials such as bricks, sandstone or mortar.

Consultation with a qualified plumber is advised immediately to identify the cause of the damp and perform remedial works as required.

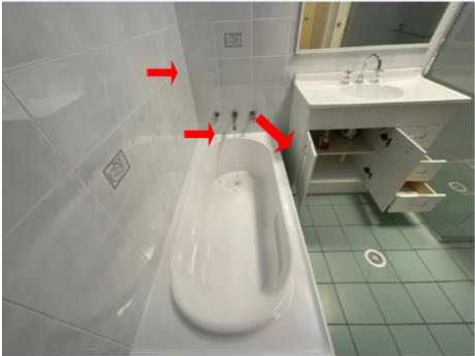
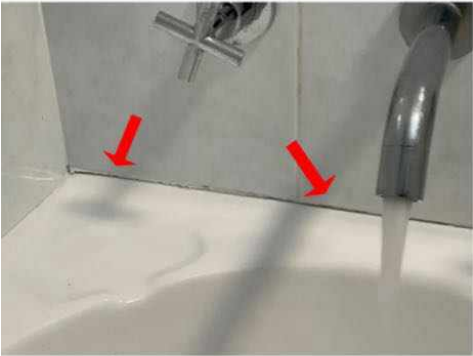
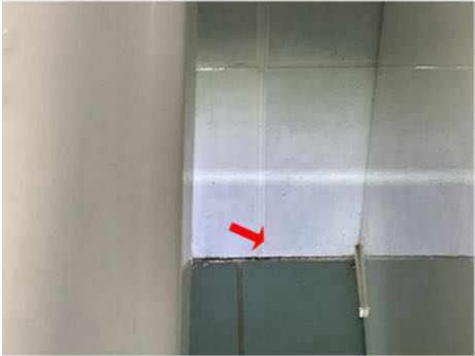
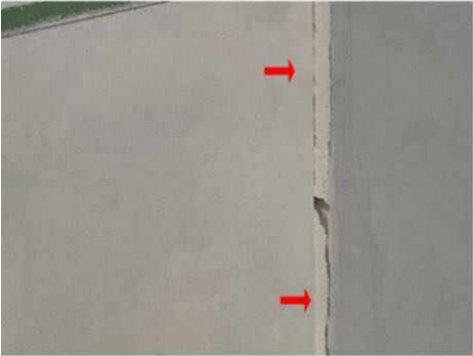
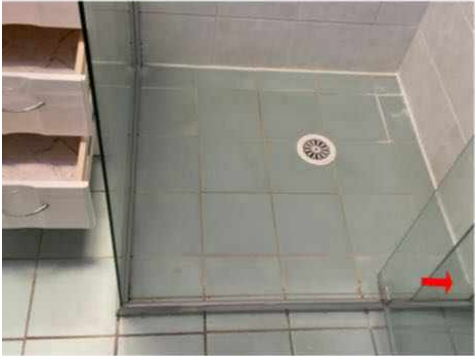
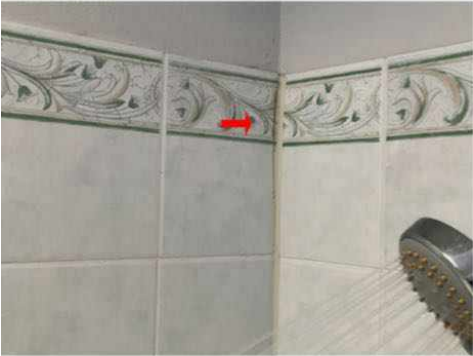
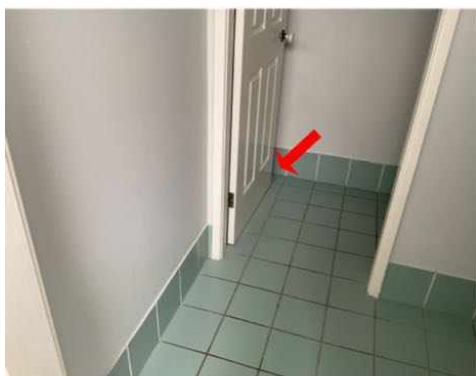
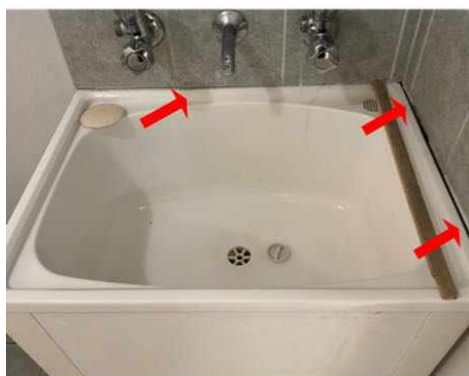
Finding 3.04

Building:	Building 1
Location:	Pictured laundry and bathroom areas
Finding:	Sealant and grouting - Missing
Information:	It was noted on inspection that sealant or grout is missing to these pictured areas of the building.

Flexible and mould resistant materials should be applied to affected areas by a sealant expert to prevent any subsequent water damage that is likely to occur.

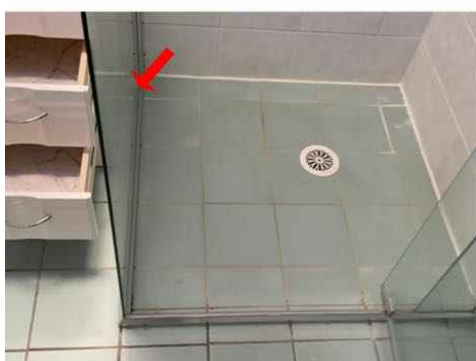
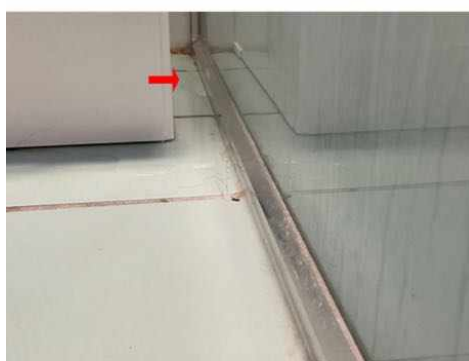
Finding 3.05

Finding: Shower screen - Leaking

Information: Leaking was evident to the shower screening at the time of inspection. It is suspected that the leaking has occurred as a result missing sealant. Leaking from the shower , where left unattended, is likely to lead to water damage to adjoining flooring and walls. Such damage can lead to water damage and necessitate extensive remedial works being required. Active water leaks may also create an environment that is susceptible to the formation and development of mould.

Appointment of a sealant expert is required to repair or replace this missing sealant. Such works should be performed as soon as possible to ensure that no further damage occurs.

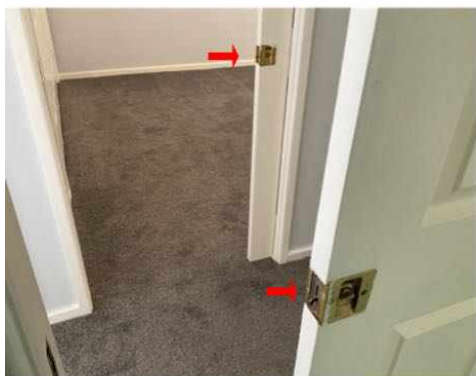
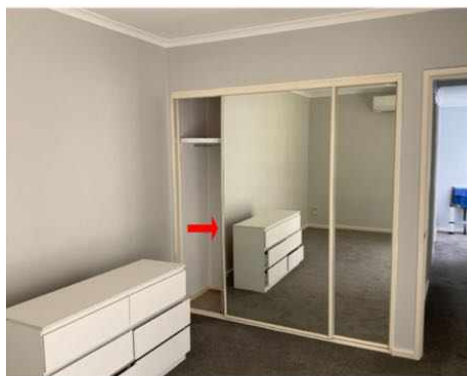
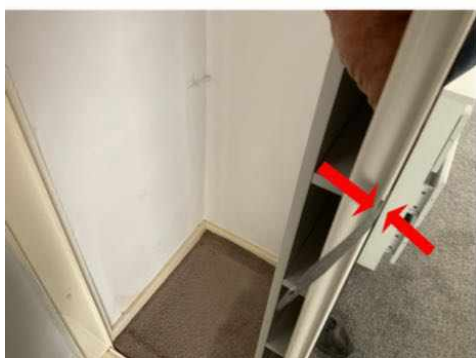
Finding 3.06

Finding: Building elements - Damaged

Information: Evidence of damage was identified to the following areas -

1. The door locks are hard to use and need adjustment to lock/latch.
2. The wardrobe sliding glass door trim is loose requiring urgent replacement by a wardrobe installer.
3. The upstairs balcony light is missing a cover and the rangehood light cover has cracked no affecting its function.

A carpenter is required to repair this area and bring it back to full function.

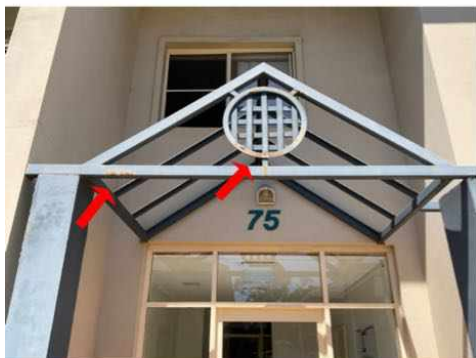
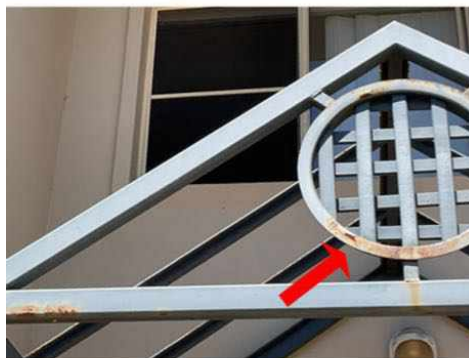
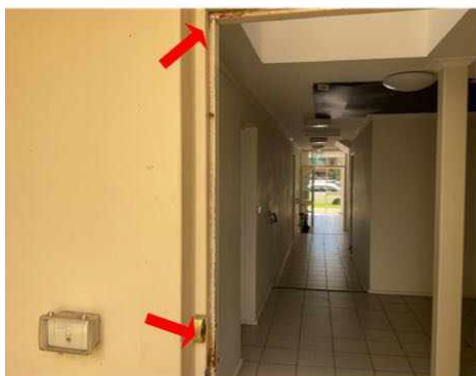
Finding 3.07

Building:	Main Building
Location:	Pictured wall areas
Finding:	Building elements - Rusted or corroded
Information:	These building elements show evidence of rusting and corrosion, which is likely to have developed as a result of excessive exposure to moisture and or inadequate coatings.

As surface rust provides no protection to the underlying iron, the deteriorating condition is likely to worsen if not addressed in the short-term future.

Rusting and corrosion should be managed by ideally removing or limiting the affected surface from exposure to moisture. A registered builder may be appointed to replace any building elements that have been severely affected by rust or water damage.

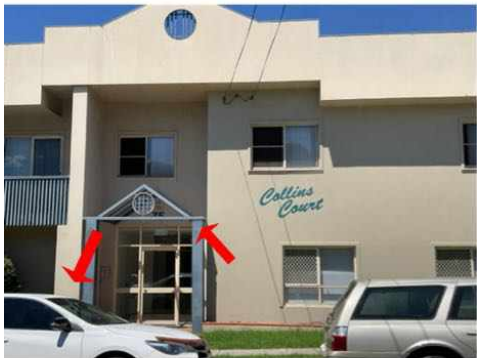
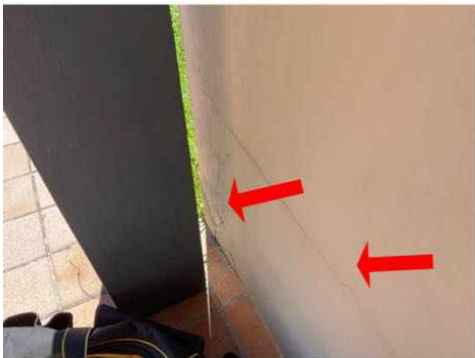
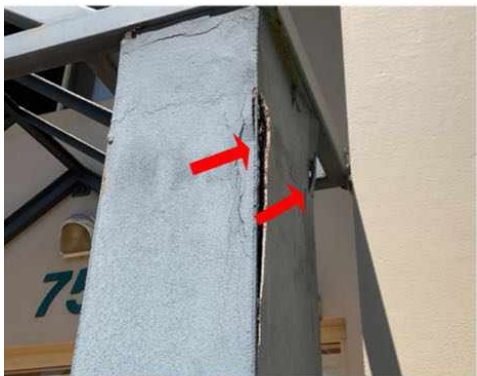
Finding 3.08

Building:	Main Building
Location:	Front wall
Finding:	Render (external) cracking.
Information:	It has been observed that cracking to some external rendered surfaces. The degree of damage is described as "slight" noticeable cracks which are easily filled. Cracking of this size are generally less than 5mm in width.

Always contact your building inspector should cracks widen, lengthen, or become more numerous.

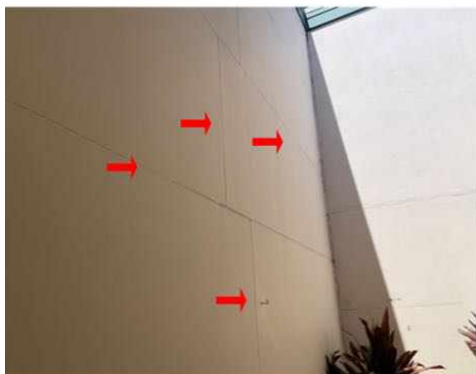
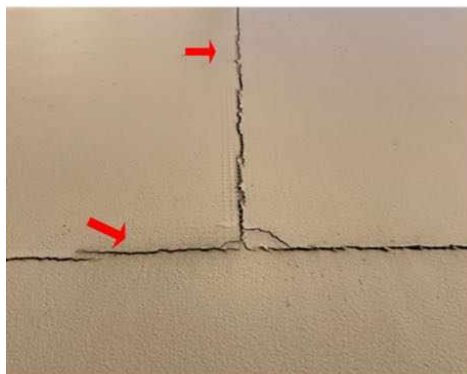
Finding 3.09

Building: Building 1
Location: Courtyard
Finding: Sealant (external) - Missing.
Information: It was noted on inspection that areas of external sealant was missing to small areas of the external walls.

Flexible sealants should be applied to these affected areas to prevent any subsequent water damage that is likely to occur.

A sealant specialist or skilled handy person should be appointed to complete these works as soon as possible

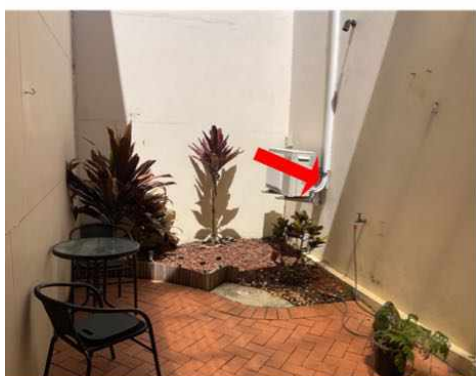
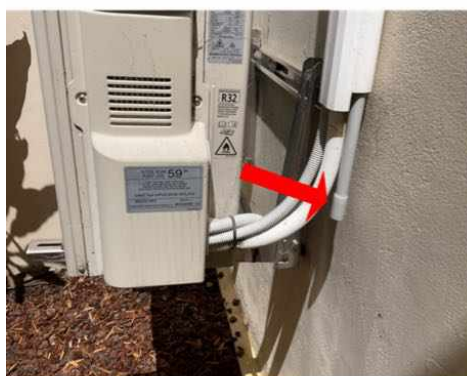
Finding 3.10

Building:	Building 1
Location:	Courtyard
Finding:	Site drainage - Inadequate
Information:	The site drainage in this area was found to be inadequate at the time of inspection, creating potential for subsequent water damage to associated building elements.

Where site drainage is inadequate, installation of an Agricultural (Aggie) Drain may be required. A qualified plumber should be appointed to further inspect the property and perform any remedial works as necessary. Water damage and secondary defects are likely to occur if left unmanaged.

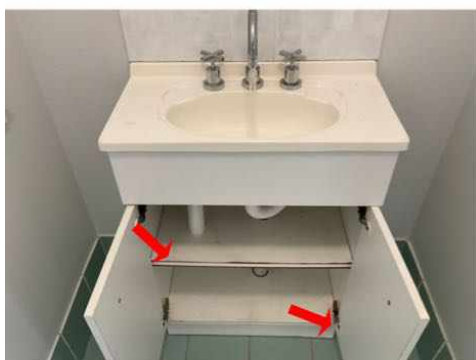
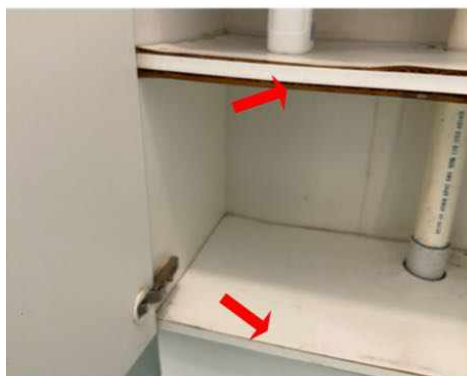
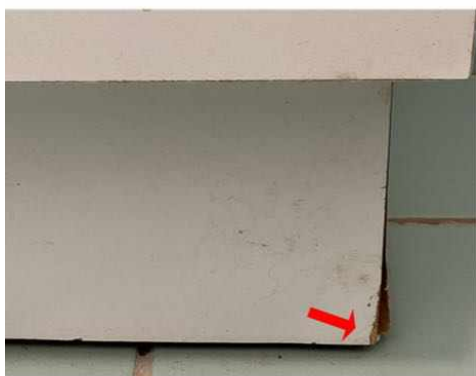
Finding 3.11

Finding: Vanity - Swollen
 Information: Swollen building elements generally indicate that the building materials have been affected by excessive moisture over a prolonged period of time, and have swollen as a result. The structural integrity of this vanity cannot be guaranteed, and further damage is likely to develop if left unmanaged.

Excessive moisture is likely to lead to the development of secondary damage to any associated building elements, which may necessitate major reparation works if left unmanaged. Repair and/or replacement of this vanity should be conducted by a qualified carpenter or plumber. No leaks to this vanity area could be found at the time of the inspection.

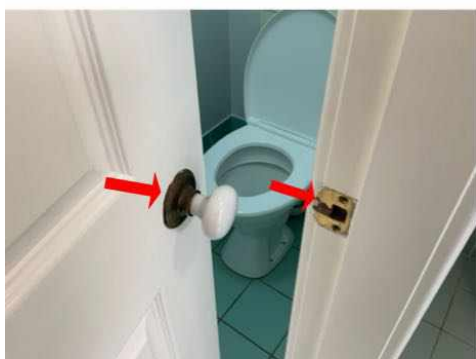
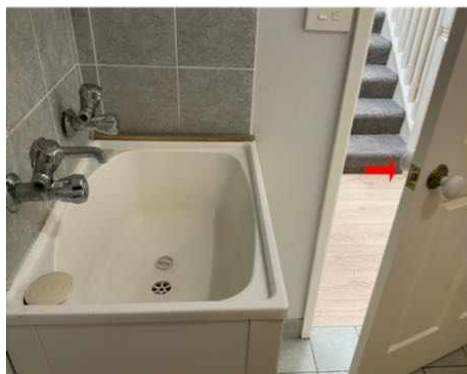
Finding 3.12

Building: Building 1
 Location: Upstairs Toilet & laundry
 Finding: Door handles - Not latching
 Information: It was noted that the doors here were not latching during operation at the time of inspection.

It is suspected that this defect has occurred due to minor issues with the associated hinges. Such damage is identified as general wear and tear, which is expected for building elements of this age.

A qualified carpenter or general handyperson may be appointed to perform rectification works as necessary, at client discretion. If left unattended, further functional impairment is likely to occur.

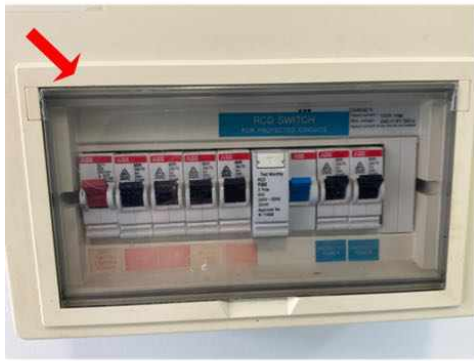
Building:	Main Building
Location:	Meter board
Finding:	Termite Management System - no evidence of a chemical installation or durable notice
Information:	The application of a post-construction chemical termite barrier is highly recommended for all properties. Such barriers are highly effective in preventing termite attack on any timber building elements throughout the property.

A durable notice should be placed in the switchboard unit to indicate current termite barriers. At the time of inspection, the durable notice was missing and it appeared as though no chemical termite management system has been installed, with no evidence to suggest preventative works taking place since the property was built.

The client may consider gaining further advice from the body corporate and a pest controller as to the costs and procedures involved with a 'chemical' application.

It is recommended that obtaining such advice be a short-term priority.
