## Building Inspection Report

Inspection Date: Sat, 24 Jan 2026

Property Address: a405/22 Rhodes St, Hillsdale NSW 2036,  
Australia

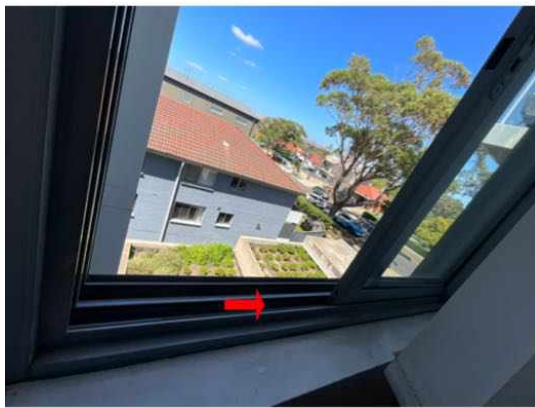
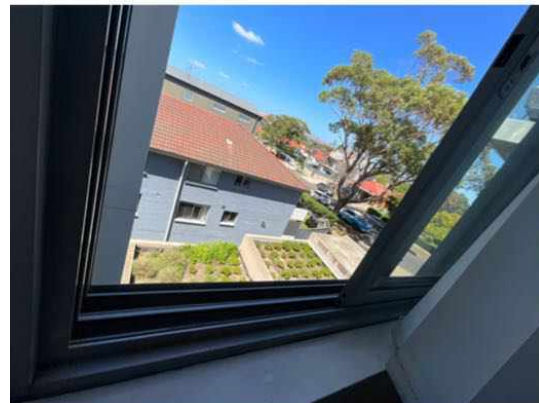
#### Defects 1.01

Building:	Main Building
Location:	All Areas
Finding:	Window child lock missing
Information:	The window in question lacks a child lock mechanism, which poses a potential safety risk to young occupants in the premises. As per Australian Standards windows accessible to children should be equipped with appropriate child safety locks to prevent accidental opening, reducing the risk of falls and ensuring compliance with safety regulations.

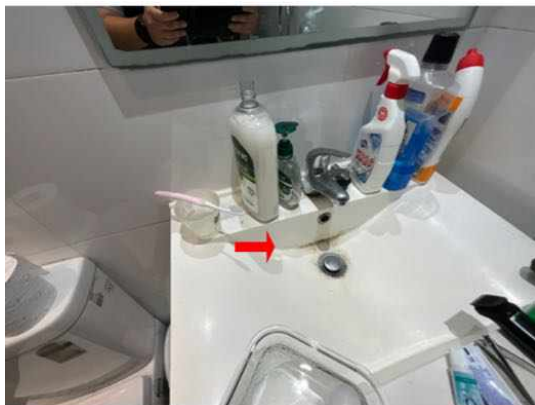
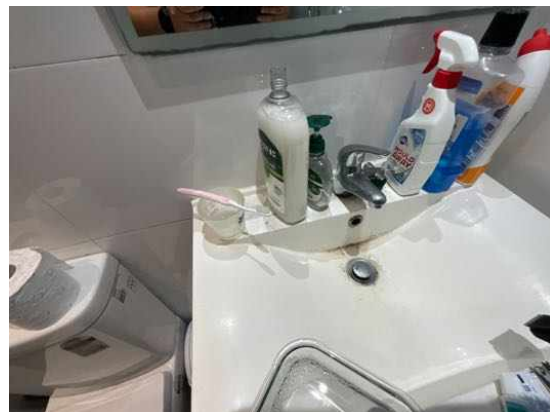
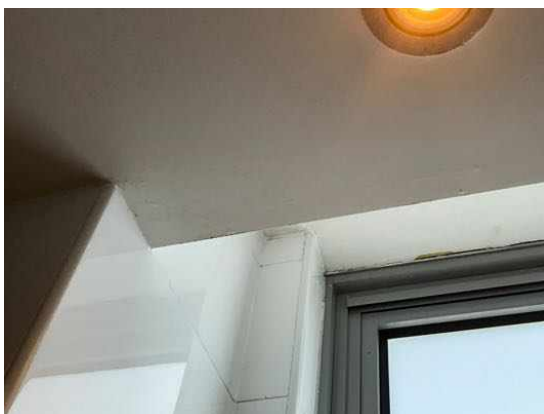
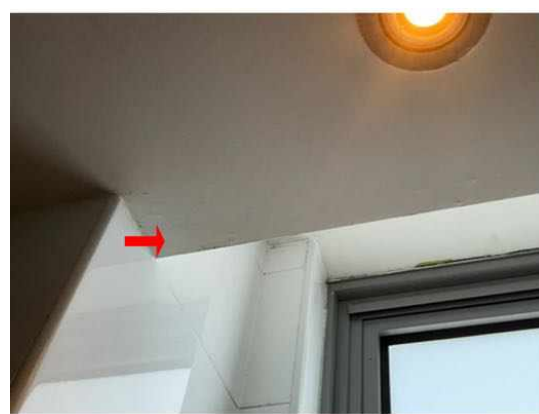
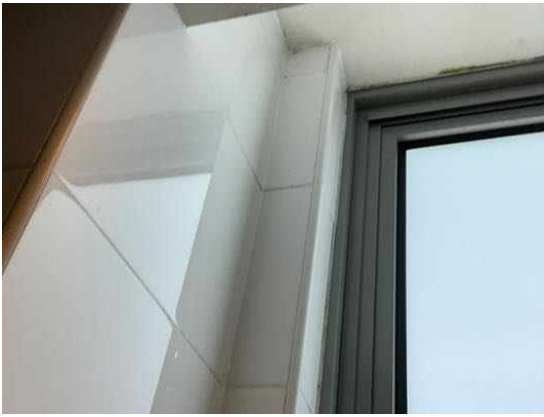
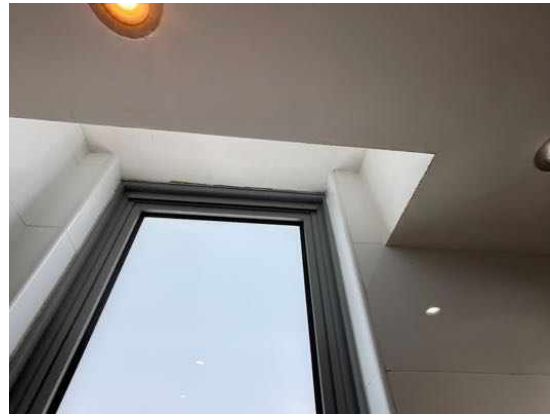
#### Defects 1.02

Building:	Main Building
Location:	Ensuite
Finding:	Mould - Present
Information:	Mold growth is present throughout the property, primarily due to inadequate ventilation. Poor airflow and moisture accumulation within the house have created

ideal conditions for mold to thrive.

- **\*\*Health Hazards\*\***: Mold growth can pose serious health risks to occupants, particularly those with allergies, asthma, or other respiratory conditions. Prolonged exposure to mold spores can cause respiratory issues, skin irritation, and other allergic reactions.
- **\*\*Structural Damage\*\***: Mold can degrade building materials over time, leading to rot and weakening of the structural components such as timber, drywall, and insulation, which can result in costly repairs.
- **\*\*Decreased Property Value\*\***: The presence of mold can significantly reduce the value of the property, as it indicates underlying moisture and ventilation issues that need addressing.

A licensed mold remediation specialist should be engaged to remove the mold and treat affected areas. In addition, a ventilation expert or builder should assess and improve the house's ventilation system, possibly installing exhaust fans, vents, or mechanical ventilation systems to ensure adequate airflow and prevent future mold growth.

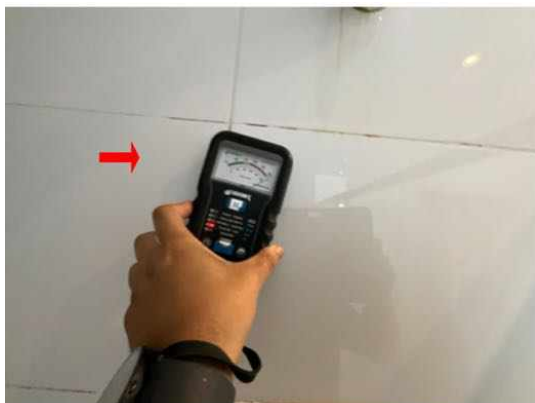
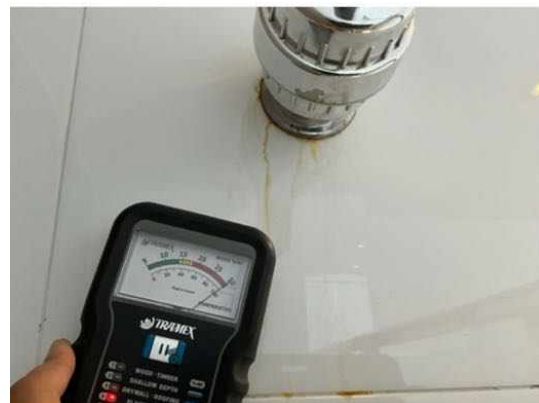
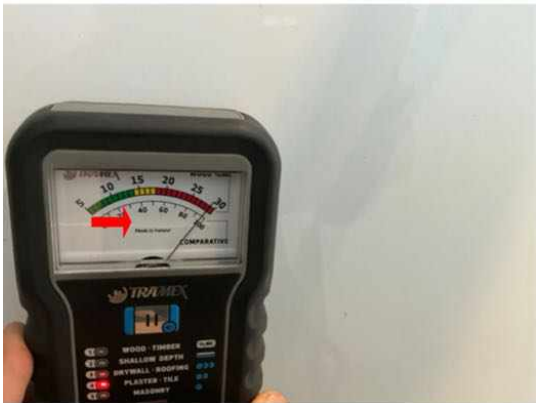
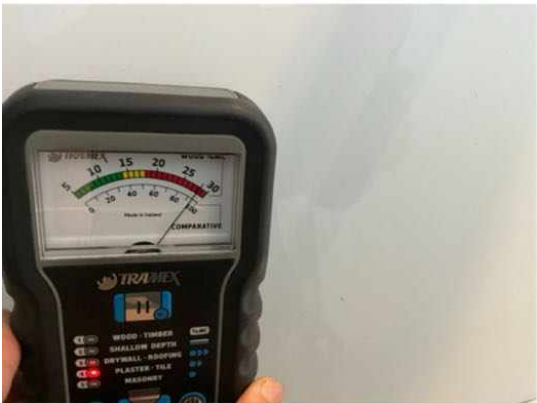
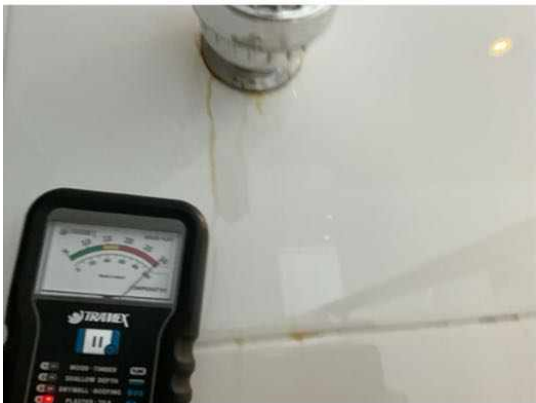
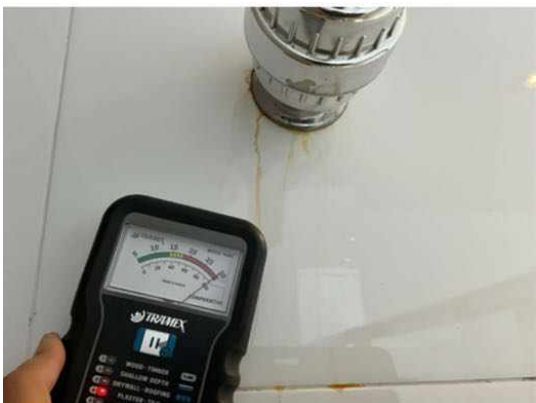
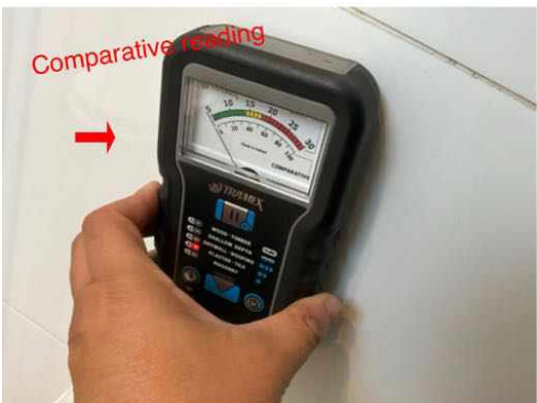
### Defects 2.01

Building:	Main Building
Location:	Ensuite
Finding:	Evidence of excessive moisture was present at the time of inspection
Information:	Excessive moisture is present behind the bathroom tiles, indicating a potential water leakage issue within the wall.

The prolonged presence of moisture can lead to mold growth, deteriorate the structure, and create an environment conducive to health hazards. Additionally, it may compromise the adhesive holding the tiles, leading to their detachment.

A licensed plumber or a qualified contractor specializing in water damage remediation should investigate the source of the moisture, fix any leaks, and address the damage. Additionally, replacing affected tiles and ensuring proper waterproofing are crucial to preventing future issues.

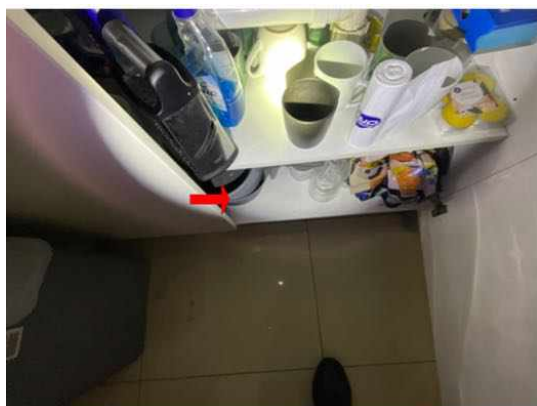
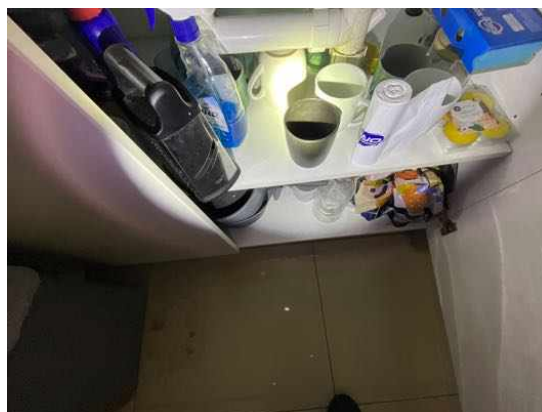
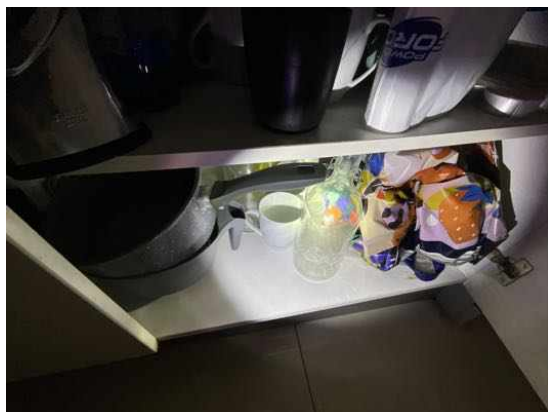
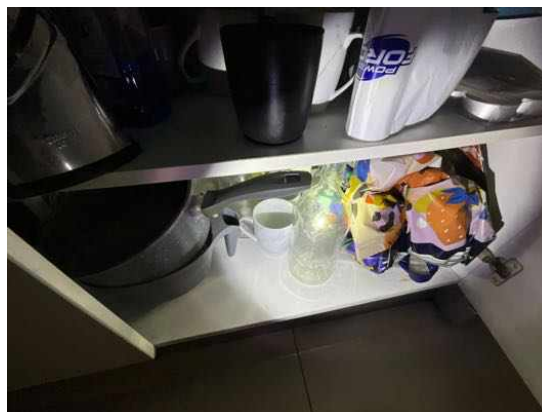
**Defects 3.01**

Building: Main Building  
 Location: Kitchen  
 Finding: Stains in Vanity  
 Information: Defect: General Stains in the Vanity

Description: The vanity surface exhibits general stains that may be due to water exposure, soap scum, cosmetics, or other substances. These stains are unsightly and

may indicate ongoing maintenance issues.

- Hygiene Concerns: Stains can harbor bacteria and germs, potentially compromising hygiene in the bathroom.
- Aesthetic Impact: Stains reduce the visual appeal of the bathroom, making it look unkempt and less inviting.
- Potential for Hidden Damage: Stains caused by water exposure could indicate underlying water damage that, if left untreated, may lead to more serious structural issues.
- Decreased Resale Value: An unappealing vanity can negatively affect the overall aesthetic and perceived value of the property.

- Clean the vanity using appropriate cleaning agents to remove stains.
- Inspect for any underlying issues, such as leaks or surface damage, and address them accordingly.
- Consider refinishing or replacing the vanity if stains are persistent and cannot be removed.

- Homeowner or Cleaning Service: For minor stains, thorough cleaning can often be done by the homeowner or a professional cleaning service using suitable cleaning products.
- Handyman: For more stubborn stains or minor repairs, a handyman can clean, repair, or refinish the vanity surface.
- General Contractor: If the stains indicate more serious damage or if a replacement is needed, a general contractor with experience in bathroom renovations can perform the necessary repairs or replacement of the vanity.

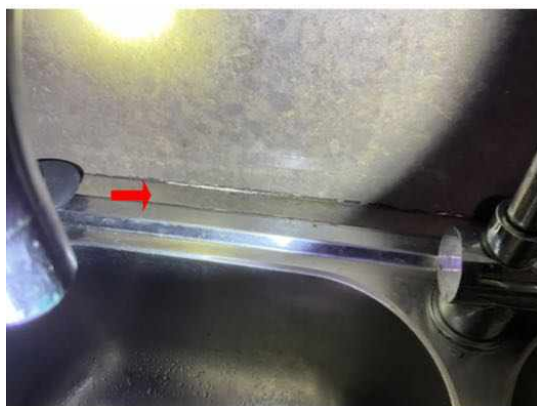
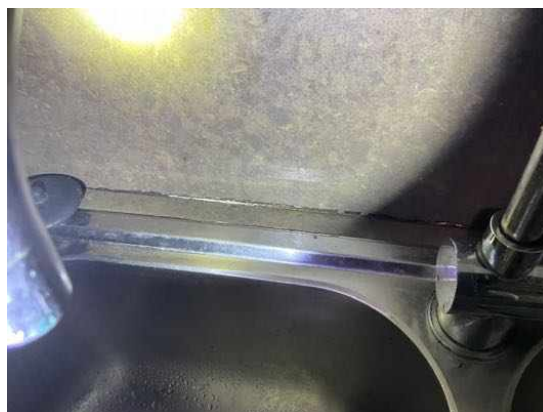
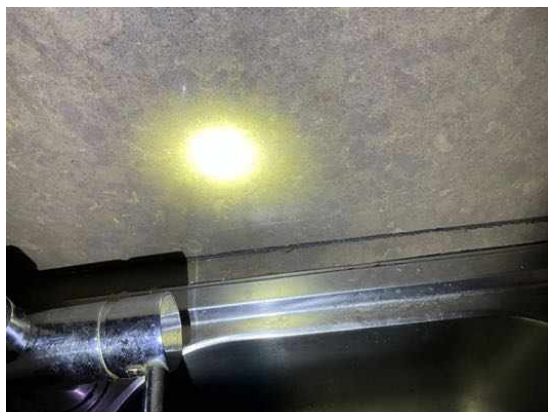
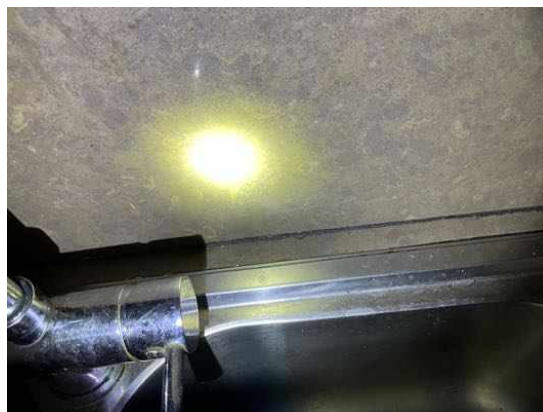
### Defects 3.02

Building: Main Building  
Location: Kitchen  
Finding: Silicone Sealant - Deteriorated Around Basin  
Information: The silicone seal around the basin has deteriorated, with visible gaps and discolouration noted along the edges.

Water penetration through the deteriorated seal may cause damage to surrounding surfaces, promote mould growth, and lead to deterioration of adjacent materials.

A licensed plumber or qualified handyman should remove the old sealant and reapply a sanitary-grade silicone to ensure watertight protection.

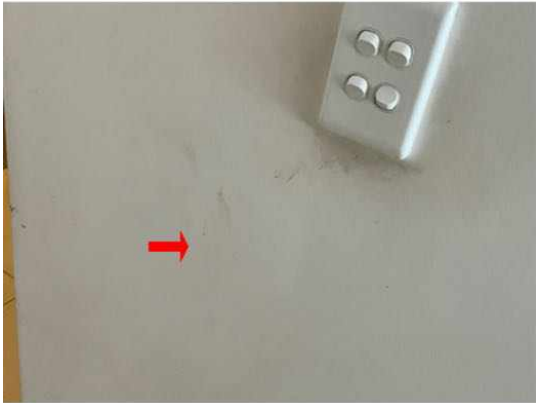
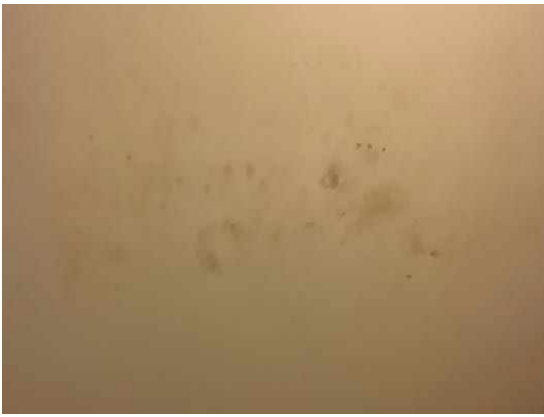
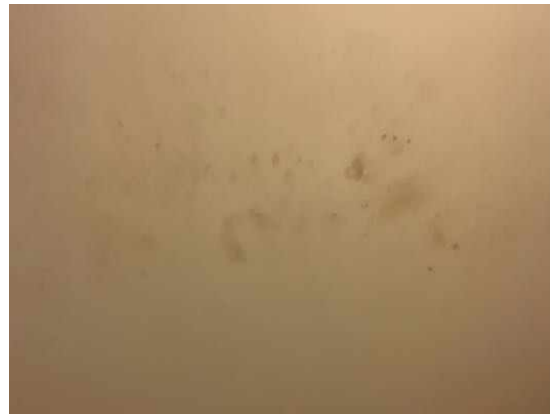
### Defects 3.03

Building:	Main Building
Location:	All Areas
Finding:	Paint surface - Scratches
Information:	Scratches have been identified on the paint surface, detracting from the overall appearance and quality of the painted surface.

1. Aesthetic Degradation: Scratches mar the appearance of the painted surface, diminishing its visual appeal and potentially lowering property value.
2. Corrosion Vulnerability: Exposed areas of bare metal due to scratched paint are susceptible to corrosion, leading to structural damage and compromised durability.
3. Environmental Hazards: Scratched paint can release hazardous chemicals into the environment, posing risks to both human health and the ecosystem.

A qualified painter should address the issue promptly to repair the scratched paint. Depending on the severity of the scratches, repair options may include sanding,

priming, and repainting the affected area to restore the integrity and appearance of the paint surface.

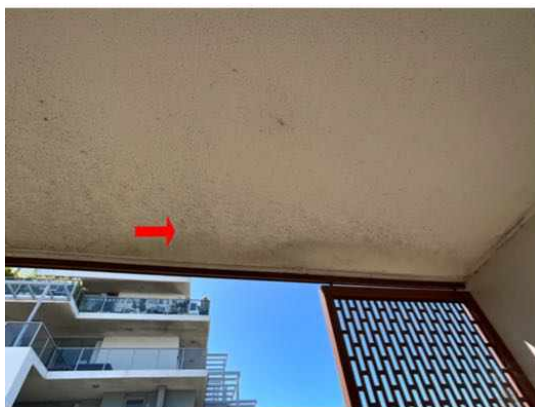
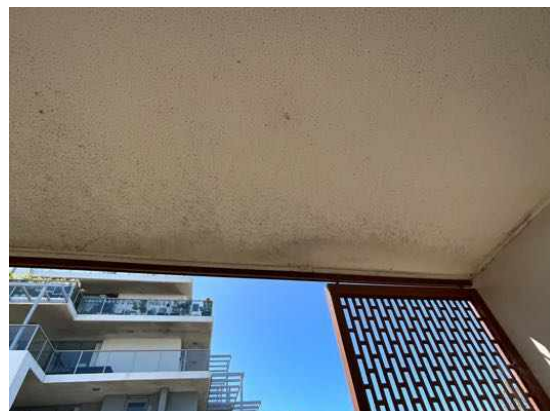
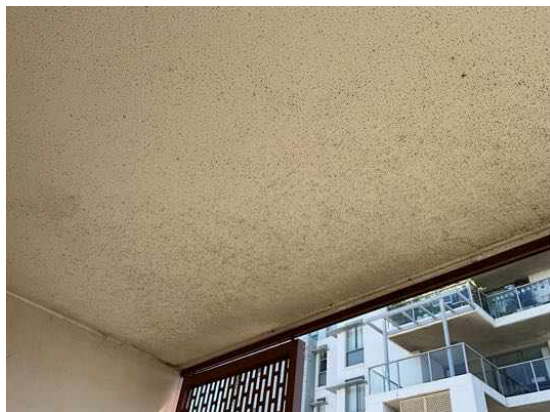
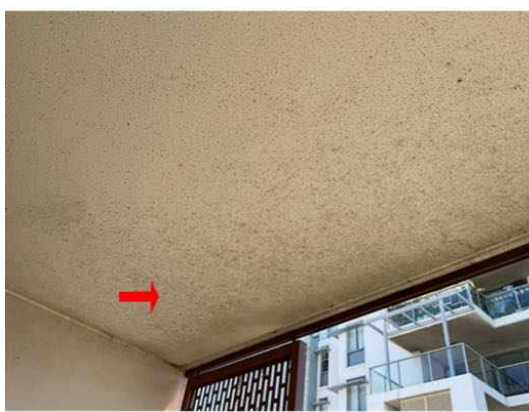
### Defects 3.04

Building: Main Building

Location: Balcony

Finding: Soffit- Water stained

Information: Water staining to Soffit in this area was evident at the time of inspection. Water staining indicates that surfaces have been exposed to excessive moisture over time. The minerals and other elements in the water lead to staining, which may graduate to corrosion and deterioration if left unmanaged.

While mostly an appearance defect, water staining can be indicative of more serious defects, which may be currently concealed by interior ceilings.

Where water staining is active, a licensed plumber must be consulted to identify the cause of the staining and to provide advice on any reparation works that may be required. Replacement of any damaged structures is advised.

Conversely, where water staining is old and inactive, affected building materials may be repaired or replaced at client discretion.

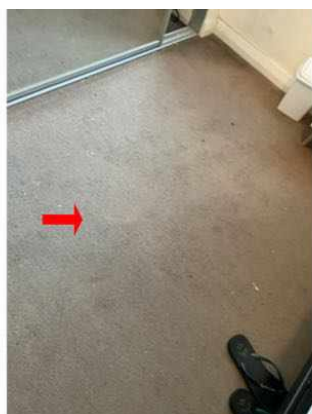
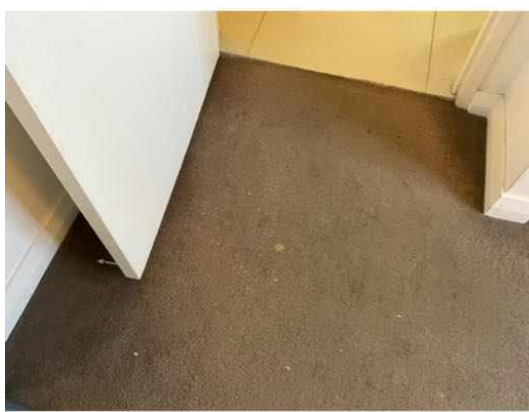
### Defects 3.05

Building:	Main Building
Location:	All Areas
Finding:	carpet exhibits visible signs of aging
Information:	Carpets are exhibiting visible signs of aging, including fraying edges, faded colors, and flattened fibers, diminishing their aesthetic appeal and functional quality.

The risk associated with aging carpets includes diminished appearance, decreased comfort, potential tripping hazards due to frayed edges, and a negative impact on indoor air quality if fibers begin to degrade and release particles into the air.

Professional carpet cleaning and restoration services can address issues such as deep cleaning to rejuvenate colors, repairing frayed edges, and restoring fibers. Additionally, replacing the carpets entirely may be necessary in severe cases of aging or damage beyond repair.

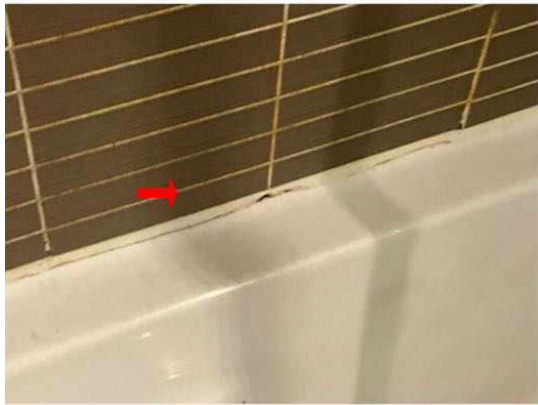
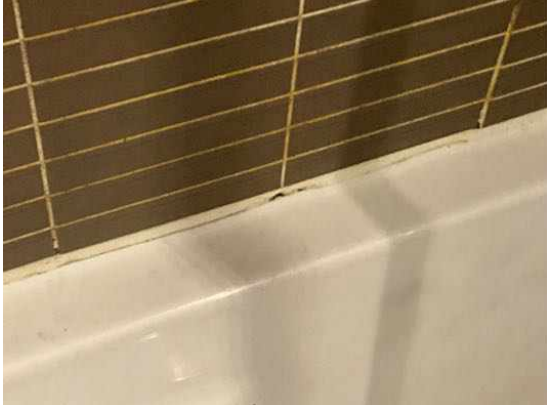
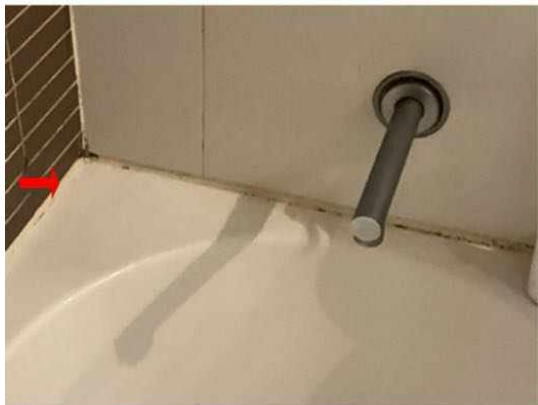
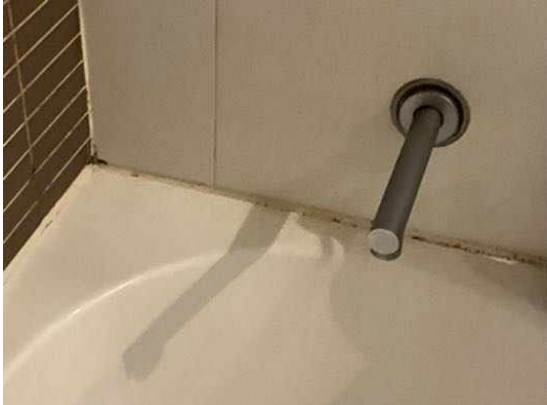
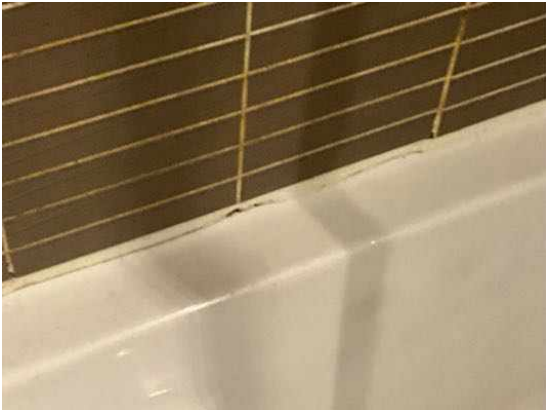
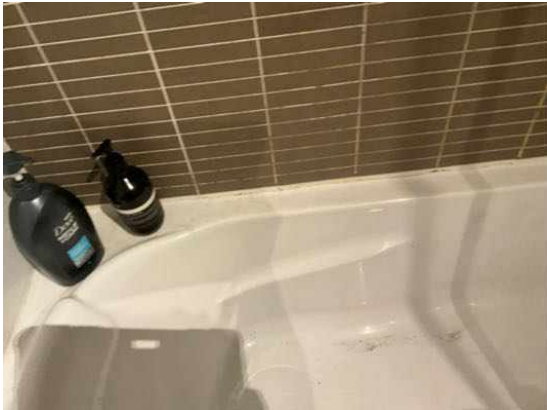
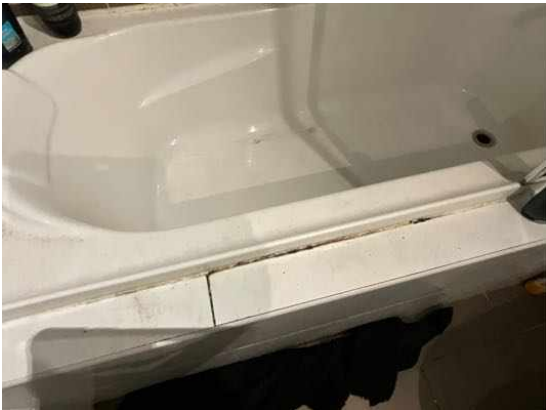
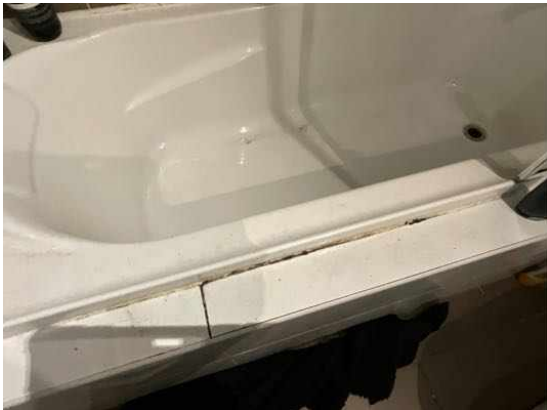
### Defects 3.06

Building:	Main Building
Location:	Bathroom
Finding:	Sealant and grouting - Missing or damaged
Information:	It was noted on inspection that sealant or grout is degraded to the tiled shower alcove and or other areas of the bathroom.

Different materials and floor areas move at different rates, generally causing cracking to grout or sealant at this point. A flexible sealant is required to allow for expected expansion and contraction, while keeping the joint water tight and protective of all associated building materials.

There appears to be excessive mould to the sealant and grout which will likely require scraping out and replacement.

Flexible and mould resistant materials should be applied to affected areas to prevent any subsequent water damage that is likely to occur. Regular maintenance and replacement of damage or missing or damaged sealant and grout is highly recommended to the wet areas, as this is a regular wear and tear defect. Sealant and grouting in areas that come into regular contact with water should be maintained for the long term care of your property.

A sealant specialist or tiling contractor should be appointed to complete these works as soon as possible

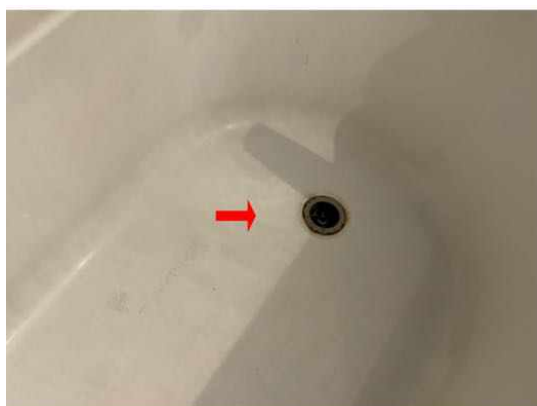
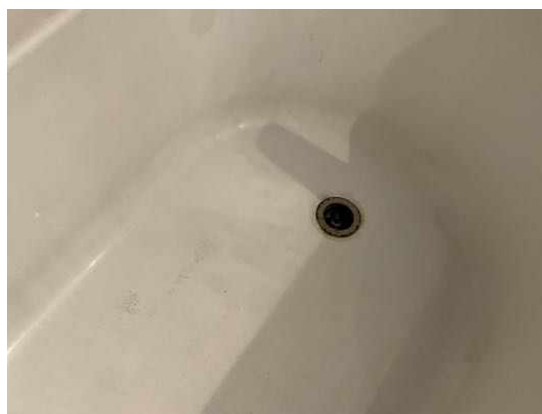
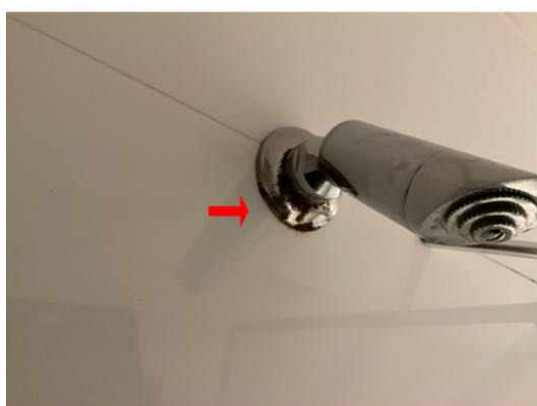
Defects 3.07

Building: Main Building  
 Location: Bathroom  
 Finding: Building element - Rusted or corroded  
 Information: This building element shows evidence of rusting and corrosion, which is likely to have developed as a result of excessive exposure to moisture and or inadequate coatings.

As surface rust provides no protection to the underlying iron, the deteriorating condition is likely to worsen if not addressed in the short-term future.

Where possible, the use of galvanized (treated) metals or aluminium coated metals aid in rust prevention, as does regular general maintenance. Rust formation can be controlled with coatings, such as paint, that isolate the iron from the environment.

Rusting and corrosion should be managed by ideally removing or limiting the affected surface from exposure to moisture. A registered builder may be appointed to replace any building elements that have been severely affected by rust or water damage.

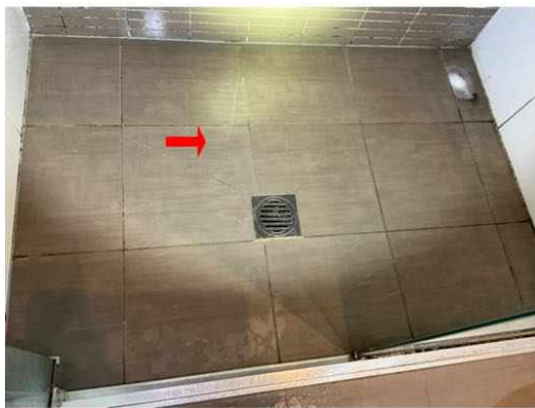
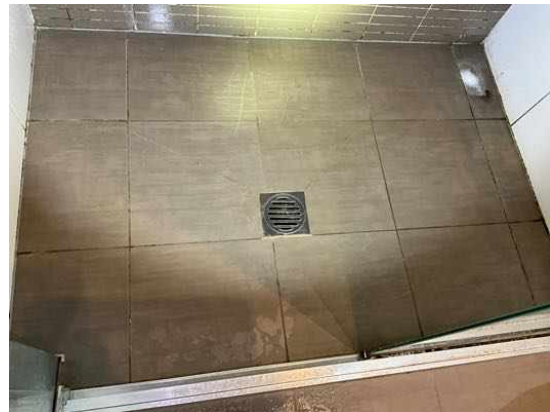
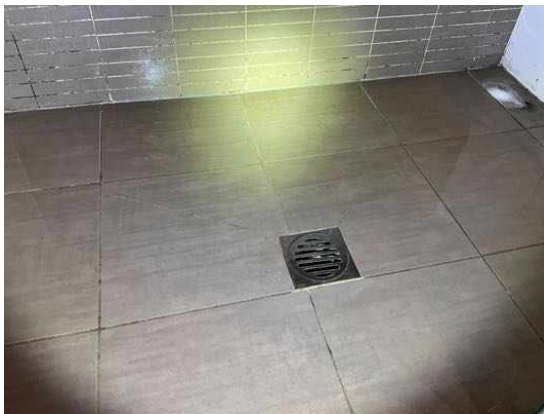
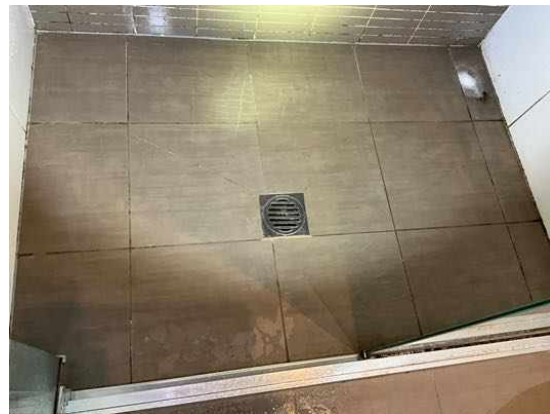
### Defects 3.08

Building: Main Building  
 Location: Ensuite  
 Finding: Shower base - Water pooling  
 Information: Evidence of water pooling around the floor waste in the shower recess was noticed at

the time of inspection. It is suspected that this excessive moisture is attributed to insufficient fall in the shower floor tiles.

This pooling is minor overall but is still considered unsatisfactory, as standard tiling practices would not permit this situation to occur. Pooling water around floor wastes can create a slip hazard in extreme cases and create conditions that are conducive to mould growth over time. Where left unmanaged, the degradation of sealant and grouting is also likely to occur, possibly necessitating further repair works.

Remedial works may involve some sections of tiling and flooring repair and replacement. A tiling contractor or bathroom specialist should be appointed to provide further advice on reparation options and to perform works as necessary.
