# Building and Timber Pest Inspection Report

Inspection Date: Tue, 13 Jan 2026

Property Address: 159 Waminda Ave, Campbelltown NSW  
2560, Australia

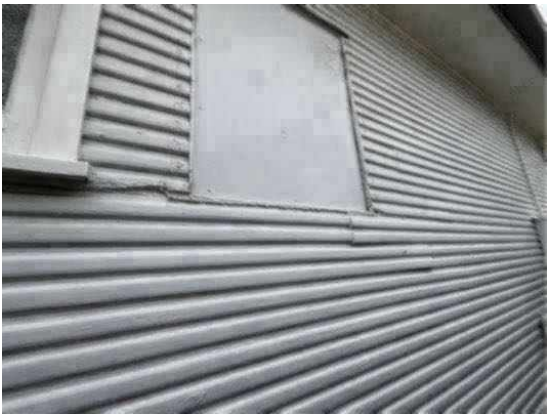
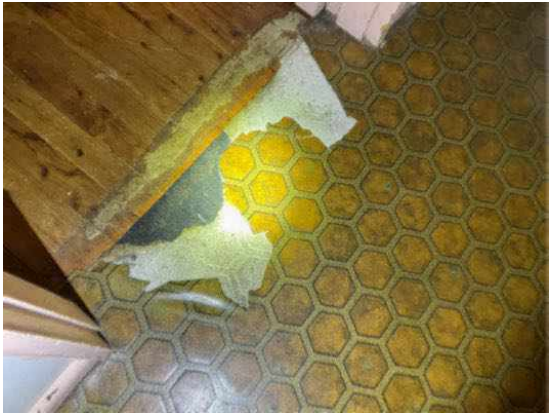
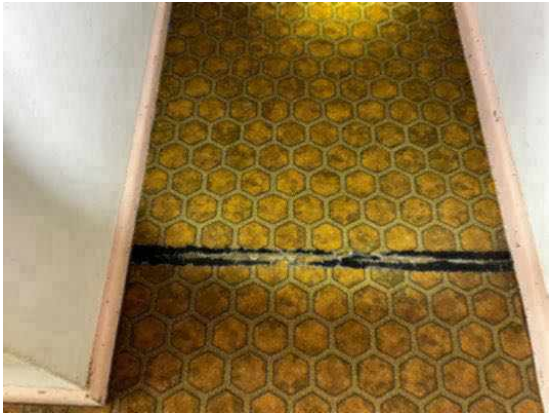
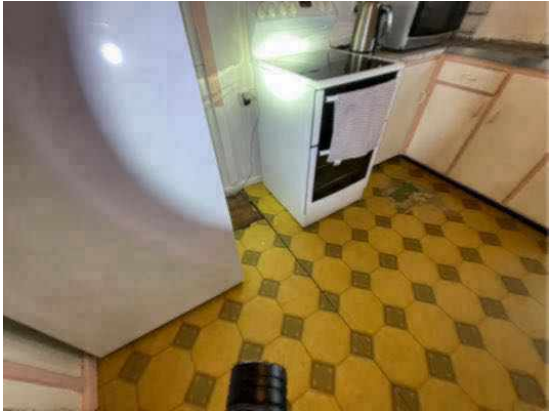
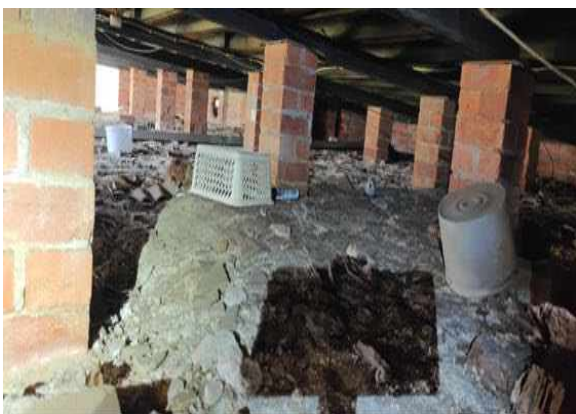
Building: Main Building  
Location: All Areas  
Finding: Asbestos - Suspected ACM Identified on Site  
Information: Reporting on Asbestos is outside the Scope of this Report. This suspected defect is highlighted as a caution only. We suspect, based on our experience in the building industry, that there is a higher risk of the identified building element containing asbestos.

As Asbestos Reporting is outside the scope of this report, we advise that you consider a separate Asbestos Inspection and Condition Audit, which can include the taking of samples for definitive confirmation of the presence of Asbestos.

In the interim, the client is advised to act with caution, especially when considering any damage to building materials general wear and tear renovations extensions demolition and general maintenance activities due to the suspected presence of Asbestos.

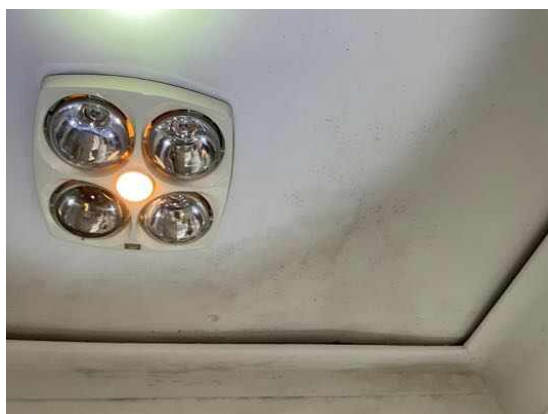
## Finding 1.02

Building:	Main Building
Location:	Bathroom
Finding:	Mould - Present
Information:	Mold growth is present throughout the property, primarily due to inadequate ventilation. Poor airflow and moisture accumulation within the house have created ideal conditions for mold to thrive.

- **Health Hazards**: Mold growth can pose serious health risks to occupants, particularly those with allergies, asthma, or other respiratory conditions. Prolonged exposure to mold spores can cause respiratory issues, skin irritation, and other allergic reactions.
- **Structural Damage**: Mold can degrade building materials over time, leading to rot and weakening of the structural components such as timber, drywall, and insulation, which can result in costly repairs.
- **Decreased Property Value**: The presence of mold can significantly reduce the value of the property, as it indicates underlying moisture and ventilation issues that need addressing.

A licensed mold remediation specialist should be engaged to remove the mold and treat affected areas. In addition, a ventilation expert or builder should assess and improve the house's ventilation system, possibly installing exhaust fans, vents, or mechanical ventilation systems to ensure adequate airflow and prevent future mold growth.

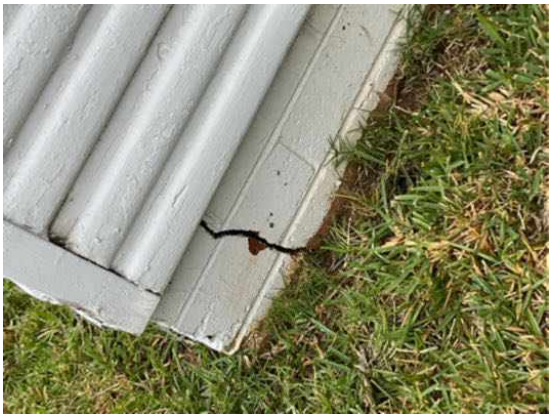
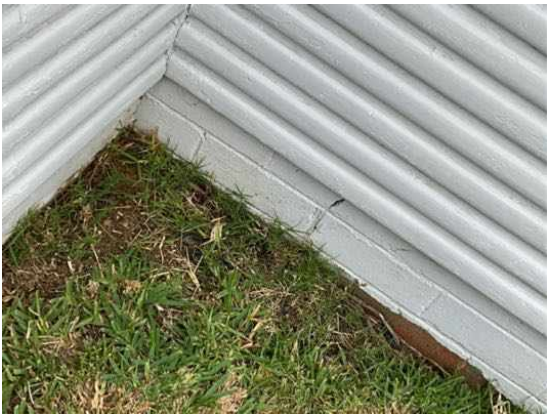
### Finding 2.01

Building:	Main Building
Location:	All Areas
Finding:	Brickwork - Cracking [Repair required]
Information:	Major cracking was identified to the brickwork in this area. Cracks of this type are likely to have been caused by minor expected movement of building elements, but may also have a structural cause that is more significant.

A crack of this size may be repaired by extensive filling. Additionally, further remedial works to associated building elements, such as eave sheeting or external door frames, is likely to be required.

A qualified bricklayer should be contacted immediately to estimate and perform repair and restoration works. Consultation with a structural engineer may be required where structural instability is found to be the underlying cause of the cracking.

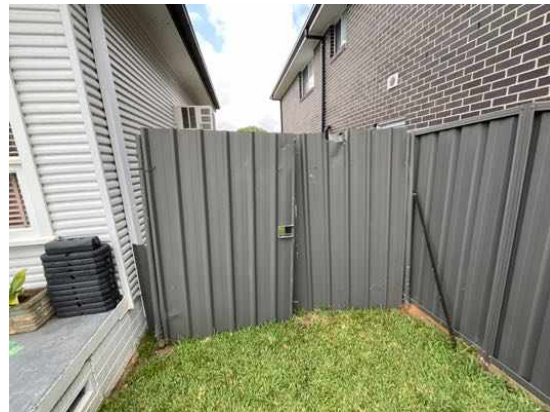
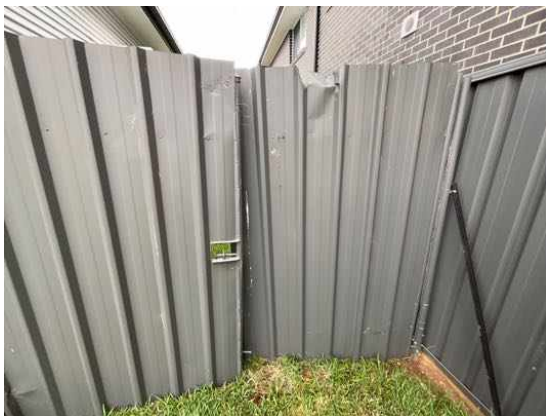
**Finding 2.02**

Building: Main Building  
Location: Yard - Side  
Finding: Gate Detached and Damaged  
Information: The gate is observed to be detached from its original hinges and fencing post. The gate shows signs of corrosion, particularly at the base and hinge points. It is stored against the side boundary fence and is not operational. The supporting post appears bent and compromised, making reinstatement unfeasible without repair or replacement.

- Safety Hazard: Risk of physical injury from sharp edges or falling if disturbed.

- Security Concern: Reduced security and control of access to the property.
- Ongoing Deterioration: Continued exposure to weather will likely worsen corrosion and structural integrity.

Engage a licensed fencing contractor or metal fabricator to assess the extent of the damage. Repair or replacement of the gate and hinge mechanism is recommended to restore both security and aesthetic function. All works should comply with local fencing standards and guidelines.

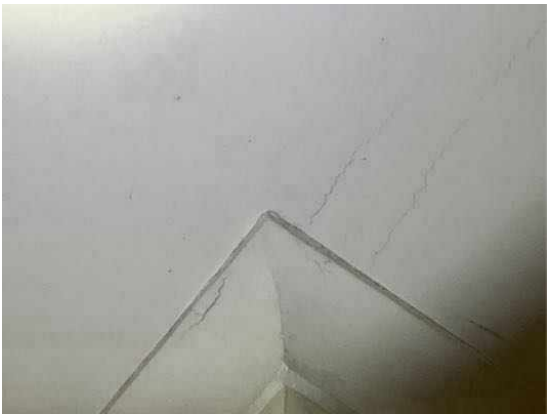
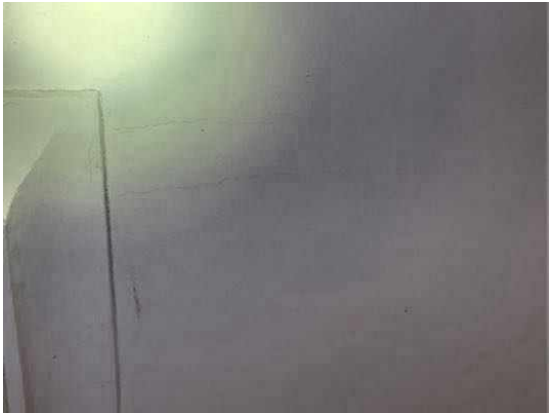
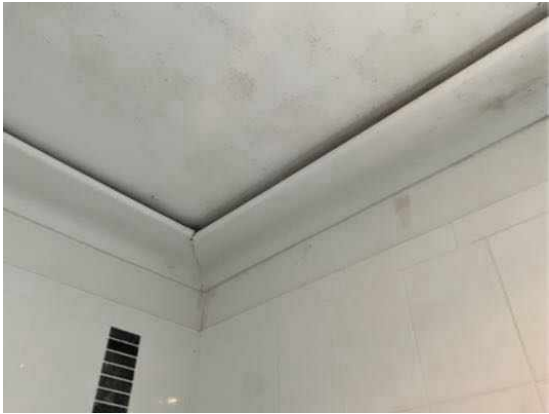
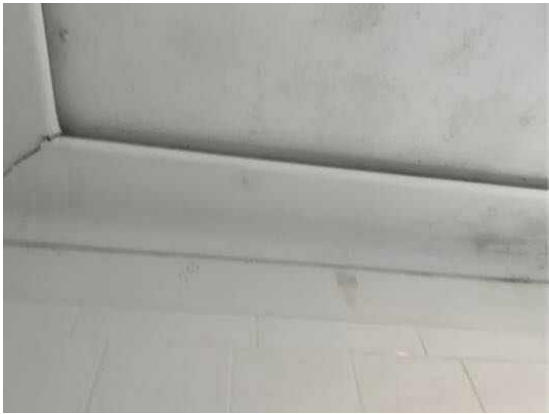
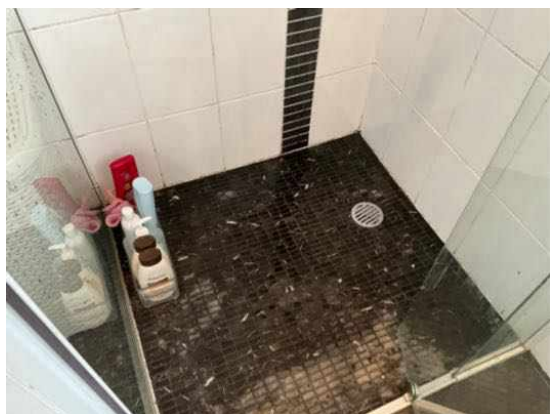
Building:	Main Building
Location:	All Areas
Finding:	Ceiling & Cornice - Cracking / Separation
Information:	Observed condition: <ul style="list-style-type: none"> <li>• Step and diagonal cracking through plaster/cornice at ceiling–wall junctions.</li> <li>• Open joints/gaps at cornice mitres and along a ceiling back-blocking/joint line.</li> <li>• Minor displacement to cornice edge; previous patching visible.</li> </ul>

Typical building movement and differential settlement/shrink–swell (seasonal moisture, framing movement, or door-head/beam deflection at opening). Contributing factors may include inadequate fixing/back-blocking, aged compounds, or prior repairs.

- Builder to check for movement or leaks.
- Plasterer to repair joints, reset cornice, and patch cracks.
- Painter to finish.
- If ongoing movement is observed, a structural engineer may be needed.

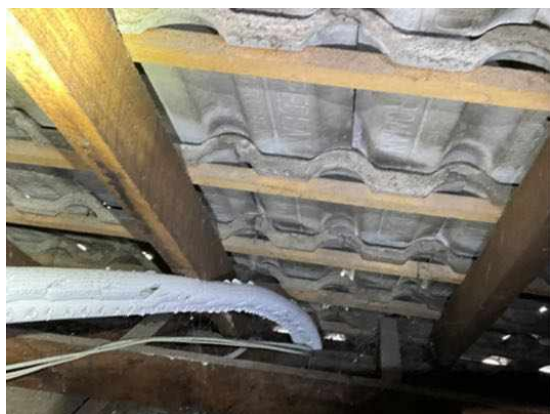
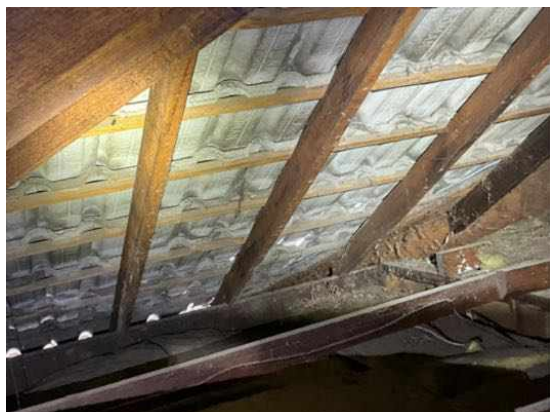
### Finding 2.05

Building: Main Building  
 Location: Roof Void  
 Finding: Roof Void - Evidence of batten movement  
 Information: Evidence of batten movement and visible daylight through the roof covering was observed from within the roof void. Several roof battens appear to have shifted or become dislodged from their original positions.

This condition compromises the structural integrity of the roof, as battens are essential for supporting roof tiles or sheeting. Movement or displacement can result in roof tile

failure, leading to water ingress and potential damage to internal building elements, including insulation, ceiling linings, and electrical wiring. It also increases the risk of wind uplift or progressive roof failure in severe weather conditions.

A licensed roofing contractor or qualified builder should be engaged urgently to assess the full extent of structural batten movement and carry out remedial works. This may include re-fixing or replacing battens, ensuring all roofing elements are adequately secured, and checking for any related structural damage.

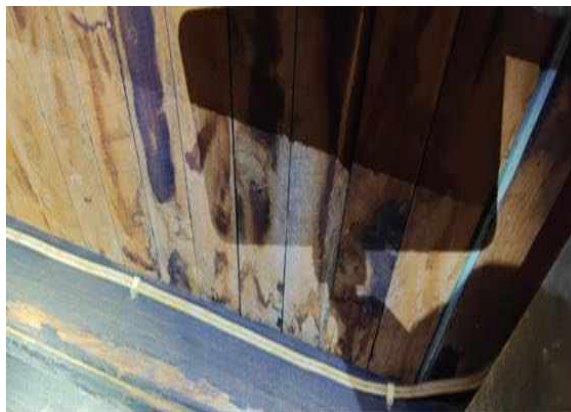
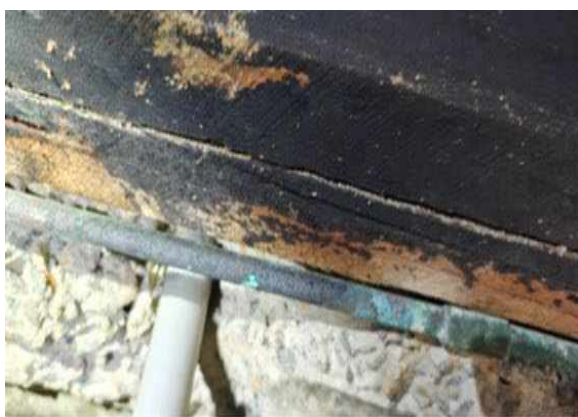
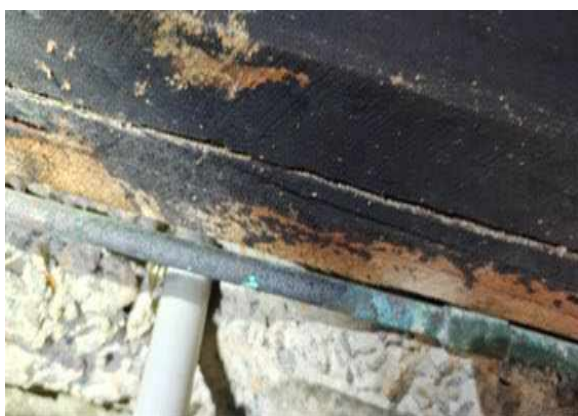
### Finding 2.06

Building: Main Building  
 Location: Subfloor  
 Finding: Subfloor- leaking plumbing fittings  
 Information: Evidence of leaking plumbing fittings was observed within the subfloor area. Moisture staining and timber deterioration suggest prolonged water exposure from faulty pipe joints or fixtures.

- Structural damage to timber framing and flooring due to continuous moisture exposure.
- Mould growth and decay, posing potential health risks and further degradation of building materials.
- Pest attraction, as damp environments are conducive to termites and other pests.
- Non-compliance with plumbing standards and risk of escalation if not addressed promptly.

- A licensed plumber should be engaged to identify the exact source of leakage,

repair or replace faulty fittings, and confirm watertight integrity. A builder may also be required to assess and rectify any structural damage.

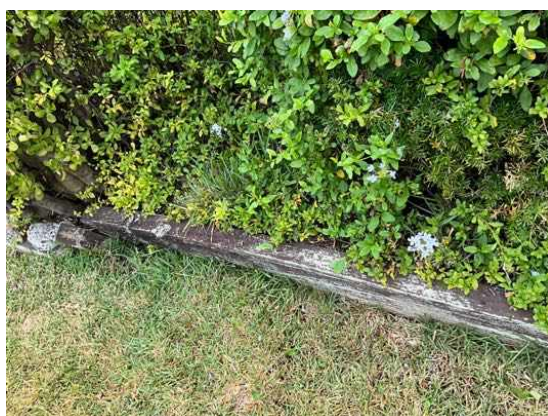
**Finding 3.02**

**Finding:** Retaining wall - Defective

**Information:** The retaining wall in this area was found to be defective at the time of inspection. Generally, defective retaining walls are caused by poor original design or material use. However, deteriorated retaining walls may also be a result of substandard construction, poor site drainage or unmanaged stormwater flows.

If left unmanaged, the retaining wall may become a safety hazard if it continues to destabilise. Where retaining walls further rot and decay, an environment is created that is conducive to termite and pest infestation.

Significant repair and replacement should be expected. Where retaining walls are considered structural walls, a structural engineer / surveyor should be consulted regarding required remedial works. Otherwise, a landscaper or retaining wall installer may be appointed to repair or replace the wall, at the discretion of the client.

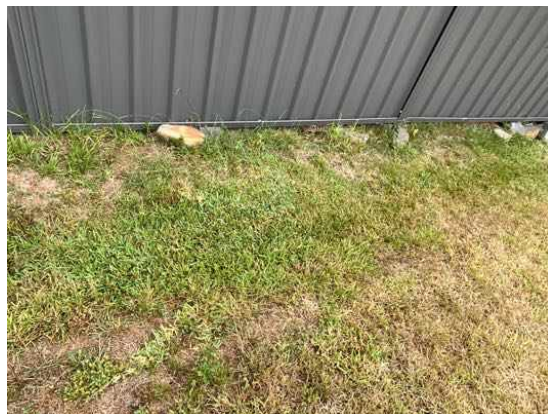
### Finding 3.03

**Information:** The perimeter ground levels were found to have an inadequate slope away from the adjoining building structure, creating potential for water pooling in this area.

Perimeter is required to fall from the building by a minimum of 25mm in the first metre and bare ground should fall away from the house by 50mm in the first meter. This standard ensures that excessive moisture does not pool around the base of building structures, which creates potential for water and structural damage, as well as making the area susceptible to termite and timber pest activity.

Such water pooling also increases the risk of termite activity and the development of fungal decay in the area.

Consult a Licensed Plumber regarding the cost of potential site drainage rectification works.

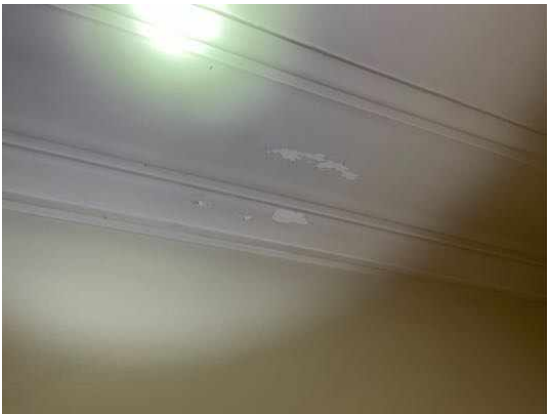
Information: Sections of the paint in this area was found to have deteriorated. Paint deteriorating is generally an indication of excessive moisture in the area that is currently hidden by the painted surface.

The presence of excessive moisture can have major implications on associated building elements if left unattended. While only seemingly minor at this stage, the damage cannot be determined due to the paint, obstructing any further inspection of the damage.

It is highly advised that the affected paint to be cleaned to allow a further, more invasive inspection by a licensed builder/painter. Failure to act on this defect may necessitate major works in the future.

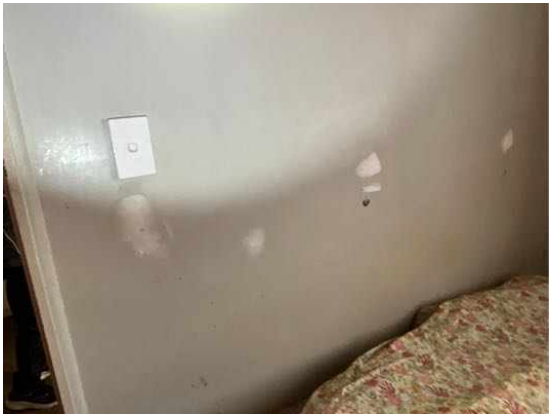
**Finding 3.07**

Building: Main Building  
Location: Bedroom 3  
Finding: Poor workmanship  
Information: The structure exhibits signs of poor workmanship, evident in various aspects of construction and finishing.

Risk: Poor workmanship poses a range of risks, including compromised structural integrity, potential safety hazards, and a decreased lifespan of the structure. It may also lead to aesthetic and functional issues.

Resolution: A qualified contractor or construction professional should be consulted to assess and address the poor workmanship. They can implement corrective measures to ensure structural soundness, safety, and overall quality of the construction.

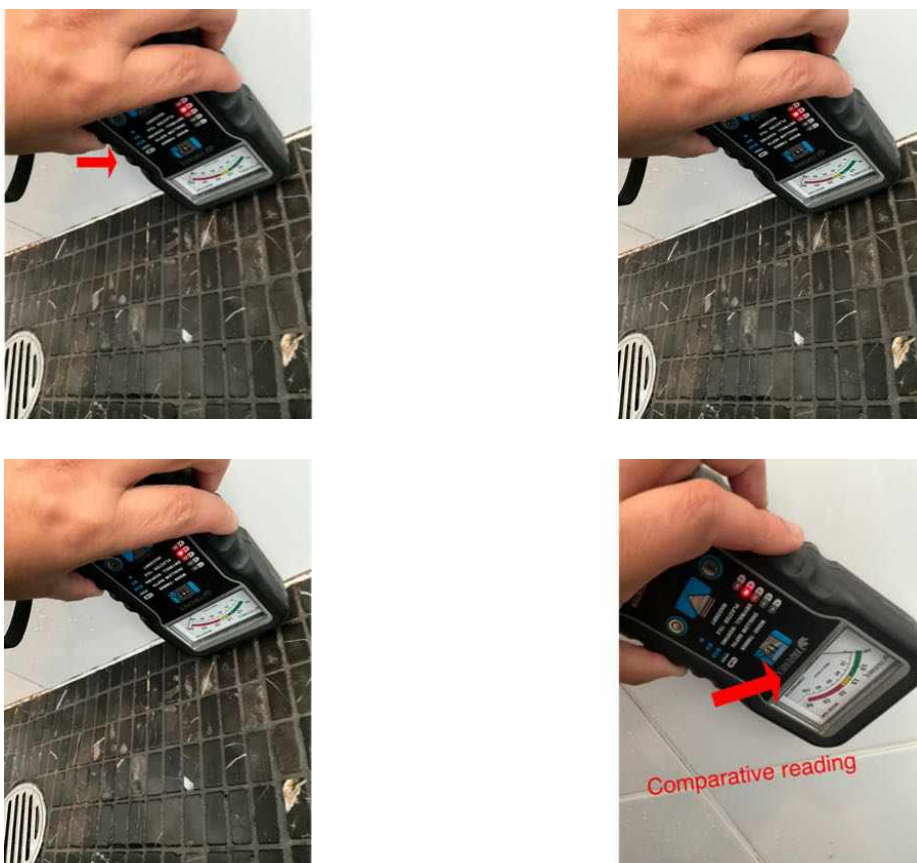
Building:	Main Building
Location:	Bathroom
Finding:	Shower - Damp
Information:	Damp is evident to the lower 300mm of wall to the shower alcove. This defect is quite common, and is suspected to have been caused by moisture permeating through the grouting in this area, which shows evidence of deterioration. Leaking pipes within the adjoining wall is also a possible cause.

Unmanaged damp in the shower recess is likely to facilitate the formation and development of mould and fungi growth, decaying associated building materials and compromising their structural integrity. It is important to address damp conditions, as the World Health Organisation notes that excess moisture leads - on almost all indoor materials - to growth of microbes such as moulds, fungi and bacteria, which subsequently emit spores and other matter into the indoor air. Exposure to these contaminants is associated with a wide range of respiratory and other health-related problems.

Consultation with a qualified plumber or bathroom specialist is advised immediately to identify the cause of damp and to perform remedial works as required. Where excessive mould growth is present, further inspection by a specialist environmental health inspector should also be considered.

Always ensure that sealant and grout is in good condition to prevent any moisture issues occurring in the future.

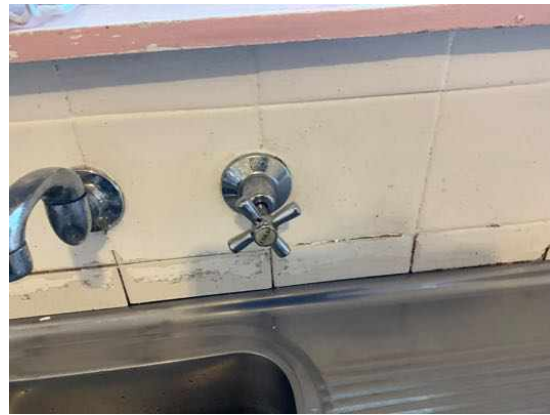
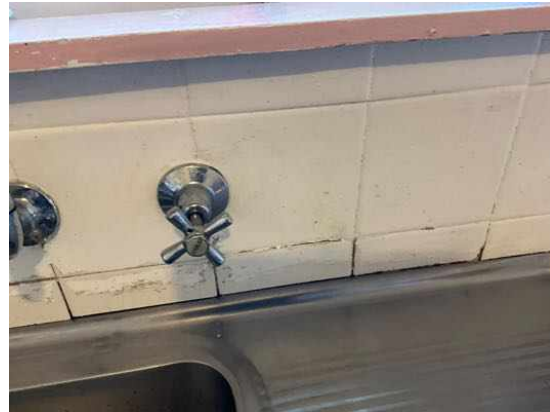
Finding: Grouting - Missing or damaged

Information: It was noted on inspection that sealant or grout is Missing or damaged. A flexible sealant is required to allow for expected expansion and contraction, while keeping the joint water tight and protective of all associated building materials.

Flexible and mould resistant materials should be applied to affected areas to prevent any subsequent water damage that is likely to occur. Regular maintenance and replacement of damage or missing or damaged sealant and grout is highly recommended, as this is a regular wear and tear defect.

A sealant specialist or tiling contractor should be appointed to complete these works as soon as possible

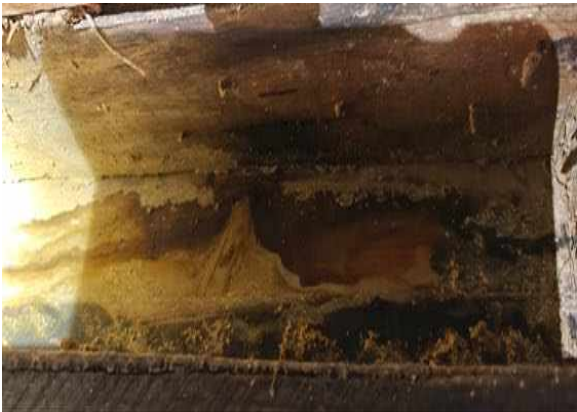
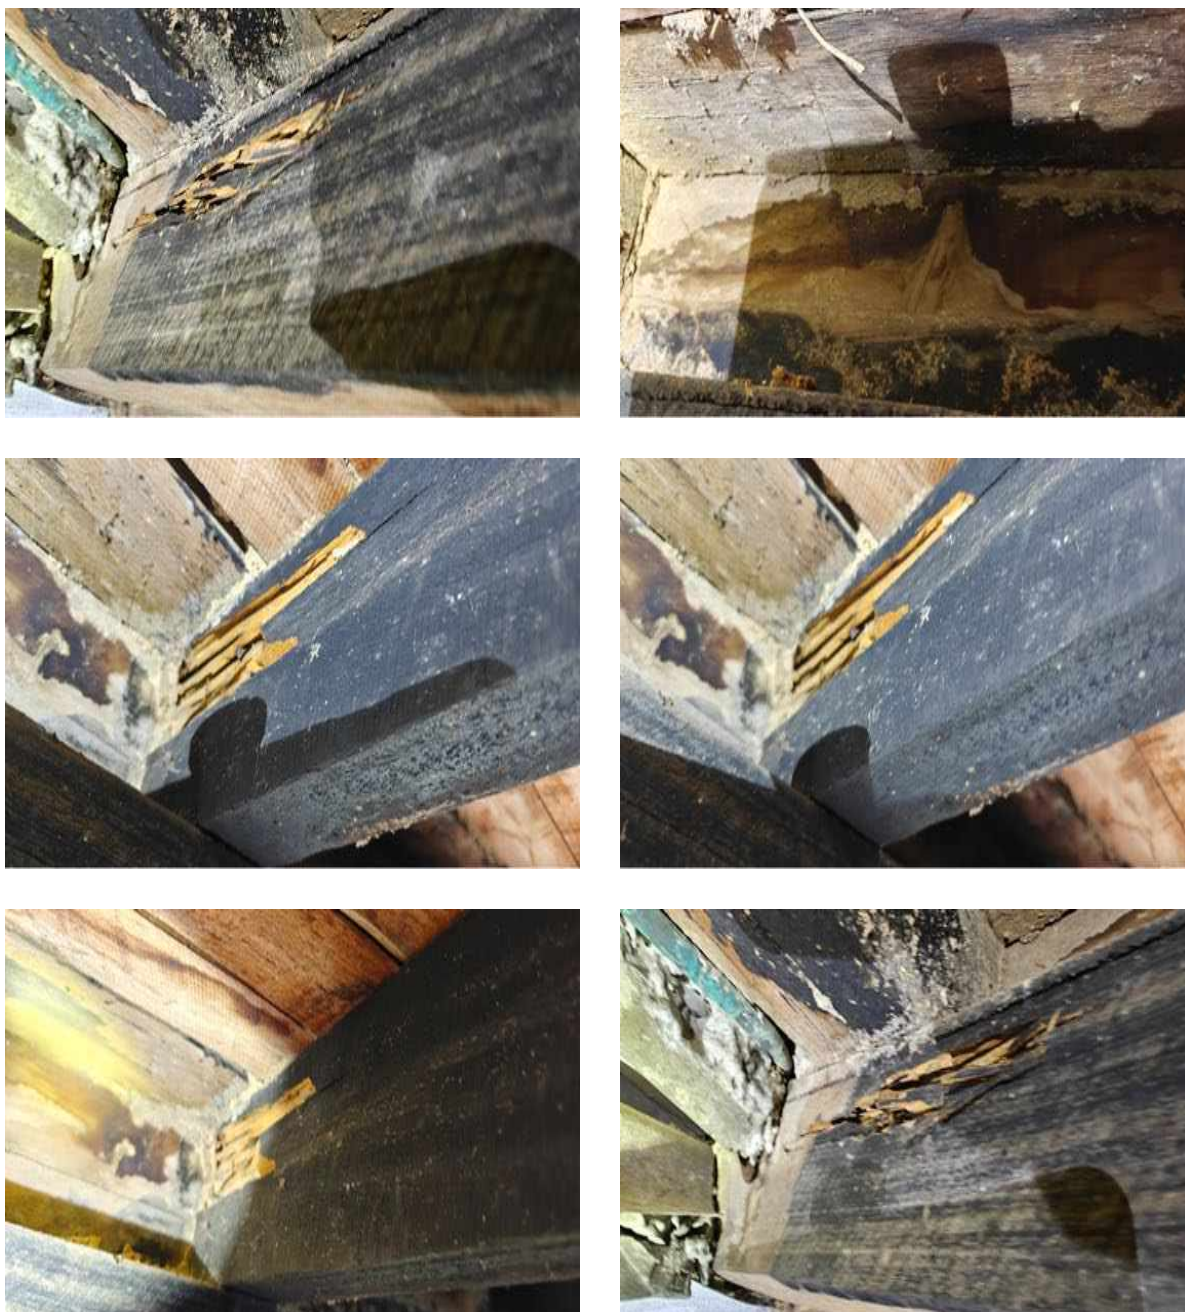
The presence of termite damage increases the risk of further structural deterioration, weakening the subfloor and potentially causing instability in the entire structure. If left unaddressed, this may lead to severe structural issues, compromising safety and necessitating extensive repairs.

A licensed pest control professional should conduct a thorough inspection to assess the extent of termite damage. Subsequently, a qualified contractor experienced in subfloor repairs should be engaged to address and rectify the damage. Swift action is crucial to prevent further harm and ensure the long-term stability of the building.

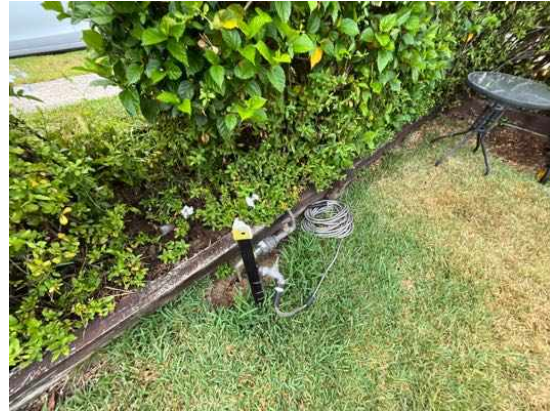
Finding 6.02

Building: Main Building  
Location: All Areas  
Finding: Dense vegetation around a property can increase the risk of termite infestation  
Information: The presence of dense vegetation around a property can increase the risk of termite infestation, as it provides a conducive environment for them. To address this, consider maintaining a clear space between the vegetation and your home. If you suspect a termite issue, it's advisable to consult with a licensed pest control professional for inspection and treatment.

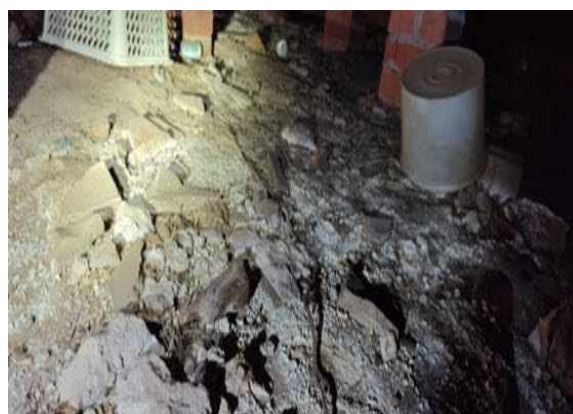
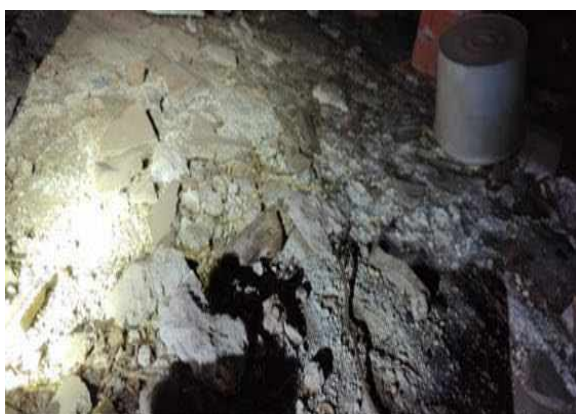
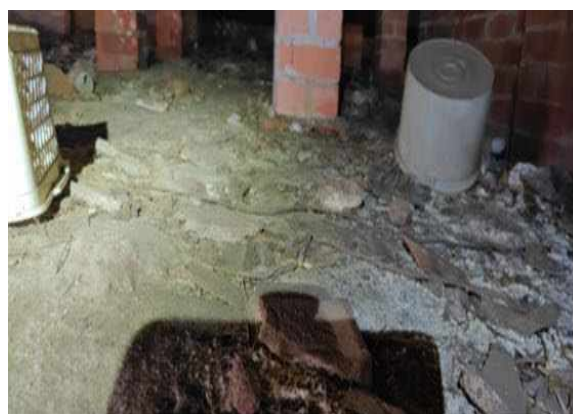
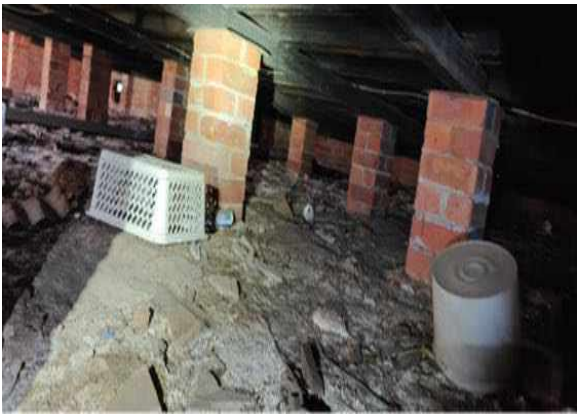
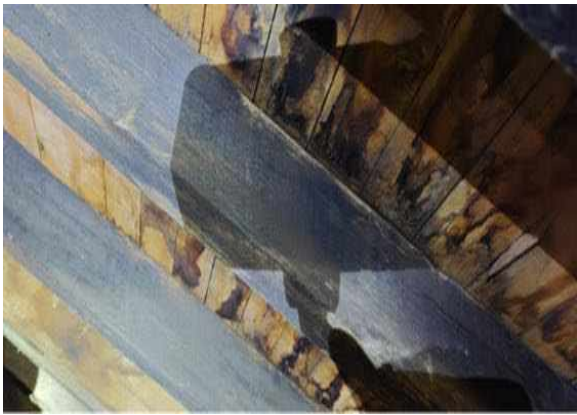
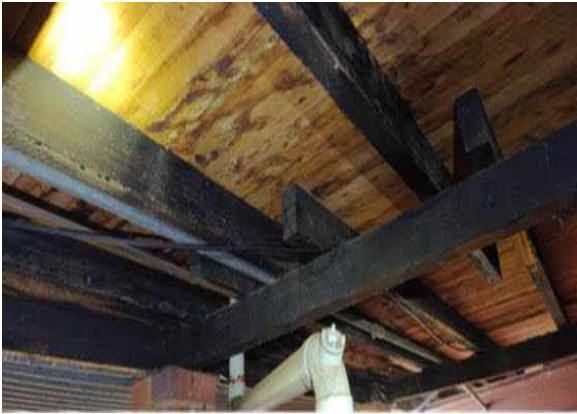
Building:	Main Building
Location:	Subfloor
Finding:	Subfloor - poor ventilation, inadequate site drainage, water stains

Risk: The combination of poor ventilation, inadequate drainage, water stains significantly increases the risk of timber pest infestations. Termites are attracted to moist environments and can thrive in subfloors with high humidity levels and water damage. The lack of proper ventilation and drainage exacerbates moisture retention, providing an ideal habitat for timber pests to establish colonies and cause extensive damage to the subfloor structure. Additionally, water stains indicate previous or ongoing moisture issues, which further attract timber pests and contribute to the deterioration of timber materials.

A licensed pest control professional specializing in timber pest management should be consulted to assess the extent of the infestation and develop a comprehensive treatment plan. They can implement strategies to eliminate existing timber pests, such as termites and prevent future infestations by addressing underlying moisture issues. Additionally, a qualified plumber or builder may be needed to improve subfloor ventilation, enhance site drainage, repair water-damaged areas. Regular inspections and maintenance are essential to ensure ongoing protection against timber pests and maintain the structural integrity of the subfloor.

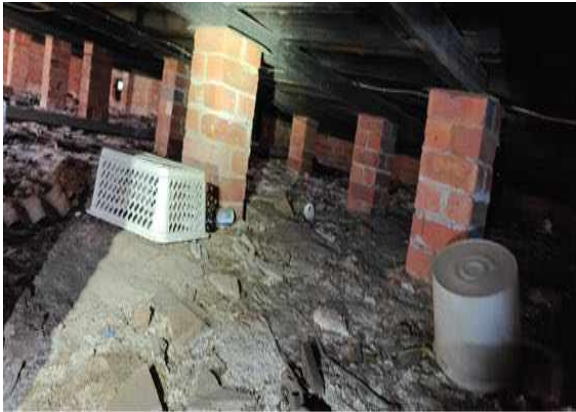
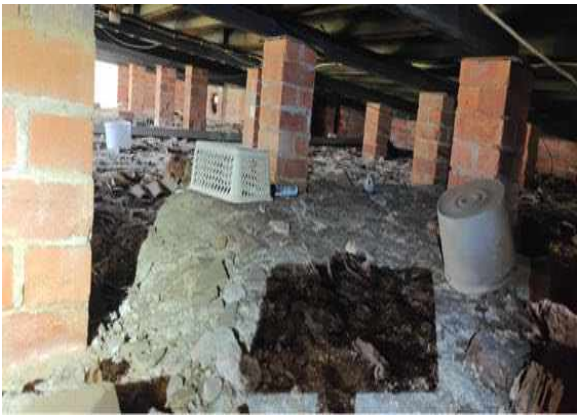
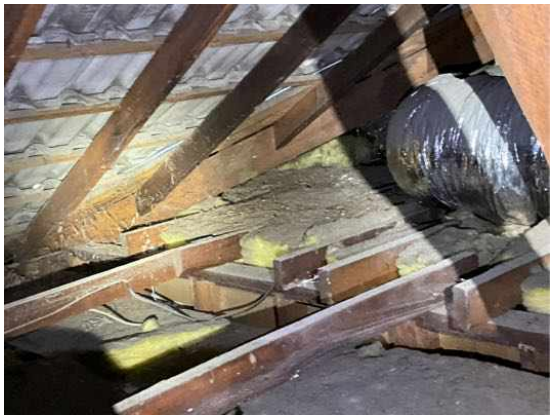
**Noted Item**

Building: Main Building  
 Location: All Areas  
 Finding: Additional Photos - Obstructions and Limitations  
 Information: These photographs are an indication of the obstructions and limitations which impeded full inspection of the property at the time of inspection. These obstructions can hide an array of defects and should be removed to allow full inspection to be carried out. A re-inspection is recommended once the areas are made accessible.
