Building and Timber Pest Inspection Report

Inspection Date: Thu, 5 Feb 2026

Property Address: 12/2 Hythe St, Mount Druitt NSW 2770,
Australia

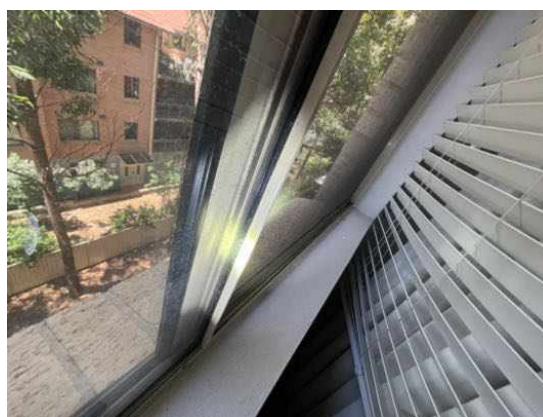
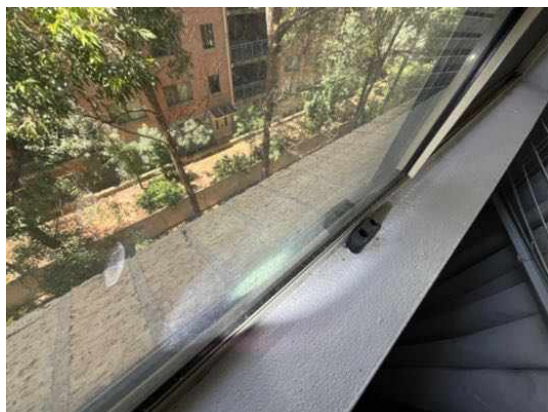
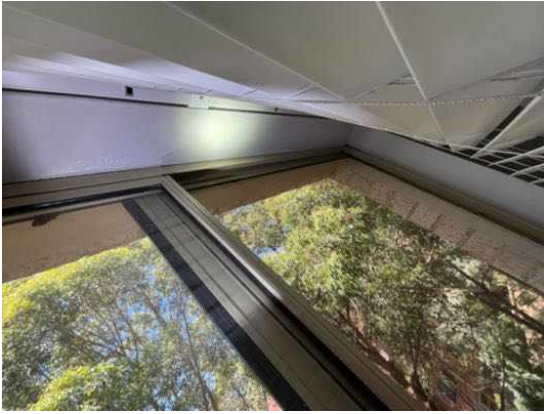
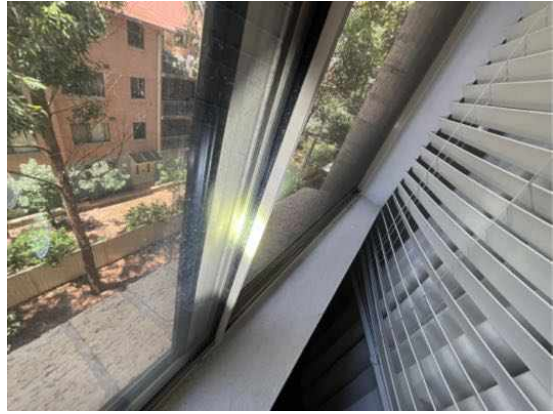
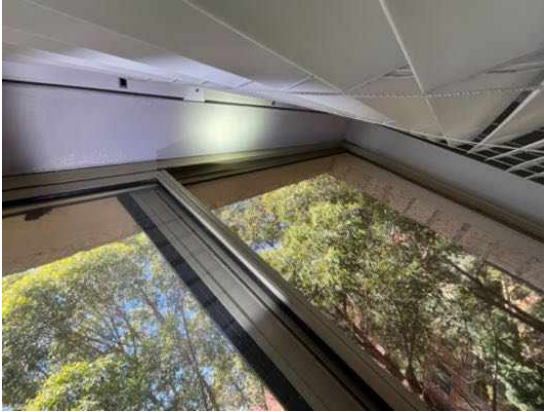
Finding 1.01

Building:	Main Building
Location:	All Areas
Finding:	Window child lock missing
Information:	The window in question lacks a child lock mechanism, which poses a potential safety risk to young occupants in the premises. As per Australian Standards windows accessible to children should be equipped with appropriate child safety locks to prevent accidental opening, reducing the risk of falls and ensuring compliance with safety regulations.

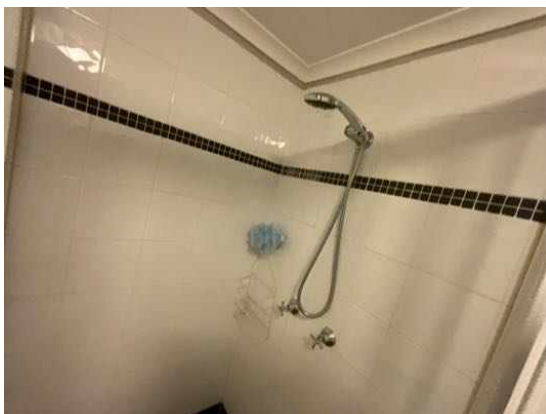
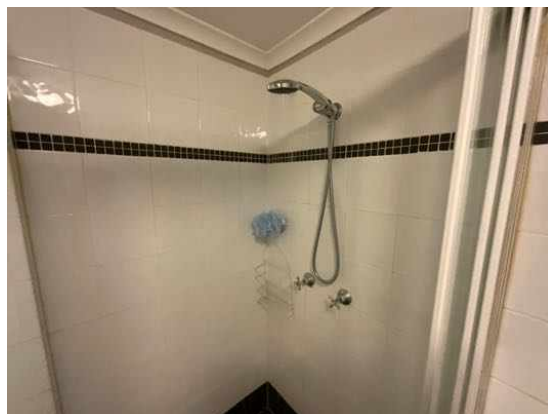
Finding 2.01

- May lead to long-term damage of internal plumbing components.
- Can cause wear and tear at joints and fittings.
- Potential for leaks or water damage if left unresolved.

A licensed plumber should be engaged to investigate and rectify the issue. Solutions may include installing water hammer arrestors, securing pipework, or adjusting water pressure.

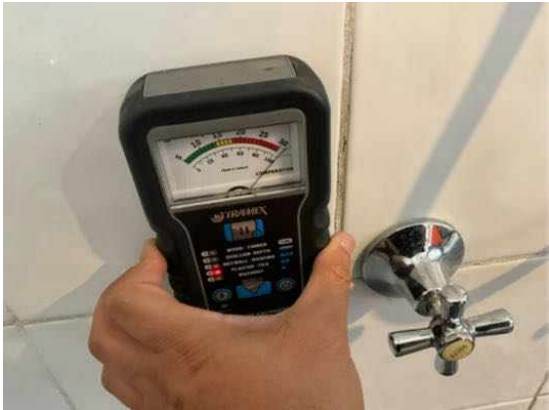
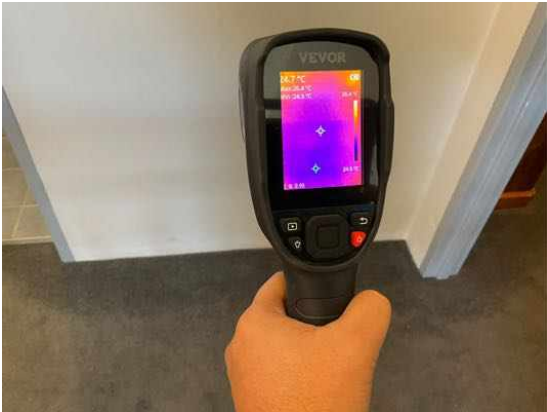
Finding 2.02

Building: Main Building
Location: Bathroom upstairs
Finding: Evidence of excessive moisture was present at the time of inspection
Information: Excessive moisture is present behind the bathroom tiles, indicating a potential water leakage issue within the wall.

The prolonged presence of moisture can lead to mold growth, deteriorate the structure, and create an environment conducive to health hazards. Additionally, it may compromise the adhesive holding the tiles, leading to their detachment.

A licensed plumber or a qualified contractor specializing in water damage remediation should investigate the source of the moisture, fix any leaks, and address the damage. Additionally, replacing affected tiles and ensuring proper waterproofing are crucial to preventing future issues.

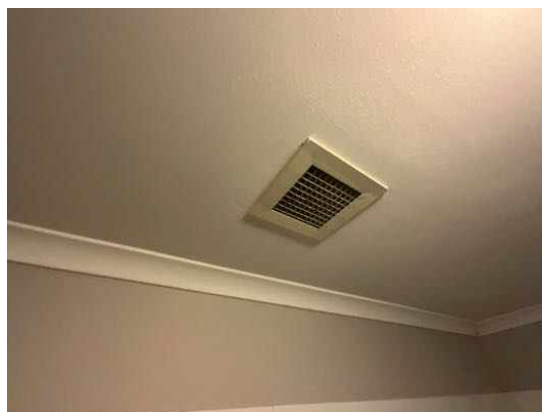
Building:	Main Building
Location:	Bathroom
Finding:	Exhaust fan - Not operating
Information:	The exhaust fan in this area appears to be damaged or blocked and is not operating as intended. If left unmanaged, a lack of general maintenance is likely to lead to the development of more significant defects, such as water damage to surrounding building materials from inadequate ventilation. If left unattended for a prolonged period of time, poor ventilation in this area may also be conducive to the development of mould.

Where no secondary damage has developed, the Homeowner may undertake minor cleaning of the area and consider replacement of the exhaust fan. Alternatively, consultation with a Licensed Electrician is required to check for any secondary or concealed damage and consider repair or replacement.

Please be advised that a cabinet maker or qualified carpenter may also be required if water damage has occurred and that an additional specialist mould inspection may be required if severe mould has resulted.

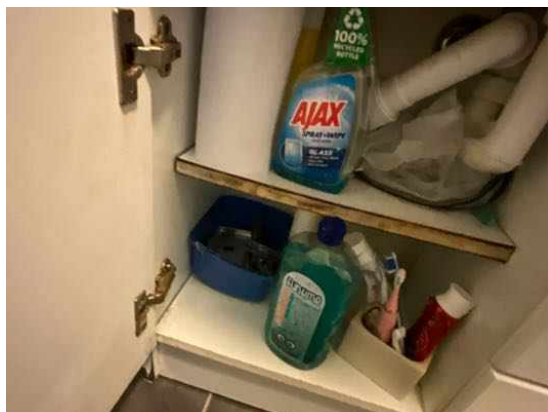
Finding 3.03

Building:	Main Building
Location:	Bathroom
Finding:	Water damage / Vanity
Information:	"The vanity in the shower area has sustained water damage, resulting in swelling and discoloration of the wood, as well as potential structural issues. This damage compromises both the aesthetic and functional aspects of the vanity."

1. **Carpenter or Woodworker:** They can assess and repair the damage to the vanity, potentially replacing any irreparable parts.
2. **Plumber:** If the water damage is due to plumbing issues, a plumber can fix leaks and ensure there are no further water-related problems.
3. **General Contractor:** If the damage is extensive and affects the surrounding area, a general contractor can coordinate the repair work, including both the vanity and any related structural or cosmetic repairs.

Make sure to obtain quotes from these professionals to determine the most cost-effective and efficient solution for your specific situation.

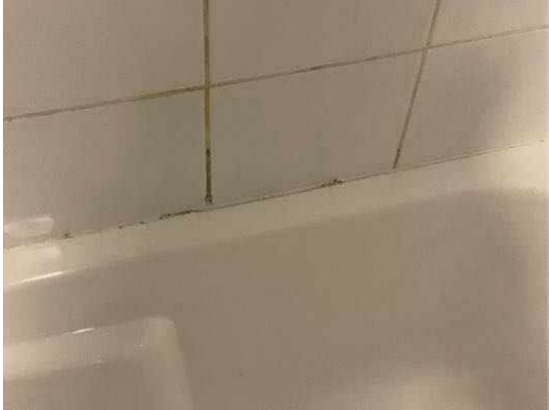
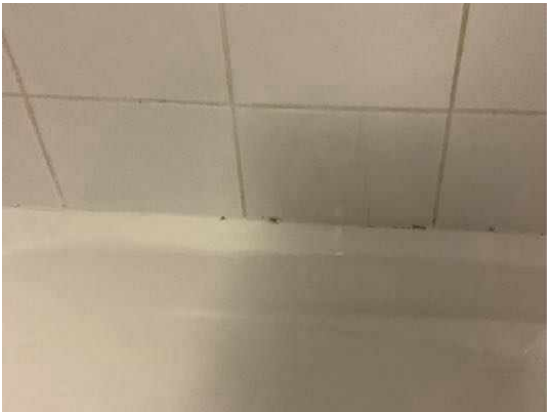
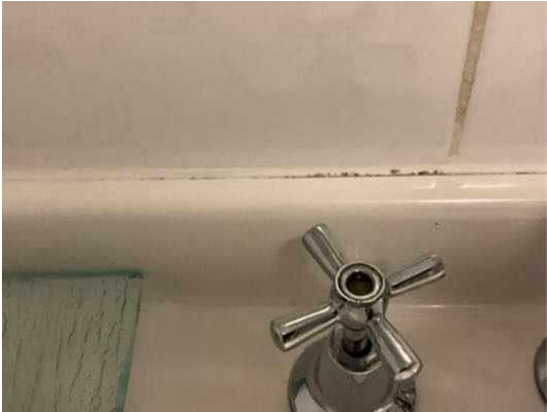
Finding 3.04

Building:	Main Building
Location:	Bathroom
Finding:	Sealant and grouting - Missing or damaged
Information:	It was noted on inspection that sealant or grout is degraded to the tiled shower alcove and or other areas of the bathroom.

Different materials and floor areas move at different rates, generally causing cracking to grout or sealant at this point. A flexible sealant is required to allow for expected expansion and contraction, while keeping the joint water tight and protective of all associated building materials.

There appears to be excessive mould to the sealant and grout which will likely require scraping out and replacement.

Flexible and mould resistant materials should be applied to affected areas to prevent any subsequent water damage that is likely to occur. Regular maintenance and replacement of damage or missing or damaged sealant and grout is highly recommended to the wet areas, as this is a regular wear and tear defect. Sealant and grouting in areas that come into regular contact with water should be maintained for the long term care of your property.

A sealant specialist or tiling contractor should be appointed to complete these works

as soon as possible

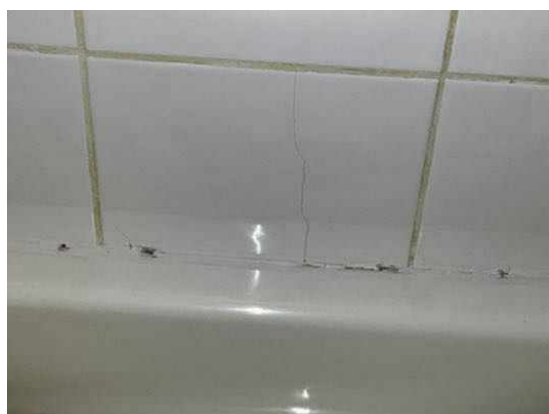
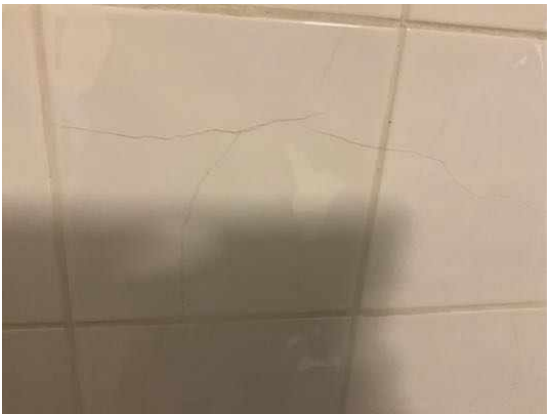
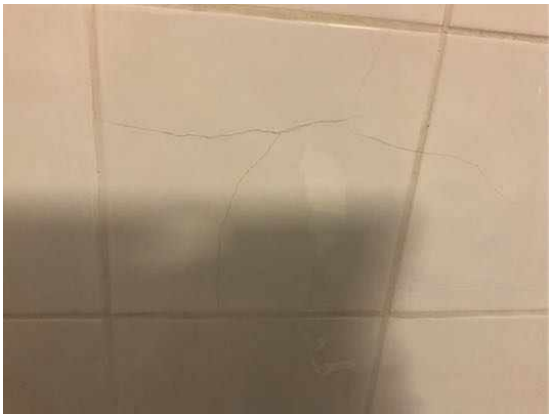
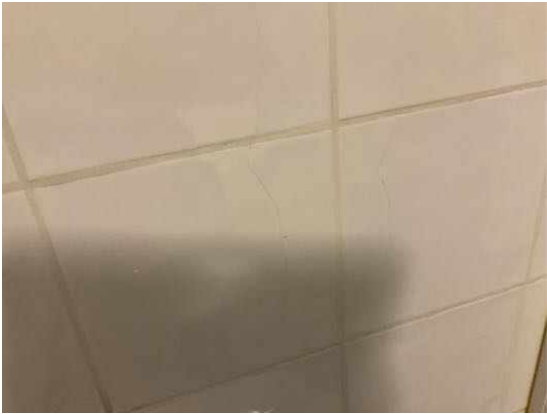
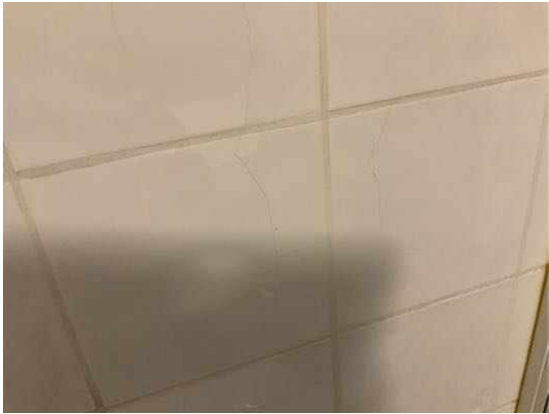
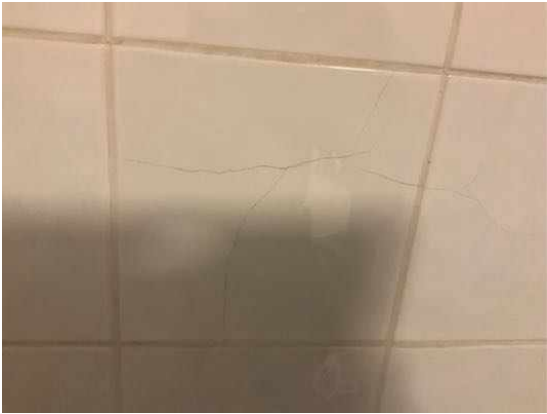
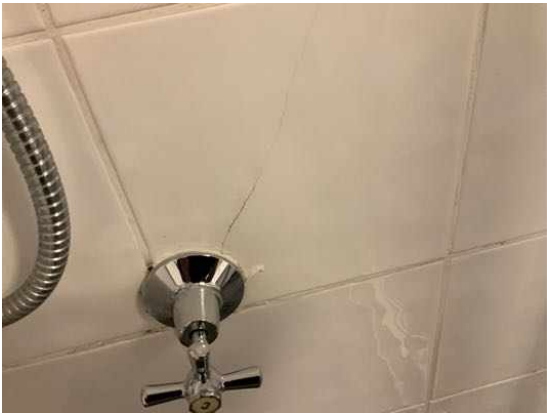
Finding 3.05

Building: Main Building
Location: Bathroom
Finding: Tiles - Cracked or damaged
Information: Cracking was evident to the tiling in this area at the time of inspection. While the cracking appears to be minor, this area is frequently exposed to water, allowing potential for water penetration into adjoining sections of walls or flooring.

If left unmanaged, water penetration to these areas may lead to subsequent water damage, which is likely necessitate repair work to affected building elements.

A tiling contractor should be appointed to ensure that no further water damage occurs. The re-application of silicone and grouting throughout remaining tile work is also advised, to further protect the area against water penetration.

Where water penetration has led to water damage, appointment of a relevant tradesperson may be required to repair damaged building elements.

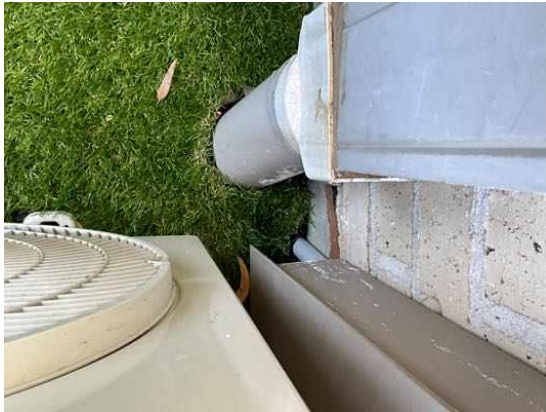
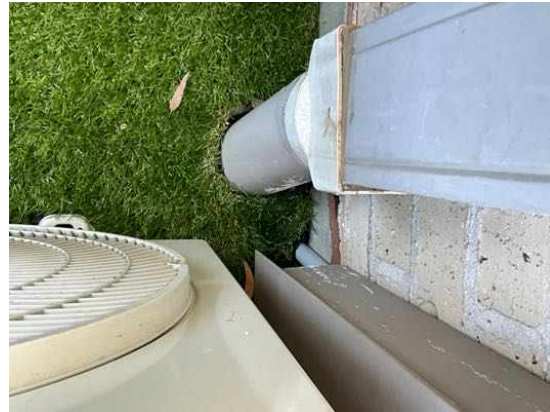
Building:	Main Building
Location:	Balcony
Finding:	Air conditioner - Disconnected overflow
Information:	The Air Conditioner (A/C) overflow was found to be disconnected from storm water drainage and is creating excessive moisture in the surrounding area.

Such leaking creates an environment which is conducive to an array of defects, including water damage to associated building elements and the attraction of termite or timber pest infestation.

It is highly recommended that a licensed plumber be appointed to connect the A/C overflow in order to prevent such an environment from being created. These minor works should be carried out as soon as possible.

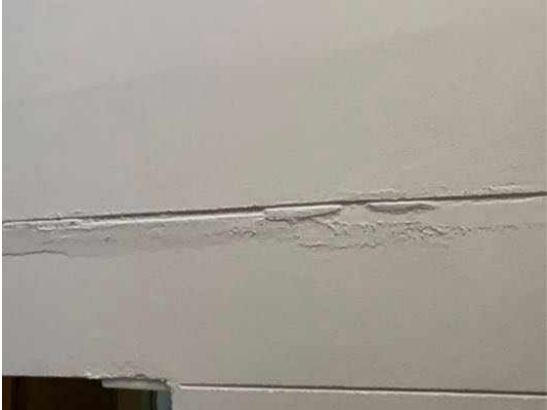
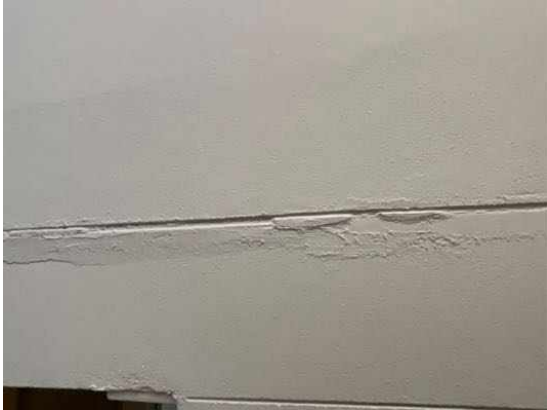
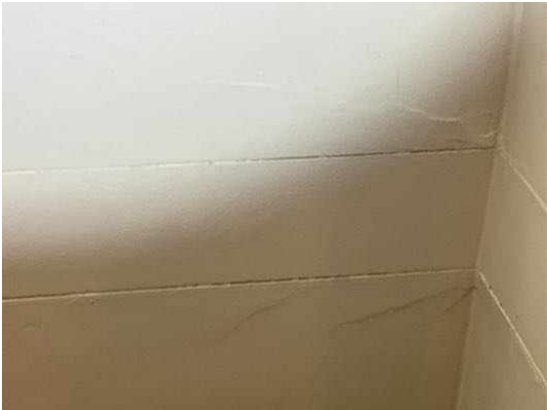
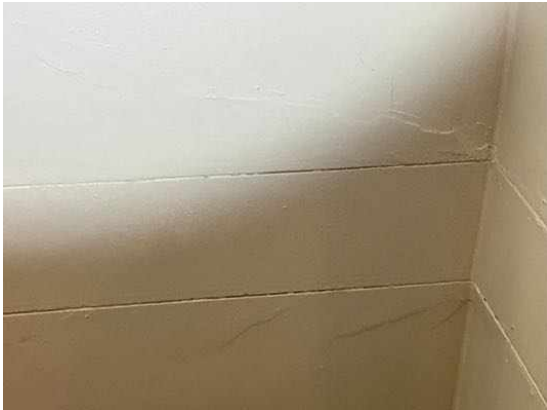
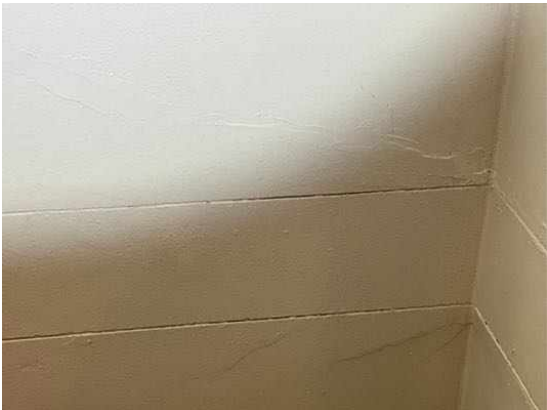
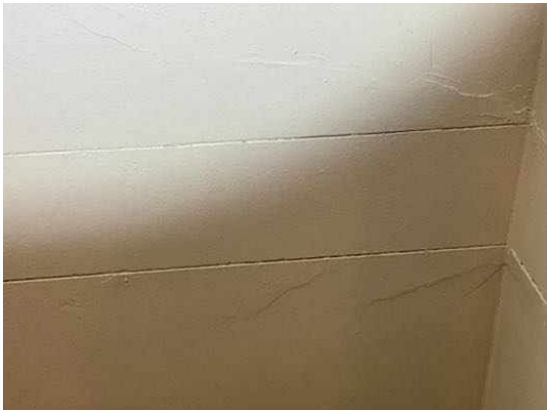
Finding 3.08

Building: Main Building
 Location: Stairs - Internal
 Finding: Poor workmanship
 Information: The structure exhibits signs of poor workmanship, evident in various aspects of construction and finishing.

Risk: Poor workmanship poses a range of risks, including compromised structural integrity, potential safety hazards, and a decreased lifespan of the structure. It may also lead to aesthetic and functional issues.

Resolution: A qualified contractor or construction professional should be consulted to assess and address the poor workmanship. They can implement corrective measures to ensure structural soundness, safety, and overall quality of the construction.

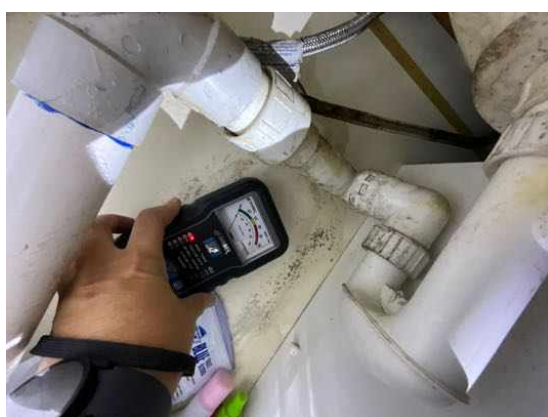
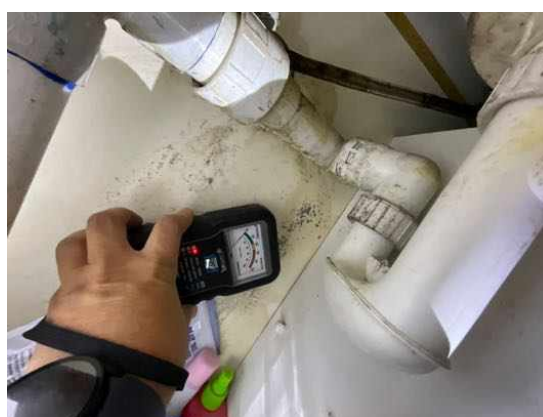
Building: Main Building
 Location: Bathroom upstairs
 Finding: Water damage / Vanity
 Information: "The vanity in the shower area has sustained water damage, resulting in swelling and discoloration of the wood, as well as potential structural issues. This damage compromises both the aesthetic and functional aspects of the vanity."

1. ****Carpenter or Woodworker:**** They can assess and repair the damage to the vanity, potentially replacing any irreparable parts.
2. ****Plumber:**** If the water damage is due to plumbing issues, a plumber can fix leaks and ensure there are no further water-related problems.
3. ****General Contractor:**** If the damage is extensive and affects the surrounding area, a general contractor can coordinate the repair work, including both the vanity and any related structural or cosmetic repairs.

Make sure to obtain quotes from these professionals to determine the most cost-effective and efficient solution for your specific situation.

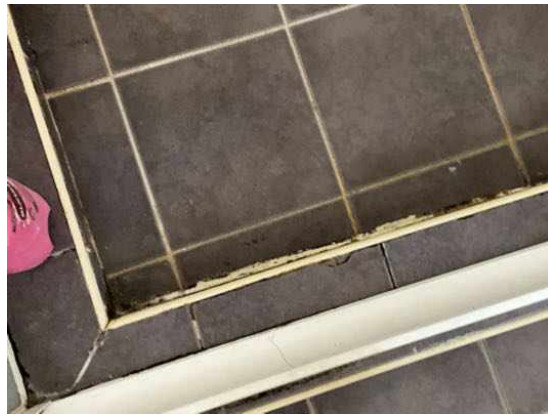
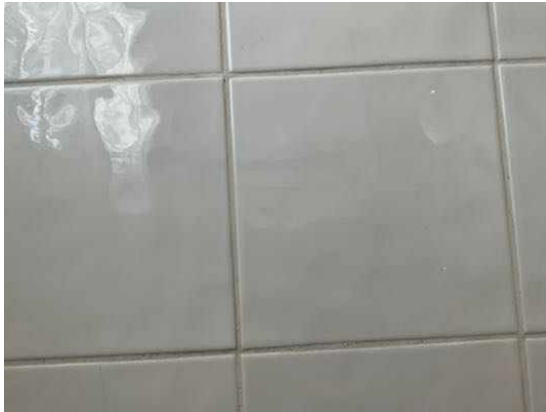
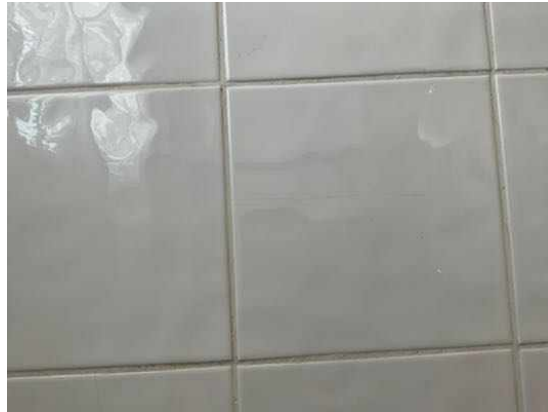
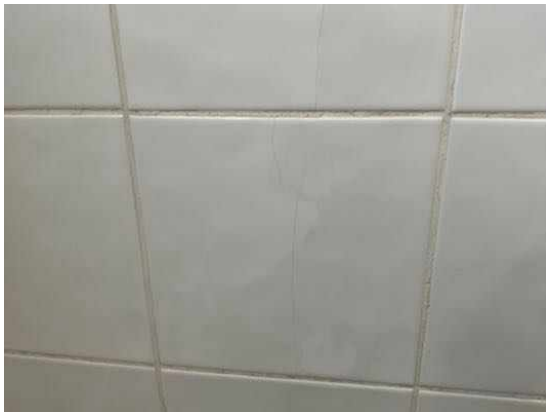
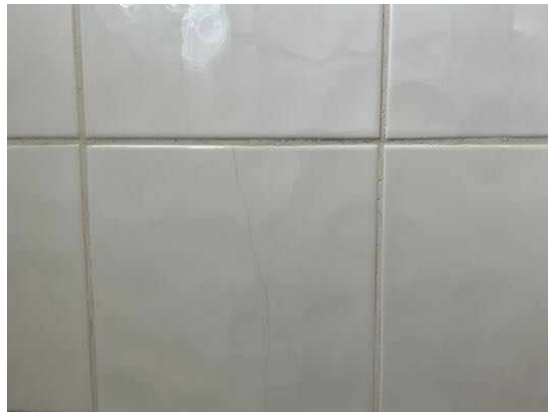
Finding 3.11

Building:	Main Building
Location:	Bathroom upstairs
Finding:	Tiles - Cracked or damaged
Information:	Cracking was evident to the tiling in this area at the time of inspection. While the cracking appears to be minor, this area is frequently exposed to water, allowing potential for water penetration into adjoining sections of walls or flooring.

If left unmanaged, water penetration to these areas may lead to subsequent water damage, which is likely necessitate repair work to affected building elements.

A tiling contractor should be appointed to ensure that no further water damage occurs. The re-application of silicone and grouting throughout remaining tile work is also advised, to further protect the area against water penetration.

Where water penetration has led to water damage, appointment of a relevant tradesperson may be required to repair damaged building elements.

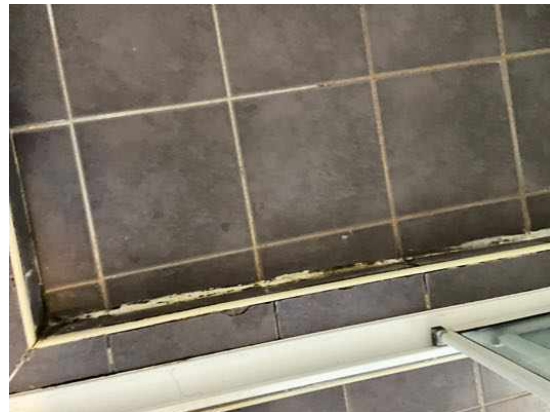
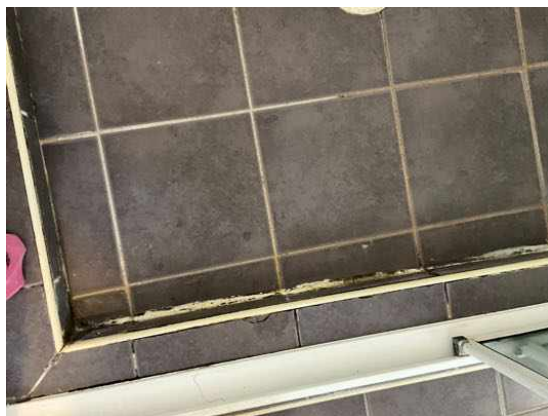
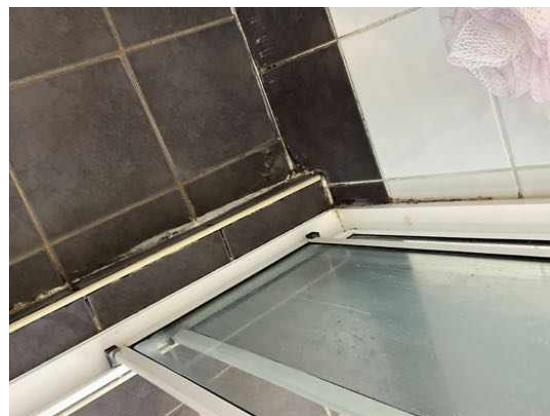
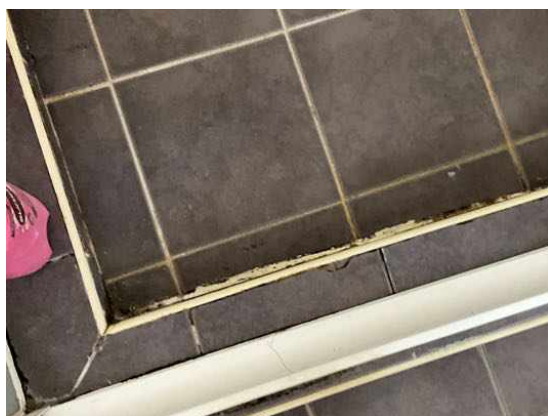
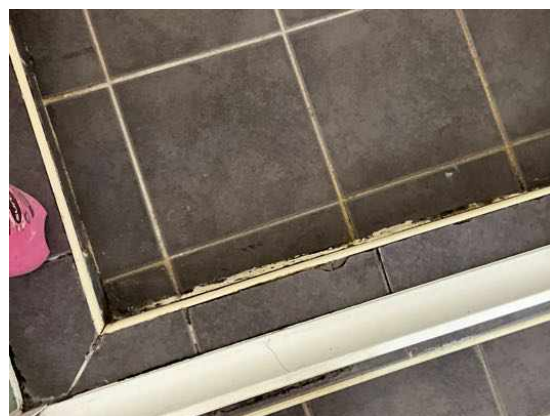
Finding 3.12

Building:	Main Building
Location:	Bathroom upstairs
Finding:	Sealant and grouting - Missing or damaged
Information:	It was noted on inspection that sealant or grout is degraded to the tiled shower alcove and or other areas of the bathroom.

Different materials and floor areas move at different rates, generally causing cracking to grout or sealant at this point. A flexible sealant is required to allow for expected expansion and contraction, while keeping the joint water tight and protective of all associated building materials.

There appears to be excessive mould to the sealant and grout which will likely require scraping out and replacement.

Flexible and mould resistant materials should be applied to affected areas to prevent any subsequent water damage that is likely to occur. Regular maintenance and replacement of damage or missing or damaged sealant and grout is highly recommended to the wet areas, as this is a regular wear and tear defect. Sealant and grouting in areas that come into regular contact with water should be maintained for the long term care of your property.

A sealant specialist or tiling contractor should be appointed to complete these works as soon as possible

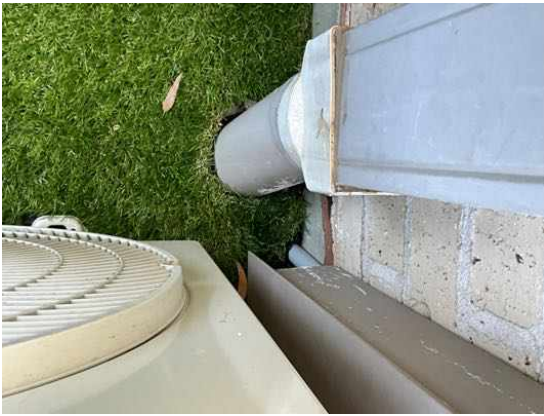
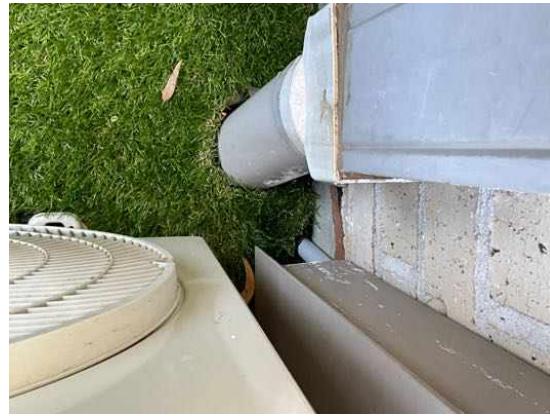
Finding: Aircon - Excessive moisture conducive condition near Air-conditioner
Information: Excessive moisture near an air conditioner can indeed create conducive conditions for termites. Termites are attracted to damp and decaying wood, which can be found in areas with high moisture levels. To fix this issue:

1. Fix Leaks: Check for any leaks or condensation around your air conditioning unit. Repair any damaged pipes, drains, or insulation

2. Proper Drainage: Ensure that your air conditioner has proper drainage. Make sure the condensate drain line is clear and directed

3. Ventilation: Improve ventilation around the unit. Ensure that the area is well-ventilated to reduce humidity levels.

4. Regular Maintenance: Schedule regular maintenance for your air conditioning system. This can help prevent leaks and ensure

5. Please consult a HVAC Technician: HVAC (Heating, Ventilation, and Air Conditioning) technicians are trained to diagnose and

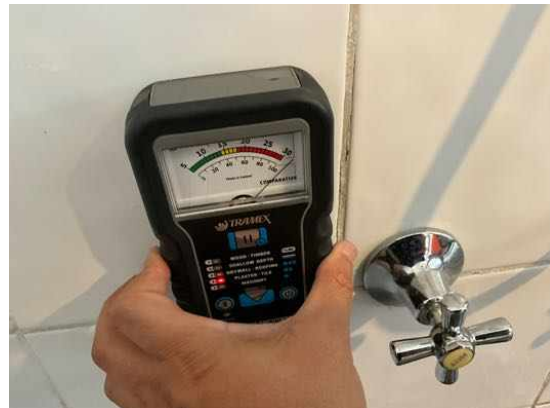
Finding 6.03

Building:	Main Building
Location:	Bathroom upstairs
Finding:	Excessive moisture - Conducive to Timber pest
Information:	Excessive moisture can attract termites and produce conditions that promote fungal growth and wood decay.

Excessive moisture is generally caused by deteriorated inadequate or missing roof drainage leaking plumbing pipes or fixtures poorly plumbed HWS overflows or condenser units and poor site drainage.

Prior to any remedial works being performed a qualified plumber should be appointed to further inspect the property and to identify the cause of the excessive moisture. Works to remove affected building elements may then be necessary and should be performed by an appropriate tradesperson.
